ASBESTOS SURVEY REPORT FOR MONKWEARMOUTH ACADEMY CARETAKERS HOUSE 1, SUNDERLAND

*Control of Asbestos
Regulations 2012*

**MONKWEARMOUTH CARETAKERS HOUSE 1,
SUNDERLAND**

Premises Manager / Samo: - Tenant Date: 03 June 2024

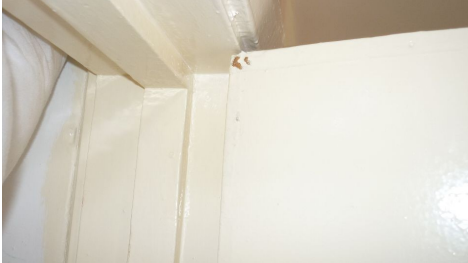
Item 1 Ref: ME1446/10

The debris to the inside of the door in the cupboard to the landing (Rm 1/05) does not contain asbestos.

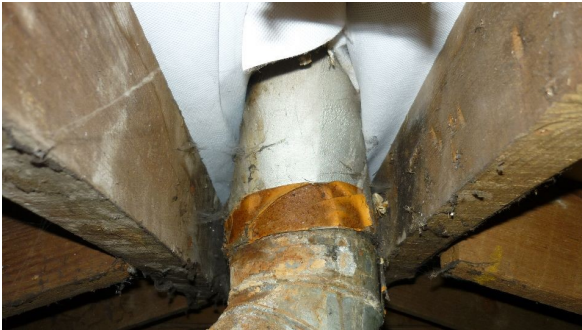
Item 2 - Ref:ME1445/10

The coating to the elbow of the flue pipe in the loft space (Area L1/03) contains asbestos.

Any change in its appearance should be recorded and passed to Property Services.

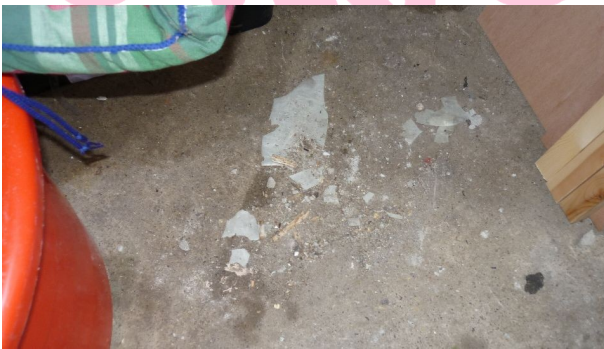
Item 3 - Ref: ME1447/10

The debris to the floor in the garage (Rm E/2) does not contain asbestos.

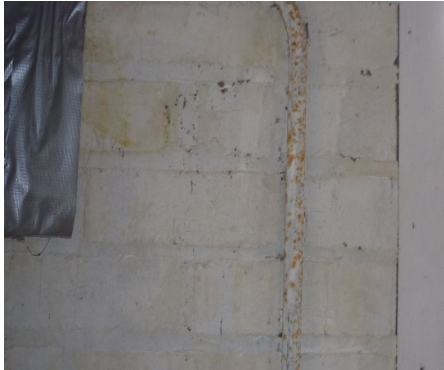
Item 4 - Ref: ME1449/10

The debris to the wall in the garage (Rm E/2) does not contain asbestos.

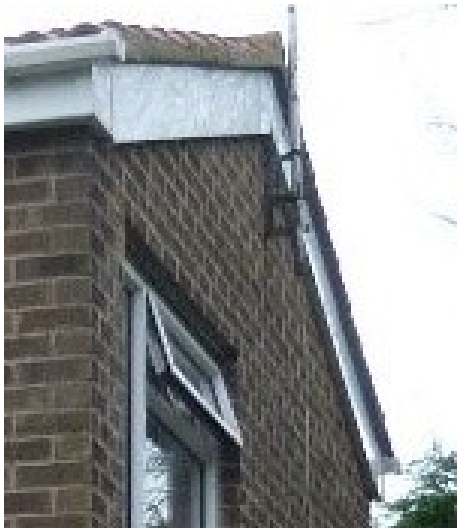
Item 5 - Ref: Presumed

The under cloaking to the external of the building (E/1) is presumed to contain asbestos.

Any change in its appearance should be recorded and passed to Property Services.

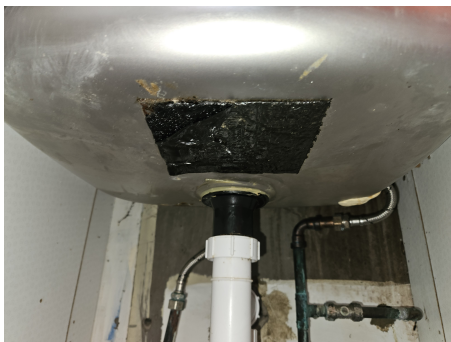
Item 6 Ref: 240524BW-101

The sink pad (Rm 4 Kitchen) does not contain asbestos.

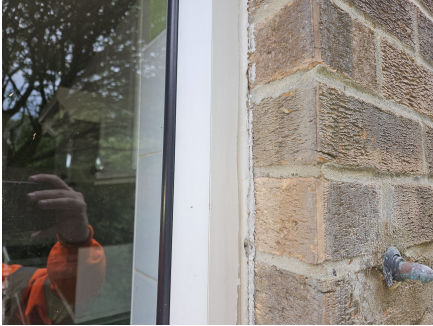
Item 7 Ref: 240524BW-103

The mastic remnants to windows (Externals) contains asbestos.

Any change in its appearance should be recorded and passed to Property Services.
