ASBESTOS SURVEY REPORT FOR FORESHORE OFFICE, MARINE WALK, ROKER SUNDERLAND.

### **Asbestos Register for Foreshore Office, Marine Walk, Roker, Sunderland**

**Date: 06 October 2023**

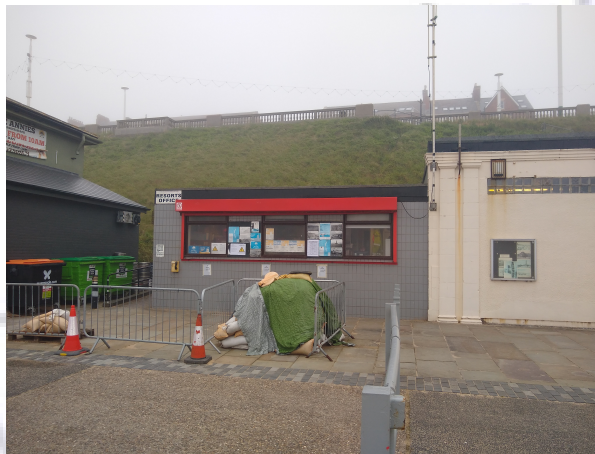
## **Plan of Building and Samples Location**

- (Item 1) Ref: 416779-1 – Sink pad (0/006 Kitchen) – Very Low Risk
- (Item 2) Ref: 416779-2 – Floor covering (0/006 Kitchen) – Very Low Risk
- (Item 3) Ref: 416779-3 – Remnant floor tile adhesive (0/007 Men's wash room) – Very Low Risk
- (Item 4) Ref: As 416779-3 - Remnant floor tile adhesive (0/008 Men's WC) – Very Low Risk
- (Item 5) Ref: As 416779-3 - Remnant floor tile adhesive (0/009 Ladies WC) – Very Low Risk
- (Item 6) Ref: 416779-4 – Sealant to rear flue collars (External) – No Risk

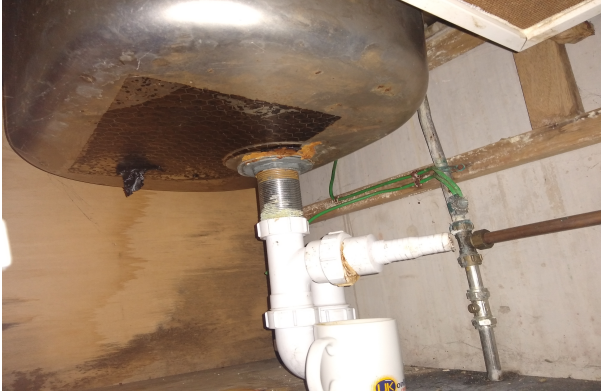
### **Item 1 Ref: 416779-1**

The sink pad in the kitchen (Rm 0/006) does contains asbestos.

Any change in its appearance should be recorded and passed to Property Services.

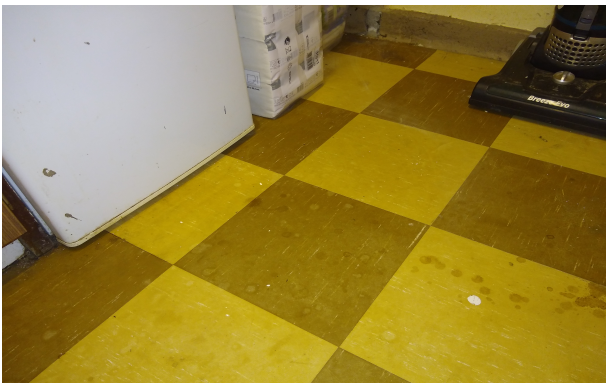
### **Item 2 Ref: 416779-2**

The floor covering in the kitchen (Rm 0/006) does contains asbestos.

Any change in its appearance should be recorded and passed to Property Services.

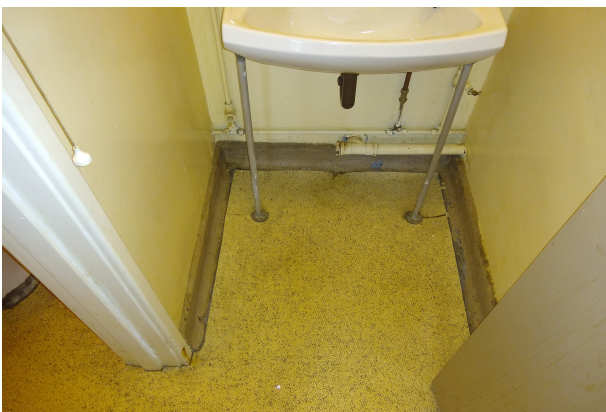
### **Item 3 Ref: 416779-3**

The remnant floor tile adhesive in the men's washroom (Rm 0/007) does contains asbestos.

Any change in its appearance should be recorded and passed to Property Services.

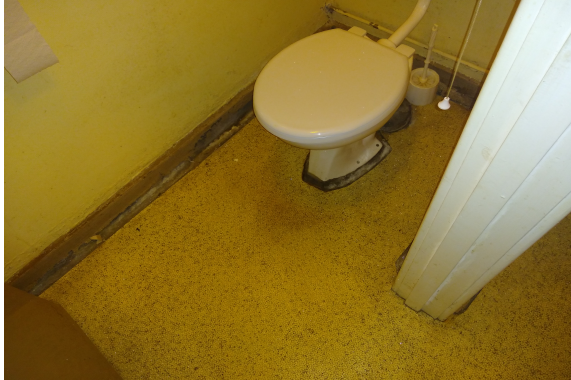
**Item 4 Ref: As 416779-3**

The remnant floor tile adhesive in the men's WC (Rm 0/008) does contain asbestos.

Any change in its appearance should be recorded and passed to Property Services.

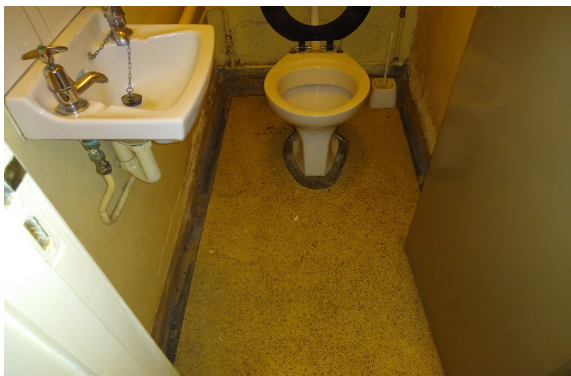
**Item 5 Ref: As 416779-3**

The remnant floor tile adhesive in the ladies' WC (Rm 0/009) does contain asbestos.

Any change in its appearance should be recorded and passed to Property Services.

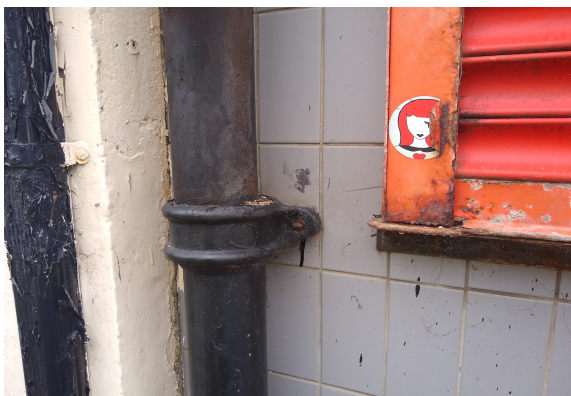
**Item 6 Ref: 416779-4**

The sealant to the flue collars (External) does not contain asbestos.
