### **ASBESTOS SURVEY REPORT FOR ROKER VOLUNTEER LIFE BRIGADE WATCH HOUSE, PIER VIEW, ROKER, SUNDERLAND**

**ROKER VOLUNTEER LIFE BRIGADE WATCH HOUSE,  
PIER VIEW, ROKER, SUNDERLAND**

**Date: 17 November 2022**

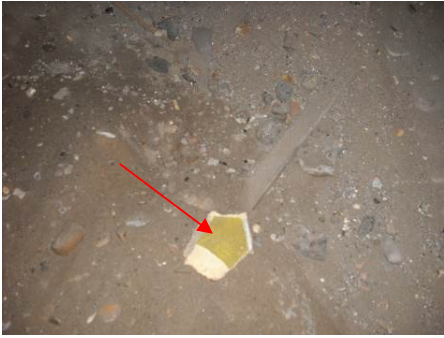
### **Item 1 Ref: JJ2336/08**

The debris next to the entrance (fibre board) in the duct (B1/2) does not contain asbestos.

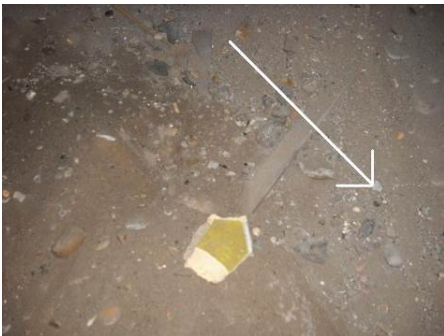
### **Item 2 - Ref: JJ2337/08**

The debris to the entrance of the duct (B1/2) does not contain asbestos.

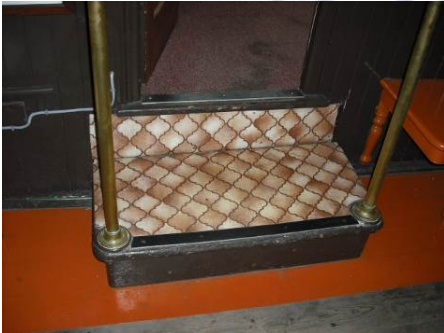
### **Item 3 - Ref: JJ2333/08**

The floor covering to the large lifeboat display area (Rm 0/1) does not contain asbestos.

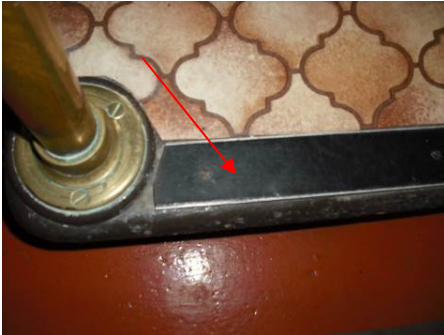
**Item 4 - Ref: JJ2334/08**

The nosing to the stairs in the large lifeboat display area (Rm 0/1) does not contain asbestos.
