ASBESTOS SURVEY REPORT FOR BARNES PARK, SUNDERLAND SR4 7PY

*Control of Asbestos
Regulations 2012*

Asbestos Register for

Barnes Park, Sunderland, SR4 7PY

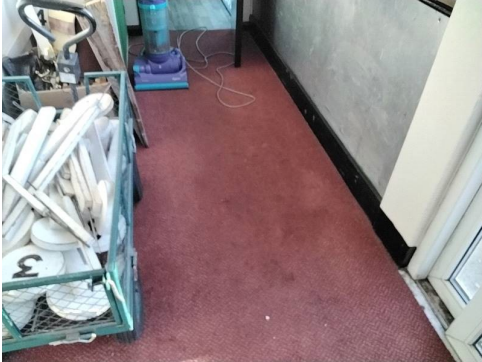
Item 1 Ref: KX000456/001

The Floor - Tile (Under floor covering) - beige, painted green in Bowling Pavilion G/001 - Entrance Hall/Foyer/Lobby does not contain asbestos.

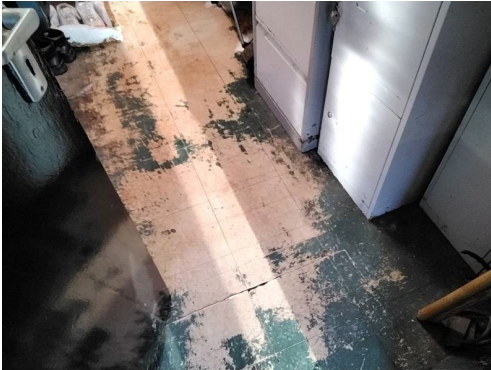
Item 2 Ref: As KX000456

The Floor - Tile (Under floor covering) - beige, painted green in Bowling Pavilion G/006 – Staffroom does not contain asbestos.

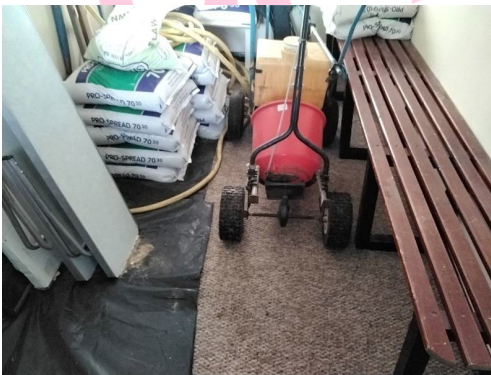
Item 3 Ref: KX000458/003

The Floor - Tile (Under floor covering) - Red in Bowling Pavilion G/007 – Staff Room/Storeroom does not contain asbestos.

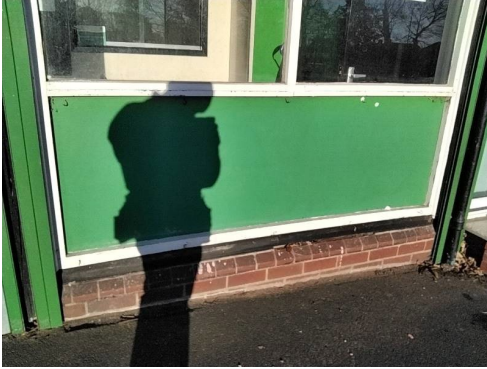
Item 4 Ref: KX000459/004

The Window - Infill Panel in Bowling Pavilion E/001 – External does not contain asbestos.

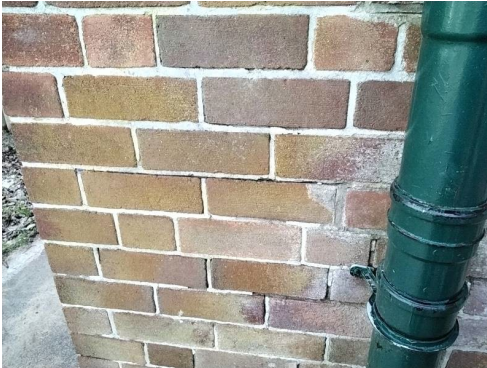
Item 5 Ref: KX000461/007

The Damp Proof Course in Bowling Pavilion E/001 – External does not contain asbestos.

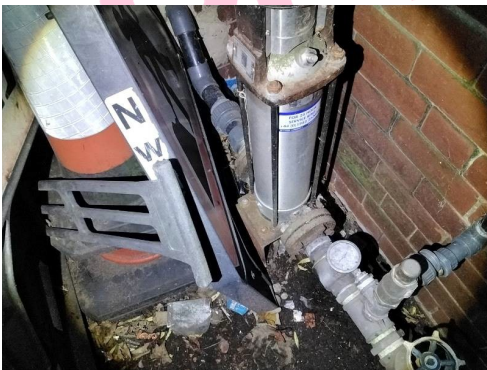
Item 6 Ref: Presumed

6.	Presumed	Pipework Gasket	Bowling Pavilion E/001 – External	Very Low Risk
7.	KX000460/006	Door - frame sealant to wall	Bowling Pavilion E/002 – External	No Risk

The Pipework Gasket in Rm Bowling Pavilion E/001 – External is presumed to contain asbestos.

Any change in its appearance should be recorded and passed to Property Services.

5.	Damp Proof Course	Bowling Pavilion E/001 – External	No Risk	N/A	N/A	N/A	N/A	N/A
6.	Pipework Gasket	Bowling Pavilion E/001 – External	12 Monthly	18/01/2027

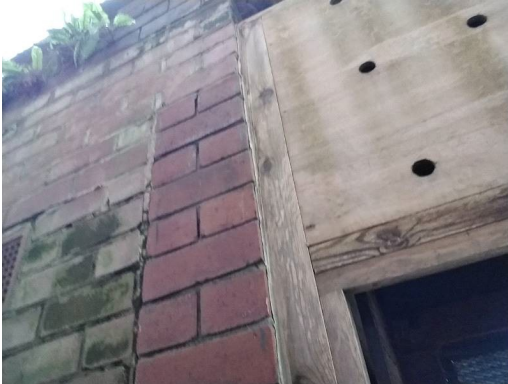
Item 7 Ref: KX000460/006

The Door - frame sealant to wall in Bowling Pavilion E/002 – External does not contain asbestos.

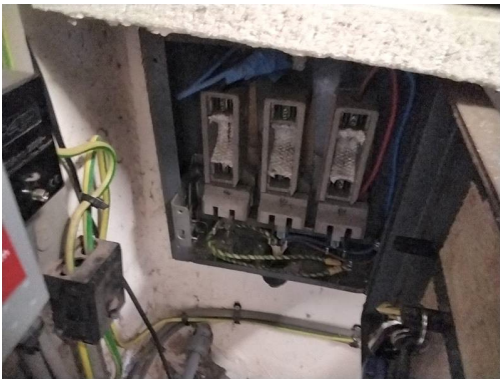
Item 8 Ref: KX000464/014

8.	KX000464/014	Electrical Services - Fuses/Flashguards	Barnes West End Men's Pavilion G/006 - Staffroom	Low Risk
9.	KX000465/015	Under Sink Mat - to old sink discarded in loft	Pavilion – Roof Void R/001 Loft Space	No Risk

The Electrical Services - Fuses/Flashguards in Barnes West End Men's Pavilion G/006 - Staffroom contains asbestos.

Any change in its appearance should be recorded and passed to Property Services.

7.	Door - frame sealant to wall	Bowling Pavilion E/002 – External	No Risk	N/A	N/A	N/A	N/A	N/A
8.	Electrical Services - Fuses/Flashguards	Barnes West End Men's Pavilion G/006 - Staffroom	6 Monthly	18/01/2027

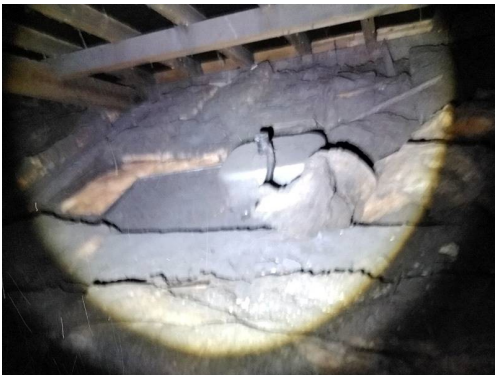
Item 9 Ref: KX000465/015

The Under Sink Mat - to old sink discarded in loft in Pavilion – Roof Void R/001 Loft Space does not contain asbestos.

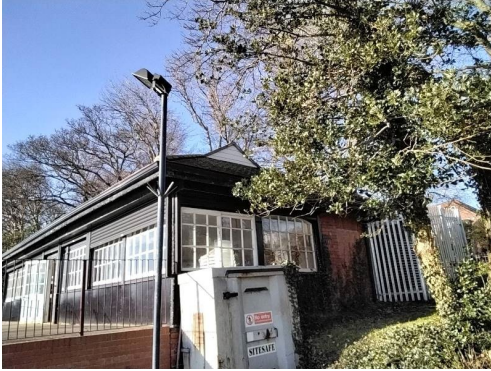
Item 10 Ref: As KX000466

The Undercloak - to peak in Barnes West End Men's Pavilion – External E/001 does not contain asbestos.

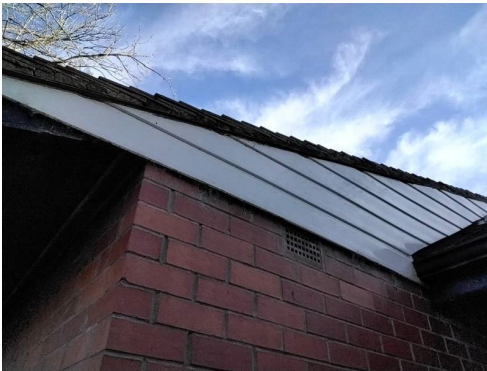
Item 11 Ref: KX000466/017

The Undercloak - to toilet block in Barnes West End Men's Pavilion – External E/001 does not contain asbestos.
