ASBESTOS SURVEY REPORT FOR PROMENADE SHELTER - LITTLE ITALY SEAFRONT SUNDERLAND

Promenade Shelter, Little Italy Restaurant Establishment - Last updated 24/11/2022 -
Version 2

**Asbestos Register for
Little Italy – Promenade Shelter**

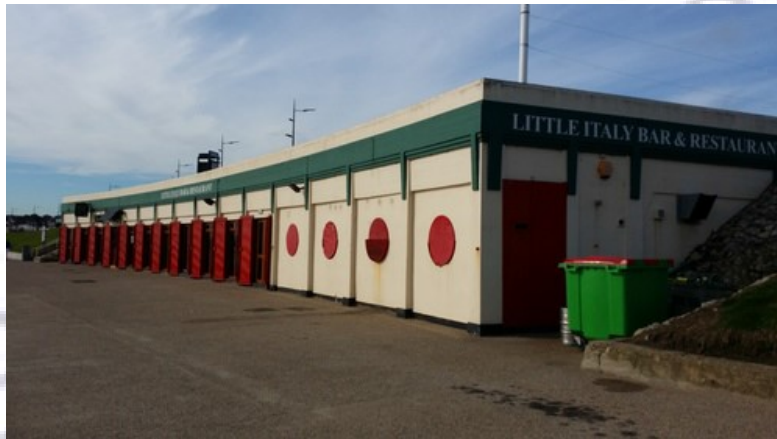
Plan of Building and Samples Location

93425 - 1 – Sink pad (Room 0/07) (Item 1) - No Risk

Hatch – (Room 0/09) No access

93425-2 – Roof covering (External) (Item 2) - No Risk

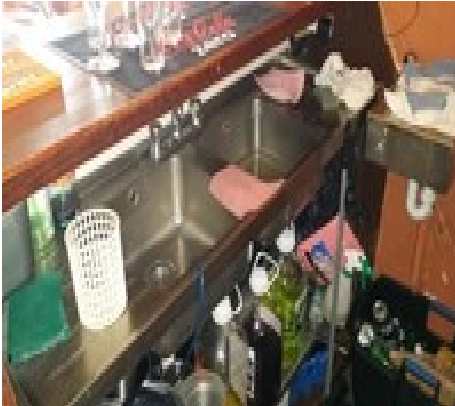
Item 1 Ref: 93425 - 1

The sink pad to the seating area (Room 0/07) does not contain asbestos.

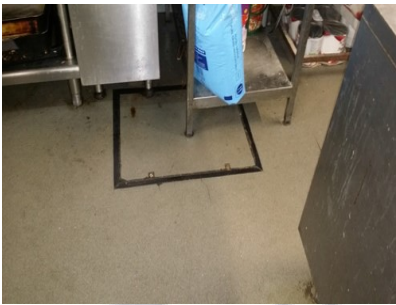
There was no access to the hatch in the kitchen (Room 0/09).

Prior to any access or remedial works, further inspections should be carried out.

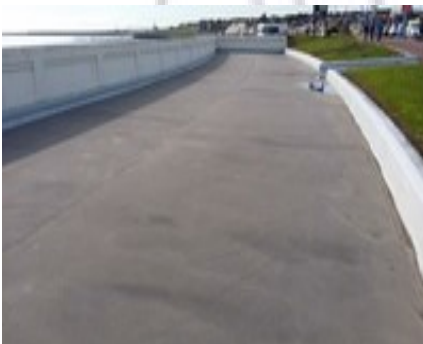
Item 2 Ref: 93425-2

The roof covering to the external does not contain asbestos.
