ASBESTOS SURVEY REPORT FOR NO 3 MACHINERY HOUSE, EAST SIDE PORT OF SUNDERLAND

Asbestos Register for

**NO 3 MACHINERY HOUSE, EAST SIDE,
PORT OF SUNDERLAND**

Date: 31st July 2023

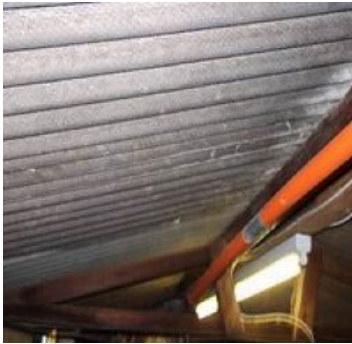
Item 1 Ref: VP002087

VP002087 – Cement Roof (Room 1) (Item 1) Very Low Risk

The cement roof to the inside of the machinery house (Room 1) contains asbestos.

Any change in its appearance should be recorded and passed to Property Services.

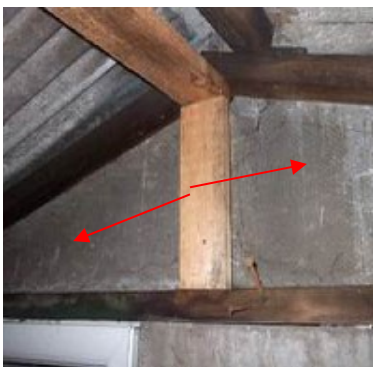
Item 2 - Ref: VP002088

VP002088 – Cement Bulk heads (Room 1) (Item 2) Very Low Risk

The cement bulkheads to the machinery house (Room 1) contain asbestos.

Any change in its appearance should be recorded and passed to Property Services.

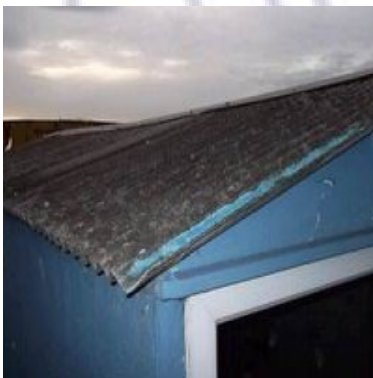
Item 3 - As VP002087

As VP002087 - Cement Roof (External) (Item 3) Very Low Risk

The cement roof to the external of the building contains asbestos.

Any change in its appearance should be recorded and passed to Property Services.

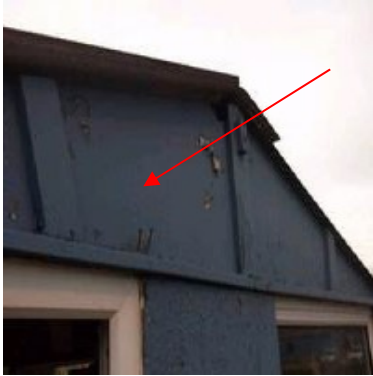
Item 4 - As VP002088

As VP002088 – Cement Bulkheads (External) (Item 4) Very Low Risk

The cement bulkheads to the exterior of the machinery house contain asbestos.

Any change in its appearance should be recorded and passed to Property Services.
