ASBESTOS SURVEY REPORT FOR ATHENAEUM BUILDINGS, 27 FAWCETT STREET, SUNDERLAND, SR1 1RE

Atheneum Buildings, 27 Fawcett Street, Sunderland

Date: 20 November 2024

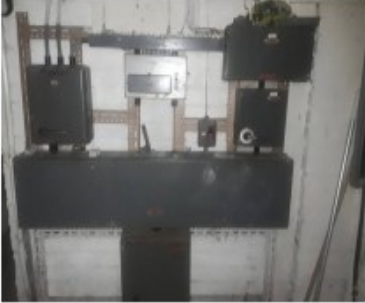
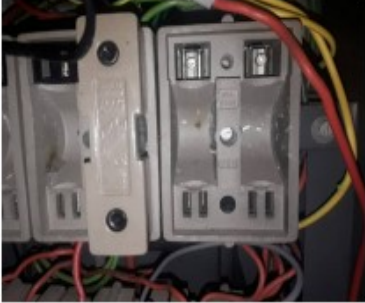
| 1 | NZ001746 | <i>Electrical services – fuses/flashguards including remnants from removed fuses within all fuse boxes in basement area</i> | <i>Switch Room within basement area (Z1/001)</i> | <i>Removed November 2024</i> |

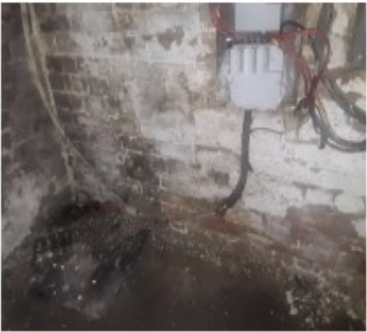
| 2 | Presumed | Electrical services – cable braiding/insulation to main feed should not affect the scope of works | Switch Room within basement area (Z1/001) | Very Low Risk 12 monthly |
