Technical Note

Project title	IAMP	Job number	[REDACTED]
cc	[REDACTED]	File reference	[REDACTED]
Prepared by	[REDACTED] (Tweed Ecology)	Date	18 March 2016
Subject	IAMP: [REDACTED]

Tweed Ecology was commissioned by Arup to undertake a [REDACTED] carrying the River Don under the A19 at Downhill Lane, West Boldon, South Tyneside on 18 March 2016. Prior to undertaking the culvert inspection, confined spaces training was held with Mine Rescue Services (MRS) Training and Rescue at their offices at Houghton-le-Spring. The aim of the survey [REDACTED] of the culvert, and to advise on further surveys that may need to be undertaken.

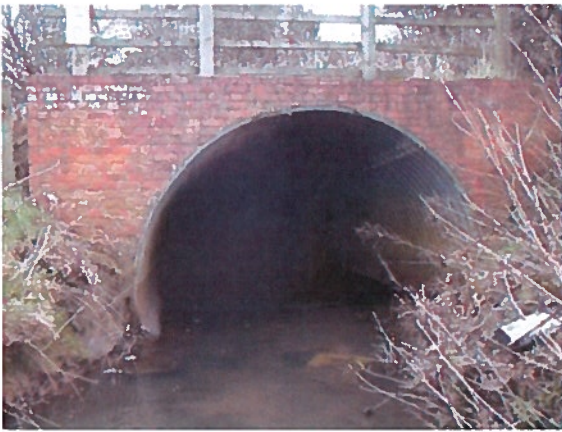
Photo 1. South-east culvert portal

wide and is lined for approximately 95% of its length with corrugated iron with a waterproof coating. At the south-western (upstream) end of the culvert, the portal is brick-lined (**Photo 1**) while at the north-eastern (downstream) end, no portal has been built around the corrugated iron (**Photo 2**).

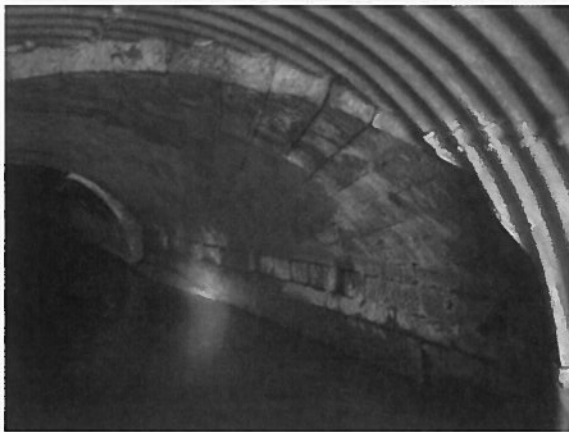
Photo 3. Sandstone underbridge section

The 7m section of sandstone-lined bridge barrel (**Photo 3**) towards the south-western end of the culvert is assessed as having 'Moderate' BRP on account of multiple cavities between the sandstone blocks extending to >30cm depth, and which are sufficiently wide [REDACTED] There is also continuous cavity between the sandstone bridge barrel and the newer corrugated iron culvert on the upstream side, which also offers BRP.

Hibernaculum checks (between November and February) can be restricted to the sandstone underbridge section towards the south-western end of the culvert.

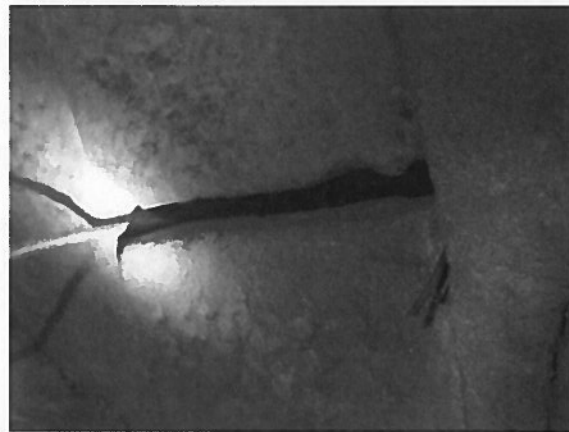
Photo 4. Typical cavity with endoscope inserted
