### **ASBESTOS SURVEY REPORT FOR PLAINS FARM ACADEMY, SUNDERLAND**

## **Asbestos Register for PLAINS FARM ACADEMY**

**Date: 27 January 2022**

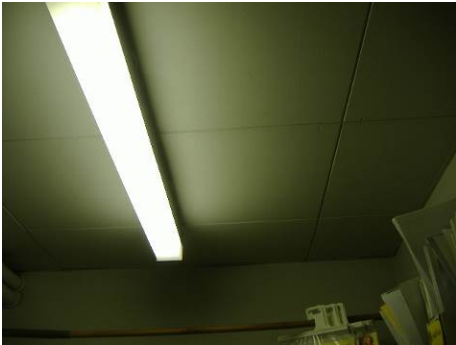
### **Item 5 - Ref: Presumed**

The ceiling tiles to the store room (Rm 0/04) are presumed to contain asbestos.

Any change in its appearance should be recorded, and passed to Property Services.

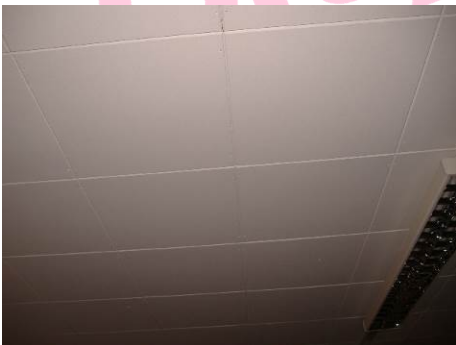
### **Item 6 - Ref: Presumed**

The ceiling tiles to the year 5 classroom (Rm 0/05) are presumed to contain asbestos.

Any change in its appearance should be recorded, and passed to Property Services.

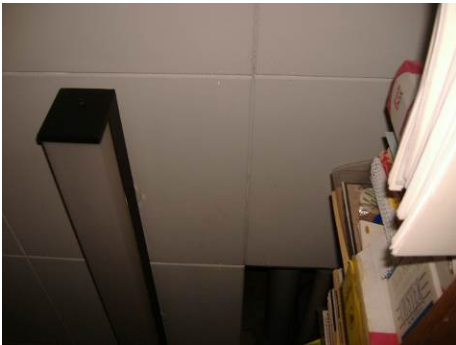
### **Item 8 - Ref: Presumed**

The ceiling tiles to the store room (Rm 0/07) are presumed to contain asbestos.

Any change in its appearance should be recorded, and passed to Property Services.

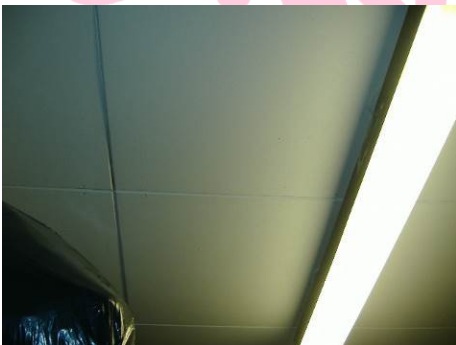
### **Item 10 - Ref: Presumed**

The ceiling tiles to the store room (Rm 0/08) are presumed to contain asbestos.

Any change in its appearance should be recorded, and passed to Property Services.

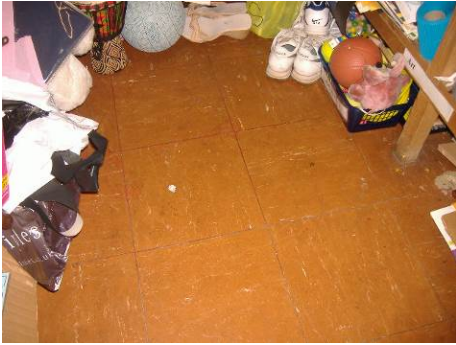
### **Various Ref: AW0428/08**

The orange floor tiles to the store room (Rm 0/08) do not contain asbestos (Item 11).

Similar flooring is located in room 0/07 (Item 9).

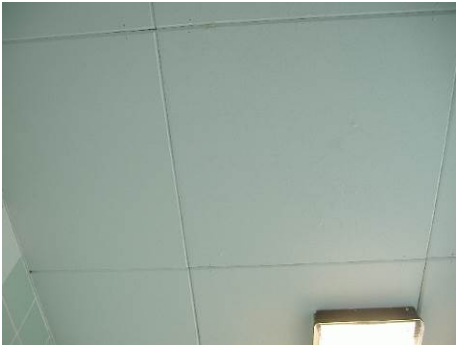
### **Item 12 - Ref: Presumed**

The ceiling tiles to the male toilets (Rm 0/09) are presumed to contain asbestos.

Any change in its appearance should be recorded, and passed to Property Services.

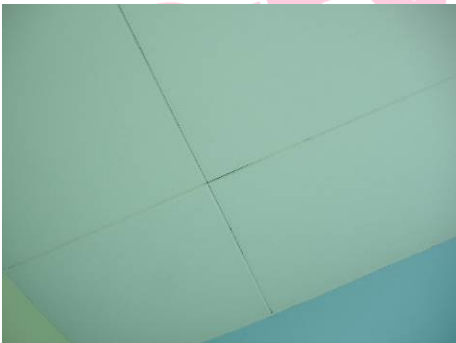
### **Item 13 - Ref: Presumed**

The ceiling tiles to the disabled toilet (Rm 0/10) are presumed to contain asbestos.

Any change in its appearance should be recorded, and passed to Property Services.

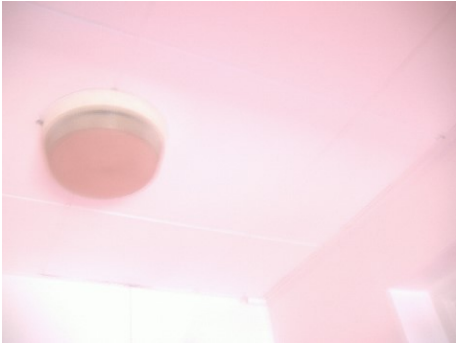
### **Item 14 Ref: AW0428/08**

The ceiling tiles to the lobby (Rm 0/11) are presumed to contain asbestos.

Any change in its appearance should be recorded, and passed to Property Services.

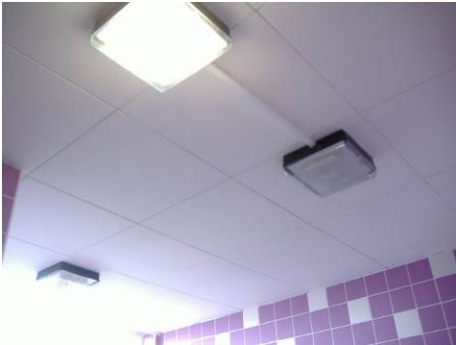
### **Item 15 - Ref: Presumed**

The ceiling tiles to the female toilets (Rm 0/12) are presumed to contain asbestos.

Any change in its appearance should be recorded, and passed to Property Services.

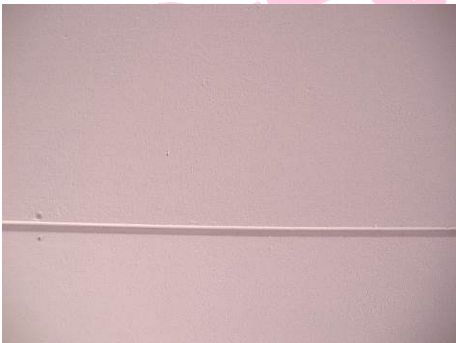
### **Item 16 - Ref: Presumed**

The ceiling tiles to the cleaners cupboard (Rm 0/13) are presumed to contain asbestos.

Any change in its appearance should be recorded, and passed to Property Services.

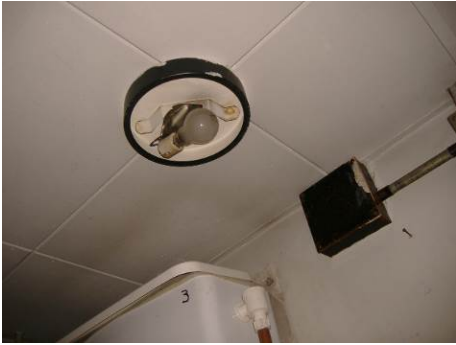
### **Item 17 Ref: Presumed**

The ceiling tiles to the store room (Rm 0/14) are presumed to contain asbestos.

Any change in its appearance should be recorded, and passed to Property Services.

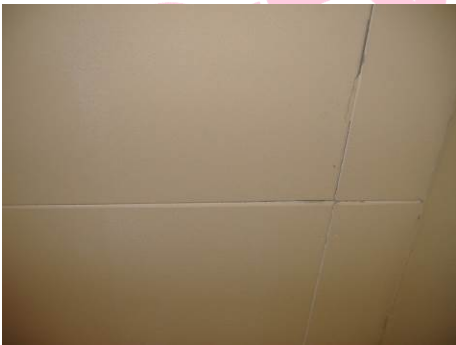
### **Item 19 - Ref: Presumed**

The ceiling tiles to the cupboard store (Rm 0/16) are presumed to contain asbestos.

Any change in its appearance should be recorded, and passed to Property Services.

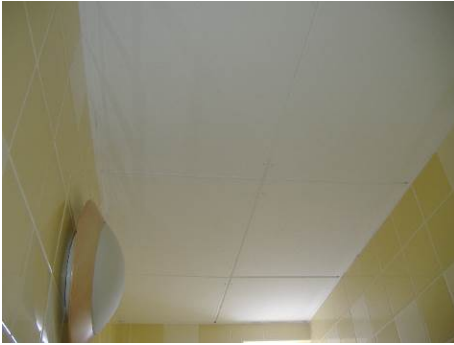
### **Item 20 Ref: Presumed**

The ceiling tiles to the staff toilets (Rm 0/17) are presumed to contain asbestos.

Any change in its appearance should be recorded, and passed to Property Services.

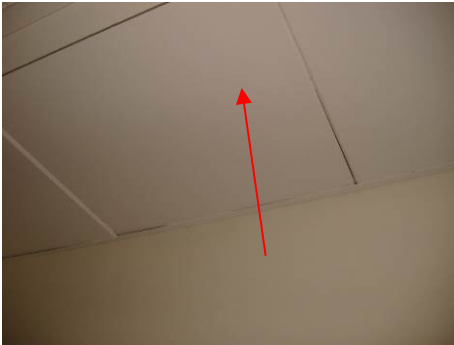
### **Item 21 - Ref: Presumed**

The ceiling tiles to the recess in the office (Rm 0/20) are presumed to contain asbestos.

Any change in its appearance should be recorded, and passed to Property Services.

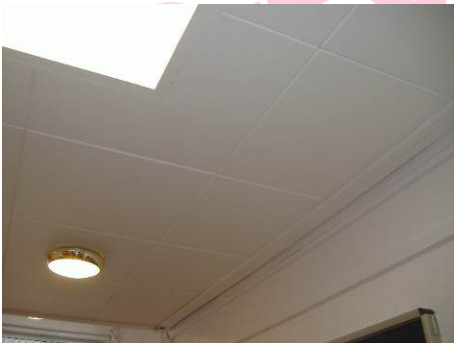
### **Item 22 - Ref: Presumed**

The ceiling tiles to the corridor (Rm 0/21) are presumed to contain asbestos.

Any change in its appearance should be recorded, and passed to Property Services.

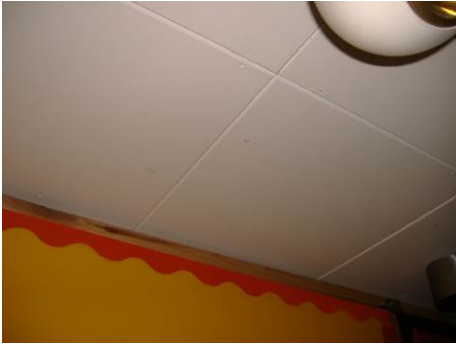
### **Item 23 Ref: Presumed**

The ceiling tiles above the stage area in the main hall (Rm 0/23) are presumed to contain asbestos.

Any change in its appearance should be recorded, and passed to Property Services.

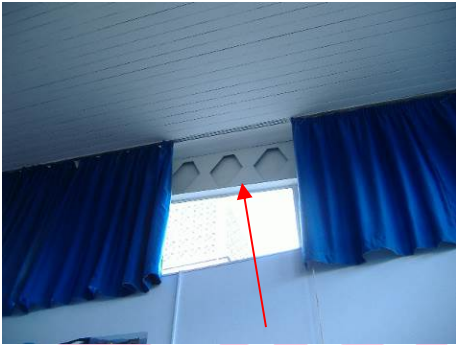
### **Item 24 - Ref: Presumed**

The wall panels at high level behind the girder in the main hall (Rm 0/23) are presumed to contain asbestos.

Any change in its appearance should be recorded, and passed to Property Services.

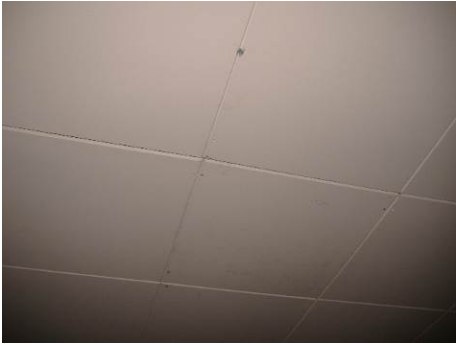
### **Item 26 Ref: Presumed**

The ceiling tiles to the female toilets (Rm 0/25) are presumed to contain asbestos.

Any change in its appearance should be recorded, and passed to Property Services.

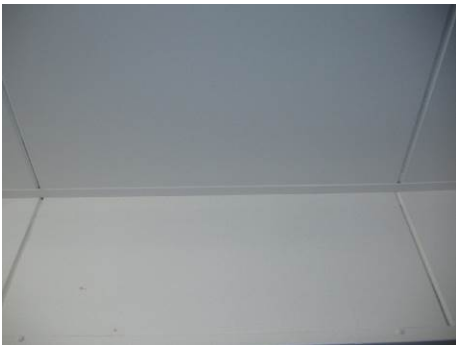
### **Item 27 - Ref: Presumed**

The ceiling tiles to the cleaners cupboard (Rm 0/26) are presumed to contain asbestos.

Any change in its appearance should be recorded, and passed to Property Services.

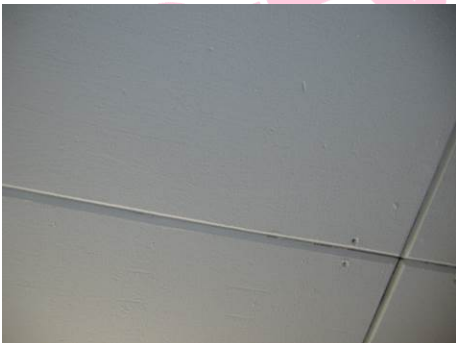
### **Item 28 - Ref: Presumed**

The ceiling tiles to the classroom (Rm 0/27) are presumed to contain asbestos.

Any change in its appearance should be recorded, and passed to Property Services.

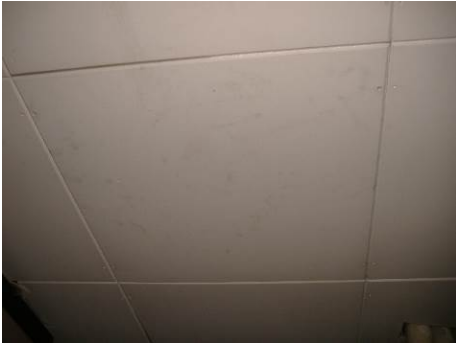
### **Item 29 Ref: Presumed**

The ceiling tiles to the electrical cupboard (Rm 0/28) are presumed to contain asbestos.

Any change in its appearance should be recorded, and passed to Property Services.

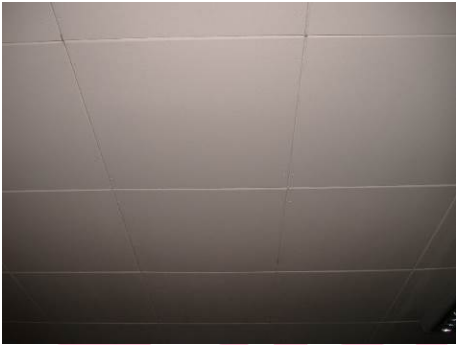
### **Item 30 - Ref: Presumed**

The ceiling tiles to the classroom (Rm 0/29) are presumed to contain asbestos.

Any change in its appearance should be recorded, and passed to Property Services.

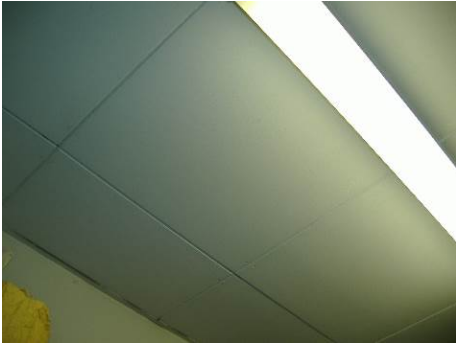
### **Item 32 Ref: AW0430/08**

The ceiling tiles to the store room (Rm 0/31) contain asbestos.

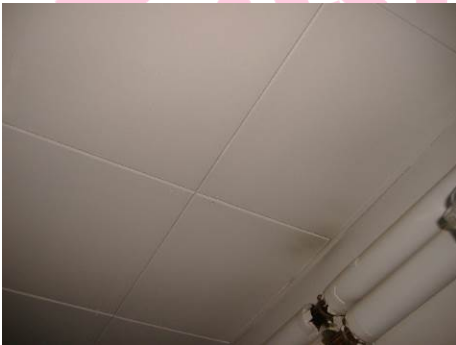
### **Item 34 - Ref: Presumed**

The ceiling tiles to the store room (Rm 0/32) are presumed to contain asbestos.

Any change in its appearance should be recorded, and passed to Property Services.

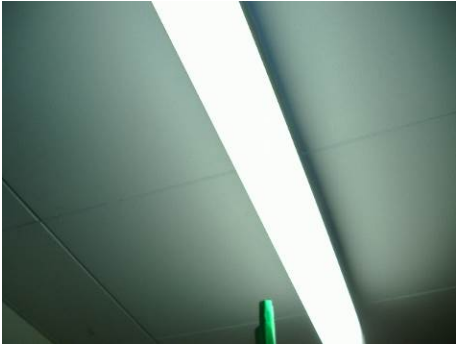
### **Item 35 - Ref: Presumed**

The ceiling tiles to the store room (Rm 0/33) are presumed to contain asbestos.

Any change in its appearance should be recorded, and passed to Property Services.

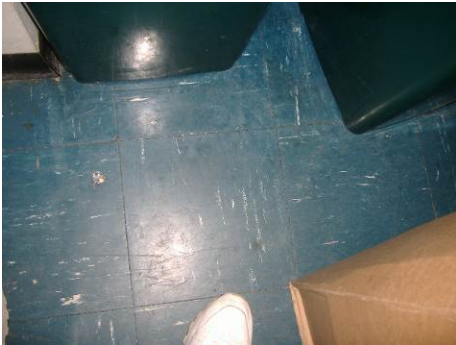
### **Various Ref: AW0431/08**

The blue floor tiles to the store room (Rm 0/33) contain asbestos (Item 36).

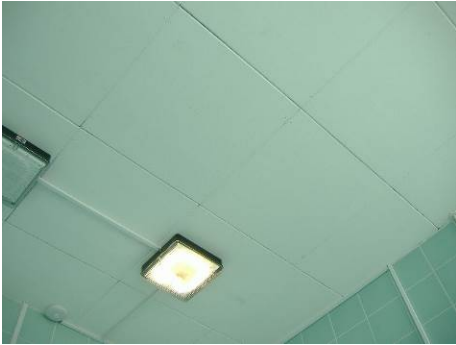
### **Item 38 - Ref: Presumed**

The ceiling tiles to the male toilets (Rm 0/35) are presumed to contain asbestos.

Any change in its appearance should be recorded, and passed to Property Services.

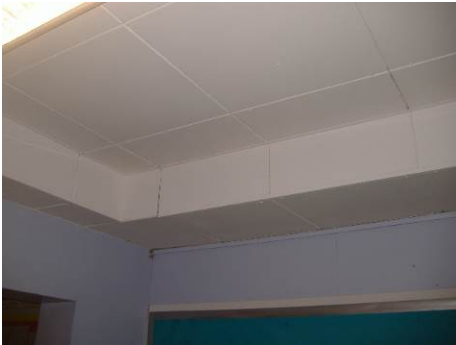
### **Item 39 Ref: Presumed**

The ceiling tiles to the classroom (Rm 0/36) were presumed to contain asbestos.

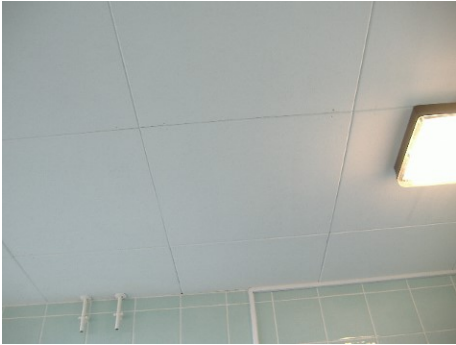
### **Item 42 - Ref: Presumed**

The ceiling tiles to the male toilets (Rm 0/38) were presumed to contain asbestos.

*These ceiling tiles were removed in August 2015.*

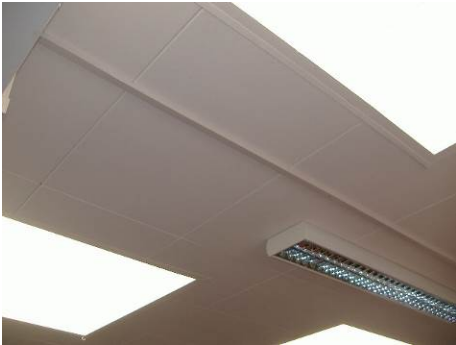
### **Item 43 Ref: Presumed**

The ceiling tiles to the classroom (Rm 0/39) were presumed to contain asbestos.

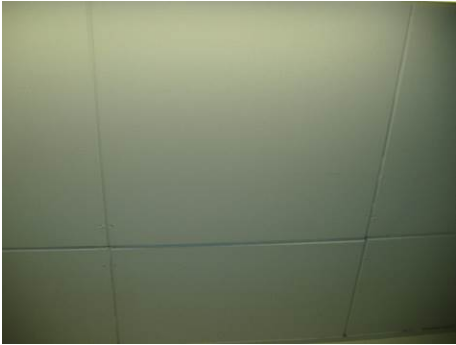
### **Item 45 - Ref: Presumed**

The ceiling tiles to the store room (Rm 0/41) were presumed to contain asbestos.

*These ceiling tiles were removed in August 2015.*

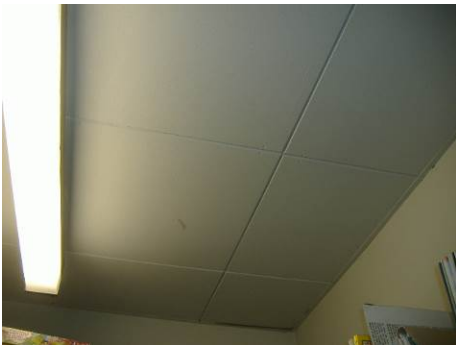
### **Item 46 Ref: Presumed**

The ceiling tiles to the store room (Rm 0/42) are presumed to contain asbestos.

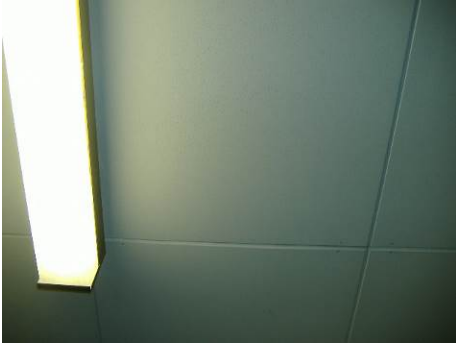
### **Item 48 - Ref: Presumed**

The ceiling tiles to the store room (Rm 0/44) were presumed to contain asbestos.

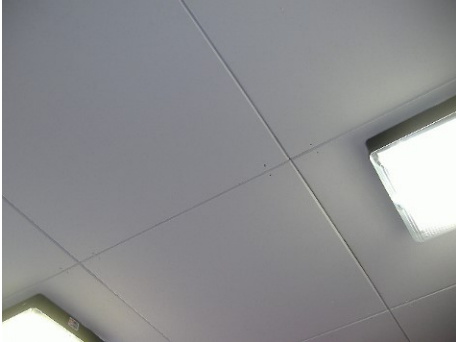
### **Item 51 - Ref: Presumed**

The ceiling tiles to the female toilets (Rm 0/47) were presumed to contain asbestos.

*These ceiling tiles were removed in August 2015.*

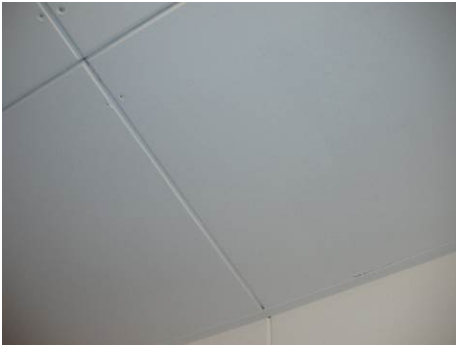
### **Item 52 - Ref: Presumed**

The ceiling tiles to the cleaners cupboard (Rm 0/48) were presumed to contain asbestos.

*These ceiling tiles were removed in August 2015.*

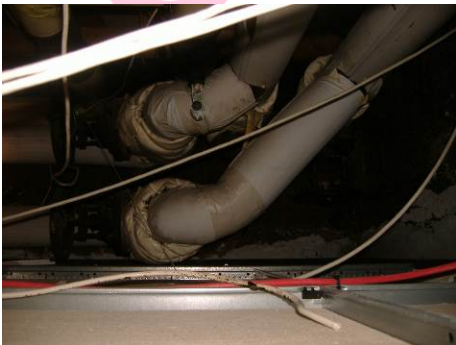
### **Item 53 - Ref: Presumed**

The pipework flange gaskets in the ceiling void of the corridor (Rm 0/49) are presumed to contain asbestos.

Any change in its appearance should be recorded, and passed to Property Services.

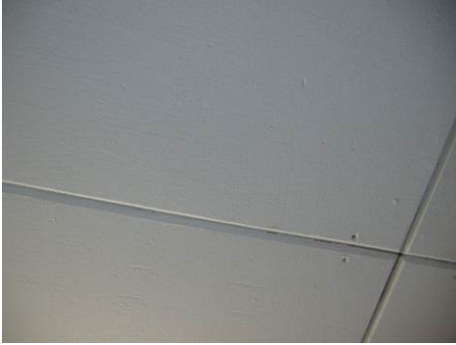
### **Item 54 - Ref: Presumed**

The ceiling tiles to the lobby (Rm 0/51) are presumed to contain asbestos.

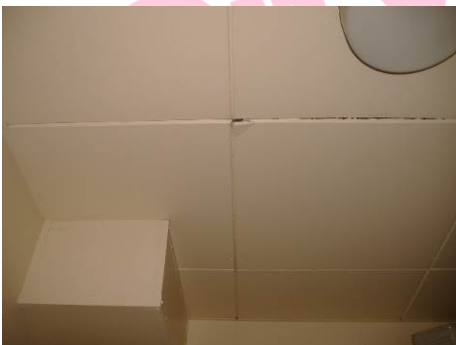
### **Item 56 - Ref: Presumed**

The ceiling tiles to the store room (Rm 0/67) contain asbestos.

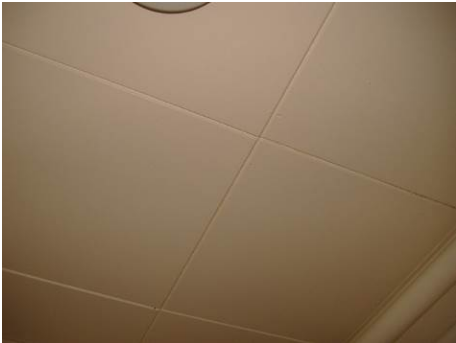
### **Item 58 - Ref: Presumed**

The ceiling tiles to the staff room (Rm 0/69) are presumed to contain asbestos.

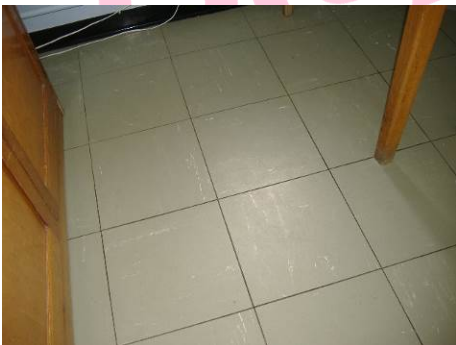
### **Item 59 - Ref: AW0433/08**

The green floor tiles to the staff room (Rm 0/69) contain asbestos.

Any change in its appearance should be recorded, and passed to Property Services.

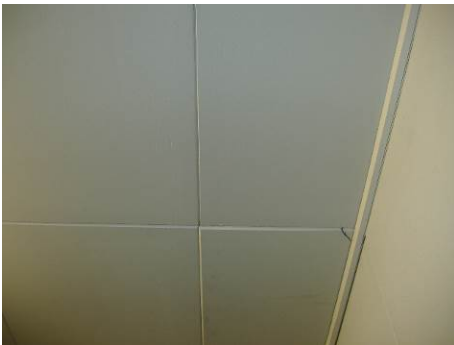
### **Item 61 - Ref: Presumed**

The ceiling tiles to the store room (Rm 0/72) are presumed to contain asbestos.

Any change in its appearance should be recorded, and passed to Property Services.

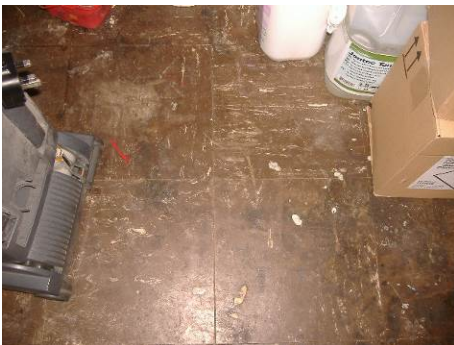
### **Item 62 - Ref: AW0434/08**

The brown floor tiles to the store room (Rm 0/73) do not contain asbestos.

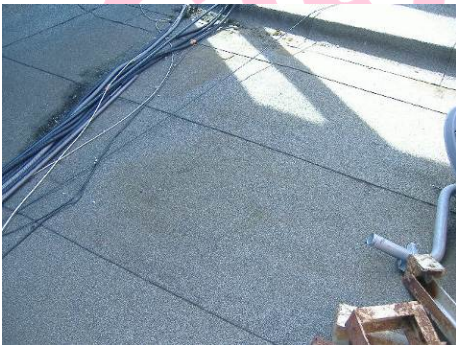
### **Item 65 - Ref: AW0437/08**

The roof felt to the building does not contain asbestos.

*(tested again on sample ref nos: 270749-1 & 270749-3 – no risk)*

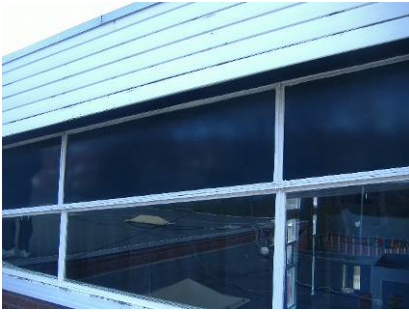
### **Item 66 - Ref: Presumed**

The backing to the black window infill panels to the exterior were presumed to contain asbestos.

*These have now been removed.*

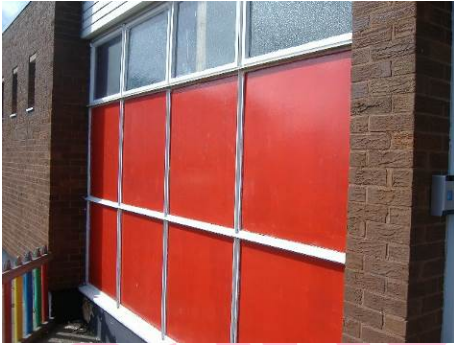
### **Item 67 - Ref: Presumed**

The backing to the red infill panels to the exterior were presumed to contain asbestos.
