ASBESTOS SURVEY REPORT FOR ALBANY PRIMARY SCHOOL, CROSSGILL, WASHINGTON, NE37 1UA.

### **Asbestos Register for Albany Primary School, Crossgill, Washington**

**Date: 02 April 2025**

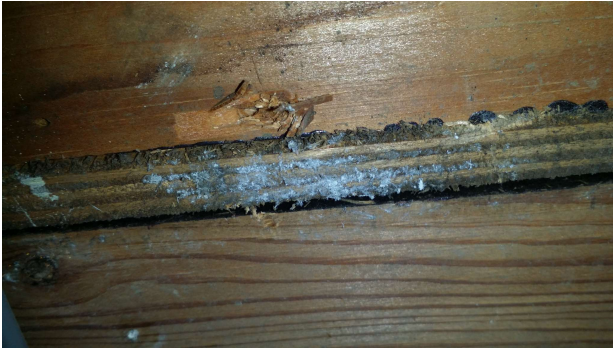
### **Item 1 Ref: 369386-6**

- (Item 1) Ref: 369386-6 – Debris to beam and within nail holes (004/Corridor void above) - Low Risk
- (Item 2) Ref: 369386-50 – Ceiling (012/Boiler Room) – No Risk

The debris to beam and within nail holes in Rm 004/Corridor void above contains asbestos.

Any change in its appearance should be recorded and passed to Property Services.

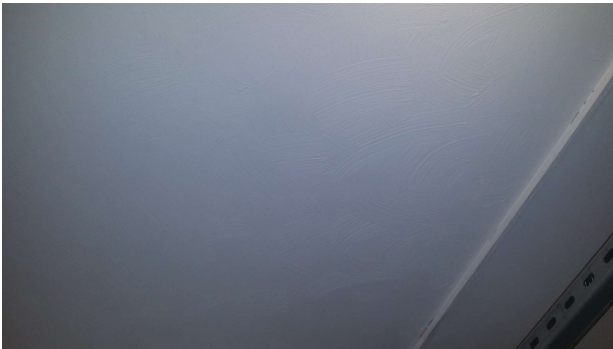
### **Item 2 Ref: 369386-50**

The ceiling in Rm 012/Boiler Room does not contain asbestos.

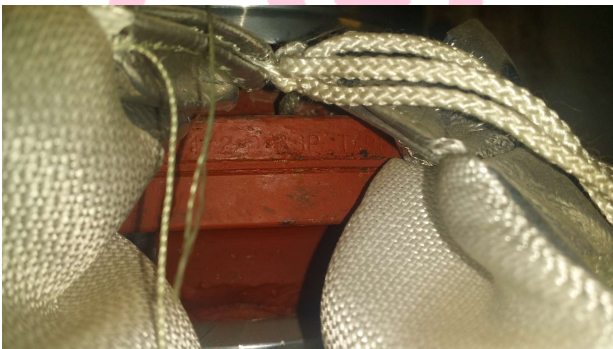
### **Item 3 Ref: 369386-51**

The gasket to pipework in Rm 012/Boiler Room does not contain asbestos.

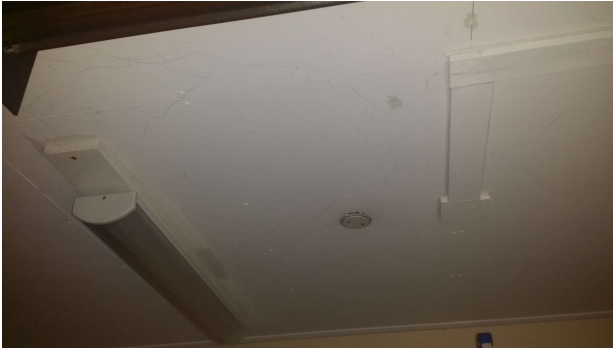
### **Item 4 Ref: 369386-47**

The ceiling in Rm 013/Hall Store does not contain asbestos.

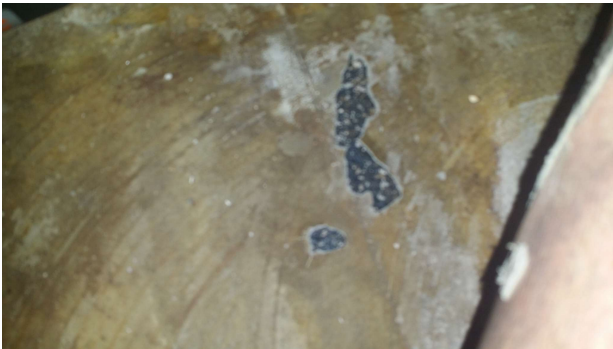
### **Item 5 Ref: As 369386-44**

The remnant adhesive backing to floor in Rm 013/Hall Store contains asbestos.

Any change in its appearance should be recorded and passed to Property Services.

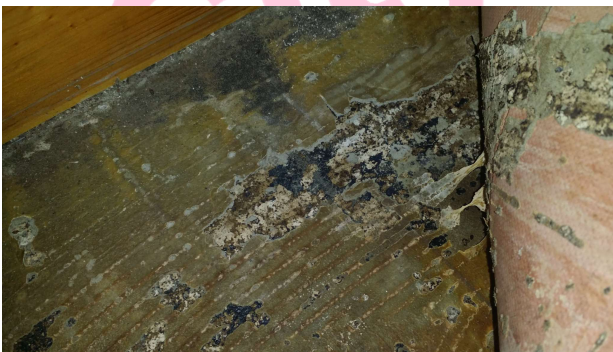
### **Item 6 Ref: 369386-44**

The remnant adhesive backing to floor in Rm 014/Hall Dining Area contains asbestos.

Any change in its appearance should be recorded and passed to Property Services.

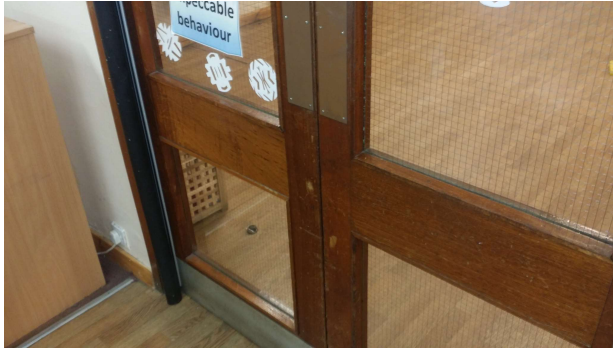
### **Item 7 Ref: As 369386-27**

The mastic to glazing at doors in Rm 014/Hall dining area contains asbestos.

Any change in its appearance should be recorded and passed to Property Services.

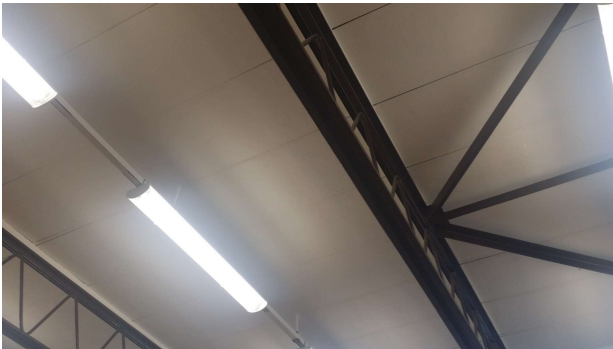
### **Item 8 Ref: 369386-58**

The underside of roof to hall in Rm 014/Hall dining area does not contain asbestos.

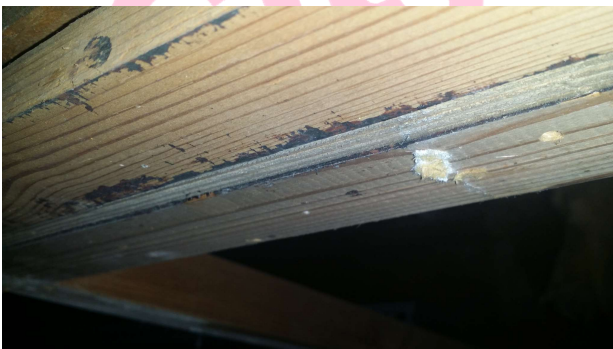
### **Item 9 Ref: 369386-45**

The residue to beams and joists in Rm 014/Hall dining area void above contain asbestos.

Any change in its appearance should be recorded and passed to Property Services.

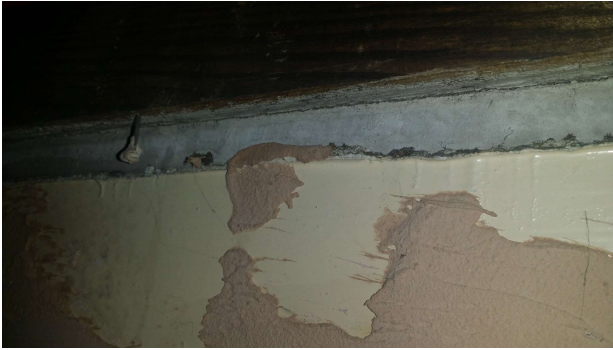
### **Item 10 Ref: As 369386-45**

The residue to wall tops in Rm 014/Hall dining area void above contains asbestos.

Any change in its appearance should be recorded and passed to Property Services.

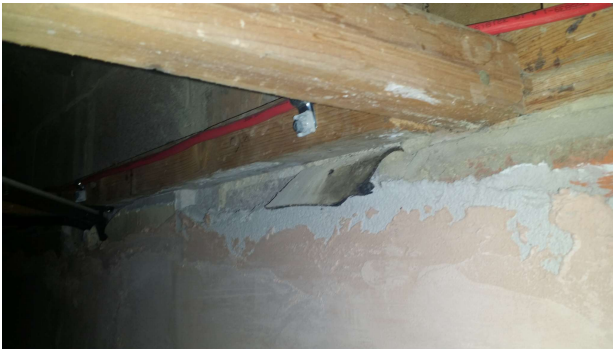
### **Item 11 Ref: 369386-46**

The packer below beam in Rm 014/Hall dining area void above does not contain asbestos.

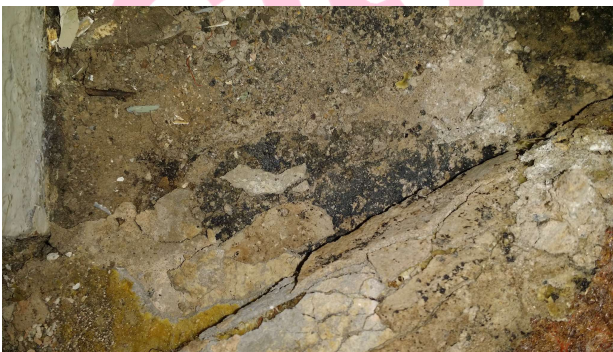
### **Item 12 Ref: 369386-30**

The remnant adhesive backing to floor in Rm 015/Cabinet of curiosities contains asbestos.

Any change in its appearance should be recorded and passed to Property Services.

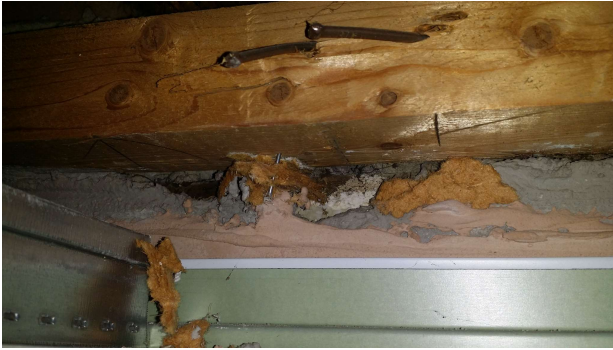
### **Item 13 Ref: 369386-41**

The residue to perimeter walls in Rm 015/Cabinet of curiosities void above contains asbestos.

Any change in its appearance should be recorded and passed to Property Services.

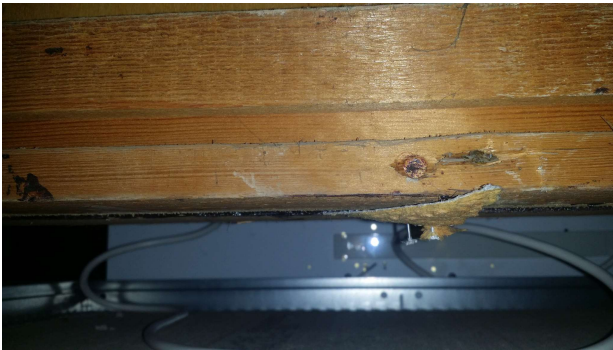
### **Item 14 Ref: As 369386-41**

The remnant ceiling to beams in Rm 015/Cabinet of curiosities void above contains asbestos.

Any change in its appearance should be recorded and passed to Property Services.

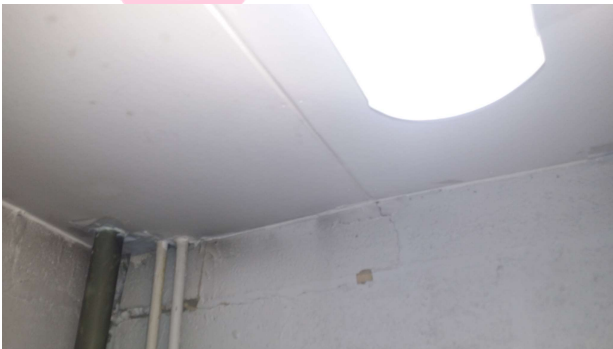
### **Item 15 Ref: As 369386-26**

The ceiling in Rm 015b/IT cupboard does not contain asbestos.

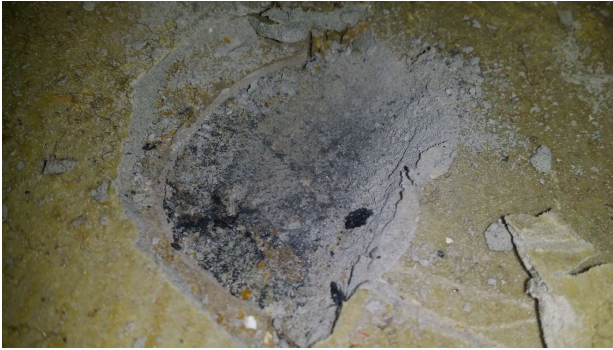
### **Item 16 Ref: 369386-42**

The subfloor in Rm 015b/IT cupboard contains asbestos.

Any change in its appearance should be recorded and passed to Property Services.

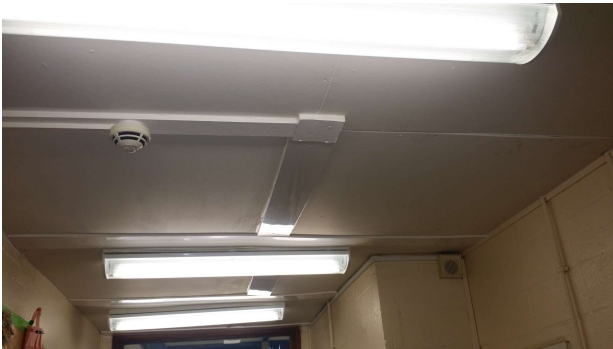
### **Item 17 Ref: 369386-26**

The ceiling in Rm 016/Corridor does not contain asbestos.

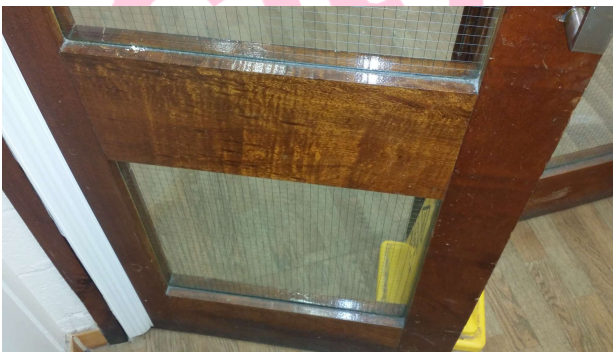
### **Item 18 Ref: 369386-27**

The mastic to glazing at fire doors into hall in Rm 016/Corridor contains asbestos.

Any change in its appearance should be recorded and passed to Property Services.

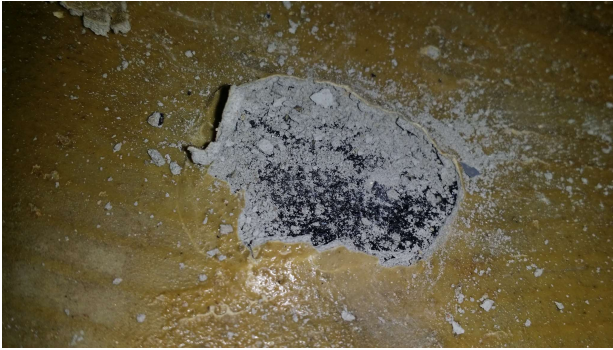
### **Item 19 Ref: As 369386-25**

The remnant adhesive backing to floor in Rm 016/Corridor contains asbestos.

Any change in its appearance should be recorded and passed to Property Services.

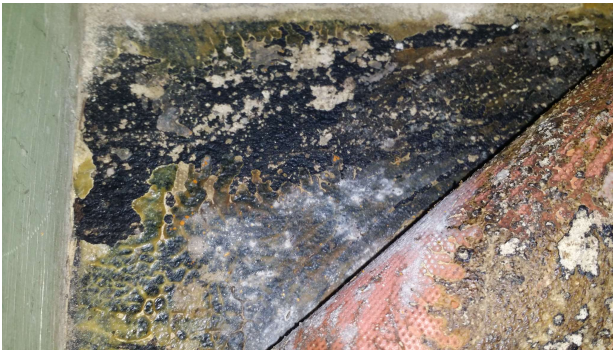
### **Item 20 Ref: As 369386-25**

The remnant adhesive backing to floor in 016a/electrics room contains asbestos.

Any change in its appearance should be recorded and passed to Property Services.

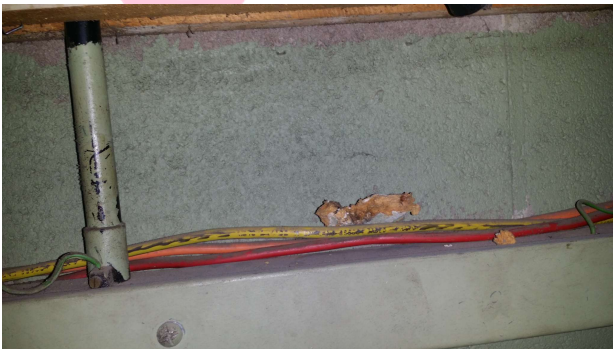
### **Item 21 Ref: 369386-29**

The debris to top of cable trunking in Rm 016a/electrics room contains asbestos.

Any change in its appearance should be recorded and passed to Property Services.

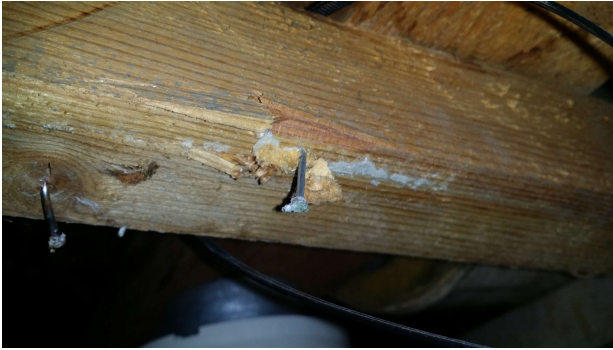
### **Item 22 Ref: As 369386-29**

The residue to beams in Rm 016a/electrics room contains asbestos.

Any change in its appearance should be recorded and passed to Property Services.

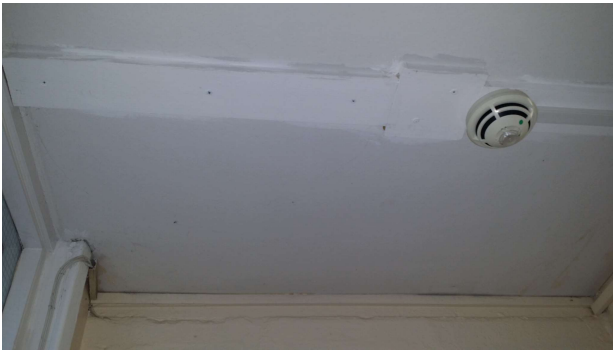
### **Item 23 Ref: As 369386-26**

The ceiling in Rm 016b/ Corridor lobby does not contain asbestos.

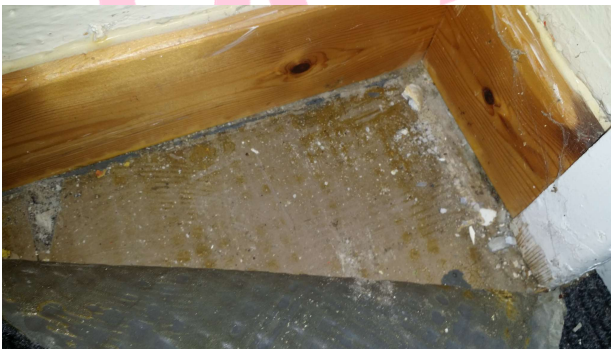
### **Item 24 Ref: 369386-28**

The subfloor in Rm 016b/ Corridor lobby contains asbestos.

Any change in its appearance should be recorded and passed to Property Services.

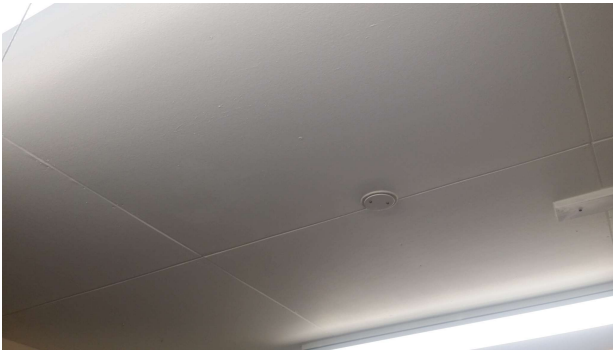
### **Item 25 Ref: As 369386-26**

The ceiling in Rm 017/Sensory room does not contain asbestos.

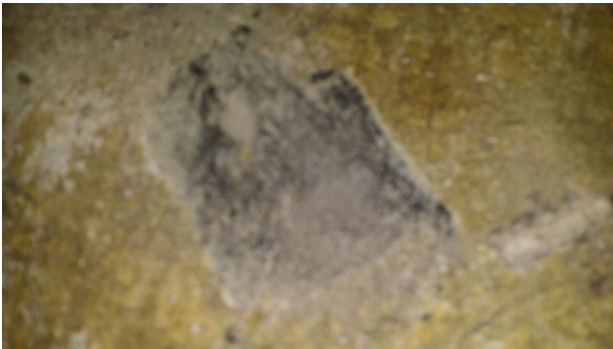
### **Item 26 Ref: As 369386-30**

The remnant adhesive backing to floor in Rm 017/Sensory room contains asbestos.

Any change in its appearance should be recorded and passed to Property Services.

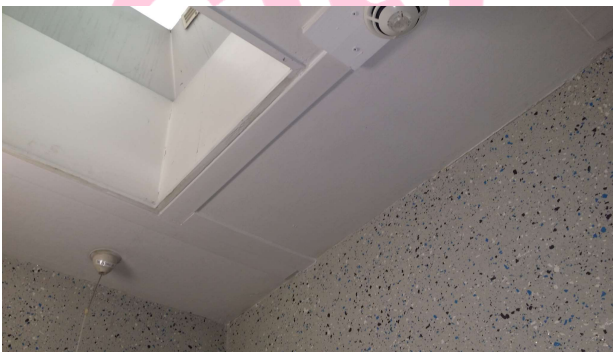
### **Item 27 Ref: As 369386-26**

The ceiling in Rm 018/Male toilet does not contain asbestos.

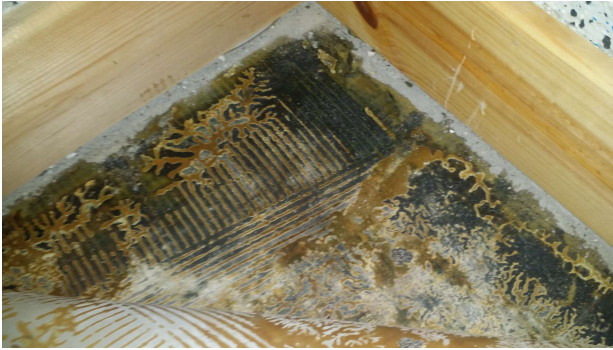
### **Item 28 Ref: As 369386-30**

The remnant adhesive backing to floor in Rm 018/Male toilet contains asbestos.

Any change in its appearance should be recorded and passed to Property Services.

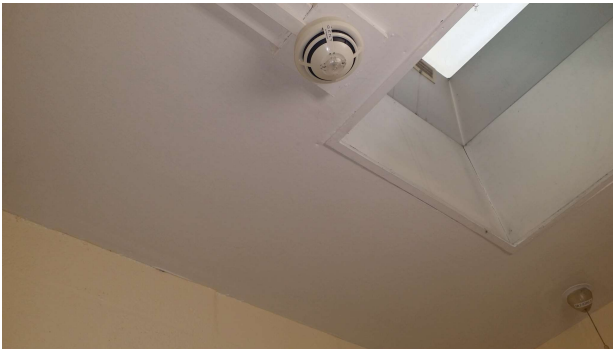
### **Item 29 Ref: As 369386-26**

The ceiling in Rm 019/Female toilet does not contain asbestos.

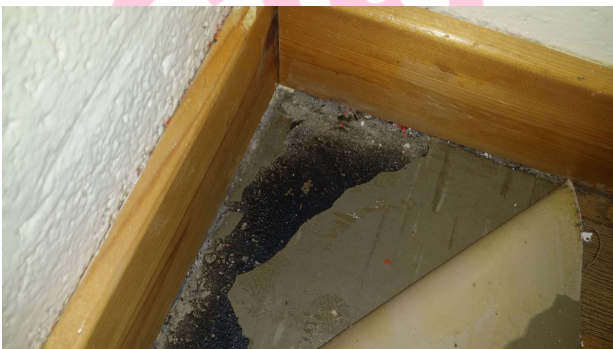
### **Item 30 Ref: As 369386-30**

The remnant adhesive backing to floor in Rm 019/Female toilet contains asbestos.

Any change in its appearance should be recorded and passed to Property Services.

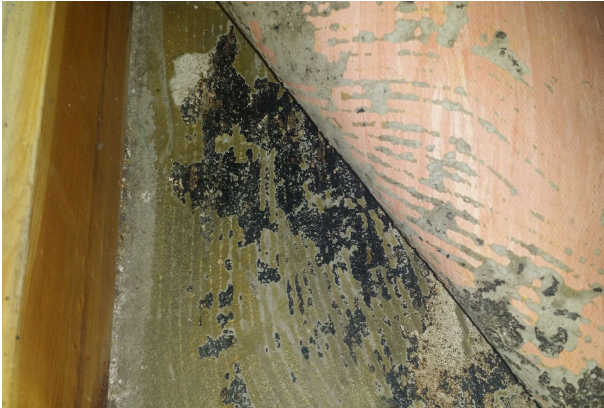
#### **Item 34 Ref: As 369386-44**

The remnant adhesive backing to floor in Rm 021/Hall Store contains asbestos.

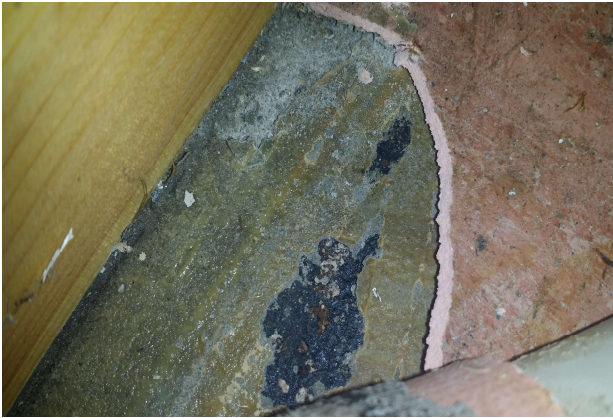
#### **Item 37 Ref: As 369386-44**

The remnant adhesive backing to floor in Rm 022/Hall Store contains asbestos.

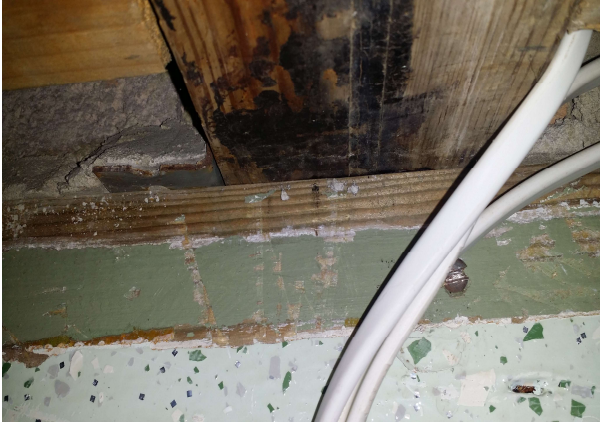
### **Item 40 Ref: 369386-91**

The residue to joints in Rm 024/Classroom – void above contains asbestos.

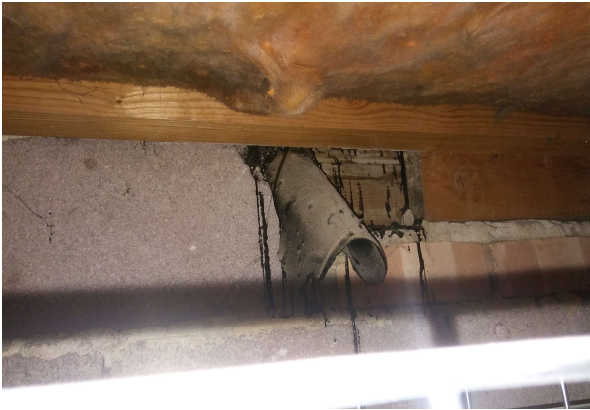
#### **Item 46 Ref: 369386-93**

The packing to underside of roof in Rm 026b/Classroom – void above contains asbestos.

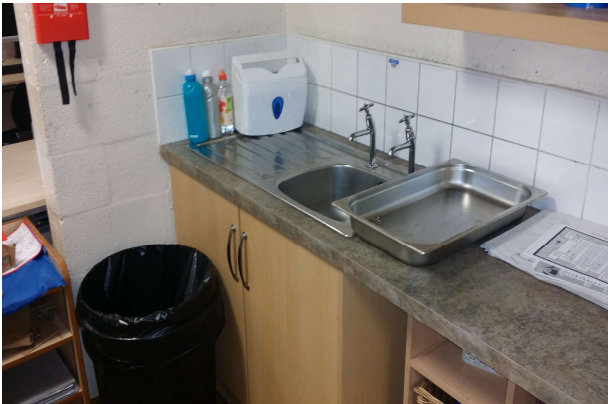
#### **Item 68 Ref: As 369386-7**

The sink pad in Rm 035/Classroom does not contain asbestos.

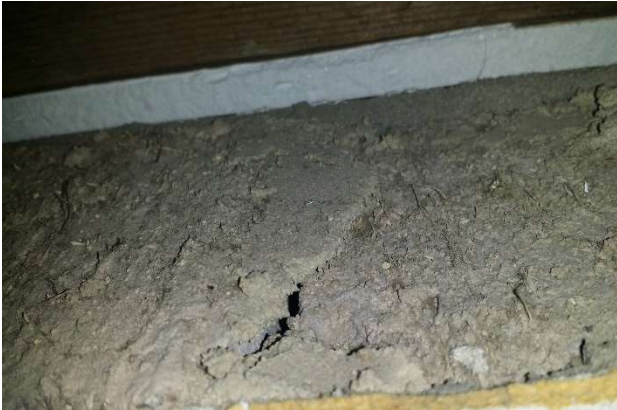
### **Item 71 Ref: As 369386-10**

The remnant fibreboard to cupboard wall tops in Rm 035/Classroom – void above contains asbestos.

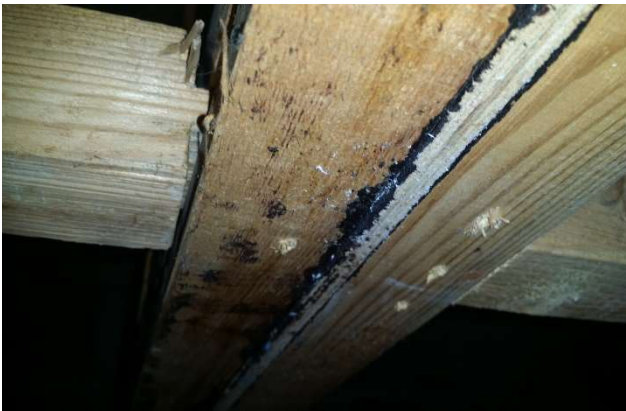
#### **Item 74 Ref: 369386-15**

The remnant fibreboard to joists in Rm 036/Classroom – void above contains asbestos.

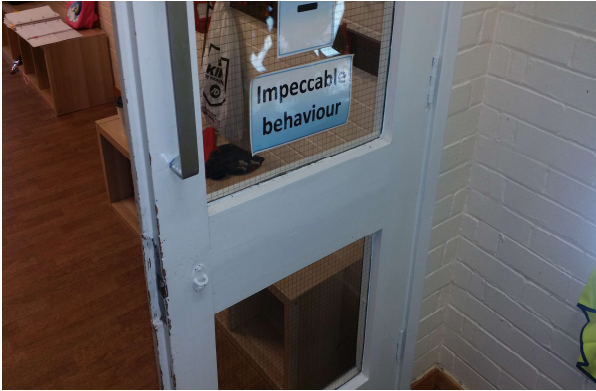
### **Item 76 Ref: 369386-5**

The mastic to glazing on fire door in Rm 037a/Corridor contains asbestos.

Any change in its appearance should be recorded and passed to Property Services.

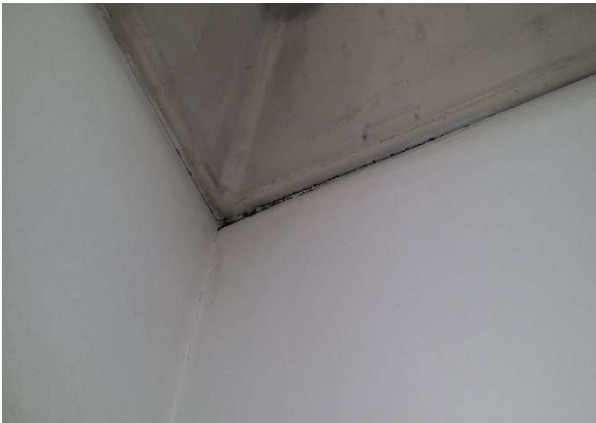
### **Item 77 Ref: 369386-4**

The packing to skylight tops in Rm 038/Cloakroom does not contain asbestos.

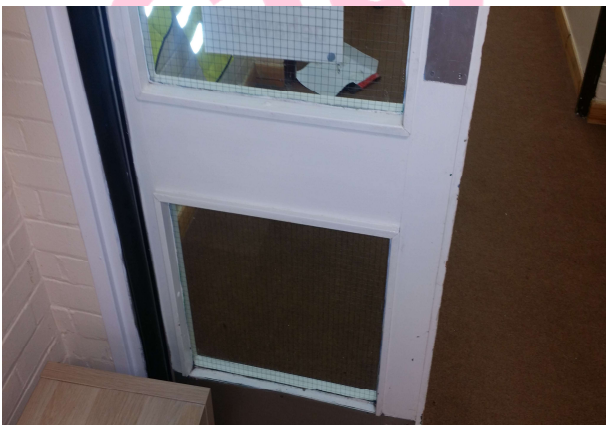
### **Item 78 Ref: As 369386-5**

The mastic to fire doors in Rm 038/Cloakroom contains asbestos.

Any change in its appearance should be recorded and passed to Property Services.

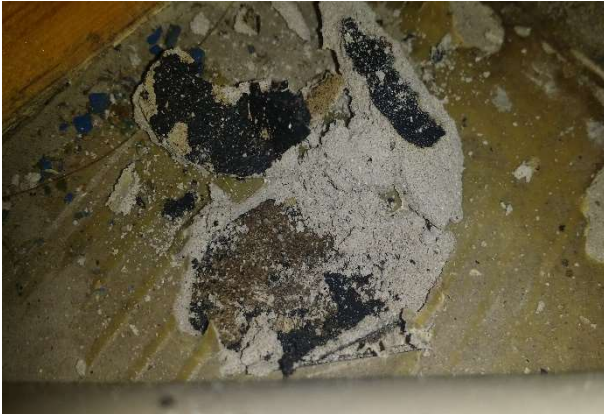
#### **Item 88 Ref: As 369386-59**

The remnant adhesive backing to floor in Rm 041/Classroom contains asbestos.

Any change in its appearance should be recorded and passed to Property Services.

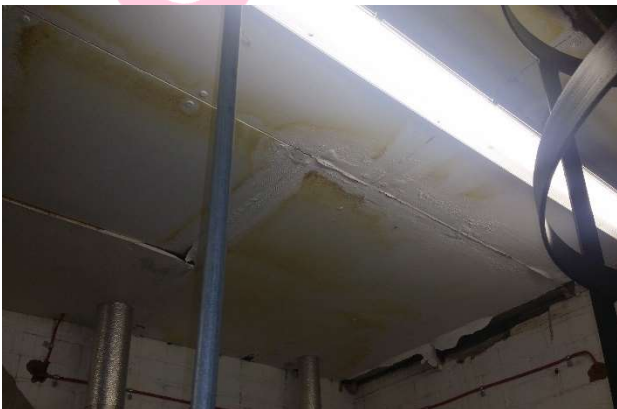
### **Item 93 Ref: 369386-55**

The ceiling in Rm 043/Boiler Room does not contain asbestos.

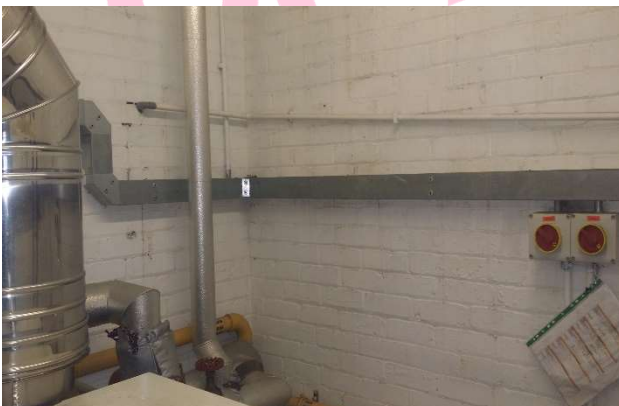
**Item 96 Ref: 369386-56**

The debris to walls in Rm 043/Boiler Room does not contain asbestos.

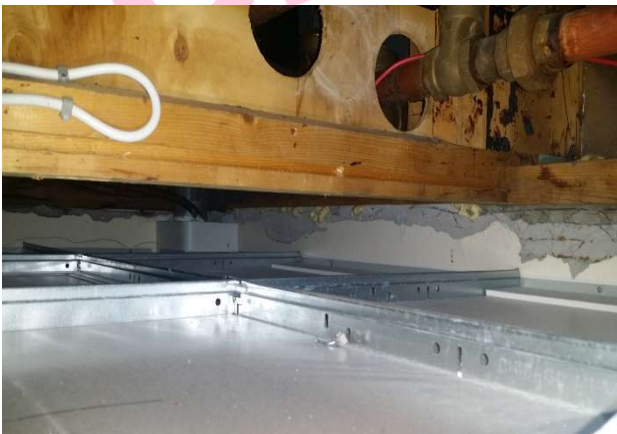
#### **Item 99 Ref: Presumed**

The debris to wall gap in Rm 044/Boys Toilet – void above contains asbestos.

Removed August 2023

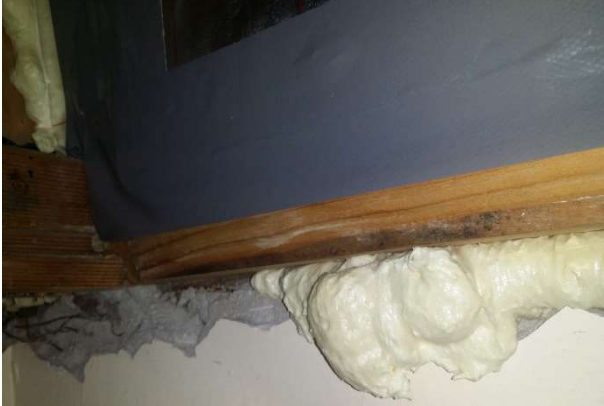
#### **Item 100 Ref: Presumed**

The debris to wall gap behind foam insulation in Rm 046/Girls Toilet – void above contains asbestos.

Removed August 2023

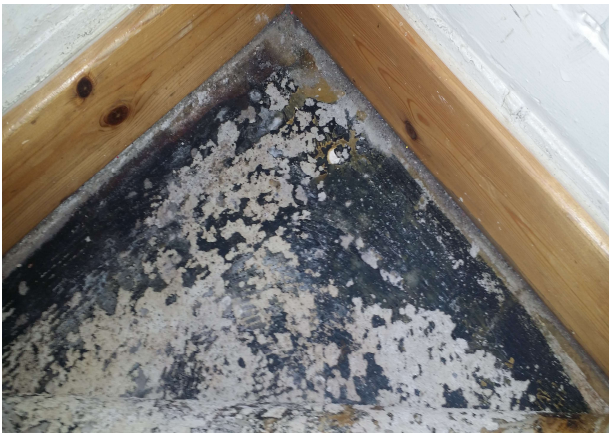
#### **Item 101 Ref: 369386-85**

The remnant adhesive backing to floor in Rm 047/Hall contains asbestos.

Any change in its appearance should be recorded and passed to Property Services.

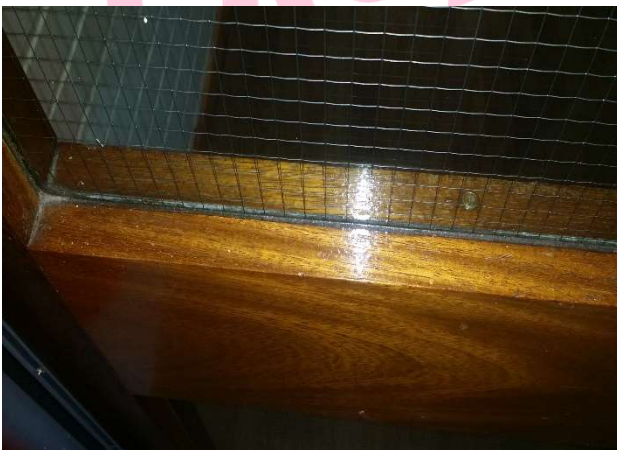
#### **Item 102 Ref: 369386-84**

The mastic to glazing at doors in Rm 047/Hall does not contain asbestos.

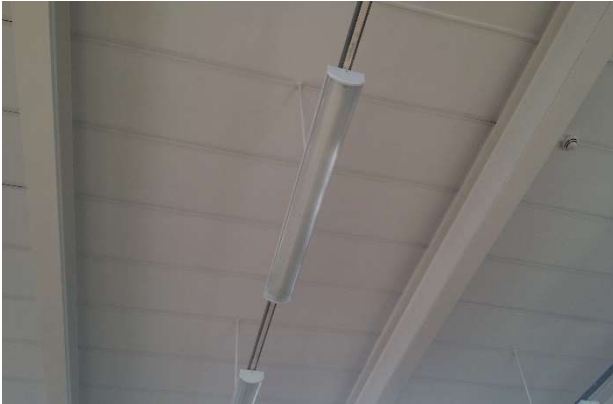
#### **Item 103 Ref: 369386-86**

The underside of roof to hall in Rm 047/Hall does not contain asbestos.

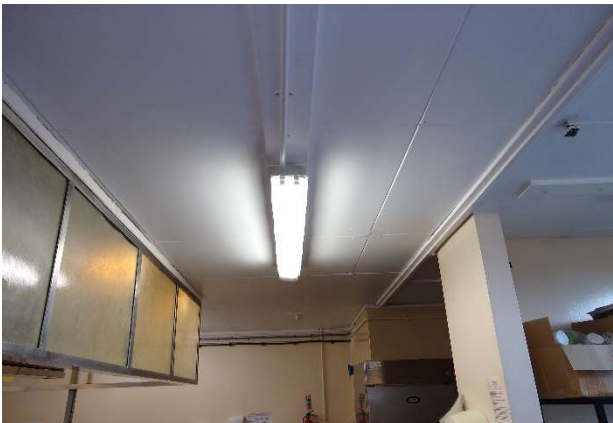
#### **Item 104 Ref: 369386-74**

The fixed ceiling tiles in Rm 048/Kitchen contains asbestos.

Any change in its appearance should be recorded and passed to Property Services.

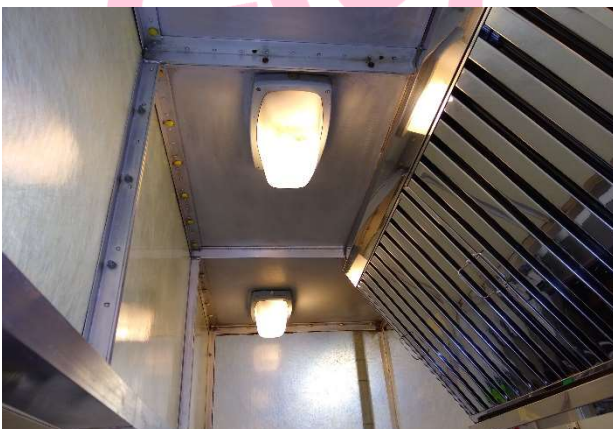
#### **Item 105 Ref: 369386-73**

The sealant to lights within extraction bulkhead in Rm 048/Kitchen contains asbestos.

Any change in its appearance should be recorded and passed to Property Services.

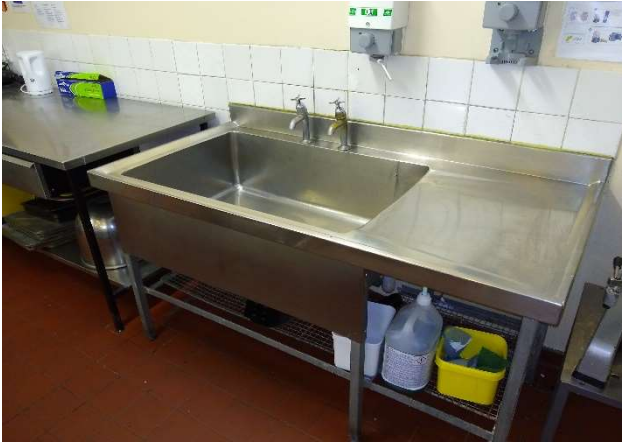
### **Item 106 Ref: 369386-72**

The acoustic seal to sink base in Rm 048/Kitchen does not contain asbestos.

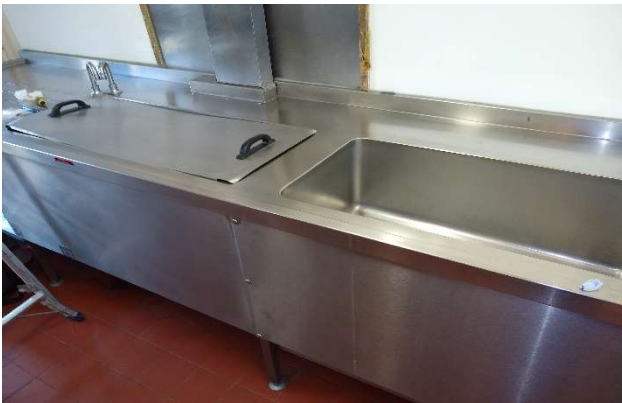
### **Item 107 Ref: 369386-71**

The sink pad in Rm 048/Kitchen does not contain asbestos.

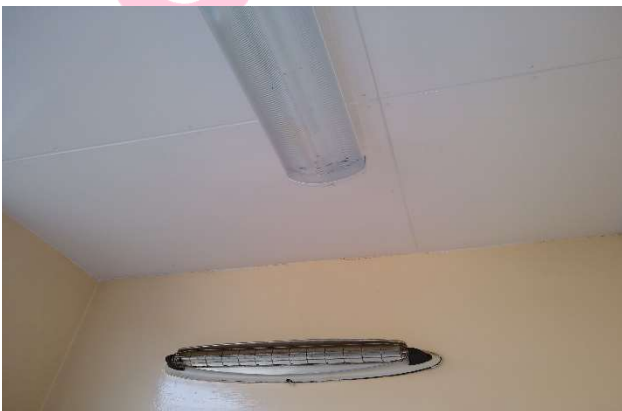
### **Item 108 Ref: 369386-62**

The fixed ceiling tiles in Rm 048a/Kitchen Office contains asbestos.

Any change in its appearance should be recorded and passed to Property Services.

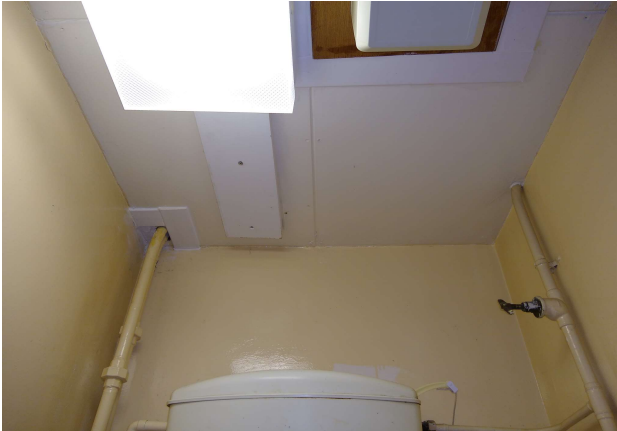
### **Item 109 Ref: 369386-61**

The fixed ceiling tiles in Rm 048b/Kitchen Toilet contains asbestos.

Any change in its appearance should be recorded and passed to Property Services.

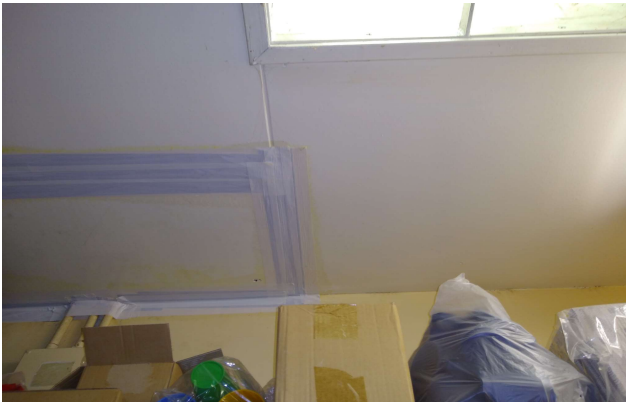
### **Item 110 Ref: As 369386-74**

The fixed ceiling tiles in Rm 048c/Dry Store contains asbestos.

Any change in its appearance should be recorded and passed to Property Services.

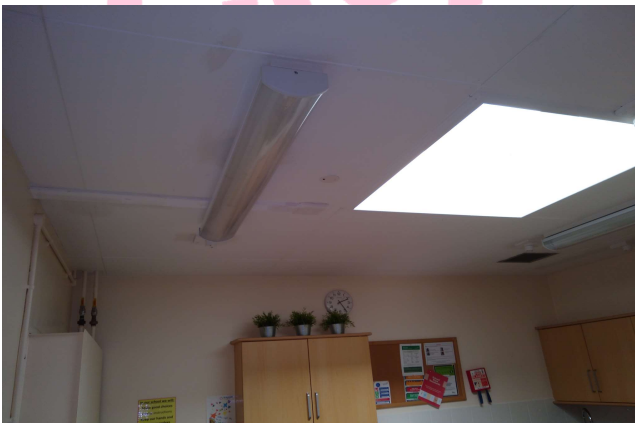
### **Item 111 Ref: 369386-68**

The fixed ceiling tiles in Rm 050/Breakfast Room contains asbestos.

Any change in its appearance should be recorded and passed to Property Services.

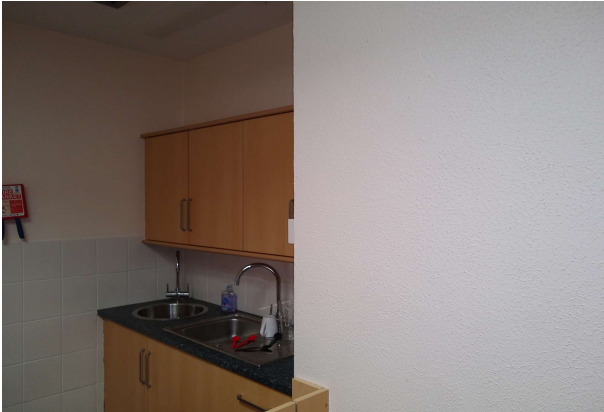
### **Item 112 Ref: 369386-69**

The coating to wall in Rm 050/Breakfast Room does not contain asbestos.

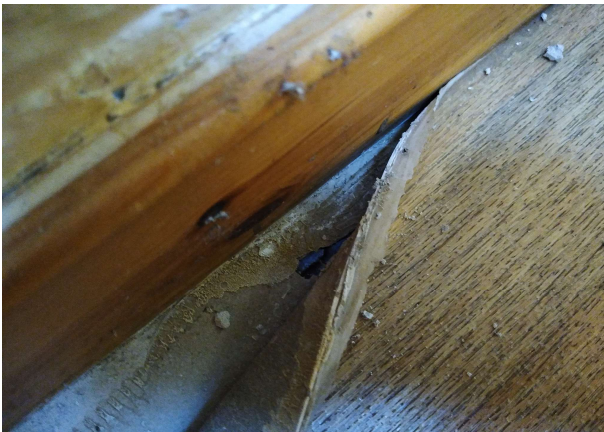
### **Item 113 Ref: As 369386-76**

The floor in Rm 051/Corridor contains asbestos.

Any change in its appearance should be recorded and passed to Property Services.

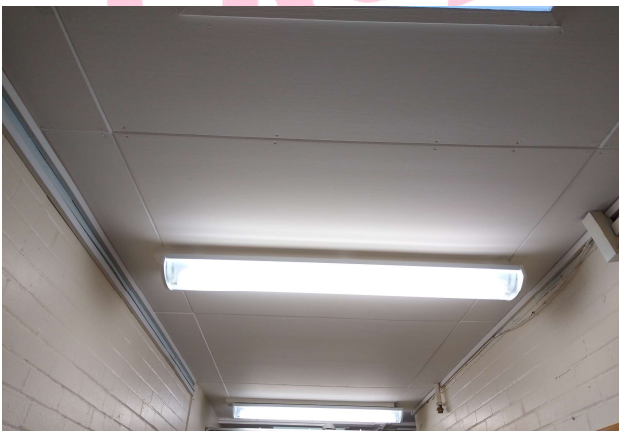
### **Item 114 Ref: As 369386-80**

The ceiling in Rm 051/Corridor contains asbestos.

Any change in its appearance should be recorded and passed to Property Services.

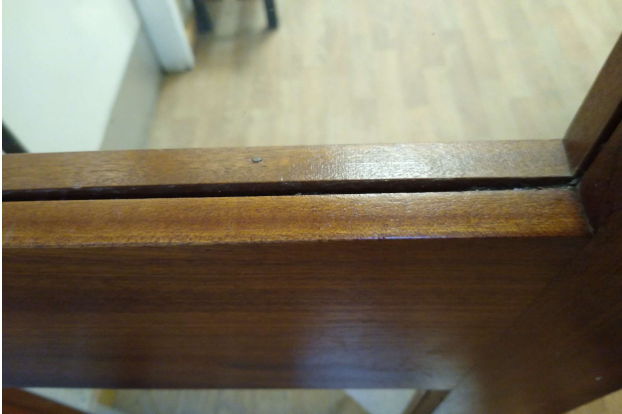
### **Item 115 Ref: As 369386-84**

The sealant to doors in Rm 051/Corridor does not contain asbestos.

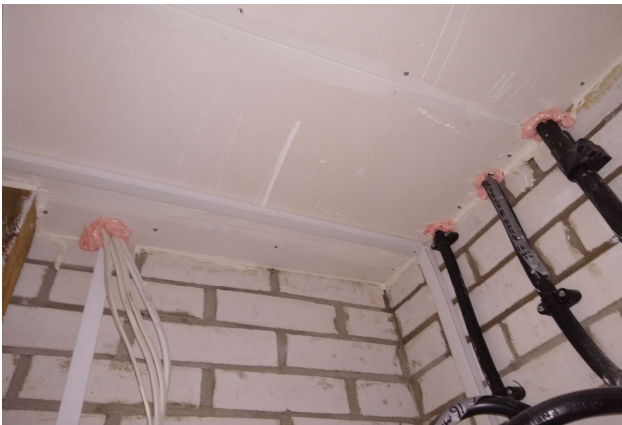
### **Item 116 Ref: 369386-75**

The fixed ceiling tiles in Rm 051a/Electric Cupboard does not contain asbestos.

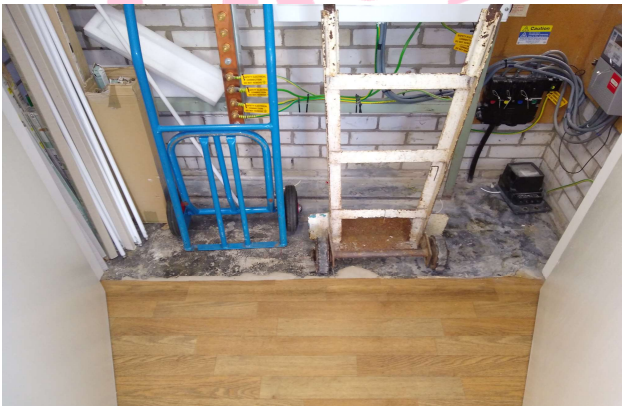
### **Item 117 Ref: 369386-76**

The adhesive to floor in Rm 051a/Electric Cupboard contains asbestos.

Any change in its appearance should be recorded and passed to Property Services

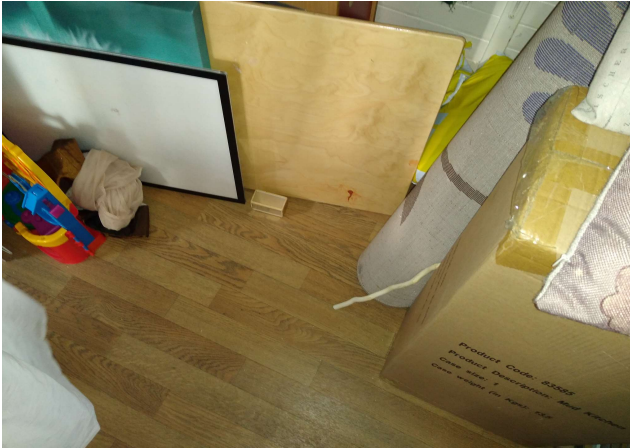
### **Item 118 Ref: As 369386-66**

The floor under screed in Rm 051a/Store contains asbestos.

Any change in its appearance should be recorded and passed to Property Services.

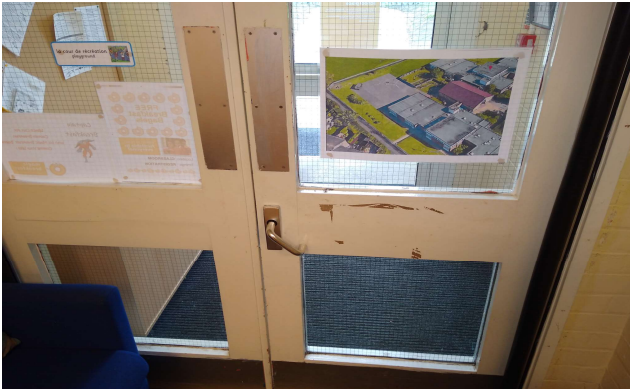
### **Item 119 Ref: 369386-40**

The sealant to lobby door window panels in Rm 051b/Corridor contains asbestos.

Any change in its appearance should be recorded and passed to Property Services.

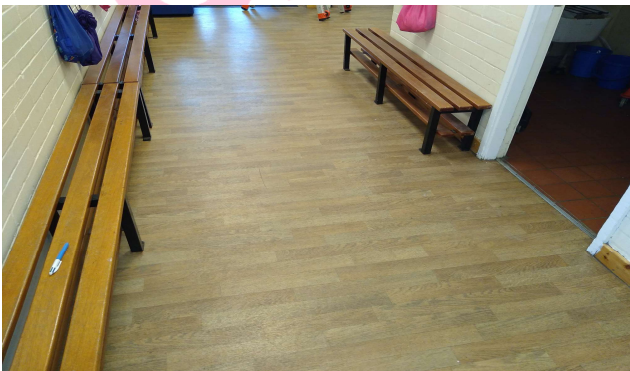
### **Item 120 Ref: As 369386-66**

The floor under screed in Rm 051b/Corridor contains asbestos.

Any change in its appearance should be recorded and passed to Property Services.

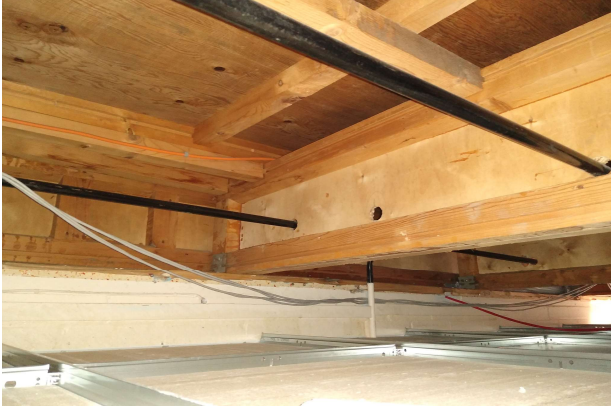
### **Item 121 Ref: 369386-63**

The debris to beams in Rm 051b/Corridor – void above suspended ceiling contains asbestos.

Removed August 2023

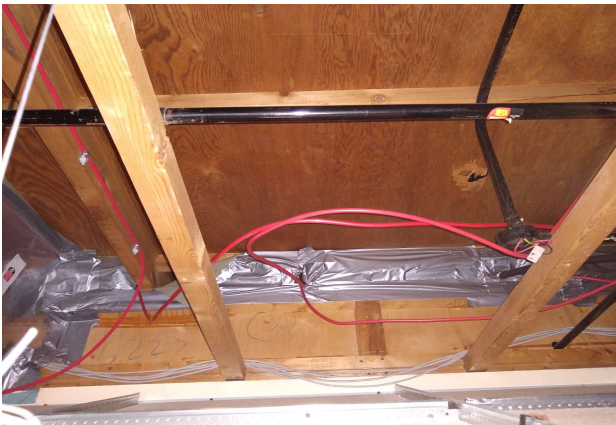
### **Item 122 Ref: 369386-77**

The debris to nail holes in Rm 051b/Entrance Lobby – void above does not contain asbestos.

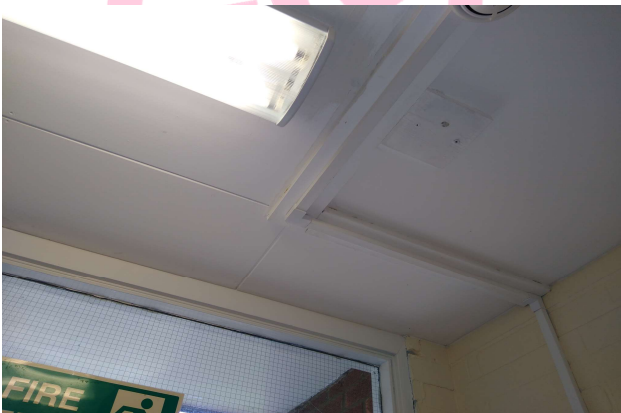
### **Item 123 Ref: 369386-64**

The ceiling in Rm 051c/Lobby contains asbestos.

Any change in its appearance should be recorded and passed to Property Services.

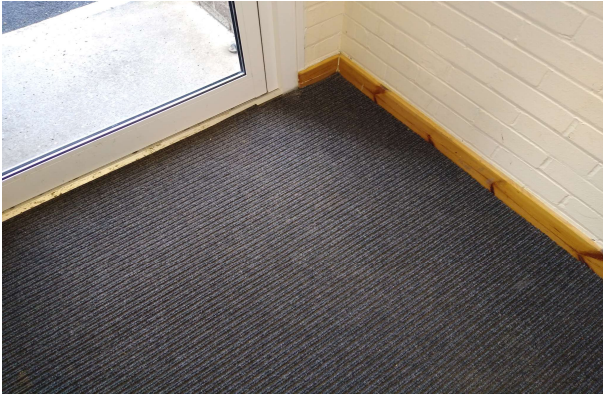
#### **Item 124 Ref: 369386-65**

The floor covering under carpet in Rm 051c/Lobby contains asbestos.

Any change in its appearance should be recorded and passed to Property Services.

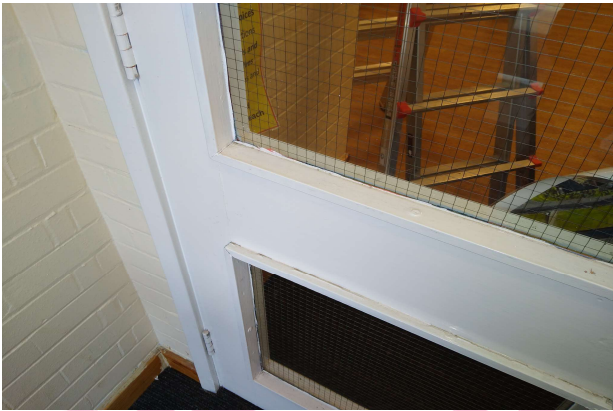
#### **Item 125 Ref: As 369386-40**

The sealant to corridor door window panels in Rm 051c/Lobby contains asbestos.

Any change in its appearance should be recorded and passed to Property Services.

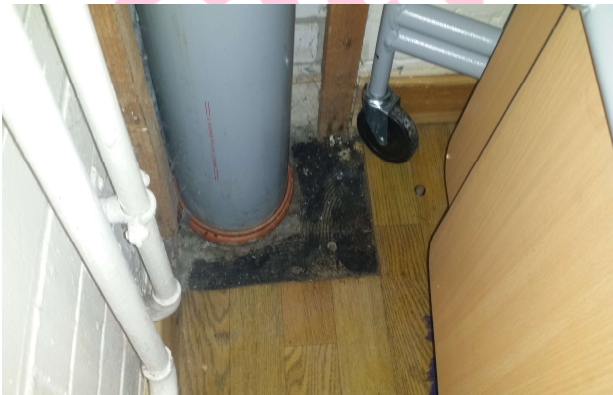
#### **Item 126 Ref: As 369386-85**

The remnant adhesive backing to floor in Rm 052/Hall Store contains asbestos.

Any change in its appearance should be recorded and passed to Property Services.

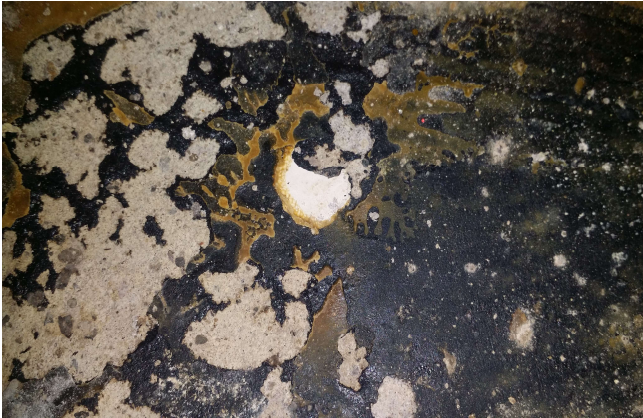
#### **Item 127 Ref: As 369386-85**

The remnant adhesive backing to floor in Rm 053/Hall Store contains asbestos.

Any change in its appearance should be recorded and passed to Property Services.

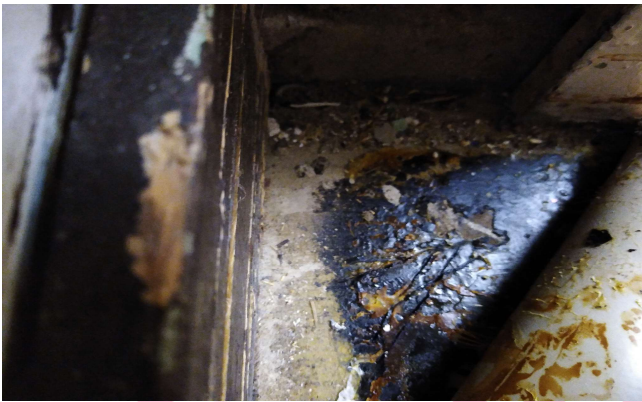
#### **Item 128 Ref: As 369386-76**

The floor in Rm 054/Cleaners Cupboard contains asbestos.

Any change in its appearance should be recorded and passed to Property Services.

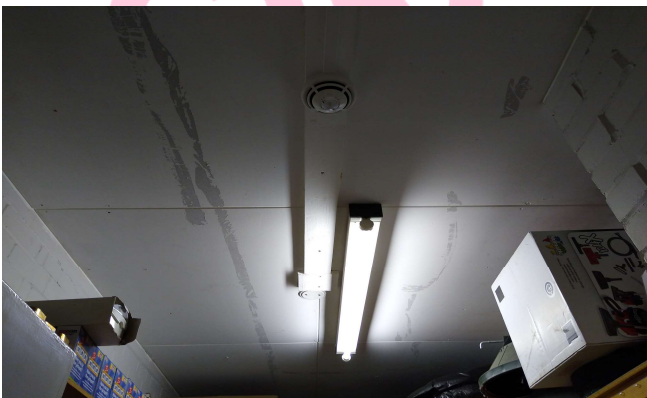
#### **Item 129 Ref: 369386-80**

The ceiling in Rm 054/Cleaners Cupboard contains asbestos.

Any change in its appearance should be recorded and passed to Property Services.

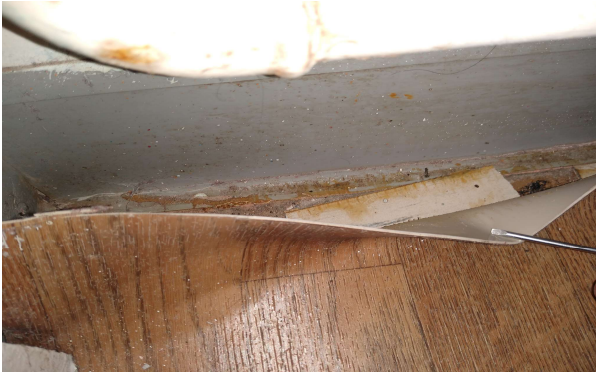
#### **Item 130 Ref: As 369386-87**

The floor in Rm 055/Staff Toilet contains asbestos.

Any change in its appearance should be recorded and passed to Property Services.

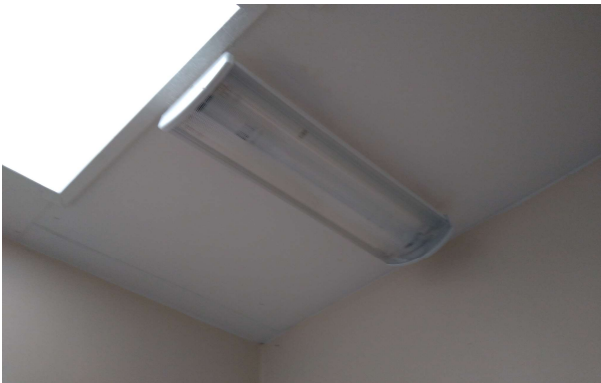
#### **Item 131 Ref: As 369386-80**

The ceiling in Rm 055/Staff Toilet contains asbestos.

Any change in its appearance should be recorded and passed to Property Services.

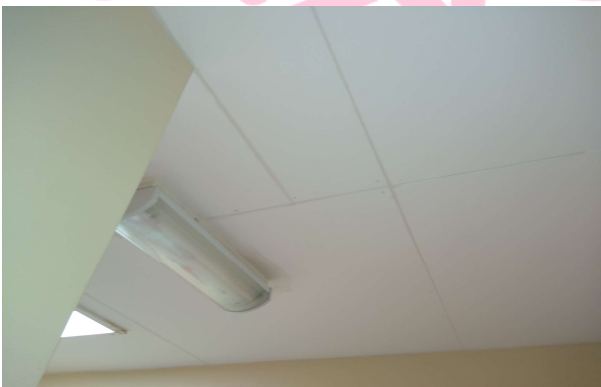
#### **Item 132 Ref: As 369386-64**

The ceiling in Rm 058/Girls WC contains asbestos.

Any change in its appearance should be recorded and passed to Property Services.

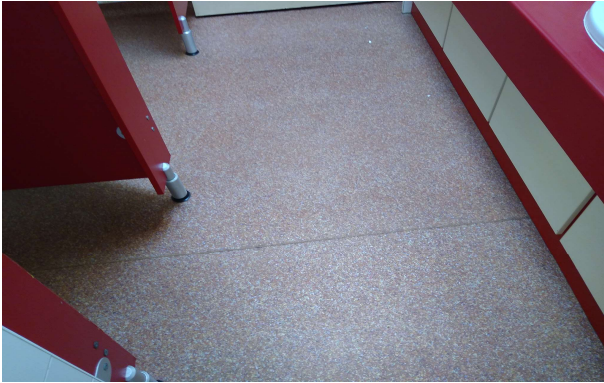
#### **Item 133 Ref: As 369386-66**

The floor under screed in Rm 058/Girls WC contains asbestos.

Any change in its appearance should be recorded and passed to Property Services.

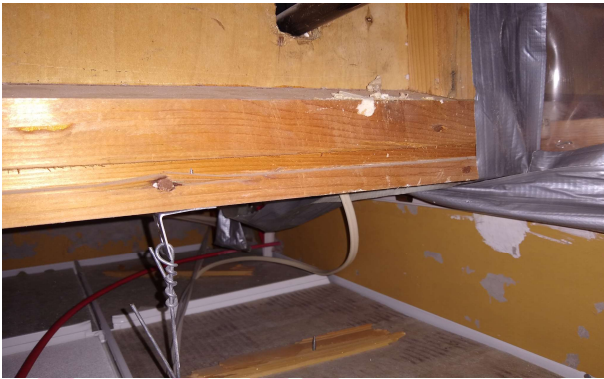
#### **Item 134 Ref: 369386-70**

The residue to beams in Rm 059/Accessible WC – void above does not contain asbestos.

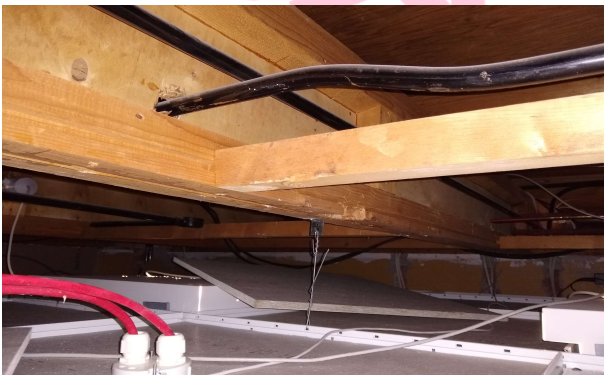
#### **Item 135 Ref: 369386-78**

The residue to beams in Rm 059/Accessible WC – void above does not contain asbestos.

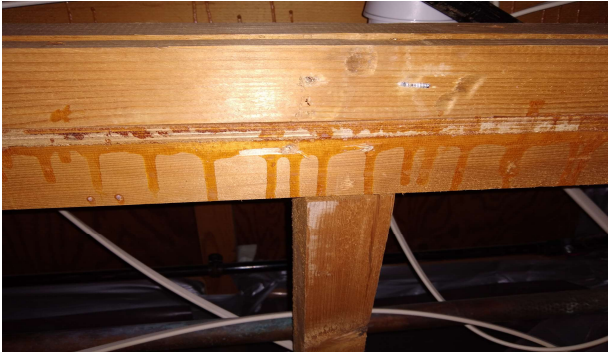
### **Item 136 Ref: 369386-79**

The debris to nail holes in Rm 059/Accessible WC – void above does not contain asbestos.
