ASBESTOS SURVEY REPORT FOR ALBANY PRIMARY SCHOOL, CROSSGILL, WASHINGTON, NE37 1UA.

### **Asbestos Register for Albany Primary School, Crossgill, Washington**

**Date: 02 April 2025**

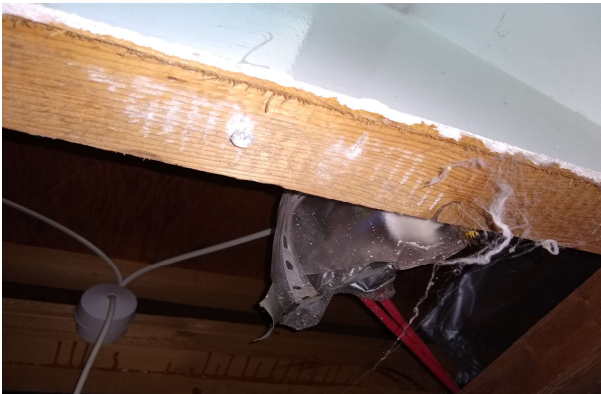
### **Item 137 Ref: 369386-88**

The debris to screw and screw holes in Rm 060/Store – void above contains asbestos.

Any change in its appearance should be recorded and passed to Property Services.

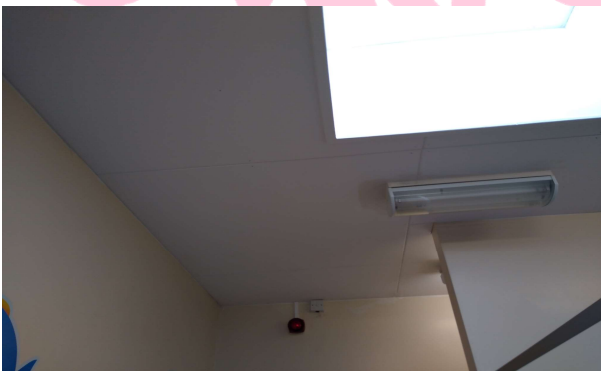
### **Item 138 Ref: As 369386-80**

The ceiling in Rm 061/Boys Toilet contains asbestos.

Any change in its appearance should be recorded and passed to Property Services.

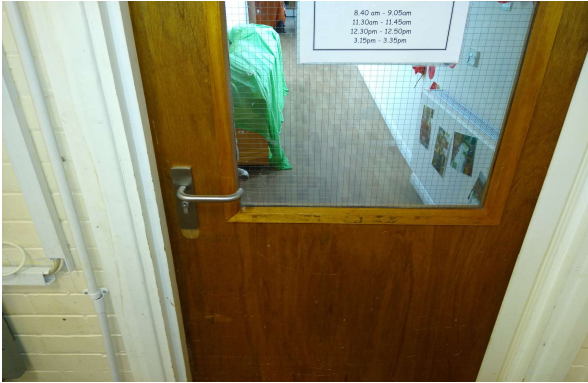
### **Item 139 Ref: As 369386-33**

The sealant to link corridor door window panel in Rm 062/Classroom does not contain asbestos.

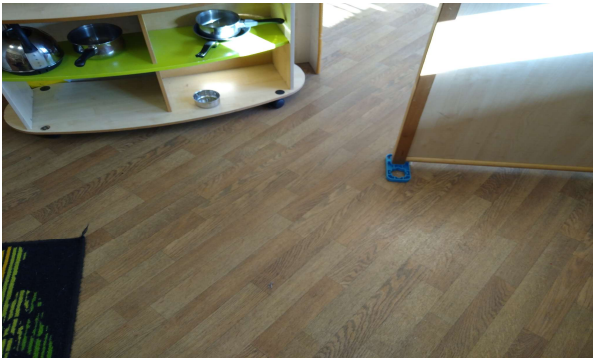
### **Item 140 Ref: 369386-66**

The floor under screed in Rm 062/Classroom contains asbestos.

Any change in its appearance should be recorded and passed to Property Services.

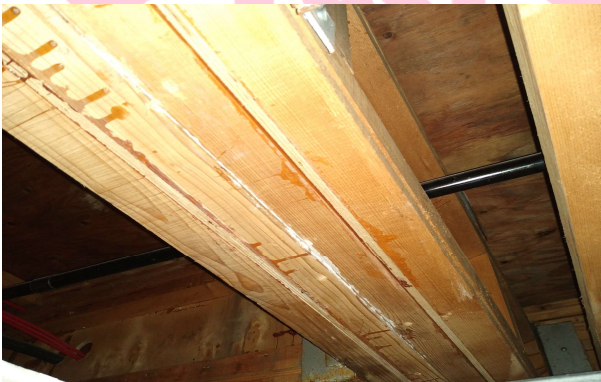
### **Item 141 Ref: 369386-38**

The debris to beams in Rm 062/Classroom – void above suspended ceiling contains asbestos.

Removed August 2023

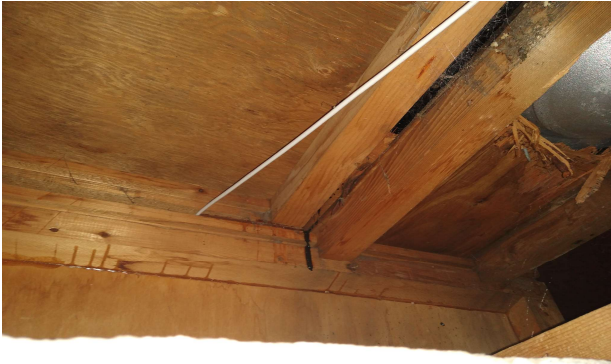
### **Item 142 Ref: As 369386-37**

The remnants of roof covering to brick wall in Rm 062/Classroom – void above suspended ceiling does not contain asbestos.

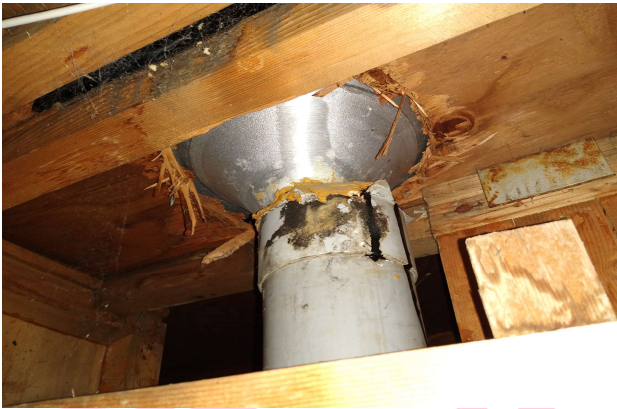
### **Item 143 Ref: 369386-39**

The soil pipe collar sealant in Rm 062/Classroom – void above suspended ceiling does not contain asbestos.

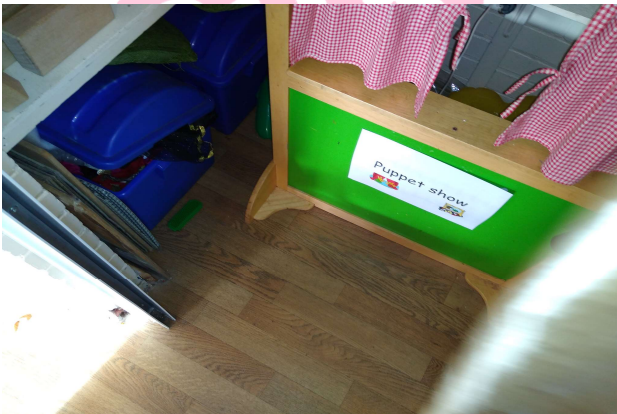
### **Item 144 Ref: As 369386-66**

The floor under screed in Rm 062a/Store contains asbestos.

Any change in its appearance should be recorded and passed to Property Services.

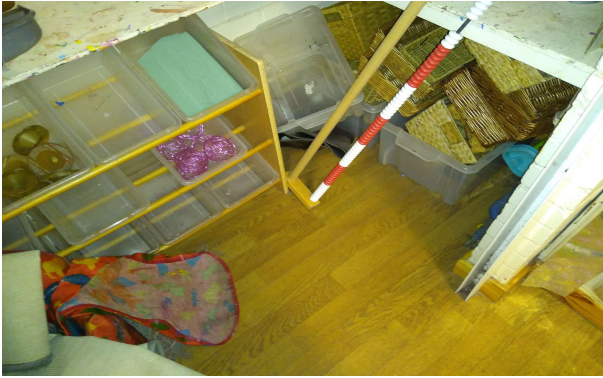
#### **Item 145 Ref: As 369386-66**

The floor under screed in Rm 063/Store contains asbestos.

Any change in its appearance should be recorded and passed to Property Services.

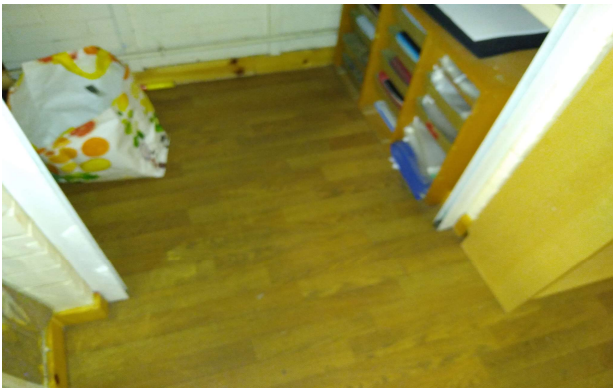
#### **Item 146 Ref: As 369386-66**

The floor under screed in Rm 064a/Store contains asbestos.

Any change in its appearance should be recorded and passed to Property Services.

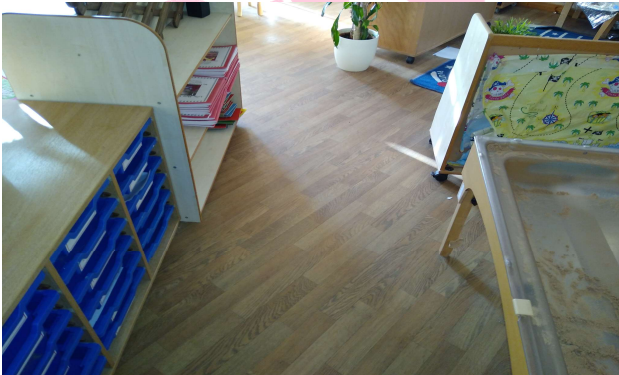
#### **Item 147 Ref: As 369386-66**

The floor under screed in Rm 064/Classroom contains asbestos.

Any change in its appearance should be recorded and passed to Property Services.

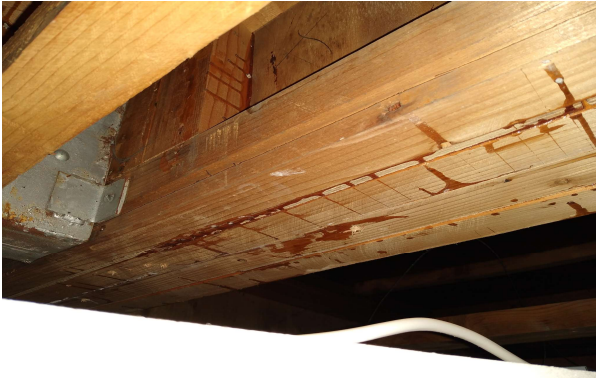
### **Item 148 Ref: As 369386-38**

The debris to beams in Rm 064/Classroom – void above suspended ceiling contains asbestos.

Removed August 2023

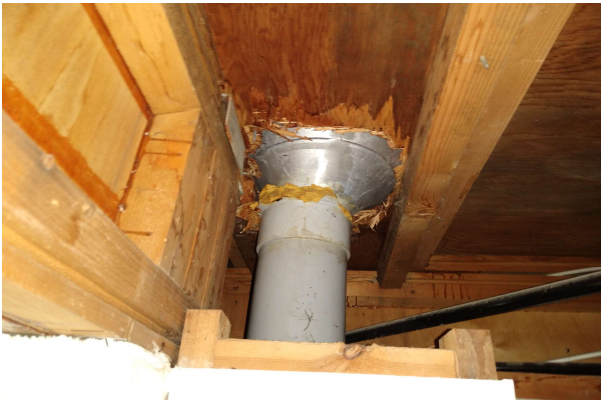
### **Item 149 Ref: As 369386-39**

The soil pipe collar sealant in Rm 064/Classroom – void above suspended ceiling does not contain asbestos.

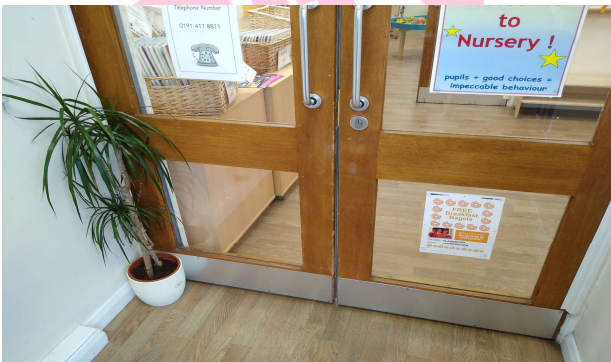
### **Item 150 Ref: As 369386-36**

The sealant to cloakroom door window panels in Rm 065/Link Corridor does not contain asbestos.

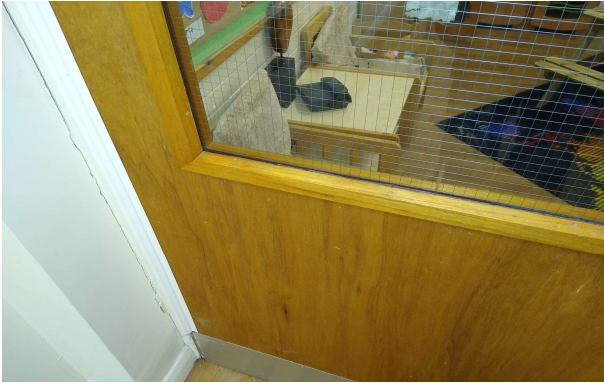
### **Item 151 Ref: As 369386-33**

The sealant to classroom door window panels in Rm 065/Link Corridor does not contain asbestos.

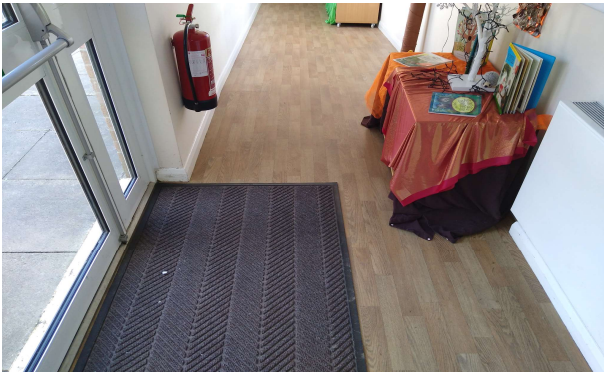
### **Item 152 Ref: As 369386-66**

The floor under screed in Rm 065/Link Corridor contains asbestos.

Any change in its appearance should be recorded and passed to Property Services.

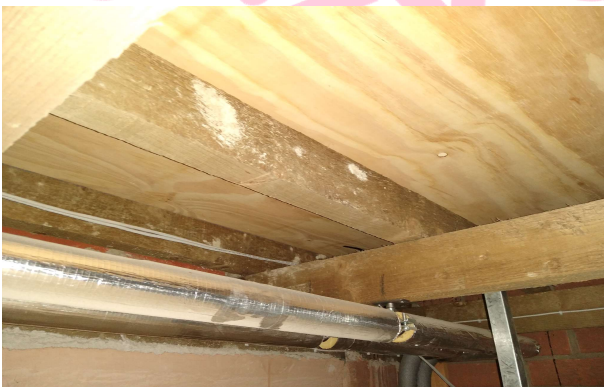
### **Item 153 Ref: As 369386-32**

The debris to beams in Rm 065/Link Corridor – void above suspended ceiling does not contain asbestos.

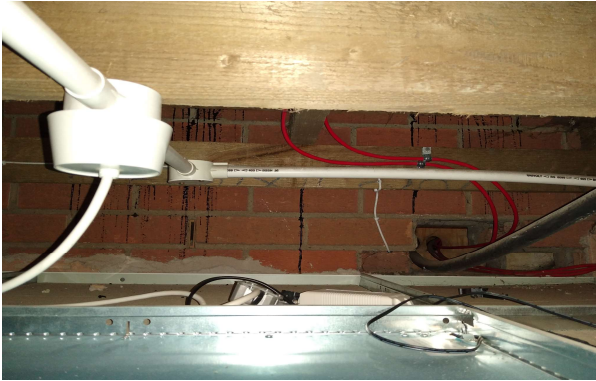
### **Item 154 Ref: 369386-37**

The remnants of roof covering to brick wall in Rm 065/Link Corridor – void above suspended ceiling does not contain asbestos.

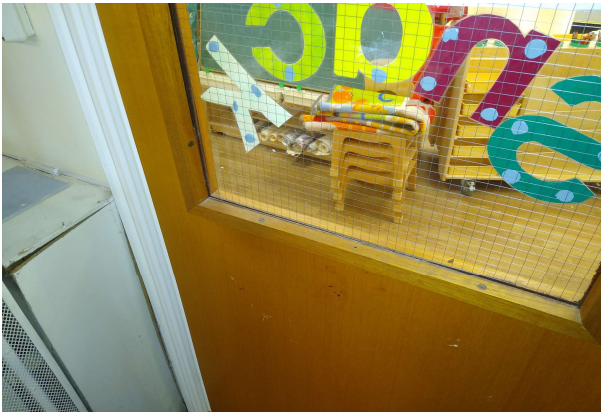
### **Item 155 Ref: As 369386-33**

The sealant to door window panel in Rm 066/Staff Kitchen does not contain asbestos.

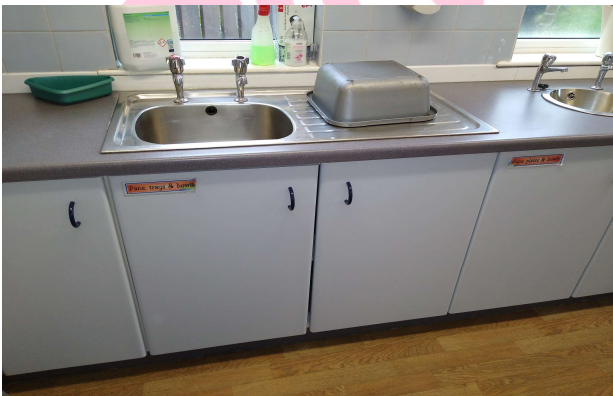
### **Item 156 Ref: 369386-35**

The sink pads to sink and drainer in Rm 066/Staff Kitchen does not contain asbestos.

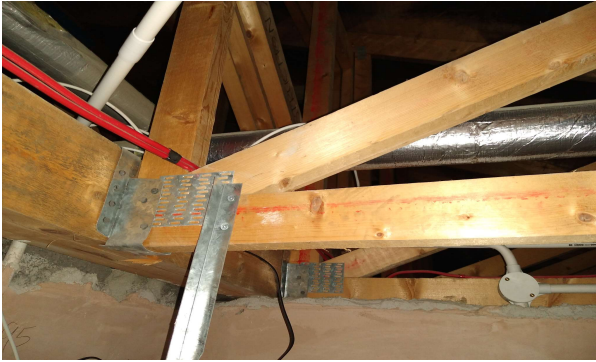
### **Item 157 Ref: As 369386-32**

The debris to beams in Rm 066/Staff Kitchen – void above suspended ceiling does not contain asbestos.

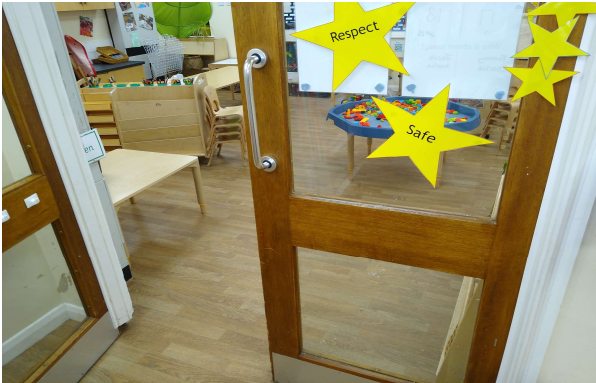
### **Item 158 Ref: 369386-36**

The sealant to nursery door window panels in Rm 067/Cloakroom does not contain asbestos.

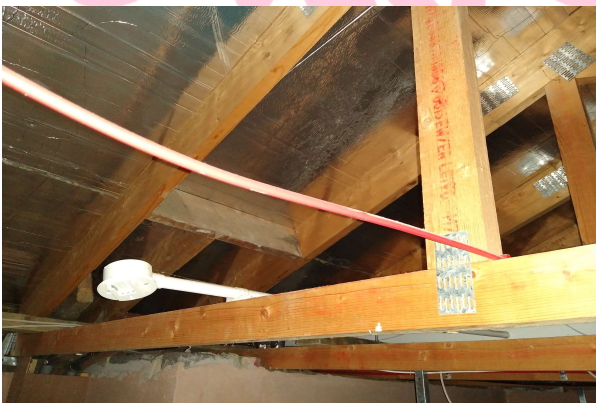
### **Item 159 Ref: As 369386-32**

The debris to beams in Rm 067/Cloakroom – void above suspended ceiling does not contain asbestos.

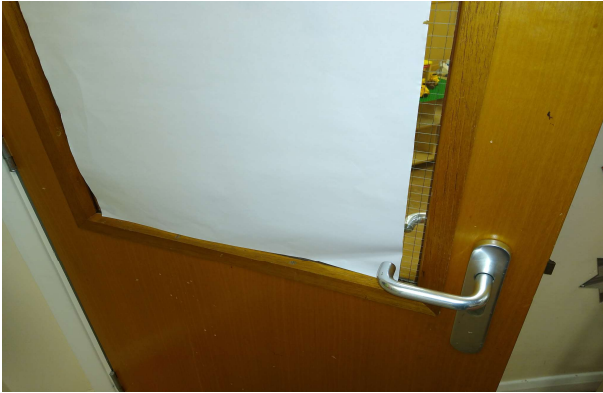
#### **Item 160 Ref: As 369386-33**

The sealant to door window panels in Rm 068/Sensory Area does not contain asbestos.

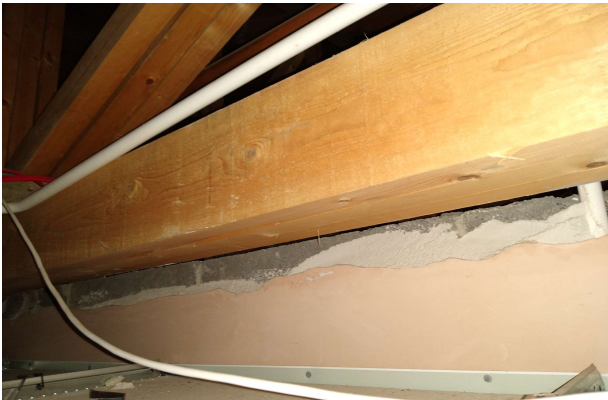
#### **Item 161 Ref: As 369386-32**

The debris to beams in Rm 068/Sensory Area – void above suspended ceiling does not contain asbestos.

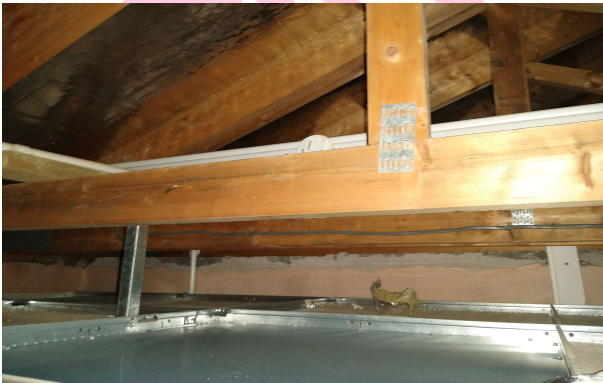
#### **Item 162 Ref: As 369386-32**

The debris to beams in Rm 068/Toilet Cubicles – void above suspended ceiling does not contain asbestos.

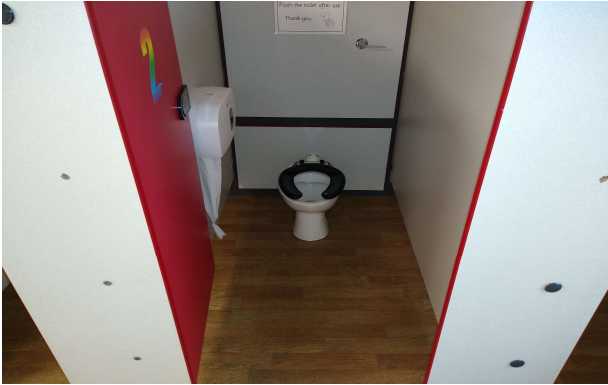
### **Item 163 Ref: 369386-34**

The toilet seats in Rm 069/Toilet Cubicles does not contain asbestos.

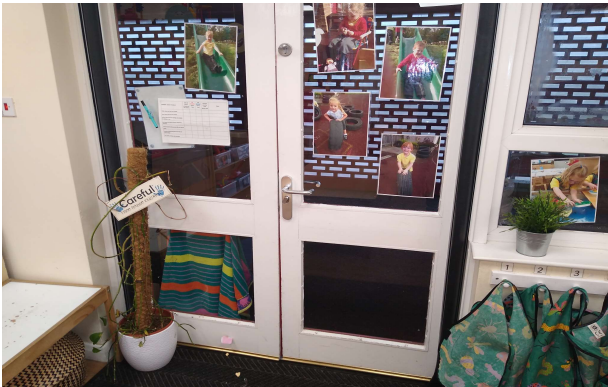
### **Item 164 Ref: As 369386-31**

The sealant to play area door window panels in Rm 070/Nursery does not contain asbestos.

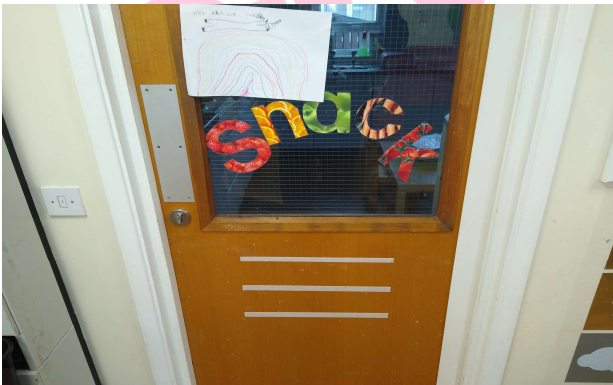
### **Item 165 Ref: 369386-33**

The sealant to staff kitchen and sensory door window panels in Rm 070/Nursery does not contain asbestos.

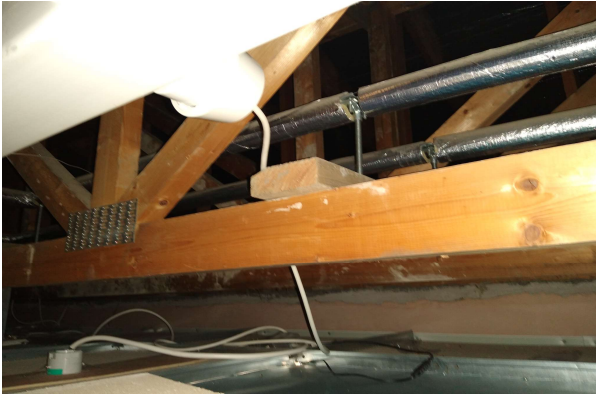
### **Item 166 Ref: As 369386-32**

The debris to beams in Rm 070/Nursery – void above suspended ceiling does not contain asbestos.

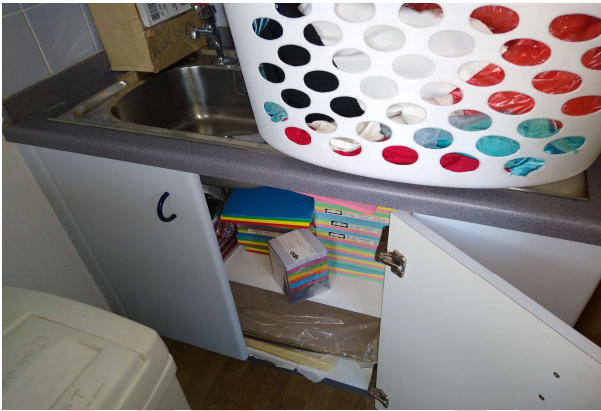
### **Item 167 Ref: 369386-67**

The sink pads to sink and drainer in Rm 071/Wash room does not contain asbestos.

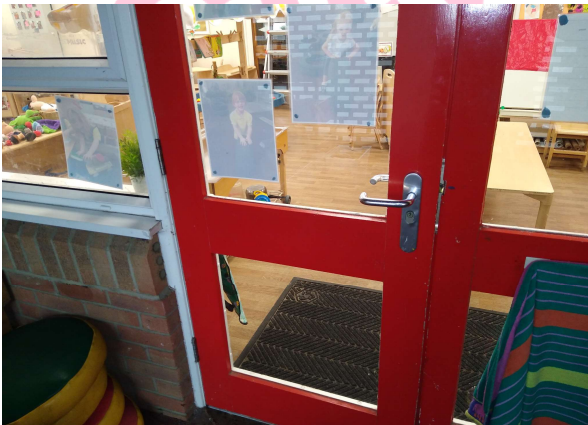
### **Item 168 Ref: 369386-31**

The sealant to door window panels in Rm 073/Play Area does not contain asbestos.

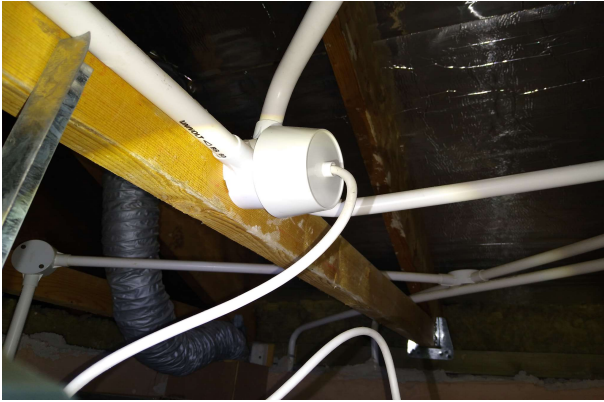
**Item 169 Ref: 369386-32**

The debris to beams in Rm 075/Accessible WC – void above suspended ceiling does not contain asbestos.

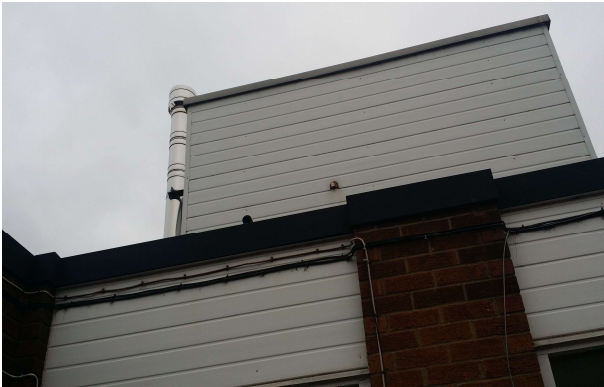
**Item 170 Ref: 369386-96**

The flat roof covering - top felt (External) does not contain asbestos.

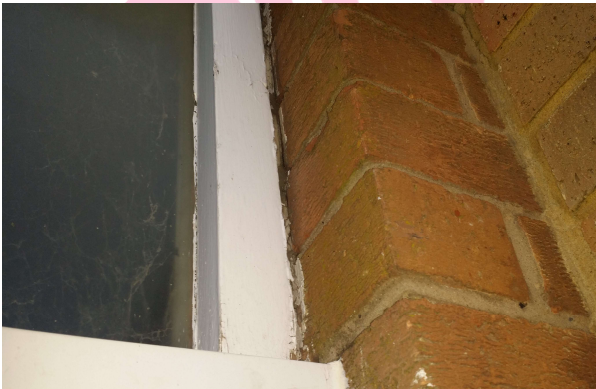
**Item 171 Ref: 369386-95**

The mastic to boiler doors (External) contains asbestos.

Any change in its appearance should be recorded and passed to Property Services.

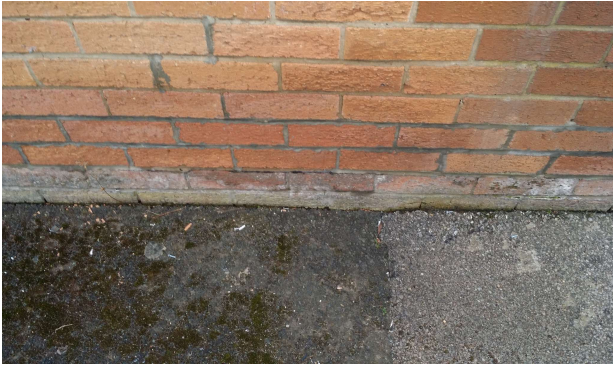
### **Item 172 Ref: 369386-97**

The damp proof course  
(External) does not contain  
asbestos.

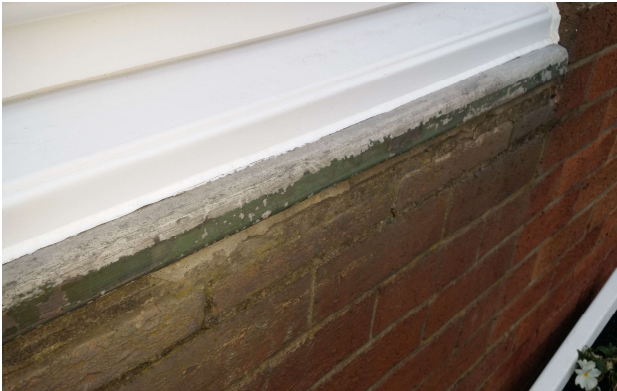
### **Item 173 Ref: 369386-98**

The windowsills to kitchen  
(External) contain asbestos.

Any change in its appearance  
should be recorded and passed  
to Property Services.

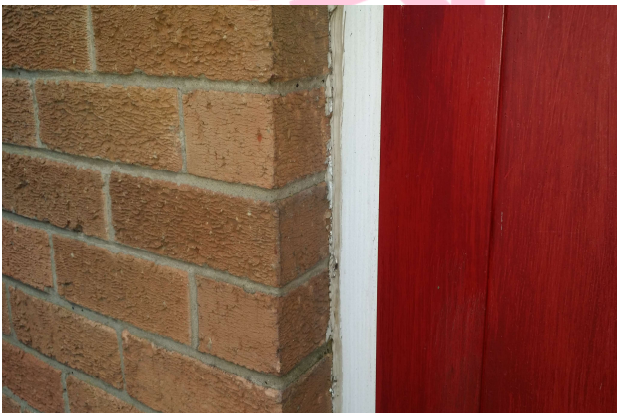
### **Item 174 Ref: 369386-99**

The mastic to kitchen door  
(External) does not contain  
asbestos.

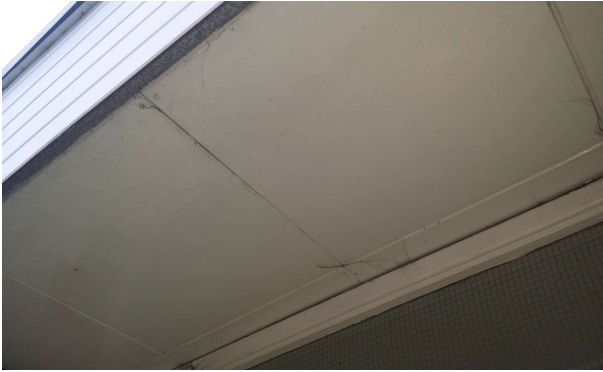
### **Item 175 Ref: 369386-100**

The canopy's (External) contain asbestos.

Any change in its appearance should be recorded and passed to Property Services.

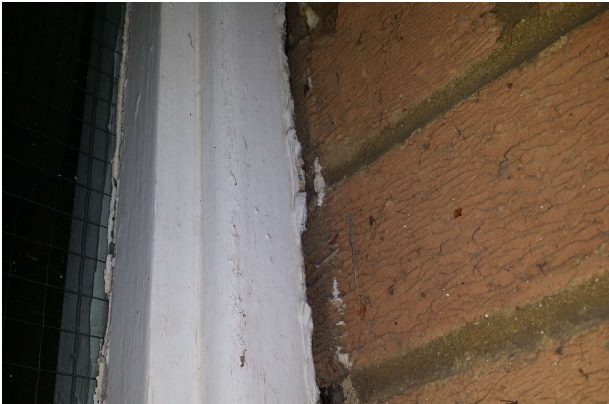
### **Item 176 Ref: 369386-101**

The mastic to frames (External) does not contain asbestos.

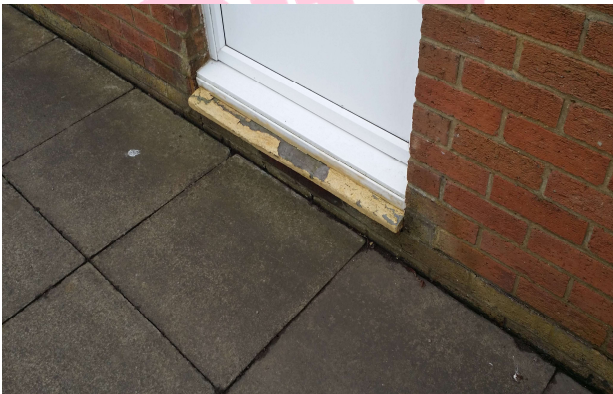
### **Item 177 Ref: As 369386-98**

The windowsill to rear of school (External) contain asbestos.

Any change in its appearance should be recorded and passed to Property Services.

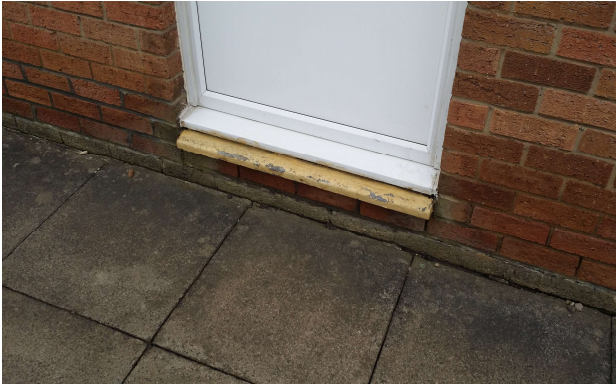
#### **Item 178 Ref: As 369386-98**

The windowsill to LHS rear of school (External) contain asbestos.

Any change in its appearance should be recorded and passed to Property Services.

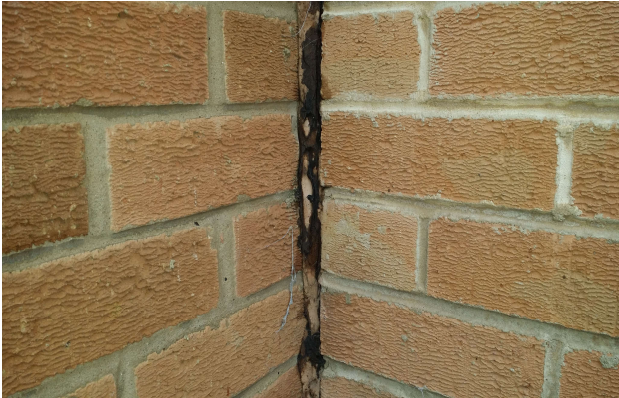
#### **Item 179 Ref: 369386-102**

The expansion gap filler to wall (External) does not contain asbestos.

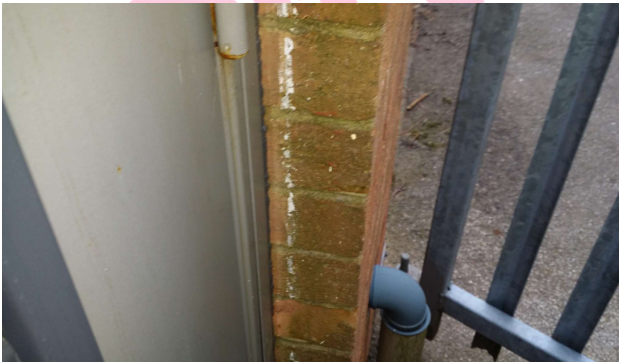
#### **Item 180 Ref: 369386-103**

The remnant mastic to walls (External) does not contain asbestos.

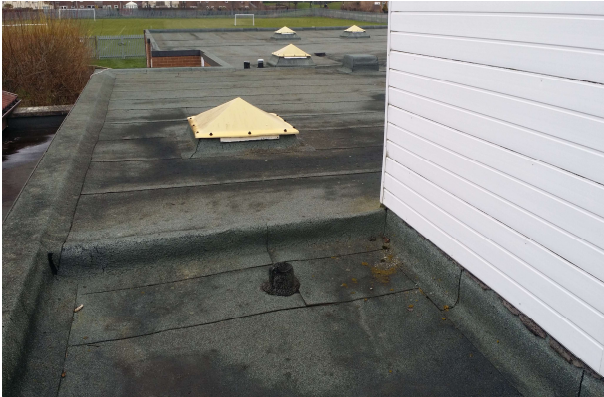
### **Item 181 Ref: 369386-104**

The flat roof covering – top felt (External) does not contain asbestos.

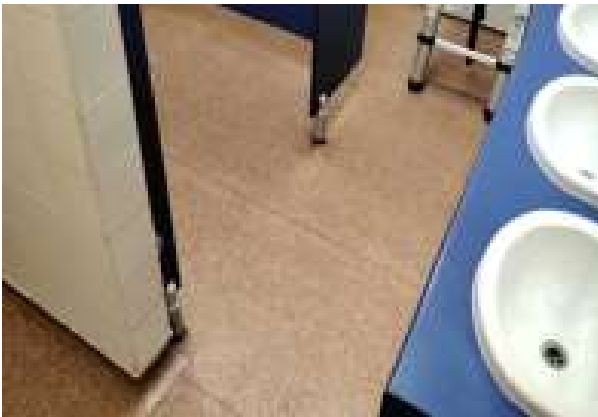
### **Item 182 Ref: DC0003614**

The floor screed below modern covering in the male toilets (Room G/001) does not contain asbestos.

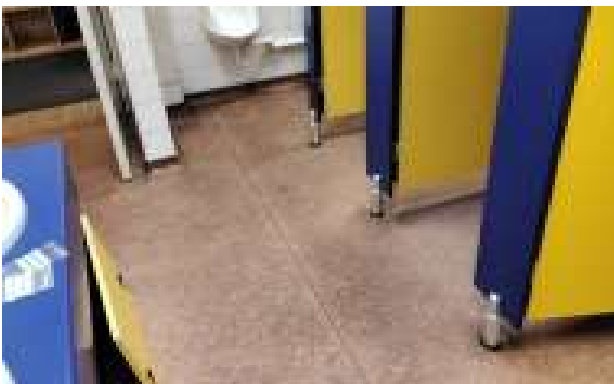
### **Item 183 Ref: DC0003615**

The floor screed below modern covering in the male toilets (Room G/002) does not contain asbestos.

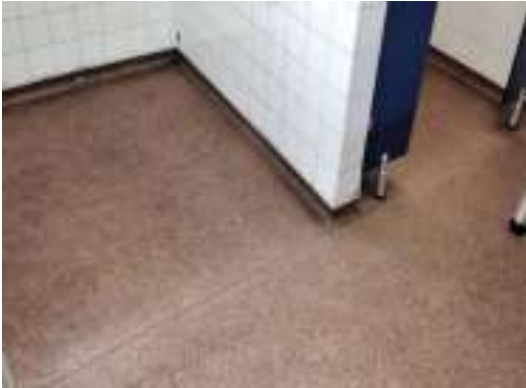
**Item 184 Ref: DC0003616**

The floor screed below modern covering in the male toilets (Room G/003) does not contain asbestos.
