ASBESTOS SURVEY REPORT FOR ALBANY PRIMARY SCHOOL, CROSSGILL, WASHINGTON, NE37 1UA.

Asbestos Register for Albany Primary School, Crossgill, Washington

Date: 13 February 2025

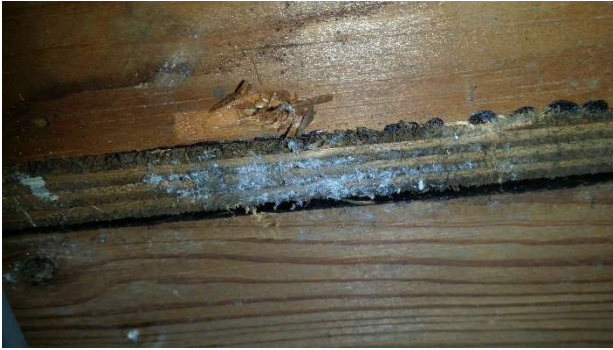
Item 1 Ref: 369386-6

- (Item 1) Ref: 369386-6 – Debris to beam and within nail holes (004/Corridor void above) - Low Risk
- (Item 2) Ref: 369386-50 – Ceiling (012/Boiler Room) – No Risk

The debris to beam and within nail holes in Rm 004/Corridor void above contains asbestos.

Any change in its appearance should be recorded and passed to Property Services.

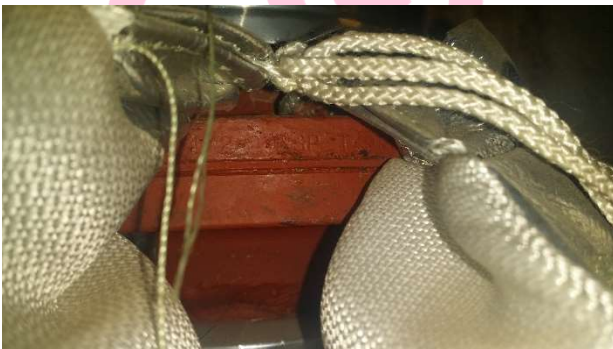
Item 3 Ref: 369386-51

The gasket to pipework in Rm 012/Boiler Room does not contain asbestos.

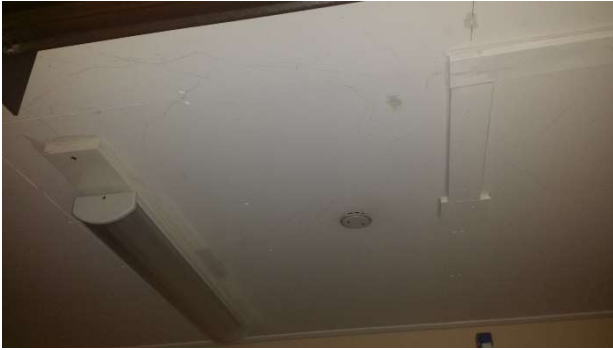
Item 4 Ref: 369386-47

The ceiling in Rm 013/Hall Store does not contain asbestos.

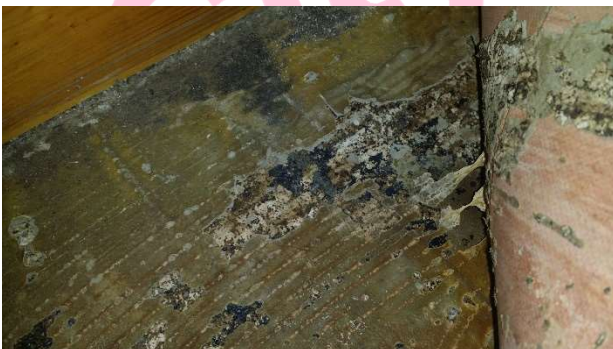
Item 6 Ref: 369386-44

The remnant adhesive backing to floor in Rm 014/Hall Dining Area contains asbestos.

Any change in its appearance should be recorded and passed to Property Services.

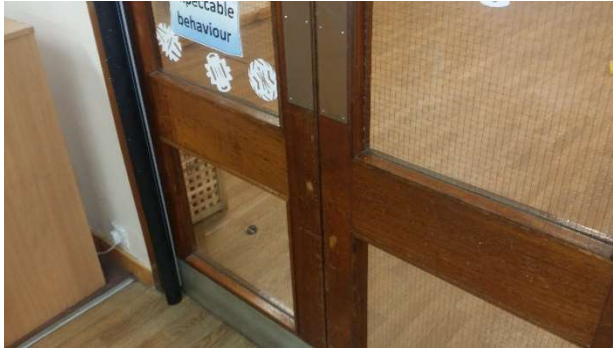
Item 7 Ref: As 369386-27

The mastic to glazing at doors in Rm 014/Hall dining area contains asbestos.

Any change in its appearance should be recorded and passed to Property Services.

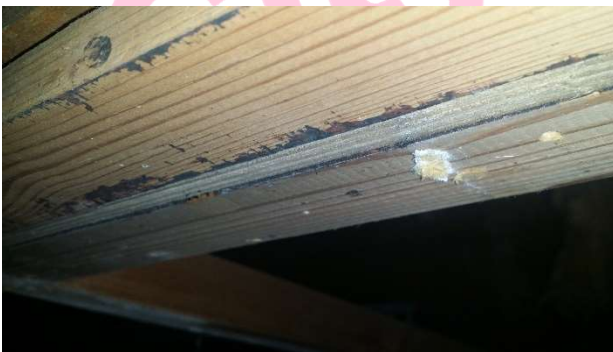
Item 9 Ref: 369386-45

The residue to beams and joists in Rm 014/Hall dining area void above contain asbestos.

Any change in its appearance should be recorded and passed to Property Services.

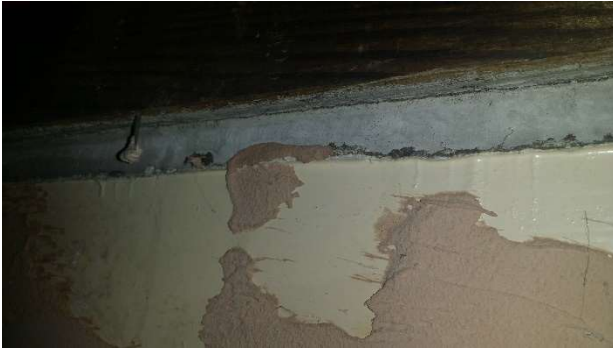
Item 10 Ref: As 369386-45

The residue to wall tops in Rm 014/Hall dining area void above contains asbestos.

Any change in its appearance should be recorded and passed to Property Services.

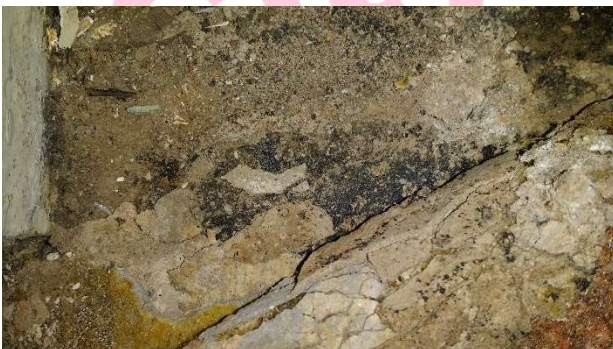
Item 12 Ref: 369386-30

The remnant adhesive backing to floor in Rm 015/Cabinet of curiosities contains asbestos.

Any change in its appearance should be recorded and passed to Property Services.

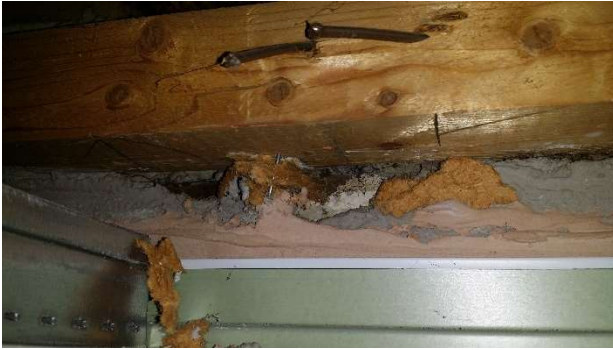
Item 13 Ref: 369386-41

The residue to perimeter walls in Rm 015/Cabinet of curiosities void above contains asbestos.

Any change in its appearance should be recorded and passed to Property Services.

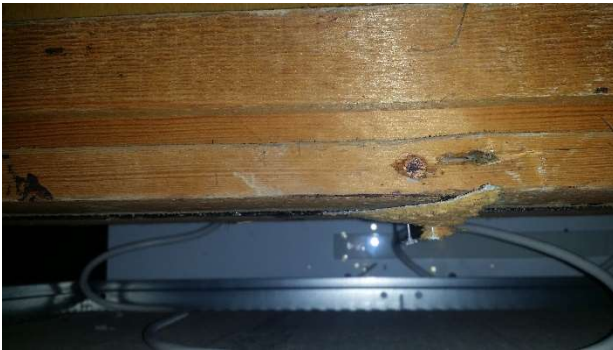
Item 14 Ref: As 369386-41

The remnant ceiling to beams in Rm 015/Cabinet of curiosities void above contains asbestos.

Any change in its appearance should be recorded and passed to Property Services.

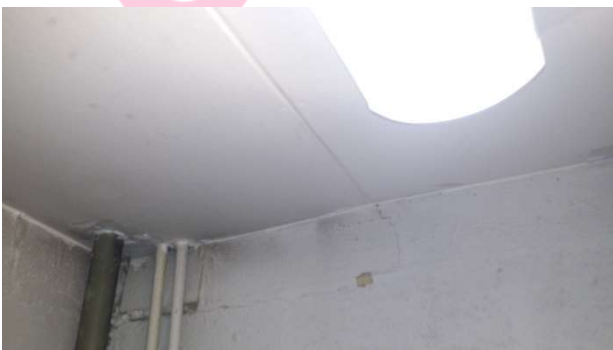
Item 15 Ref: As 369386-26

The ceiling in Rm 015b/IT cupboard does not contain asbestos.

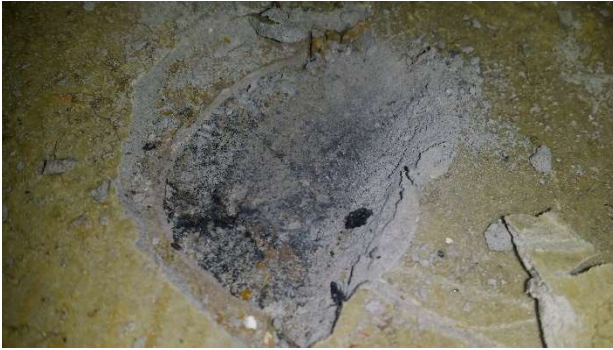
Item 16 Ref: 369386-42

The subfloor in Rm 015b/IT cupboard contains asbestos.

Any change in its appearance should be recorded and passed to Property Services.

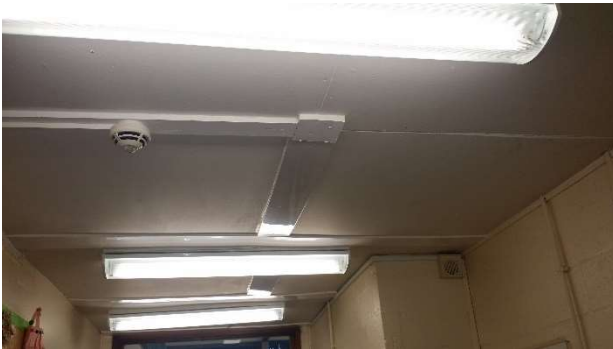
Item 17 Ref: 369386-26

The ceiling in Rm 016/Corridor does not contain asbestos.

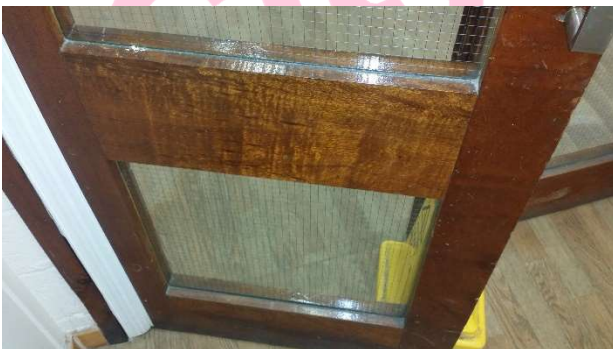
Item 18 Ref: 369386-27

The mastic to glazing at fire doors into hall in Rm 016/Corridor contains asbestos.

Any change in its appearance should be recorded and passed to Property Services.

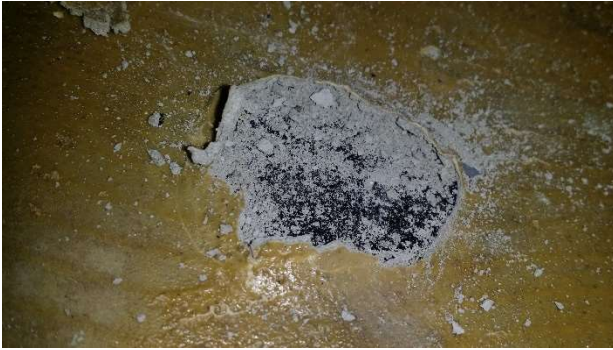
Item 19 Ref: As 369386-25

The remnant adhesive backing to floor in Rm 016/Corridor contains asbestos.

Any change in its appearance should be recorded and passed to Property Services.

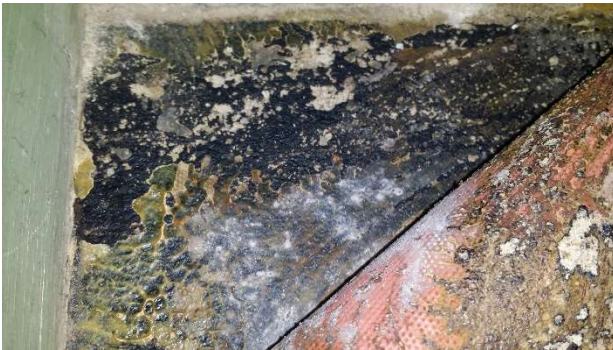
Item 20 Ref: As 369386-25

The remnant adhesive backing to floor in 016a/electrics room contains asbestos.

Any change in its appearance should be recorded and passed to Property Services.

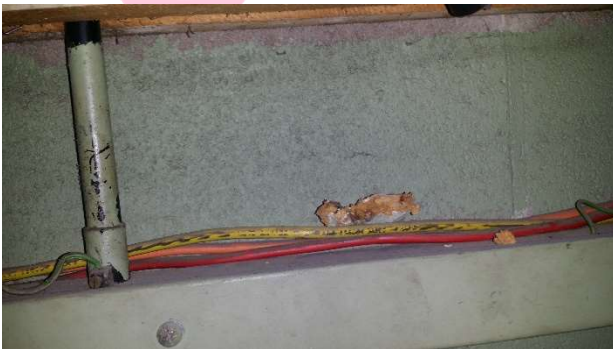
Item 21 Ref: 369386-29

The debris to top of cable trunking in Rm 016a/electrics room contains asbestos.

Any change in its appearance should be recorded and passed to Property Services.

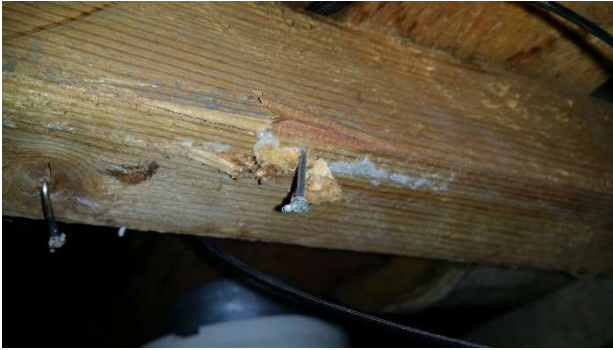
Item 22 Ref: As 369386-29

The residue to beams in Rm 016a/electrics room contains asbestos.

Any change in its appearance should be recorded and passed to Property Services.

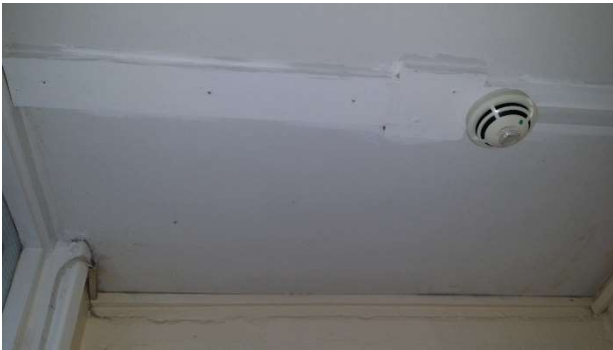
Item 23 Ref: As 369386-26

The ceiling in Rm 016b/ Corridor lobby does not contain asbestos.

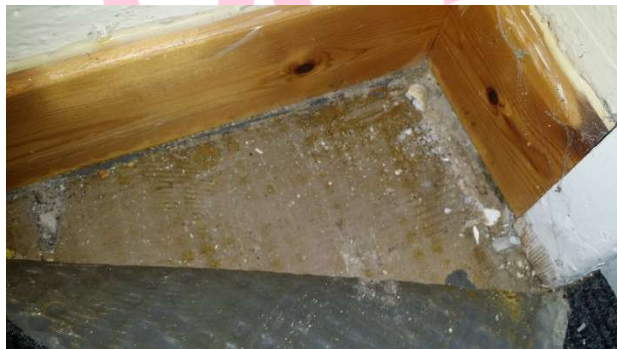
Item 24 Ref: 369386-28

The subfloor in Rm 016b/ Corridor lobby contains asbestos.

Any change in its appearance should be recorded and passed to Property Services.

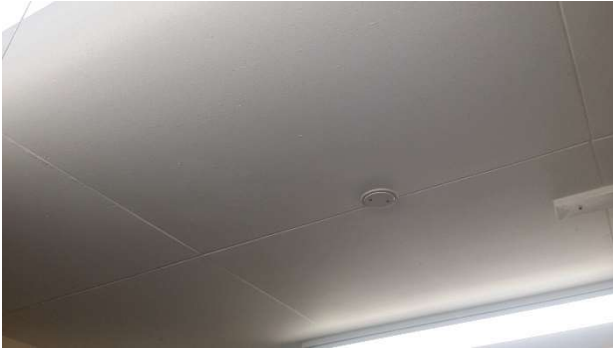
Item 25 Ref: As 369386-26

The ceiling in Rm 017/Sensory room does not contain asbestos.

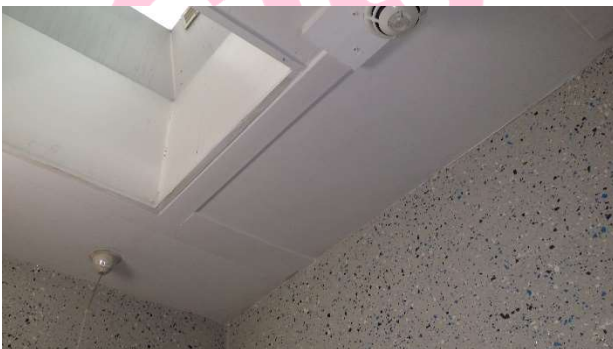
Item 27 Ref: As 369386-26

The ceiling in Rm 018/Male toilet does not contain asbestos.

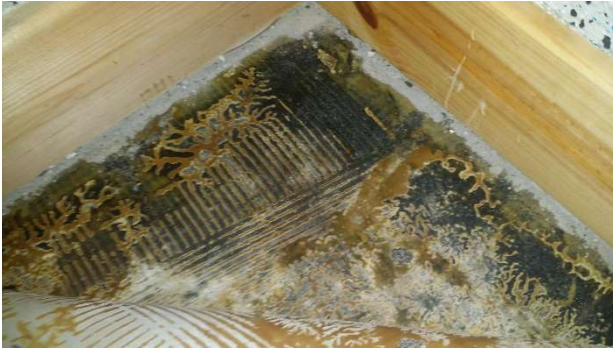
Item 28 Ref: As 369386-30

The remnant adhesive backing to floor in Rm 018/Male toilet contains asbestos.

Any change in its appearance should be recorded and passed to Property Services.

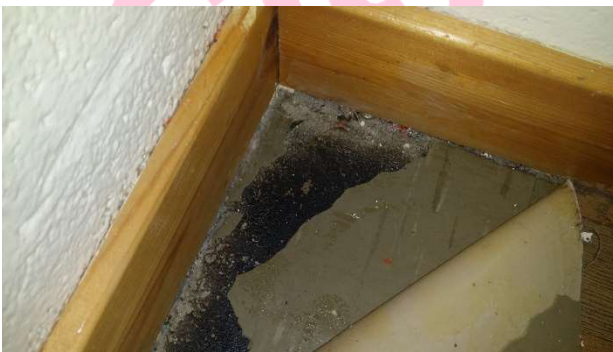
Item 30 Ref: As 369386-30

The remnant adhesive backing to floor in Rm 019/Female toilet contains asbestos.

Any change in its appearance should be recorded and passed to Property Services.

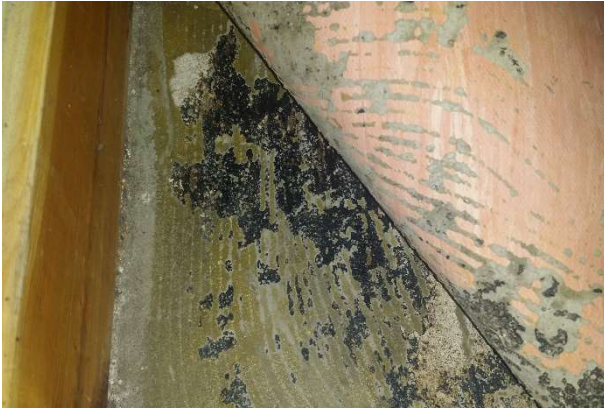
Item 34 Ref: As 369386-44

- (Item 34) Ref: As 369386-44 – Remnant adhesive backing to floor (021/Hall store) – Very Low Risk
- (Item 35) Ref: 369386-48 – Packing to skylight top (021/Hall store) – No Risk

The remnant adhesive backing to floor in Rm 021/Hall Store contains asbestos.

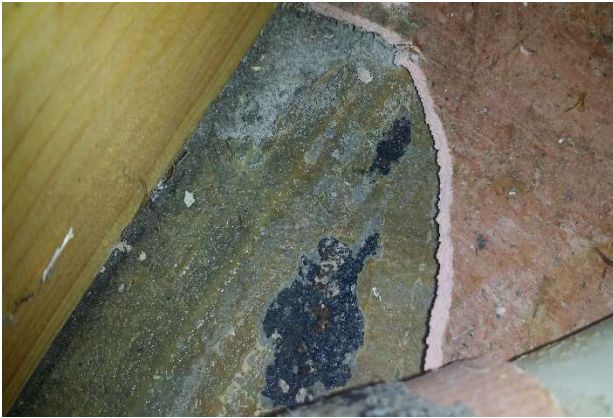
Item 37 Ref: As 369386-44

- (Item 36) Ref: 369386-49 – Ceiling (022/Hall Store) – Very Low Risk
- (Item 37) Ref: As 369386-44 – Remnant adhesive backing to floor (022/Hall Store) – Very Low Risk

The remnant adhesive backing to floor in Rm 022/Hall Store contains asbestos.

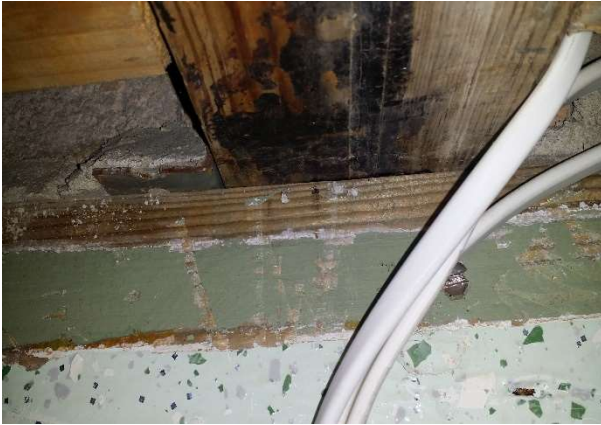
Item 40 Ref: 369386-91

- (Item 40) Ref: 369386-91 – Residue to joists (024/Classroom void above) – Low Risk
- (Item 41) Ref: 369386-92 – Packing to joists (024/Classroom void above) - No Risk

The residue to joints in Rm 024/Classroom – void above contains asbestos.

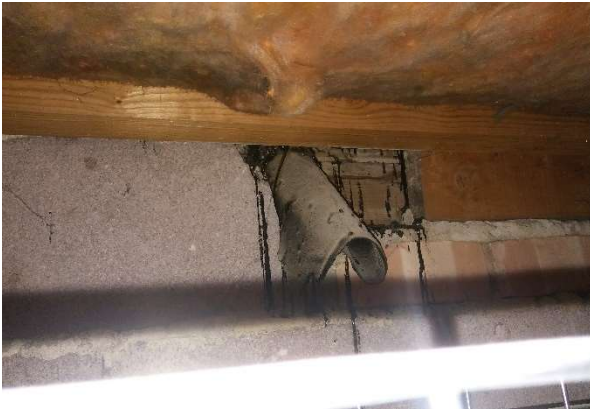
Item 46 Ref: 369386-93

The packing to underside of roof in Rm 026b/Classroom – void above contains asbestos.

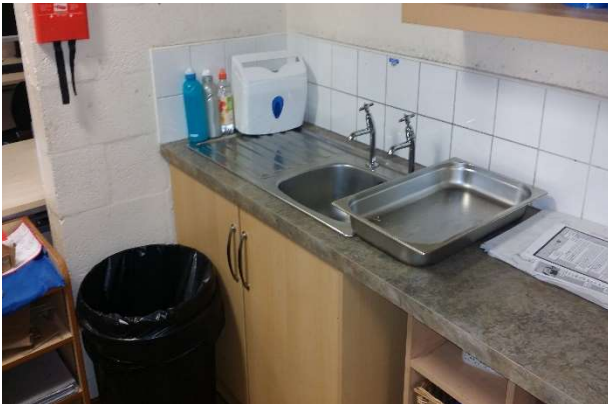
Item 68 Ref: As 369386-7

The sink pad in Rm 035/Classroom does not contain asbestos.

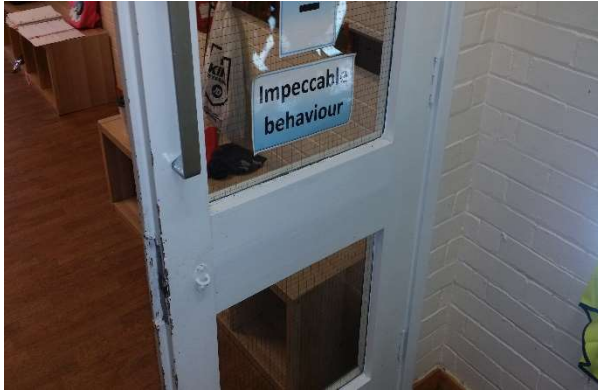
Item 76 Ref: 369386-5

The mastic to glazing on fire door in Rm 037a/Corridor contains asbestos.

Any change in its appearance should be recorded and passed to Property Services.

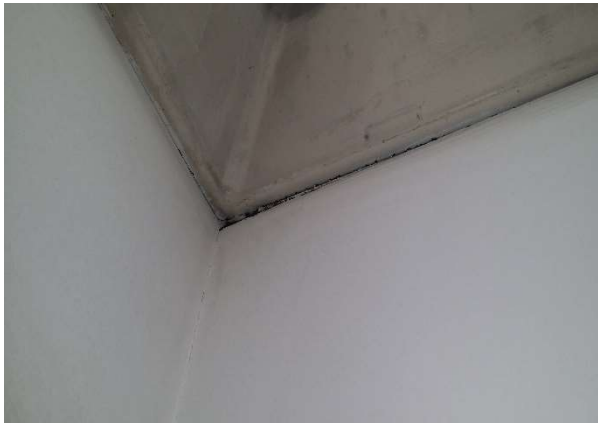
Item 77 Ref: 369386-4

The packing to skylight tops in Rm 038/Cloakroom does not contain asbestos.

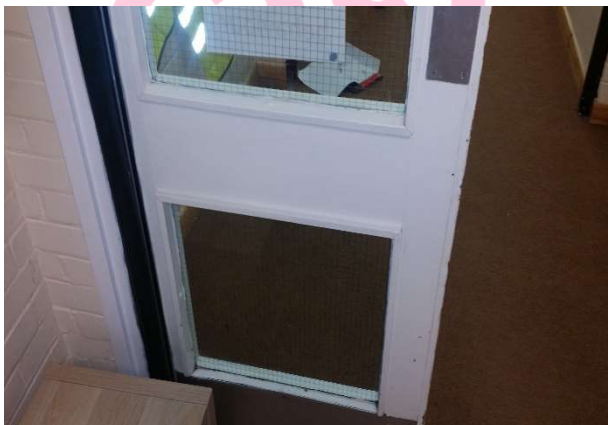
Item 78 Ref: As 369386-5

The mastic to fire doors in Rm 038/Cloakroom contains asbestos.

Any change in its appearance should be recorded and passed to Property Services.

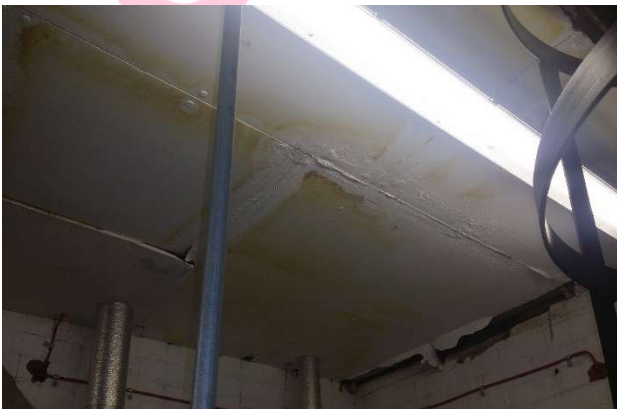
Item 93 Ref: 369386-55

The ceiling in Rm 043/Boiler Room does not contain asbestos.

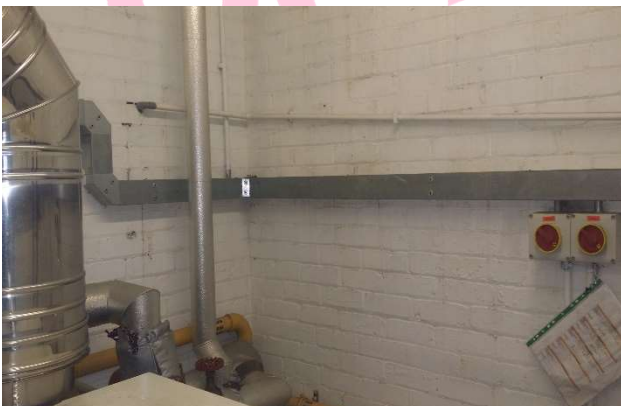
Item 96 Ref: 369386-56

The debris to walls in Rm 043/Boiler Room does not contain asbestos.

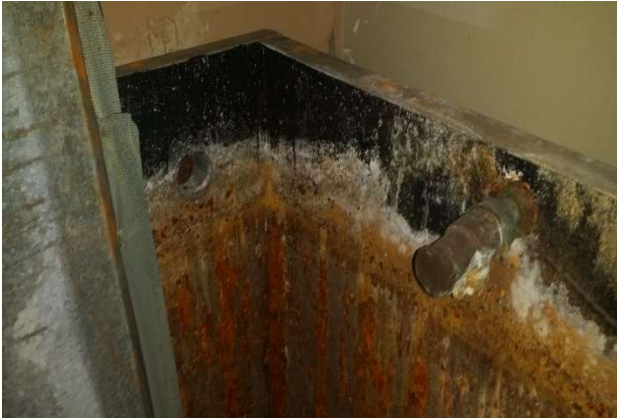
Item 97 Ref: 369386-57

The paint to metal tanks in Rm 043/Boiler Room – void above does not contain asbestos.

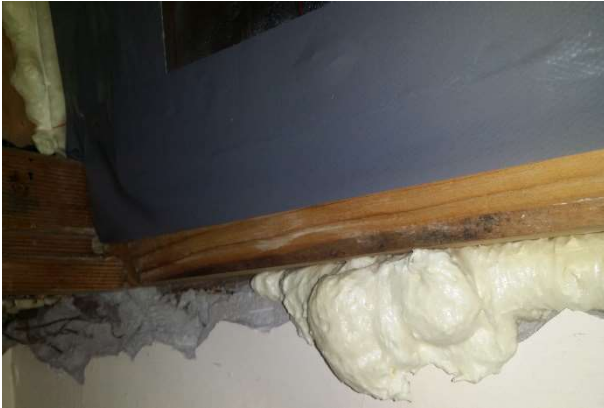
Item 100 Ref: Presumed

The debris to wall gap behind foam insulation in Rm 046/Girls Toilet – void above contains asbestos.

Removed August 2023

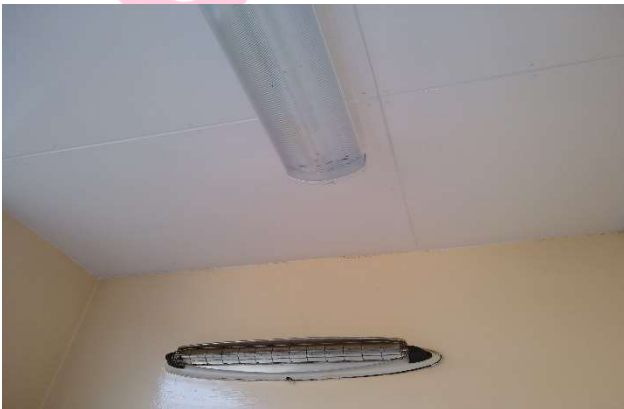
Item 108 Ref: 369386-62

The fixed ceiling tiles in Rm 048a/Kitchen Office contains asbestos.

Any change in its appearance should be recorded and passed to Property Services.

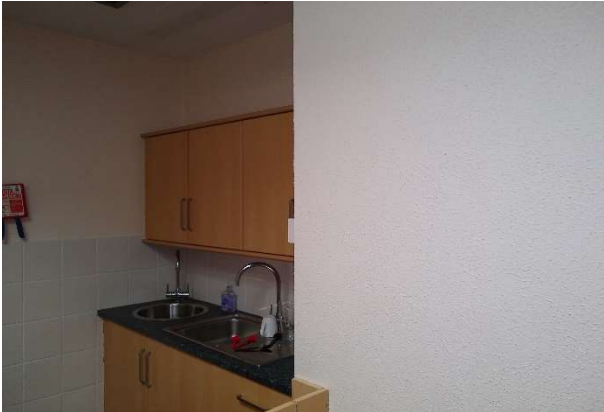
Item 112 Ref: 369386-69

The coating to wall in Rm 050/Breakfast Room does not contain asbestos.

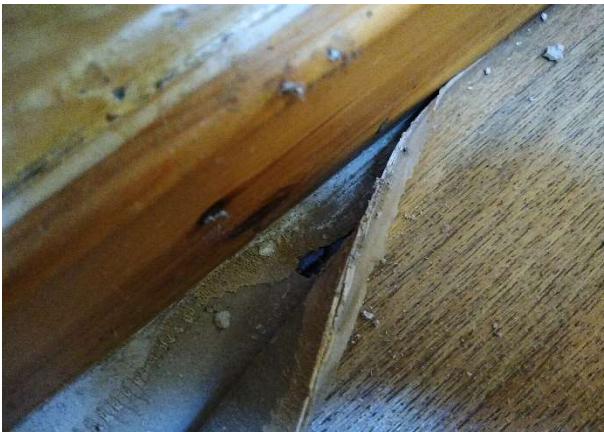
Item 113 Ref: As 369386-76

The floor in Rm 051/Corridor contains asbestos.

Any change in its appearance should be recorded and passed to Property Services.

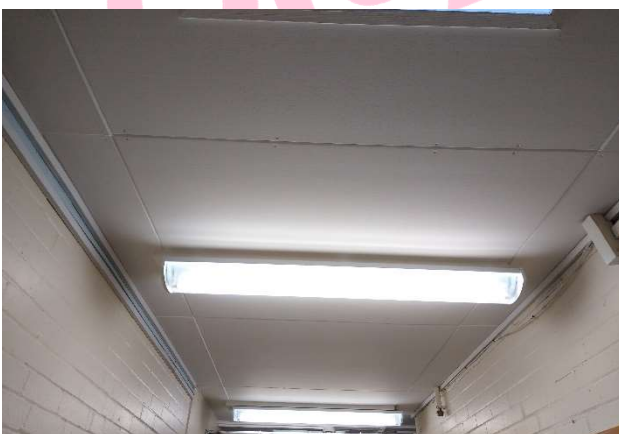
Item 114 Ref: As 369386-80

The ceiling in Rm 051/Corridor contains asbestos.

Any change in its appearance should be recorded and passed to Property Services.

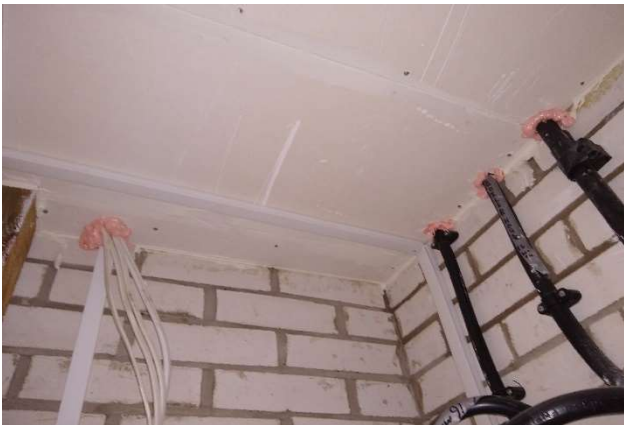
Item 116 Ref: 369386-75

The fixed ceiling tiles in Rm 051a/Electric Cupboard does not contain asbestos.

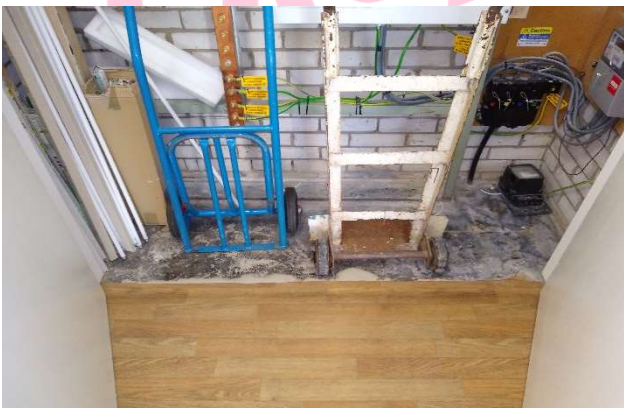
Item 117 Ref: 369386-76

The adhesive to floor in Rm 051a/Electric Cupboard contains asbestos.

Any change in its appearance should be recorded and passed to Property Services

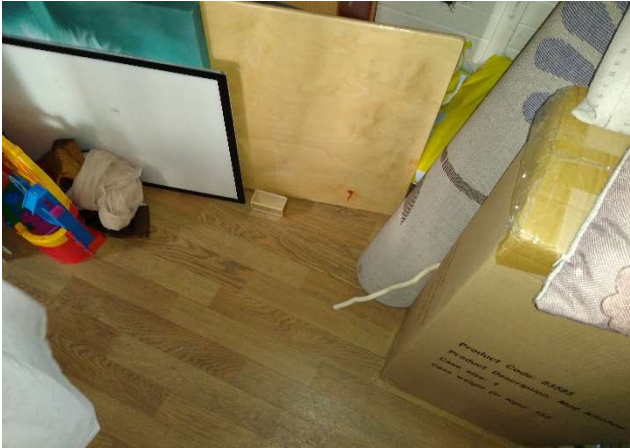
Item 118 Ref: As 369386-66

The floor under screed in Rm 051a/Store contains asbestos.

Any change in its appearance should be recorded and passed to Property Services.

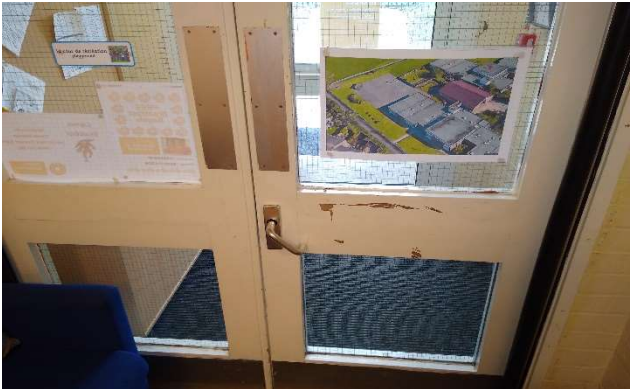
Item 119 Ref: 369386-40

The sealant to lobby door window panels in Rm 051b/Corridor contains asbestos.

Any change in its appearance should be recorded and passed to Property Services.

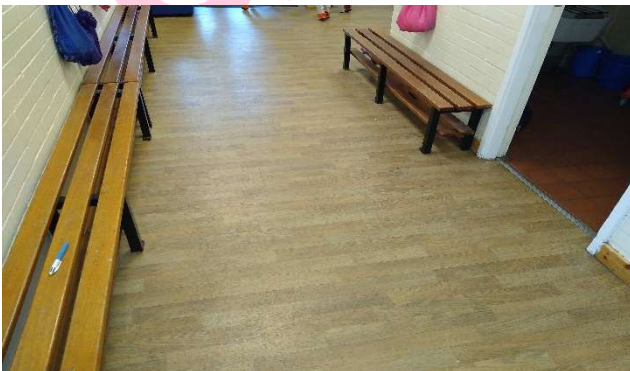
Item 120 Ref: As 369386-66

The floor under screed in Rm 051b/Corridor contains asbestos.

Any change in its appearance should be recorded and passed to Property Services.

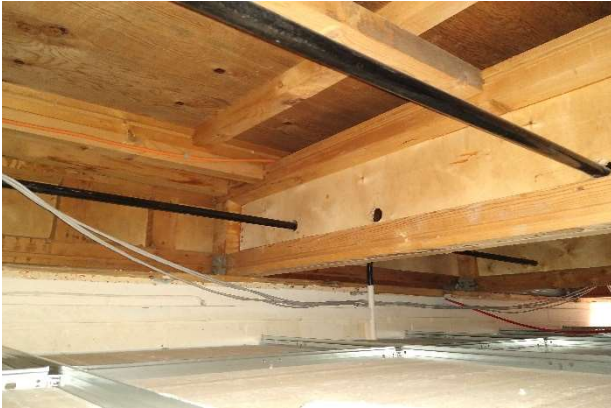
Item 121 Ref: 369386-63

The debris to beams in Rm 051b/Corridor – void above suspended ceiling contains asbestos.

Removed August 2023

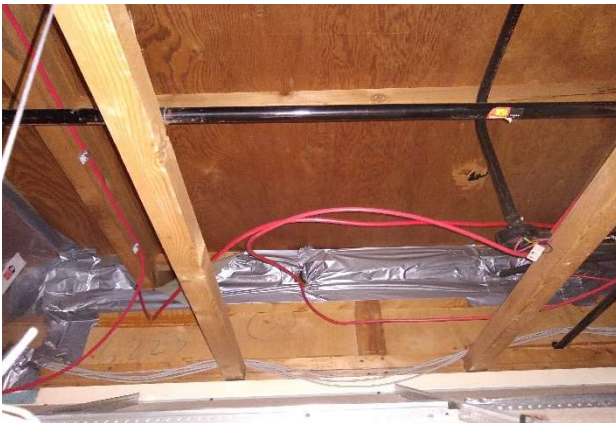
Item 122 Ref: 369386-77

The debris to nail holes in Rm 051b/Entrance Lobby – void above does not contain asbestos.

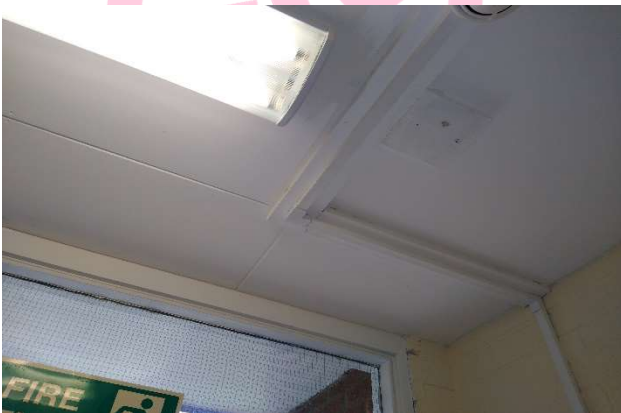
Item 123 Ref: 369386-64

The ceiling in Rm 051c/Lobby contains asbestos.

Any change in its appearance should be recorded and passed to Property Services.

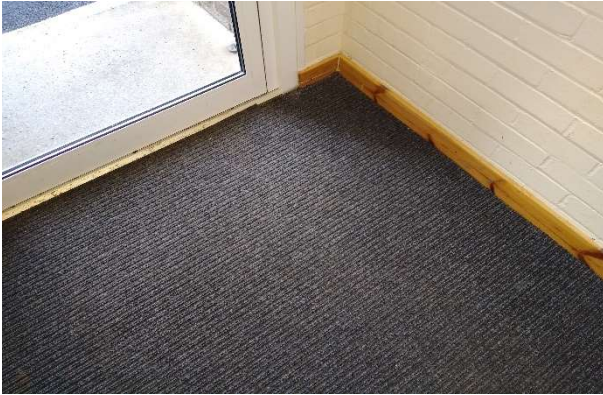
Item 124 Ref: 369386-65

The floor covering under carpet in Rm 051c/Lobby contains asbestos.

Any change in its appearance should be recorded and passed to Property Services.

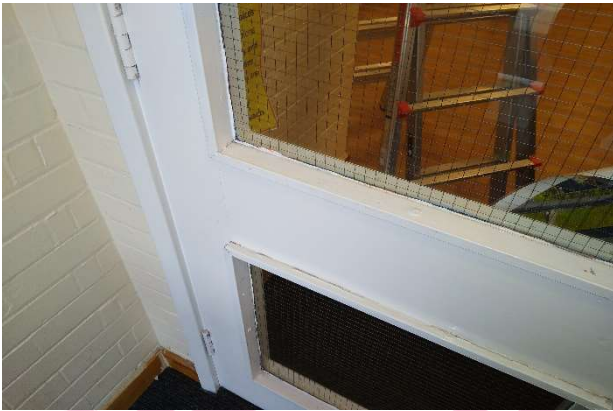
Item 125 Ref: As 369386-40

The sealant to corridor door window panels in Rm 051c/Lobby contains asbestos.

Any change in its appearance should be recorded and passed to Property Services.

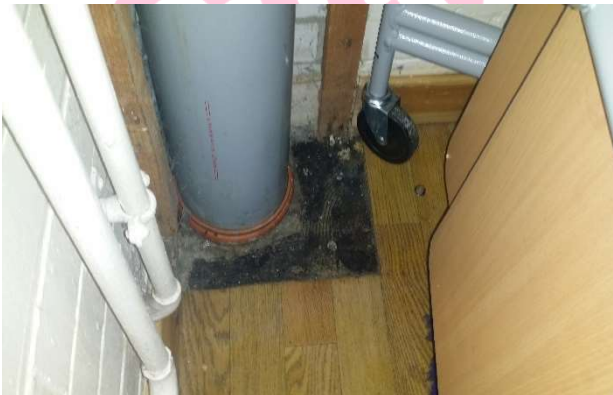
Item 126 Ref: As 369386-85

The remnant adhesive backing to floor in Rm 052/Hall Store contains asbestos.

Any change in its appearance should be recorded and passed to Property Services.

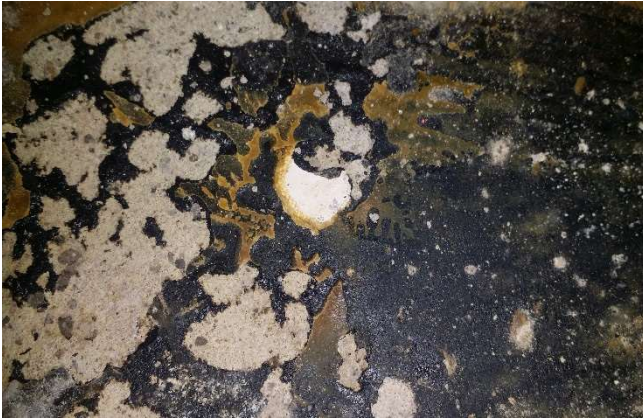
Item 127 Ref: As 369386-85

The remnant adhesive backing to floor in Rm 053/Hall Store contains asbestos.

Any change in its appearance should be recorded and passed to Property Services.

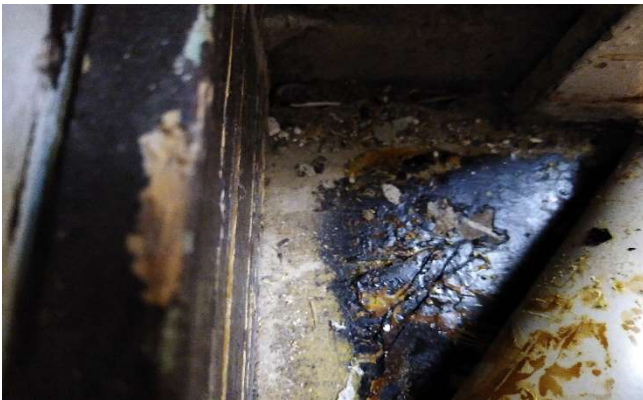
Item 128 Ref: As 369386-76

The floor in Rm 054/Cleaners Cupboard contains asbestos.

Any change in its appearance should be recorded and passed to Property Services.

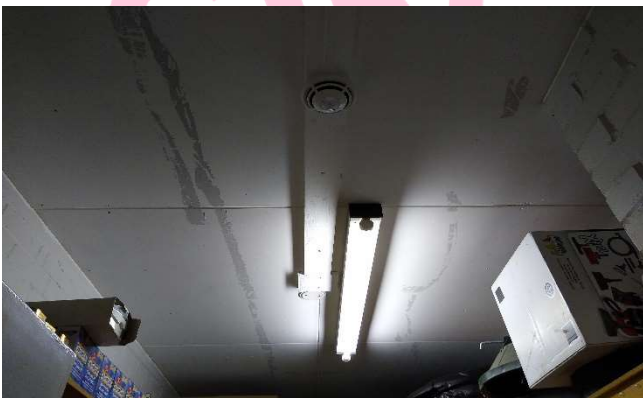
Item 129 Ref: 369386-80

The ceiling in Rm 054/Cleaners Cupboard contains asbestos.

Any change in its appearance should be recorded and passed to Property Services.

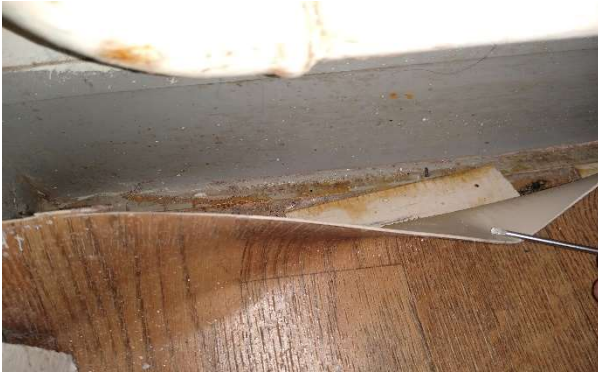
Item 130 Ref: As 369386-87

The floor in Rm 055/Staff Toilet contains asbestos.

Any change in its appearance should be recorded and passed to Property Services.

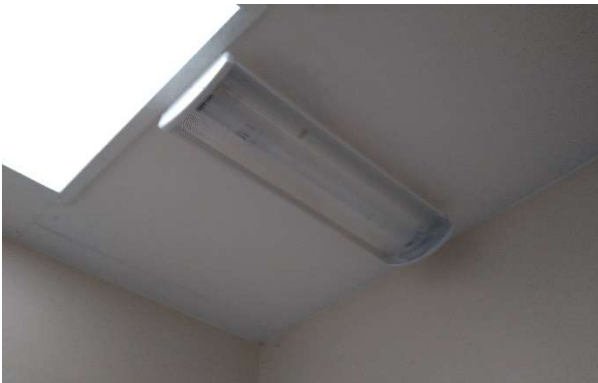
Item 131 Ref: As 369386-80

The ceiling in Rm 055/Staff Toilet contains asbestos.

Any change in its appearance should be recorded and passed to Property Services.

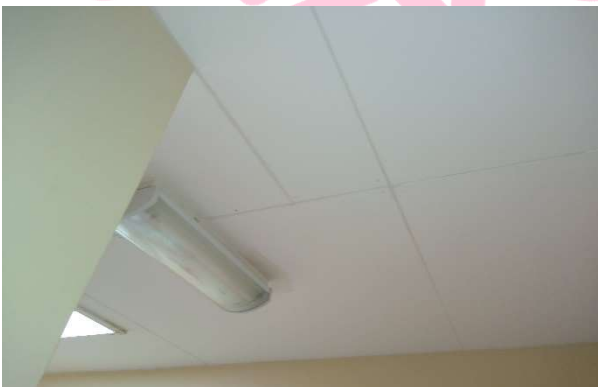
Item 132 Ref: As 369386-64

The ceiling in Rm 058/Girls WC contains asbestos.

Any change in its appearance should be recorded and passed to Property Services.

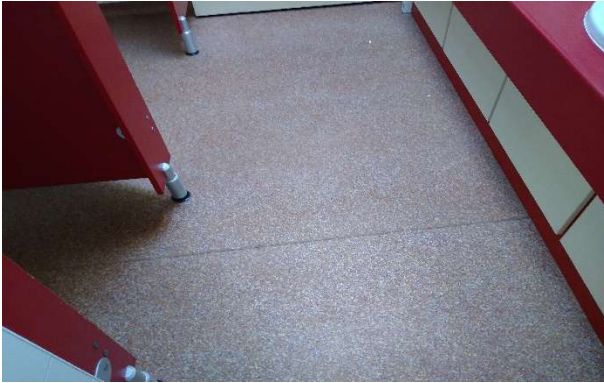
Item 133 Ref: As 369386-66

The floor under screed in Rm 058/Girls WC contains asbestos.

Any change in its appearance should be recorded and passed to Property Services.

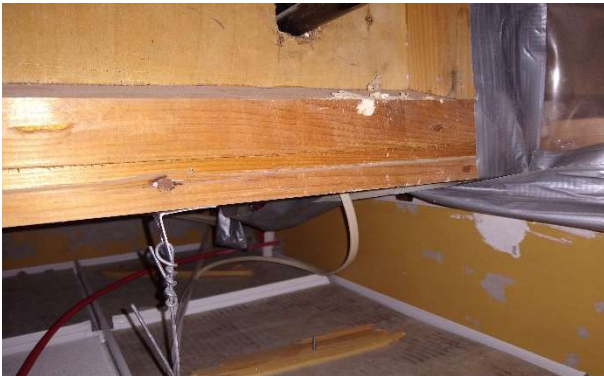
Item 134 Ref: 369386-70

The residue to beams in Rm 059/Accessible WC – void above does not contain asbestos.

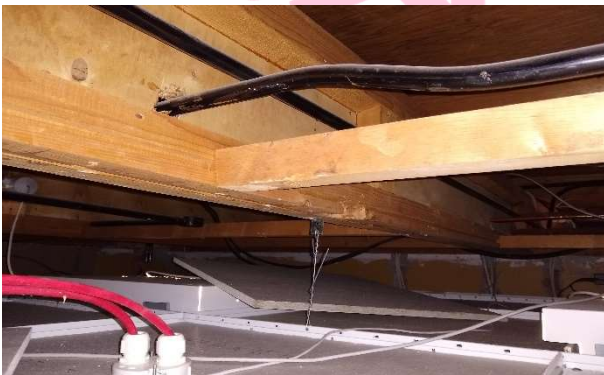
Item 135 Ref: 369386-78

The residue to beams in Rm 059/Accessible WC – void above does not contain asbestos.

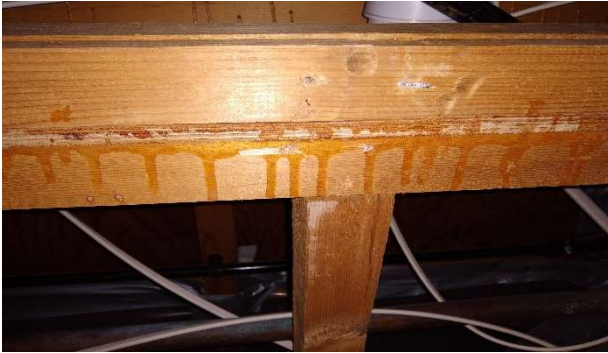
Item 136 Ref: 369386-79

The debris to nail holes in Rm 059/Accessible WC – void above does not contain asbestos.

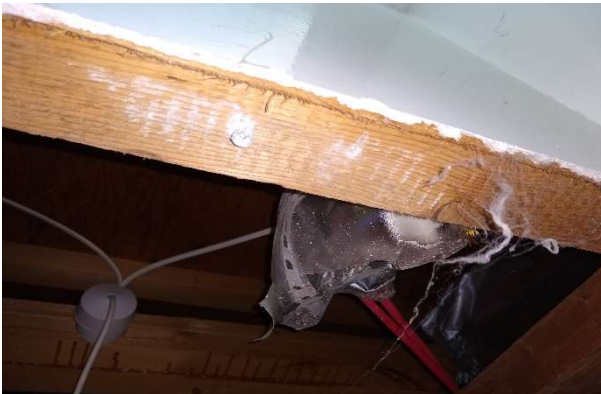
Item 137 Ref: 369386-88

The debris to screw and screw holes in Rm 060/Store – void above contains asbestos.

Any change in its appearance should be recorded and passed to Property Services.

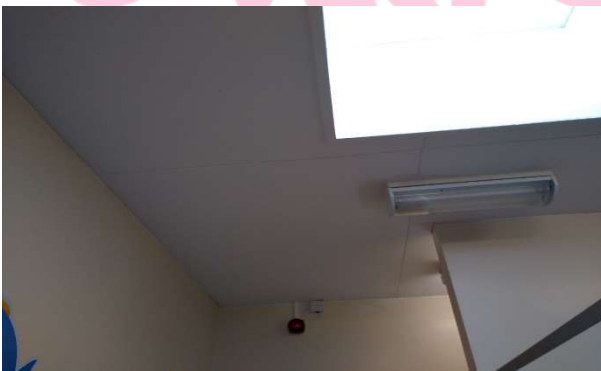
Item 138 Ref: As 369386-80

The ceiling in Rm 061/Boys Toilet contains asbestos.

Any change in its appearance should be recorded and passed to Property Services.

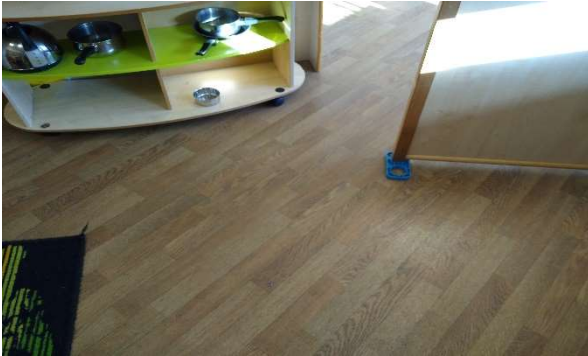
Item 140 Ref: 369386-66

The floor under screed in Rm 062/Classroom contains asbestos.

Any change in its appearance should be recorded and passed to Property Services.

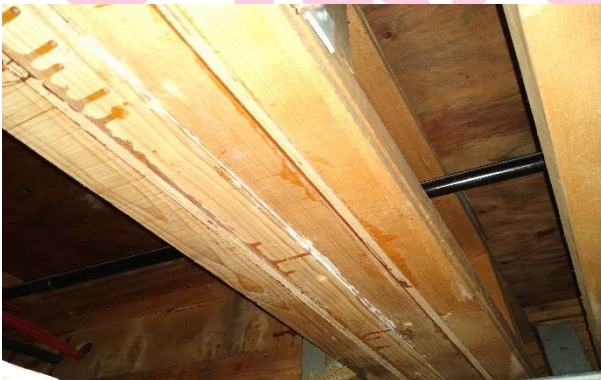
Item 141 Ref: 369386-38

The debris to beams in Rm 062/Classroom – void above suspended ceiling contains asbestos.

Removed August 2023

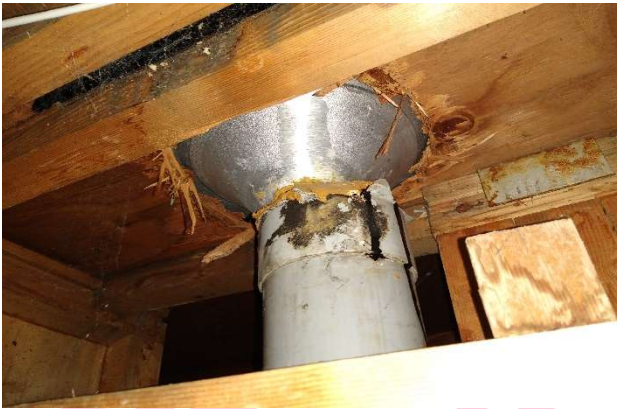
Item 143 Ref: 369386-39

The soil pipe collar sealant in Rm 062/Classroom – void above suspended ceiling does not contain asbestos.

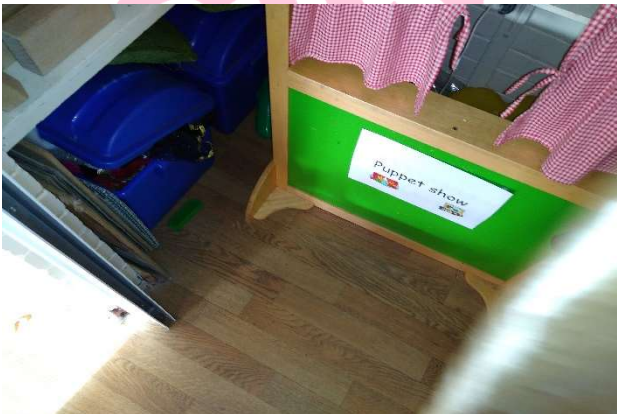
Item 144 Ref: As 369386-66

The floor under screed in Rm 062a/Store contains asbestos.

Any change in its appearance should be recorded and passed to Property Services.

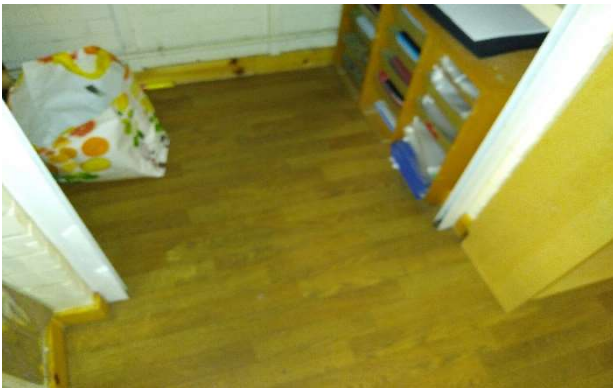
Item 146 Ref: As 369386-66

The floor under screed in Rm 064a/Store contains asbestos.

Any change in its appearance should be recorded and passed to Property Services.

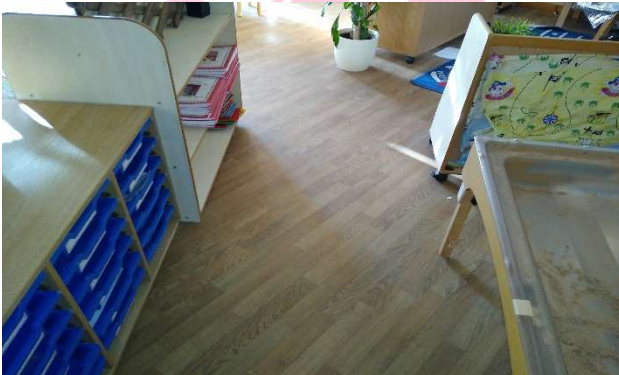
Item 147 Ref: As 369386-66

The floor under screed in Rm 064/Classroom contains asbestos.

Any change in its appearance should be recorded and passed to Property Services.

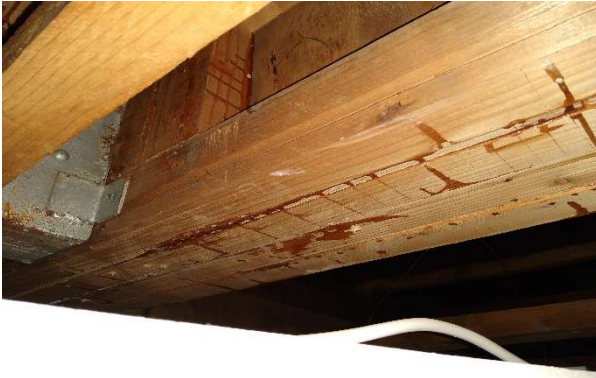
Item 148 Ref: As 369386-38

The debris to beams in Rm 064/Classroom – void above suspended ceiling contains asbestos.

Removed August 2023

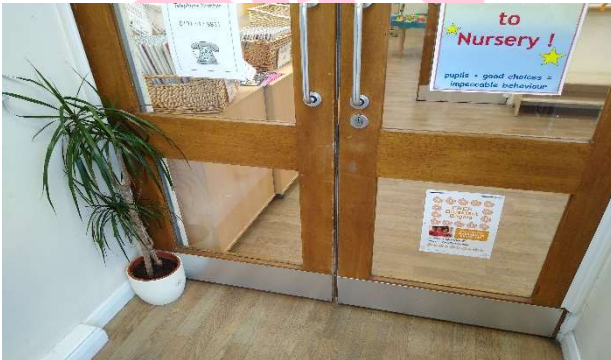
Item 150 Ref: As 369386-36

The sealant to cloakroom door window panels in Rm 065/Link Corridor does not contain asbestos.

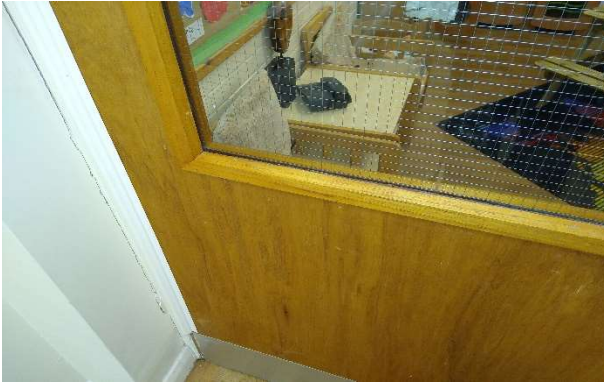
Item 151 Ref: As 369386-33

The sealant to classroom door window panels in Rm 065/Link Corridor does not contain asbestos.

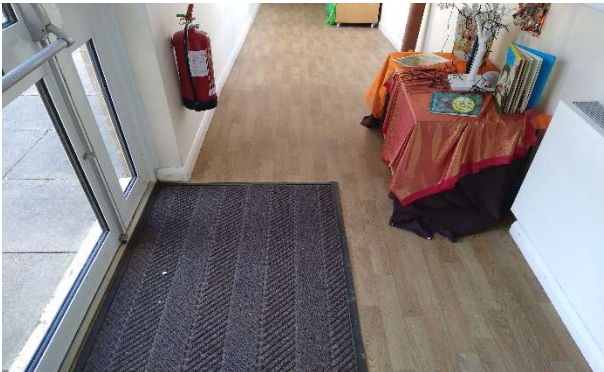
Item 152 Ref: As 369386-66

The floor under screed in Rm 065/Link Corridor contains asbestos.

Any change in its appearance should be recorded and passed to Property Services.

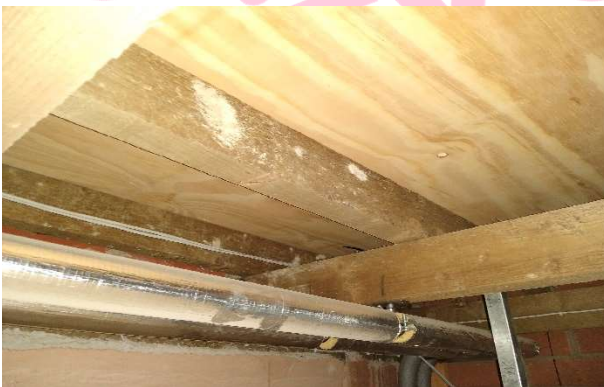
Item 153 Ref: As 369386-32

The debris to beams in Rm 065/Link Corridor – void above suspended ceiling does not contain asbestos.

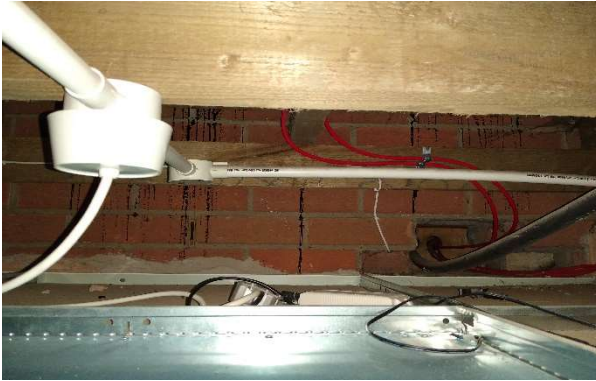
Item 154 Ref: 369386-37

The remnants of roof covering to brick wall in Rm 065/Link Corridor – void above suspended ceiling does not contain asbestos.

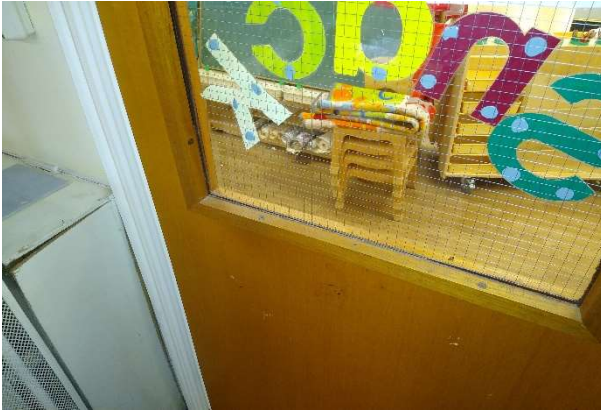
Item 155 Ref: As 369386-33

The sealant to door window panel in Rm 066/Staff Kitchen does not contain asbestos.

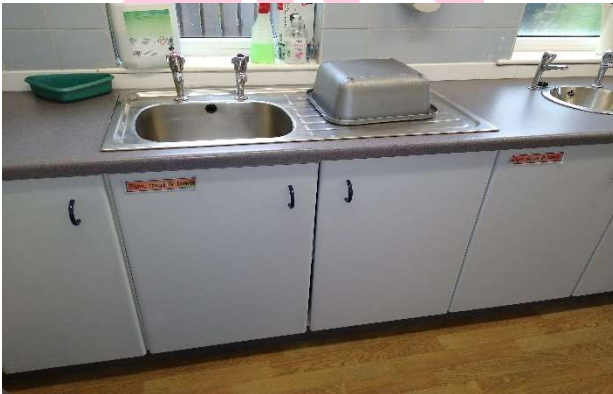
Item 156 Ref: 369386-35

The sink pads to sink and drainer in Rm 066/Staff Kitchen does not contain asbestos.

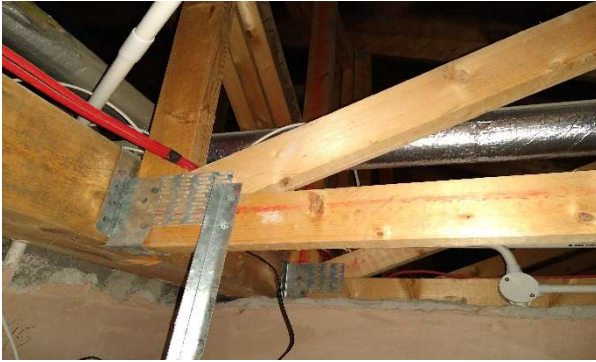
Item 157 Ref: As 369386-32

The debris to beams in Rm 066/Staff Kitchen – void above suspended ceiling does not contain asbestos.

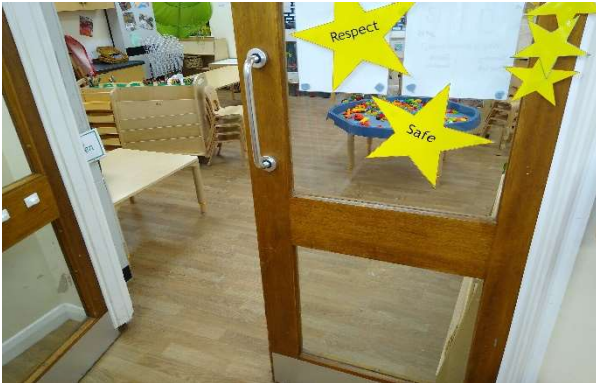
Item 158 Ref: 369386-36

The sealant to nursery door window panels in Rm 067/Cloakroom does not contain asbestos.

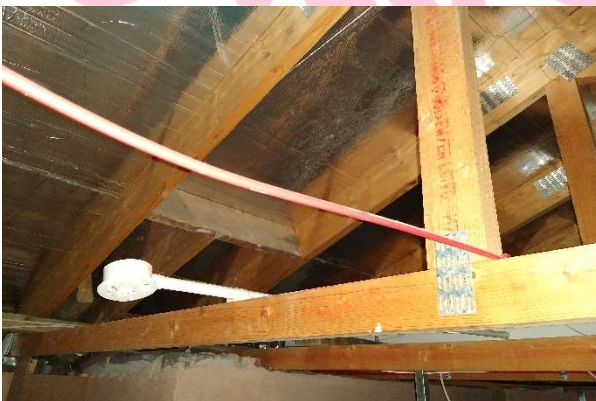
Item 159 Ref: As 369386-32

The debris to beams in Rm 067/Cloakroom – void above suspended ceiling does not contain asbestos.

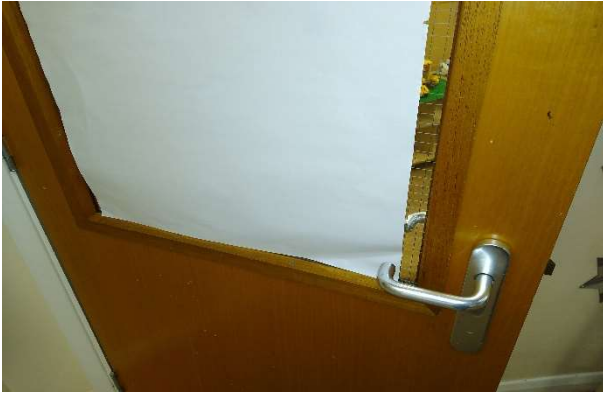
Item 160 Ref: As 369386-33

The sealant to door window panels in Rm 068/Sensory Area does not contain asbestos.

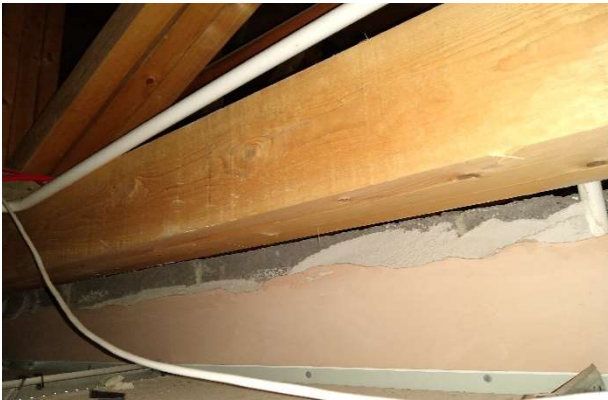
Item 161 Ref: As 369386-32

The debris to beams in Rm 068/Sensory Area – void above suspended ceiling does not contain asbestos.

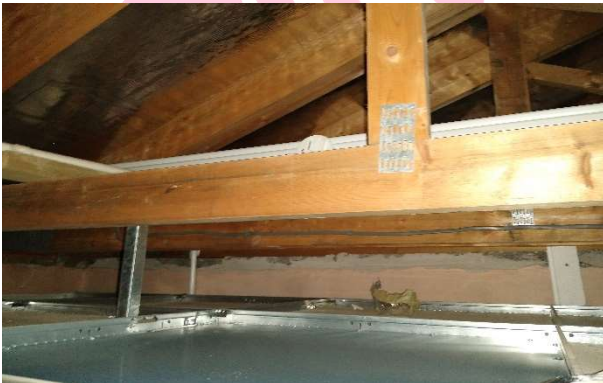
Item 162 Ref: As 369386-32

The debris to beams in Rm 068/Toilet Cubicles – void above suspended ceiling does not contain asbestos.
