ASBESTOS SURVEY REPORT FOR ALBANY PRIMARY SCHOOL, CROSSGILL, WASHINGTON, NE37 1UA.

Asbestos Register for Albany Primary School, Crossgill, Washington

Date: 13 February 2025

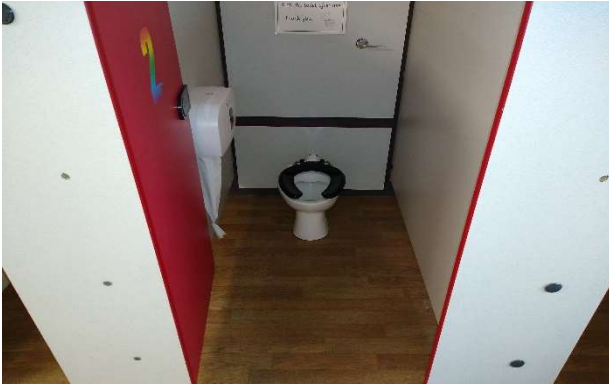
Item 163 Ref: 369386-34

The toilet seats in Rm 069/Toilet Cubicles does not contain asbestos.

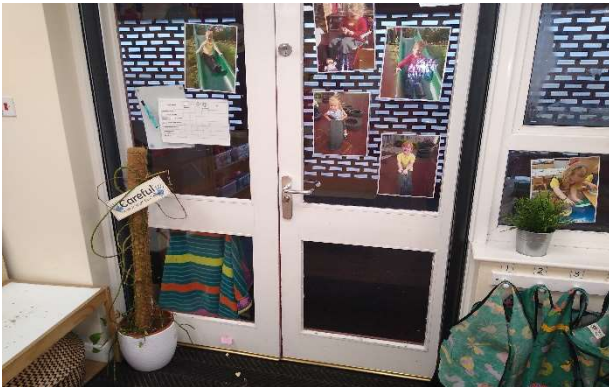
Item 164 Ref: As 369386-31

The sealant to play area door window panels in Rm 070/Nursery does not contain asbestos.

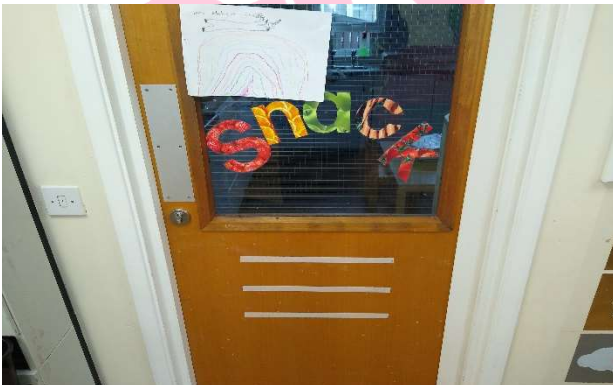
Item 165 Ref: 369386-33

The sealant to staff kitchen and sensory door window panels in Rm 070/Nursery does not contain asbestos.

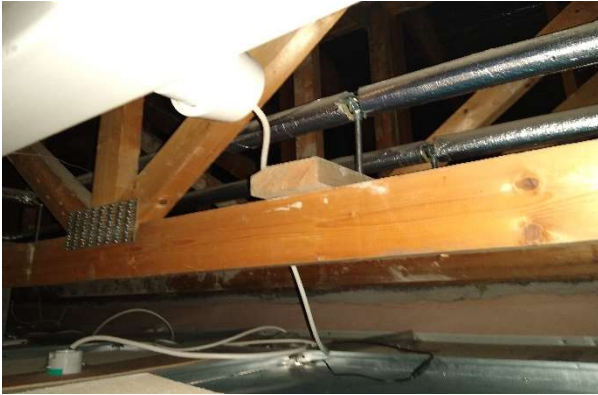
Item 166 Ref: As 369386-32

The debris to beams in Rm 070/Nursery – void above suspended ceiling does not contain asbestos.

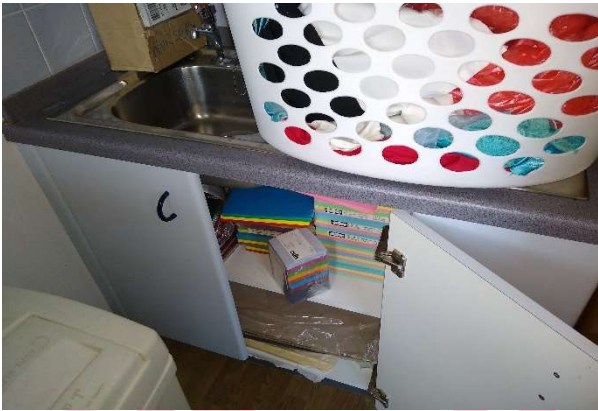
Item 167 Ref: 369386-67

The sink pads to sink and drainer in Rm 071/Wash room does not contain asbestos.

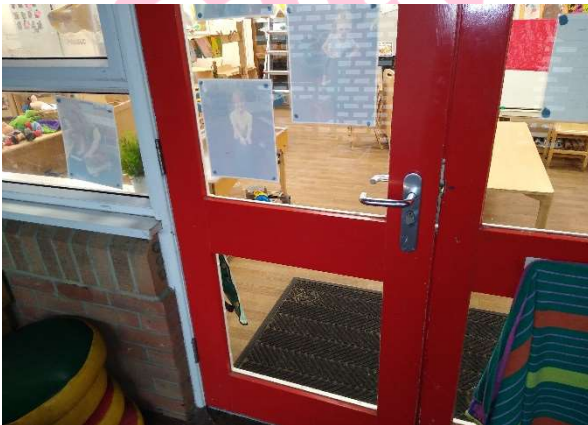
Item 168 Ref: 369386-31

The sealant to door window panels in Rm 073/Play Area does not contain asbestos.

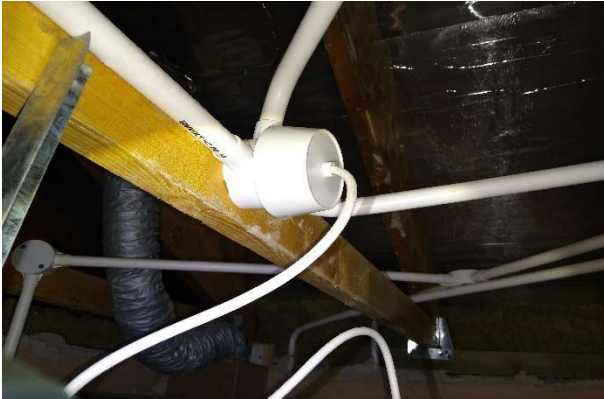
Item 169 Ref: 369386-32

The debris to beams in Rm 075/Accessible WC – void above suspended ceiling does not contain asbestos.

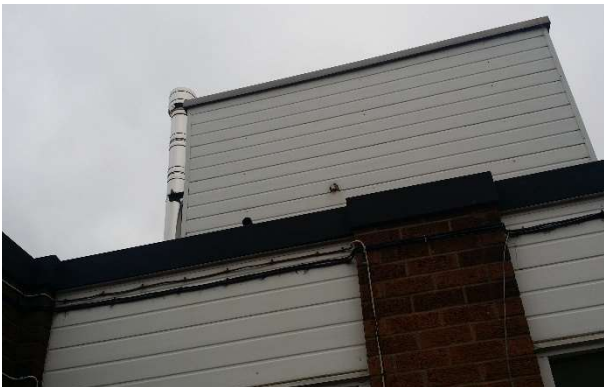
Item 170 Ref: 369386-96

The flat roof covering - top felt (External) does not contain asbestos.

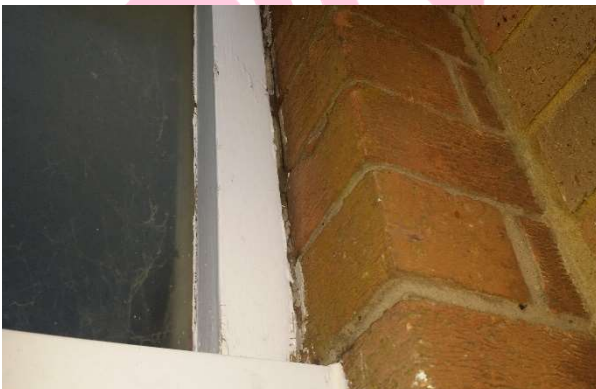
Item 171 Ref: 369386-95

The mastic to boiler doors (External) contains asbestos.

Any change in its appearance should be recorded and passed to Property Services.

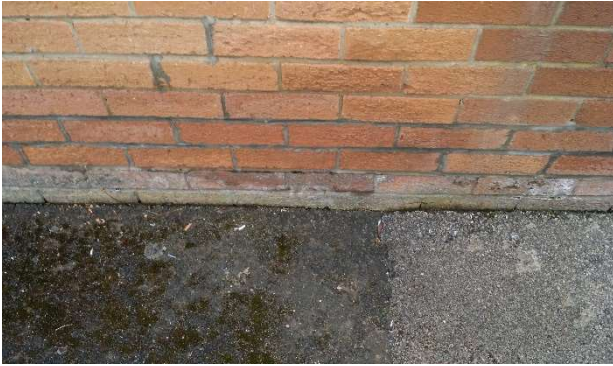
Item 172 Ref: 369386-97

The damp proof course
(External) does not contain
asbestos.

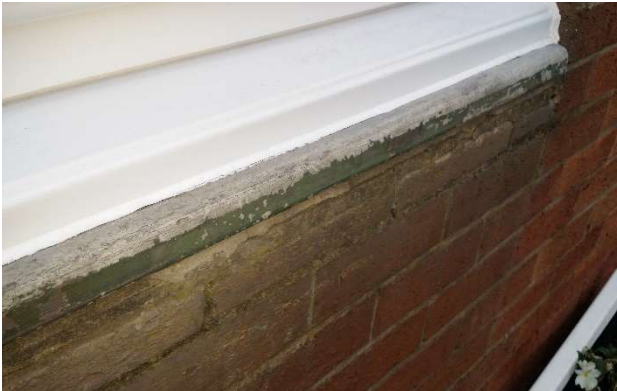
Item 173 Ref: 369386-98

The windowsills to kitchen
(External) contain asbestos.

Any change in its appearance
should be recorded and passed
to Property Services.

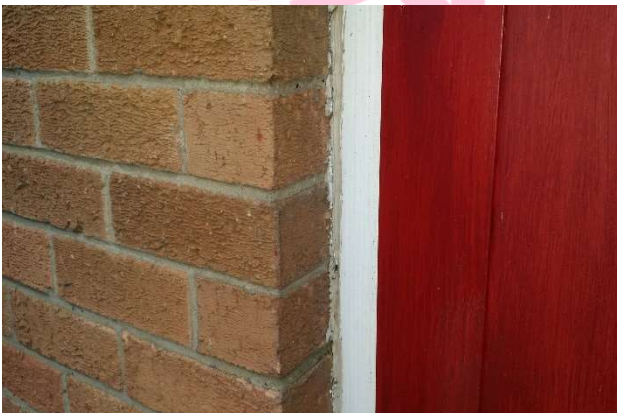
Item 174 Ref: 369386-99

The mastic to kitchen door
(External) does not contain
asbestos.

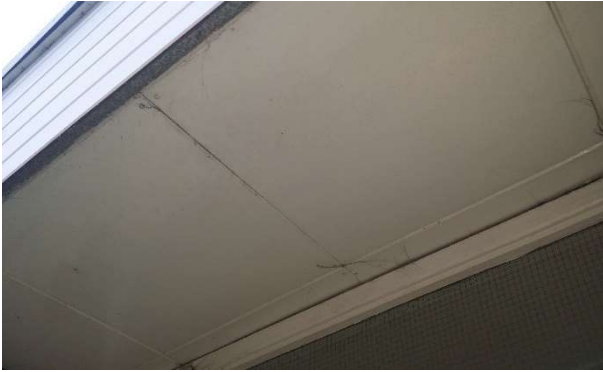
Item 175 Ref: 369386-100

The canopy's (External) contain asbestos.

Any change in its appearance should be recorded and passed to Property Services.

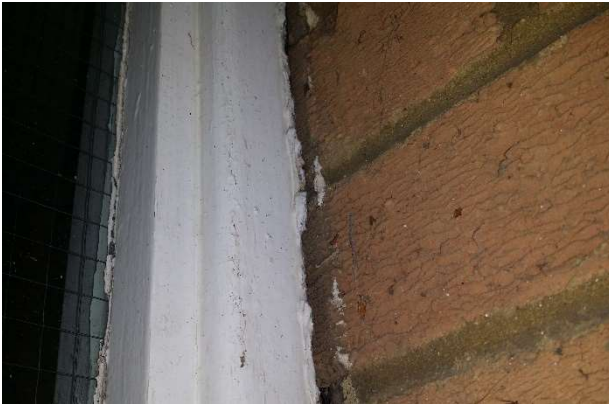
Item 176 Ref: 369386-101

The mastic to frames (External) does not contain asbestos.

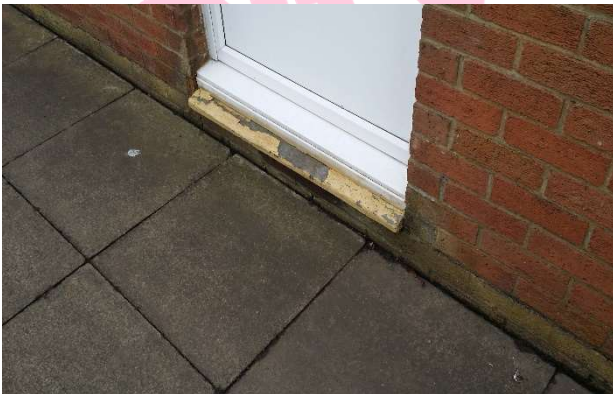
Item 177 Ref: As 369386-98

The windowsill to rear of school (External) contain asbestos.

Any change in its appearance should be recorded and passed to Property Services.

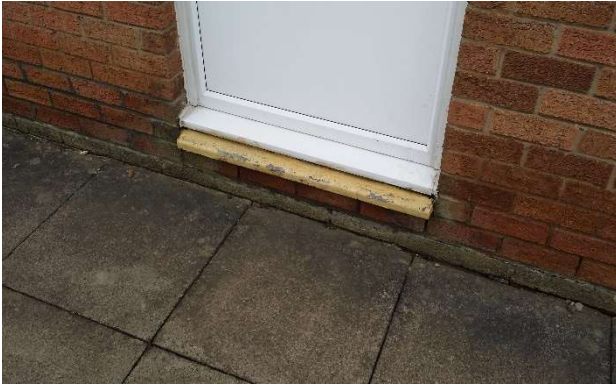
Item 178 Ref: As 369386-98

The windowsill to LHS rear of school (External) contain asbestos.

Any change in its appearance should be recorded and passed to Property Services.

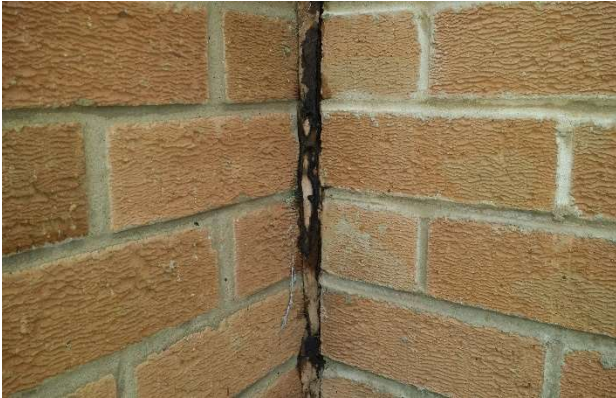
Item 179 Ref: 369386-102

The expansion gap filler to wall (External) does not contain asbestos.

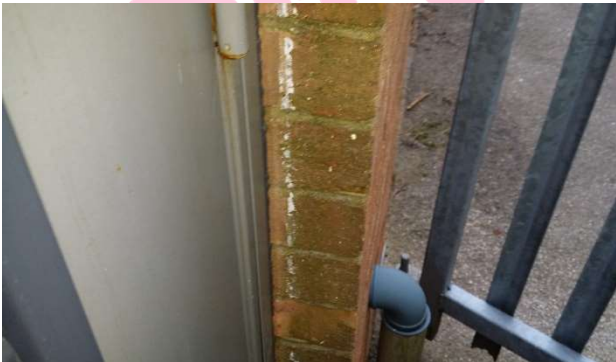
Item 180 Ref: 369386-103

The remnant mastic to walls (External) does not contain asbestos.

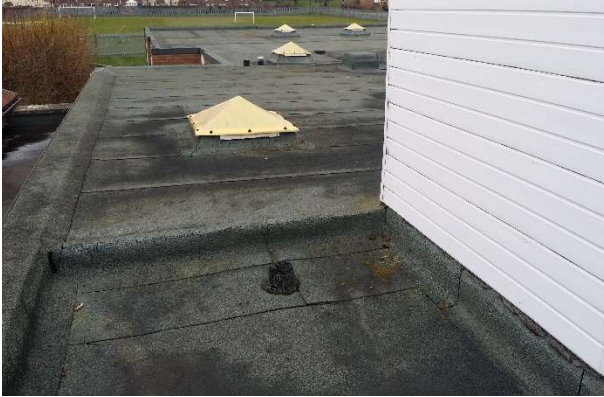
Item 181 Ref: 369386-104

The flat roof covering – top felt (External) does not contain asbestos.

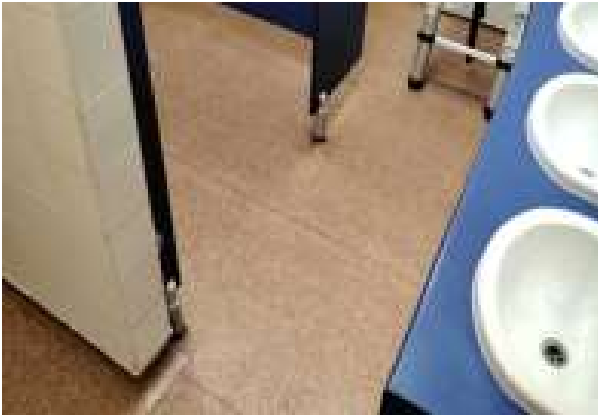
Item 182 Ref: DC0003614

The floor screed below modern covering in the male toilets (Room G/001) does not contain asbestos.
