### **ASBESTOS SURVEY REPORT FOR THE PALLION CENTRE, WAVERLEY TERRACE, SUNDERLAND**

## **Asbestos Register for The Pallion Centre**

**UPRN: - J565255**

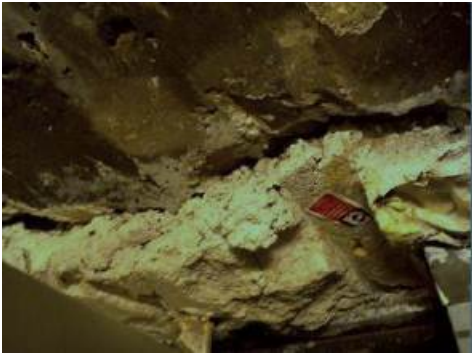
### **Item 1 Ref: Presumed**

It is possible that there will be some asbestos fibres to the porous concrete ceiling of the boiler room (Sub level Room 1).

This should be encapsulated.

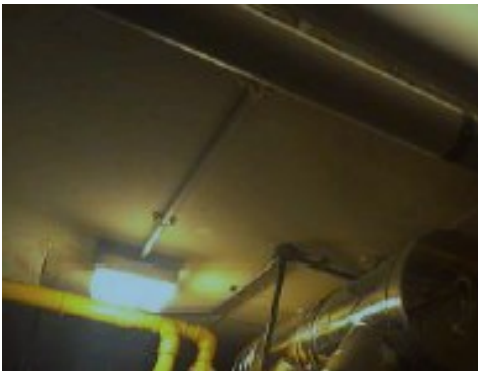
### **Item 2 Ref: AP001909**

The insulating board to the ceiling in the boiler room (Sub level Room 1) does not contain asbestos.

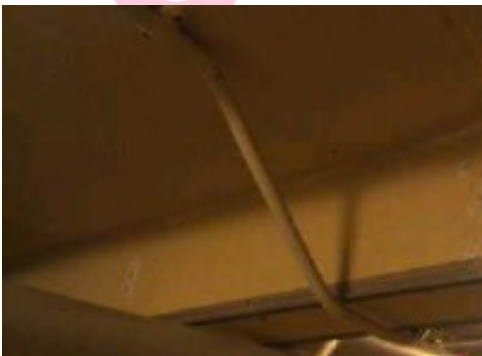
### **Item 3 As AP001909**

The insulating board to the high level boxing to the ceiling in the boiler room (Sub level Rm 1) does not contain asbestos.

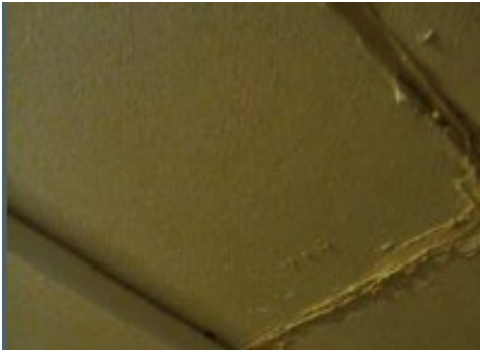
### **Item 4 Ref: AP001910**

The mastic between the ceiling panels to the ceiling of the boiler room (Sub level Room 001) does not contain asbestos.

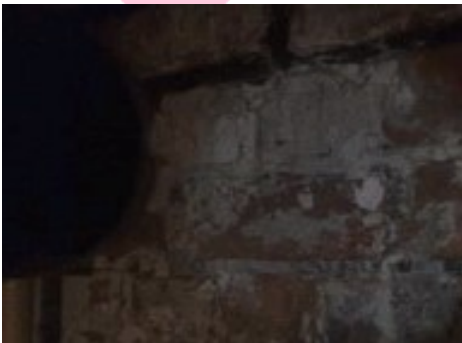
### **Item 6 Ref: AP001912**

The residue to the wall in the boiler room (Sub level Room 1) contains asbestos.

Any change in its appearance should be recorded and passed to Property Services.

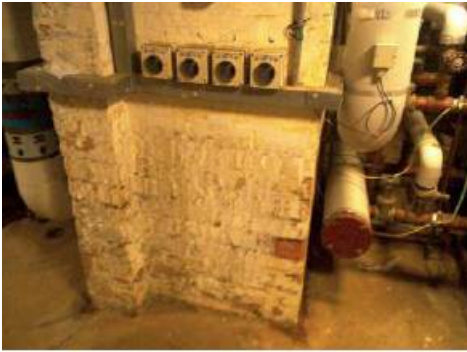
### **Item 7 Ref: AP001913**

The residue to the central brick column to the plant room (Sub level Room 1) does not contain asbestos.

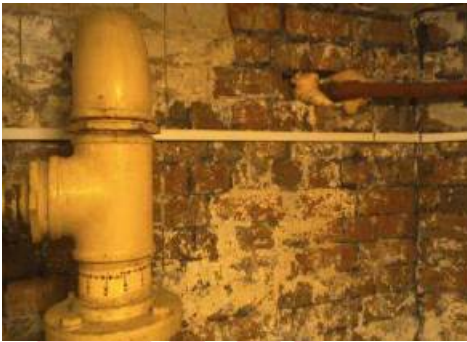
### **Item 8 Ref: AP001914**

The residue to the wall in the boiler room (Sub level Room 1) contains asbestos.

This is encapsulated and no works should take place on the walls.

Any change in its appearance should be recorded and passed to Property Services.

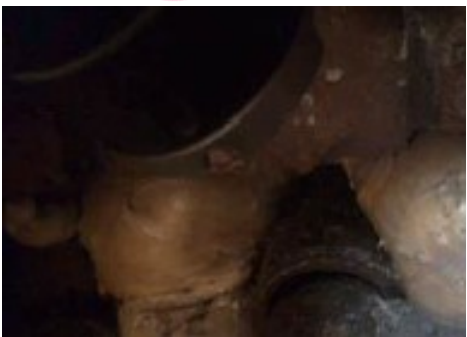
### **Item 9 Ref: AP001915**

The residue to the pipe on the wall in the boiler room (Sub level Room 1) contains asbestos.

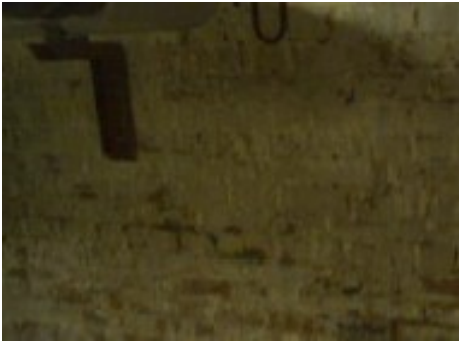
#### **Item 10 Ref: AP001916**

The residue to the wall in the plant room (Sub level Room 1) does not contain asbestos.

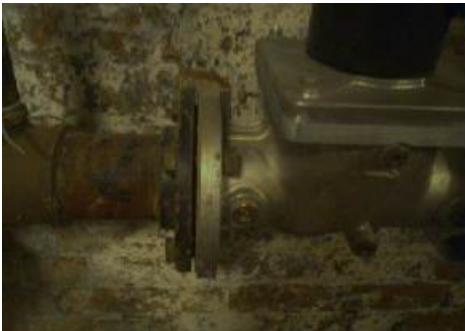
#### **Item 11 Ref: AP001917**

The gaskets to the flanges in the boiler room (Sub level Room 1) contain asbestos.

Any change in its appearance should be recorded and passed to Property Services.

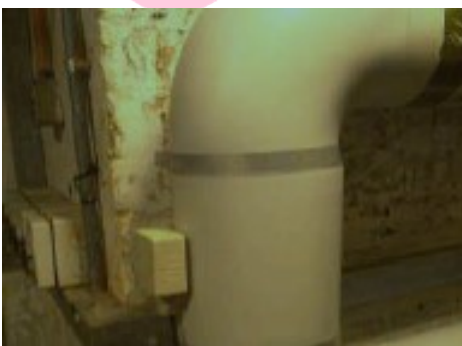
#### **Item 12 Ref: AP001918**

The large bore pipe insulation in the boiler room (Sub level Room 1) does not contain asbestos.

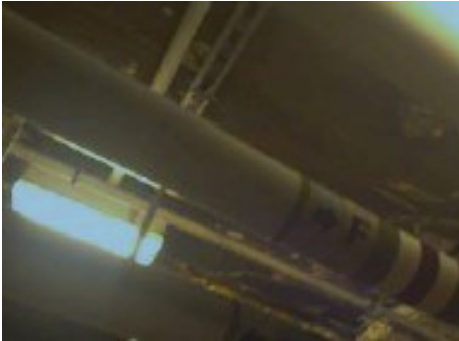
#### **Item 13 Ref: AP001919**

The small bore pipe insulation to the plant room (Sub level Room 1) does not contain asbestos.

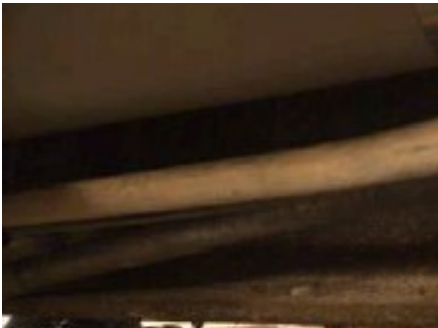
#### **Item 14 Ref: AP001920**

The debris to the horizontal surface on the beam in the boiler room (Sub level Room 1) contained asbestos.

An environmental clean should be carried out.

Any change in its appearance should be recorded and passed to Property Services.

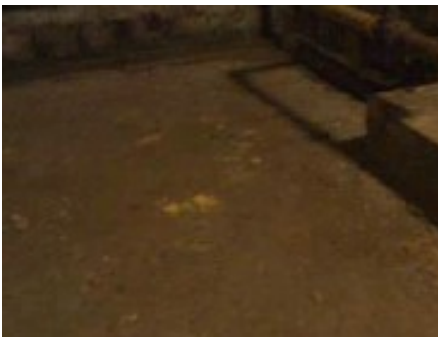
#### **Item 15 Ref: AP001921**

The general floor debris to the boiler room (Sub level Room 1) does not contain asbestos.

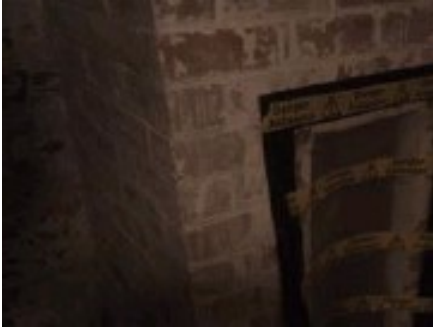
There is possibly asbestos within the sealed brick riser in the plant room (Sub level Room 1). Prior to any intrusive works, a survey must be carried out.

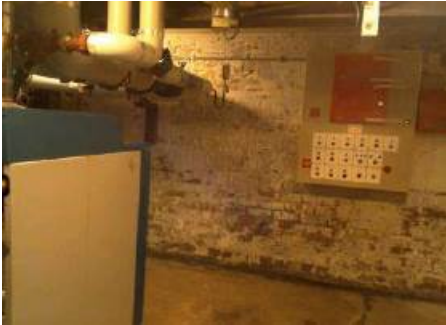
There was no access to the live electrics in the boiler room (Sub level Room 1). Prior to any work starting, carry out further surveying.

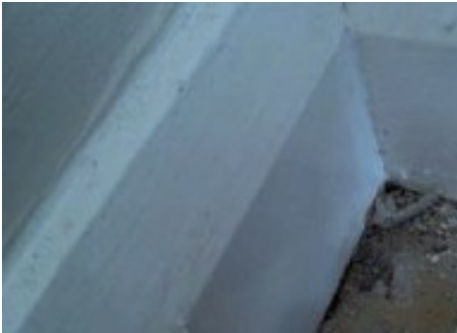
### **Item 17 As: AP001884**

The remaining adhesive to the floor beneath the carpet and modern screed in the entrance lobby (Room 2) contains asbestos.

Any change in its appearance should be recorded and passed to Property Services.

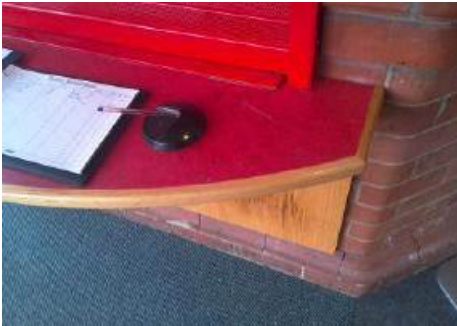
### **Item 18 Ref: AP001885**

The vinyl to the hatch in the entrance lobby (Room 2) does not contain asbestos.

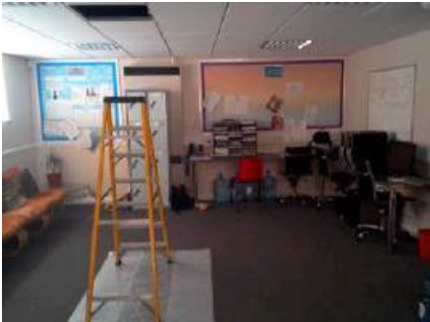
The staff room (Room 4) was accessed, and no suspect materials were found.

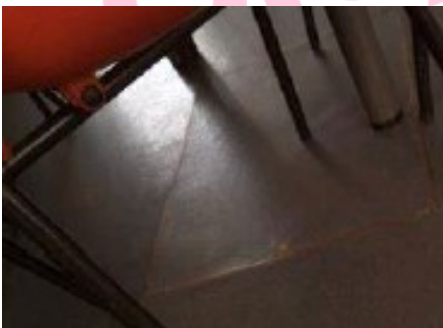
There was no access to the floor duct in the staff kitchen (Room 5).

Prior to any works, there needs to be further investigation.

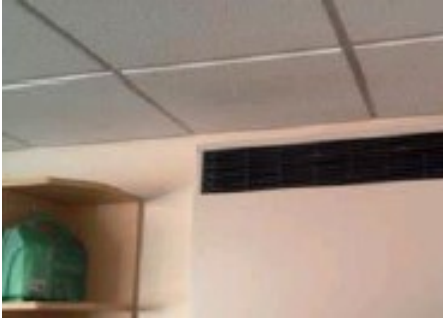
There was no access to the storage heater in the staff kitchen (Room 5) as it was live plant.

Prior to any works, there needs to be further investigation.

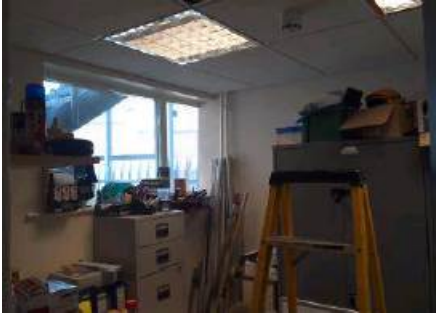
The caretakers office (Room 11) was accessed and no suspect materials were found.

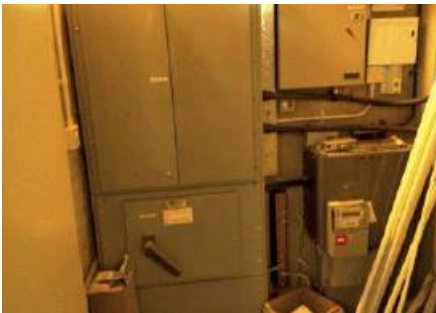
There was no access to the electrics in the electrical store (Room 12) due to live plant.

Prior to work taking place, prior investigation needs to be carried out.

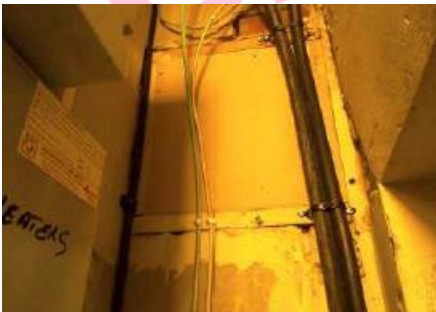
There was no access behind the plasterboard panel in the electrical store (Room 12) due to possible damage.

Prior to work taking place, prior investigation needs to be carried out.

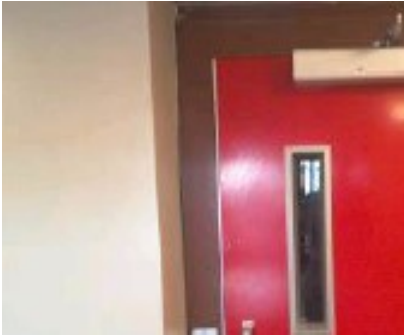
There was no access within the lift shaft (Room 13).

Prior to any works taking place, further investigation is required.

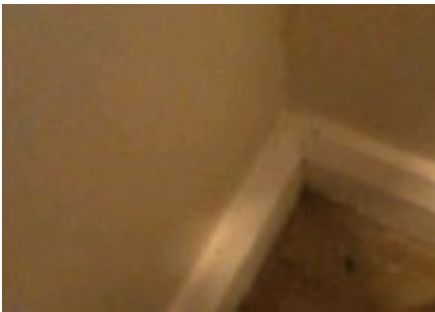
#### **Item 19 As AP001884**

The remaining adhesive to the floor beneath the carpet and modern screed in the reception lobby (Room 14) contains asbestos.

Any change in its appearance should be recorded and passed to Property Services.

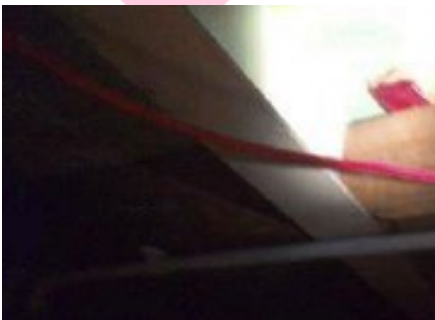
#### **Item 20 Ref: AP001886**

The fibreboard packer to between the concrete and the wood beam in the reception lobby (Room 14) does not contain asbestos.

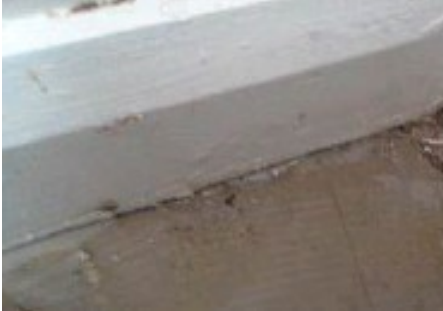
### **Item 21 As AP001884**

The remaining adhesive to the floor beneath the carpet and modern screed in the reception (Room 15) contains asbestos.

Any change in its appearance should be recorded and passed to Property Services.

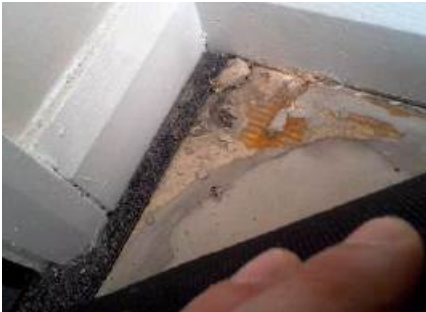
### **Item 22 As AP001884**

The remaining adhesive to the floor beneath the carpet and modern screed in the repro room (Room 16) contains asbestos.

Any change in its appearance should be recorded and passed to Property Services.

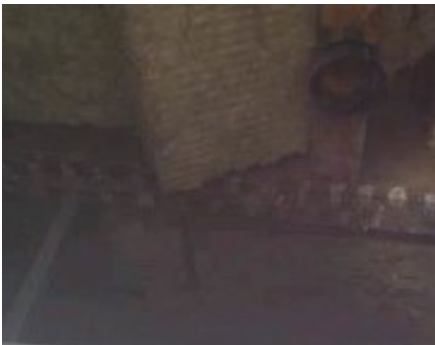
The Admin office (Room 17) was accessed and no suspect materials were found.

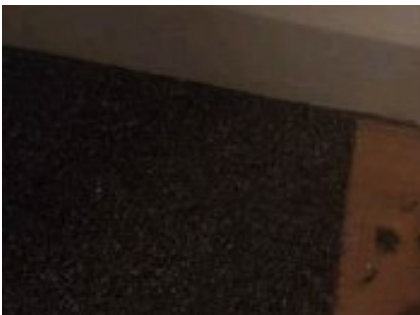
There was no access beneath the vinyl under the carpet in the lobby (Room 20) due to causing possible damage.

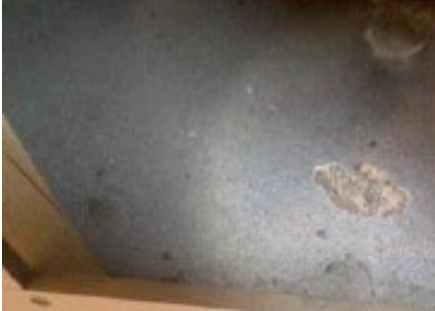
### **Item 25 Ref: AP001888**

The adhesive to the concrete floor beneath the modern lino to the female wc (Room 21) does not contain asbestos.

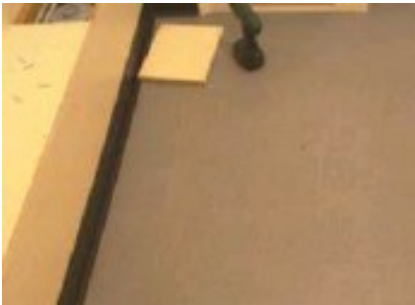
There was no access beneath the modern lino to the Disabled WC (Room 22) without causing possible damage.

Prior to any works taking place investigation should be carried out.

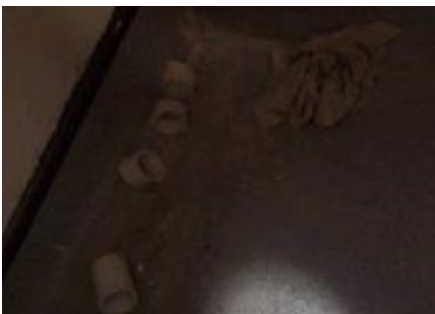
### **Item 26 As: AP001888**

The adhesive to the concrete floor beneath the modern lino and screed to the male wc (Room 23) does not contain asbestos.

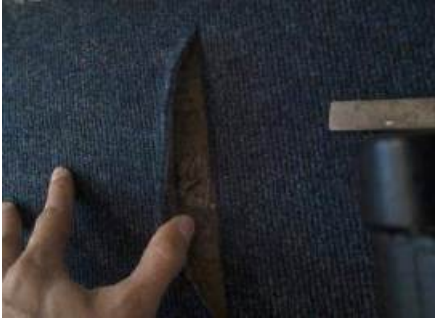
### **Item 27 As: AP001888**

The adhesive to the concrete floor beneath the modern lino to the electronic engineers (Room 24) does not contain asbestos.

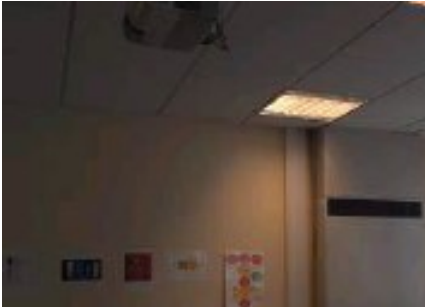
There was no access to the storage heaters in the electronic engineers (Room 24) due to the plant being live.

This should be investigated prior to any works being carried out.

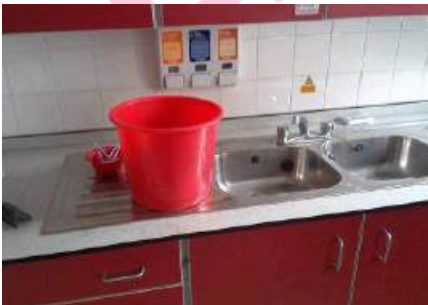
### **Item 28 Ref: AP001889**

The bitumen sink pads to the sink in the machine shop (Room 25) do not contain asbestos.

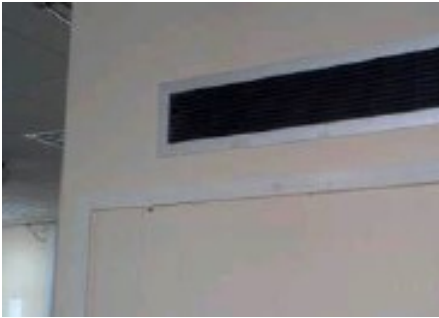
There was no access within the heater in the machine shop (Room 25) due to live plant.

Prior to any works being carried out, further investigation will be required.

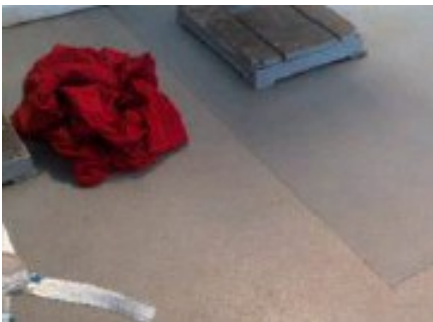
### **Item 29 As: AP001888**

The adhesive to the concrete floor beneath the modern lino to the machine shop (Room 25) does not contain asbestos.

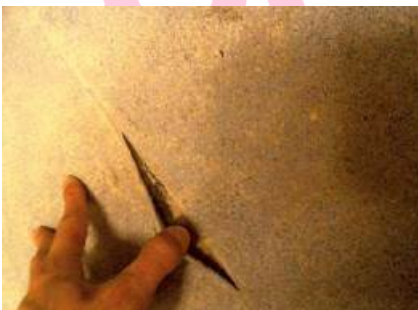
### **Item 30 As: AP001888**

The adhesive to the concrete floor beneath the modern lino to the bar rack store (Room 26) does not contain asbestos.

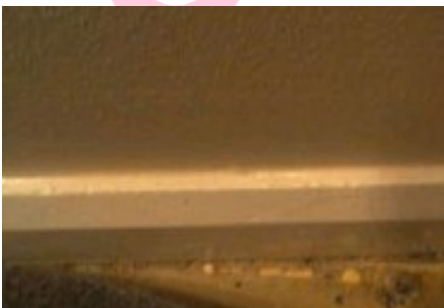
**Item 31 As: AP001888**

The bitumen adhesive to the concrete floor beneath the modern lino to the stairwell lobby (Room 28) does not contain asbestos.

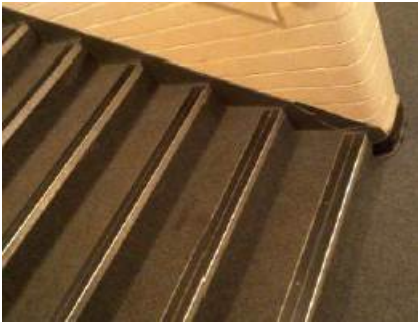
### **Item 32 Ref: AP001890**

The stair nosing to the stairs (Room 30) does not contain asbestos.

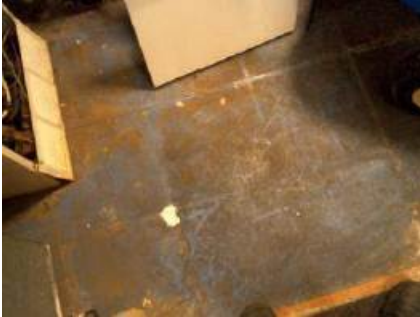
### **Item 33 Ref: AP001891**

The floor tiles to the boiler cupboard (Room 32) do not contain asbestos.

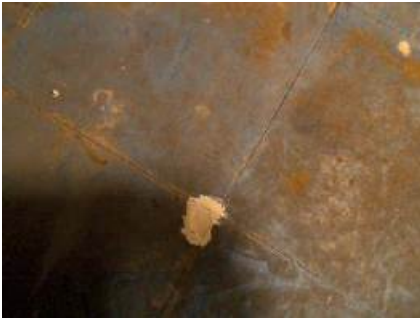
### **Item 34 Ref: AP001892**

The bitumen adhesive to the floor to the boiler cupboard (Room 32) does not contain asbestos.

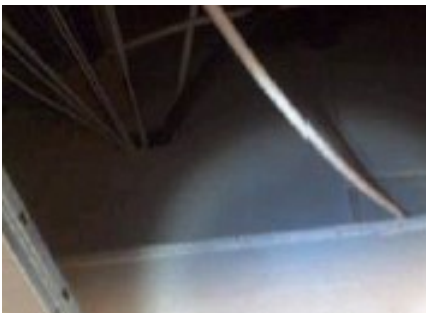
### **Item 35 Ref: AP001893**

The firebreak between the corridor and the restaurant (Room 35) within the ceiling void does not contain asbestos.

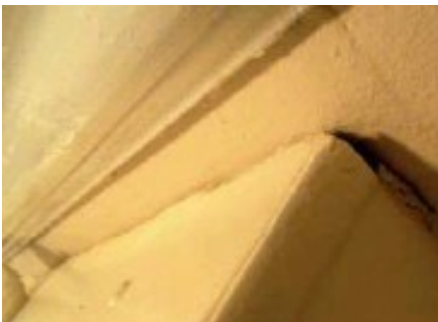
### **Item 36 Ref: AP001894**

The foam between the metal rad hangers and brick wall in the corridor (Room 35) does not contain asbestos.

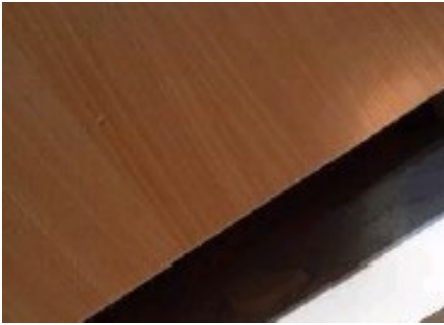
### **Item 37 Ref: Presumed**

The bitumen beneath the modern lino and the parquet flooring in the community room (Room 36) is presumed to contain asbestos.

Any change in its appearance should be recorded and passed to Property Services.

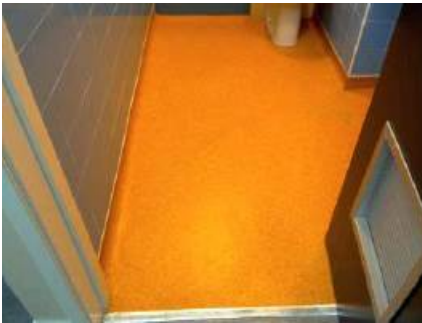
### **Item 38 Ref: Presumed**

The bitumen beneath the modern lino and the parquet flooring in the community room wc (Room 37) is presumed to contain asbestos.

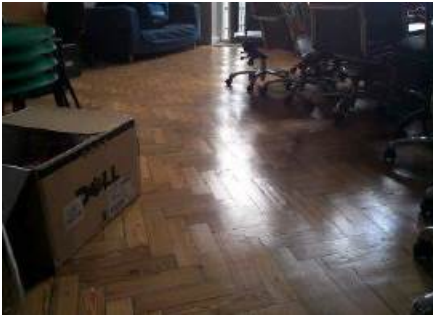
### **Item 39 Ref: 41620-9**

The bitumen beneath the parquet flooring in the plumbing room (Room 38) is presumed to contain asbestos.

Any change in its appearance should be recorded and passed to Property Services.

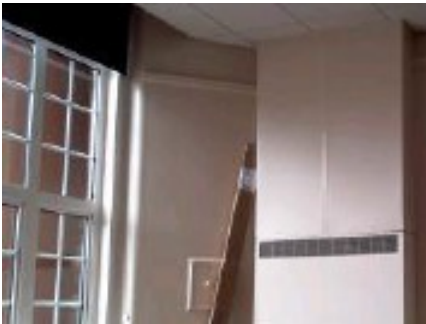
There was no access to the store heater within the plumbing room (Room 38). Prior to any work, this needs to be checked out.

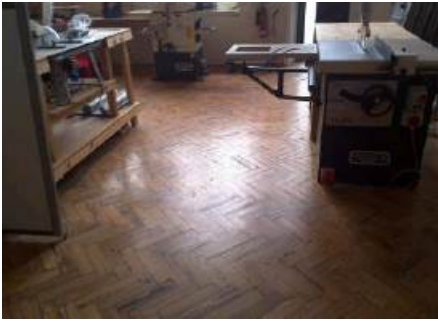
### **Item 40 Ref: As 41620-9**

The bitumen beneath the parquet flooring in the joinery machine area (Room 39) is presumed to contain asbestos.

Any change in its appearance should be recorded and passed to Property Services.

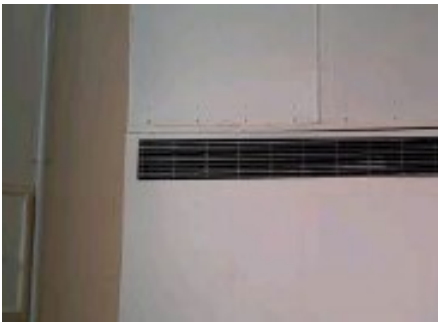
There was no access to the store heater within the joinery machine area (Room 39).

Prior to any work, this needs to be checked out.

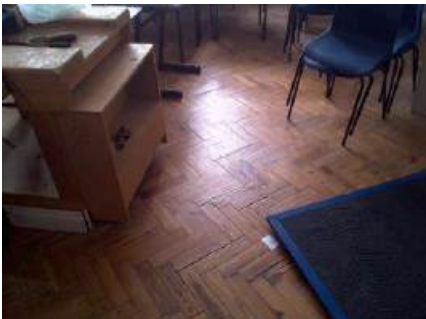
### **Item 41 Ref: As 41620-9**

The bitumen beneath the parquet flooring in the joinery Room (Room 40) is presumed to contain asbestos.

Any change in its appearance should be recorded and passed to Property Services.

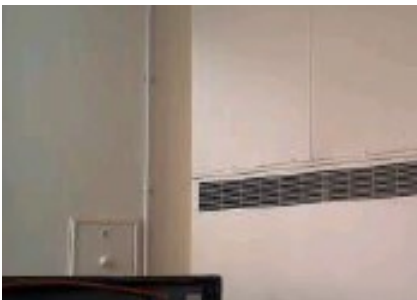
There was no access to the store heater within the joinery room (Room 40). Prior to any work, this needs to be checked out.

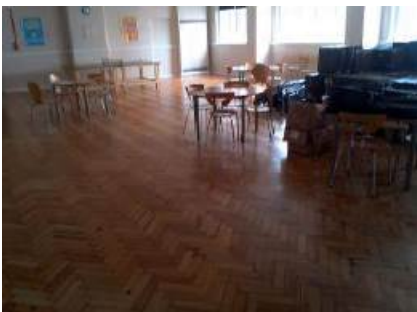
**Item 42 Ref: 41620-9**

The bitumen beneath the parquet flooring in the restaurant (Room 41) is presumed to contain asbestos.

Any change in its appearance should be recorded, and passed to Property Services.

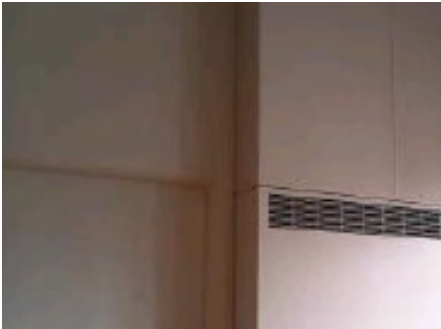
There was no access to the store heater within the restaurant (Room 41).

Prior to any work, this needs to be checked out.

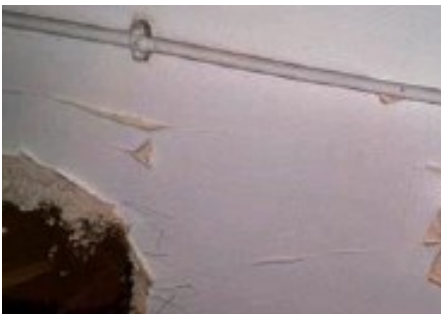
#### **Item 43 Ref: Presumed**

The textured coating to the ceiling visible within the void in the kitchen (Room 42) is presumed to contain asbestos.

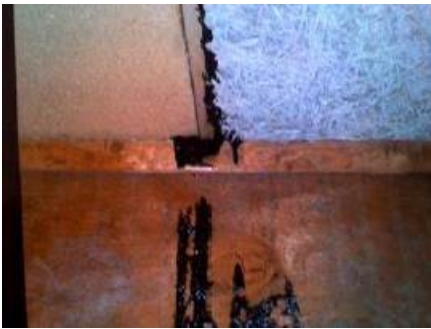
### **Item 44 Ref: AP001895**

The bitumen to the stramit board roof in the kitchen ceiling void (Room 42) does not contain asbestos.

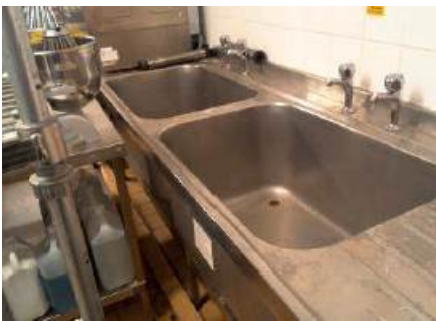
### **Item 45 Ref: AP001896**

The bitumen sink pads to the kitchen (Room 42) do not contain asbestos.

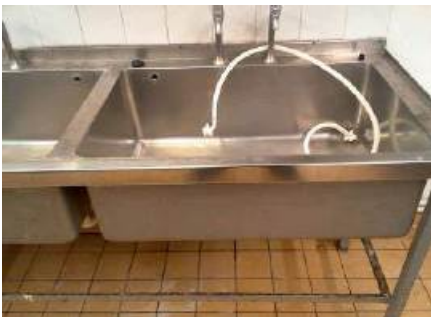
### **Item 46 Ref: AP001897**

The bitumen sink pads to the sink and drainer sinks to the perimeter wall of the kitchen (Room 42) do not contain asbestos.

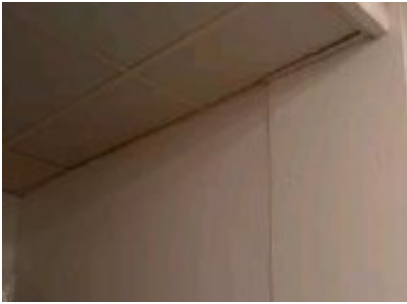
There was no access behind the wood access panel in the kitchen (Room 42) without causing further damage.

Prior to any works, further checks will be required.

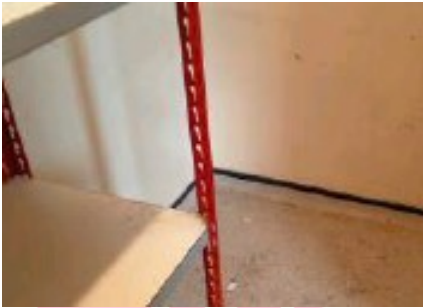
There was no access beneath the modern lino in the kitchen store (Room 43) without causing damage.

Prior to works this needs to be checked out.

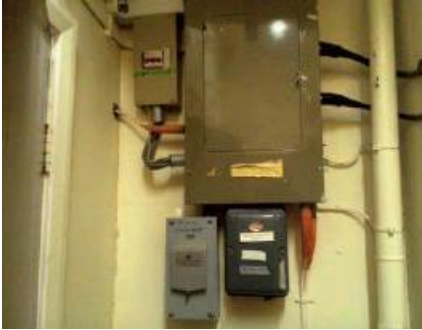
There was no access within the electrics to the dry store (Room 47) as they were live.

Prior to any disturbance, further checks with be required.

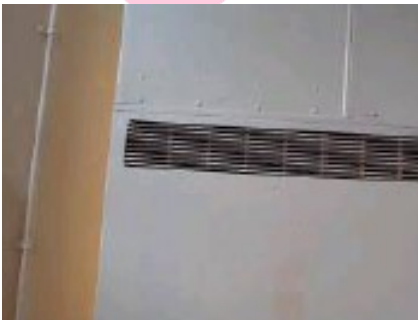
There was no access to the storage heater in the painting and decorating area (Room 49) as it was live.

Prior to any works, additional checks may need to be carried out.

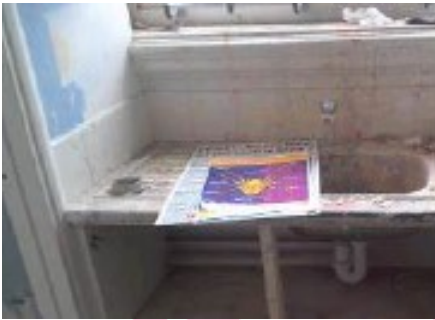
### **Item 47 As: AP001896**

The sink pads to the underside of the sink and drainer in the Painting and decorating (Room 49) do not contain asbestos.

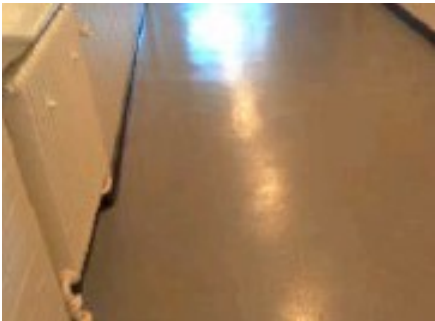
There was no access beneath the modern lino in the corridor (Room 50) as it would cause damage.

Prior to any works, additional checks may need to be carried out.

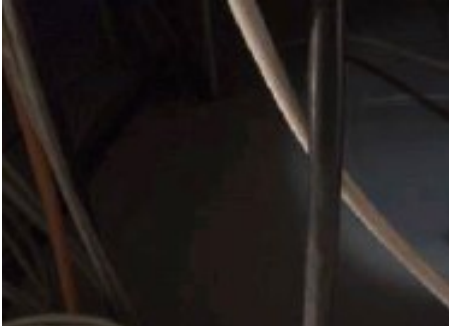
### **Item 48 Ref: AP001898**

The firebreak between the corridor and the restaurant (Room 50) does not contain asbestos.

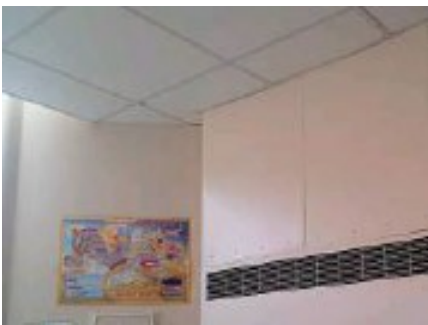
There was no access to the storage heater in the cookery area (Room 51) due to the plant being live.

Prior to any works, additional checks may need to be carried out.

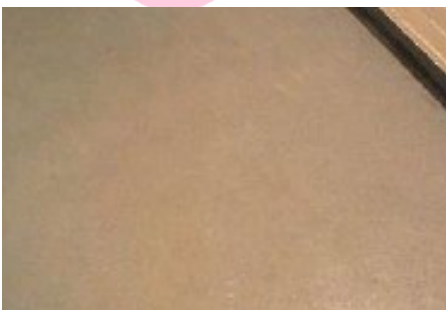
There was no access beneath the modern lino in the cookery store (Room 52) as it would cause damage.

Prior to any works, additional checks may need to be carried out.

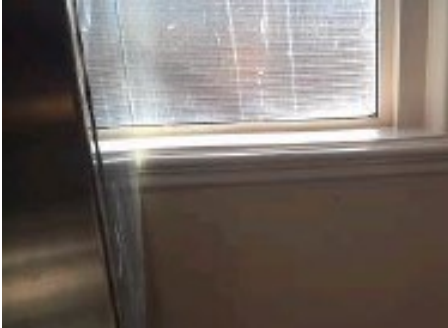
### **Item 49 Ref: AP001899**

The fibreboard panels to the cookery store (Room 52) do not contain asbestos.

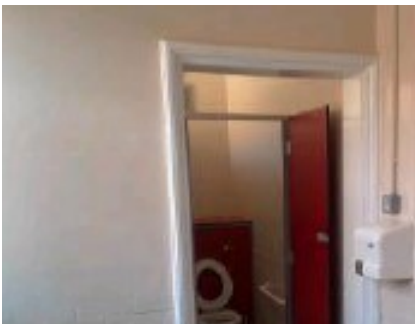
The male wc (Room 54) was accessed and no suspect materials were found.

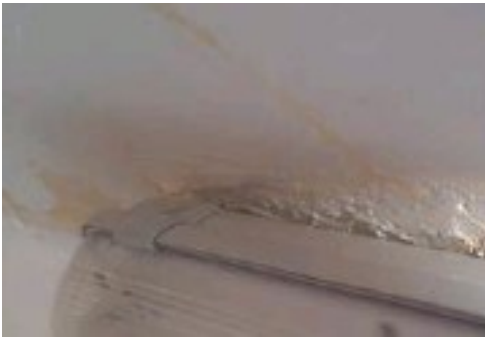
### **Item 50 Ref: Presumed**

The textured coating to the ceiling in the shower room (Room 55) is presumed to contain asbestos.

***SGS confirmed removed.***

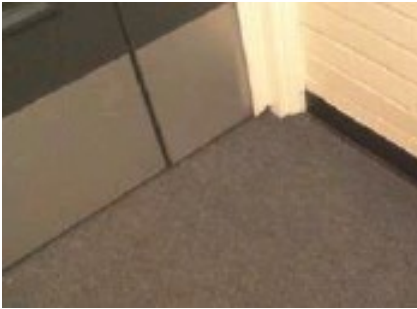
There was no access beneath the modern lino to the corridor (Room 57) as it would cause damage.

Prior to any works, additional checks may need to be carried out.

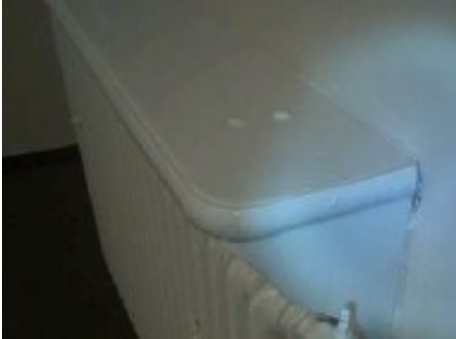
### **Item 53 As: AP001894**

The foam between brick plaster wall and metal read hanger to the stairwell (Room 58) does not contain asbestos.

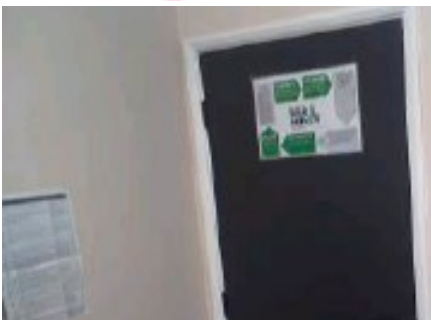
There was no access to the community room store (Room 59). Therefore, it must be presumed that it may contain asbestos.

Prior to any works being carried out, further checks will need to be done.

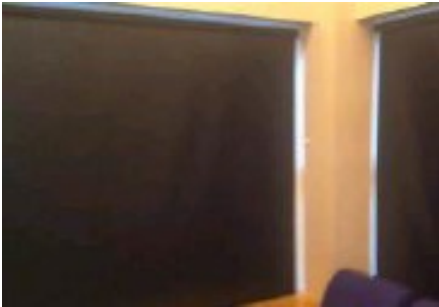
The health and development room (Room 60) was accessed, and no suspect materials were found.

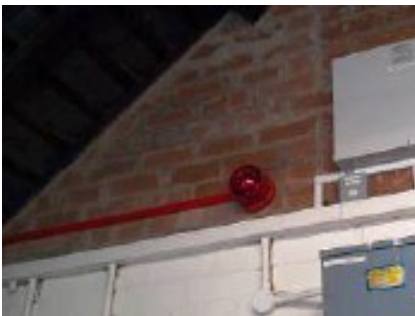
There was no access to the electrics within the bike store (Room 61) due to live plant.

Prior to accessing further checks will need to be carried out.

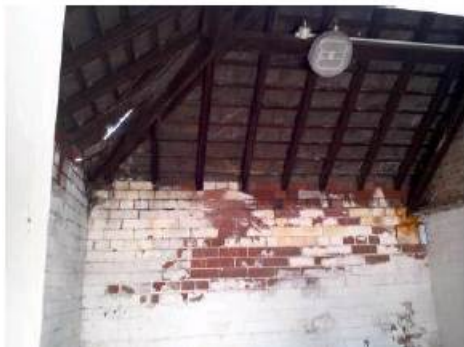
The paint store (Room 62) was accessed, and no suspect materials were found.

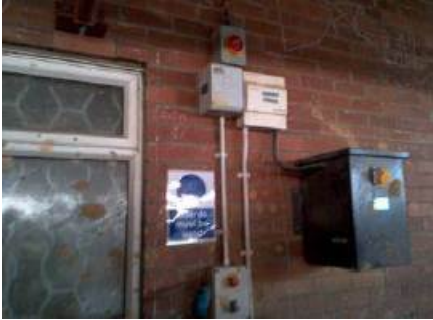
There was no access to the electrics in the brick yard (Room 63) due to being live.

Prior to accessing further checks will need to be carried out.

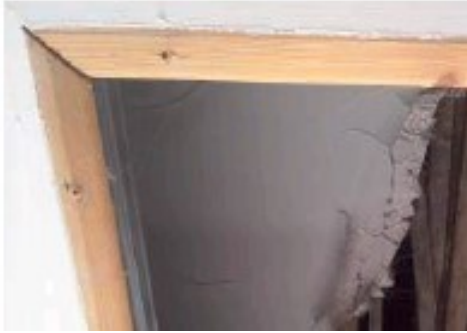
### **Item 55 Ref: AP001902**

The textured coating above the plasterboard ceiling via the access hatch in the ladies wc (Rm 1/03) does not contain asbestos.

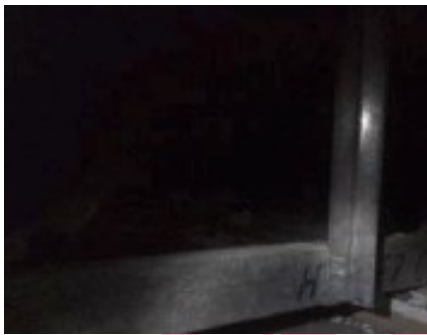
### **Item 56 As: AP001902**

The textured coating debris to the plasterboard ceiling via the access hatch in the ladies wc (Rm 1/03) does not contain asbestos.

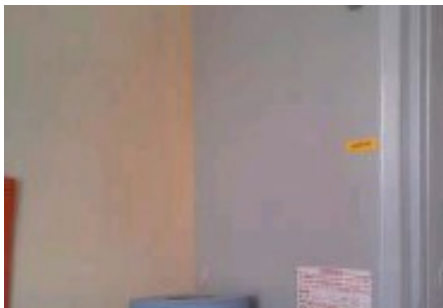
There was no access to the electrics in the cleaners store (Room 1/04) due to the plant being live.

Prior to any works, additional checks may need to be carried out.

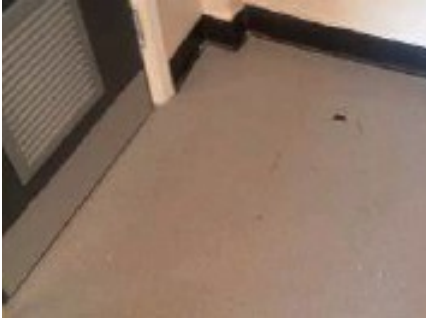
There was no access beneath the modern lino to the lobby (Room 1/05) as it would cause damage.

Prior to any works, additional checks may need to be carried out.

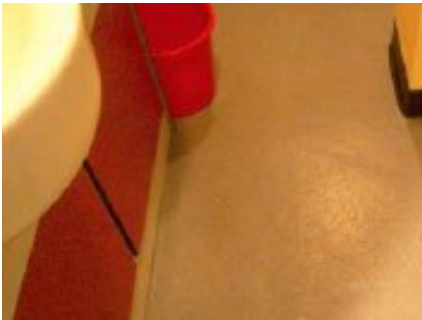
There was no access beneath the modern lino to the male wc (Room 1/06) as it would cause damage.

Prior to any works, additional checks may need to be carried out.

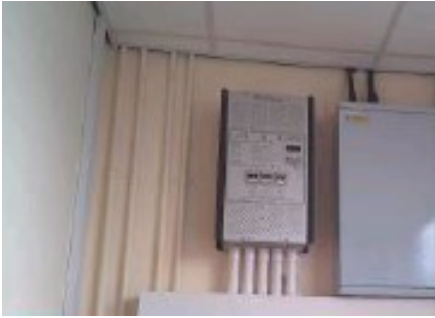
There was no access to the electrics in the store room (Room 1/08) due to the plant being live.

Prior to any works, additional checks may need to be carried out.

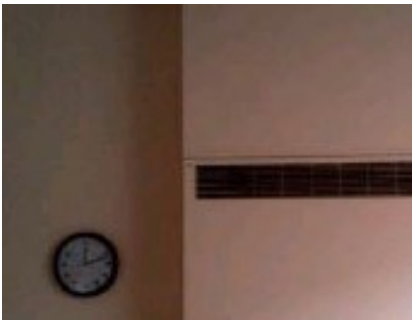
There was no access to the storage heater in the stairwell (Room 1/09) due to the plant being live.

Prior to any works, additional checks may need to be carried out.

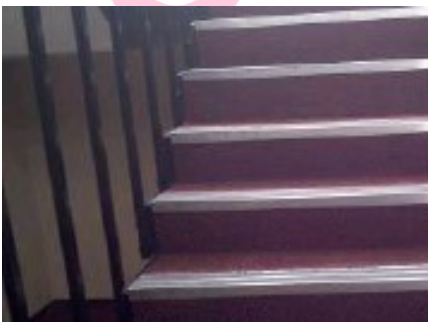
#### **Item 57 As: AP001901**

The stair nosing to the stairwell (Room 1/09) does not contain asbestos.

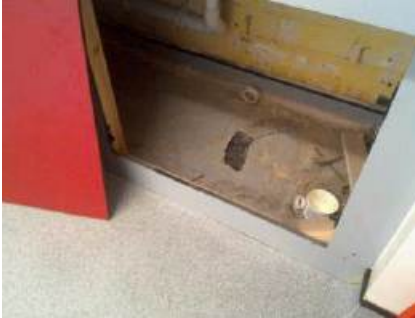
### **Item 58 Ref: AP001903**

The bitumen adhesive to the floor accessed via panel under the sink in the ladies WC (Room 1/10) contains asbestos.

Any change in its appearance should be noted and passed to Property Services.

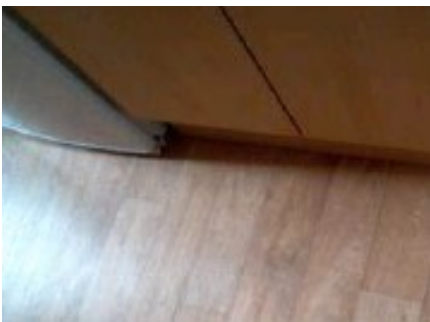
### **Item 60 As : AP001903**

The bitumen adhesive to the concrete beneath the modern lino and screed floor in the kitchen (Room 1/12) contains asbestos.

Any change in its appearance should be noted and passed to Property Services.

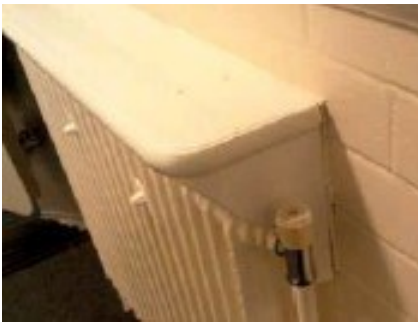
### **Item 62 Ref: AP001904**

The foam between the metal rad hanger and the wall in the corridor (Room 1/13) does not contain asbestos.

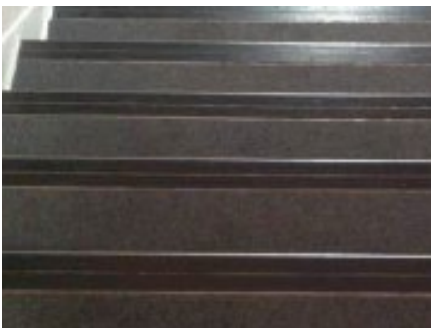
### **Item 63 As: AP001901**

The stair nosing to the corridor in the corridor (Room 1/13) does not contain asbestos.

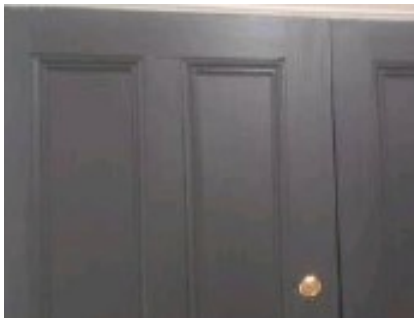
There was no access to the store in ICT (Room 1/14).

Prior to any works, further checks may need to be carried out.

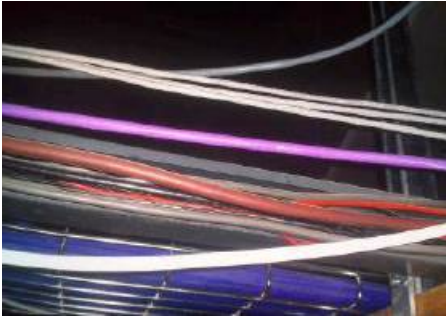
The corridor (Room 1/16) was accessed, and no suspect materials were found.

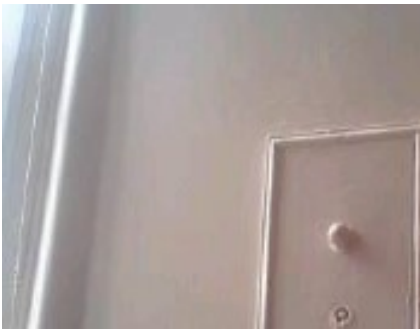
There was no access within the metal hatches to the wall in the hair salon (Room 1/17) without causing possible damage.

Prior to any works, further checks may need to be carried out.

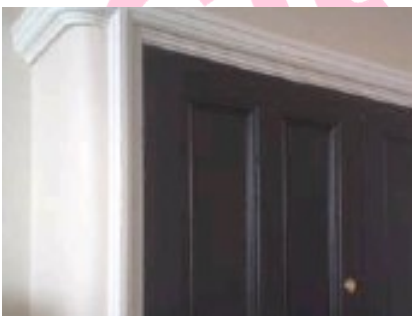
There was no access to the store in the hair salon (Room 1/17).

Prior to any works, further checks may need to be carried out.

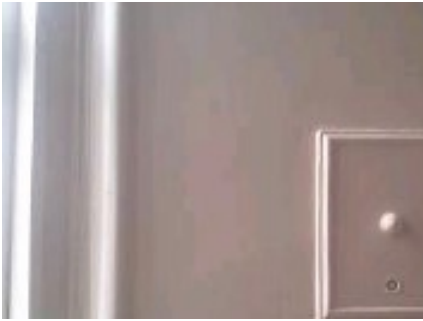
There was no access within the metal hatches to the wall in beauty salon (Room 1/18) without causing possible damage.

Prior to any works, further checks may need to be carried out.

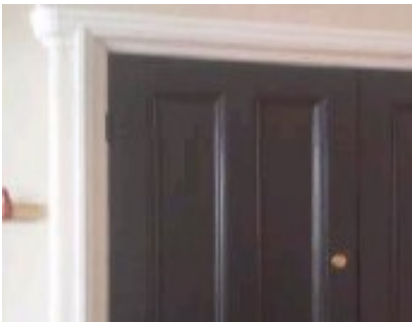
There was no access to the store in the beauty salon (Room 1/18).

Prior to any works, further checks may need to be carried out.

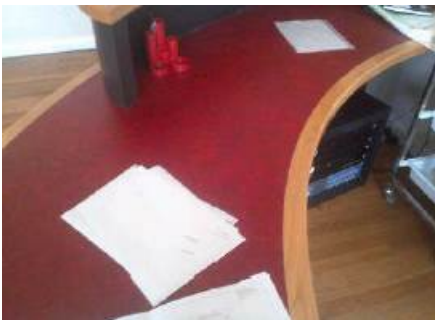
### **Item 64 Ref: AP001905**

The vinyl to the reception desk in the beauty salon (Room 1/18) does not contain asbestos.

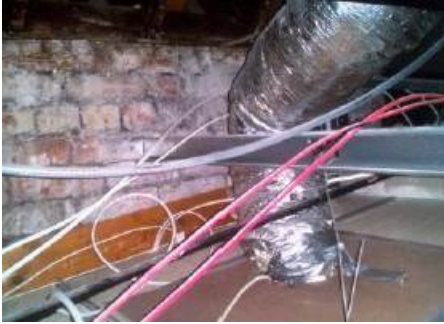
The salon WC (Room 1/19) was accessed, and no suspect materials were found.

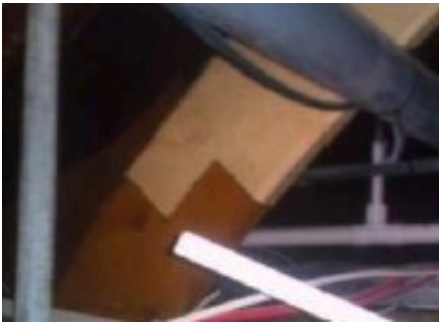
The laundry room (Room 1/20) was accessed and no suspect materials were found.

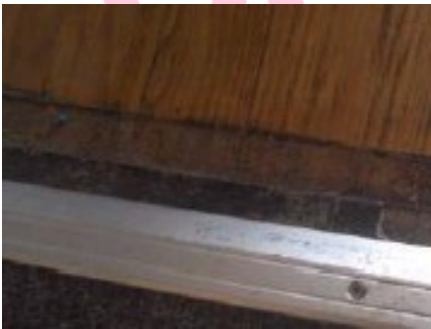
**Item 65 Ref: AP001906**

The floor tiles beneath the modern carpet to the corridor (Room 1/21) contain asbestos.

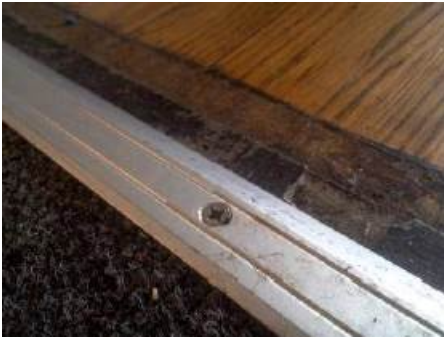
### **Item 66 Ref: AP001907**

The bitumen adhesive to the floor tiles in the corridor (Room 1/21) contains asbestos.

***SGS confirmed removed.***

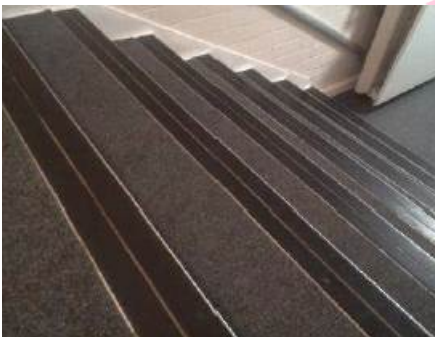
### **Item 67 As: AP001901**

The stair nosing to the corridor (Room 1/21) does not contain asbestos.

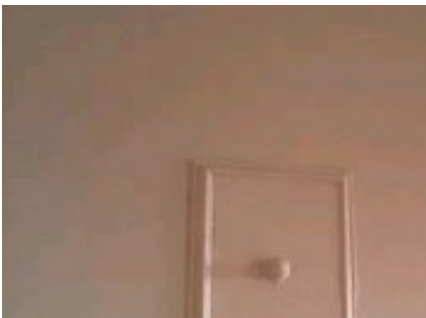
There was no access within the metal hatches to the wall in classroom (Room 1/24) without causing possible damage.

Prior to any works, further checks may need to be carried out.

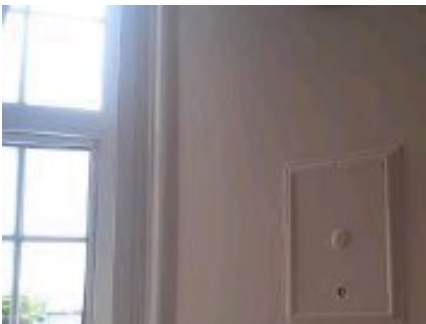
There was no access within the metal hatches to the wall in classroom (Room 1/25) without causing possible damage.

Prior to any works, further checks may need to be carried out.

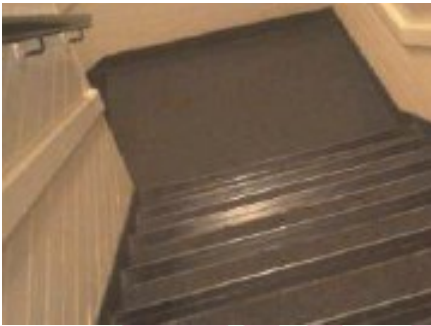
### **Item 68 As: AP001901**

The stair nosing to the stairwell (Room 1/27) does not contain asbestos.

Prior to any works, further checks may need to be carried out.

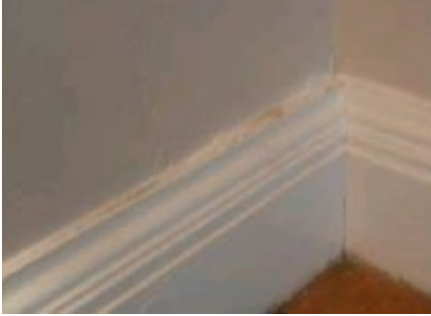
There was no access beneath the newly fitted carpet to the WC lobby (Room 1/28) without causing possible damage.

Prior to any works, further checks may need to be carried out.

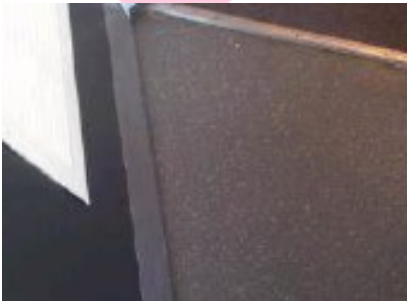
There was no access beneath the lino to the female WC (Room 1/30) without causing possible damage.

Prior to any works, further checks may need to be carried out.

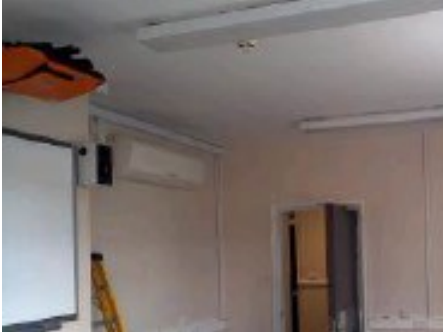
The family room (Room 1/31) was accessed, and no suspect materials were found.

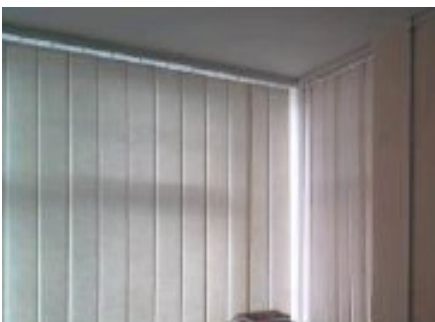
The office (Room 1/33) was accessed, and no suspect materials were found.

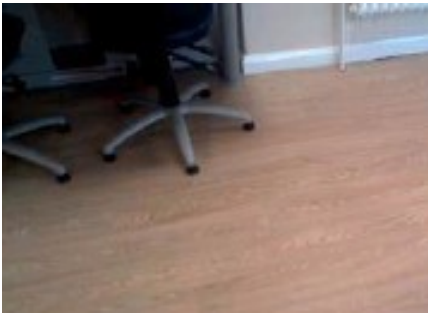
There was no access beneath the modern lino to the lift lobby (Room 1/35) without causing possible damage.

Prior to any works, further checks may need to be carried out.

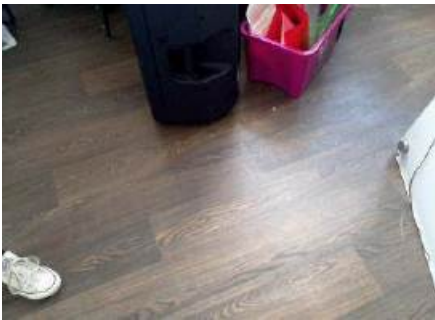
There was no access beneath the modern lino to Audio Room 1 (Room 1/37) without causing possible damage.

Prior to any works, further checks may need to be carried out.

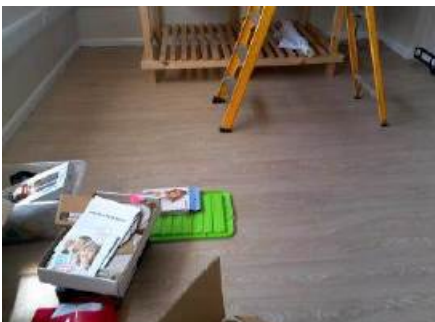
There was no access beneath the modern lino to Audio Room 2 (Room 1/38) without causing possible damage.

Prior to any works, further checks may need to be carried out.

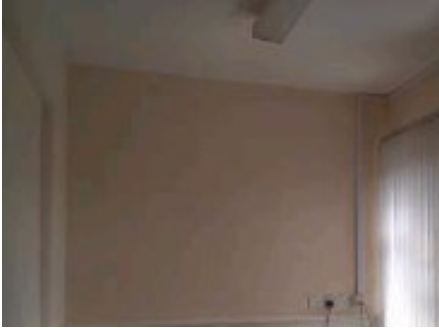
The office (Room 1/39) was accessed, and no suspect materials were found.

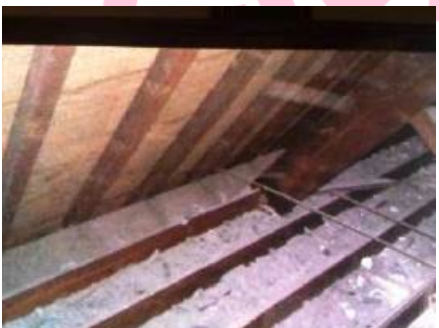
The roof void 1 was accessed and no suspect materials were found.

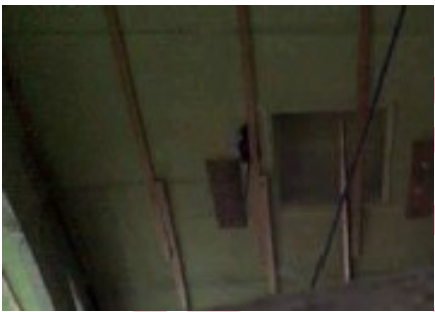
The roof void 3 was unable to be accessed due to health and safety reasons.

Prior to any works, further checks will need to be carried out.

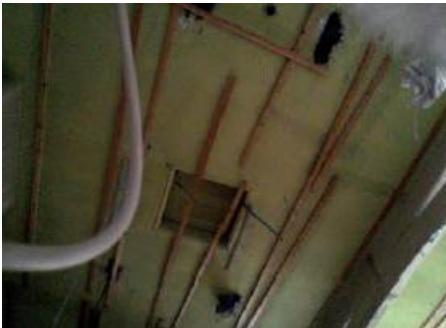
The roof void 4 was unable to be accessed due to health and safety reasons.

Prior to any works, further checks will need to be carried out.

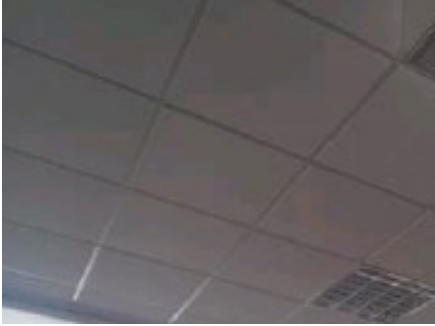
The roof void 5 was unable to be accessed due to health and safety reasons.

Prior to any works, further checks will need to be carried out.

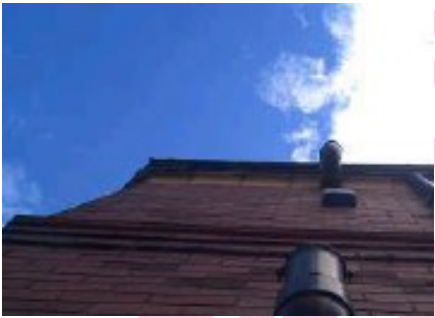
#### **Item 70 Ref: AP001922**

The cement flue to the north elevation to the external contains asbestos.

Any change in its appearance should be noted and passed to Property Services.

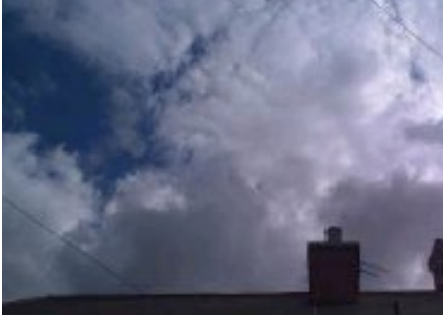
### **Item 72 Ref: Presumed**

The cement flue penetrating roof is presumed to contain asbestos.

Any change in its appearance should be noted and passed to Property Services.

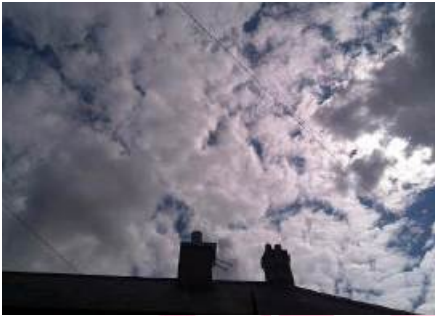
### **Item 73 Ref: Presumed**

*The cement cowl to the chimney stack is presumed to contain asbestos.*

*Removed 2014*

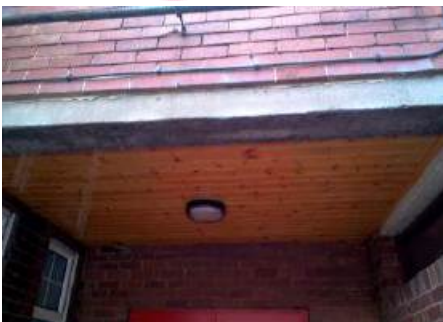
The wood canopy to the external was accessed and no suspect materials were found.

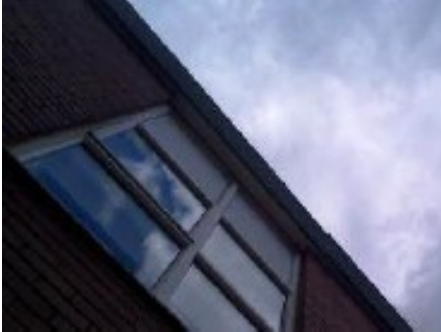
The soffits to the seminar area are wooden.

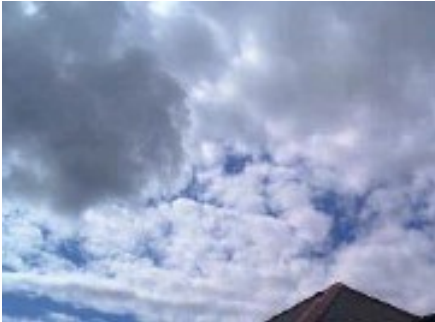
### **Item 74 Ref: AP001924**

The slate roof to the engineers block does not contain asbestos.

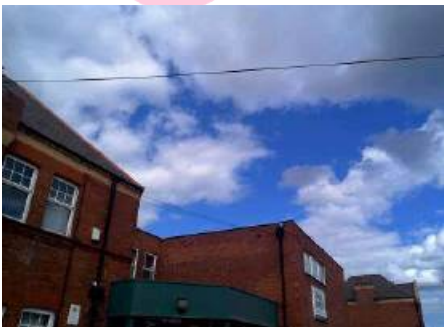
### **Item 75 Ref: Presumed**

All flat felt roofs were presumed to have asbestos in.

Prior to any works being carried out on site, further testing should be carried out.

Any change in its appearance should be noted and passed to Property Services.
