### **ASBESTOS SURVEY REPORT FOR THE PALLION CENTRE, WAVERLEY TERRACE, SUNDERLAND**

## **Asbestos Register for The Pallion Centre**

**UPRN: - J565255**

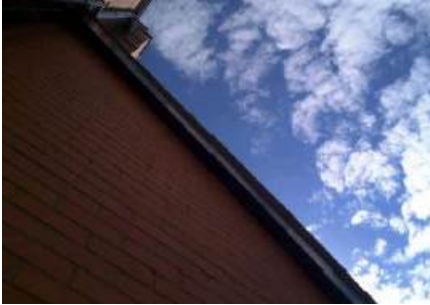
### **Item 76 Ref: AP001925**

The verge tiles on the gable end of Roof 1 do not contain asbestos.

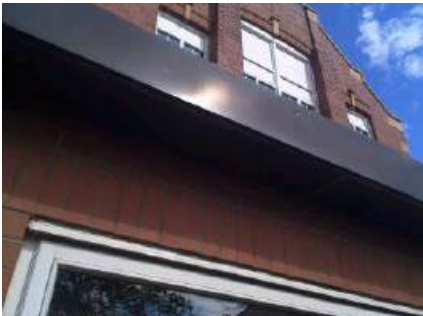
The soffits to the external of Roof 1 are metal.

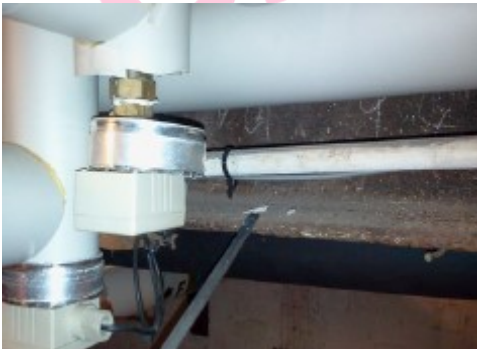
### **Item 77 Ref: 41620-15**

*The insulation board debris in the Boiler Room/Rm 001 contains asbestos.*

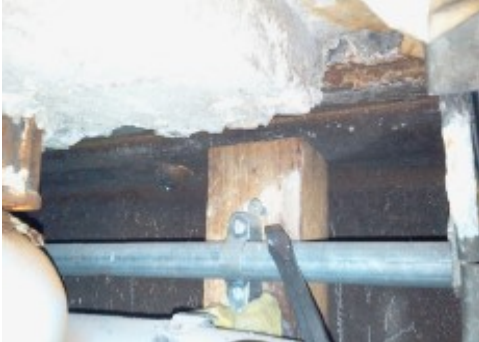
### **Item 78 Ref: 41620-16**

*The debris to nail in timber baton in the Boiler Room/Rm 001 contains asbestos.*

*Removed 2014*

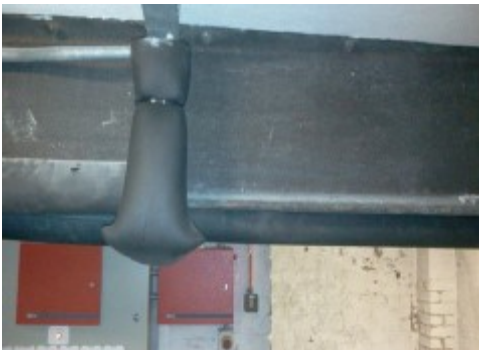
### **Item 79 Ref: 41620-17**

*The debris to beam in the Boiler Room/Rm 001 contains asbestos.*

*Removed 2014*

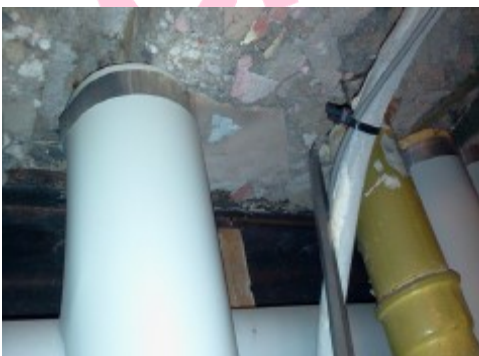
### **Item 80 Ref: As 41620-15**

*The remnant board to yellow gas pipe in the Boiler Room/Rm 001 contains asbestos.*

*Removed 2014*

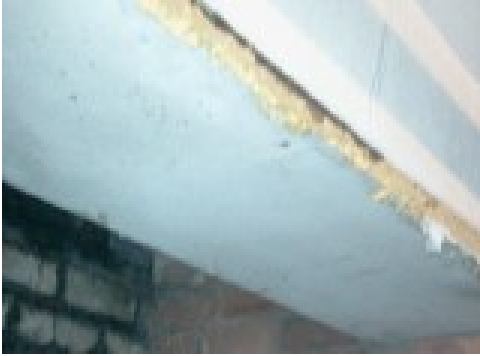
### **Item 81 Ref: 41620-18**

*The shuttering to underside of beam in the Boiler Room/Rm 001 contains asbestos.*

*Removed 2014*

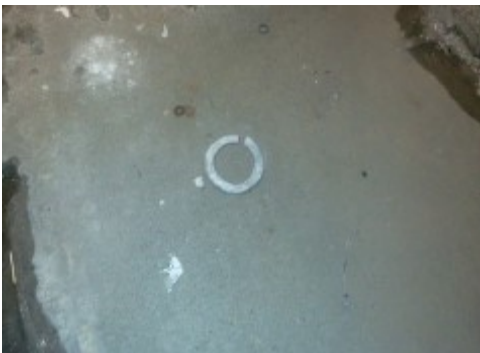
### **Item 82 Ref: 41620-19**

The Loose lying gasket to floor in the Boiler Room/Rm 001 does not contain asbestos.

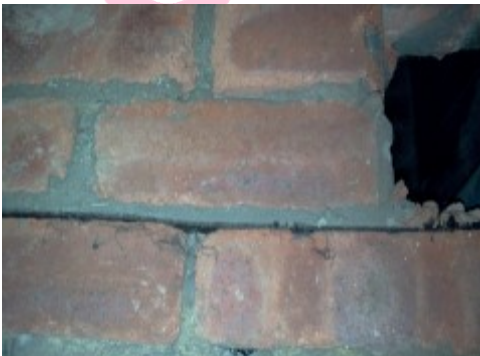
### **Item 83 Ref: 41620-20**

The damp proof course in the Boiler Room/Rm 001 does not contain asbestos.

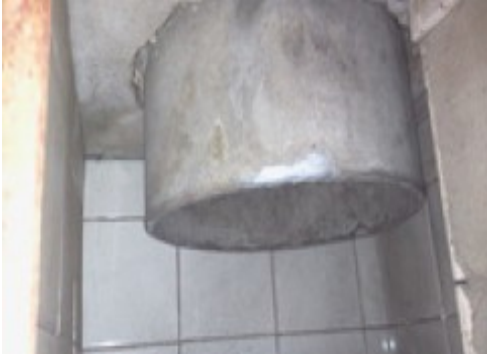
### **Item 84 Ref: 41620-31**

*The flue situated within riser in the Boiler Room/Rm 001 contains asbestos.*

*Removed 2014*

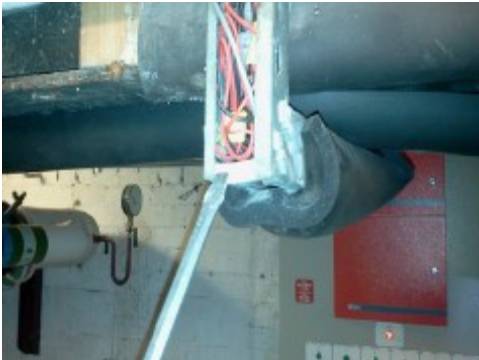
### **Item 85 Ref: As 41620-14**

*The board within cable tray in the Boiler Room/Rm 001 does not contain asbestos.*

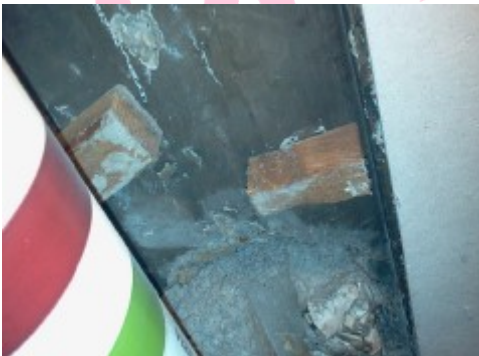
### **Item 86 Ref: 41620-21**

*The insulation board debris in the Boiler Room/Rm 001 contains asbestos.*

*Removed 2014*

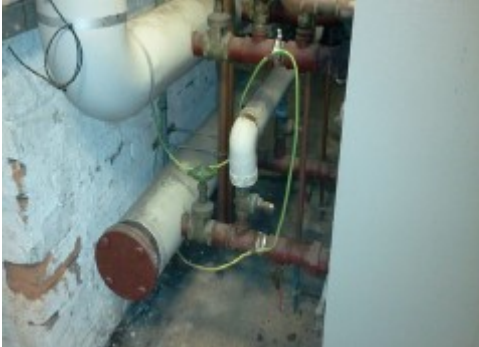
### **Item 87 Ref: 41620-22**

*The pipework flange gasket in the Boiler Room/Rm 001 contains asbestos.*

*Removed 2014*

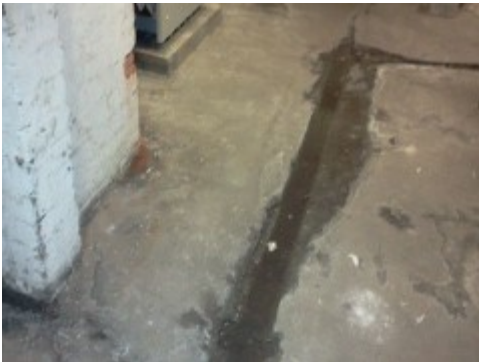
### **Item 88 Ref: 41620-23**

*The general debris to floor in the Boiler Room/Rm 001 does not contain asbestos.*

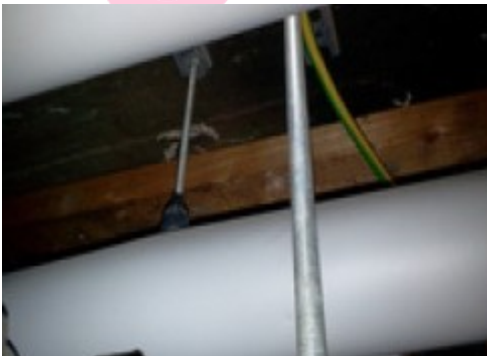
### **Item 89 Ref: Presumed**

*The insulation board debris in the Boiler Room/Rm 001 is presumed to contain asbestos.*

*Removed 2014*

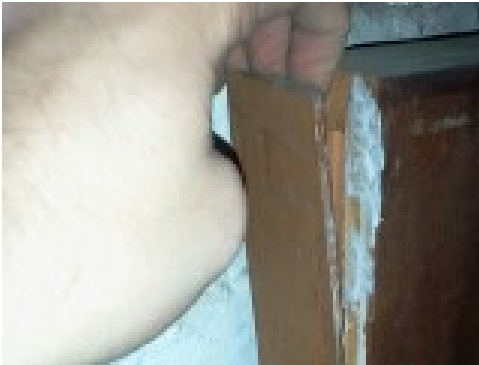
### Item 90 Ref: 41620-24

The panel within door in the Boiler Room/Rm 001 contains asbestos.

***SGS to confirm removed.***

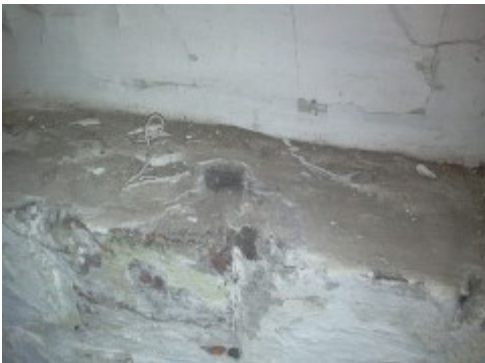
### Item 91 Ref: 41620-25

The string debris to wall in the Boiler Room/Rm 001 does not contain asbestos.

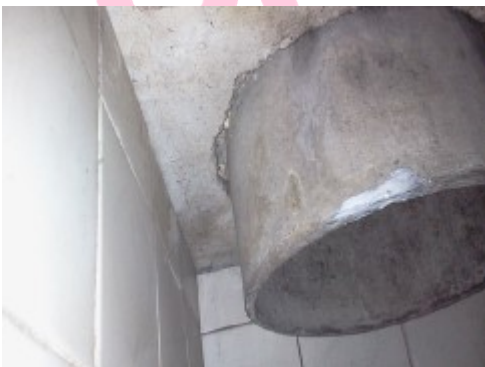
### Item 92 Ref: 41620-32

*The shuttering to cement flue in the Boiler Room/Rm 001 contains asbestos.*

*Removed 2014*

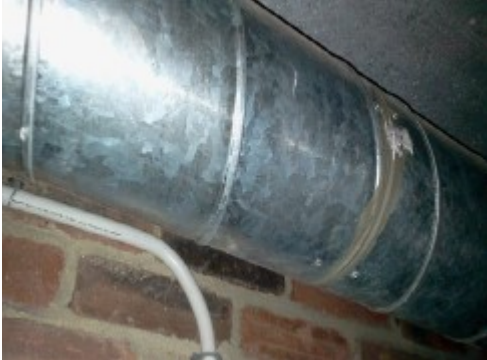
### **Item 93 Ref: 41620-1**

The mastic to air handling ductwork joints in the Staff Room/Rm 005 ceiling void above - does not contain asbestos.

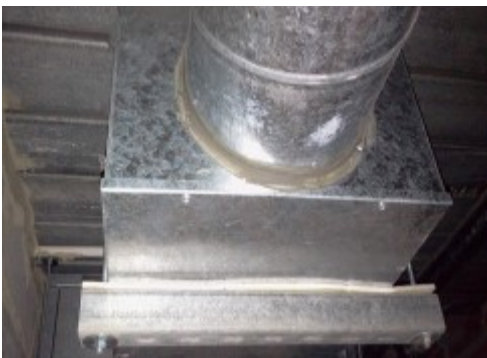
### **Item 95 Ref: As 41620-1**

The mastic to air handling ductwork joints in the Female WC/Rm 009 ceiling void above - does not contain asbestos.

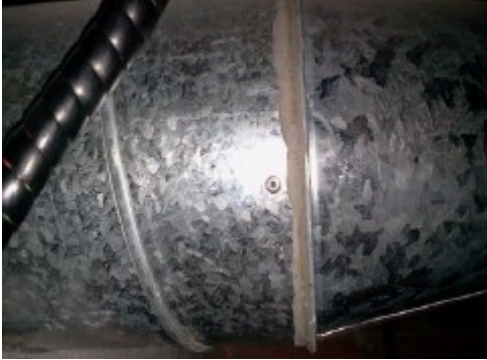
### **Item 96 Ref: As 41620-1**

The mastic to air handling ductwork joints in the Shower/Rm 010 ceiling void above - does not contain asbestos.

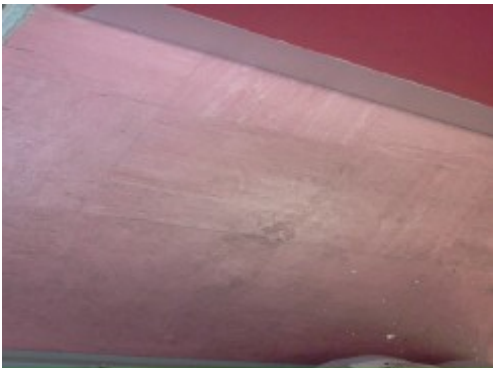
### **Item 97 Ref: 41620-2**

The floor covering in the Caretakers Store/Rm 011 does not contain asbestos.

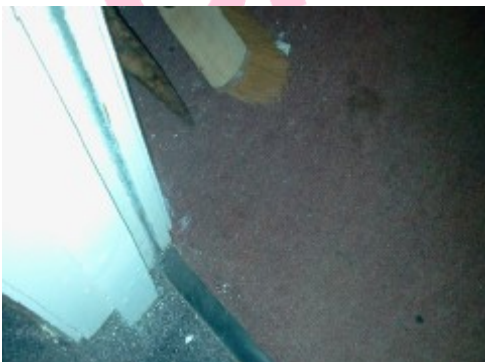
### **Item 98 Ref: 41620-2**

The subfloor in the Caretakers Store/Rm 012 does not contain asbestos.

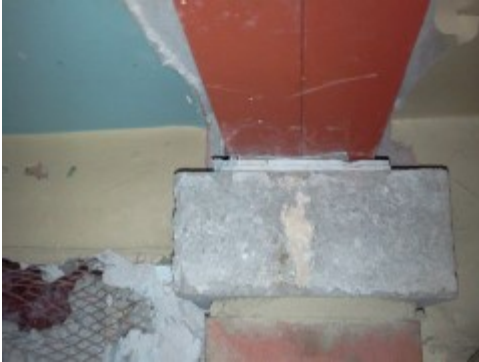
### **Item 99 Ref: 41620-3**

*The packing to underside of beam in the Office/Rm 015 contains asbestos.*

*Removed 2014*

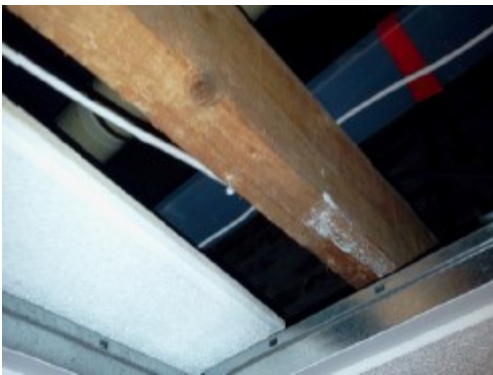
### **Item 100 Ref: 41620-4**

The debris to beam in the Corridor ceiling void above/Rm 017 does not contain asbestos.

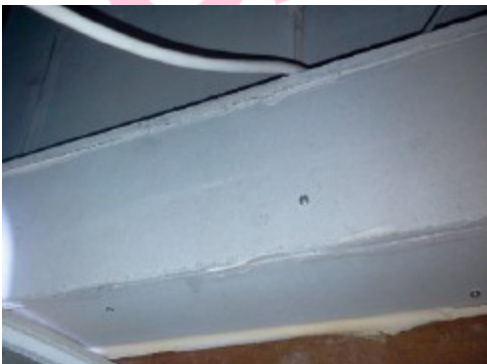
### **Item 101 Ref: As 41620-5**

The boxing to beam above door in the Corridor ceiling void above/Rm 017 does not contain asbestos.

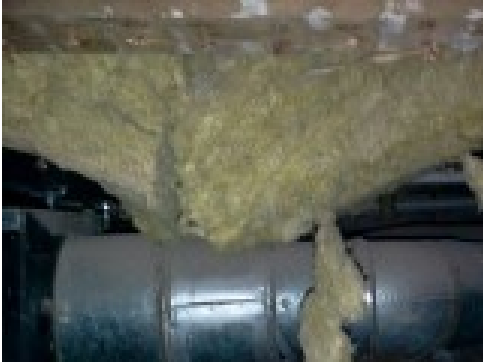
### **Item 102 Ref: As 41620-1**

The mastic to air handling ductwork joints in the Office/Rm 018 ceiling void above does not contain asbestos.

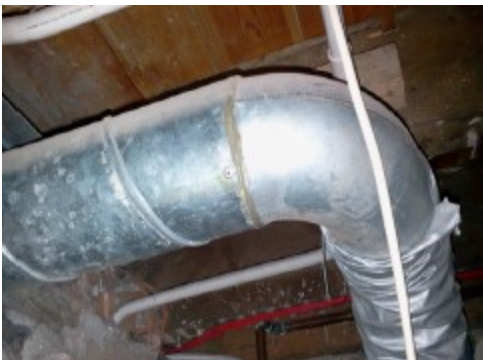
### **Item 103 Ref: As 41620-1**

The mastic to air handling ductwork joints in the WC/Rm 019 ceiling void above does not contain asbestos.

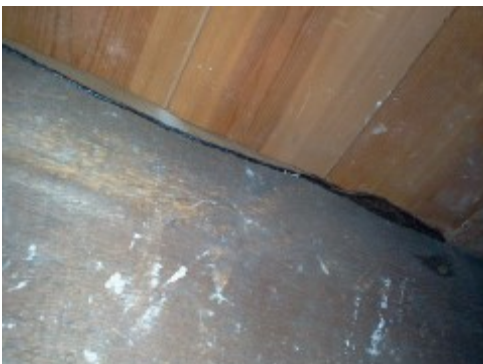
### **Item 104 Ref: 41620-6**

The packing to top of wall and underside of floor in the WC/Rm 019 ceiling void above does not contain asbestos.

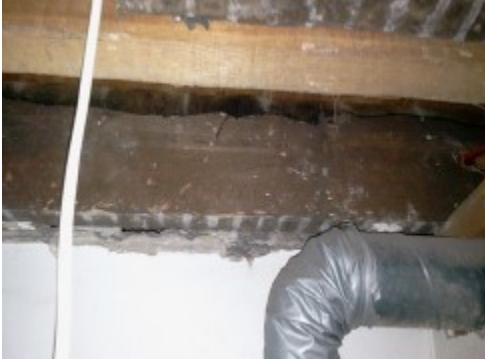
### **Item 105 Ref: As 41620-6**

The packing to top of wall and underside of floor in the WC/Rm 020 ceiling void above does not contain asbestos.

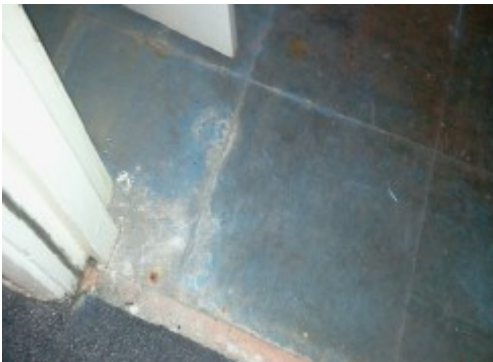
### **Item 106 Ref: 41620-7**

The floor covering in the Cleaners cupboard/Rm 026 does not contain asbestos.

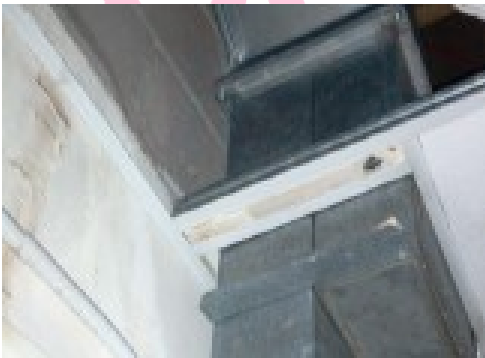
### **Item 107 Ref: As 41620-1**

The mastic to air handling ductwork joints in the Cleaners Cupboard/Rm 026 does not contain asbestos.

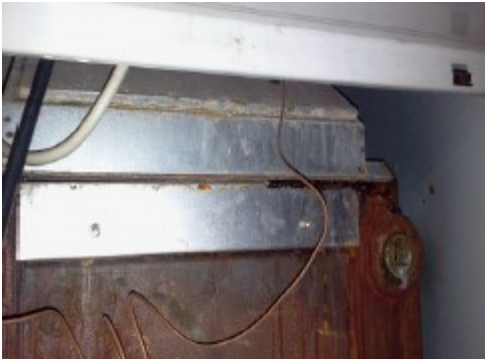
#### **Item 108 Ref: 41620-8**

The mastic to top of boiler plate in the Cleaners Cupboard/Rm 026 does not contain asbestos.

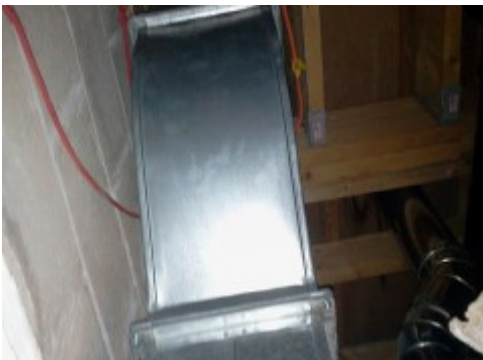
#### **Item 109 Ref: As 41620-1**

The mastic to air handling ductwork joints in the Cleaners Cupboard/Rm 026 ceiling void above - does not contain asbestos.

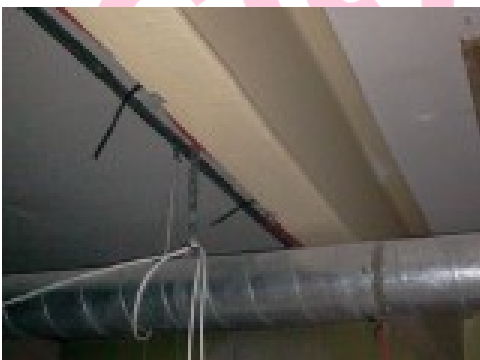
#### **Item 110 Ref: As 41620-1**

The mastic to air handling ductwork joints in the Community Room/Rm 032 ceiling void above - does not contain asbestos.

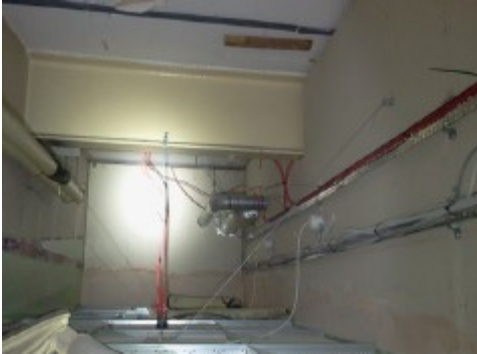
### **Item 111 Ref: As 41620-1**

The mastic to air handling ductwork joints in the Store Cupboard /Rm 033 ceiling void above - does not contain asbestos.

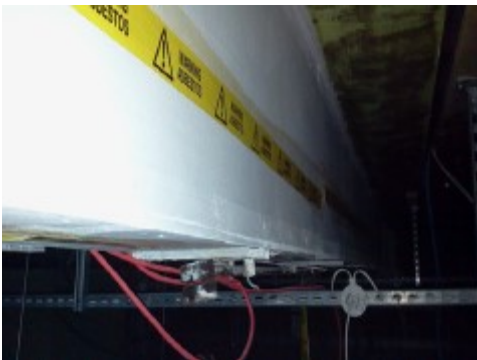
### **Item 112 Ref: 41620-11**

*The boxing to beams in the Restaurant/Rm 040 ceiling voids above contains asbestos.*

*Removed 2014*

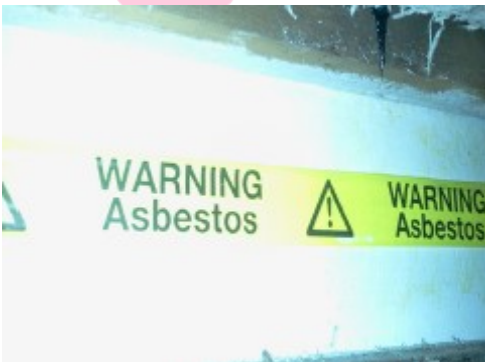
### **Item 113 Ref: As 41620-11**

*The extractor hood surround in the Kitchen/Rm 041 ceiling voids above contains asbestos.*

*Removed 2014*

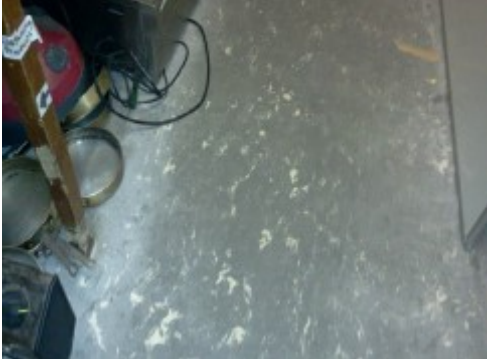
### **Item 114 Ref: 41620-13**

*The floor in the Dry Store/Rm 042 contains asbestos.*

*Removed 2014*

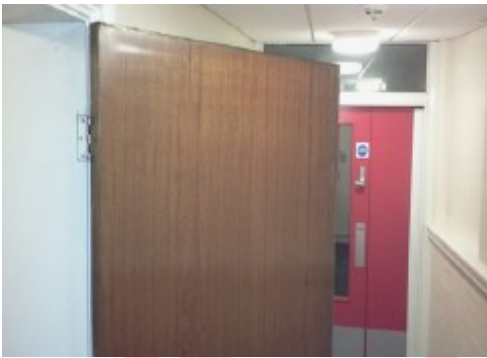
### **Item 115 Ref: As 41620-24**

*The panel within door in the Stairwell leading to boiler Room/Rm 057 contains asbestos.*

*Removed 2014*

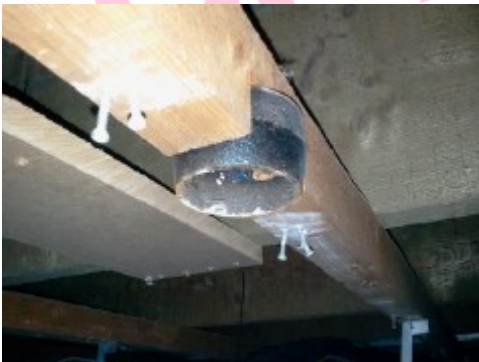
### **Item 116 Ref: 41620-26**

*The debris to beams in the audio room/Rm 1/001 ceiling void above contains asbestos.*

*Removed 2014*

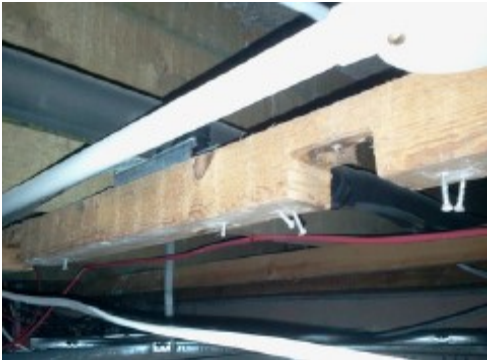
### **Item 117 Ref: As 41620-26**

*The debris to beams in the audio room/Rm 1/002 ceiling void above contains asbestos.*

*Removed 2014*

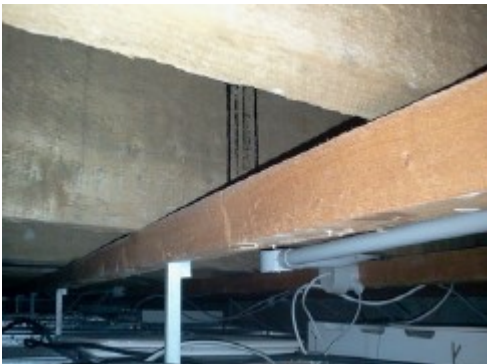
### **Item 118 Ref: As 41620-26**

*The debris to beams in the computer room/Rm 1/003 ceiling void above contains asbestos.*

*Removed 2014*

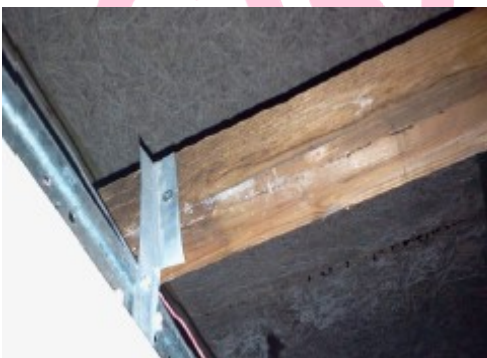
### **Item 119 Ref: As 41620-26**

*The debris to beams in the Corridor/Rm 1/004 ceiling void above contains asbestos.*

*Removed 2014*

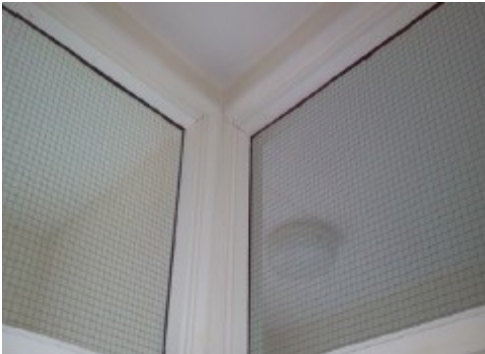
### **Item 120 Ref: 41620-27**

The mastic to glass panels above door in the Corridor/Rm 1/011 does not contain asbestos.

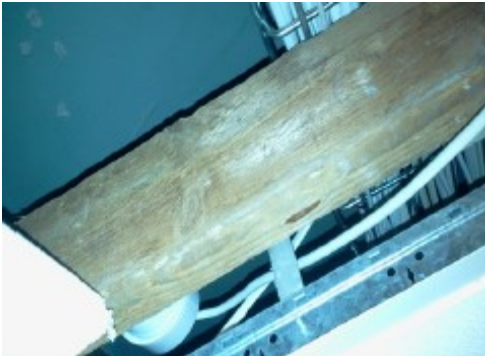
### **Item 121 Ref: As 41620-26**

*The debris to beams in the Corridor/Rm 1/014 ceiling void above contains asbestos.*

*Removed 2014*

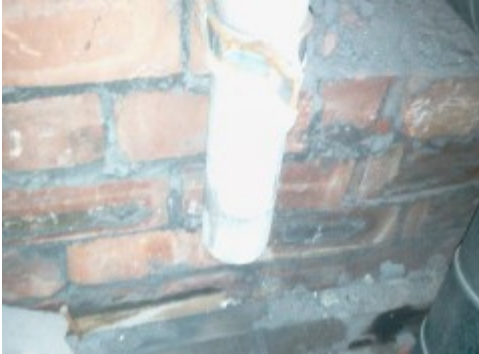
### **Item 129 Ref: 41620-30**

*The redundant pipework to wall in the Male WC/Rm1/036 roof void contains asbestos.*

*Removed 2014*

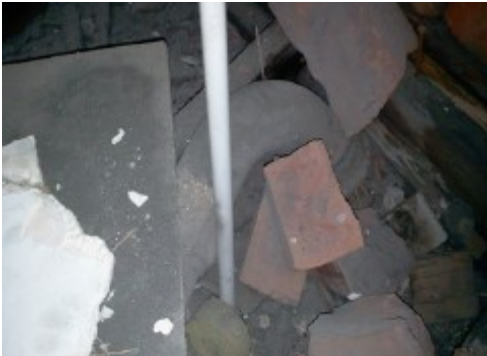
### **Item 130 Ref: As 41620-29**

*The redundant pipework to floor in the Male WC/Rm1/036 roof void contains asbestos.*

*Removed 2014*

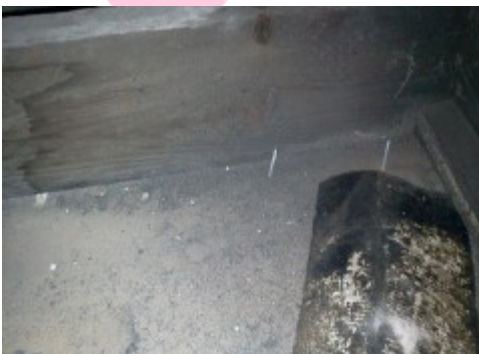
### **Item 131 Ref: 41620-29**

*The remnant roof felt in the Male WC/Rm1/036 roof void contains asbestos.*

*Removed 2014*

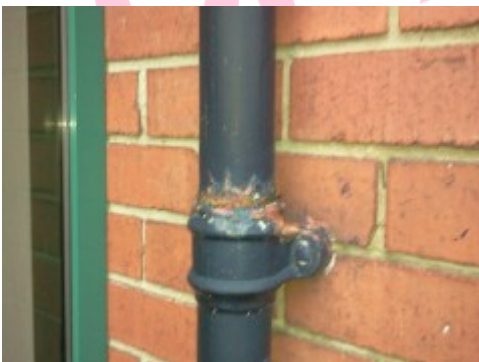
### **Item 134 Ref: 41620-33**

The sealant to downpipe collars (External) does not contain asbestos.

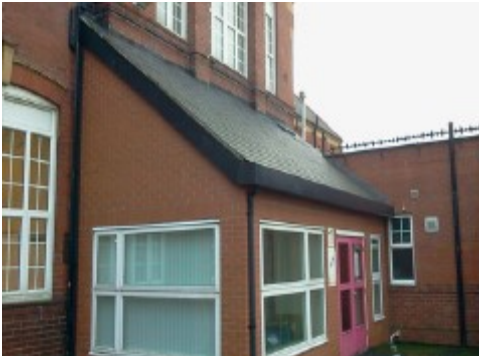
### **Item 135 Ref: 41620-35**

The fillet to pitched roof at LHS elevation adj sitting area (External) does not contain asbestos.

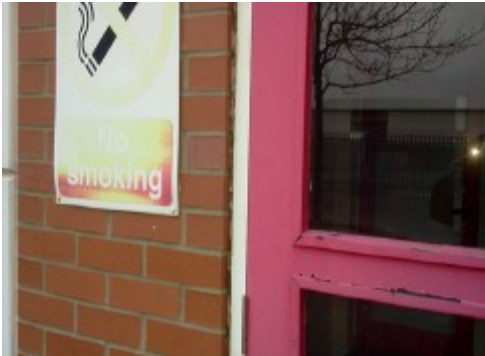
### **Item 136 Ref: 41620-36**

The mastic to doorframe at double red doors lhs elevation adj seating area (External) does not contain asbestos.

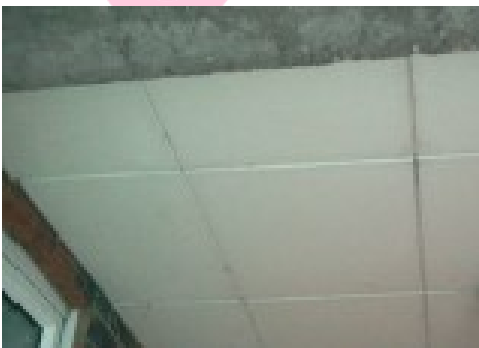
### **Item 137 Ref: 41620-36**

*The tiles to rear canopy exit from corridor (External) contains asbestos.*

*Removed 2014*

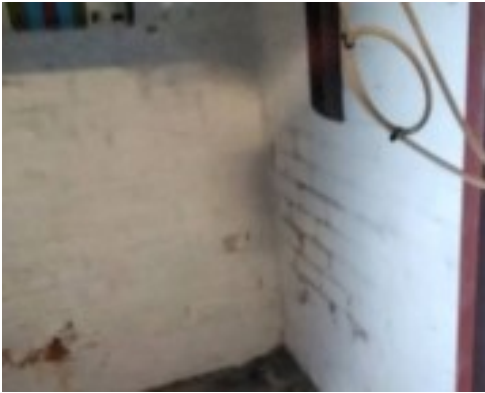
### **Item 141 Ref: KX001000**

The debris/residue to the stairwell wall in the Boiler Room does not contain asbestos.

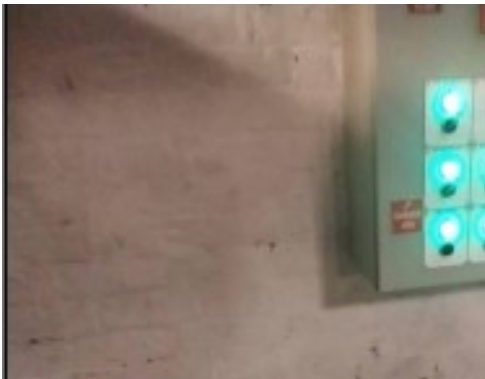
### **Item 142 Ref: KX001001**

The debris/residue in the Boiler Room does not contain asbestos.

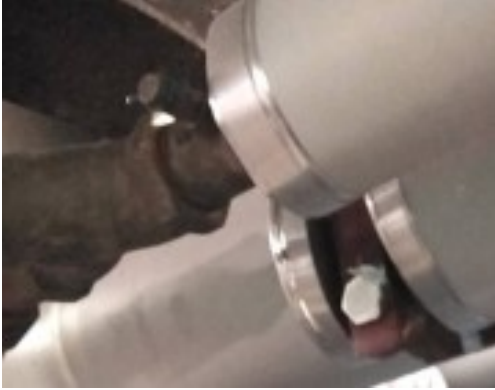
### **Item 144 Ref: KX001004**

The debris/residue to the pipe brackets/surfaces/penetrations of thick bore pipes in the Boiler Room does not contain asbestos.

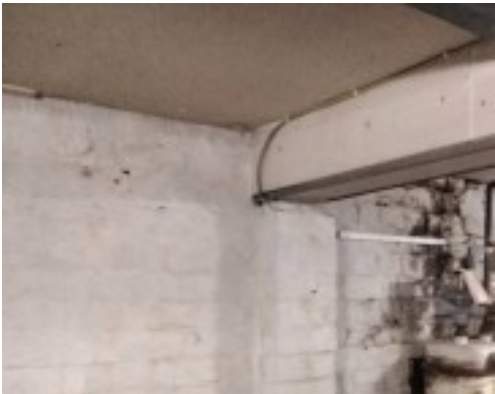
### **Item 145 Ref: KX001005**

The debris/residue in the Boiler Room does not contain asbestos.

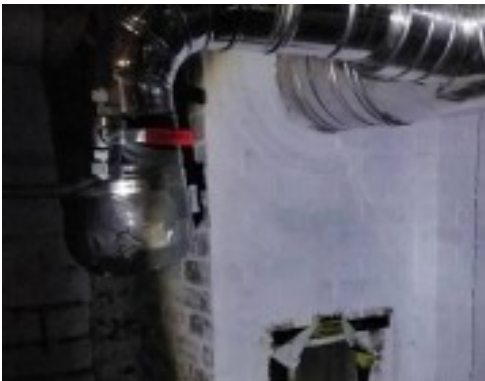
### **Item 146 Ref: KX001006**

The debris/residue in the Boiler Room does not contain asbestos.

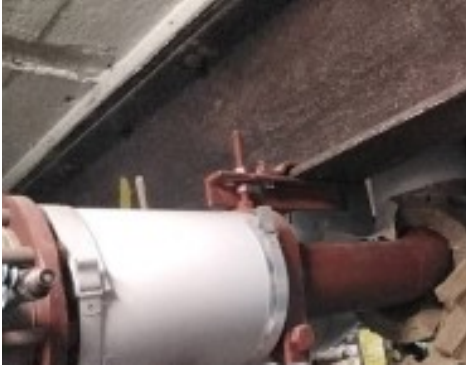
### **Item 147 Ref: KX001007**

The debris/residue in the Boiler Room does not contain asbestos.

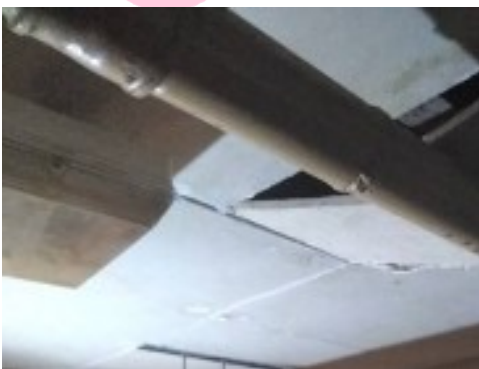
### **Item 149 Ref: KX000996**

The beam cladding in the Boiler Room does not contain asbestos. (Limited inspection within)

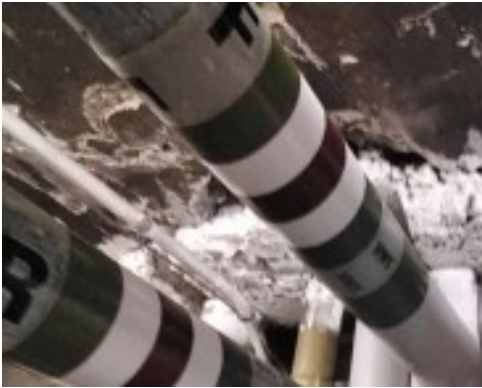
### **Item 150 Ref: KX001011**

The debris/residue to the floor nearer the rear wall in the Boiler Room does not contain asbestos.

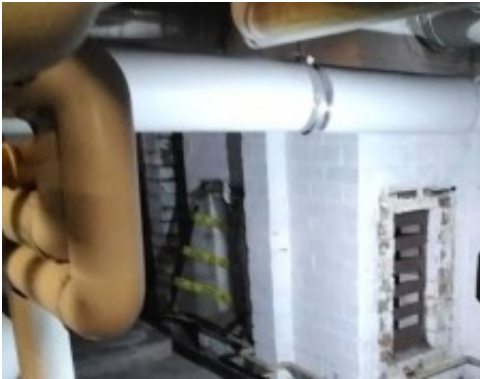
### **Item 151 Ref: KX000999**

The debris/residue to walls at wall grilles to old flues (Boiler Room) does not contain asbestos.

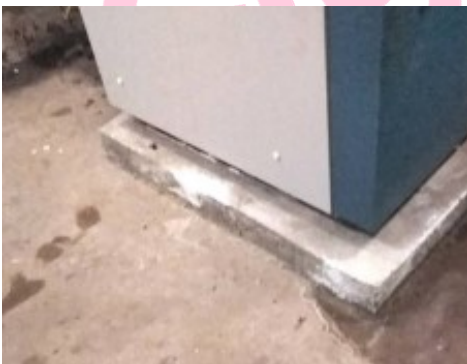
### **Item 152 Ref: KX001909**

The debris/residue to floor plinths under boilers nearest stairs (Boiler Room) does not contain asbestos.

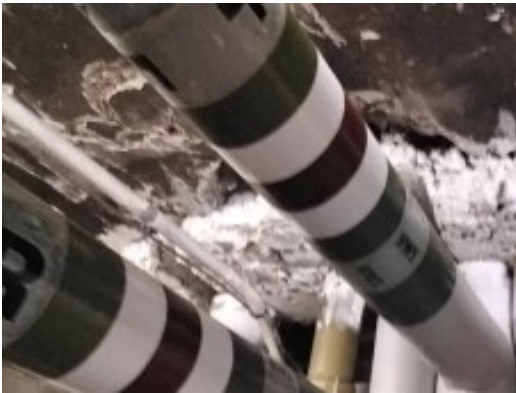
#### **Item 153 Ref: KX001013**

The debris/residue shuttering remnants from pipe penetration (Boiler Room) does not contain asbestos.

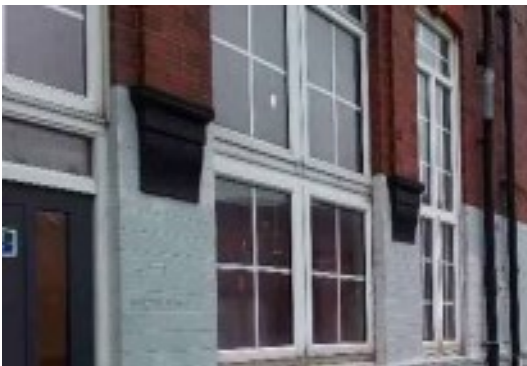
#### **Item 154 Ref: OQ000417**

The window sealant to wall (External) does not contain asbestos.
