### ASBESTOS SURVEY REPORT FOR THE PALLION CENTRE, WAVERLEY TERRACE, SUNDERLAND

## **Asbestos Register for The Pallion Centre**

**Date: 26 September 2024**

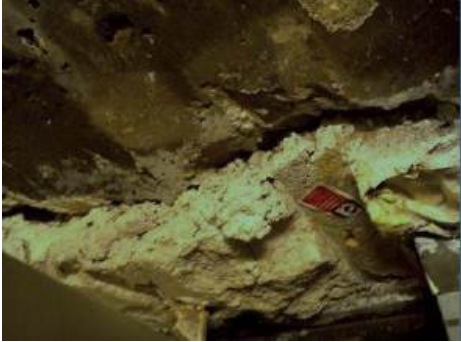
### **Item 1 Ref: Presumed**

It is possible that there will be some asbestos fibres to the porous concrete ceiling of the boiler room (Sub level Room 1).

This should be encapsulated.

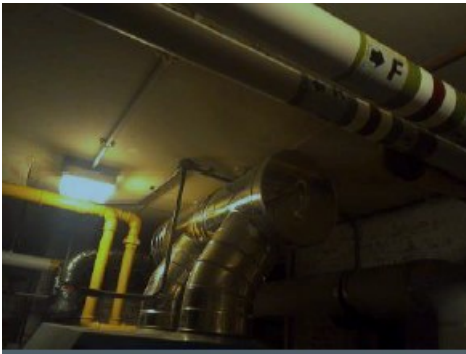
### **Item 2 Ref: AP001909**

The insulating board to the ceiling in the boiler room (Sub level Room 1) does not contain asbestos.

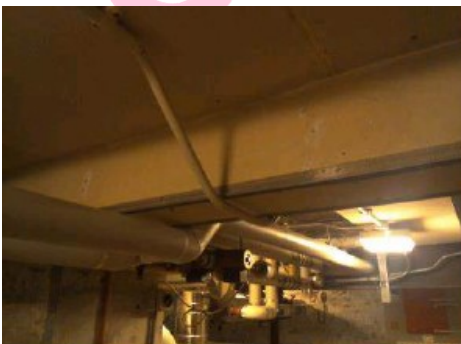
### **Item 3 As AP001909**

The insulating board to the high level boxing to the ceiling in the boiler room (Sub level Rm 1) does not contain asbestos.

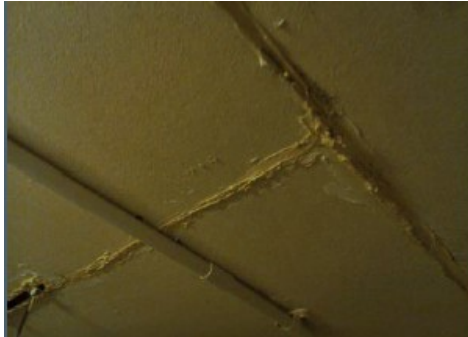
**Item 4 Ref: AP001910**

The mastic between the ceiling panels to the ceiling of the boiler room (Sub level Room 001) does not contain asbestos.

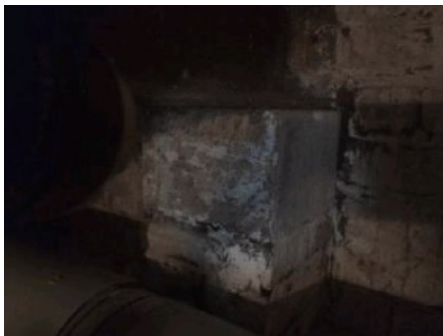
**Item 5 Ref: AP001911**

The residue to the wall in the boiler room (Sub level Room 1) contains asbestos.

This is encapsulated and no works should take place on the walls.

Any change in its appearance should be recorded and passed to Property Services.

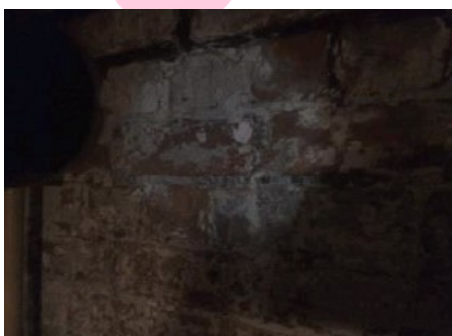
**Item 6 Ref: AP001912**

The residue to the wall in the boiler room (Sub level Room 1) contains asbestos.

Any change in its appearance should be recorded and passed to Property Services.

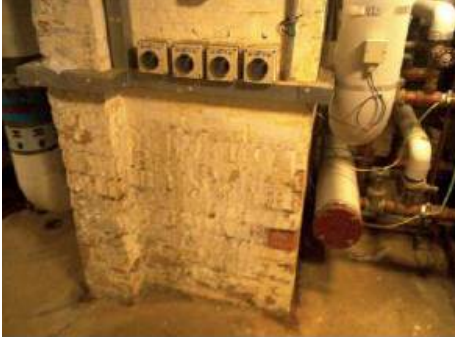
**Item 7 Ref: AP001913**

The residue to the central brick column to the plant room (Sub level Room 1) does not contain asbestos.

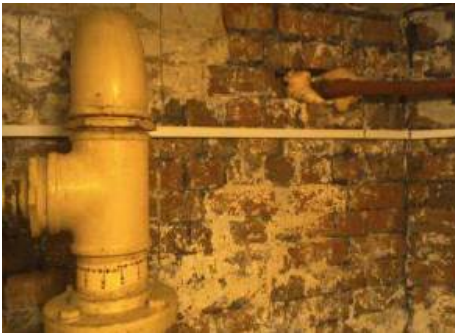
**Item 8 Ref: AP001914**

The residue to the wall in the boiler room (Sub level Room 1) contains asbestos.

This is encapsulated and no works should take place on the walls.

Any change in its appearance should be recorded and passed to Property Services.

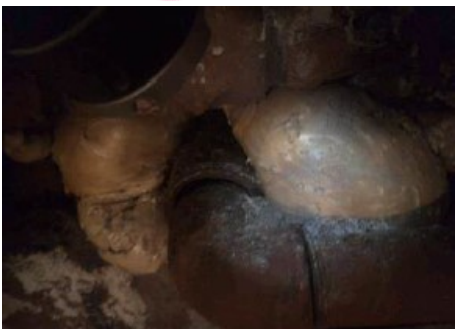
**Item 9 Ref: AP001915**

The residue to the pipe on the wall in the boiler room (Sub level Room 1) contains asbestos.

Any change in its appearance should be recorded and passed to Property Services.

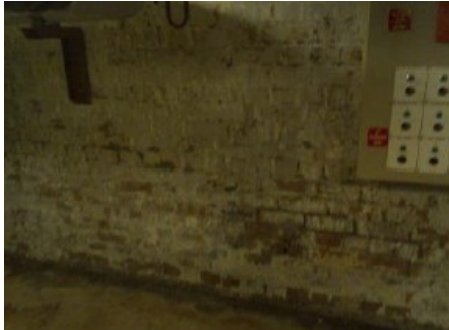
**Item 10 Ref: AP001916**

The residue to the wall in the plant room (Sub level Room 1) does not contain asbestos.

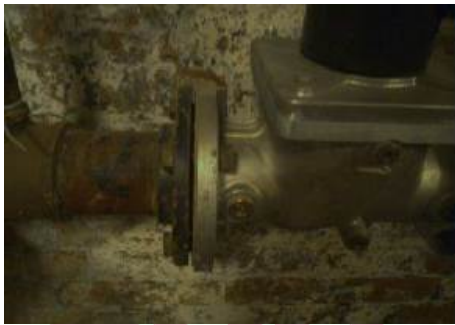
**Item 11 Ref: AP001917**

The gaskets to the flanges in the boiler room (Sub level Room 1) contain asbestos.

Any change in its appearance should be recorded and passed to Property Services.

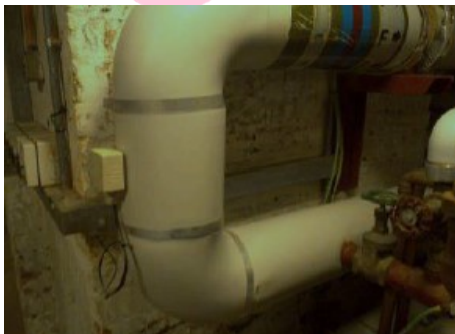
**Item 12 Ref: AP001918**

The large bore pipe insulation in the boiler room (Sub level Room 1) does not contain asbestos.

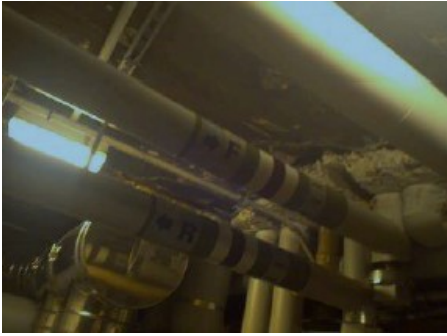
#### **Item 13 Ref: AP001919**

The small bore pipe insulation to the plant room (Sub level Room 1) does not contain asbestos.

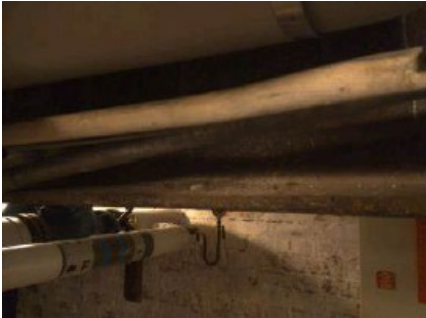
#### **Item 14 Ref: AP001920**

The debris to the horizontal surface on the beam in the boiler room (Sub level Room 1) contained asbestos.

An environmental clean should be carried out.

Any change in its appearance should be recorded and passed to Property Services.

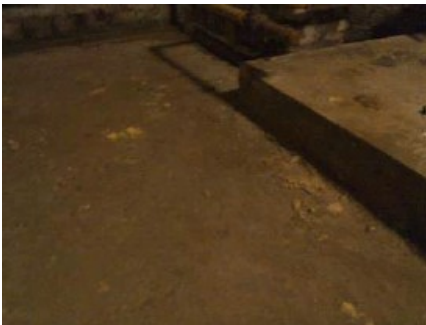
#### **Item 15 Ref: AP001921**

The general floor debris to the boiler room (Sub level Room 1) does not contain asbestos.

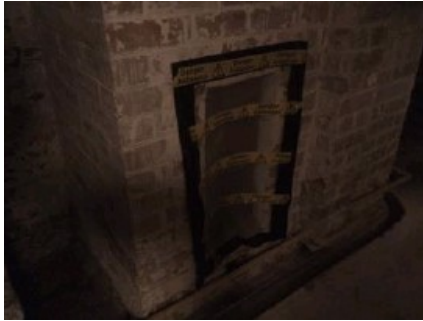
There is possibly asbestos within the sealed brick riser in the plant room (Sub level Room 1). Prior to any intrusive works, a survey must be carried out.

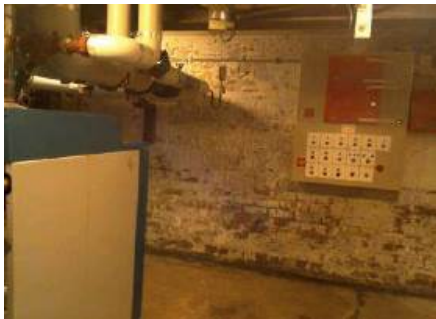
There was no access to the live electrics in the boiler room (Sub level Room 1). Prior to any work starting, carry out further surveying.

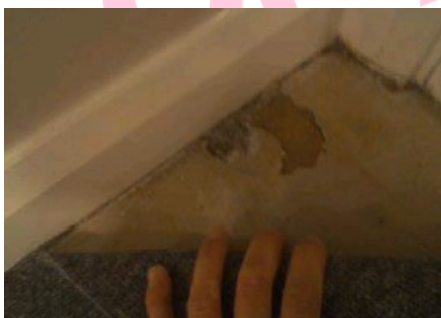
### **Item 16 Ref: AP001884**

The remaining adhesive to the floor beneath the carpet to the lobby (Room 1) contains asbestos.

Any change in its appearance should be recorded and passed to Property Services.

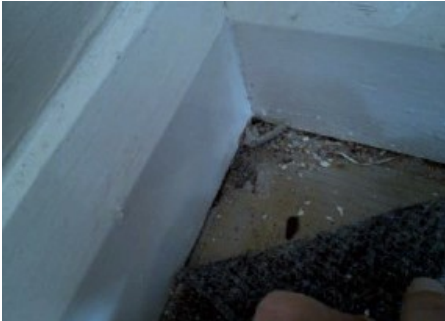
**Item 17 As: AP001884**

The remaining adhesive to the floor beneath the carpet and modern screed in the entrance lobby (Room 2) contains asbestos.

Any change in its appearance should be recorded and passed to Property Services.

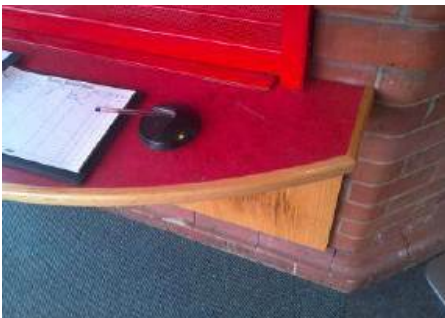
**Item 18 Ref: AP001885**

The vinyl to the hatch in the entrance lobby (Room 2) does not contain asbestos.

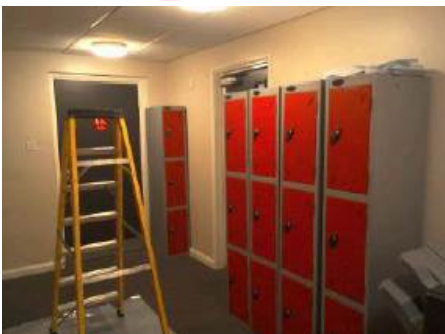
The staff lobby (Room 3) was accessed, and no suspect materials were found.

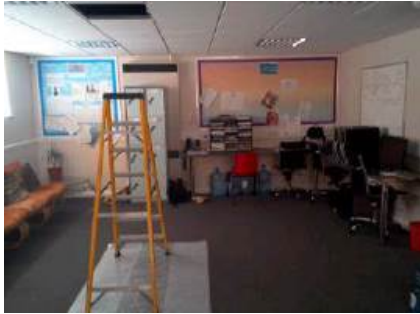
The staff room (Room 4) was accessed, and no suspect materials were found.

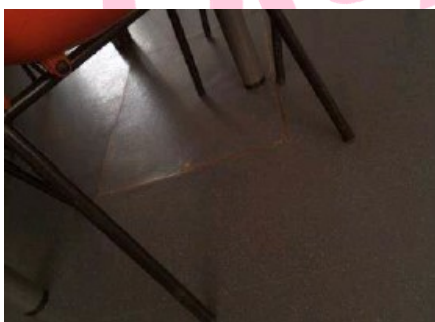
There was no access to the floor duct in the staff kitchen (Room 5).

Prior to any works, there needs to be further investigation.

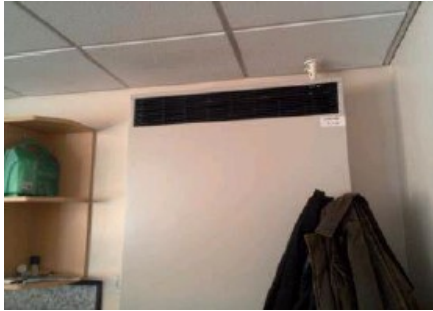
There was no access to the storage heater in the staff kitchen (Room 5) as it was live plant.

Prior to any works, there needs to be further investigation.

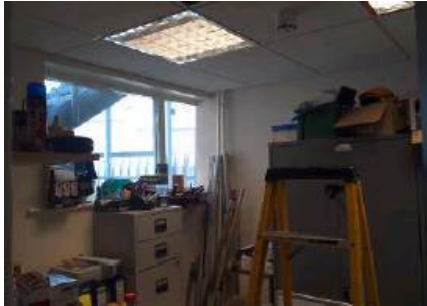
The caretakers office (Room 11) was accessed and no suspect materials were found.

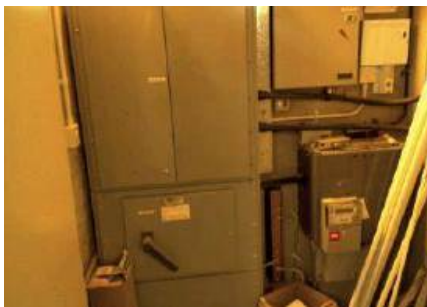
There was no access to the electrics in the electrical store (Room 12) due to live plant.

Prior to work taking place, prior investigation needs to be carried out.

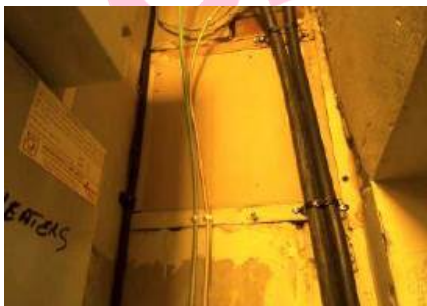
There was no access behind the plasterboard panel in the electrical store (Room 12) due to possible damage.

Prior to work taking place, prior investigation needs to be carried out.

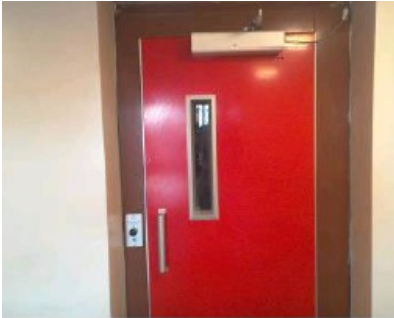
There was no access within the lift shaft (Room 13).

Prior to any works taking place, further investigation is required.

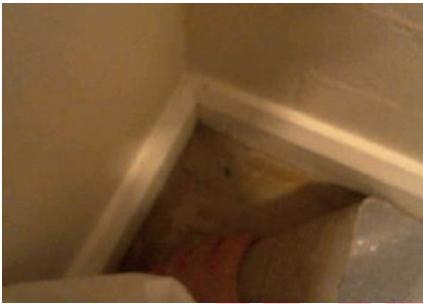
#### **Item 19 As AP001884**

The remaining adhesive to the floor beneath the carpet and modern screed in the reception lobby (Room 14) contains asbestos.

Any change in its appearance should be recorded and passed to Property Services.

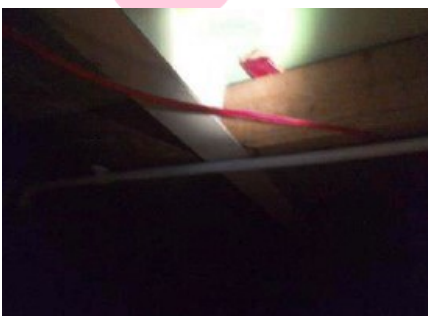
#### **Item 20 Ref: AP001886**

The fibreboard packer to between the concrete and the wood beam in the reception lobby (Room 14) does not contain asbestos.

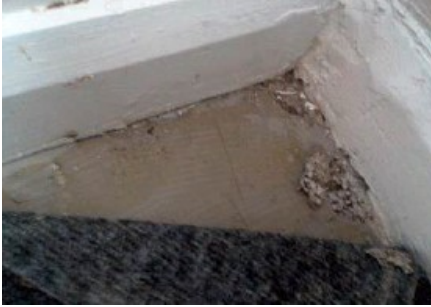
### **Item 21 As AP001884**

The remaining adhesive to the floor beneath the carpet and modern screed in the reception (Room 15) contains asbestos.

Any change in its appearance should be recorded and passed to Property Services.

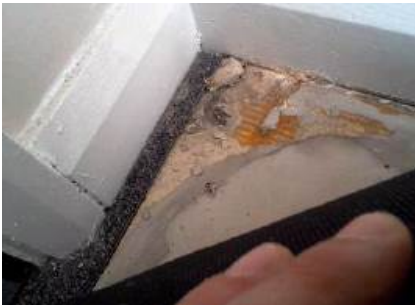
### **Item 22 As AP001884**

The remaining adhesive to the floor beneath the carpet and modern screed in the repro room (Room 16) contains asbestos.

Any change in its appearance should be recorded and passed to Property Services.

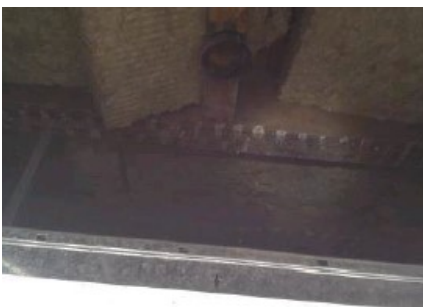
The Admin office (Room 17) was accessed and no suspect materials were found.

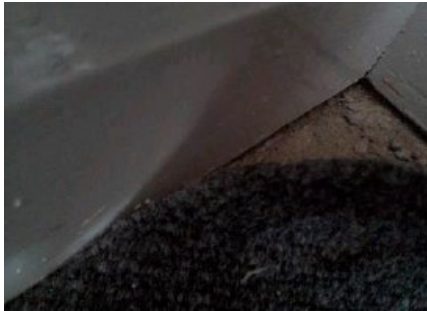
**Item 23 As AP001884**

The remaining adhesive to the floor beneath the carpet and modern screed in the office (Room 18) contains asbestos.

Any change in its appearance should be recorded and passed to Property Services.

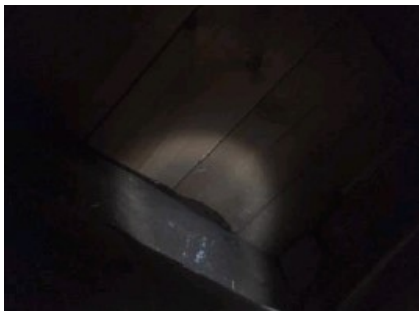
**Item 24 Ref: AP001887**

The bitumen drip to the ceiling void in the Admin WC (Room 19) does not contain asbestos.

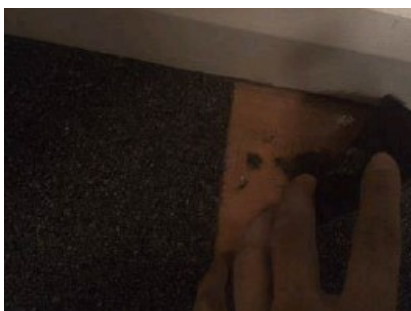
There was no access beneath the vinyl under the carpet in the lobby (Room 20) due to causing possible damage.

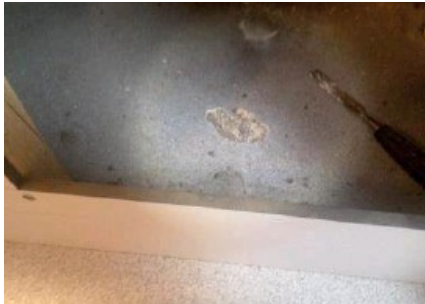
**Item 25 Ref: AP001888**

The adhesive to the concrete floor beneath the modern lino to the female wc (Room 21) does not contain asbestos.

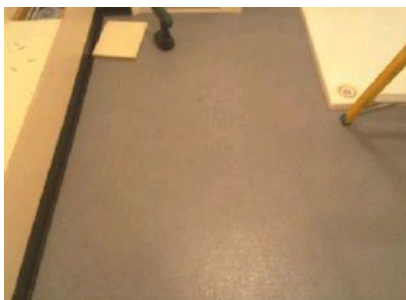
There was no access beneath the modern lino to the Disabled WC (Room 22) without causing possible damage.

Prior to any works taking place investigation should be carried out.

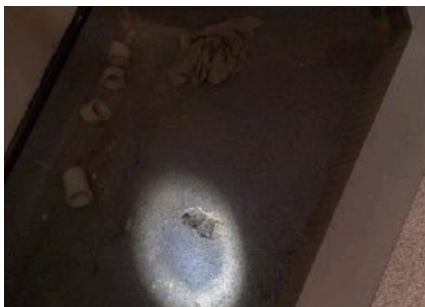
**Item 26 As: AP001888**

The adhesive to the concrete floor beneath the modern lino and screed to the male wc (Room 23) does not contain asbestos.

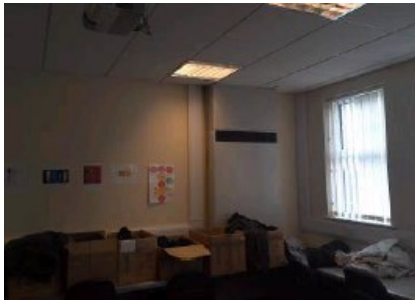
There was no access to the storage heaters in the electronic engineers (Room 24) due to the plant being live.

This should be investigated prior to any works being carried out.

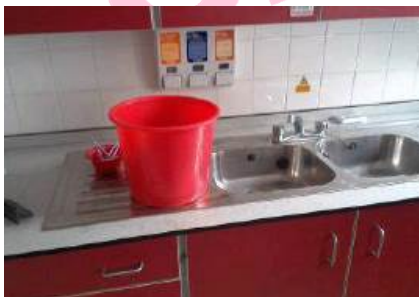
**Item 28 Ref: AP001889**

The bitumen sink pads to the sink in the machine shop (Room 25) do not contain asbestos.

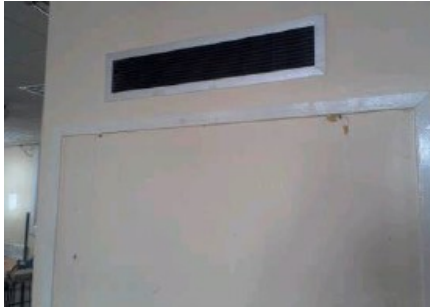
There was no access within the heater in the machine shop (Room 25) due to live plant.

Prior to any works being carried out, further investigation will be required.

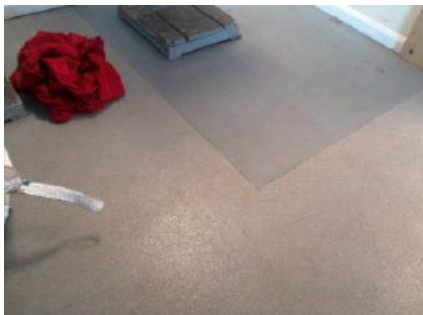
### **Item 29 As: AP001888**

The adhesive to the concrete floor beneath the modern lino to the machine shop (Room 25) does not contain asbestos.

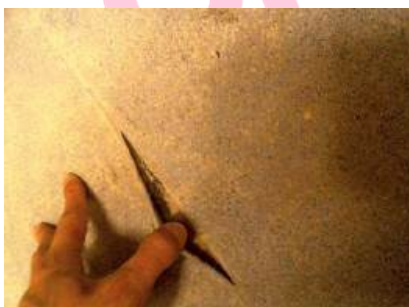
### **Item 30 As: AP001888**

The adhesive to the concrete floor beneath the modern lino to the bar rack store (Room 26) does not contain asbestos.

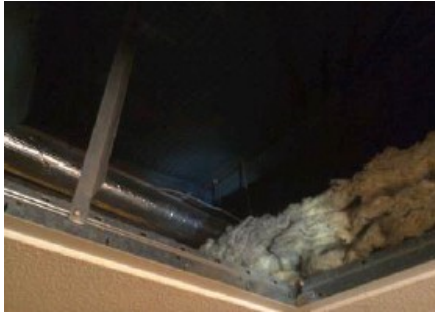
The safe store (Room 27) was accessed, and no suspect materials were found.

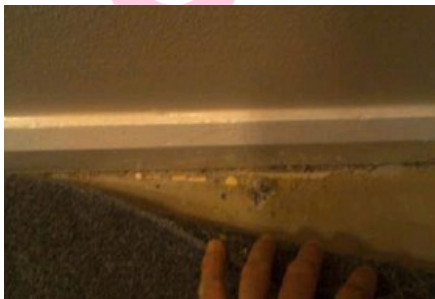
#### **Item 31 As: AP001888**

The bitumen adhesive to the concrete floor beneath the modern lino to the stairwell lobby (Room 28) does not contain asbestos.

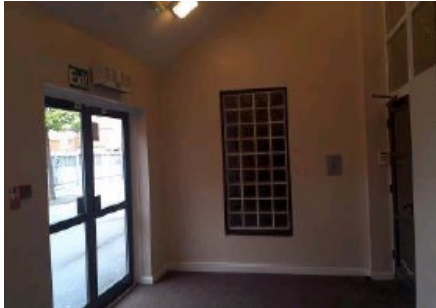
The rear porch (Room 29) was accessed, and no suspect materials were found.

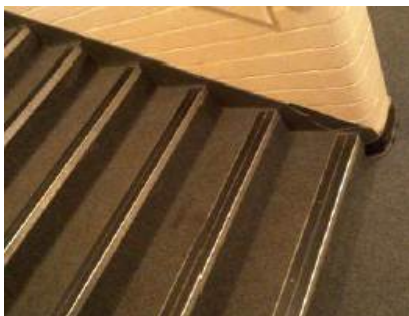
### **Item 32 Ref: AP001890**

The stair nosing to the stairs (Room 30) does not contain asbestos.

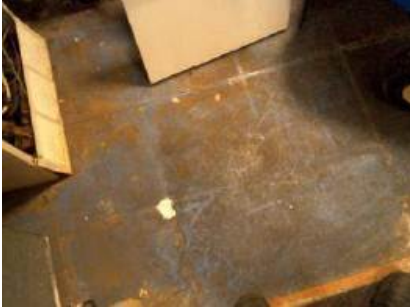
**Item 33 Ref: AP001891**

The floor tiles to the boiler cupboard (Room 32) do not contain asbestos.

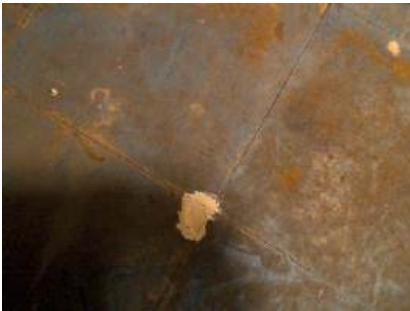
**Item 34 Ref: AP001892**

The bitumen adhesive to the floor to the boiler cupboard (Room 32) does not contain asbestos.

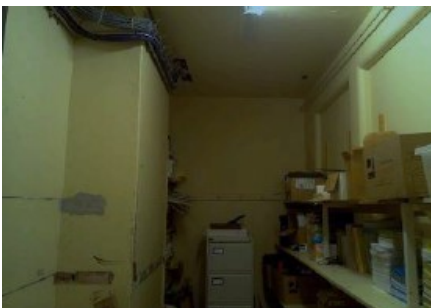
The stock room (Room 30) was accessed, and suspect materials were found.

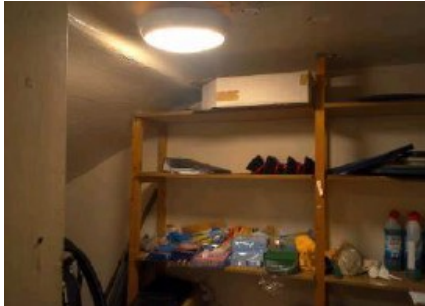
The cleaners store (Room 34) was accessed, and no suspect materials were found.

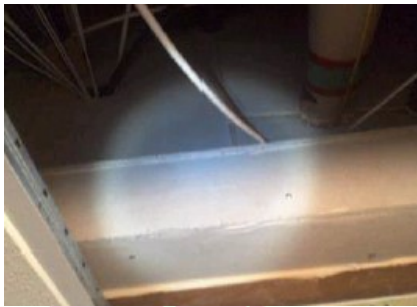
### **Item 35 Ref: AP001893**

The firebreak between the corridor and the restaurant (Room 35) within the ceiling void does not contain asbestos.

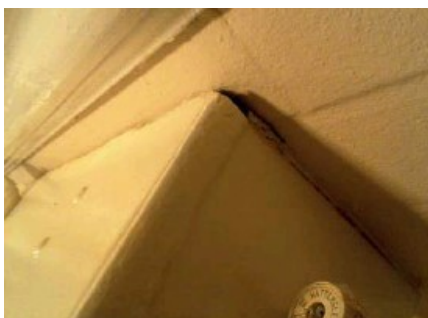
### **Item 36 Ref: AP001894**

The foam between the metal rad hangers and brick wall in the corridor (Room 35) does not contain asbestos.

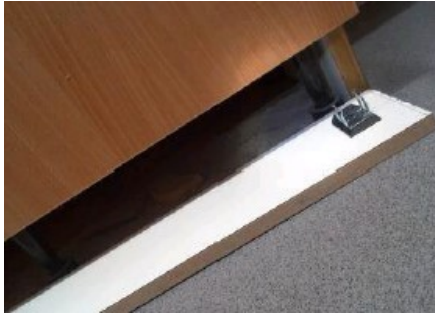
### **Item 37 Ref: Presumed**

The bitumen beneath the modern lino and the parquet flooring in the community room (Room 36) is presumed to contain asbestos.

Any change in its appearance should be recorded and passed to Property Services.

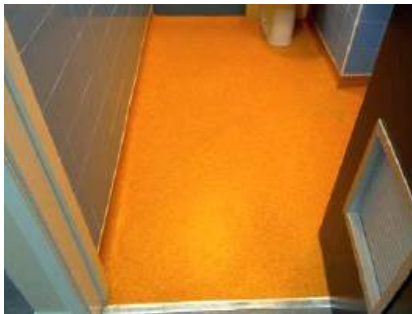
### **Item 38 Ref: Presumed**

The bitumen beneath the modern lino and the parquet flooring in the community room wc (Room 37) is presumed to contain asbestos.

Any change in its appearance should be recorded and passed to Property Services.

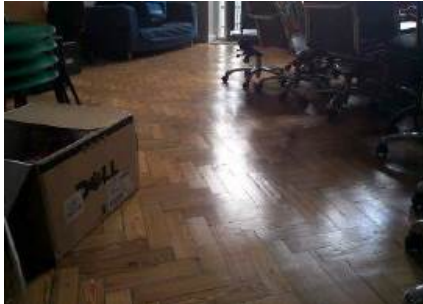
### **Item 39 Ref: 41620-9**

The bitumen beneath the parquet flooring in the plumbing room (Room 38) is presumed to contain asbestos.

Any change in its appearance should be recorded and passed to Property Services.

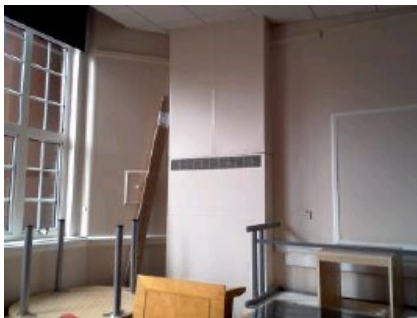
There was no access to the store heater within the plumbing room (Room 38). Prior to any work, this needs to be checked out.

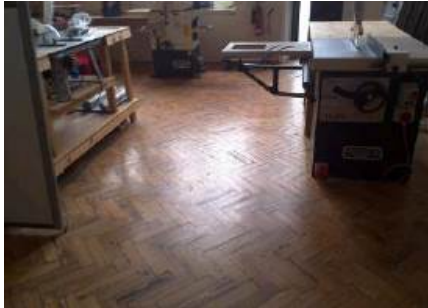
**Item 40 Ref: As 41620-9**

The bitumen beneath the parquet flooring in the joinery machine area (Room 39) is presumed to contain asbestos.

Any change in its appearance should be recorded and passed to Property Services.

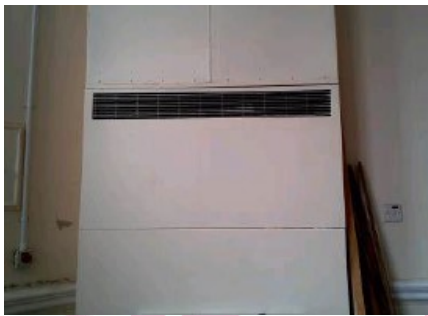
There was no access to the store heater within the joinery machine area (Room 39).

Prior to any work, this needs to be checked out.

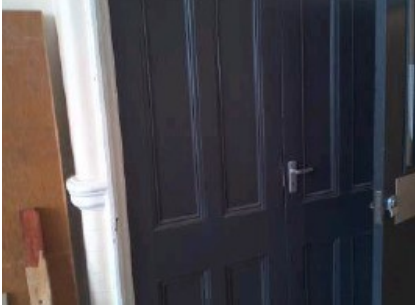
There was no access to the joinery store (Room 39), therefore it should be presumed to contain asbestos unless otherwise proven.

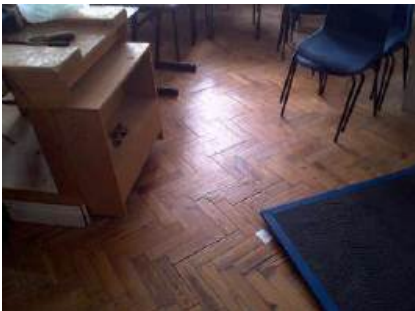
#### **Item 41 Ref: As 41620-9**

The bitumen beneath the parquet flooring in the joinery Room (Room 40) is presumed to contain asbestos.

Any change in its appearance should be recorded and passed to Property Services.

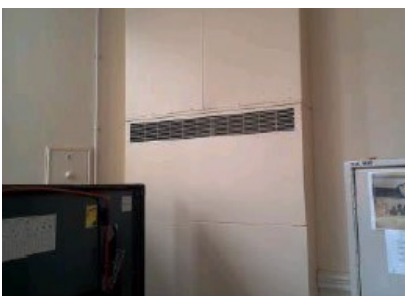
There was no access to the store heater within the joinery room (Room 40). Prior to any work, this needs to be checked out.

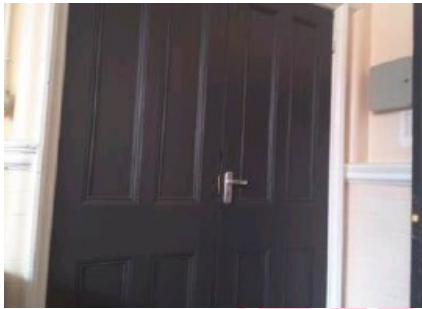
There was no access to the joinery store (Room 40), therefore it should be presumed to contain asbestos unless otherwise proven.

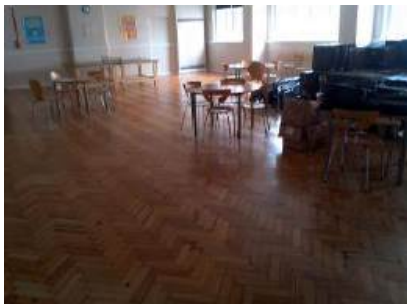
**Item 42 Ref: 41620-9**

The bitumen beneath the parquet flooring in the restaurant (Room 41) is presumed to contain asbestos.

Any change in its appearance should be recorded, and passed to Property Services.

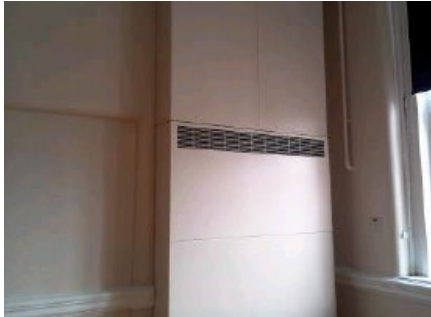
There was no access to the store heater within the restaurant (Room 41).

Prior to any work, this needs to be checked out.

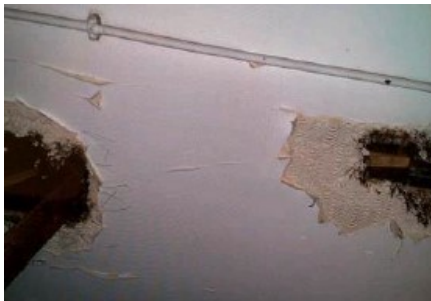
### **Item 43 Ref: Presumed**

The textured coating to the ceiling visible within the void in the kitchen (Room 42) is presumed to contain asbestos.

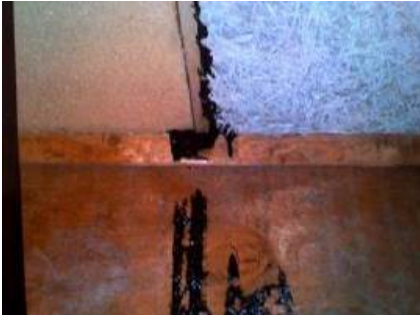
**Item 44 Ref: AP001895**

The bitumen to the stramit board roof in the kitchen ceiling void (Room 42) does not contain asbestos.

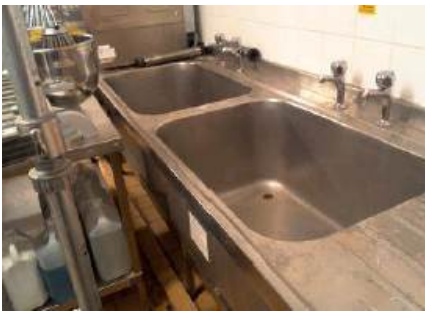
**Item 45 Ref: AP001896**

The bitumen sink pads to the kitchen (Room 42) do not contain asbestos.

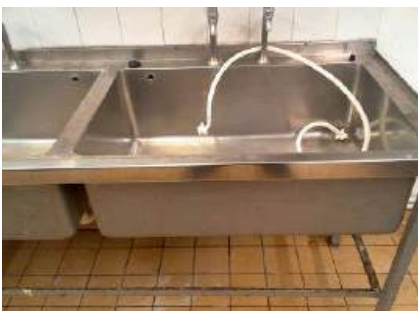
**Item 46 Ref: AP001897**

The bitumen sink pads to the sink and drainer sinks to the perimeter wall of the kitchen (Room 42) do not contain asbestos.

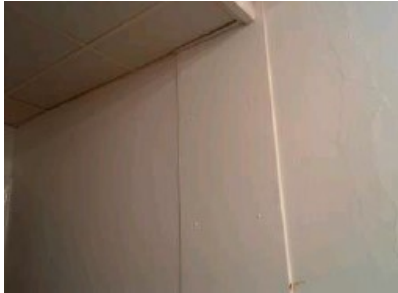
There was no access behind the wood access panel in the kitchen (Room 42) without causing further damage.

Prior to any works, further checks will be required.

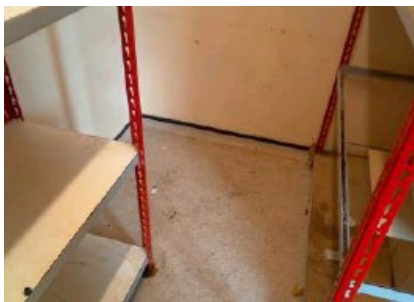
There was no access beneath the modern lino in the kitchen store (Room 43) without causing damage.

Prior to works this needs to be checked out.

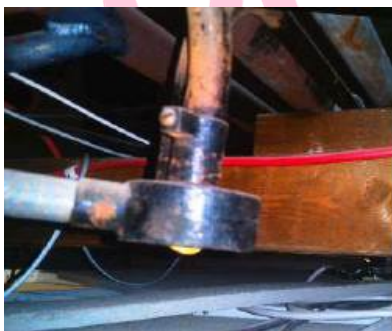
The lobby (Room 44) was accessed, and no suspect materials were found.

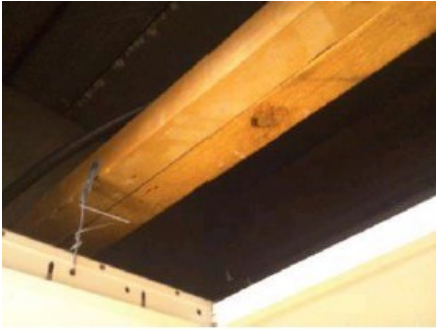
The kitchen wc (Room 45) was accessed and no suspect materials were found.

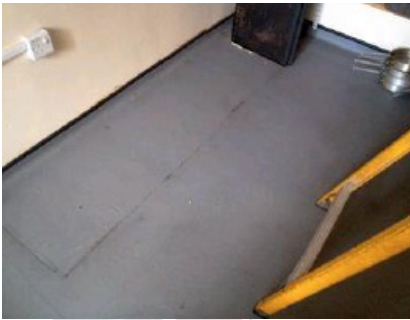
There was no access beneath the modern lino in the Kitchen office (Room 46) as it would cause damage.

Prior to any works, additional checks may need to be carried out.

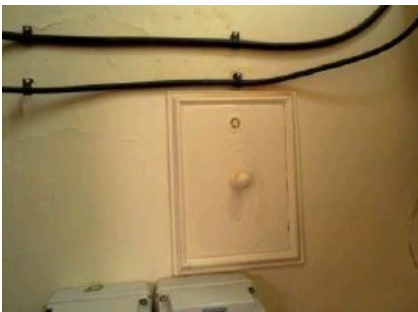
There was no access behind the metal access hatch to the dry store (Room 47) without causing damage.

Prior to any works, additional checks may need to be carried out.

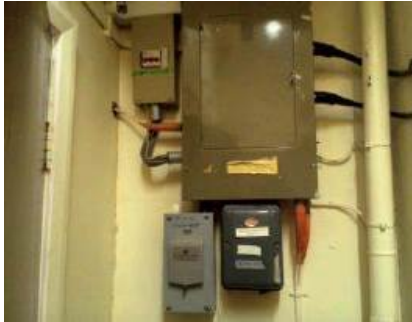
There was no access within the electrics to the dry store (Room 47) as they were live.

Prior to any disturbance, further checks will be required.

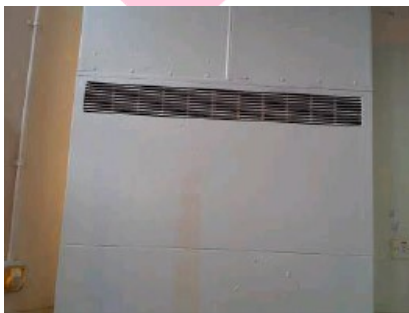
There was no access to the storage heater in the painting and decorating area (Room 49) as it was live.

Prior to any works, additional checks may need to be carried out.

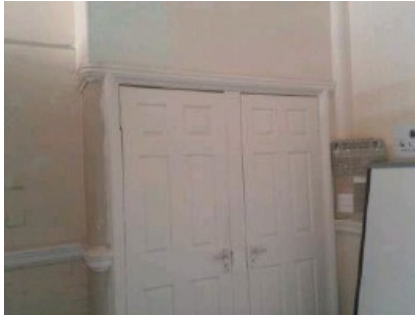
There was no access to the painting and decorating store (Room 49).

Prior to any works, additional checks may need to be carried out.

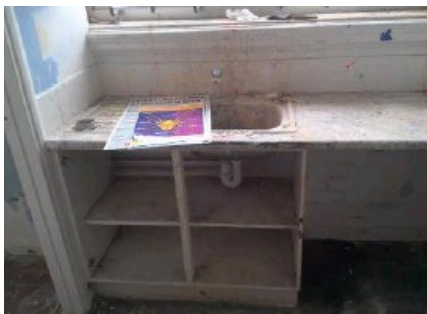
#### **Item 47 As: AP001896**

The sink pads to the underside of the sink and drainer in the Painting and decorating (Room 49) do not contain asbestos.

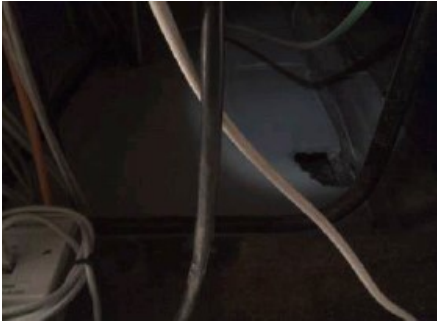
### Item 48 Ref: AP001898

The firebreak between the corridor and the restaurant (Room 50) does not contain asbestos.

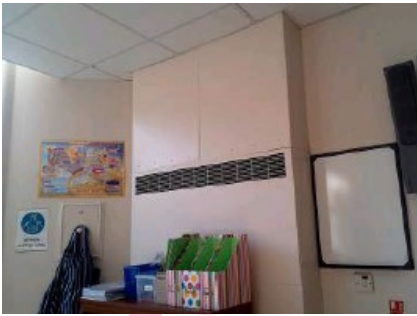
There was no access to the storage heater in the cookery area (Room 51) due to the plant being live.

Prior to any works, additional checks may need to be carried out.

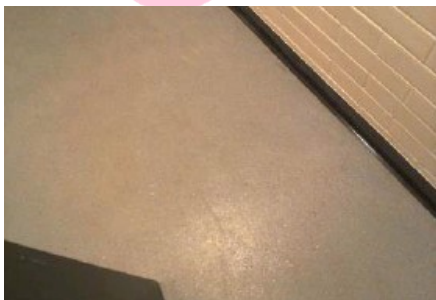
There was no access beneath the modern lino in the cookery store (Room 52) as it would cause damage.

Prior to any works, additional checks may need to be carried out.

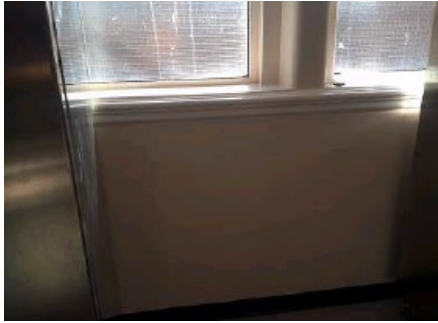
### Item 49 Ref: AP001899

The fibreboard panels to the cookery store (Room 52) do not contain asbestos.

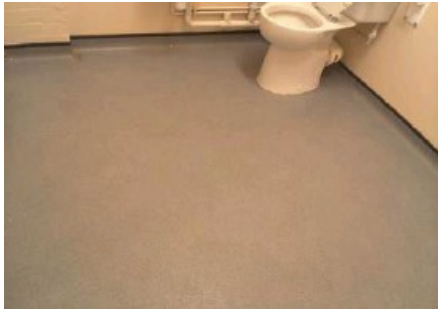
There was no access beneath the modern lino in the disabled wc (Room 53) as it would cause damage.

Prior to any works, additional checks may need to be carried out.

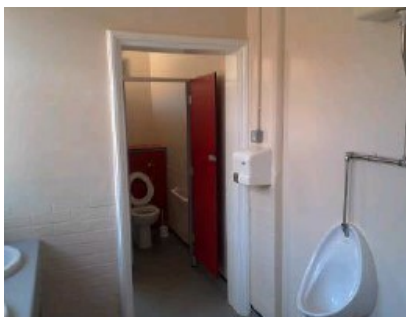
The male wc (Room 54) was accessed and no suspect materials were found.

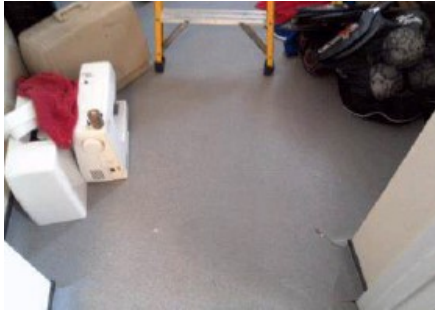
There was no access beneath the modern lino in the shower (Room 55) as it would cause damage.

Prior to any works, additional checks may need to be carried out.

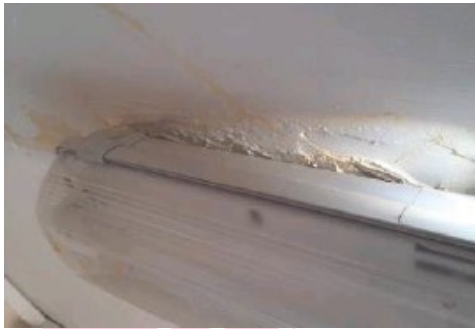
#### **Item 50 Ref: Presumed**

The textured coating to the ceiling in the shower room (Room 55) is presumed to contain asbestos.

***SGS confirmed removed.***

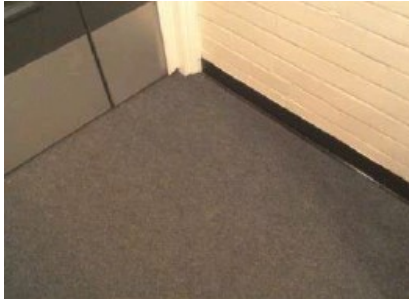
There was no access beneath the modern lino to the corridor (Room 57) as it would cause damage.

Prior to any works, additional checks may need to be carried out.

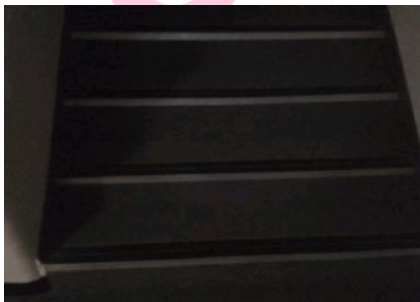
#### **Item 52 Ref: AP001901**

The stair nosing to the stairs (Room 58) does not contain asbestos.

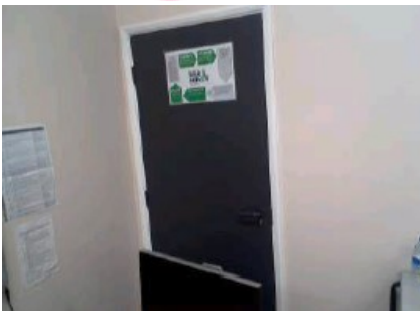
There was no access to the community room store (Room 59). Therefore, it must be presumed that it may contain asbestos.

Prior to any works being carried out, further checks will need to be done.

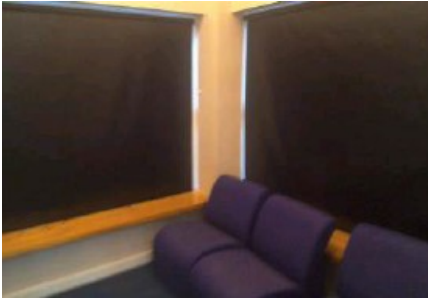
The health and development room (Room 60) was accessed, and no suspect materials were found.

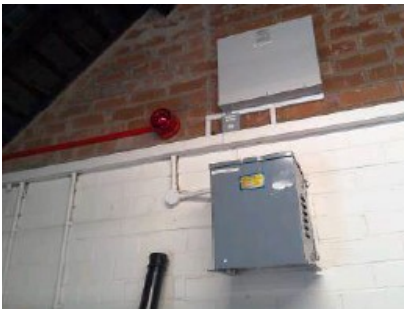
There was no access to the electrics within the bike store (Room 61) due to live plant.

Prior to accessing further checks will need to be carried out.

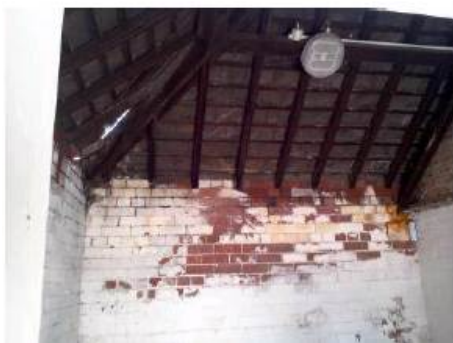
The paint store (Room 62) was accessed, and no suspect materials were found.

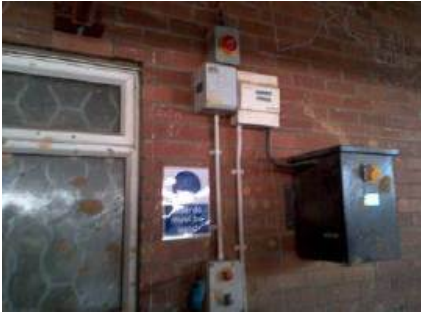
There was no access to the electrics in the brick yard (Room 63) due to being live.

Prior to accessing further checks will need to be carried out.

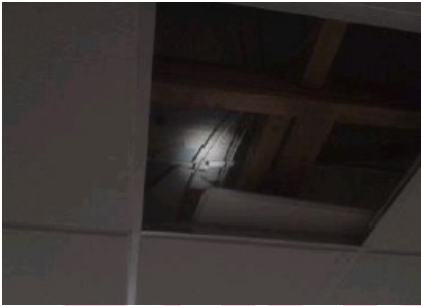
The 1<sup>st</sup> floor corridor was accessed (1/01) and no suspect materials were found.

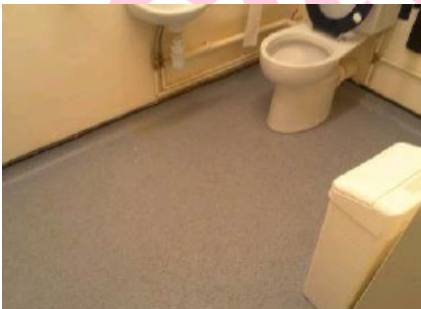
There was no access beneath the modern lino to the disabled wc (Room 1/02) as it would cause damage.

Prior to any works, additional checks may need to be carried out.

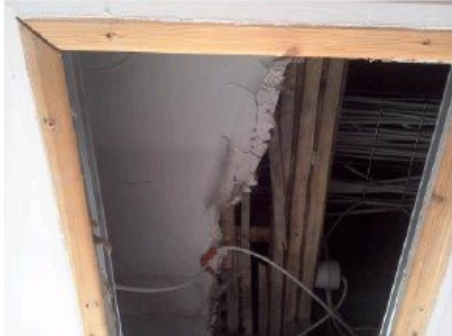
### **Item 55 Ref: AP001902**

The textured coating above the plasterboard ceiling via the access hatch in the ladies wc (Rm 1/03) does not contain asbestos.

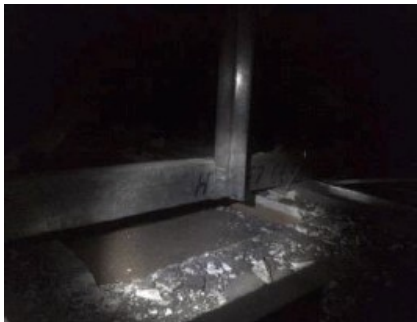
### **Item 56 As: AP001902**

The textured coating debris to the plasterboard ceiling via the access hatch in the ladies wc (Rm 1/03) does not contain asbestos.

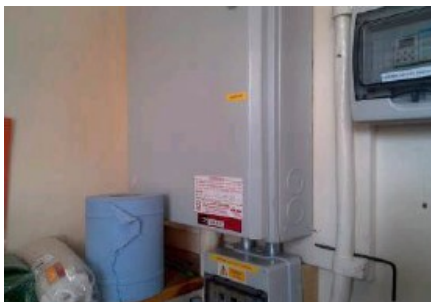
There was no access to the electrics in the cleaners store (Room 1/04) due to the plant being live.

Prior to any works, additional checks may need to be carried out.

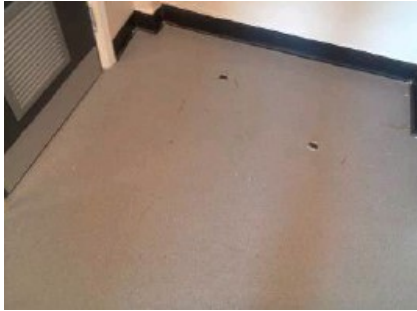
There was no access beneath the modern lino to the lobby (Room 1/05) as it would cause damage.

Prior to any works, additional checks may need to be carried out.

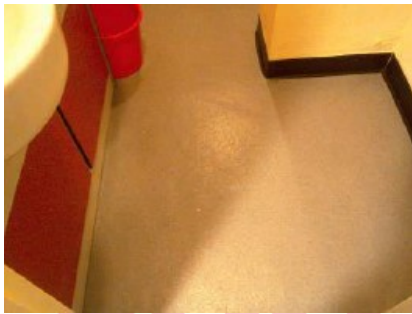
There was no access beneath the modern lino to the male wc (Room 1/06) as it would cause damage.

Prior to any works, additional checks may need to be carried out.

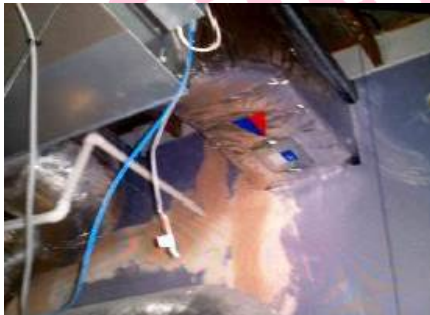
The lobby (Room 1/07) was accessed, and no suspect materials were found

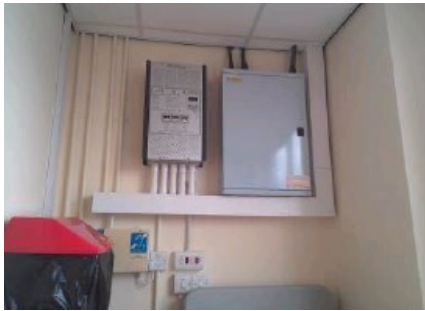
There was no access to the electrics in the store room (Room 1/08) due to the plant being live.

Prior to any works, additional checks may need to be carried out.

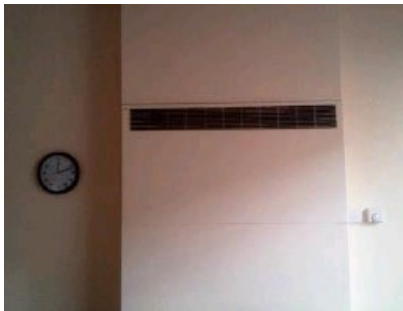
There was no access to the storage heater in the stairwell (Room 1/09) due to the plant being live.

Prior to any works, additional checks may need to be carried out.

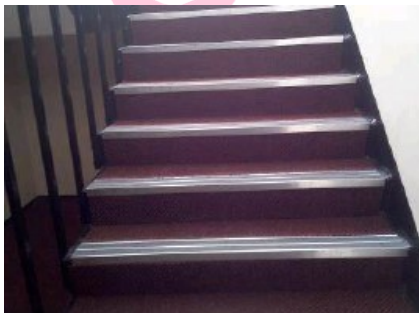
**Item 57 As: AP001901**

The stair nosing to the stairwell (Room 1/09) does not contain asbestos.

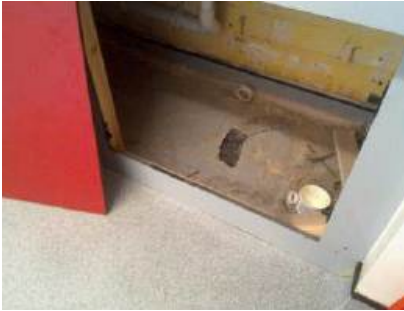
### **Item 58 Ref: AP001903**

The bitumen adhesive to the floor accessed via panel under the sink in the ladies WC (Room 1/10) contains asbestos.

Any change in its appearance should be noted and passed to Property Services.

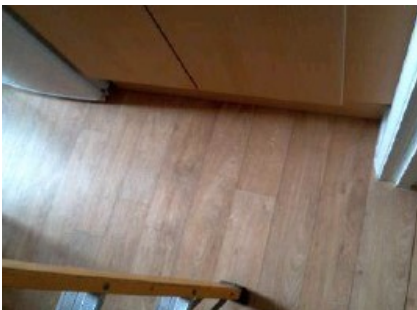
### **Item 60 As : AP001903**

The bitumen adhesive to the concrete beneath the modern lino and screed floor in the kitchen (Room 1/12) contains asbestos.

Any change in its appearance should be noted and passed to Property Services.

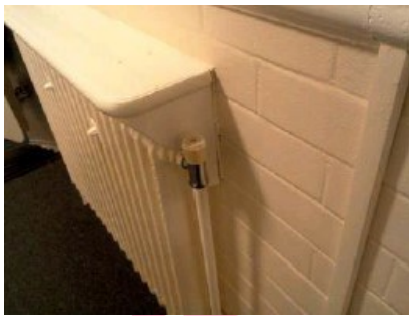
**Item 62 Ref: AP001904**

The foam between the metal rad hanger and the wall in the corridor (Room 1/13) does not contain asbestos.

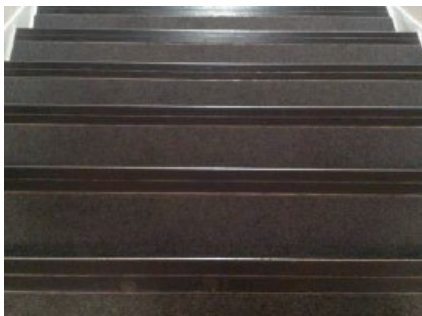
**Item 63 As: AP001901**

The stair nosing to the corridor in the corridor (Room 1/13) does not contain asbestos.

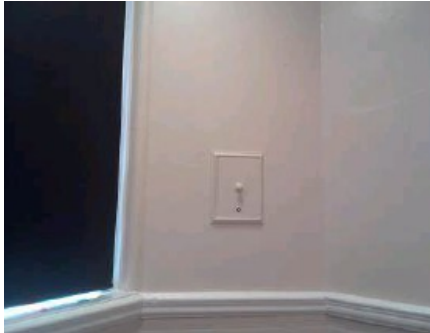
There was no access within the metal hatches to the wall in ICT (Room 1/14) without causing possible damage.

Prior to any works, further checks may need to be carried out.

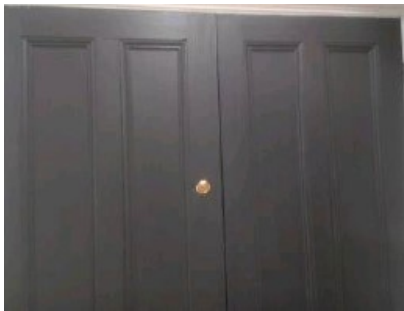
There was no access to the store in ICT (Room 1/14).

Prior to any works, further checks may need to be carried out.

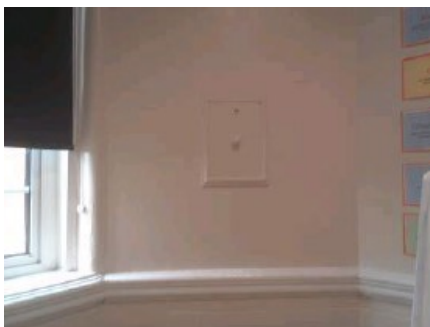
There was no access within the metal hatches to the wall in the classroom (Room 1/15) without causing possible damage.

Prior to any works, further checks may need to be carried out.

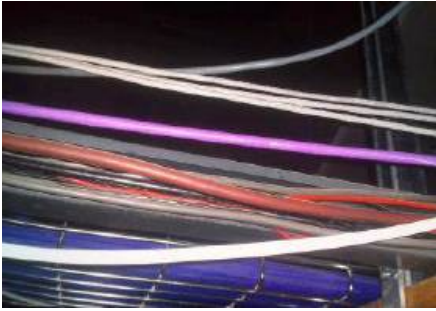
The corridor (Room 1/16) was accessed, and no suspect materials were found.

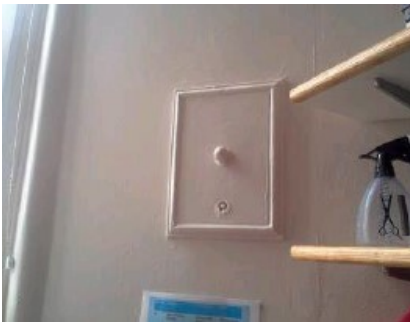
There was no access within the metal hatches to the wall in the hair salon (Room 1/17) without causing possible damage.

Prior to any works, further checks may need to be carried out.

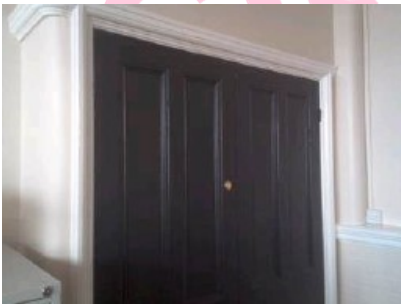
There was no access to the store in the hair salon (Room 1/17).

Prior to any works, further checks may need to be carried out.

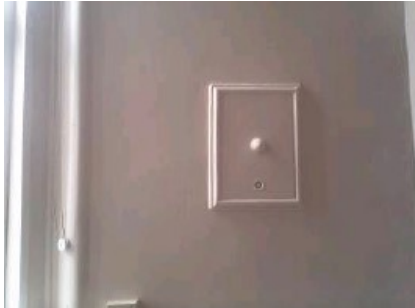
There was no access within the metal hatches to the wall in beauty salon (Room 1/18) without causing possible damage.

Prior to any works, further checks may need to be carried out.

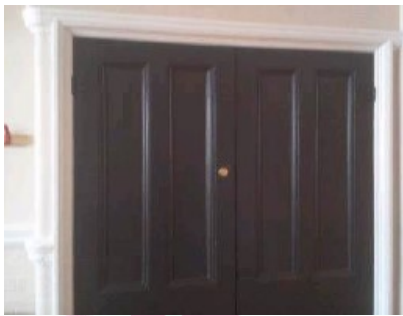
There was no access to the store in the beauty salon (Room 1/18).

Prior to any works, further checks may need to be carried out.

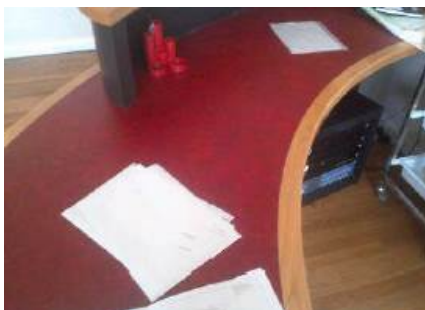
The vinyl to the reception desk in the beauty salon (Room 1/18) does not contain asbestos.

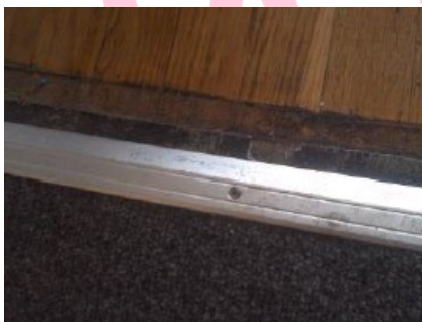
**Item 65 Ref: AP001906**

The floor tiles beneath the modern carpet to the corridor (Room 1/21) contain asbestos.

***SGS confirmed removed.***

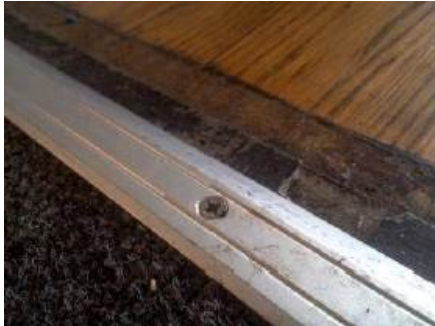
**Item 66 Ref: AP001907**

The bitumen adhesive to the floor tiles in the corridor (Room 1/21) contains asbestos.

***SGS confirmed removed.***

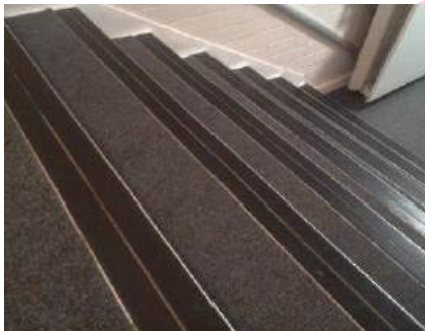
**Item 67 As: AP001901**

The stair nosing to the corridor (Room 1/21) does not contain asbestos.

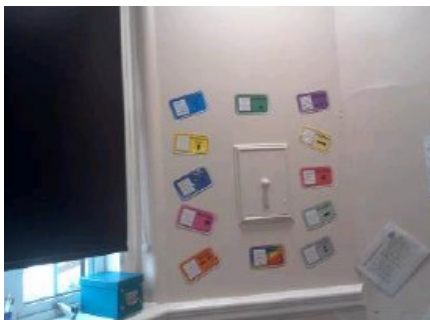
There was no access within the metal hatches to the wall in classroom (Room 1/22) without causing possible damage.

Prior to any works, further checks may need to be carried out.

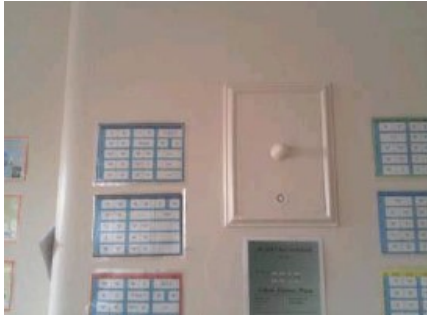
There was no access within the metal hatches to the wall in classroom (Room 1/23) without causing possible damage.

Prior to any works, further checks may need to be carried out.

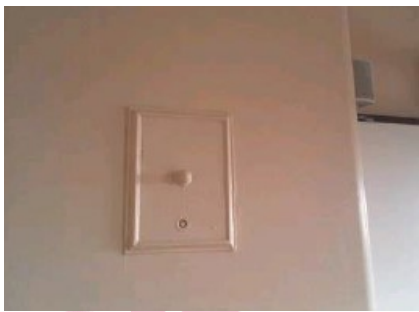
There was no access within the metal hatches to the wall in classroom (Room 1/24) without causing possible damage.

Prior to any works, further checks may need to be carried out.

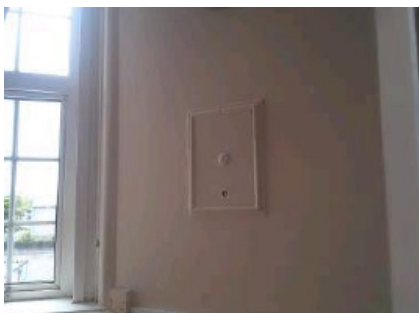
There was no access within the metal hatches to the wall in classroom (Room 1/25) without causing possible damage.

Prior to any works, further checks may need to be carried out.

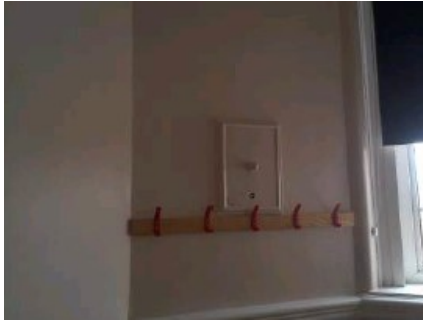
There was no access within the metal hatches to the wall in classroom (Room 1/26) without causing possible damage.

Prior to any works, further checks may need to be carried out.

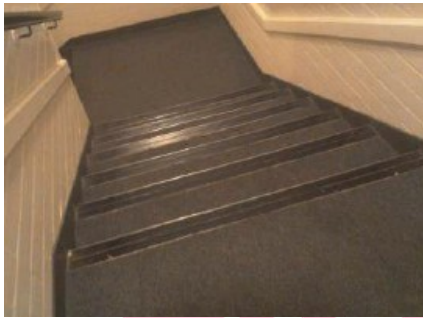
### **Item 68 As: AP001901**

The stair nosing to the stairwell (Room 1/27) does not contain asbestos.

Prior to any works, further checks may need to be carried out.

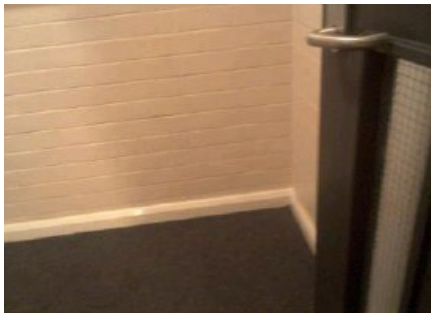
There was no access beneath the newly fitted carpet to the stairwell (Room 1/27) without causing possible damage.

Prior to any works, further checks may need to be carried out.
