### ASBESTOS SURVEY REPORT FOR THE PALLION CENTRE, WAVERLEY TERRACE, SUNDERLAND

## **Asbestos Register for The Pallion Centre**

**Date: 26 September 2024**

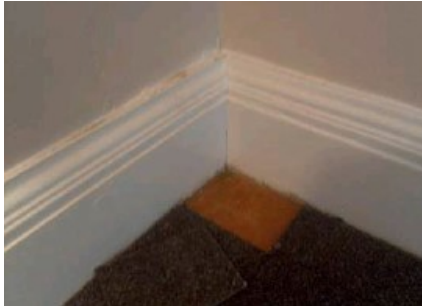
There was no access beneath the newly fitted carpet to the WC lobby (Room 1/28) without causing possible damage.

Prior to any works, further checks may need to be carried out.

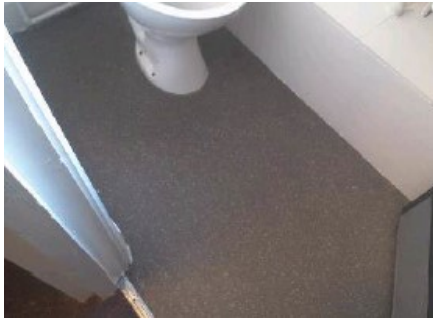
There was no access beneath the lino to the gents WC (Room 1/29) without causing possible damage.

Prior to any works, further checks may need to be carried out.

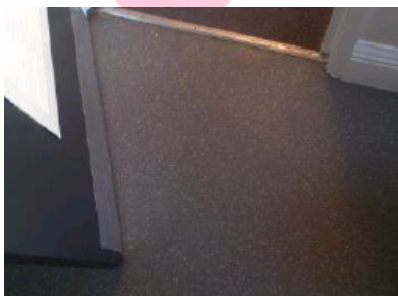
There was no access beneath the lino to the female WC (Room 1/30) without causing possible damage.

Prior to any works, further checks may need to be carried out.

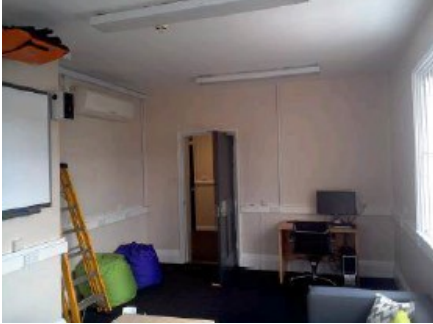
The family room (Room 1/31) was accessed, and no suspect materials were found.

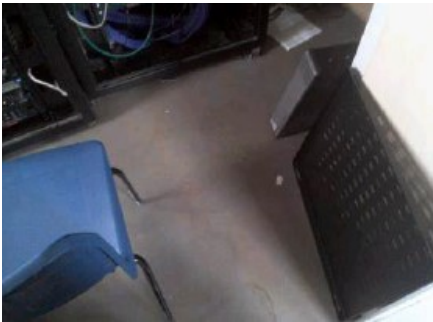
There was no access beneath the modern lino to the server room (Room 1/32) without causing possible damage.

Prior to any works, further checks may need to be carried out.

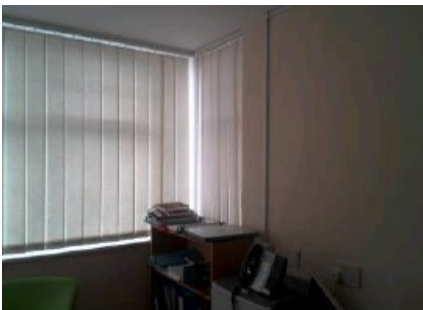
The office (Room 1/33) was accessed, and no suspect materials were found.

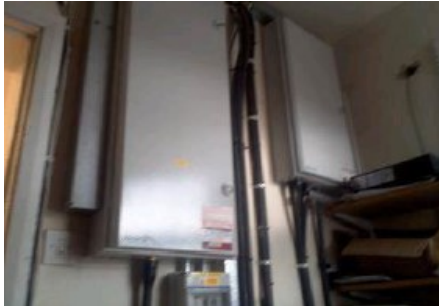
There was no access within the electrics in the office (Room 1/34) due to live plant.

Prior to any works, further checks may need to be carried out.

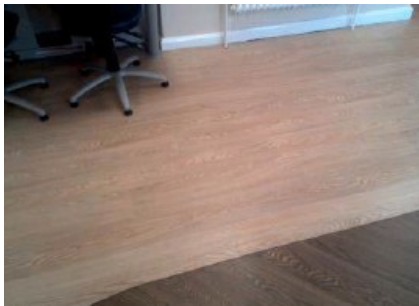
There was no access beneath the modern lino to the lift lobby (Room 1/35) without causing possible damage.

Prior to any works, further checks may need to be carried out.

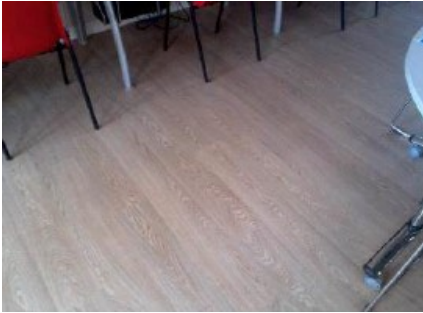
There was no access beneath the modern lino to graphic design (Room 1/36) without causing possible damage.

Prior to any works, further checks may need to be carried out.

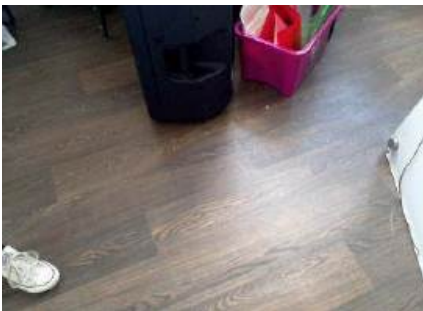
There was no access beneath the modern lino to Audio Room 1 (Room 1/37) without causing possible damage.

Prior to any works, further checks may need to be carried out.

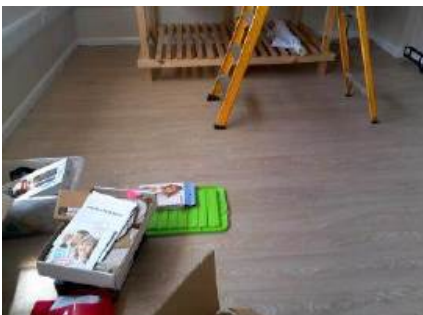
There was no access beneath the modern lino to Audio Room 2 (Room 1/38) without causing possible damage.

Prior to any works, further checks may need to be carried out.

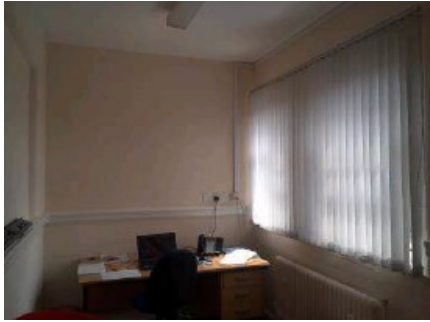
The office (Room 1/39) was accessed, and no suspect materials were found.

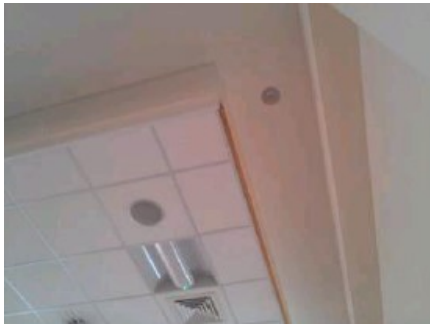
There was no access above the suspended ceiling in the seminar room (Room 1/40) due to height restrictions.

Prior to any works, further checks may need to be carried out.

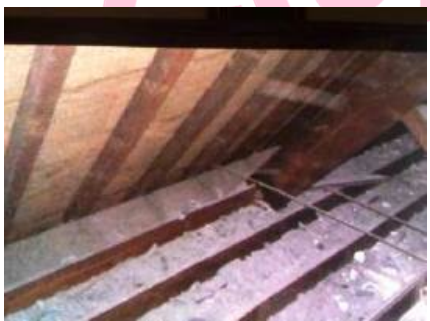
The roof void 1 was accessed and no suspect materials were found.

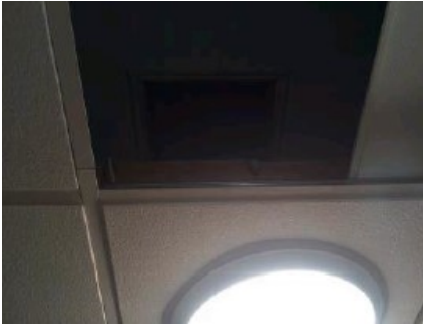
The roof void 2 was unable to be accessed due to health and safety reasons.

Prior to any works, further checks will need to be carried out.

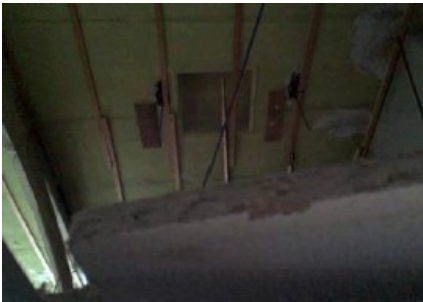
The roof void 3 was unable to be accessed due to health and safety reasons.

Prior to any works, further checks will need to be carried out.

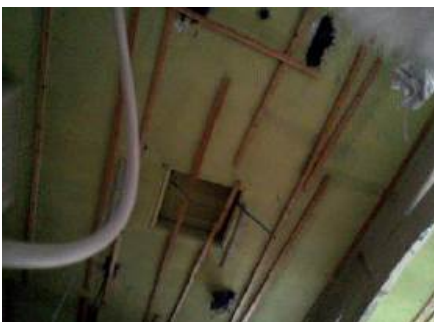
The roof void 4 was unable to be accessed due to health and safety reasons.

Prior to any works, further checks will need to be carried out.

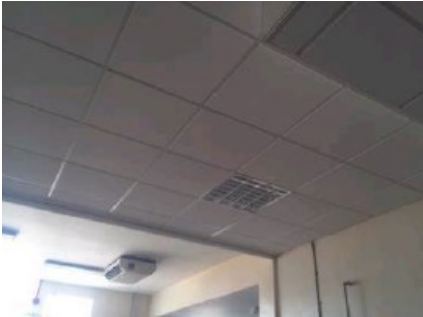
The roof void 5 was unable to be accessed due to health and safety reasons.

Prior to any works, further checks will need to be carried out.

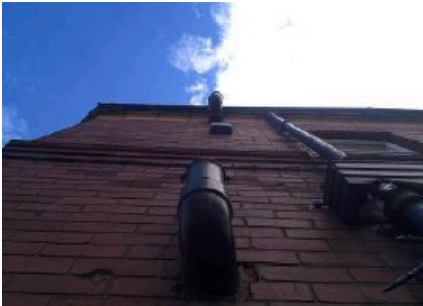
#### **Item 70 Ref: AP001922**

The cement flue to the north elevation to the external contains asbestos.

Any change in its appearance should be noted and passed to Property Services.

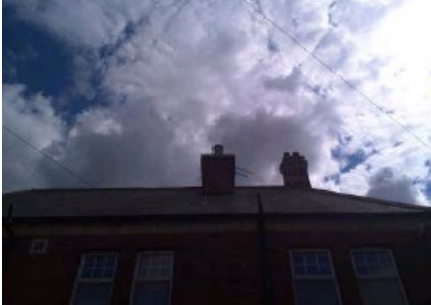
### **Item 72 Ref: Presumed**

The cement flue penetrating roof is presumed to contain asbestos.

Any change in its appearance should be noted and passed to Property Services.

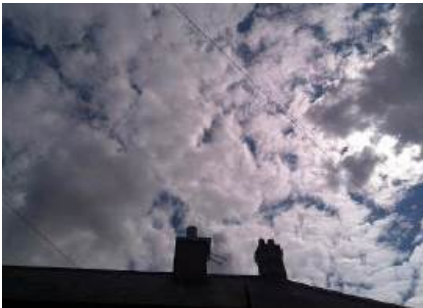
### **Item 73 Ref: Presumed**

*The cement cowl to the chimney stack is presumed to contain asbestos.*

*Removed 2014*

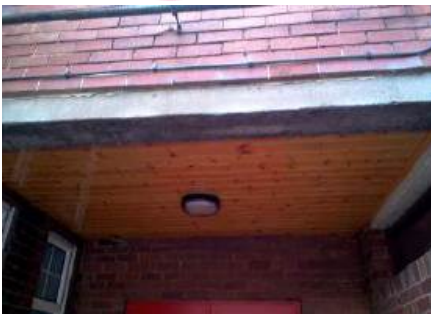
The wood canopy to the external was accessed and no suspect materials were found.

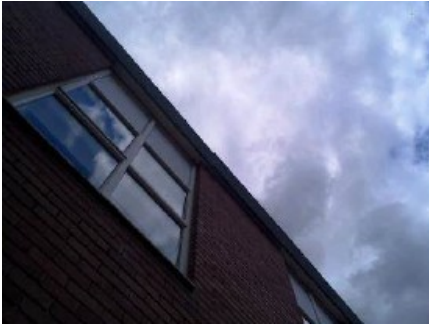
The soffits to the seminar area are wooden.

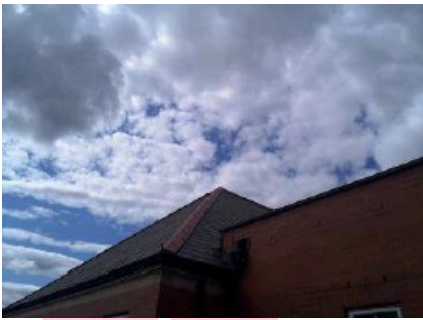
### **Item 74 Ref: AP001924**

The slate roof to the engineers block does not contain asbestos.

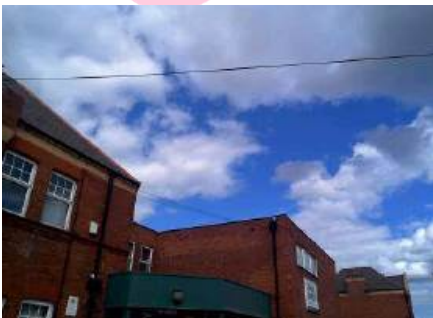
### **Item 75 Ref: Presumed**

All flat felt roofs were presumed to have asbestos in.

Prior to any works being carried out on site, further testing should be carried out.

Any change in its appearance should be noted and passed to Property Services.

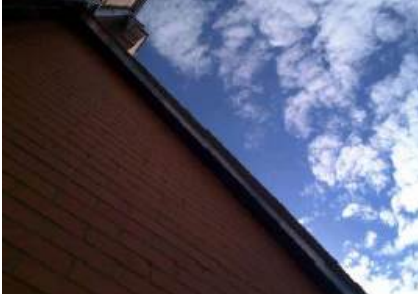
**Item 76 Ref: AP001925**

The verge tiles on the gable end of Roof 1 do not contain asbestos.

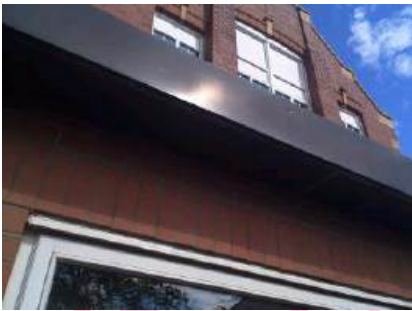
The soffits to the external of Roof 1 are metal.

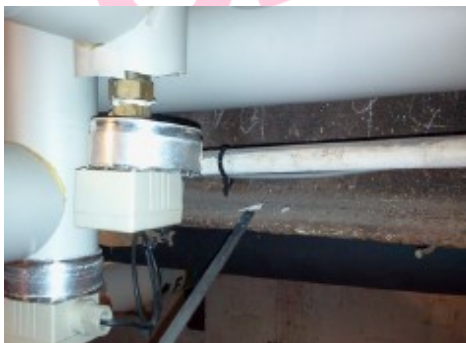
**Item 77 Ref: 41620-15**

*The insulation board debris in the Boiler Room/Rm 001 contains asbestos.*

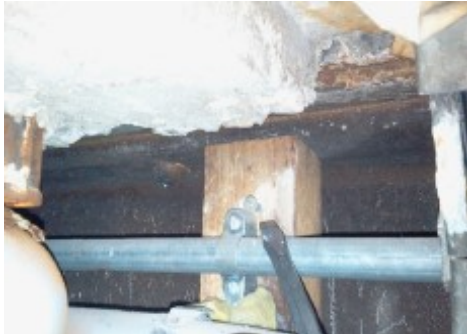
**Item 78 Ref: 41620-16**

*The debris to nail in timber baton in the Boiler Room/Rm 001 contains asbestos.*

*Removed 2014*

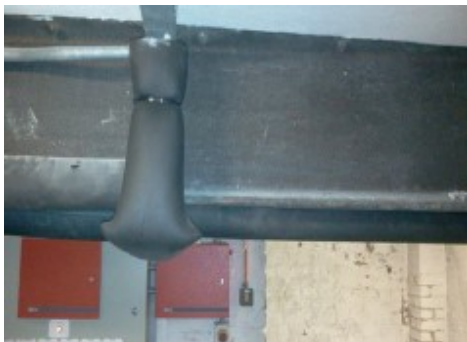
**Item 79 Ref: 41620-17**

*The debris to beam in the Boiler Room/Rm 001 contains asbestos.*

*Removed 2014*

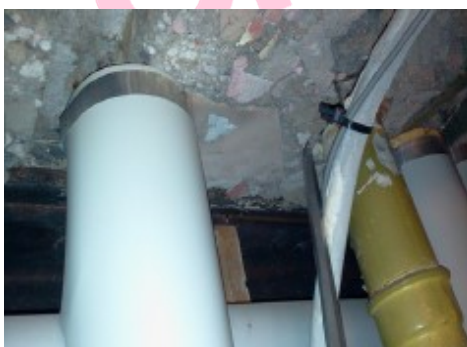
**Item 80 Ref: As 41620-15**

*The remnant board to yellow gas pipe in the Boiler Room/Rm 001 contains asbestos.*

*Removed 2014*

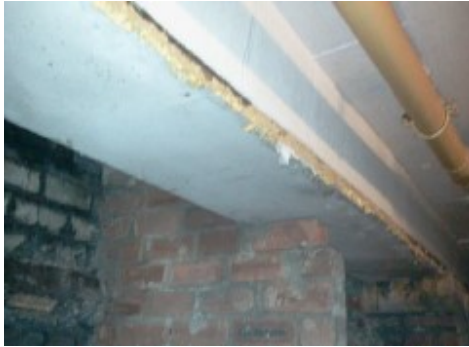
**Item 81 Ref: 41620-18**

*The shuttering to underside of beam in the Boiler Room/Rm 001 contains asbestos.*

*Removed 2014*

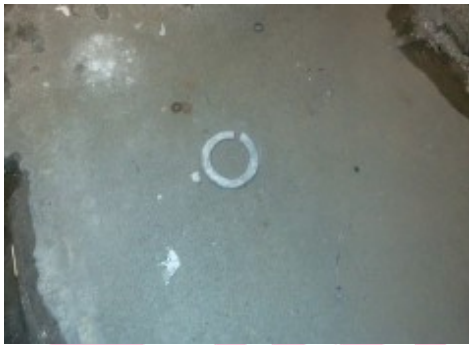
**Item 82 Ref: 41620-19**

*The Loose lying gasket to floor in the Boiler Room/Rm 001 does not contain asbestos.*

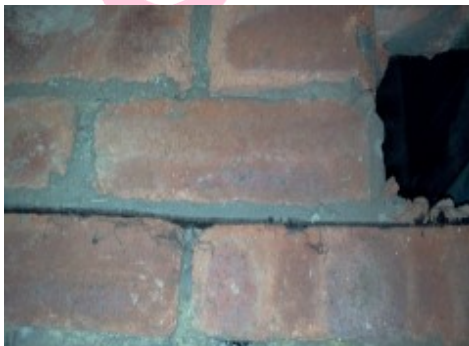
**Item 83 Ref: 41620-20**

*The damp proof course in the Boiler Room/Rm 001 does not contain asbestos.*

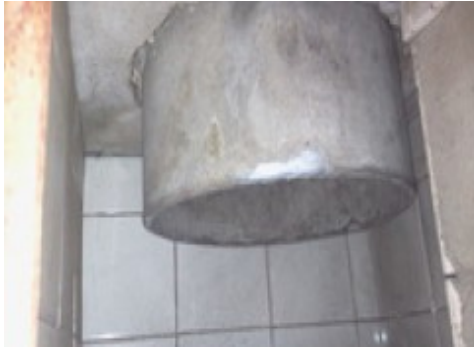
**Item 84 Ref: 41620-31**

*The flue situated within riser in the Boiler Room/Rm 001 contains asbestos.*

*Removed 2014*

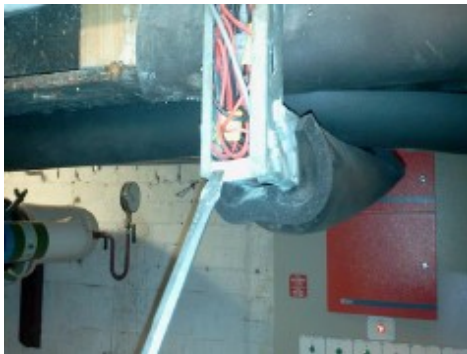
**Item 85 Ref: As 41620-14**

*The board within cable tray in the Boiler Room/Rm 001 does not contain asbestos.*

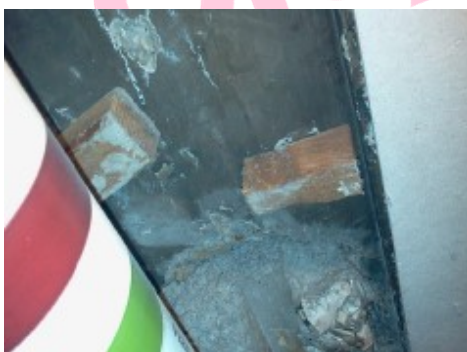
**Item 86 Ref: 41620-21**

*The insulation board debris in the Boiler Room/Rm 001 contains asbestos.*

*Removed 2014*

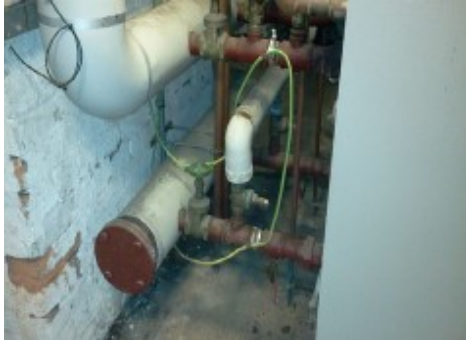
**Item 87 Ref: 41620-22**

*The pipework flange gasket in the Boiler Room/Rm 001 contains asbestos.*

*Removed 2014*

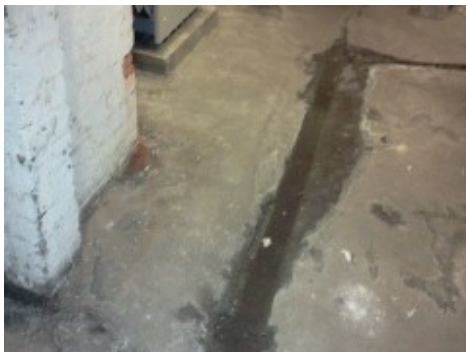
**Item 88 Ref: 41620-23**

*The general debris to floor in the Boiler Room/Rm 001 does not contain asbestos.*

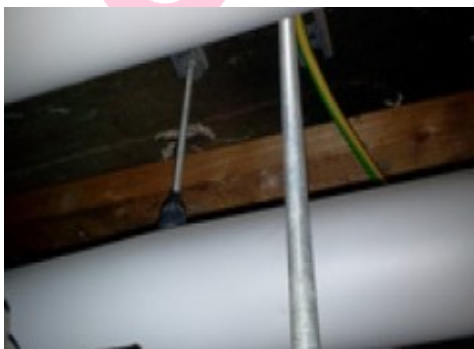
**Item 89 Ref: Presumed**

*The insulation board debris in the Boiler Room/Rm 001 is presumed to contain asbestos.*

*Removed 2014*

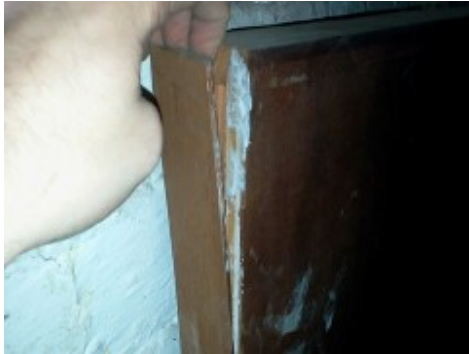
**Item 90 Ref: 41620-24**

The panel within door in the Boiler Room/Rm 001 contains asbestos.

***SGS to confirm removed.***

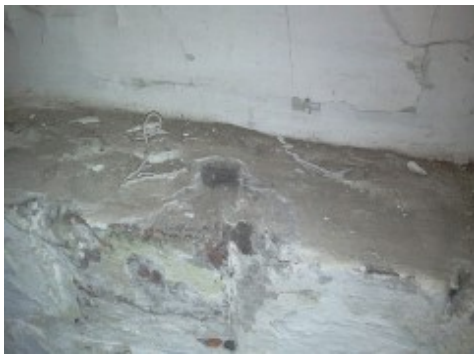
**Item 91 Ref: 41620-25**

The string debris to wall in the Boiler Room/Rm 001 does not contain asbestos.

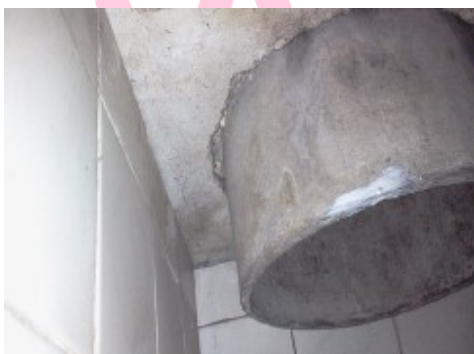
**Item 92 Ref: 41620-32**

*The shuttering to cement flue in the Boiler Room/Rm 001 contains asbestos.*

*Removed 2014*

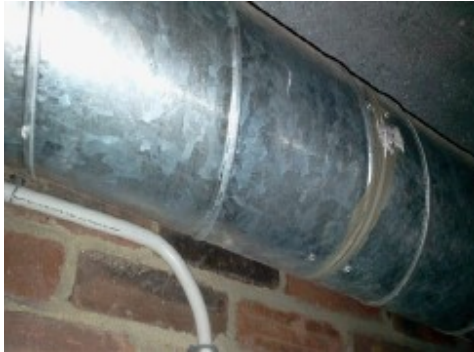
**Item 93 Ref: 41620-1**

The mastic to air handling ductwork joints in the Staff Room/Rm 005 ceiling void above - does not contain asbestos.

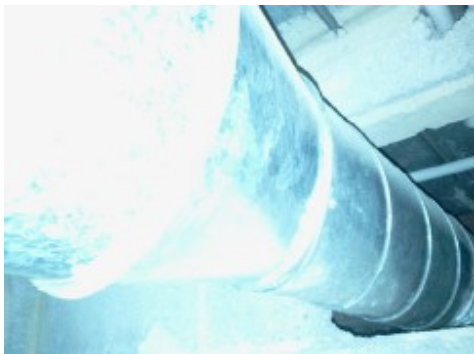
**Item 94 Ref: As 41620-1**

The mastic to air handling ductwork joints in the Disabled WC/Rm 006 ceiling void above - does not contain asbestos.

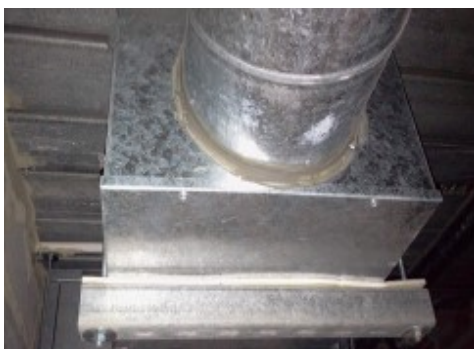
**Item 95 Ref: As 41620-1**

The mastic to air handling ductwork joints in the Female WC/Rm 009 ceiling void above - does not contain asbestos.

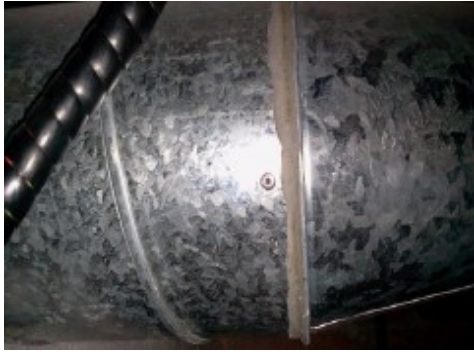
**Item 96 Ref: As 41620-1**

The mastic to air handling ductwork joints in the Shower/Rm 010 ceiling void above - does not contain asbestos.

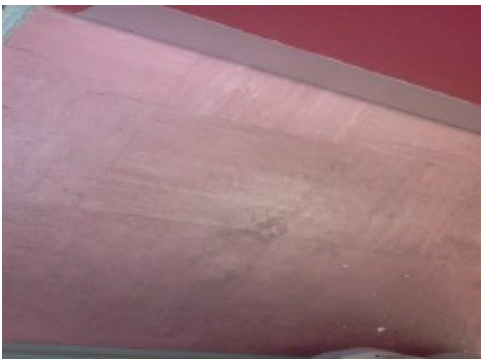
**Item 97 Ref: 41620-2**

The floor covering in the Caretakers Store/Rm 011 does not contain asbestos.

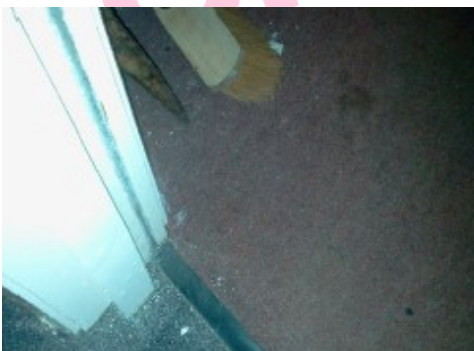
**Item 98 Ref: 41620-2**

The subfloor in the Caretakers Store/Rm 012 does not contain asbestos.

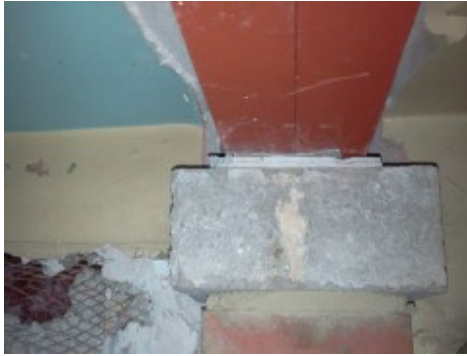
**Item 99 Ref: 41620-3**

*The packing to underside of beam in the Office/Rm 015 contains asbestos.*

*Removed 2014*

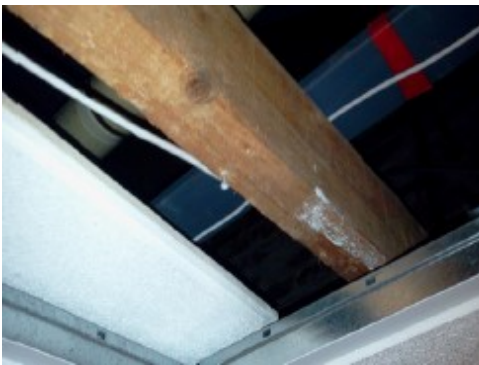
**Item 100 Ref: 41620-4**

The debris to beam in the Corridor ceiling void above/Rm 017 does not contain asbestos.

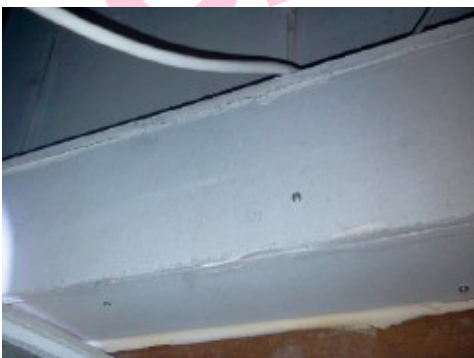
**Item 101 Ref: As 41620-5**

The boxing to beam above door in the Corridor ceiling void above/Rm 017 does not contain asbestos.

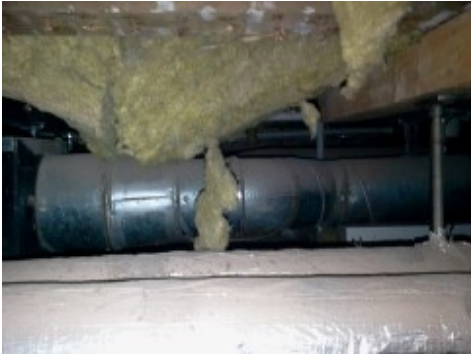
**Item 102 Ref: As 41620-1**

The mastic to air handling ductwork joints in the Office/Rm 018 ceiling void above does not contain asbestos.

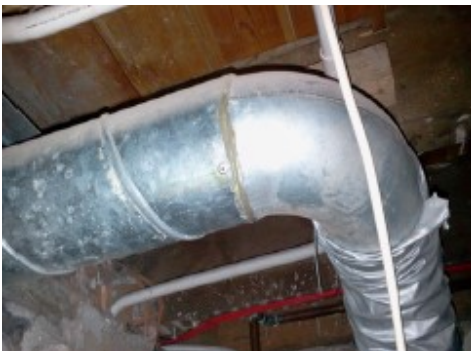
**Item 103 Ref: As 41620-1**

The mastic to air handling ductwork joints in the WC/Rm 019 ceiling void above does not contain asbestos.

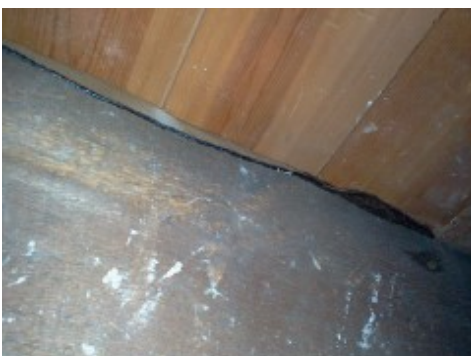
**Item 104 Ref: 41620-6**

The packing to top of wall and underside of floor in the WC/Rm 019 ceiling void above does not contain asbestos.

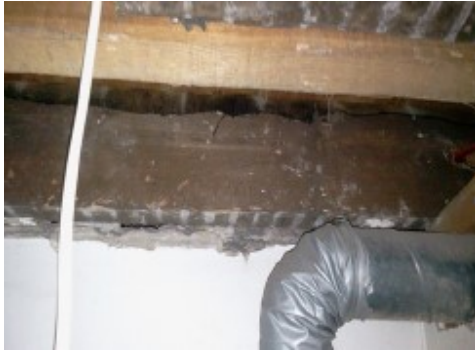
**Item 105 Ref: As 41620-6**

The packing to top of wall and underside of floor in the WC/Rm 020 ceiling void above does not contain asbestos.

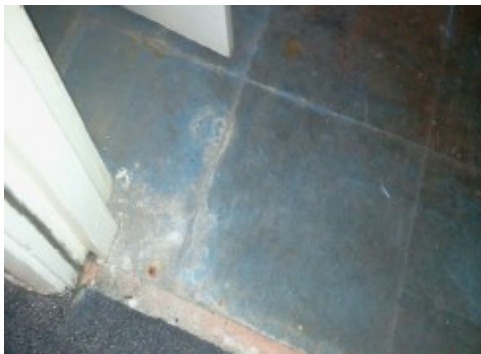
**Item 106 Ref: 41620-7**

The floor covering in the Cleaners cupboard/Rm 026 does not contain asbestos.

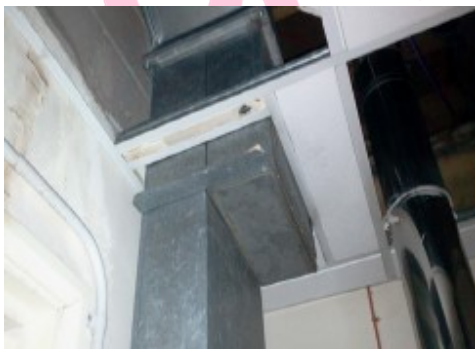
**Item 107 Ref: As 41620-1**

The mastic to air handling ductwork joints in the Cleaners Cupboard/Rm 026 does not contain asbestos.

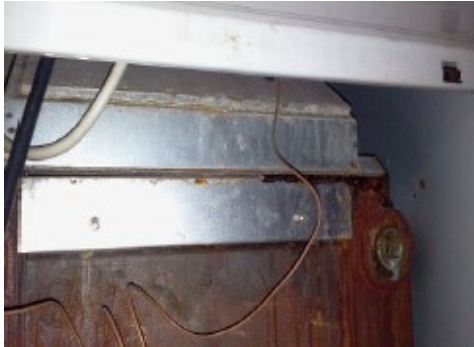
**Item 108 Ref: 41620-8**

The mastic to top of boiler plate in the Cleaners Cupboard/Rm 026 does not contain asbestos.

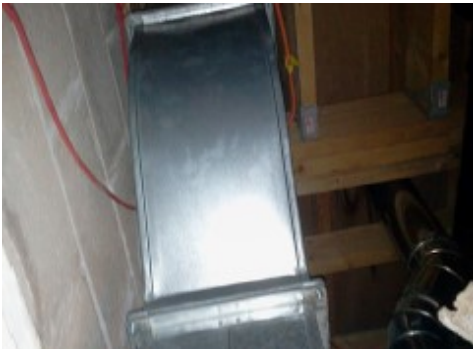
**Item 109 Ref: As 41620-1**

The mastic to air handling ductwork joints in the Cleaners Cupboard/Rm 026 ceiling void above - does not contain asbestos.

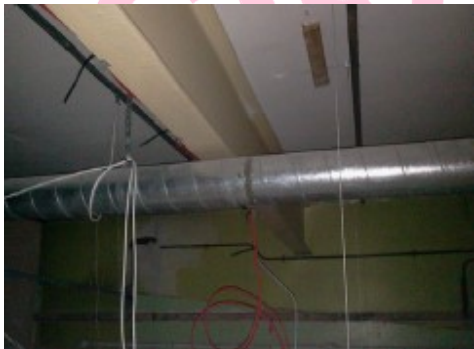
**Item 110 Ref: As 41620-1**

The mastic to air handling ductwork joints in the Community Room/Rm 032 ceiling void above - does not contain asbestos.

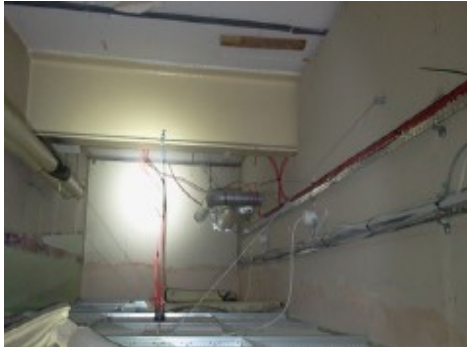
**Item 111 Ref: As 41620-1**

The mastic to air handling ductwork joints in the Store Cupboard /Rm 033 ceiling void above - does not contain asbestos.

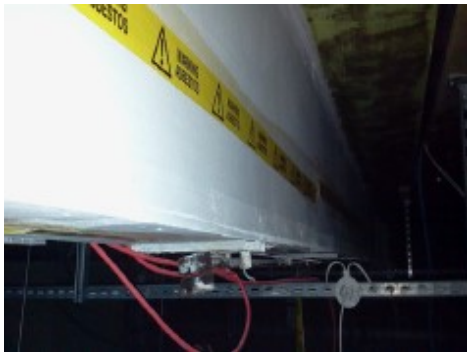
**Item 112 Ref: 41620-11**

*The boxing to beams in the Restaurant/Rm 040 ceiling voids above contains asbestos.*

*Removed 2014*

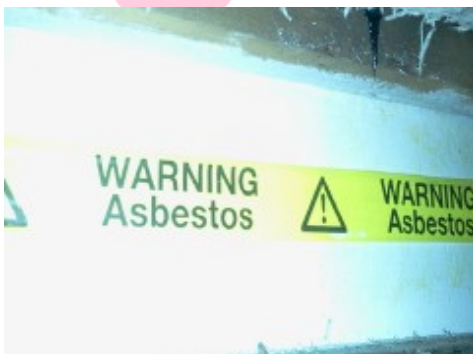
**Item 113 Ref: As 41620-11**

*The extractor hood surround in the Kitchen/Rm 041 ceiling voids above contains asbestos.*

*Removed 2014*

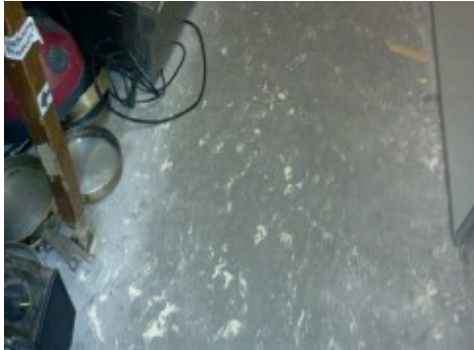
**Item 114 Ref: 41620-13**

*The floor in the Dry Store/Rm 042 contains asbestos.*

*Removed 2014*

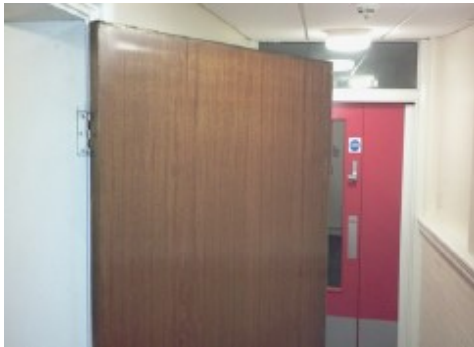
**Item 115 Ref: As 41620-24**

*The panel within door in the Stairwell leading to boiler Room/Rm 057 contains asbestos.*

*Removed 2014*

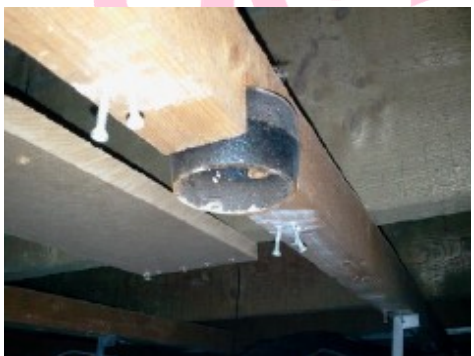
**Item 116 Ref: 41620-26**

*The debris to beams in the audio room/Rm 1/001 ceiling void above contains asbestos.*

*Removed 2014*

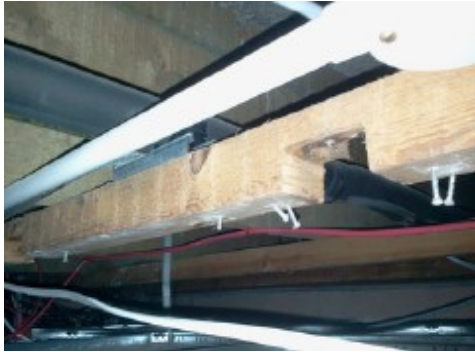
**Item 117 Ref: As 41620-26**

*The debris to beams in the audio room/Rm 1/002 ceiling void above contains asbestos.*

*Removed 2014*

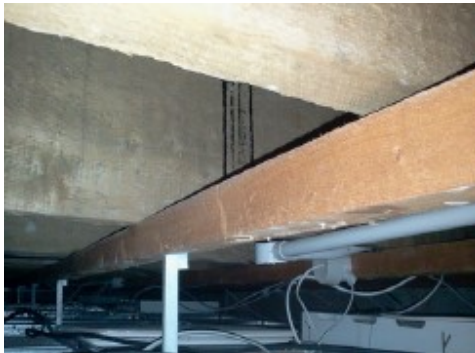
**Item 118 Ref: As 41620-26**

*The debris to beams in the computer room/Rm 1/003 ceiling void above contains asbestos.*

*Removed 2014*

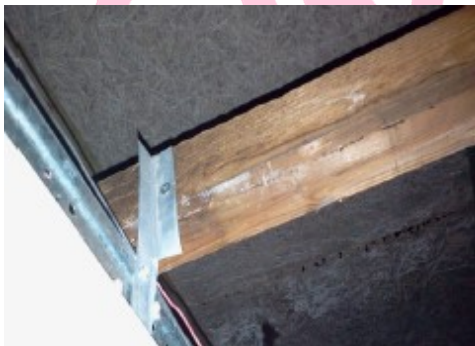
**Item 119 Ref: As 41620-26**

*The debris to beams in the Corridor/Rm 1/004 ceiling void above contains asbestos.*

*Removed 2014*

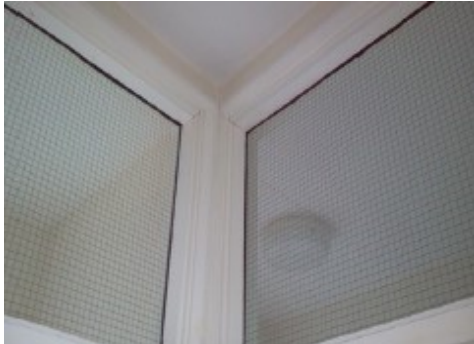
### **Item 120 Ref: 41620-27**

The mastic to glass panels above door in the Corridor/Rm 1/011 does not contain asbestos.

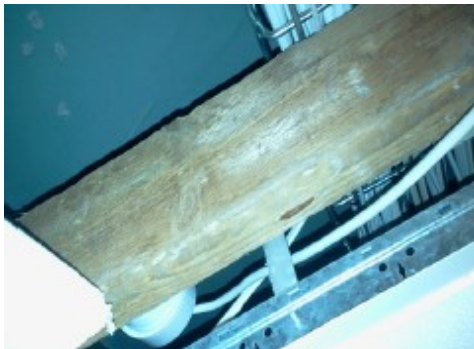
### **Item 121 Ref: As 41620-26**

*The debris to beams in the Corridor/Rm 1/014 ceiling void above contains asbestos.*

*Removed 2014*

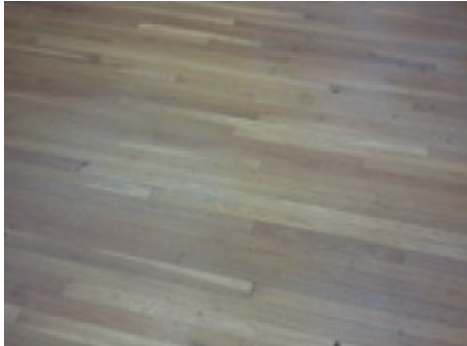
**Item 126 Ref: Presumed**

The adhesive to parquet flooring in Classroom/Rm 1/022 is presumed to contain asbestos.

Any change in its appearance should be noted and passed to Property Services.

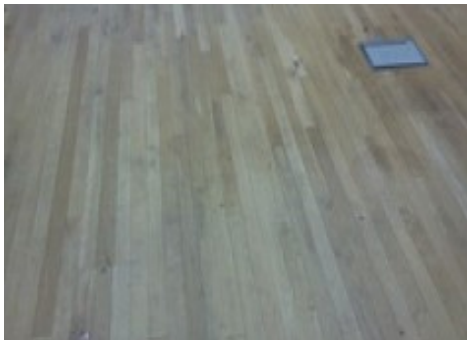
**Item 127 Ref: Presumed**

The adhesive to parquet flooring in Classroom/Rm 1/023 is presumed to contain asbestos.

Any change in its appearance should be noted and passed to Property Services.

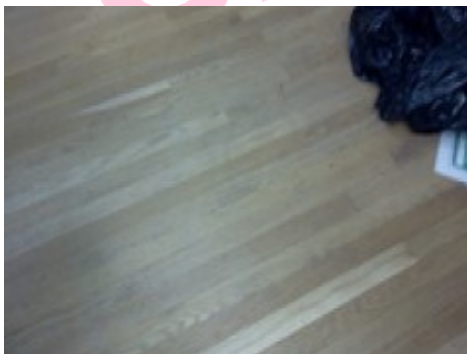
**Item 128 Ref: Presumed**

The adhesive to parquet flooring in Classroom/Rm 1/024 is presumed to contain asbestos.

Any change in its appearance should be noted and passed to Property Services.

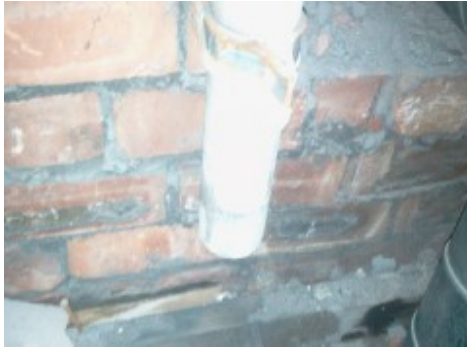
**Item 129 Ref: 41620-30**

*The redundant pipework to wall in the Male WC/Rm1/036 roof void contains asbestos.*

*Removed 2014*

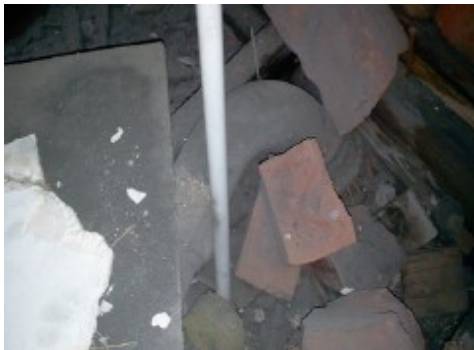
**Item 130 Ref: As 41620-29**

*The redundant pipework to floor in the Male WC/Rm1/036 roof void contains asbestos.*

*Removed 2014*

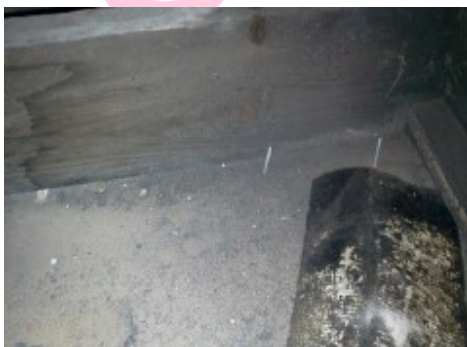
**Item 131 Ref: 41620-29**

*The remnant roof felt in the Male WC/Rm1/036 roof void contains asbestos.*

*Removed 2014*

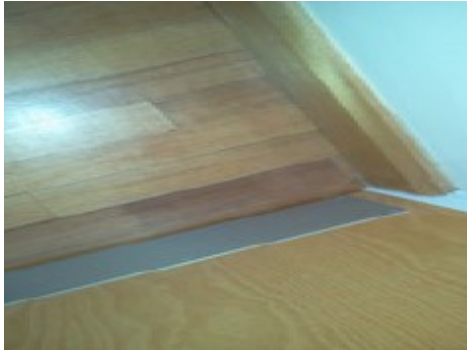
### **Item 132 Ref: Presumed**

The adhesive to parquet flooring in the Store/Rm 1/040 is presumed to contain asbestos.

Any change in its appearance should be noted and passed to Property Services.

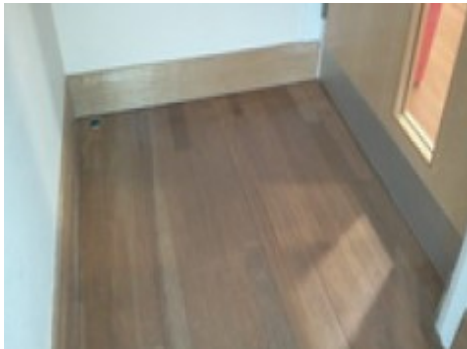
### **Item 133 Ref: Presumed**

The adhesive to parquet flooring in the Stairwell/Rm 1/041 is presumed to contain asbestos.

Any change in its appearance should be noted and passed to Property Services.

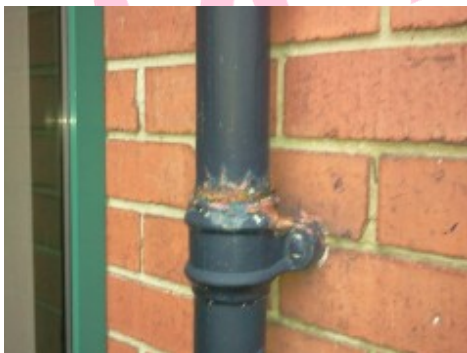
### **Item 134 Ref: 41620-33**

The sealant to downpipe collars (External) does not contain asbestos.

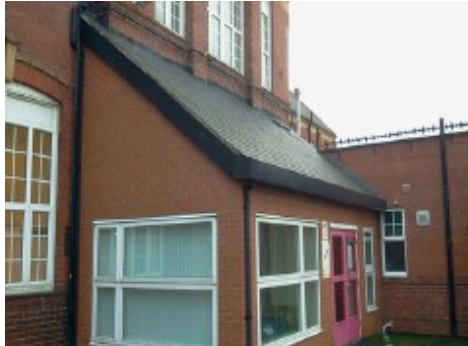
**Item 135 Ref: 41620-35**

The fillet to pitched roof at LHS elevation adj sitting area (External) does not contain asbestos.

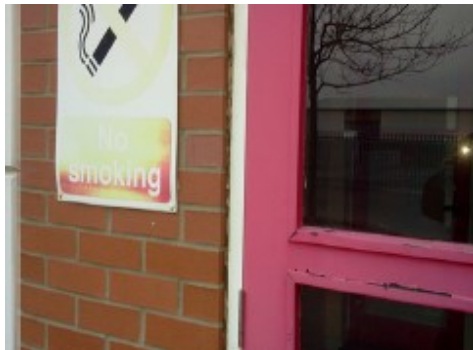
**Item 136 Ref: 41620-36**

The mastic to doorframe at double red doors lhs elevation adj seating area (External) does not contain asbestos.

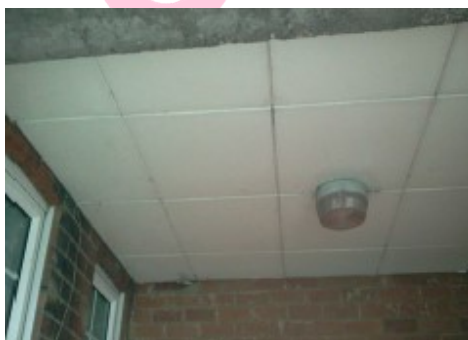
**Item 137 Ref: 41620-36**

*The tiles to rear canopy exit from corridor (External) contains asbestos.*

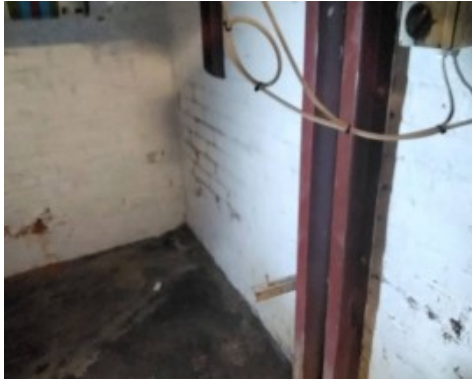
**Item 141 Ref: KX001000**

The debris/residue to the stairwell wall in the Boiler Room does not contain asbestos.

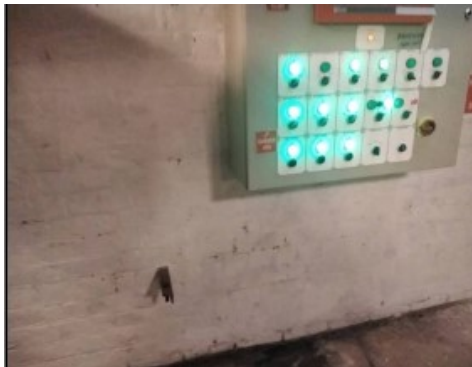
**Item 142 Ref: KX001001**

The debris/residue in the Boiler Room does not contain asbestos.

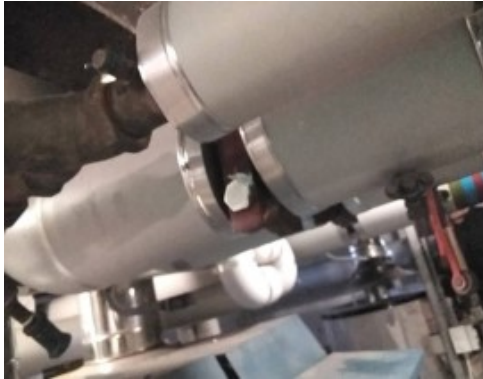
**Item 144 Ref: KX001004**

The debris/residue to the pipe brackets/surfaces/penetrations of thick bore pipes in the Boiler Room does not contain asbestos.

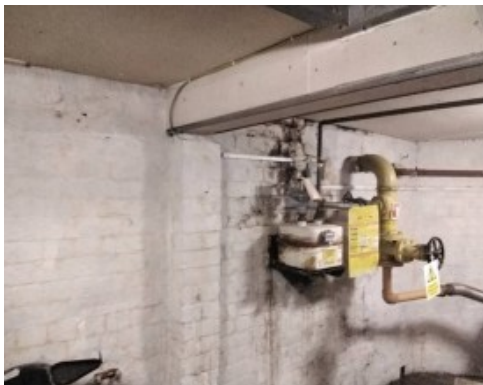
**Item 145 Ref: KX001005**

The debris/residue in the Boiler Room does not contain asbestos.

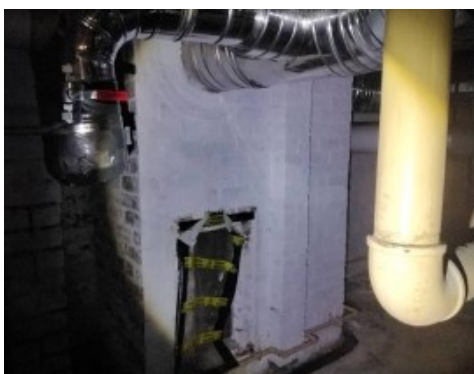
**Item 146 Ref: KX001006**

The debris/residue in the Boiler Room does not contain asbestos.

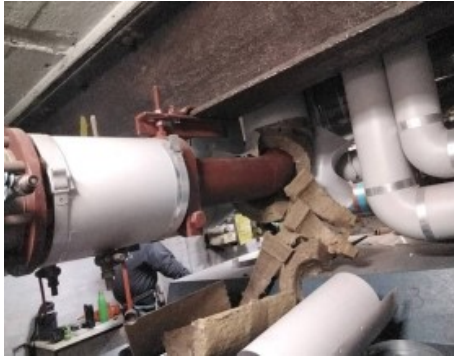
**Item 147 Ref: KX001007**

The debris/residue in the Boiler Room does not contain asbestos.

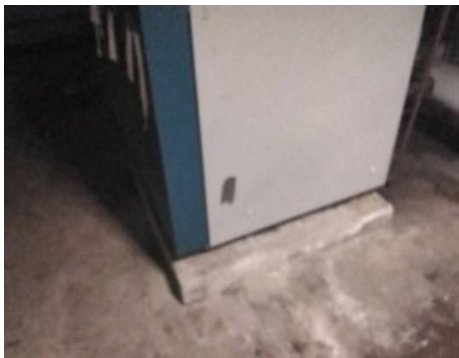
**Item 148 Ref: KX001010**

The debris/residue to plinth under boilers furthest from stairs in the Boiler Room does not contain asbestos.

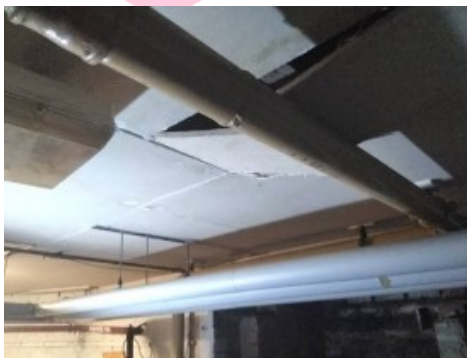
**Item 149 Ref: KX000996**

The beam cladding in the Boiler Room does not contain asbestos. (Limited inspection within)

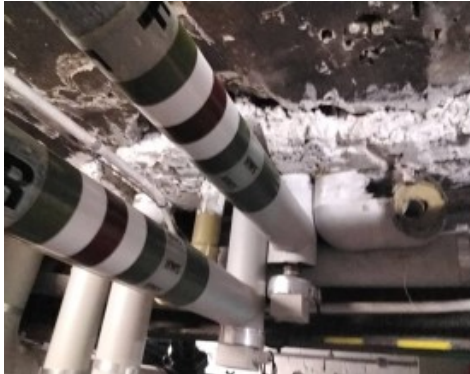
**Item 150 Ref: KX001011**

The debris/residue to the floor nearer the rear wall in the Boiler Room does not contain asbestos.

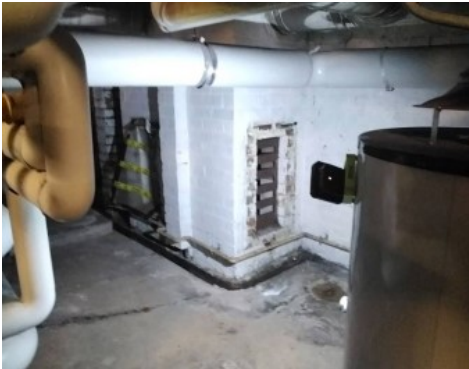
**Item 151 Ref: KX000999**

The debris/residue to walls at wall grilles to old flues (Boiler Room) does not contain asbestos.

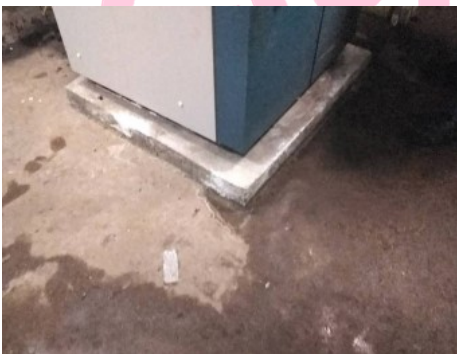
**Item 152 Ref: KX001909**

The debris/residue to floor plinths under boilers nearest stairs (Boiler Room) does not contain asbestos.

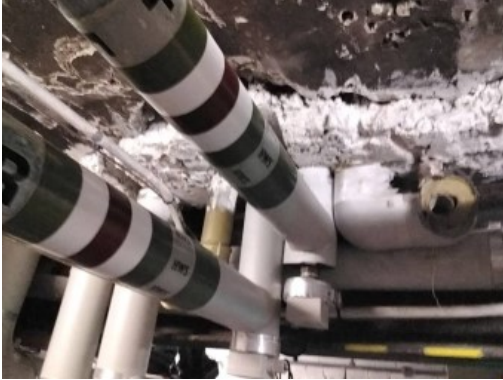
**Item 153 Ref: KX001013**

The debris/residue shuttering remnants from pipe penetration (Boiler Room) does not contain asbestos.

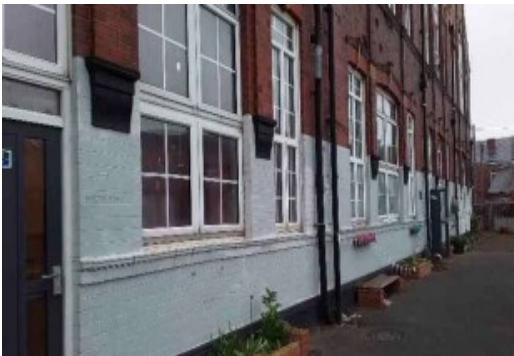
**Item 154 Ref: OQ000417**

The window sealant to wall (External) does not contain asbestos.
