ASBESTOS SURVEY REPORT FOR NORTHERN SAINTS C OF E PRIMARY SCHOOL, SUNDERLAND

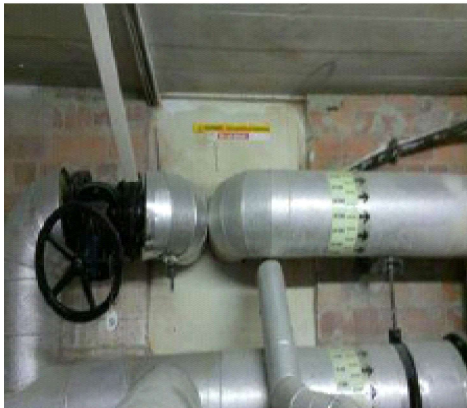
Item 1: Presumed

The duct entrances to the boiler room (Sub level 1 Room 1) are sealed and are presumed to contain asbestos lagging.

Any changes in its appearance should be noted and passed to Property Services.

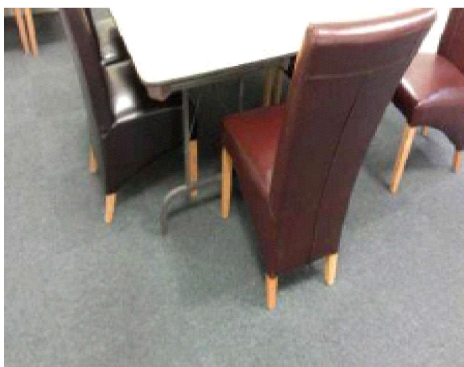
Item 2: Presumed

The bitumen adhesive to the floor below the cement skim to the floor in the meeting room (Room 2) is presumed to contain asbestos.

Any changes in its appearance should be noted and passed to Property Services.

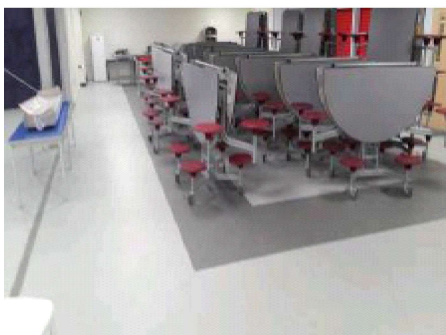
Item 3: Presumed

The bitumen adhesive to the floor below the cement skim to the floor in the dining area (Room 4) is presumed to contain asbestos.

Any changes in its appearance should be noted and passed to Property Services.

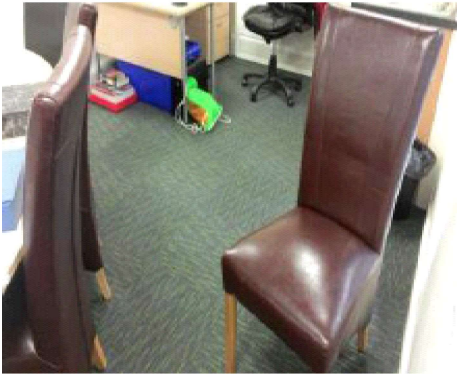
Item 4: Presumed

The bitumen adhesive to the floor below the cement skim to the floor in the office (Room 5) is presumed to contain asbestos.

Any changes in its appearance should be noted and passed to Property Services.

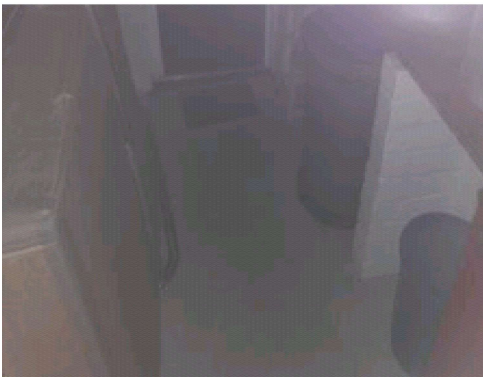
Item 6: Presumed

The bitumen adhesive to the floor below the cement skim to the floor in the kitchen vestibule /store (Room 8) is presumed to contain asbestos.

Any changes in its appearance should be noted and passed to Property Services.

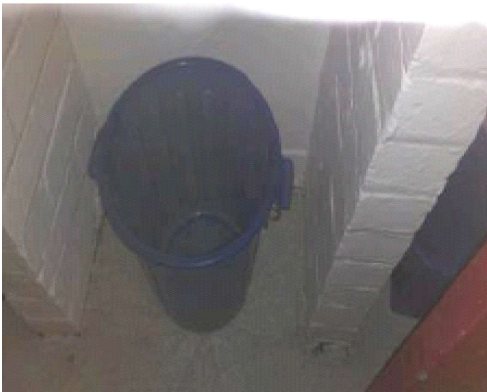
Item 7: As KR09/86

The skirting to the base of the wall in the kitchen vestibule / store (Room 8) contains asbestos.

Any changes in its appearance should be noted and passed to Property Services.

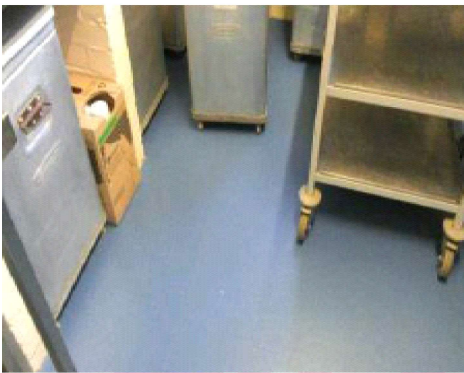
Item 8: Presumed

The bitumen adhesive to the floor below the cement skim to the floor in the kitchen store (Room 9) is presumed to contain asbestos.

Any changes in its appearance should be noted and passed to Property Services.

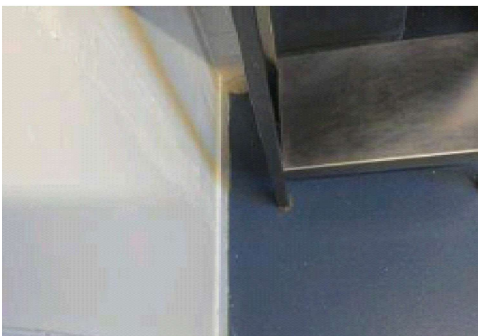
Item 9: As KR09/86

The skirting to the base of the wall in the kitchen store (Rooms 9) contains asbestos.

Any changes in its appearance should be noted and passed to Property Services.

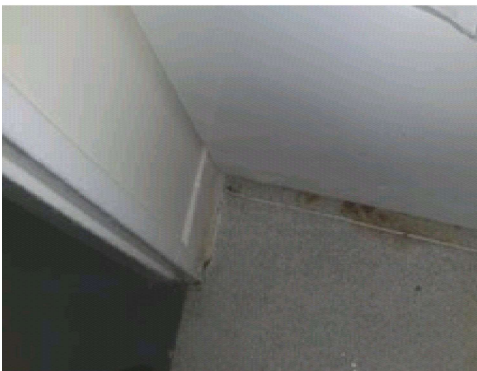
Item 11: NSPS/002

The skirting to the base of the wall in the kitchen store (Room 005) contains asbestos.

Any changes in its appearance should be noted and passed to Property Services.

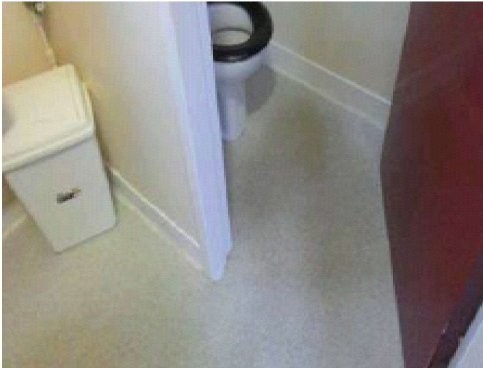
Item 14: Presumed

The bitumen adhesive below flooring in the kitchen staff toilet (Room 12) is presumed to contain asbestos.

Any changes in its appearance should be noted and passed to Property Services.

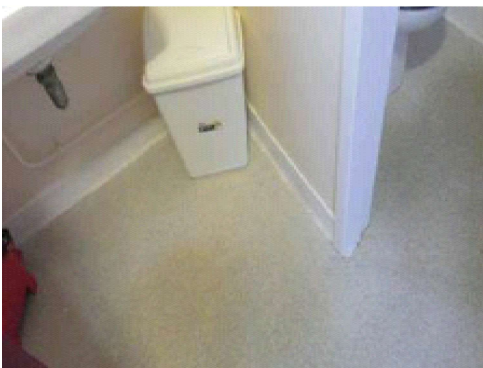
Item 15: As KR09/86

The skirting to the base of the wall in the kitchen staff toilet (Room 12) contains asbestos.

Any changes in its appearance should be noted and passed to Property Services.

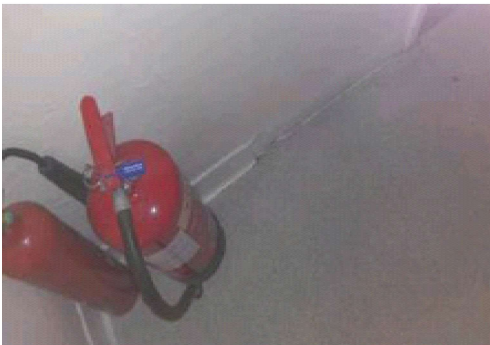
Item 17: As KR09/86

The skirting to the base of the wall in the kitchen office (Room 14) contains asbestos.

Any changes in its appearance should be noted and passed to Property Services.

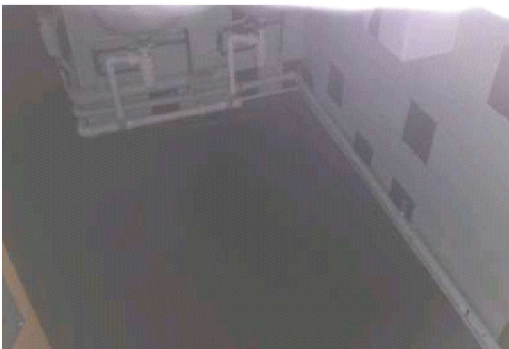
Item 20: Presumed

The vinyl floor tiles beneath the lino in the boys toilet (Room 23) contained asbestos.

These were removed in July 2015.

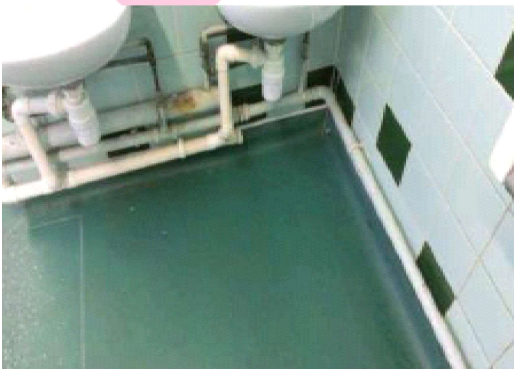
Item 21: Presumed

The skirting to the base of the wall beneath the lino in the boys wc (Room 23) contained asbestos.

These were removed in July 2015.

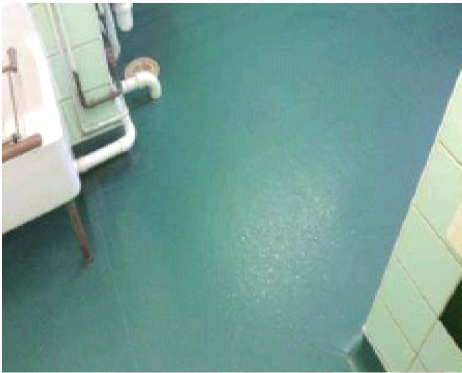
Item 23: Presumed

The vinyl floor tiles beneath the lino in the Girls toilet (Room 26) contain asbestos.

Any changes in its appearance should be noted and passed to Property Services.

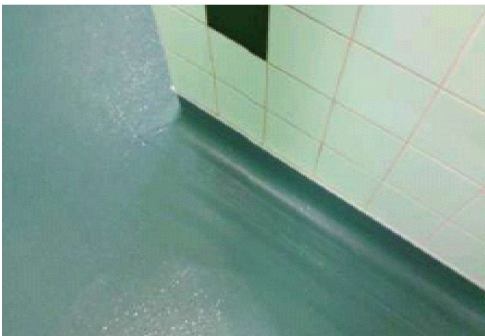
Item 24: Presumed

The skirting to the base of the wall beneath the lino in the Girls wc (Room 26) contains asbestos.

Any changes in its appearance should be noted and passed to Property Services.

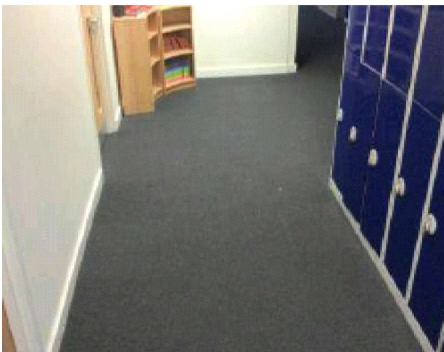
Item 26: Presumed

The bitumen adhesive to the floor below the cement skim to the floor in the corridor (Room 27) is presumed to contain asbestos.

Any changes in its appearance should be noted and passed to Property Services.

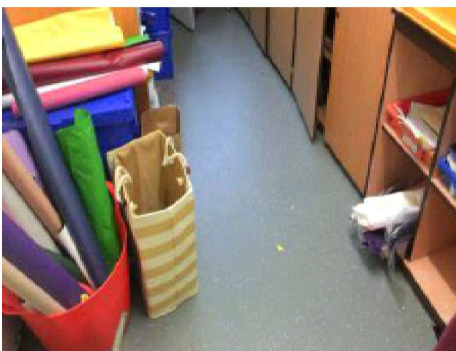
Item 27: Presumed

The bitumen adhesive to the floor below the cement skim to the floor in the store (Room 28) is presumed to contain asbestos.

Any changes in its appearance should be noted and passed to Property Services.

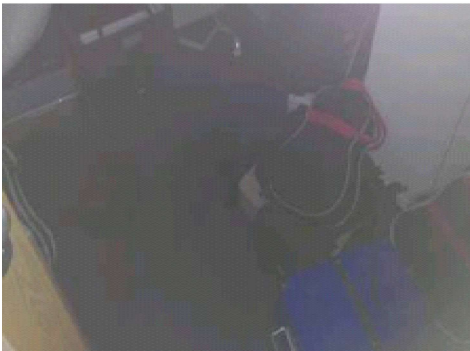
Item 29: Presumed

The bitumen adhesive to the floor below the cement skim to the floor in the store (Room 30) is presumed to contain asbestos.

Any changes in its appearance should be noted and passed to Property Services.

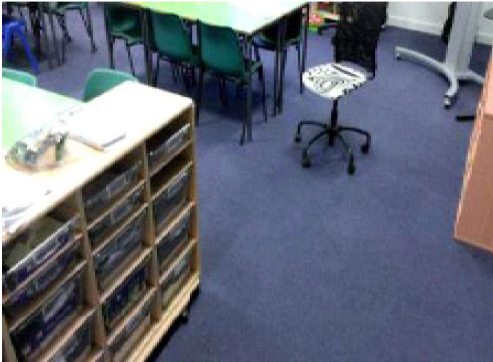
Item 31: Presumed

The bitumen adhesive to the floor below the cement skim to the floor in the classroom (Room 32) is presumed to contain asbestos.

Any changes in its appearance should be noted and passed to Property Services.

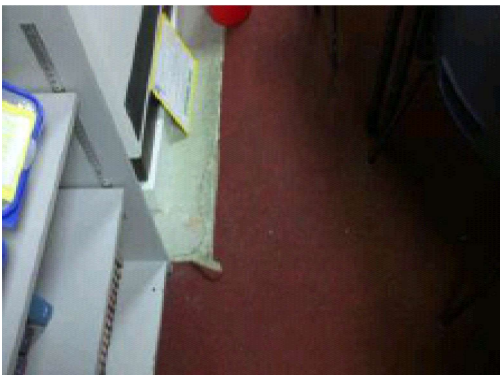
Item 32: Presumed

The bitumen adhesive to the floor in the classroom (Room 33) is presumed to contain asbestos.

Any changes in its appearance should be noted and passed to Property Services.

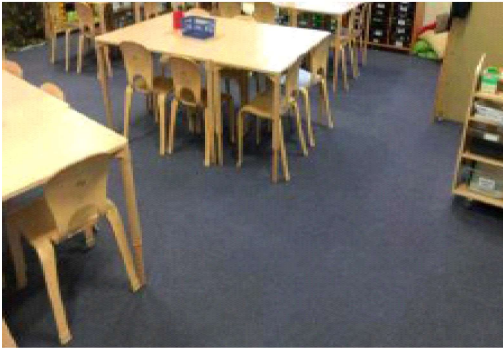
Item 34: Presumed

The bitumen adhesive to the floor below the cement skim to the floor in the classroom (Room 34) is presumed to contain asbestos.

Any changes in its appearance should be noted and passed to Property Services.

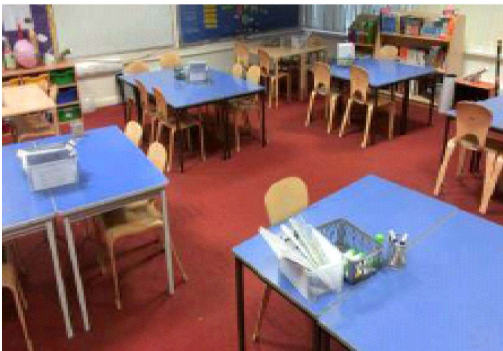
Item 35: Presumed

The bitumen adhesive to the floor in the classroom (Room 35) is presumed to contain asbestos.

Any changes in its appearance should be noted and passed to Property Services.

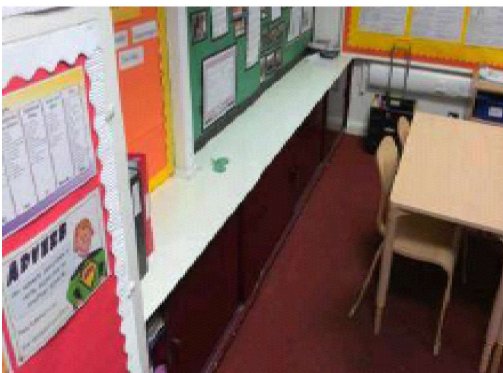
Item 36: Presumed

The skirting to the base of the wall behind the cupboards in the classroom (Room 35) was presumed to contain asbestos.

This was removed in July 2015.

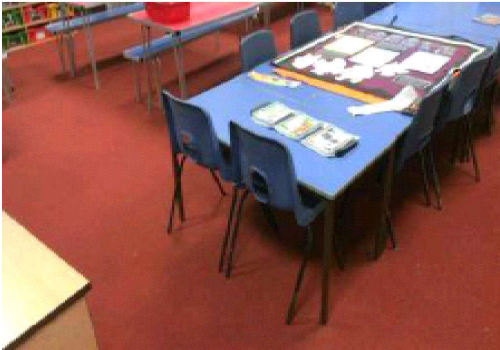
Item 37: Presumed

The bitumen adhesive to the floor in the classroom (Room 36) is presumed to contain asbestos.

Any changes in its appearance should be noted and passed to Property Services.

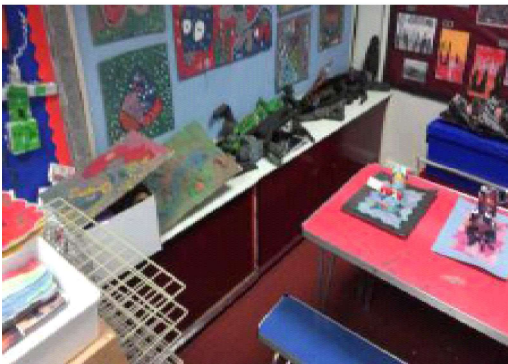
Item 38: Presumed

The skirting to the base of the wall behind the cupboards in the classroom (Room 36) was presumed to contain asbestos.

This was removed in July 2015.

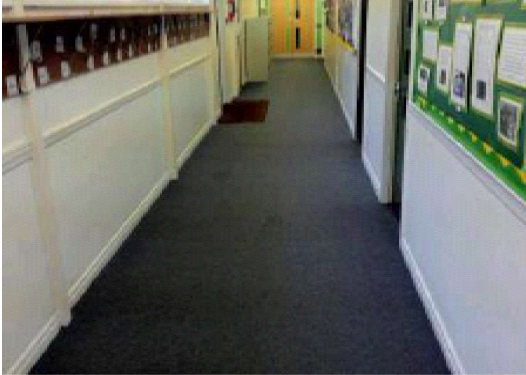
Item 40: Presumed

The bitumen adhesive to the floor below the cement skim to the floor in the corridor (Room 40) is presumed to contain asbestos.

Any changes in its appearance should be noted and passed to Property Services.

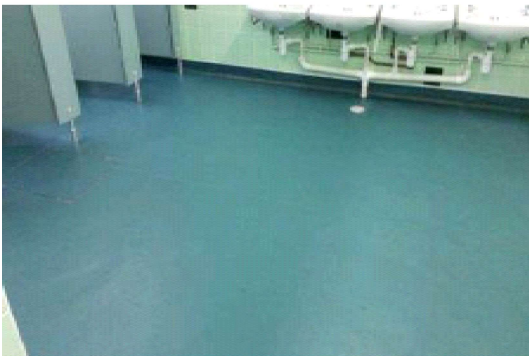
Item 41: Presumed

The vinyl floor tiles beneath the modern lino in the girls wc (Room 41) is presumed to contain asbestos.

Any changes in its appearance should be noted and passed to Property Services.

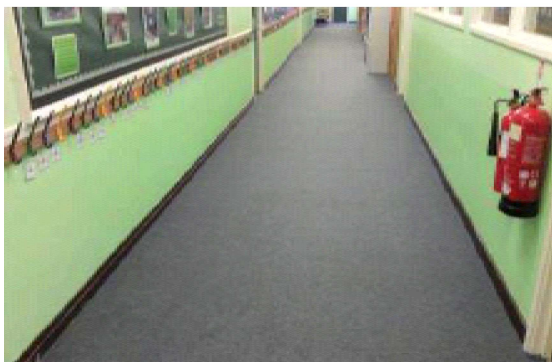
Item 45: Presumed

The bitumen adhesive to the floor in the corridor (Room 43) is presumed to contain asbestos.

Any changes in its appearance should be noted and passed to Property Services.

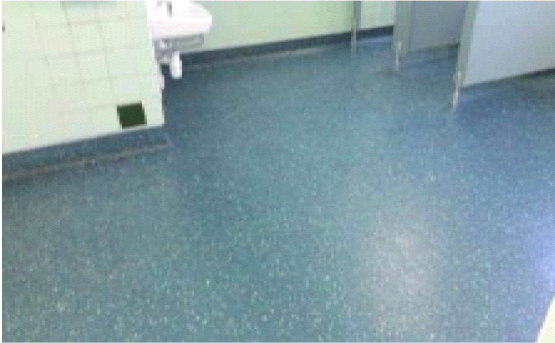
Item 46: Presumed

The vinyl floor tiles beneath the modern lino in the Boys wc (Room 44) were presumed to contain asbestos.

These were removed in July 2015.

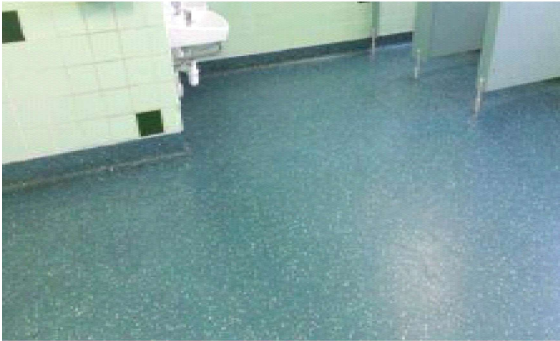
Item 47: Presumed

The bitumen adhesive beneath modern lino in the Boys wc (Room 44) is presumed to contain asbestos.

This was removed in July 2015.

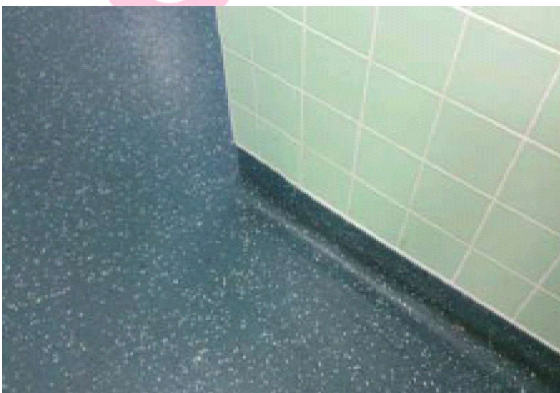
Item 48: As KR09/86

The skirting to wall beneath the lino in the Boys wc (Room 44) was presumed to contain asbestos.

This was removed in July 2015.

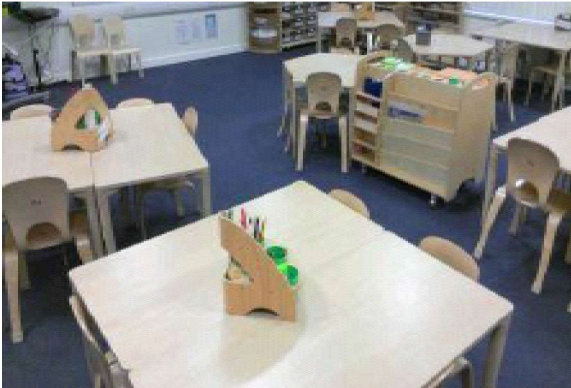
Item 49: Presumed

The bitumen adhesive to the floor below the cement skim to the floor in the classroom (Room 45) is presumed to contain asbestos.

Any changes in its appearance should be noted and passed to Property Services.

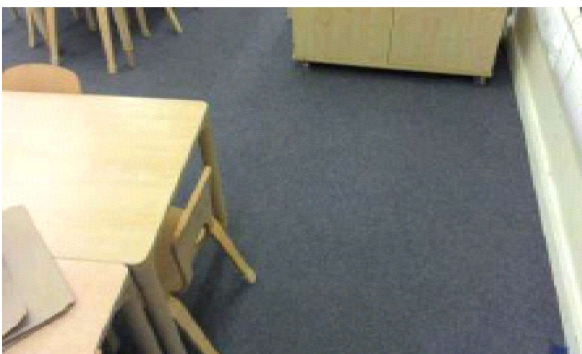
Item 51: Presumed

The bitumen adhesive beneath carpet in the classroom (Room 46) is presumed to contain asbestos.

Any changes in its appearance should be noted and passed to Property Services.

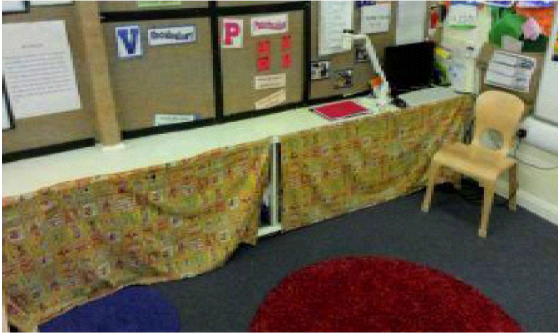
Item 52: Presumed

The skirting to wall beneath the lino in the classroom behind the cupboards (Room 46) was presumed to contain asbestos.

This was removed in July 2015.

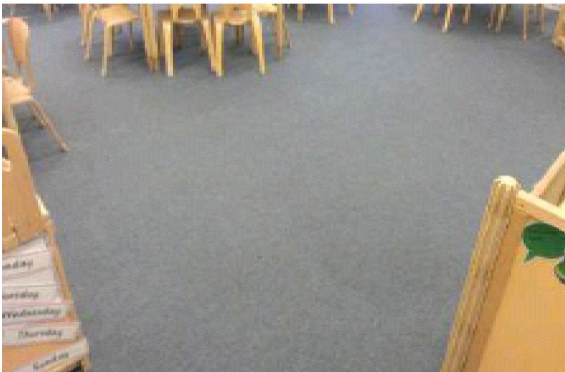
Item 53: Presumed

The vinyl floor tiles beneath the carpet in the classroom (Room 47) are presumed to contain asbestos.

This was removed August 2017.

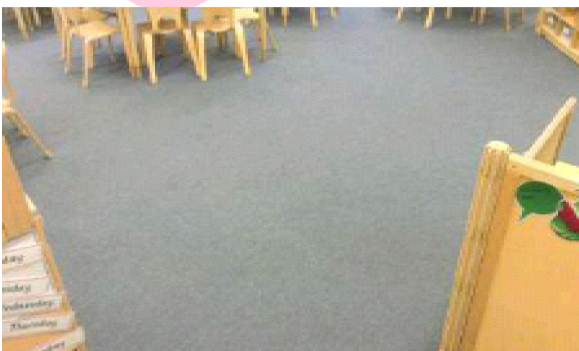
Item 54: Presumed

The bitumen adhesive beneath carpet in the classroom (Room 47) is presumed to contain asbestos.

Any changes in its appearance should be noted and passed to Property Services.

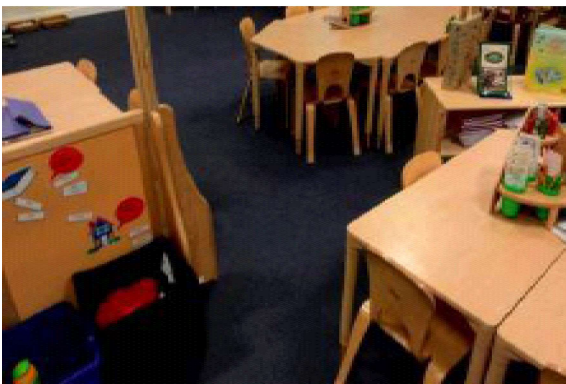
Item 56: Presumed

The bitumen adhesive to the floor below the cement skim to the floor in the classroom (Room 48) is presumed to contain asbestos.

Any changes in its appearance should be noted and passed to Property Services.

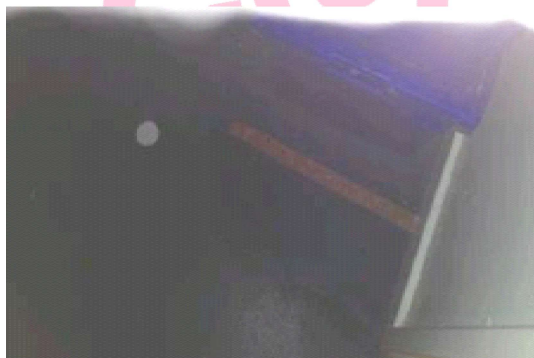
Item 63: Presumed

The vinyl floor tiles beneath the carpet in the store (Room 55) were presumed to contain asbestos.

These were removed in July 2015.

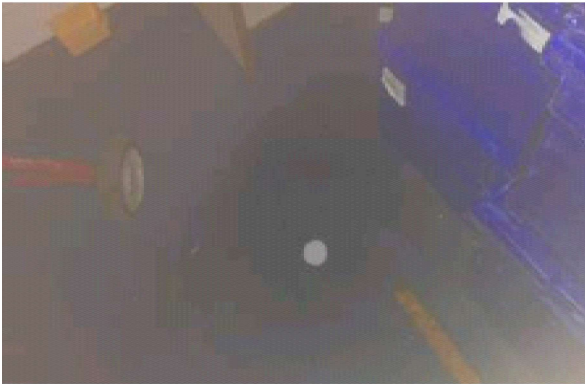
Item 64: Presumed

The bitumen adhesive to the floor in the store room (Room 55) is presumed to contain asbestos.

Any changes in its appearance should be noted and passed to Property Services.

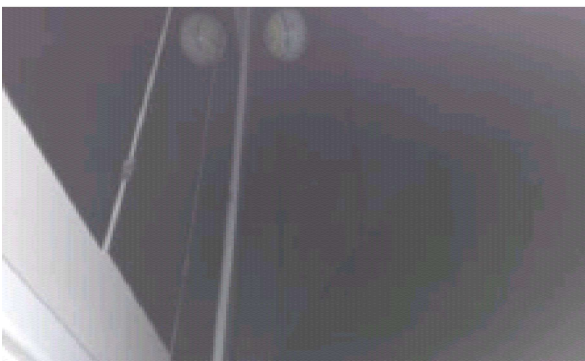
Item 66: Presumed

The bitumen adhesive to the floor in the office (Room 56) is presumed to contain asbestos.

Any changes in its appearance should be noted and passed to Property Services.

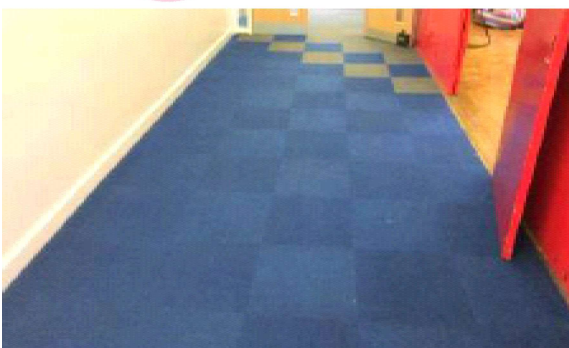
Item 81: Presumed

The bitumen adhesive to the floor in the corridor (Room 74) is presumed to contain asbestos.

Any changes in its appearance should be noted and passed to Property Services.

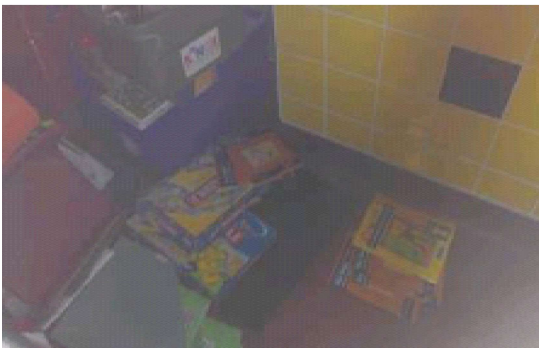
Item 86: Presumed

The vinyl floor tiles beneath the lino in the store (Room 80) are presumed to contain asbestos.

This was removed August 2017.

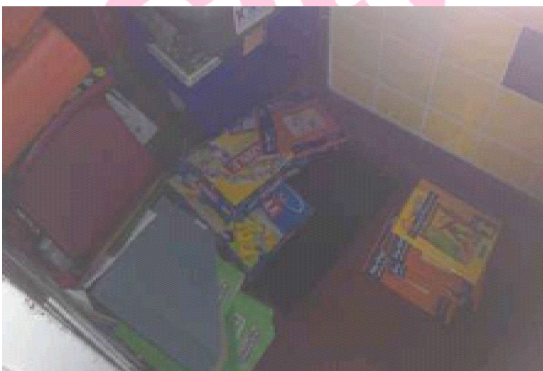
Item 87: Presumed

The bitumen adhesive to the floor in the store (Room 80) is presumed to contain asbestos.

Any changes in its appearance should be noted and passed to Property Services.

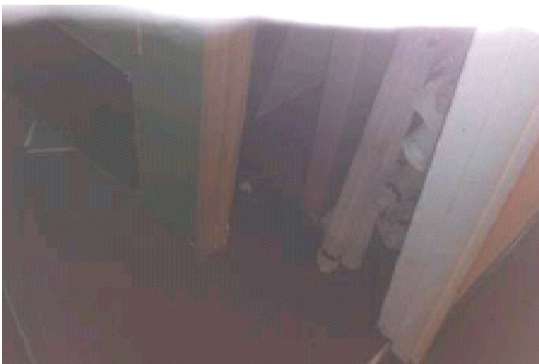
Item 89: Presumed

The bitumen adhesive to the floor in the store (Room 81) is presumed to contain asbestos.

Any changes in its appearance should be noted and passed to Property Services.

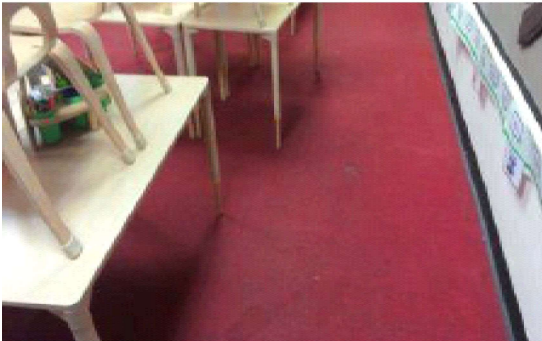
Item 94: Presumed

The vinyl floor tiles beneath the carpet in the classroom (Room 87) are presumed to contain asbestos.

This was removed August 2017.

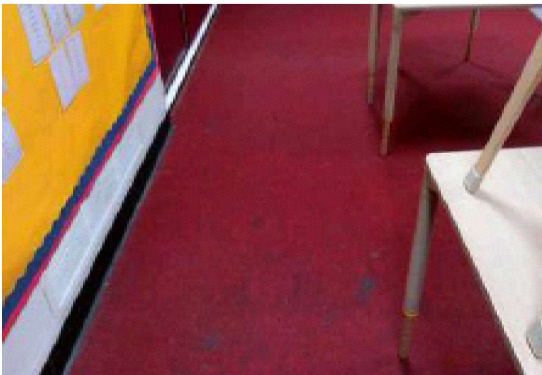
Item 95: Presumed

The bitumen adhesive to the floor in the classroom (Room 87) is presumed to contain asbestos.

Any changes in its appearance should be noted and passed to Property Services.

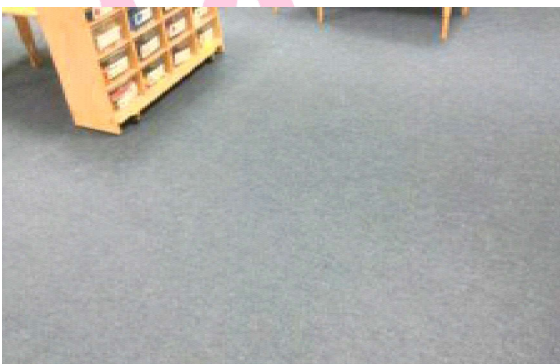
Item 99: Presumed

The bitumen adhesive beneath the carpet in the classroom (Room 89) is presumed to contain asbestos.

Any changes in its appearance should be noted and passed to Property Services.

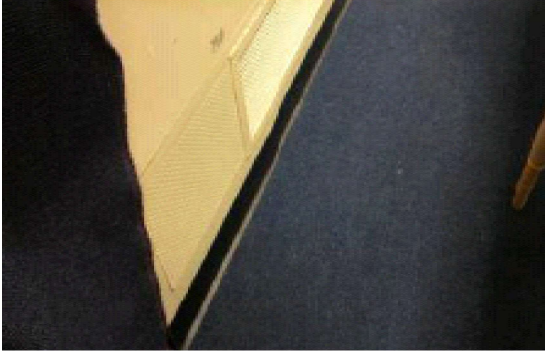
Item 100: Presumed

The skirting to base of wall behind modern in the classroom (Room 89) is presumed to contain asbestos.

This was removed August 2017.

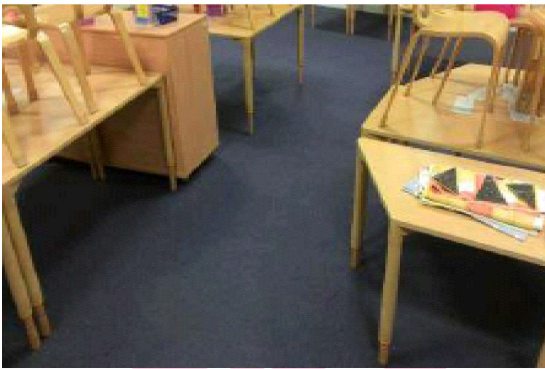
Item 101: Presumed

The bitumen adhesive below the cement skim to the floor in the classroom (Room 90) is presumed to contain asbestos.

Any changes in its appearance should be noted and passed to Property Services.

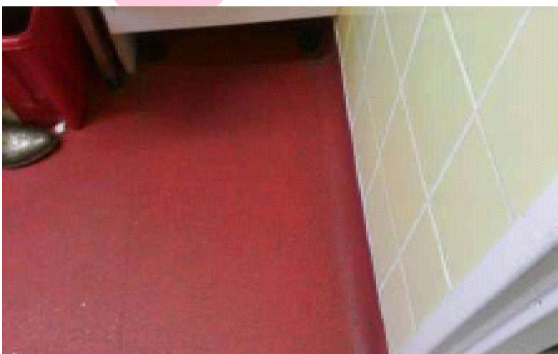
Item 105: As KR09/86

The skirting to base of wall in the store (Room 95) is presumed to contain asbestos.

Any changes in its appearance should be noted and passed to Property Services.

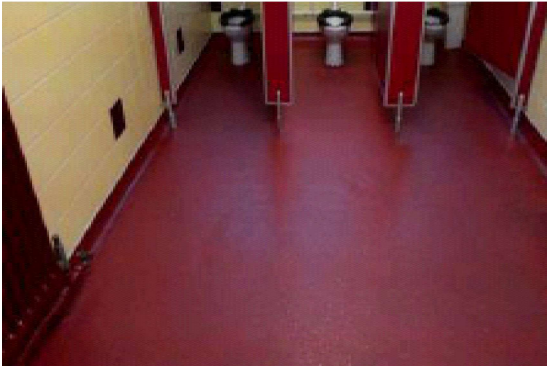
Item 106: Presumed

The vinyl floor tiles beneath the modern lino in the Girls toilets (Room 96) are presumed to contain asbestos.

Any changes in its appearance should be noted and passed to Property Services.

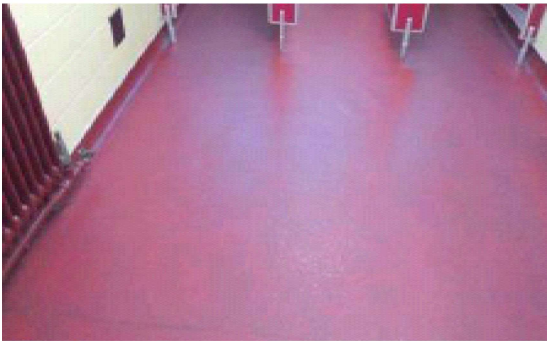
Item 107: Presumed

The bitumen adhesive beneath the modern lino to the Girls toilets (Room 96) is presumed to contain asbestos.

Any changes in its appearance should be noted and passed to Property Services.

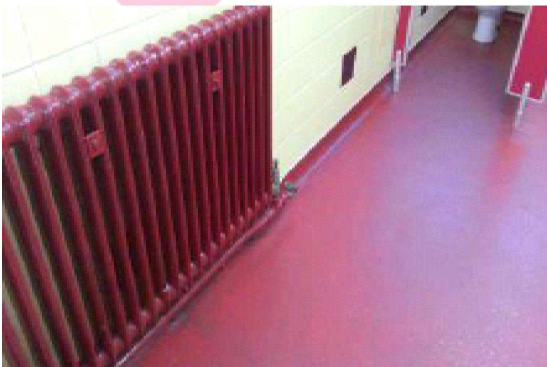
Item 108: Presumed

The skirting to base of wall behind modern lino in the Girls toilets (Room 96) is presumed to contain asbestos.

Any changes in its appearance should be noted and passed to Property Services.

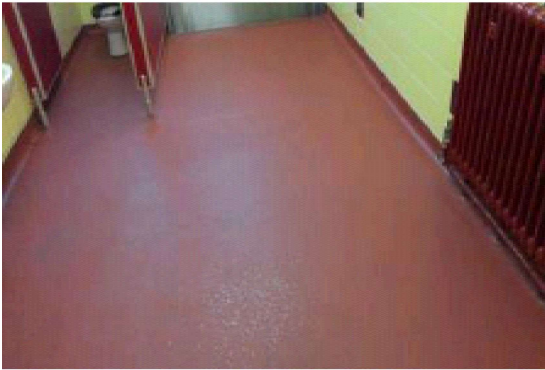
Item 109: Presumed

The vinyl floor tiles beneath the modern lino in the Boys toilets (Room 97) are presumed to contain asbestos.

Any changes in its appearance should be noted and passed to Property Services.

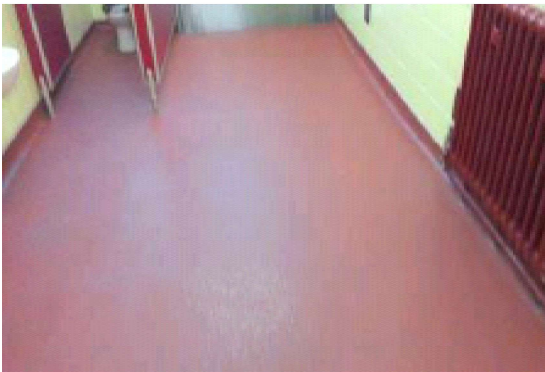
Item 110: Presumed

The bitumen adhesive beneath the modern lino to the Boys toilets (Room 97) is presumed to contain asbestos.

Any changes in its appearance should be noted and passed to Property Services.

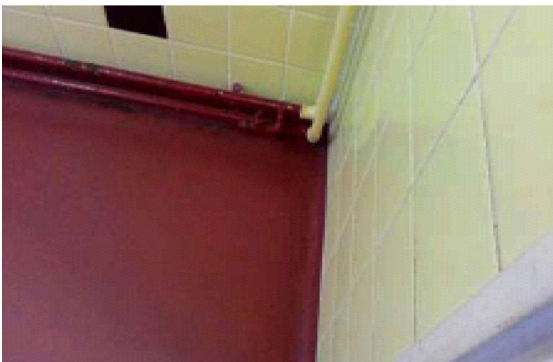
Item 111: Presumed

The skirting to base of wall behind modern lino in the Boys toilets (Room 97) is presumed to contain asbestos.

Any changes in its appearance should be noted and passed to Property Services.

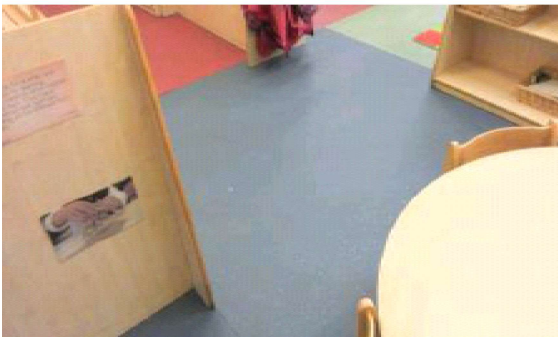
Item 113: NSPS/002

The bitumen adhesive beneath the modern lino to the classroom (Room 007) contains asbestos.

Any changes in its appearance should be noted and passed to Property Services.

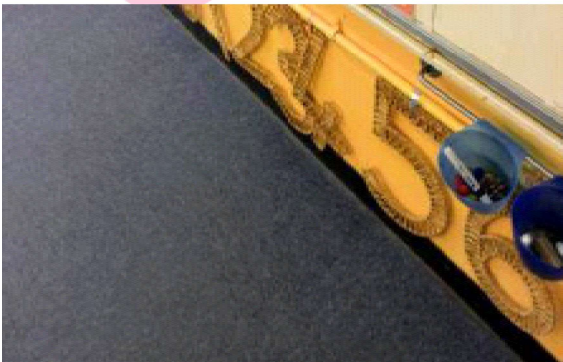
Item 114: NSPS/003

The skirting to base of wall behind modern in the classroom (Room 006) does not contain asbestos.

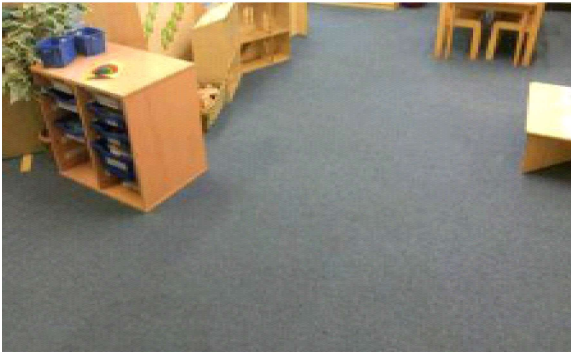
Item 115: NSPS/002

The bitumen adhesive beneath the carpet in the classroom (Room 006) contains asbestos.

Any changes in its appearance should be noted and passed to Property Services.

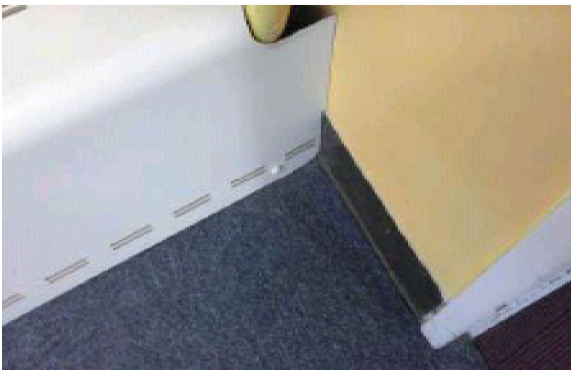
Item 116: NSPS/003

The skirting to base of wall in the classroom (Room 005) does not contain asbestos.

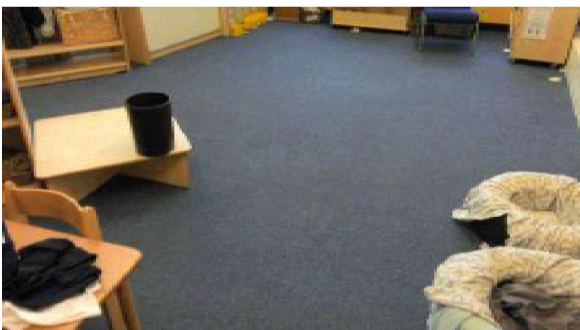
Item 117: Presumed

The bitumen adhesive beneath the carpet in the classroom (Room 102) is presumed to contain asbestos.

Any changes in its appearance should be noted and passed to Property Services.

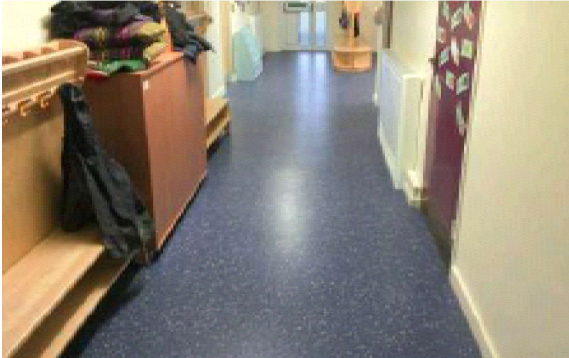
Item 118: Presumed

The bitumen adhesive below the cement skim to the corridor / lobby (Room 103) is presumed to contain asbestos.

Any changes in its appearance should be noted and passed to Property Services.

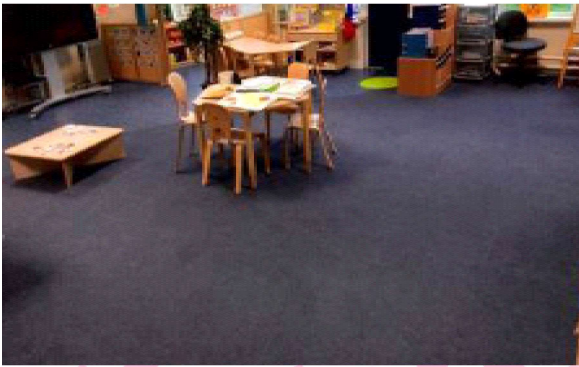
Item 119: Presumed

The bitumen adhesive beneath the cement skim to the classroom (Room 104) is presumed to contain asbestos.

Any changes in its appearance should be noted and passed to Property Services.

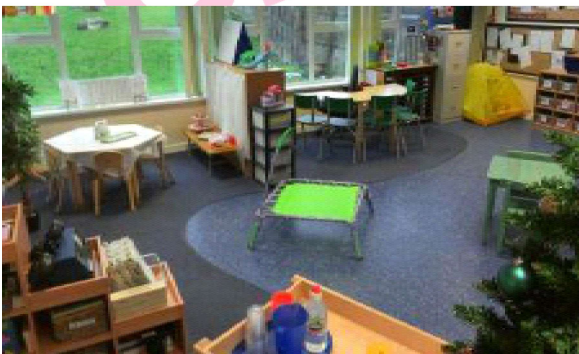
Item 120: Presumed

The bitumen adhesive beneath the cement skim to the classroom (Room 105) is presumed to contain asbestos.

Any changes in its appearance should be noted and passed to Property Services.

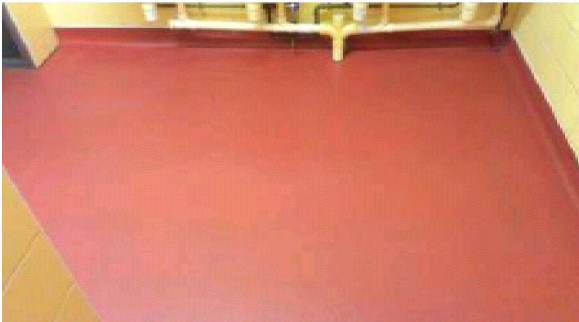
Item 121: Presumed

The vinyl floor tiles beneath the modern lino in the Boys toilets (Room 108) are presumed to contain asbestos.

Any changes in its appearance should be noted and passed to Property Services.

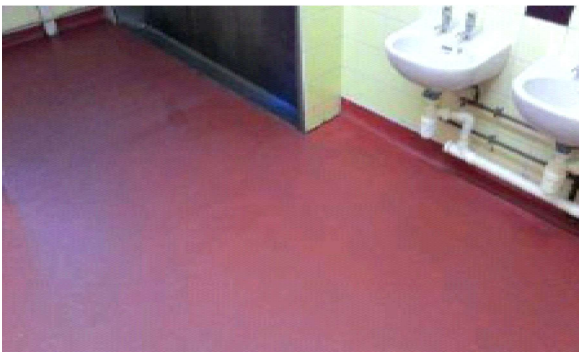
Item 122: Presumed

The bitumen adhesive beneath the modern lino to the Boys toilet (Room 108) is presumed to contain asbestos.

Any changes in its appearance should be noted and passed to Property Services.

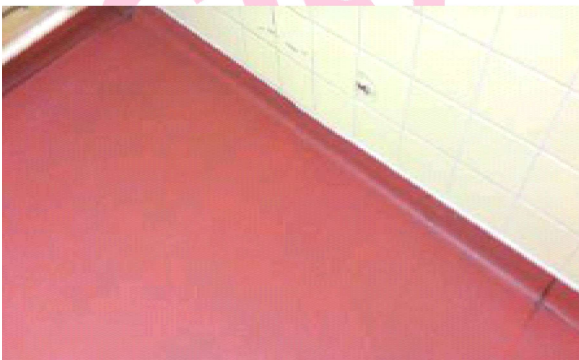
Item 123: Presumed

The skirting to base of wall behind modern lino in the boys toilet (Room 108) is presumed to contain asbestos.

Any changes in its appearance should be noted and passed to Property Services.

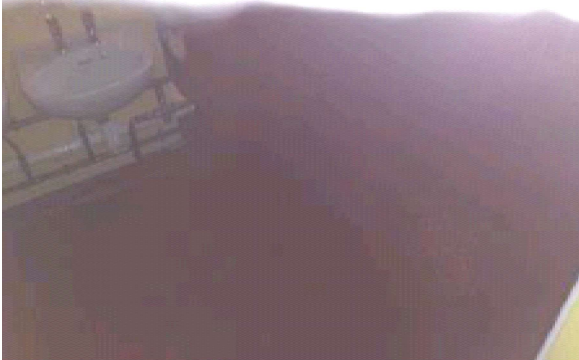
Item 124: Presumed

The vinyl floor tiles beneath the modern lino in the Girls toilets (Room 110) are presumed to contain asbestos.

Any changes in its appearance should be noted and passed to Property Services.

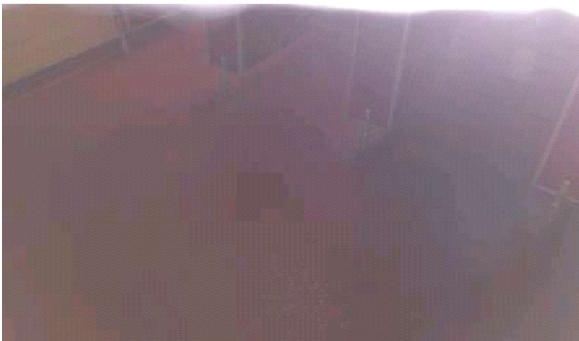
Item 125: Presumed

The bitumen adhesive beneath the modern lino in the Girls toilets (Room 110) is presumed to contain asbestos.

Any changes in its appearance should be noted and passed to Property Services.

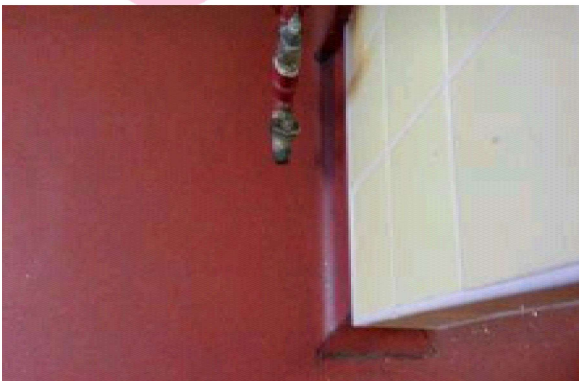
Item 126: Presumed

The skirting to base of wall behind modern lino in the Girls toilet (Room 110) is presumed to contain asbestos.

Any changes in its appearance should be noted and passed to Property Services.

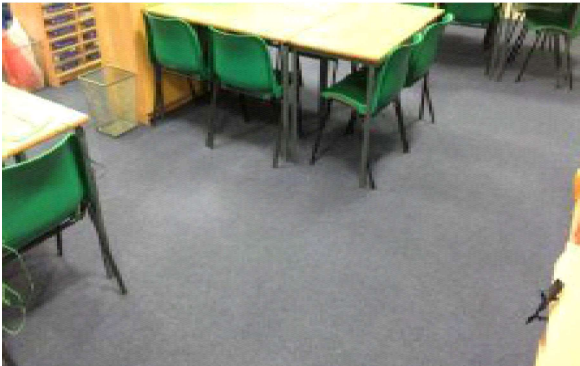
Item 127: Presumed

The bitumen adhesive to the floor below the cement skim to the classroom (Room 112) is presumed to contain asbestos.

Any changes in its appearance should be noted and passed to Property Services.

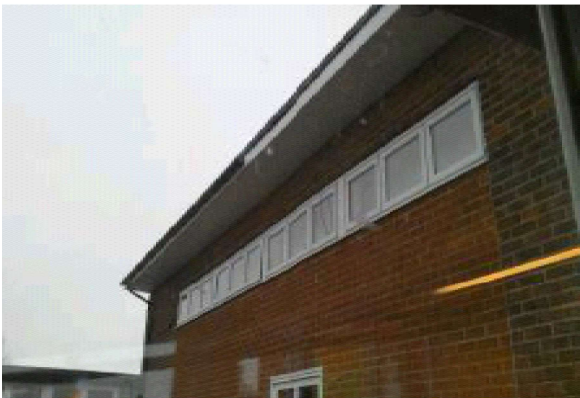
Item 128: NSPS/004

The corrugated soffits (throughout) to the external of the building contain asbestos.

Any changes in its appearance should be noted and passed to Property Services.

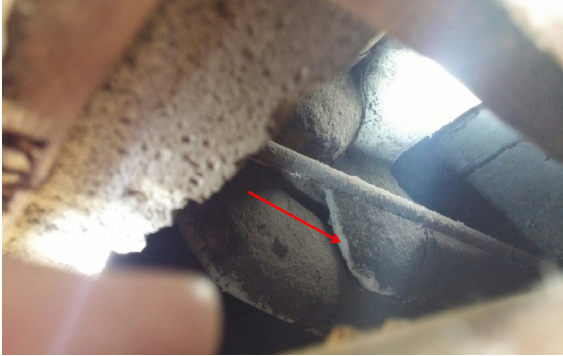
Item 130: Presumed

The pipe lagging within the heater cupboard is presumed to contain asbestos.

Any changes in its appearance should be noted and passed to Property Services.

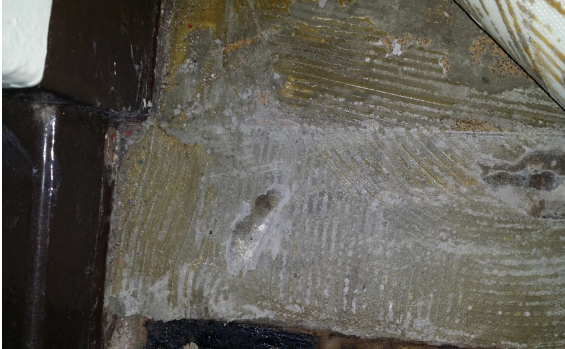
Item 133: 107693-2

The subfloor to the ramped corridor does not contain asbestos.

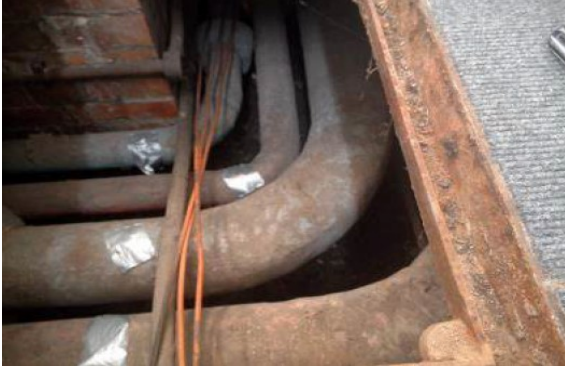
Item 142: BH000580

The debris to duct hatch lip at duct entrance in the duct adjacent head teacher's office does not contain asbestos.

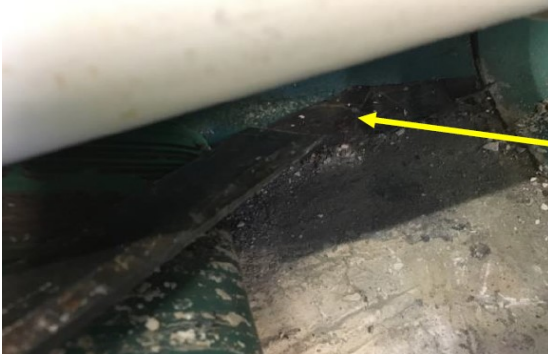
Item 145: BS001667

The black skirting beneath lino in the Year 6 Girls toilets does not contain asbestos.

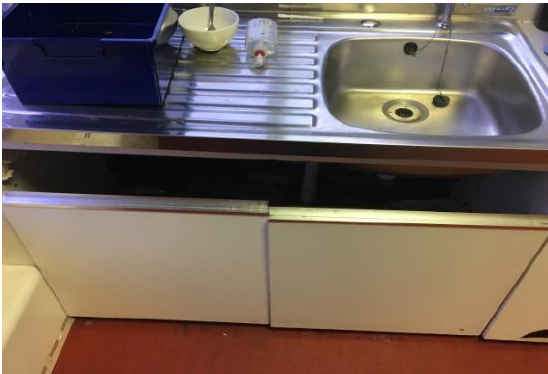
Item 146: BS001670

The sink pad in the year 4 Classroom does not contain asbestos.

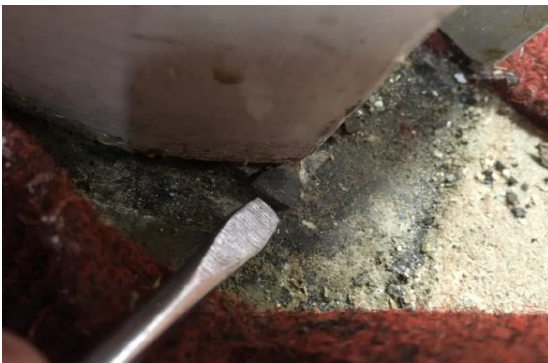
Item 147: BS001671

The floor tile remnants beneath carpet in the year 4 Classroom does not contain asbestos.

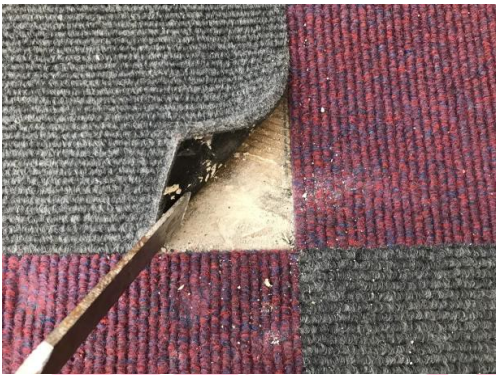
Item 149: BS017806

The floor screed to the floor below the carpet tiles in Internal cloakroom (to be WC) contains asbestos.

Any changes in its appearance should be noted and passed to Property Services.

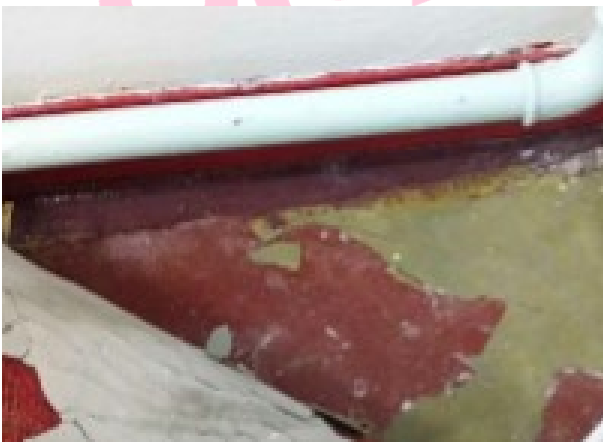
Item 150: 21-30151-1

The floor below carpet and screed (bitumen) in the classroom does not contain asbestos.

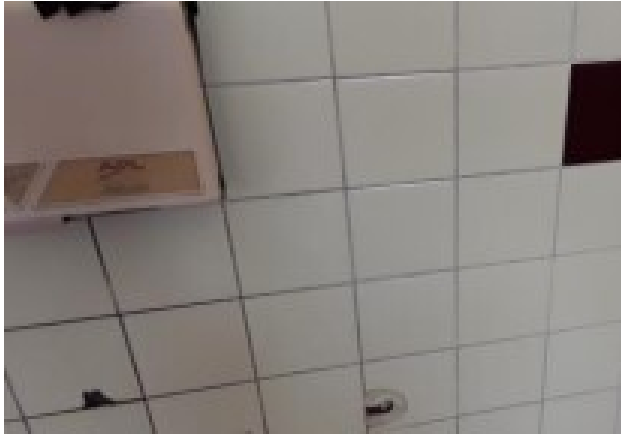
Item 151: 21-36878-1

The adhesive to the ceramic tiles to walls in (Area 1/Boys toilet) does not contain asbestos.

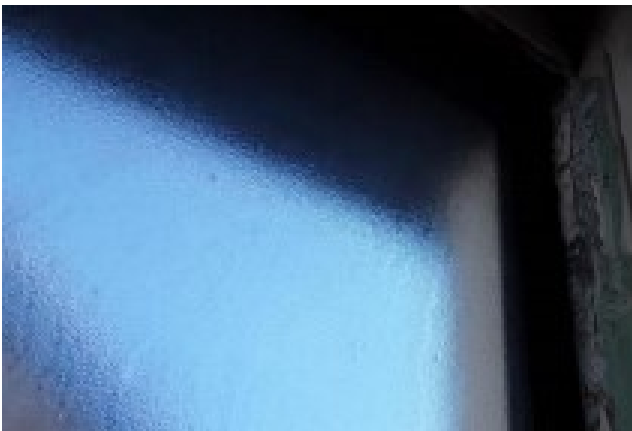
Item 152: 21-36878-2

The sealant to the old window frame (Area 1/Boys toilet) does not contain asbestos.

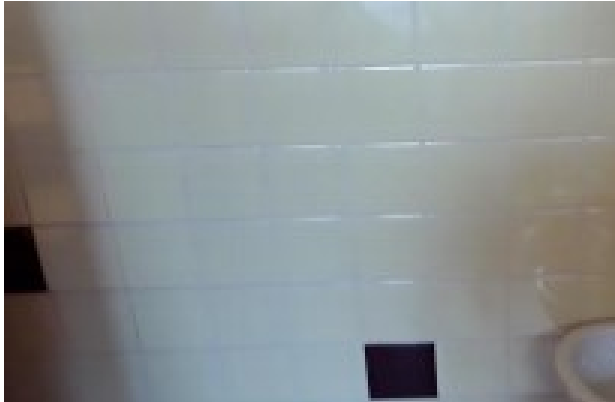
Item 154: 21-36878-3

The adhesive to the ceramic tiles to walls in (Area 2/Girls toilet) does not contain asbestos.

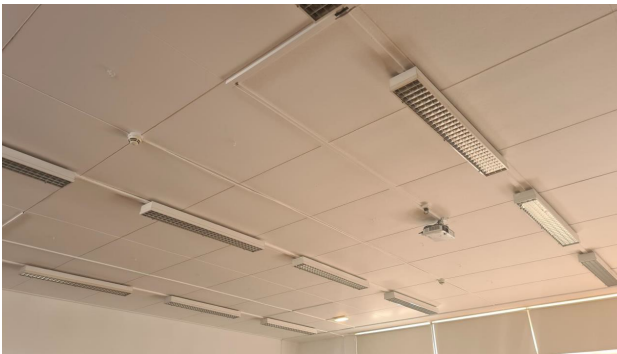
Item 155: NSPS/001

The ceiling tiles (G/001/Hall) does not contain asbestos.

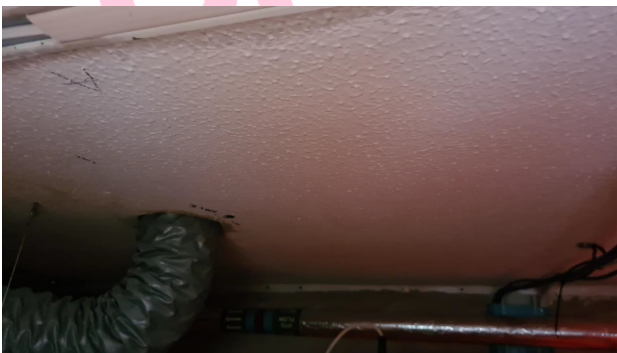
Item 156: NSPS/005

The textured coating to ceiling above suspended ceiling (G/013/Office) does not contain asbestos.

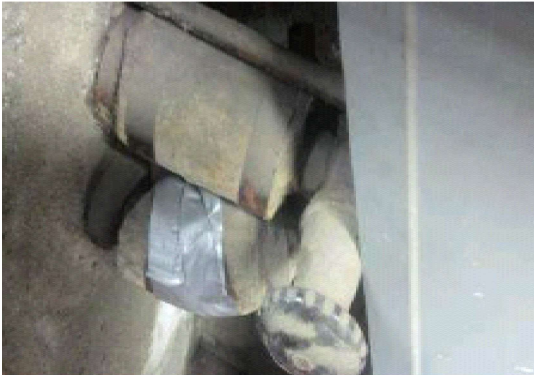
Ref: EV001734

The insulation pipe lagging to the heater in Classroom 3/4 contained asbestos.

This was removed by Building Needs in July 2015.

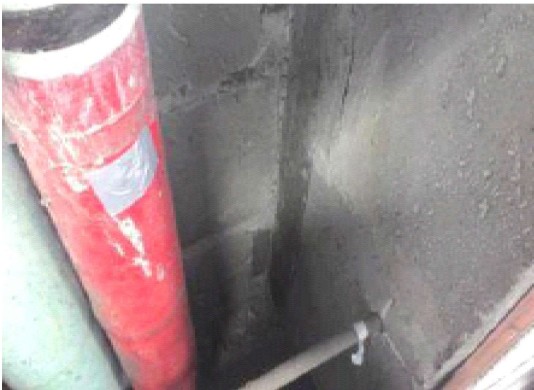
Ref: EV001735

The red pipework in the void to the left of the heater in classroom 3/4 contained asbestos.

This was removed by Building Needs in July 2015.

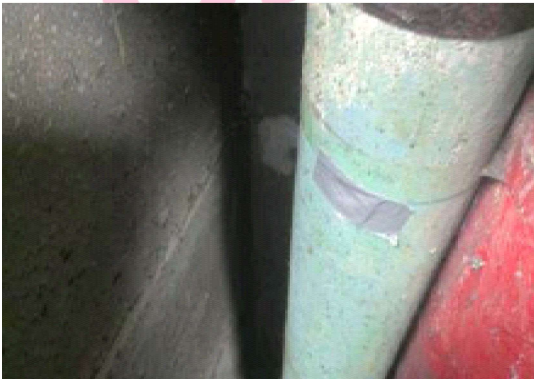
Ref: EV001736

The green pipework in the void to the left of the heater in classroom 3/4 contained asbestos.

This was removed by Building Needs in July 2015.

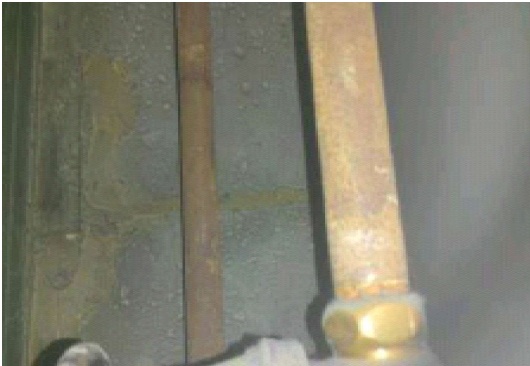
Ref: EV001737

A swab sample of the pipework to the upright heater in Year 5 room 2 does not contain asbestos.

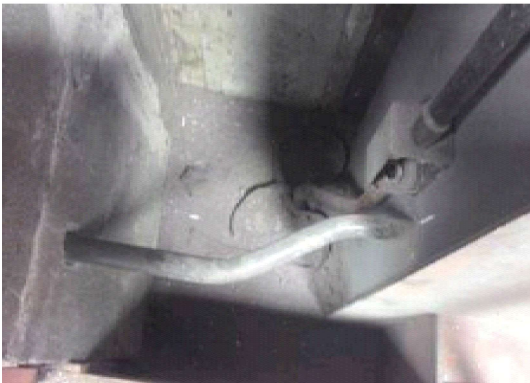
Ref: EV001738

A swab sample of the floor to the void to the upright heater in Year 5 room 2 does not contain asbestos.

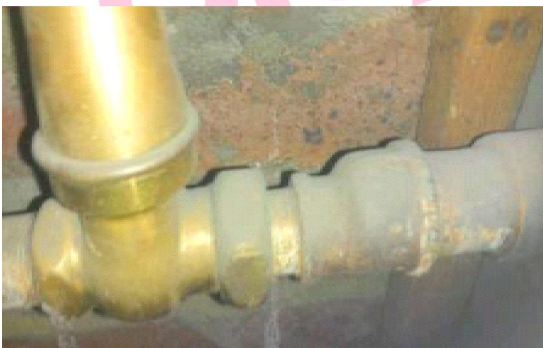
Ref: EV001739

The residue to the pipework to the void to the upright heater in Year 2 room 3 does not contain asbestos.

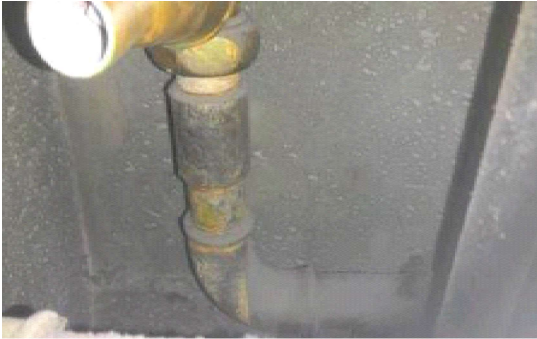
Ref: EV001740

The residue to the pipework to the void to the upright heater in Year 2 room 4 does not contain asbestos.
