ASBESTOS SURVEY REPORT FOR NORTHERN SAINTS C OF E PRIMARY SCHOOL, SUNDERLAND

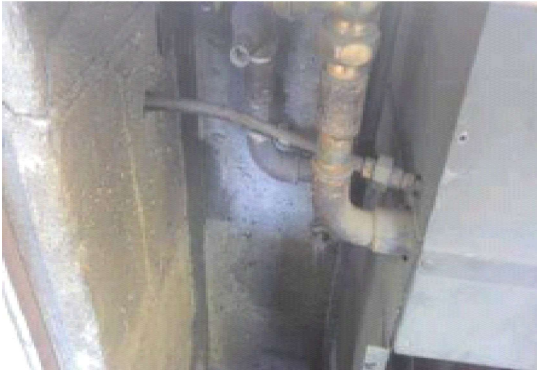
Ref: EV001741

The debris on the pipework to the void to the upright heater in Year 1 room 5 does not contain asbestos.

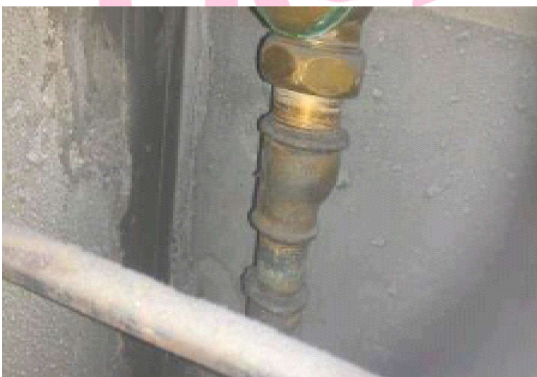
Ref: EV001742

The debris on the pipework to the void to the upright heater in Year 1 room 6 does not contain asbestos.

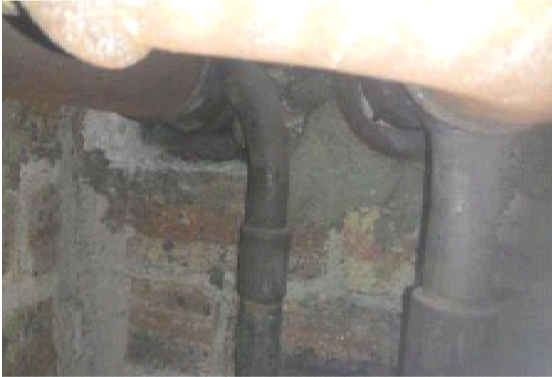
Ref: EV001743

The residue to the pipework going into the brickwork at the top of the heaters in Infant Hall unit 1 does not contain asbestos.
