ASBESTOS SURVEY REPORT FOR SEABURN DENE PRIMARY SCHOOL, SUNDERLAND

Asbestos Register for Seaburn Dene Primary School

UPRN: - 209718

Last updated 13/03/2025 V.2.0

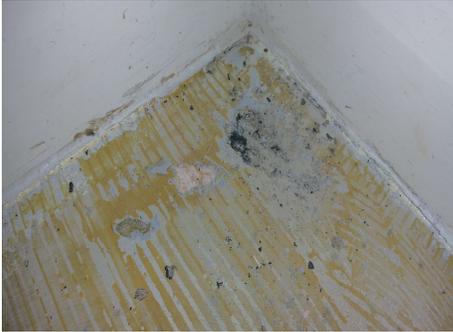
Item 1 Ref: 179537-1

The subfloor covering (Rm 0/01) containing remnant bitumen contains asbestos.

Any change in its appearance should be recorded and passed to Property Services.

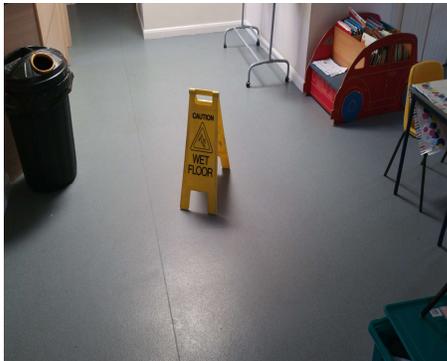
Item 2 Ref: As 179537-1

The subfloor covering (Rm 0/02) containing remnant bitumen contains asbestos.

Any change in its appearance should be recorded and passed to Property Services.

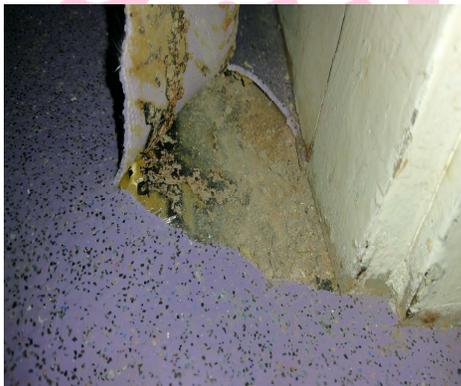
Item 3 Ref: As 179537-1

The subfloor covering (Rm 0/03) containing remnant bitumen contains asbestos.

Any change in its appearance should be recorded and passed to Property Services.

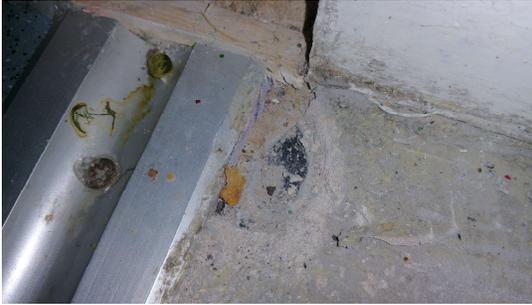
Item 4 Ref: As 179537-1

The subfloor covering (Rm 0/09) containing remnant bitumen contains asbestos.

Any change in its appearance should be recorded and passed to Property Services.

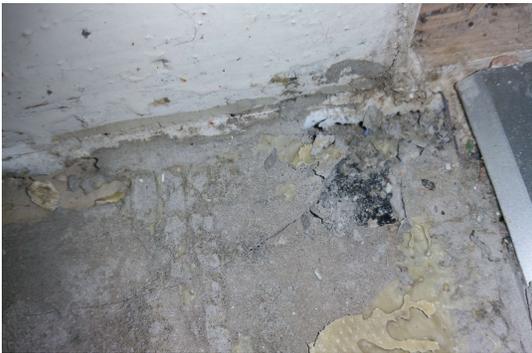
Item 5 Ref: As 179537-1

The subfloor covering (Rm 0/10) containing remnant bitumen contains asbestos.

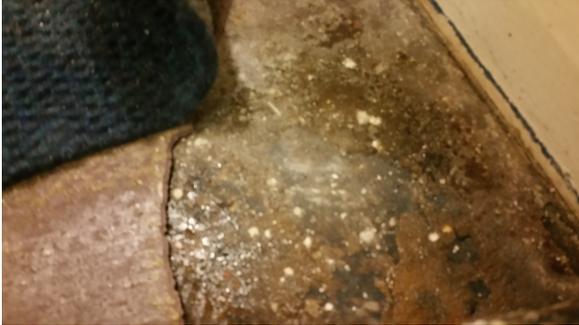
Item 19 Ref: 179537-10

The bitumen adhesive (Rm 0/59) contains asbestos.

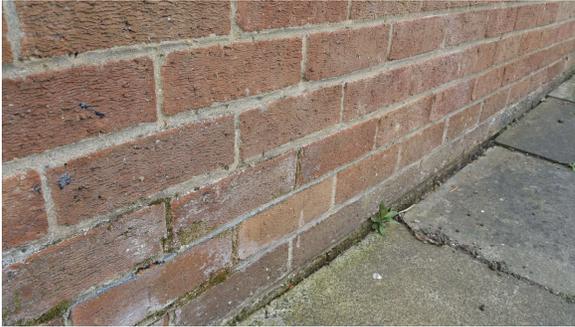
Item 22 Ref: 179537-13

The damp proof course (external) does not contain asbestos.
