### **ASBESTOS SURVEY REPORT FOR SPRINGWELL VILLAGE PRIMARY SCHOOL, WESTFIELD CRESCENT, SPRINGWELL VILLAGE, NE9 7RX.**

**Springwell Village Primary School, Westfield Crescent,  
Springwell, NE9 7RX**

**Date: 27 July 2026**

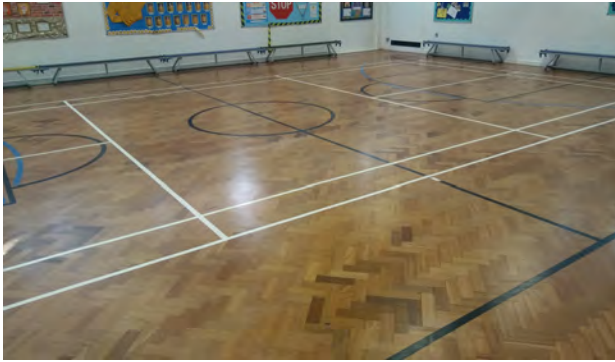
### **Item 16 Ref: As 369919-8**

The adhesive beneath parquet flooring in the main hall (Rm 0/012) does not contain asbestos.

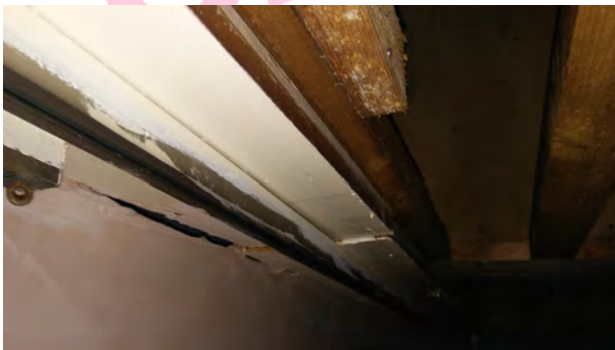
### **Item 18 Ref: 254851-7**

The residue to perimeter walls/pelmet at former ceiling height in the main hall (Rm 0/012) does contain asbestos.

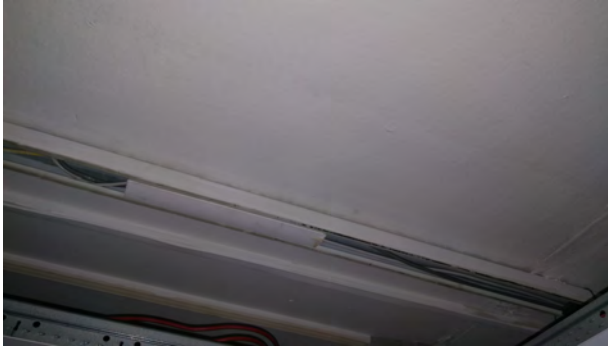
#### **Item 28 Ref: As 254851-4**

The ceiling in the office void above (Rm 0/017) does contain asbestos.

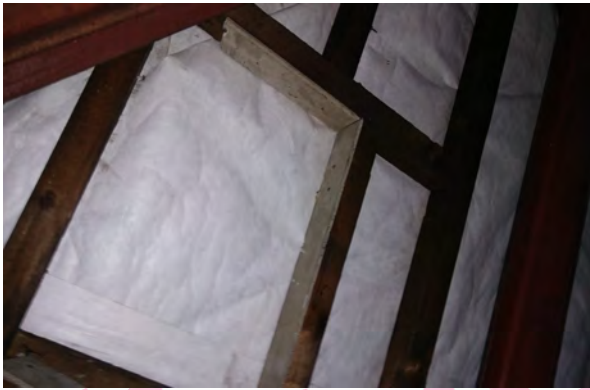
#### **Item 68 Ref: 369919-12**

The panels to the roof joists in the loft void (Rm 1/002) contain asbestos.

Any change in appearance should be reported to Property Services.

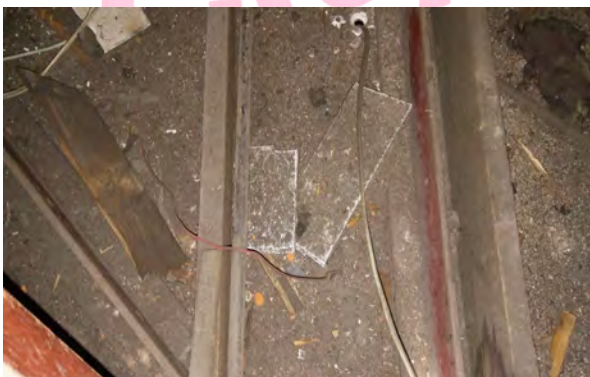
#### **Item 69 Ref: 369919-11**

The debris to topside of ceiling below in the loft void (Rm 1/002) does contain asbestos.

Any change in appearance should be reported to Property Services. Access should be restricted until this is removed.

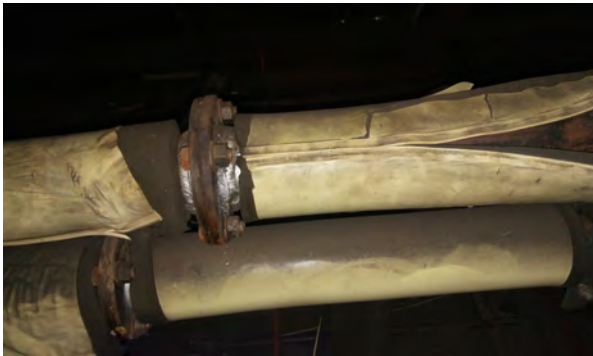
### **Item 70 Ref: Presumed**

The pipework flange gaskets in the loft void (Rm 1/002) is presumed to contain asbestos.

Further investigation is required before any works are carried out. Any change in appearance should be reported to Property Services

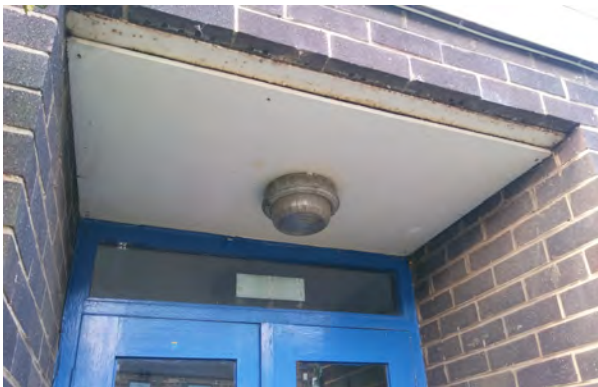
### **Item 71 Ref: 192566-5**

The canopy adjacent to the kitchen (External) does contain asbestos.

Any change in appearance should be reported to Property Services.

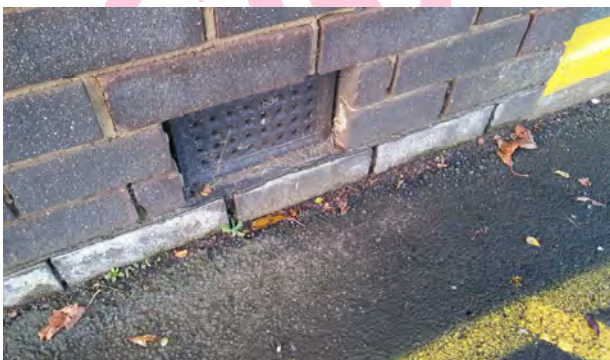
### **Item 72 Ref: 369919-16**

The damp proof course (External) does not contain asbestos.

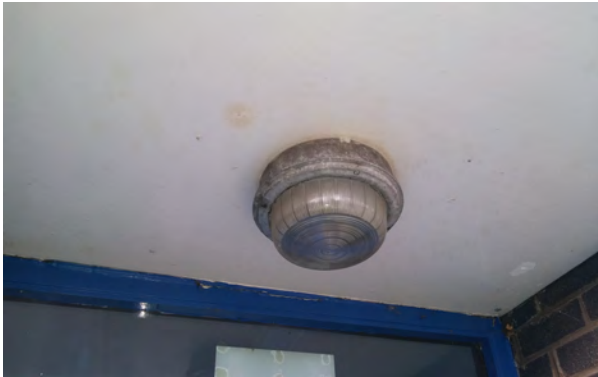
### **Item 73 Ref: 192566-4**

The mastic to light fitting to kitchen canopy (External) contain asbestos.

Any change in appearance should be reported to Property Services

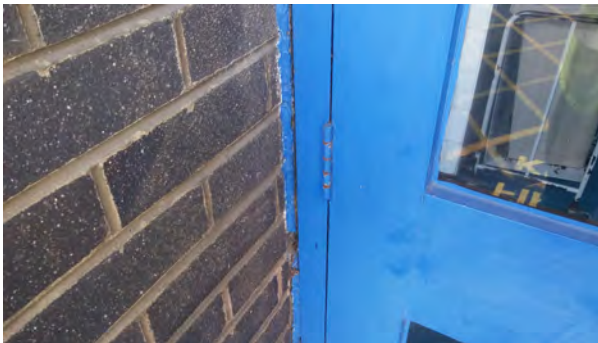
### **Item 74 Ref: 369919-17**

The sealant to the kitchen door frame (External) does contain asbestos.

*See item 83 as resampled on SGS survey J260020.*

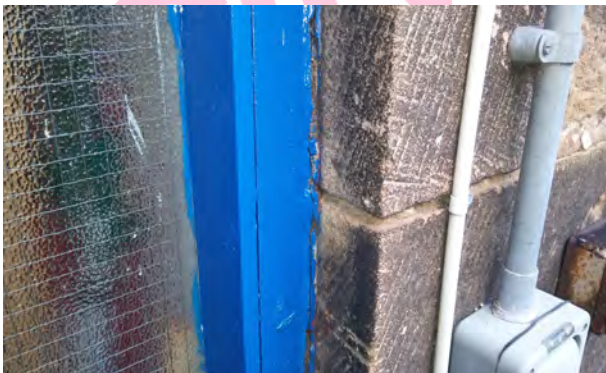
### **Item 75 Ref: 369919-18**

The sealant to the boiler room door frame (External) does contain asbestos.

Any change in appearance should be reported to Property Services.

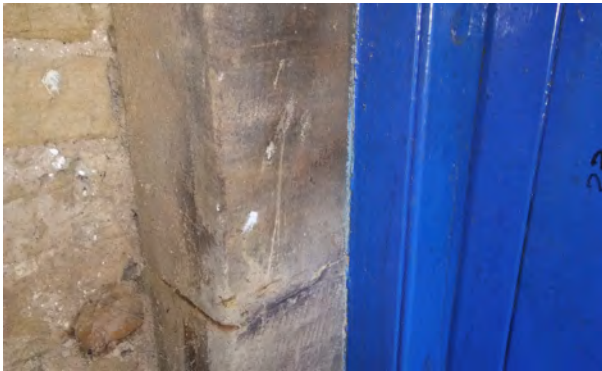
#### **Item 76 Ref: As 369919-18**

The sealant to the cellar room door frame (External) does contain asbestos.

Any change in appearance should be reported to Property Services.

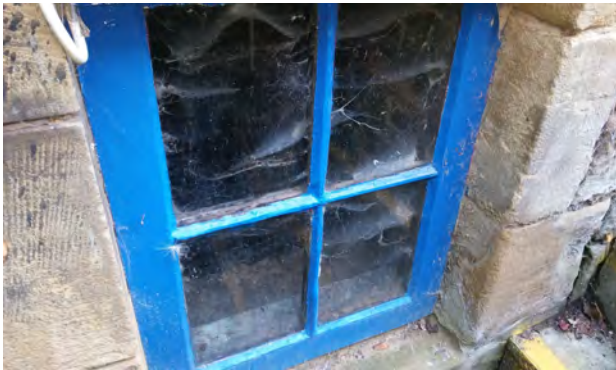
#### **Item 77 Ref: 369919-19**

The sealant to the cellar window (External) does not contain asbestos.

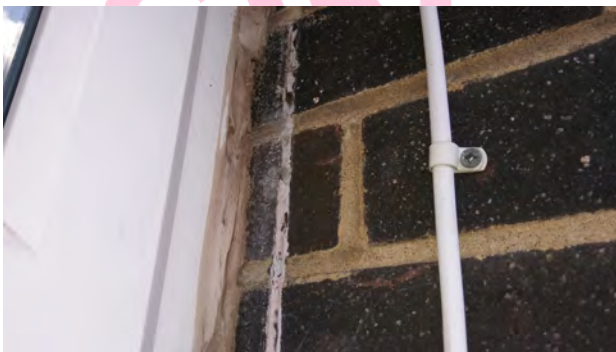
#### **Item 78 Ref: 369919-20**

The remnant sealant to windows (External) does contain asbestos.

Any change in appearance should be reported to Property Services.

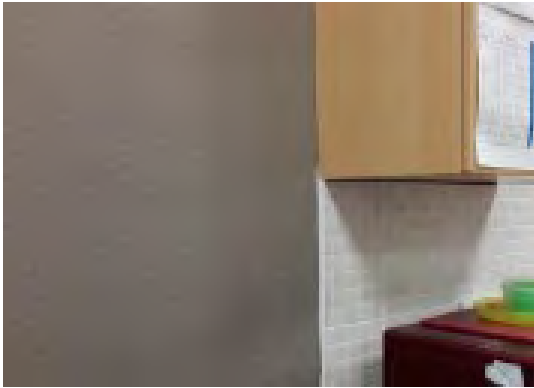
**Item 79 Ref: 21-39304-1**

The adhesive to the ceramic tiles to the walls in the staff room and cupboard (Area 1) does not contain asbestos.

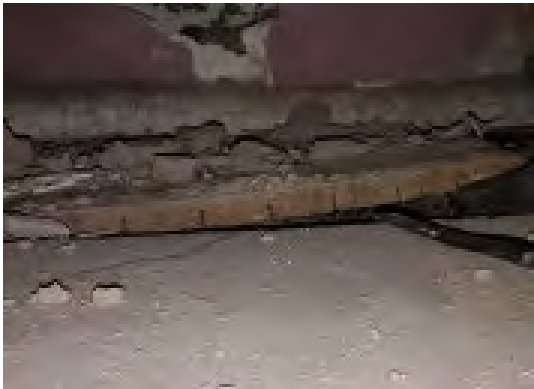
**Item 80 Ref: 21-39304-2**

The bitumen to the rear of parquet flooring in the staff room and cupboard (Area 1) does not contain asbestos.

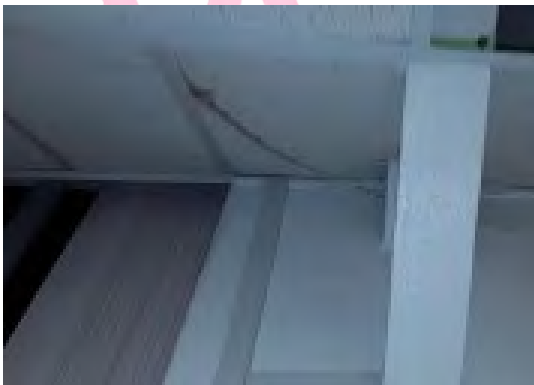
**Item 81 Ref: 21-39304-3**

The textured coating to the ceiling in the staff room and cupboard (Area 1) does not contain asbestos.

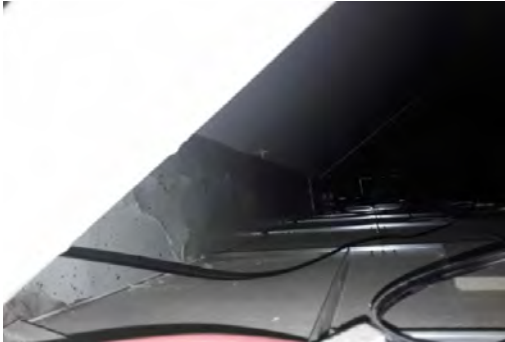
### **Item 82 Ref: 22-45686-1**

The textured coating to walls (Area 1/Room 29) does not contain asbestos.

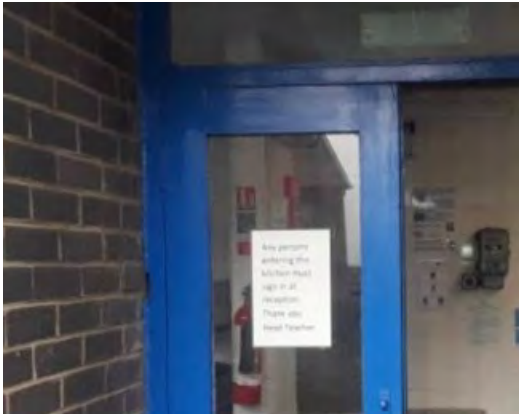
### **Item 83 Ref: NZ001545**

The door seal to the kitchen door (Kitchen External G/006) does not contain asbestos.
