### **ASBESTOS SURVEY REPORT FOR BENEDICT BISCOP, SUNDERLAND**

## **Asbestos Register for BENEDICT BISCOP, SUNDERLAND**

**Date: 11 August 2025**

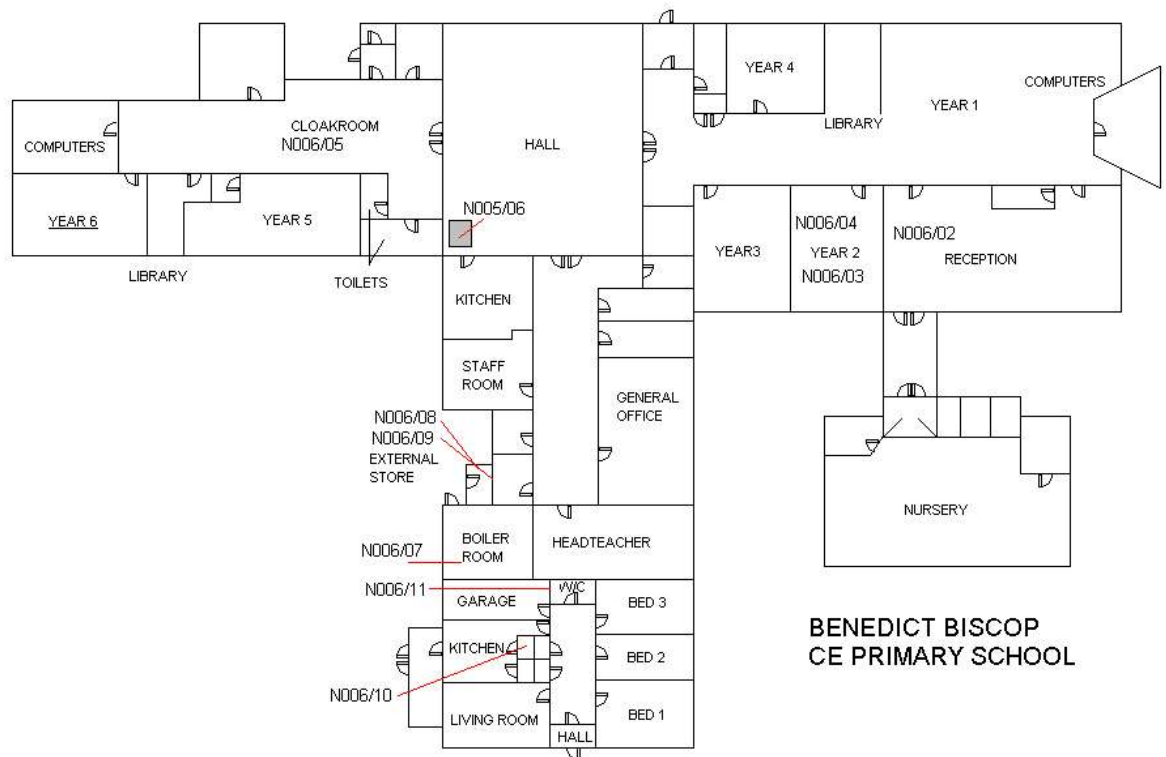
### **Plan of Building and Samples Location- Cont.**

**Computer Room/Reception Cloakroom/Nursery Cloakroom/Nursery Disabled Toilet/Nursery/Year 3 Class/Year 4 Class/Corridor Adjacent to Reception/Years 1-4 Library/Chemical Store/Boys WC 1/Girls WC 1/Year 1-4 Cloakrooms/Hall/Year 5 & 6 Boys Toilets/Year 5 & 6 Girls Toilets/Years 5 & 6 Small Cloakroom/Years 5 & 6 Toy Stores/Years 5 & 6 Main Corridor/Year 5 Class/Year 6 Class/Years 5 & 6 Library/Years 5 & 6 Computers/Kitchen/Staff Room/Disabled Toilet 2/Staff Toilet Male/Staff Toilet Female/Reception Foyer/General Office/Head Teachers Office/Corridor Adjacent to Heads Office/General Office Stationary Store/Main Switch Room/Caretakers House Kitchen/Caretakers House Bathroom/Caretakers House Heater Cupboard/Caretakers House Conservatory - No Suspect Asbestos Containing Materials Noted**

**Please note the survey carried out was non-intrusive. Should major refurbishment be planned for the property, further investigation will be required.**
