ASBESTOS SURVEY REPORT FOR CASTLETOWN PRIMARY SCHOOL

Asbestos Register for CASTLETOWN PRIMARY SCHOOL

Date: 12 December 2023

Castletown Primary - Last updated 12/12/2023 – Version 2

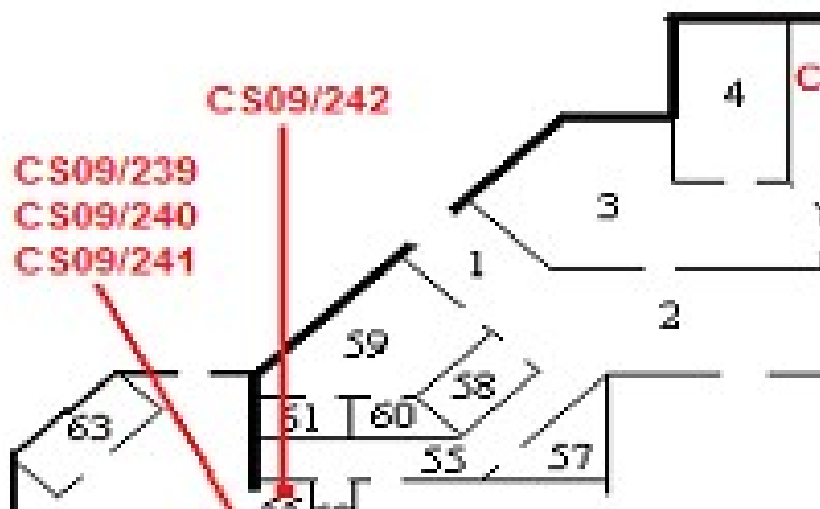
Castletown Primary, Sunderland
not to scale.

Refurbishment Survey 22-45929 was carried out to the nursery area. No samples were taken as no asbestos was noted.

No Suspect Asbestos Containing Materials Were Noted in The Following Areas:

Main Entrance	Foyer	Office	File Store	Corridor 1
Corridor 2	Corridor 3	Games Entrance	Girls Changing Rooms/Shower/WC	Boys Changing Rooms/Shower/WC
Male Staff Changing Room/Shower/WC	Disabled WC	Corridor/Junior Entrance	Junior Boys WC	Junior Girls WC
Corridor 5	Infant Entrance/Corridor	Disabled WC	Infant Boys WC	Infant Girls WC
Corridor 7	Corridor 8 (Reception Area)	Cloaks Area 1	Reception/Girls WC	Reception/Boys WC
Nursery Entrance/Cloaks Area	Secure Store 2	Computer Room/Server Room	Library	Male Staff WC Off Corridor 2
Female Staff WC Off Corridor 2	Disabled WC Off Corridor 2	Corridor 9	Servery	Foyer Disabled WC
Deputy Heads Room	Deputy Heads WC	Bin Store	Interview Room	External Cupboard Near Therapy Room
Water Tank Room	Therapy Room	Hall Fire Exit Corridor	Nursery WC and Shower	Nursery Disables WC
Corridor 6	Externals

Please note the survey carried out was non-intrusive and any areas not listed above may not have been accessed or had samples taken, should major refurbishment be planned for the property, further investigation will be required.
