ASBESTOS SURVEY REPORT FOR HILL VIEW JUNIOR SCHOOL ACADEMY,  
QUEEN ALEXANDRA ROAD, SUNDERLAND, TYNE AND WEAR, SR2 9HE.

## *Control of Asbestos Regulations 2012*

**Hill View Junior School Academy, Queen Alexandra Road, Sunderland, SR2 9HE**

**Date: 06 August 2025**

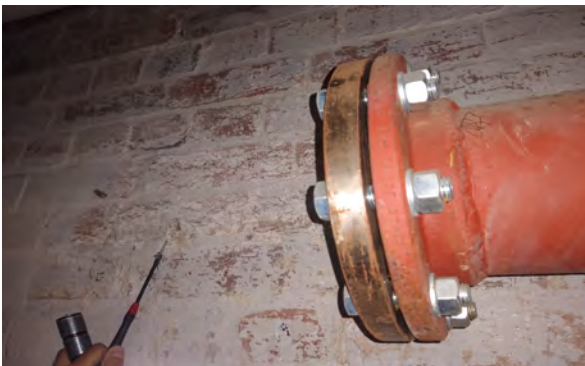
### **Item 3 Ref: 422644-1**

- (Item 3) Ref: 422644-1 – Un-encapsulated residue to walls (Boiler House -1/001) – Medium Risk
- (Item 4) Ref: 422644-2 – Encapsulated residue to walls at high level (Boiler House -1/001) – Low Risk

The un-encapsulated residue to walls in the Boiler House (Rm -1/01) contains asbestos.

Any change in its appearance should be recorded and passed to Property Services.

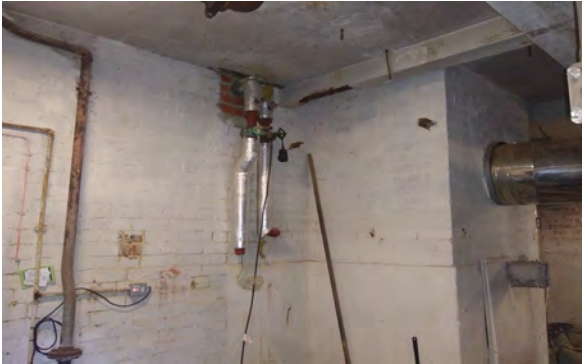
### **Item 4 Ref: 422644-2**

The encapsulated residue to walls at high level in the Boiler House (Rm -1/01) contains asbestos.

Any change in its appearance should be recorded and passed to Property Services.

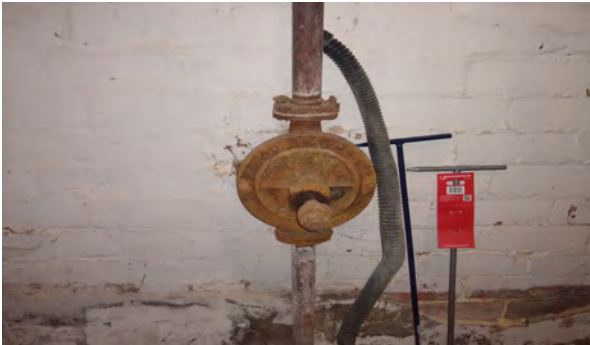
### **Item 8 Ref: 422644-6**

The manual sump pump flange gaskets in the Boiler House (Rm -1/01) contains asbestos.

Any change in its appearance should be recorded and passed to Property Services.

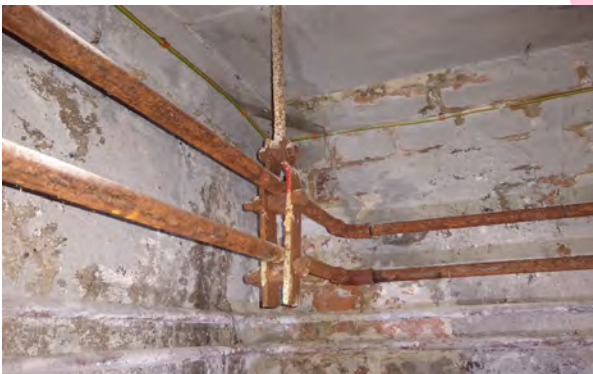
### **Item 11 Ref: 422644-8**

- (Item 11) Ref: 422644-8 – Residue to pipework and hangers (Former coal bunker -1/002) -Very Low Risk
- (Item 12) Ref: 422644-9 - Loose lying gasket to floor (Former coal bunker -1/002) – Low Risk

The residue to pipework & hangers in the Former Coal Bunker (Rm -1/02) contains asbestos.

Any change in its appearance should be recorded and passed to Property Services.

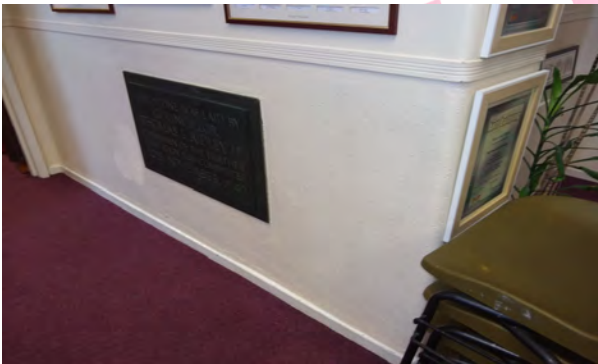
### **Item 20 Ref: 422644-17**

The decorative finish to low level walls in the Foyer (Rm 0/02) does not contain asbestos.

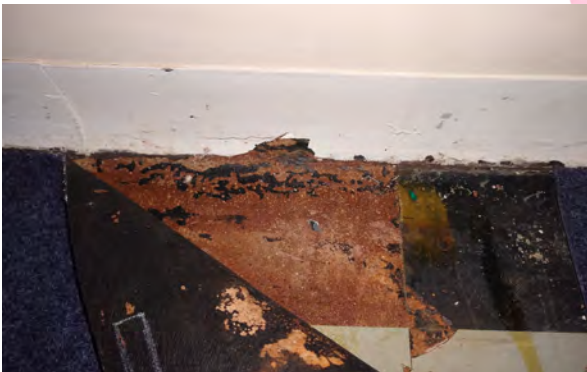
### **Item 26 Ref: 422644-21**

The floor screed in the Classroom (Rm 0/08) does not contain asbestos.

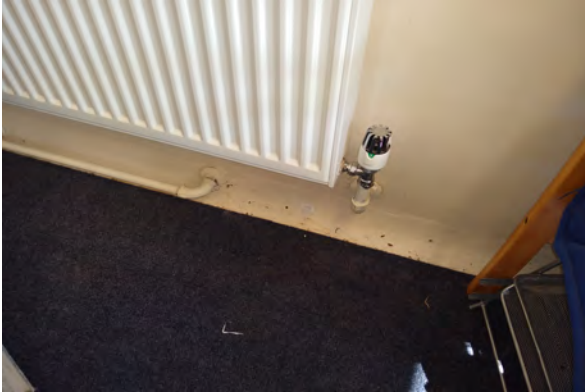
### **Item 40 Ref: As 422644-25**

The skirting in the Assistant Head Teachers room (Rm 0/21) does not contain asbestos.

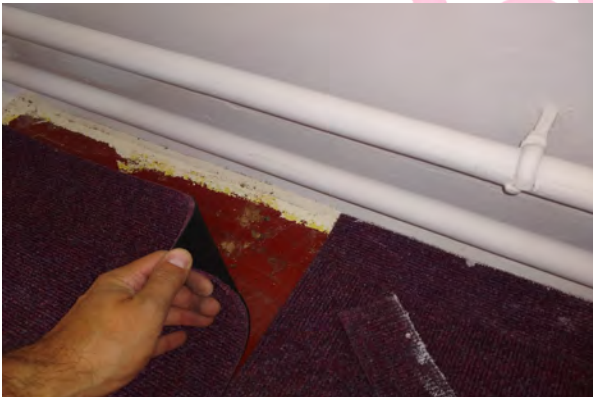
### **Item 41 Ref: As 422644-25**

The subfloor & skirting in the Deputy Head Teachers room (Rm 0/23) does not contain asbestos.

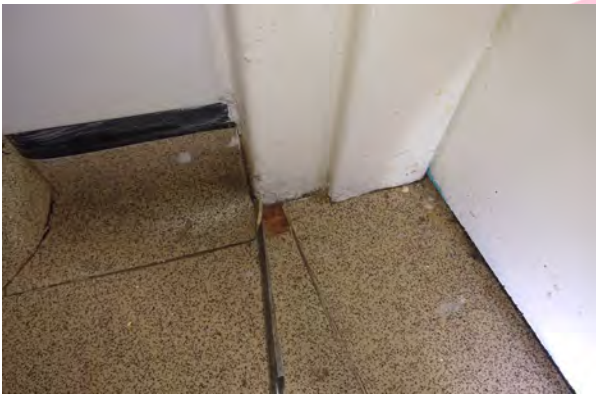
### **Item 44 Ref: 422644-29**

The floor screed in the Kitchen (Rm 0/28) does not contain asbestos.

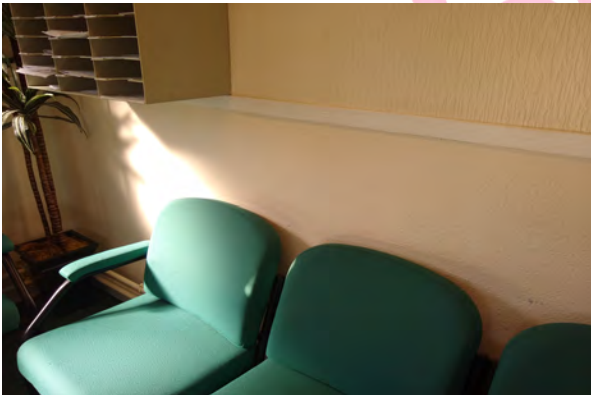
### **Item 47 Ref: As 422644-26**

The decorative finish to low level walls in the Staff Room (Rm 0/29) does not contain asbestos.

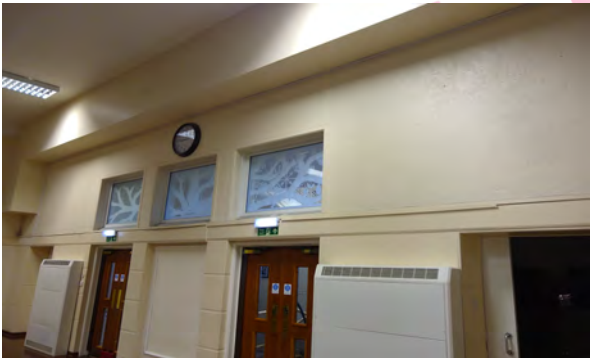
### **Item 50 Ref: 422644-32**

The textured coating to south wall at high level in the Hall (Rm 0/32) contains asbestos.

Any change in its appearance should be recorded and passed to Property Services.

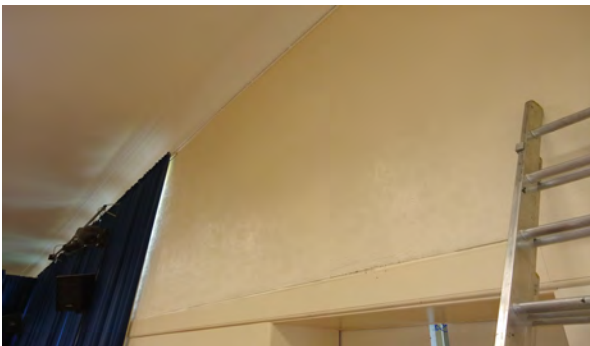
### **Item 51 Ref: 422644-33**

The textured coating to east wall at high level in the Hall (Rm 0/32) contains asbestos.

Any change in its appearance should be recorded and passed to Property Services.

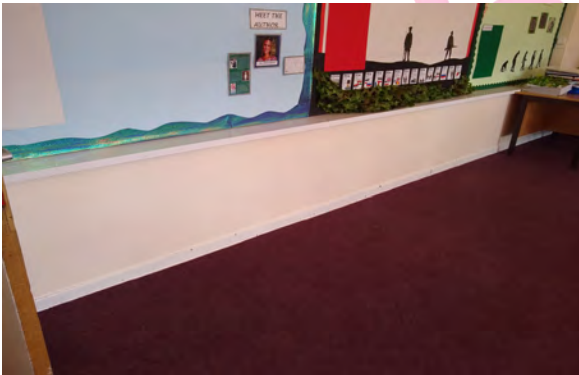
### **Item 53 Ref: 422644-36**

The decorative finish to low level walls in the Classroom 1 (Rm 0/36) does not contain asbestos.

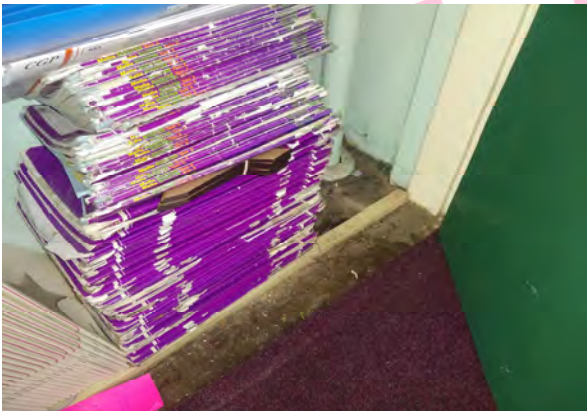
### **Item 59 Ref: As 422644-37**

The subfloor & skirting in the Classroom 3 (Rm 0/42) does not contain asbestos.

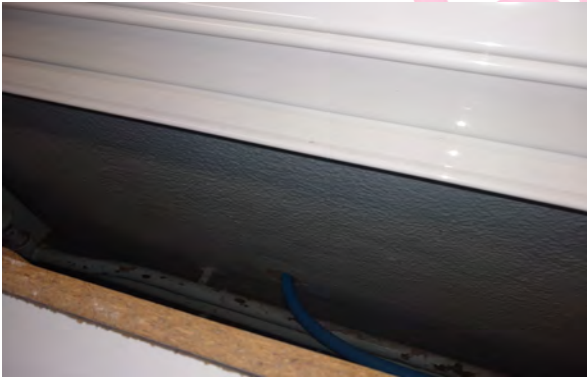
### **Item 62 Ref: As 422644-36**

The decorative finish to low level walls in the IT room (Rm 0/50) does not contain asbestos.

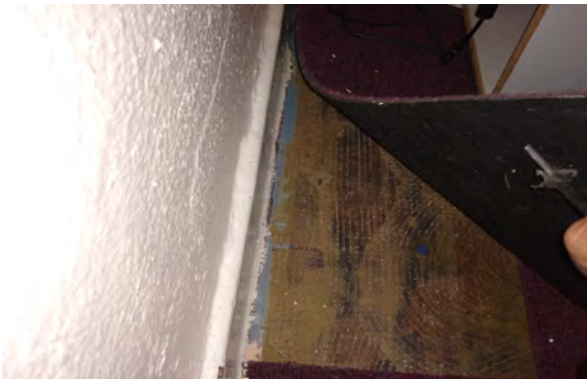
### **Item 63 Ref: As 422644-37**

The subfloor & skirting in the IT room (Rm 0/50) does not contain asbestos.

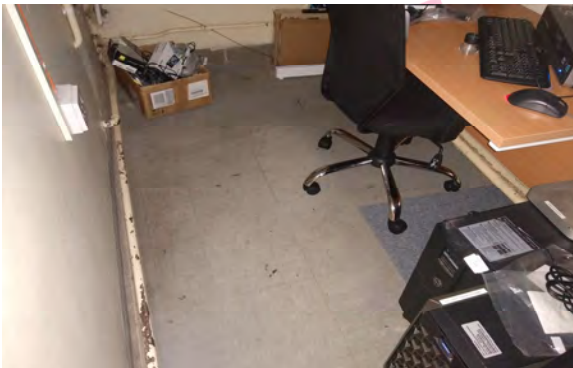
### **Item 65 Ref: 422644-40**

The floor covering in the Store (Rm 0/51) does not contain asbestos.

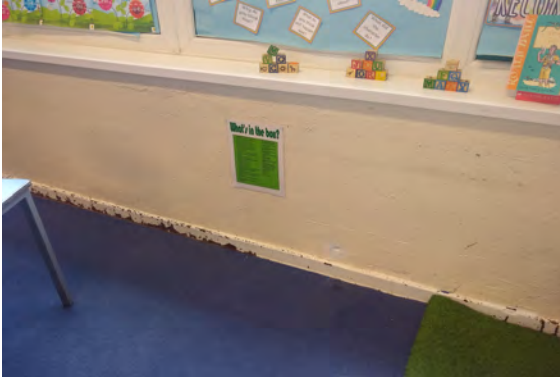
### **Item 70 Ref: 422644-43**

The decorative finish to low level walls in Classroom 5 (Rm 0/54) does not contain asbestos.

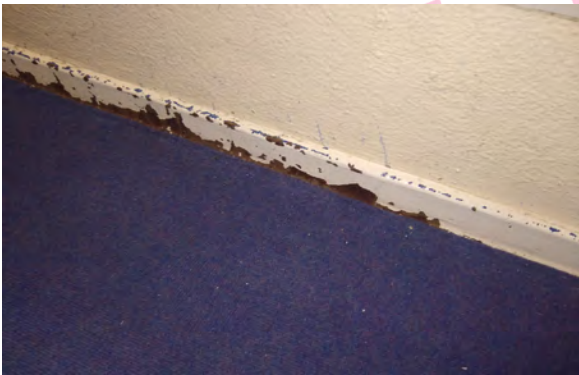
### **Item 71 Ref: 422644-44**

The subfloor and skirting in Classroom 5 (Rm 0/54) do not contain asbestos.

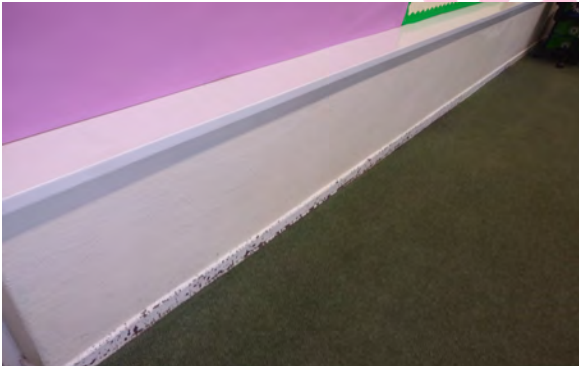
### **Item 74 Ref: As 422644-43**

The decorative finish to low level walls in Classroom 7 (Rm 0/60) does not contain asbestos.

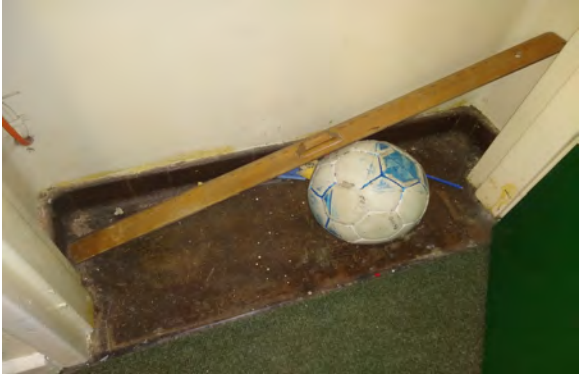
### **Item 82 Ref: As 422644-44**

The subfloor and skirting in Classroom 9 (Rm 0/64) do not contain asbestos.

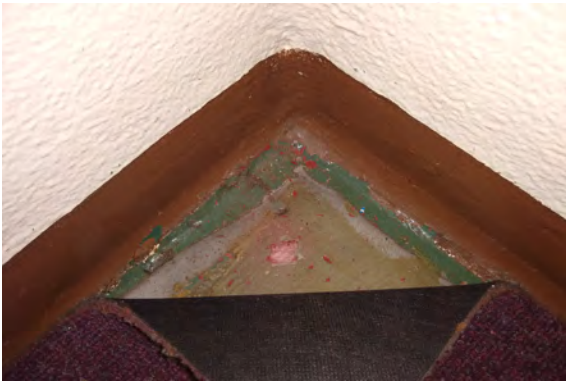
### **Item 83 Ref: 422644-48**

The floor screed in the Corridor (Rm 0/69) does not contain asbestos.

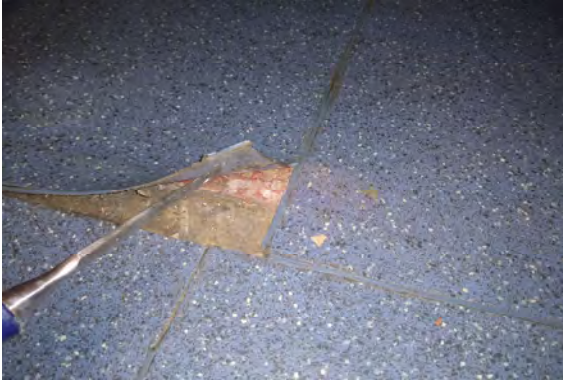
### **Item 88 Ref: As 422644-48**

The floor screed in the Cloaks area (Rm 0/74) does not contain asbestos.

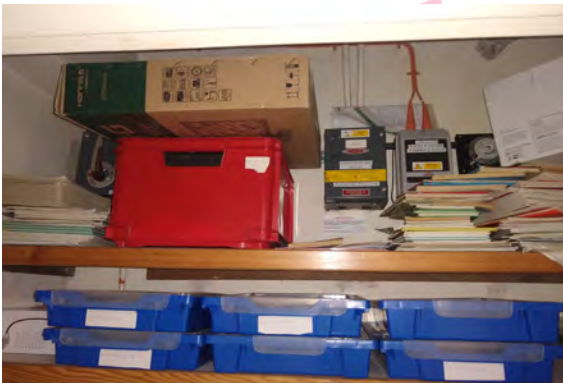
### **Item 89 Ref: Presumed**

The electrics in the Store (Rm 0/76) is presumed to contain asbestos.

Any change in its appearance should be recorded and passed to Property Services.

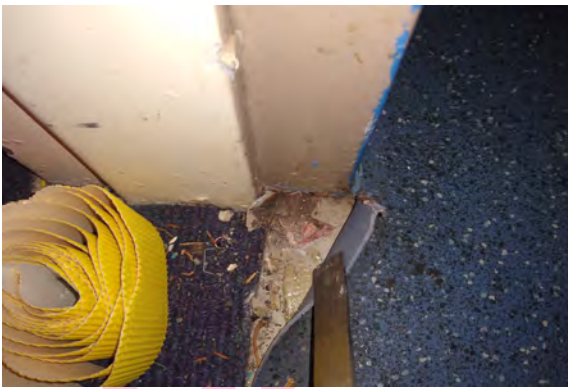
### **Item 92 Ref: As 422644-48**

The floor screed in the Cloaks area (Rm 0/79) does not contain asbestos.

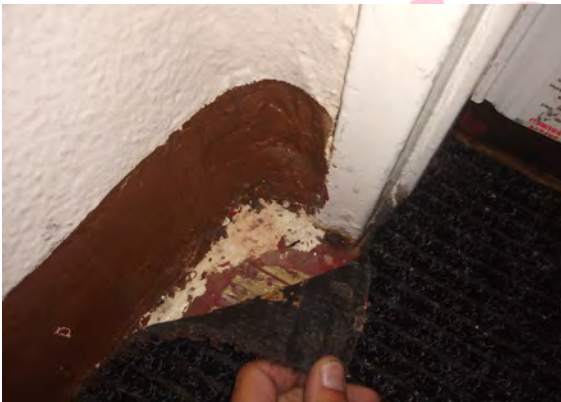
### **Item 95 Ref: As 422644-48**

The floor screed in the Corridor (Rm 0/81) does not contain asbestos.

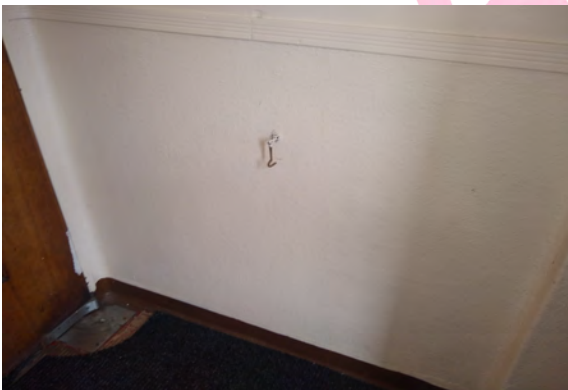
### **Item 98 Ref: As 422644-43**

The decorative finish to low level walls in the Lobby (Rm 0/82) does not contain asbestos.

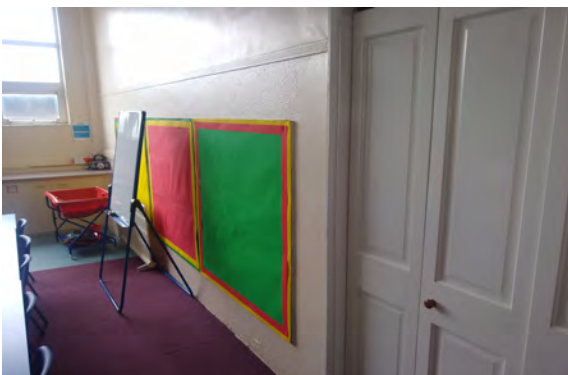
### **Item 99 Ref: As 422644-49**

The decorative finish to low level walls in the Intervention Room 3 (Rm 0/83) does not contain asbestos.

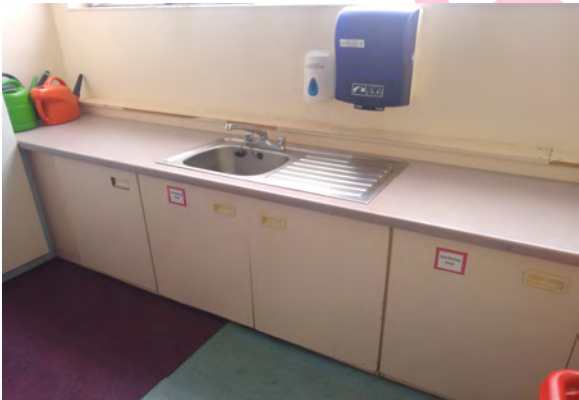
### **Item 101 Ref: 422644-50**

The sink pad in the Intervention Room 3 (Rm 0/83) does not contain asbestos.

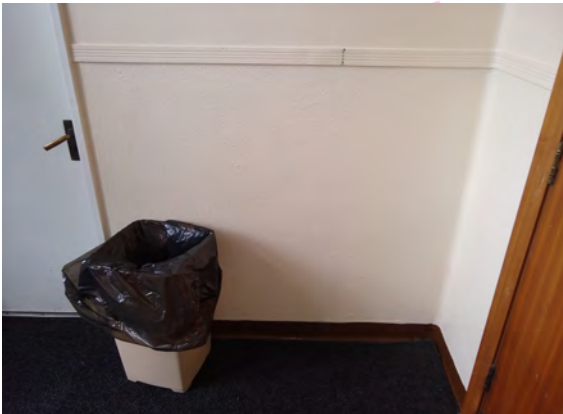
### **Item 104 Ref: As 422644-49**

The decorative finish to low level walls in the Lobby (Rm 0/86) does not contain asbestos.

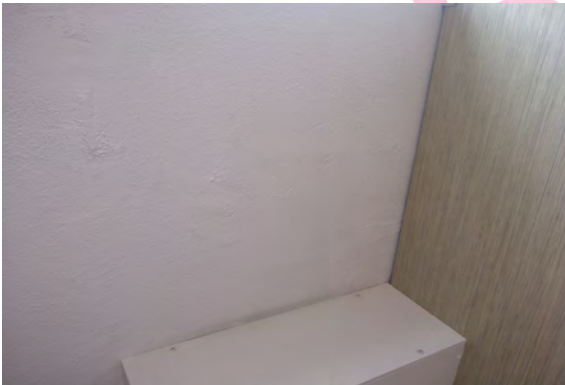
### **Item 107 Ref: 422644-53**

- (Item 107) Ref: 422644-53 – Patch repairs to decorative finish to low level walls (Female Staff WC 0/087) - No Risk
- (Item 108) Ref: As 422644-51 – Decorative finish to low level walls (Year 6 Classroom 0/089) – No Risk

The patch repairs to decorative finish to low level walls in the Female Staff WC (Rm 0/87) does not contain asbestos.

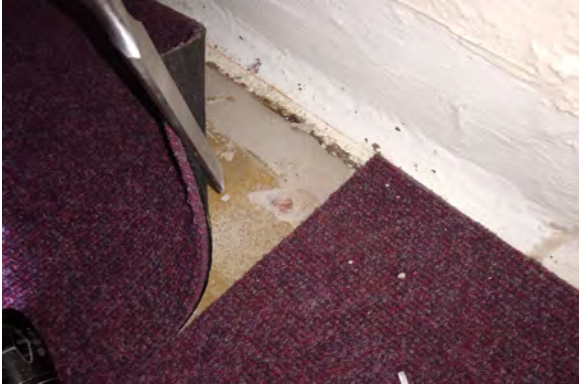
### **Item 109 Ref: As 422644-52**

The floor screed in the Year 6 Classroom (Rm 0/89) does not contain asbestos.

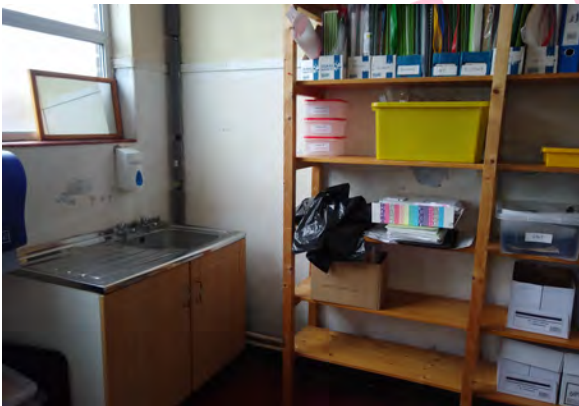
### **Item 110 Ref: As 422644-51**

The decorative finish to low level walls in the Store (Rm 0/90) does not contain asbestos.

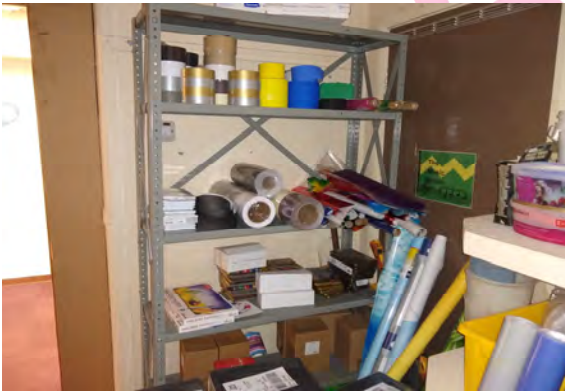
### **Item 113 Ref: As 422644-51**

The decorative finish to low level walls in the Store (Rm 0/91) does not contain asbestos.

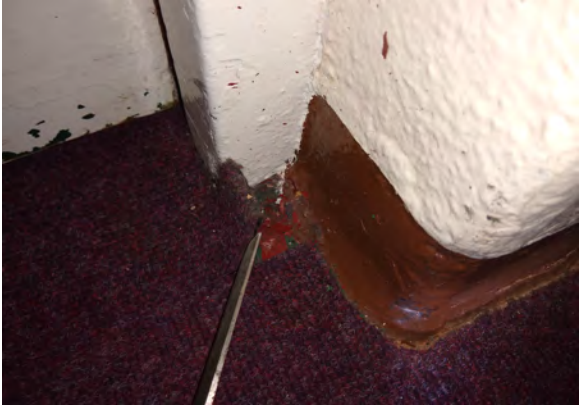
### **Item 115 Ref: As 422644-52**

The floor screed in the Corridor (Rm 0/92) does not contain asbestos.

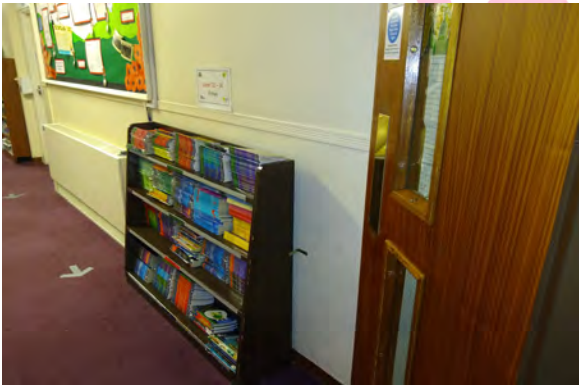
### **Item 116 Ref: As 422644-51**

The decorative finish to low level walls in the Corridor (Rm 0/92) does not contain asbestos.

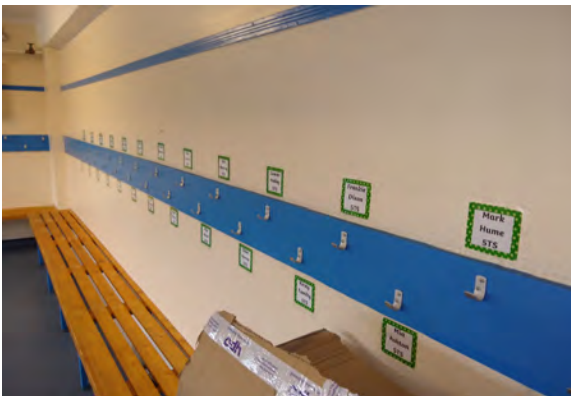
### **Item 117 Ref: As 422644-51**

The decorative finish to low level walls in the Cloaks area (Rm 0/93) does not contain asbestos.

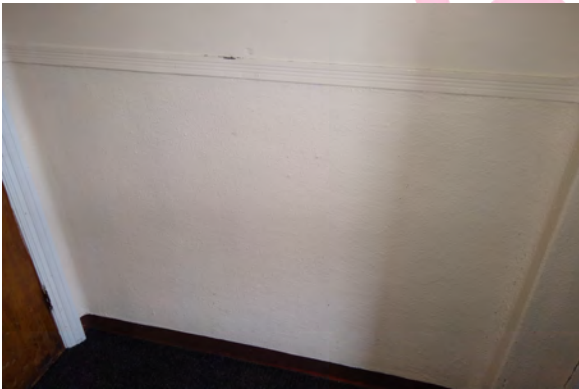
### **Item 122 Ref: As 422644-51**

The decorative finish to low level walls in the Lobby (Rm 0/97) does not contain asbestos.

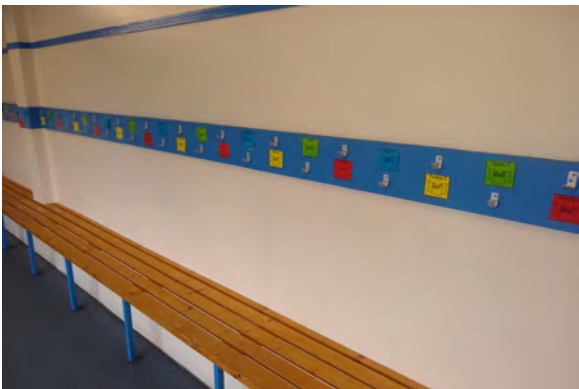
### **Item 123 Ref: As 422644-51**

The decorative finish to low level walls in the Cloaks area (Rm 0/99) does not contain asbestos.

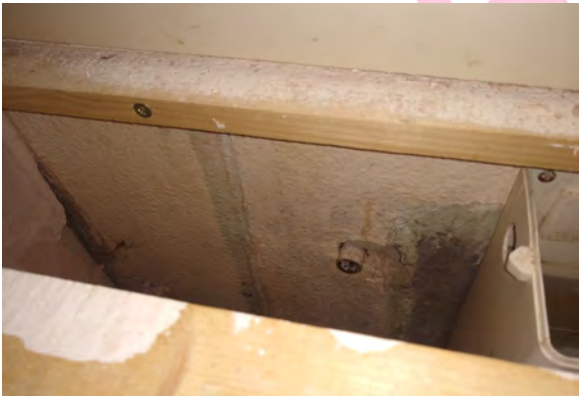
### **Item 125 Ref: As 422644-51**

The decorative finish to low level walls within toilet cistern boxing in the Girls/ Boys WC (Rm 0/101) does not contain asbestos.

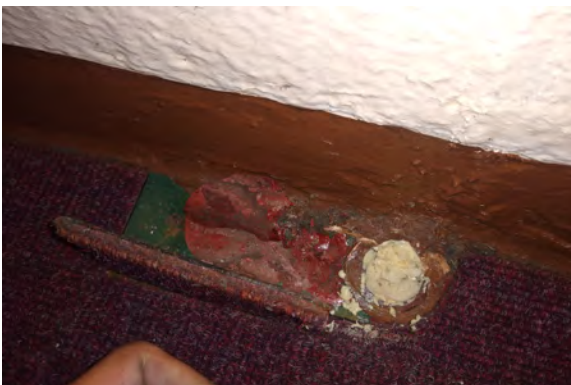
### **Item 126 Ref: As 422644-52**

The floor screed in the Corridor (Rm 0/104) does not contain asbestos.

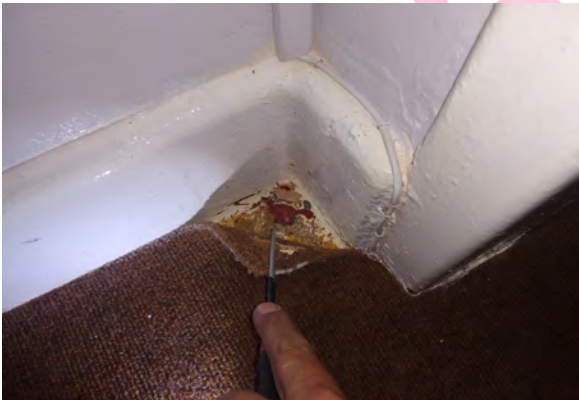
### **Item 128 Ref: As 422644-52**

The floor screed to area below stairs in the Head Teachers room (Rm 0/105) does not contain asbestos.

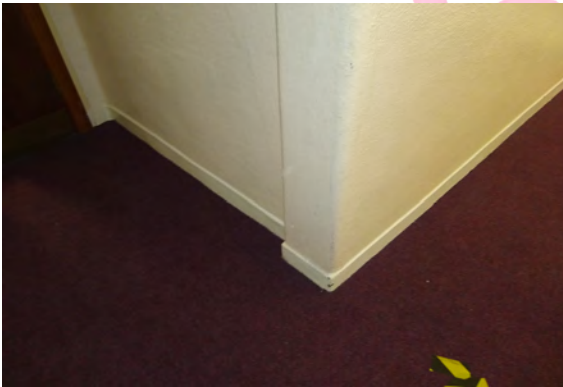
### **Item 131 Ref: As 422644-63**

The red skirting in the Landing area (Rm 1/001) does not contain asbestos.

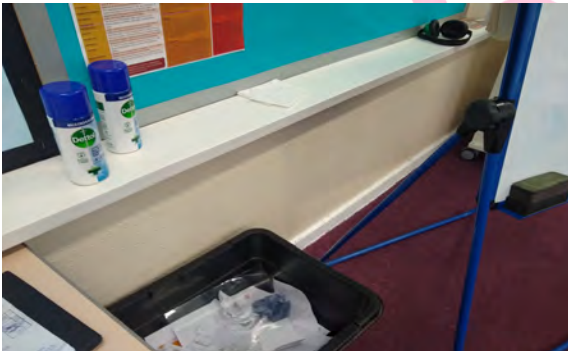
### **Item 134 Ref: As 422644-56**

The decorative finish to low level walls in Classroom 10 (Rm 1/005) does not contain asbestos.

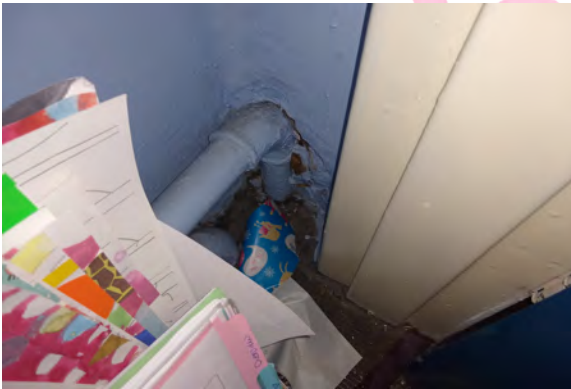
### **Item 137 Ref: As 422644-58**

The subfloor and skirting in Classroom 11 (Rm 1/008) do not contain asbestos.

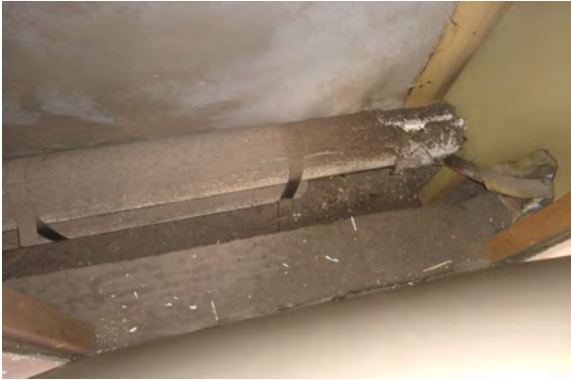
### **Item 139 Ref: 422644-60**

The debris to walls, pipe hangers & floor in Classroom 11 – void within pipework boxing between redundant heaters (Rm 1/008) contains asbestos.

Any change in its appearance should be recorded and passed to Property Services.

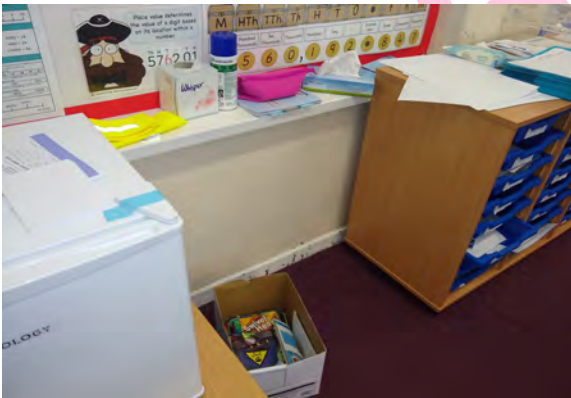
### **Item 140 Ref: As 422644-56**

The decorative finish to low level walls in Classroom 12 (Rm 1/009) does not contain asbestos.

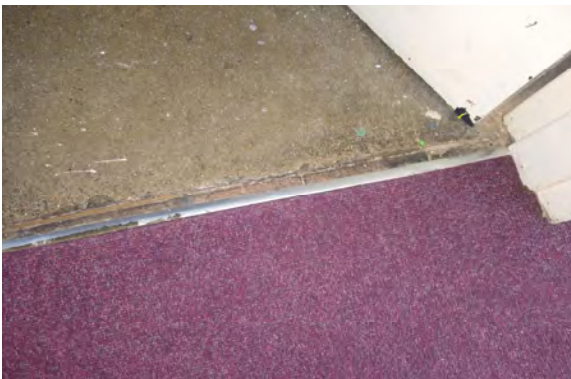
### **Item 141 Ref: As 422644-58**

The subfloor and skirting in Classroom 12 (Rm 1/009) do not contain asbestos.

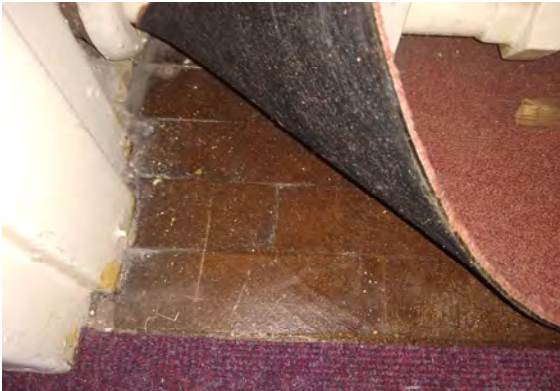
### **Item 143 Ref: As 422644-58**

The subfloor and skirting in Classroom 13 (Rm 1/012) do not contain asbestos.

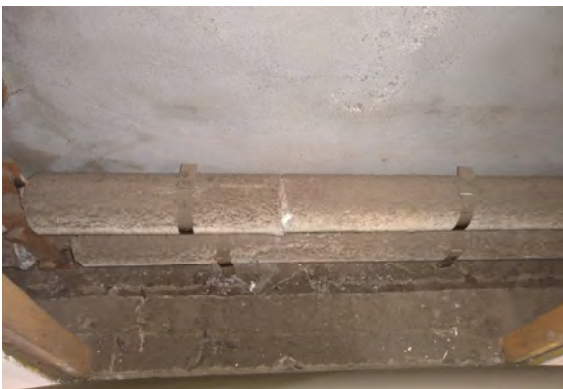
### **Item 144 Ref: 422644-61**

The pipe lagging in Classroom 13 – void within pipework boxing between redundant heaters (Rm 1/012) contains asbestos.

Any change in its appearance should be recorded and passed to Property Services.

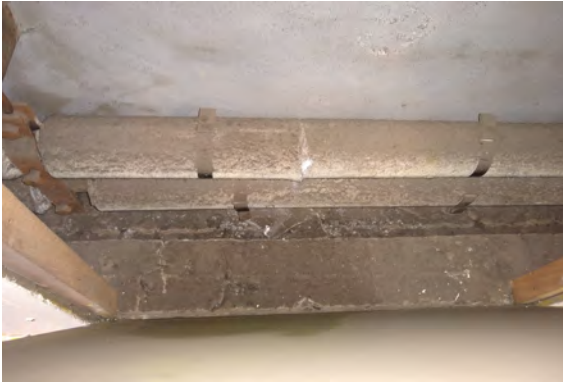
### **Item 145 Ref: 422644-62**

The debris to walls, pipe hangers & floor in Classroom 12 – void within pipework boxing between redundant heaters (Rm 1/012) contains asbestos.

Any change in its appearance should be recorded and passed to Property Services.

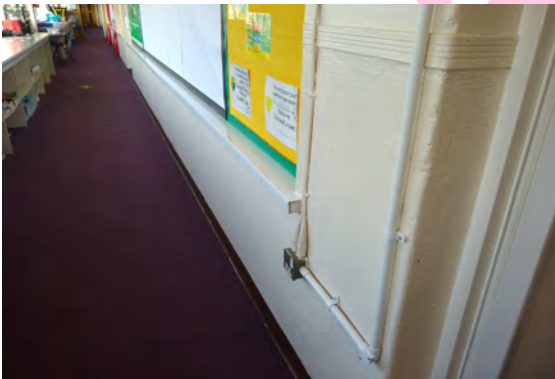
### **Item 146 Ref: As 422644-56**

The decorative finish to low level walls in Classroom 13 (Rm 1/013) does not contain asbestos.

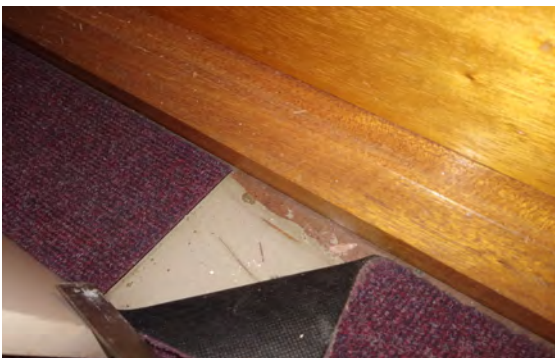
### **Item 147 Ref: As 422644-57**

The red floor screed in the Corridor (Rm 1/013) do not contain asbestos.

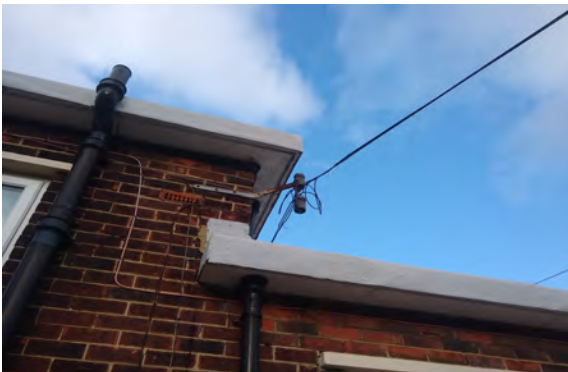
### **Item 155 Ref: 422644-69**

The telephone insulators (External) contains asbestos.

Any change in its appearance should be recorded and passed to Property Services.

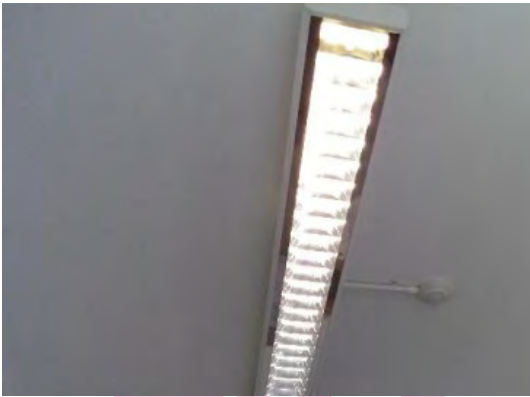
### **Item 167 Ref: VK001504**

The concrete and plaster finishes to ceilings (Ground Floor / 08 / Area 8) do not contain asbestos.

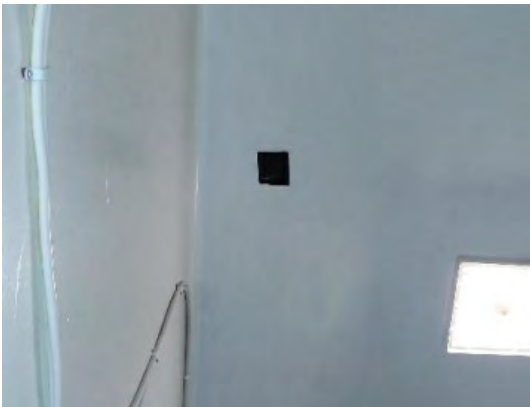
### **Item 168 Ref: VK001507**

The concrete and plaster finishes to ceilings (Ground Floor / 09 / Area 9) do not contain asbestos.

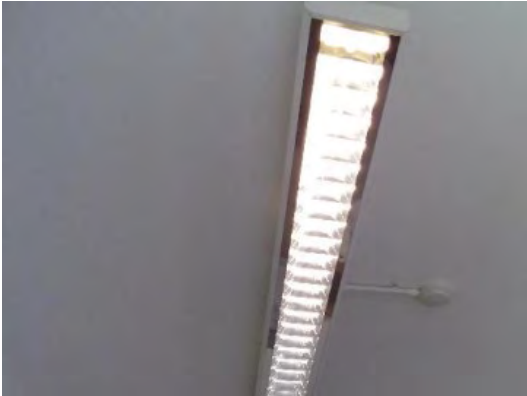
### **Item 169 Ref: VK001508**

The concrete and plaster finishes to ceilings (Ground Floor / 10 / Area 10) do not contain asbestos.

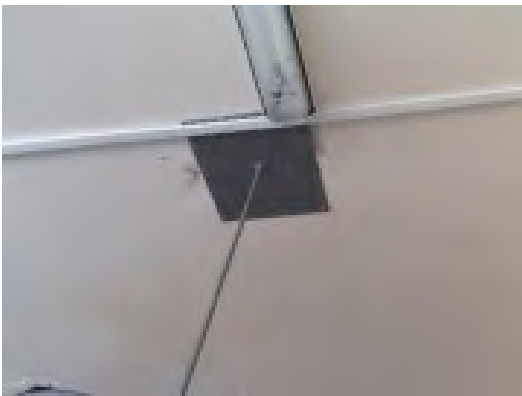
### **Item 170 Ref: VK001509**

The plaster finishes to ceilings (Ground Floor / 11 / Area 11) do not contain asbestos.

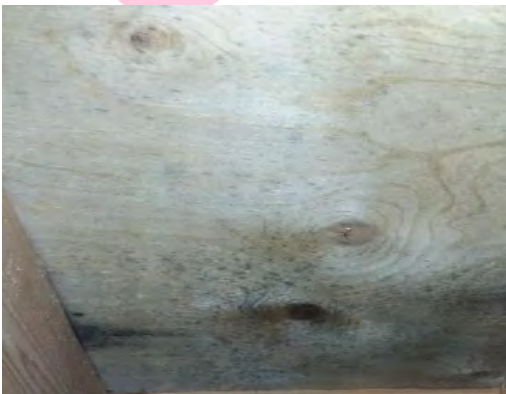
### **Item 174 Ref: VK001513**

The timber panels to roof (Ground Floor / 15 / Area 15) do not contain asbestos.
