ASBESTOS SURVEY REPORT FOR ST ANNES RC PRIMARY, SUNDERLAND

Asbestos Register for ST ANNES RC PRIMARY, SUNDERLAND

Date: 18 September 2024

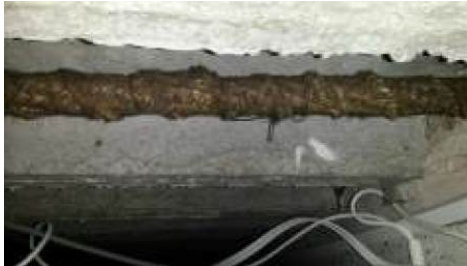
Item 7 Ref: 15-19198/8

The textile string to the pipe to the pipework to the void above the corridor (Room 21) does not contain asbestos.

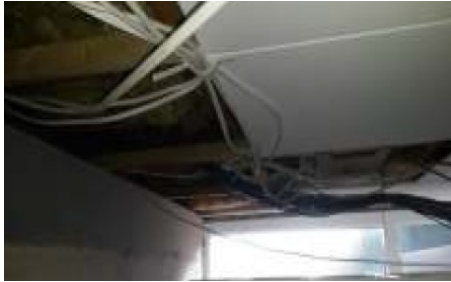
Item 22 Ref: 15-19198/18

The insulation board ceiling to the cleaners cupboard (Room 48) does not contain asbestos.
