ASBESTOS SURVEY REPORT FOR DERWENT HILL OUTDOOR EDUCATION AND TRAINING CENTRE, PORTINSCALE, KESWICK, CUMBRIA, CA12 5RD.

## **Asbestos Register for**

### **Derwent Hill Outdoor Education and Training Centre**

**Date: 29 October 2024**

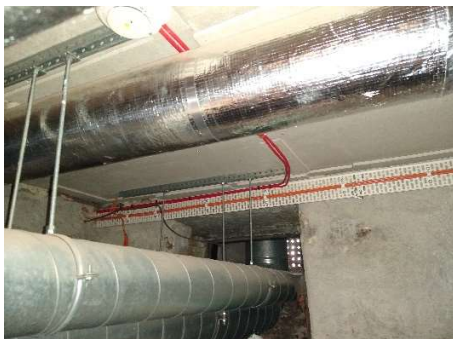
**Item 12 Ref: As 418920-16**

The ceiling in Store/-1/003 does not contain asbestos.

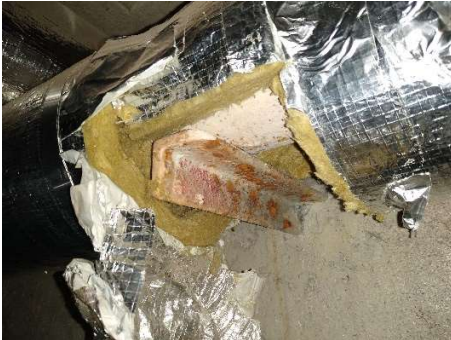
**Item 13 Ref: 418920-23**

(Item 13) Ref: 418920-23 – Debris to pipework and bracket (Store/-1/003) – Removed November 2020

The debris to pipework and bracket in Store/-1/003 contains asbestos.

***Removed November 2020***

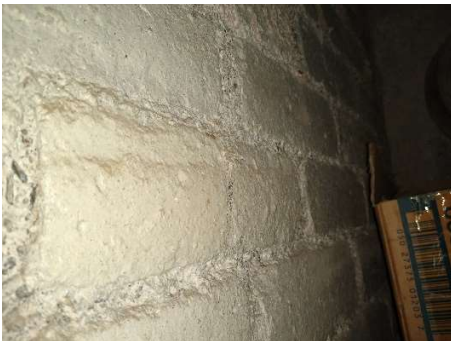
**Item 14 Ref: 418920-24**

The debris to walls in Store/-1/003 does not contain asbestos.

***Removed November 2020***

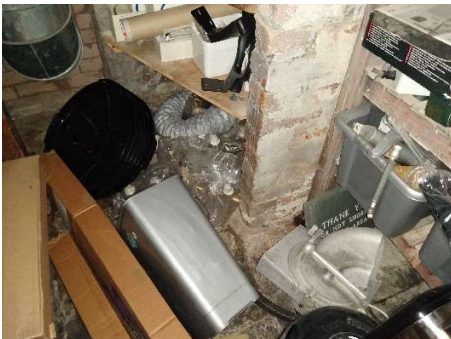
**Item 15 Ref: 418920-25**

The general debris to floor in Store/-1/003 contains asbestos.

***Removed November 2020***

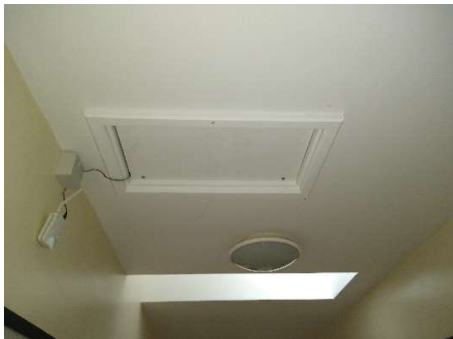
**Item 18 Ref: As 418920-30**

The panels to loft hatches in Corridor/0/012 do not contain asbestos.

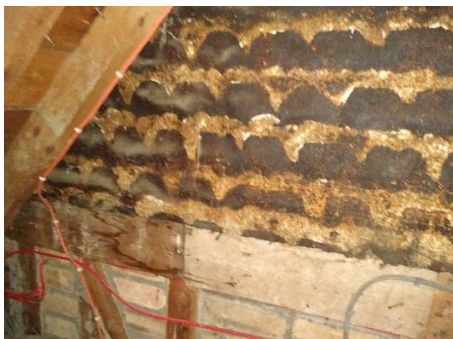
**Item 24 Ref: 418920-29**

The sarking to wall in Ennerdale loft above room and extension/0/018 does not contain asbestos.

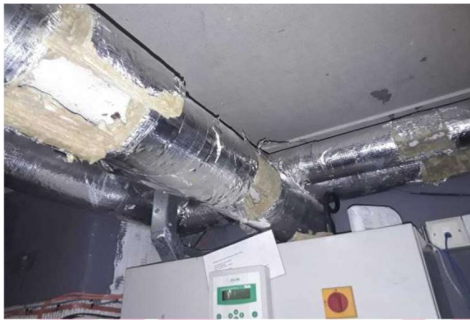
**Item 61 Ref: 22-43184-1**

The pipes - residual insulation beneath Mmmf to old pipework (thermal insulation) (Area 3/Plant Room) contain asbestos.

Any change in its appearance should be recorded and passed to Property Services.

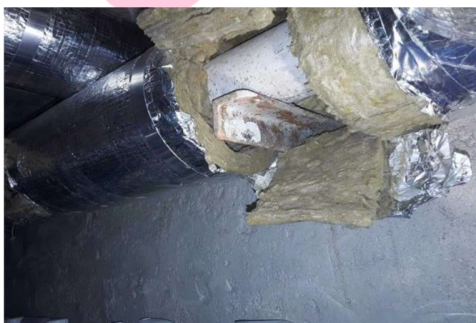
**Item 62 Ref: 22-43184-4**

The pipes – residual insulation to pipe bracket (thermal insulation) (Area 5/Cleaners Store) contain asbestos.

Any change in its appearance should be recorded and passed to Property Services.

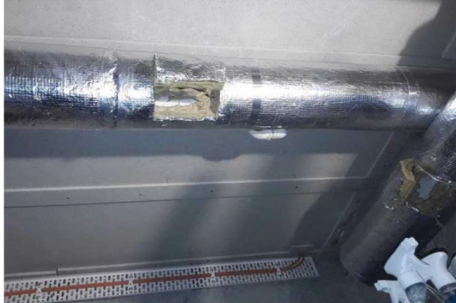
**Item 63 Ref: 22-43184-5**

The pipes - residual insulation beneath Mmmf lagging (thermal insulation) (Area 5/Cleaners Store) contain asbestos.

Any change in its appearance should be recorded and passed to Property Services.

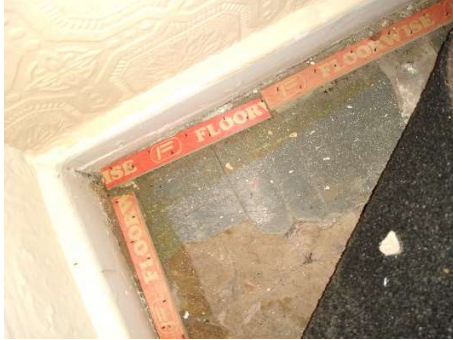
**Item 45 Ref: As 418920-2**

The sub floor covering in Living Room 0/003 contains asbestos.

Any change in its appearance should be recorded and passed to Property Services.

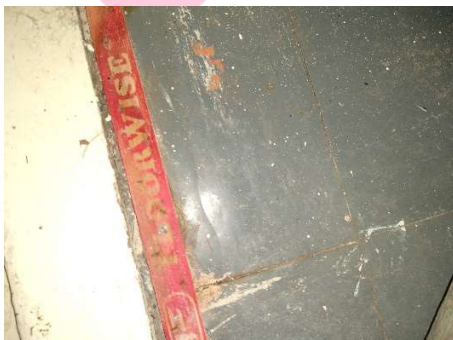
**Item 47 Ref: As 418920-2**

The sub floor covering in Hallway 0/004 contains asbestos.

Any change in its appearance should be recorded and passed to Property Services.

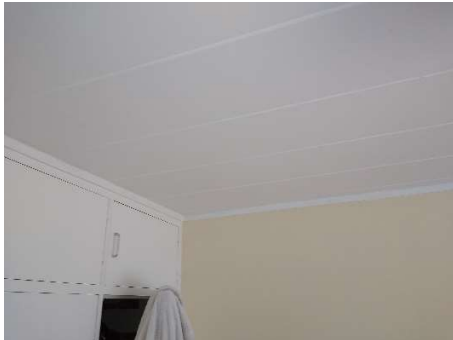
**Item 48 Ref: As 418920-1**

The ceiling in Bedroom 0/005 contains asbestos.

Any change in its appearance should be recorded and passed to Property Services.

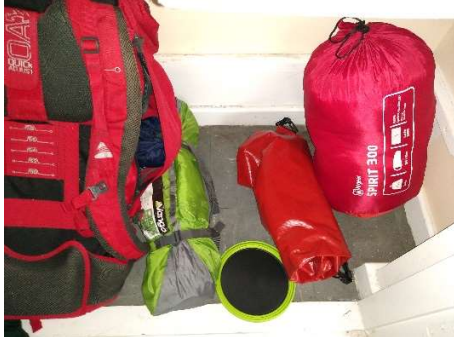
**Item 51 Ref: As 418920-2**

The sub floor covering in Bedroom 0/006 contains asbestos.

Any change in its appearance should be recorded and passed to Property Services.

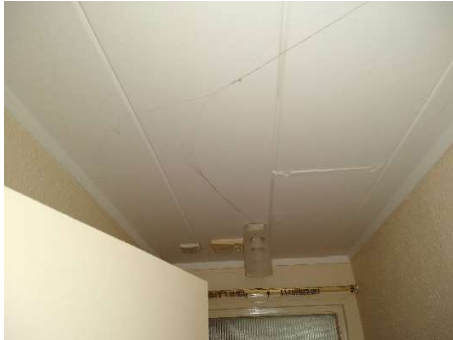
**Item 54 Ref: As 418920-1**

The ceiling in Toilet Room 0/008 contains asbestos.

Any change in its appearance should be recorded and passed to Property Services.

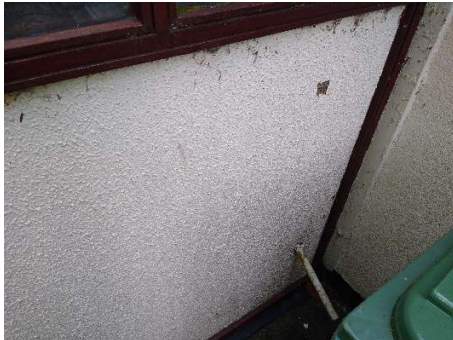
**Item 57 Ref: 418920-4**

The textured coating to panel below window (External) does not contain asbestos.

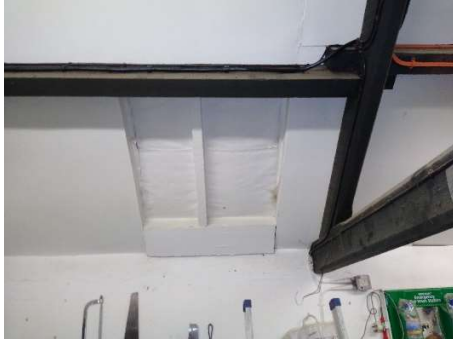
**Item 60 Ref: 418920-6**

The sarking over roof lights in Workshop 0/003 does not contain asbestos.
