ASBESTOS SURVEY REPORT FOR WASHINGTON MILLENIUM CENTRE LIBRARY/THE OVAL, WASHINGTON, NE37 2QD.

## Asbestos Register for

**Washington Millennium Centre, Washington, NE37 2QD**

**Date: 07 February 2025**

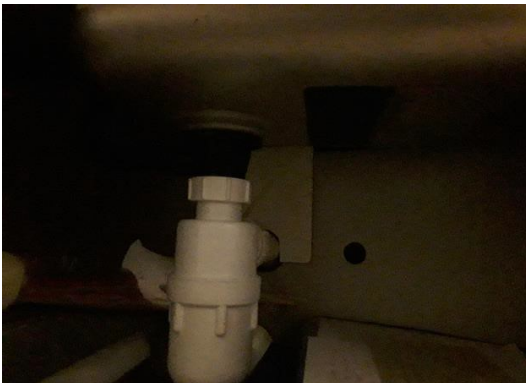
### **Item 38 Ref: 21-35078-3**

The sink pad (Area 29/Meeting Room Kitchen) does not contain asbestos.

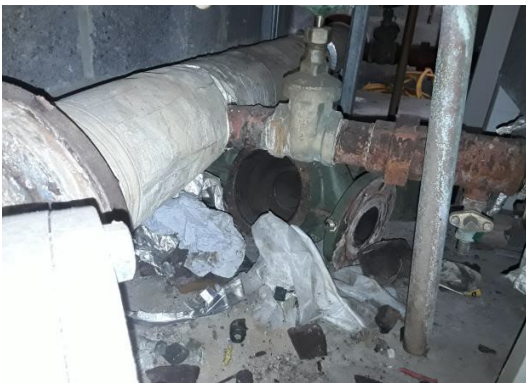
### **Item 39 Ref: 21-35078-10**

The redundant flange to floor behind boilers (Area 36/Boiler Room) contains asbestos.

Any change in appearance should be reported to Property Services.

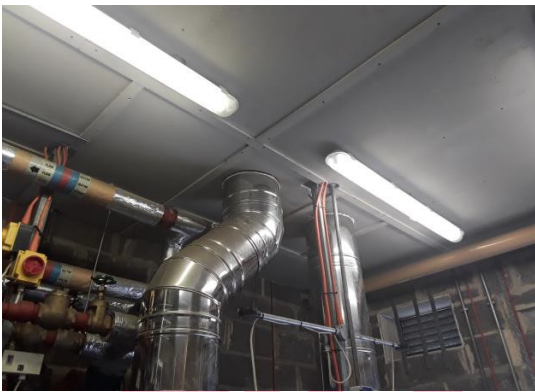
**Item 41 Ref: 21-35078-4**

The ceiling (Area 36/Boiler Room) does not contain asbestos.

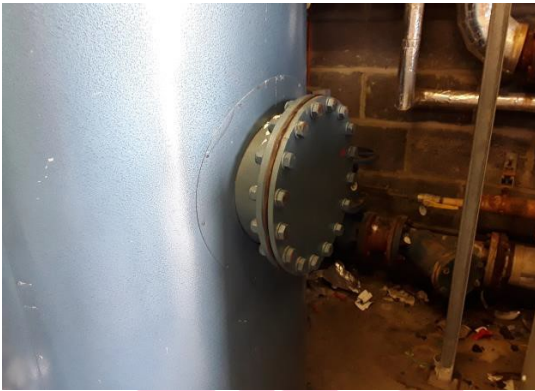
**Item 44 Ref: 21-35078-8**

The vessels tank gasket (Area 36/Boiler Room) does not contain asbestos.

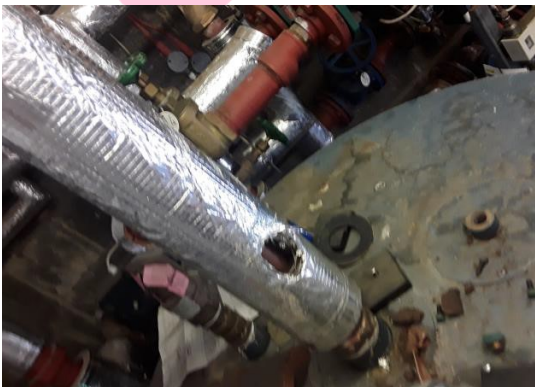
**Item 45 Ref: 21-35078-9**

The redundant gaskets on top of tank (Area 36/Boiler Room) do not contain asbestos.

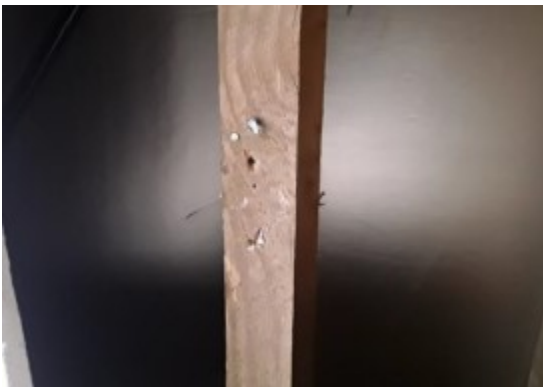
**Item 47 Ref: 21-37939-1**

The minor sporadic residue to existing nails in the ceiling (Area 2/Annexe room ceiling void) does contain asbestos.

Any change in appearance should be reported to Property Services.

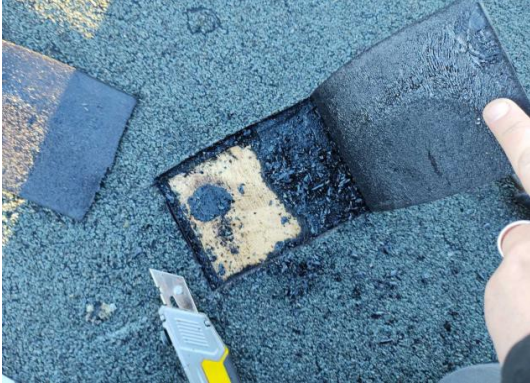
**Item 49 Ref: 22-41633-2**

The floor - felt roof (Bitumen)  
(Area: 1 Roof 1) does not  
contain asbestos.

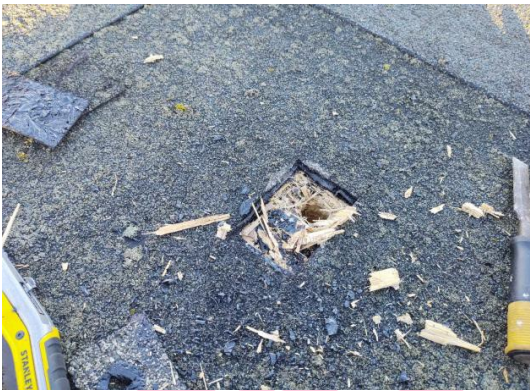
**Item 50 Ref: 22-41633-3**

The floor - felt roof (Bitumen)  
(Area: 1 Roof 1) does not  
contain asbestos.

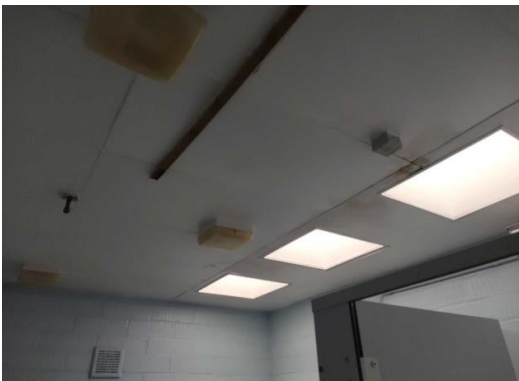
**Item 59 Ref: 22-41633-11**

The ceiling (Textile) (Area: 8 Male WC) contains asbestos.

Any change in appearance should be reported to Property Services.

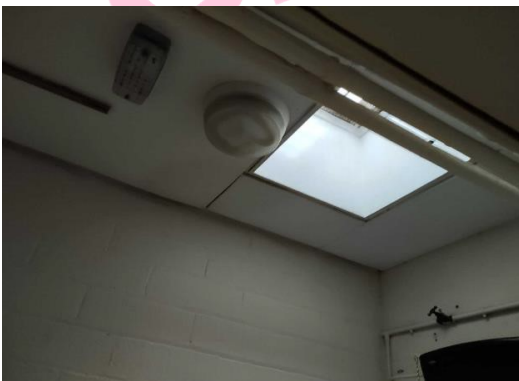
**Item 60 Ref: 22-41633-11**

The ceiling (Textile) (Area: 9 Disabled WC) contains asbestos.

Any change in appearance should be reported to Property Services.

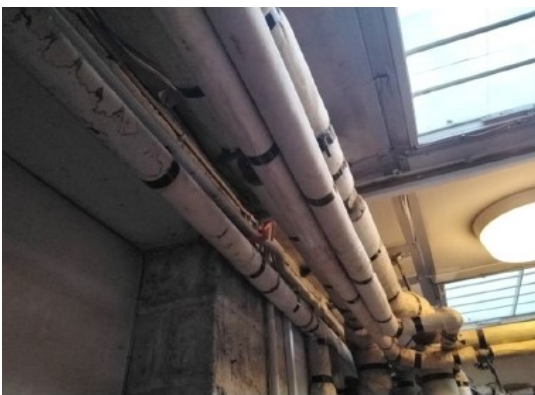
**Item 63 Ref: DC003402**

The pipework insulation in the store cupboards (Room 014/A) does not contain asbestos.

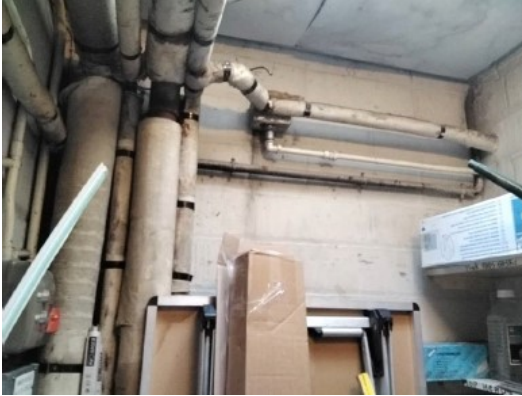
**Item 64 Ref: DC003403**

The pipework insulation in the store cupboards (Room 014/A) does not contain asbestos.

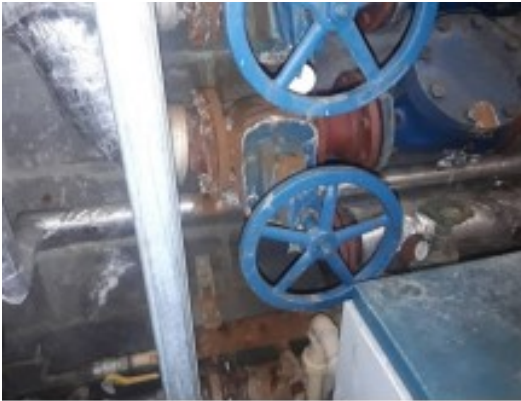
**Item 103 Ref: NZ001266**

The pipework gasket to pipework V6 left side (Boiler Room G/001 – The Oval) does contain asbestos.

Any change in appearance should be reported to Property Services.

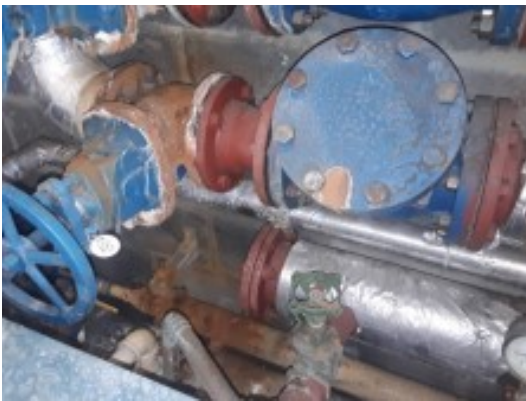
**Item 104 Ref: NZ001267**

The pipework gasket to pipework V6 right side (Boiler Room G/001 – The Oval) does contain asbestos.

Any change in appearance should be reported to Property Services

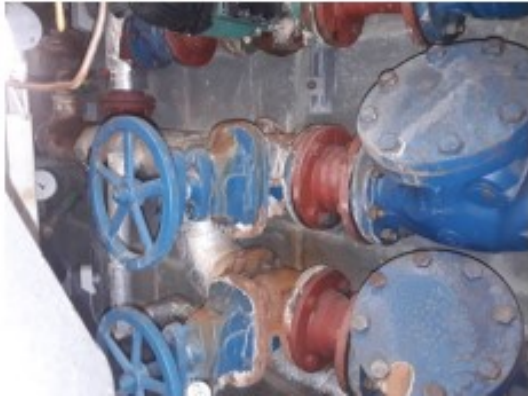
**Item 106 Ref: NZ001269**

The pipework gasket to pipework V8 right side (Boiler Room G/001 – The Oval) does contain asbestos.

Any change in appearance should be reported to Property Services

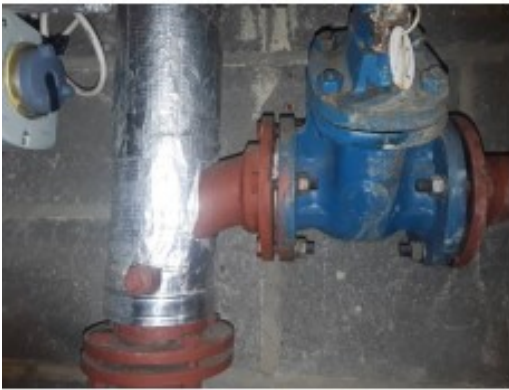
**Item 107 Ref: NZ001270**

The pipework gasket to pipework V12 left side (Boiler Room G/001 – The Oval) does contain asbestos.

Any change in appearance should be reported to Property Services

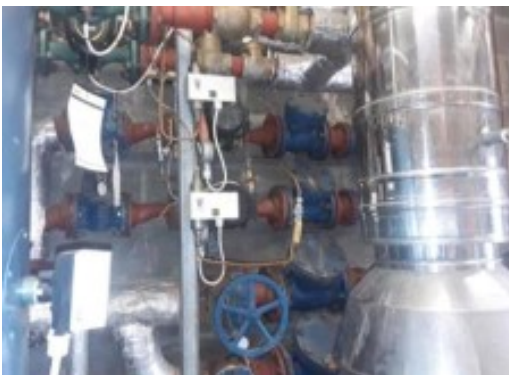
**Item 108 Ref: NZ001271**

The pipework gasket to pipework V12 right side (Boiler Room G/001 – The Oval) does contain asbestos.

Any change in appearance should be reported to Property Services

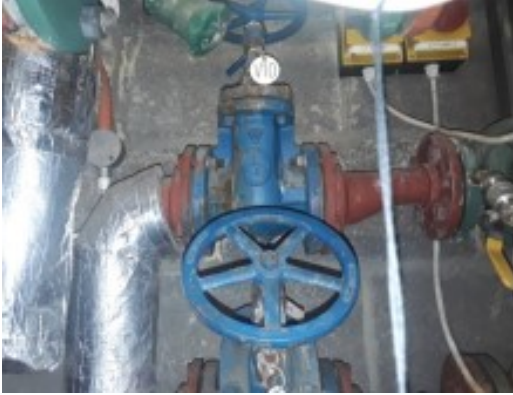
**Item 109 Ref: NZ001272**

The pipework gasket to pipework V10 left side (Boiler Room G/001 – The Oval) does contain asbestos.

Any change in appearance should be reported to Property Services

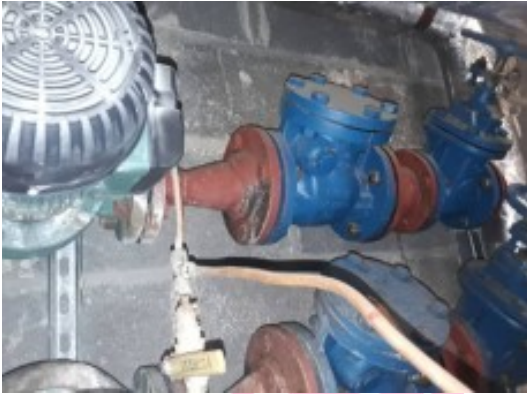
**Item 110 Ref: NZ001273**

The pipework gasket to pipework V10 right side (Boiler Room G/001 – The Oval) does contain asbestos.

Any change in appearance should be reported to Property Services

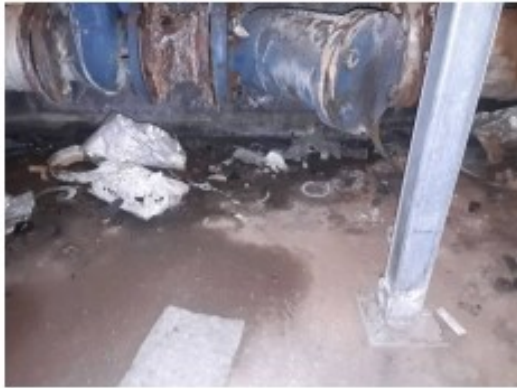
**Item 112 Ref: NZ001275**

- (Item 111) Ref: NZ001274 – Pipework Gasket to pipework right of V21 rusting black pipework (Boiler Room G/001 The Oval Building) – Removed May 2024
- (Item 112) Ref: NZ001275 – Debris/Residue to floor discarded gaskets within water and insulation (Boiler Room G/001 The Oval Building) – Low Risk

The debris/residue to floor discarded gaskets within water and insulation (Boiler Room G/001 – The Oval) does contain asbestos.

Any change in appearance should be reported to Property Services
