ASBESTOS SURVEY REPORT FOR SOUTH HYLTON HOUSE, SOUTH HYLTON BANK, SR4 0JL.

Asbestos Register for

South Hylton House, South Hylton Bank, SR4 0JL

Date: 24 March 2025

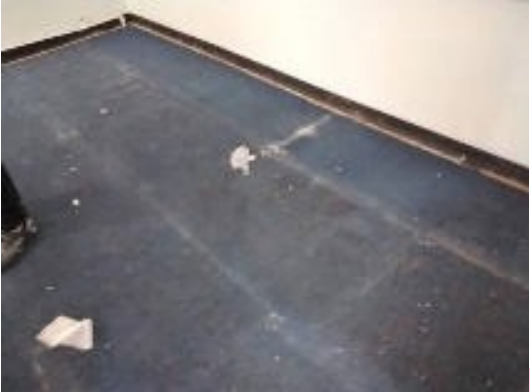
46.	KX000907	Floor adhesive residue under floor covering	Block 1, Ground Floor, Office (Room G/019)	Contains asbestos - Any change in its appearance should be recorded and passed to Property Services.

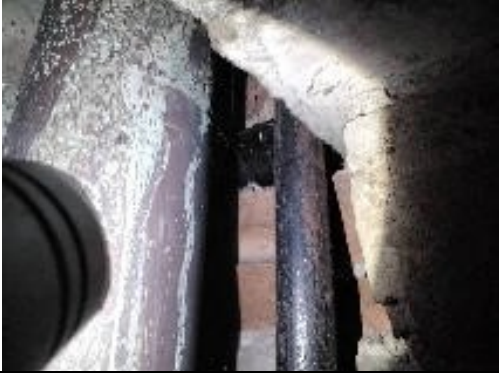
52.	As KX000906	Ceiling void debris to stench pipe penetration	Block 1, Ground Floor, Office (Room G/020)	Contains asbestos - Any change in its appearance should be recorded and passed to Property Services.

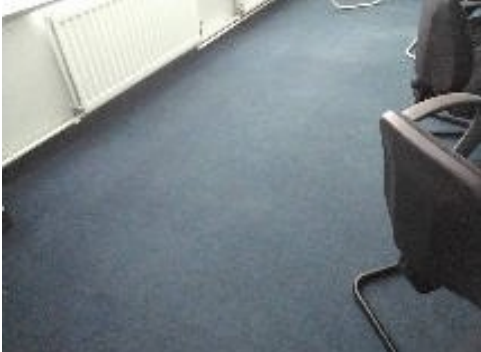
67.	As KX000907	Floor adhesive residue under floor covering	Block 1, Ground Floor, Office (Room G/023)	Contains asbestos - Any change in its appearance should be recorded and passed to Property Services.

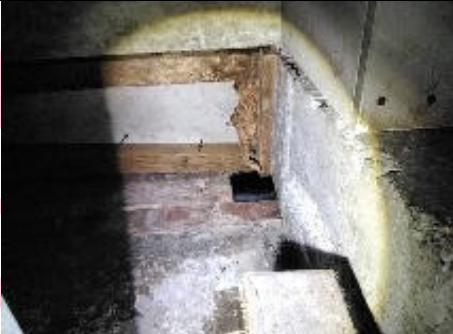
68.	As KX000906	Ceiling void debris to stench pipe penetration	Block 1, Ground Floor, Office (Room G/023)	Contains asbestos - Any change in its appearance should be recorded and passed to Property Services.

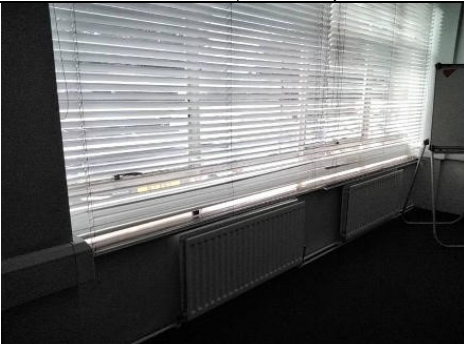
69.	As KX000898	Window Putty seal	Block 1, Ground Floor, Office (Room G/023)	Does not contain asbestos.

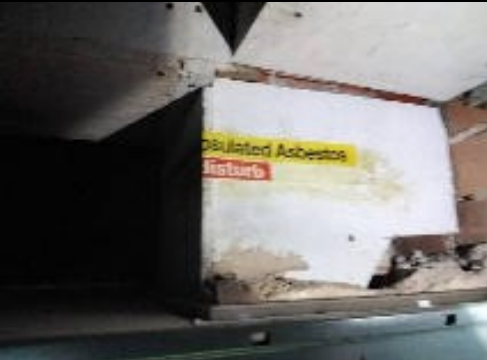
70.	As KX000897	Ceiling void column cladding	Block 1, Ground Floor, Office (Room G/023)	Contains asbestos - Any change in its appearance should be recorded and passed to Property Services.

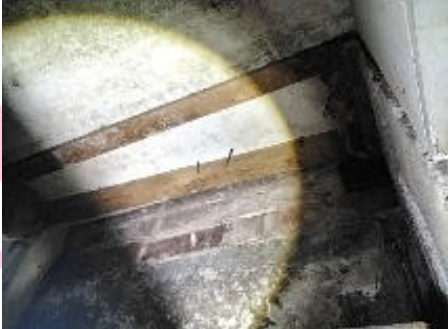
71.	KX000908	Ceiling void ceiling above possible shuttering to outer left hand corner adjacent window	Block 1, Ground Floor, Office (Room G/023)	Contains asbestos - Any change in its appearance should be recorded and passed to Property Services.

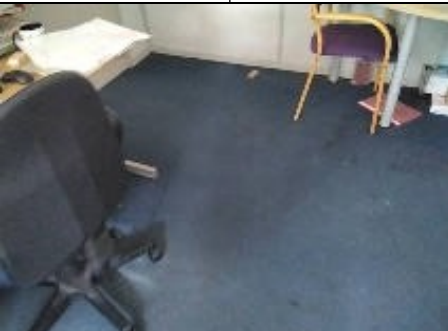
72.	As KX000907	Floor adhesive residue under floor covering	Block 1, Ground Floor, Office (Room G/024)	Contains asbestos - Any change in its appearance should be recorded and passed to Property Services.

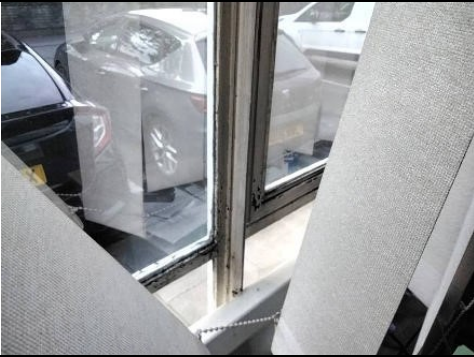
73.	As KX000898	Window Putty seal	Block 1, Ground Floor, Office (Room G/024)	Does not contain asbestos.

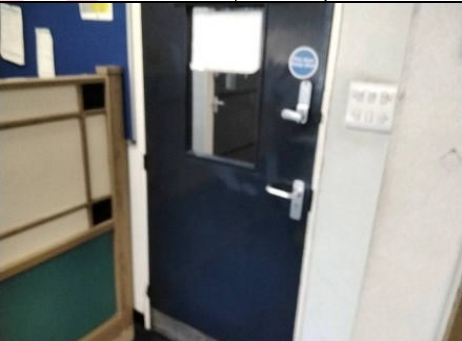
75.	As KX000905	Door window beading	Block 1, Ground Floor, Large Office (Room G/025)	Does not contain asbestos.

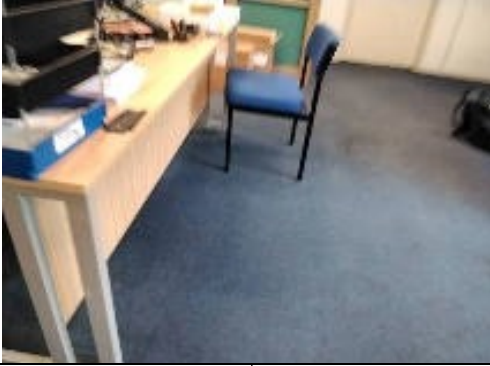
76.	As KX000907	Floor adhesive residue under floor covering	Block 1, Ground Floor, Large Office (Room G/025)	Contains asbestos - Any change in its appearance should be recorded and passed to Property Services.

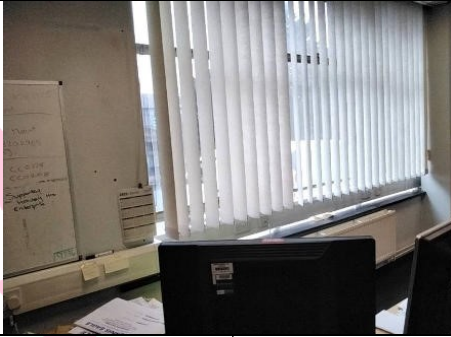
77.	As KX000898	Window Putty seal	Block 1, Ground Floor, Large Office (Room G/025)	Does not contain asbestos.

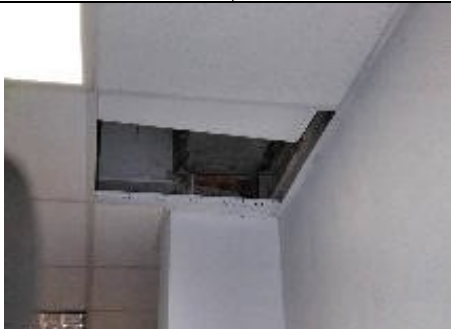
78.	As KX000897	Ceiling void column cladding remnants	Block 1, Ground Floor, Large Office (Room G/025)	Contains asbestos - Any change in its appearance should be recorded and passed to Property Services.

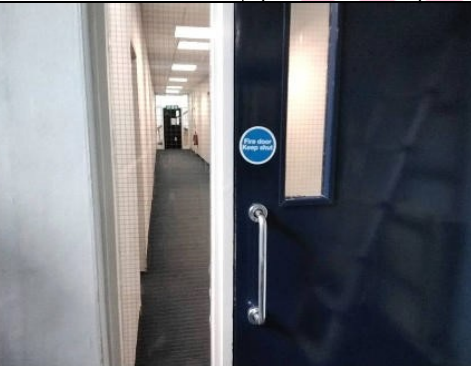
80.	As KX000900	Door window beading	Block 1, Ground Floor, Staircase/Stairwell (Room G/026)	Does not contain asbestos.

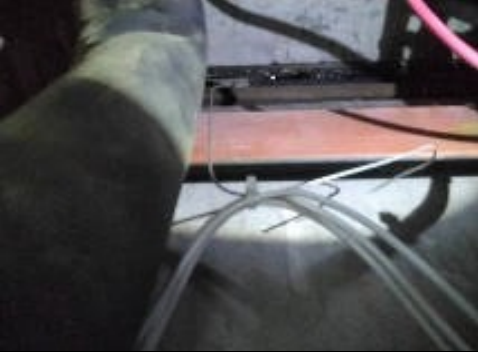
85.	As KX000906	Ceiling void debris to timber frame	Block 1, Ground Floor, Corridor (Room G/028)	Contains asbestos - Any change in its appearance should be recorded and passed to Property Services.

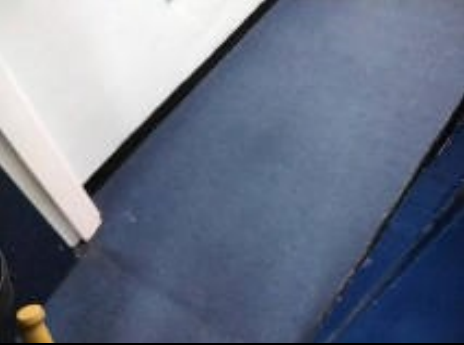
91.	As KX000907	Floor adhesive residue under floor covering	Block 1, Ground Floor, Corridor (Room G/031)	Contains asbestos - Any change in its appearance should be recorded and passed to Property Services.

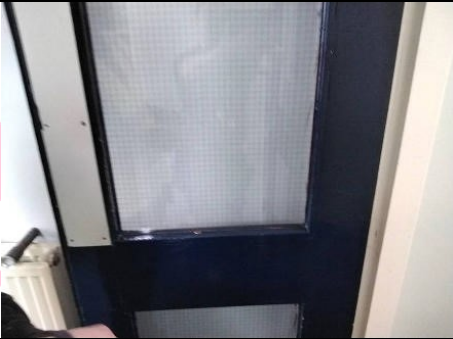
92.	KX000914	Door window beading	Block 1, Ground Floor, Corridor (Room G/031)	Does not contain asbestos.

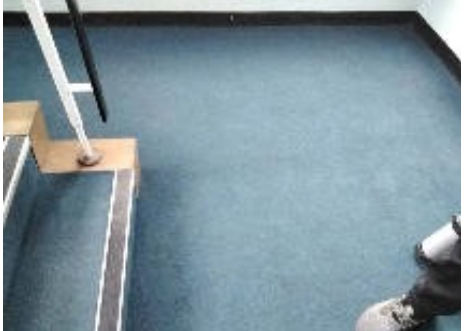
93.	As KX000907	Floor adhesive residue under floor covering	Block 1, Ground Floor, Stairwell/Staircase (Room G/032)	Contains asbestos - Any change in its appearance should be recorded and passed to Property Services.

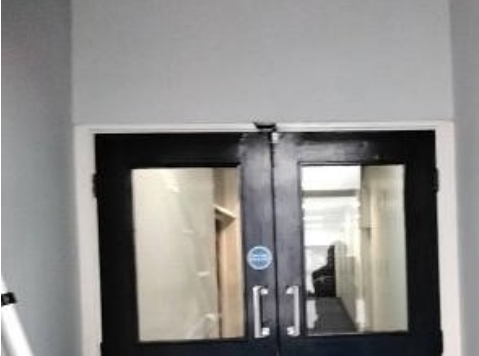
94.	As KX000914	Door window beading	Block 1, Ground Floor, Stairwell/Staircase (Room G/032)	Does not contain asbestos.

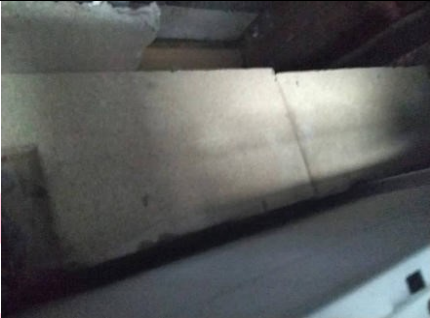
95.	As KX000912	Ceiling void beam cladding	Block 1, Ground Floor, Stairwell/Staircase (Room G/032)	Does not contain asbestos.

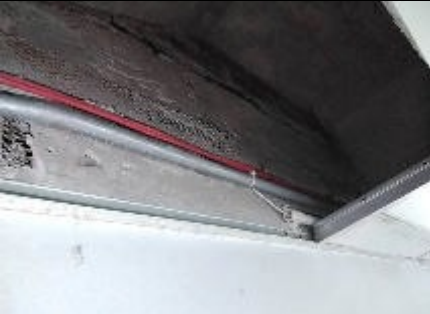
96.	As KX000906	Wall lining visible in ceiling void	Block 1, Ground Floor, Stairwell/Staircase (Room G/032)	Contains asbestos - Any change in its appearance should be recorded and passed to Property Services.

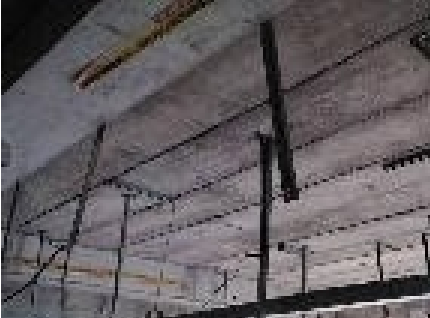
97.	As KX000894	Ceiling void beam cladding	Block 1, Ground Floor, Store Room Ceiling void inspected only (Room G/033)	Contains asbestos - Any change in its appearance should be recorded and passed to Property Services.

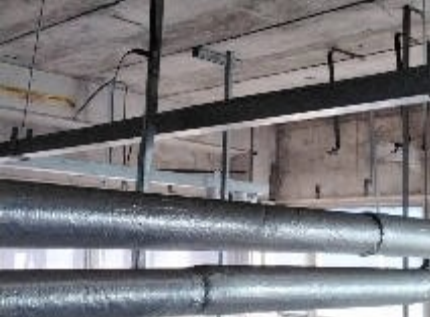
98.	As KX000897	Ceiling void column cladding	Block 1, Ground Floor, Store Room Ceiling void inspected only (Room G/033)	Contains asbestos - Any change in its appearance should be recorded and passed to Property Services.

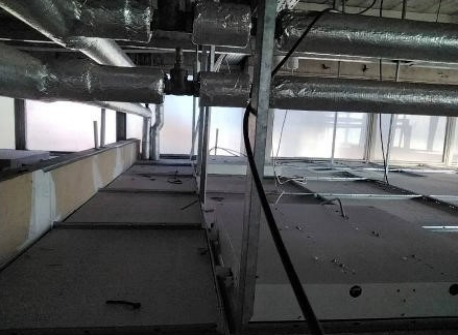
99.	KX000898	Window Putty/seal	Block 1, Ground Floor, Store Room Ceiling void inspected only (Room G/033)	Does not contain asbestos.

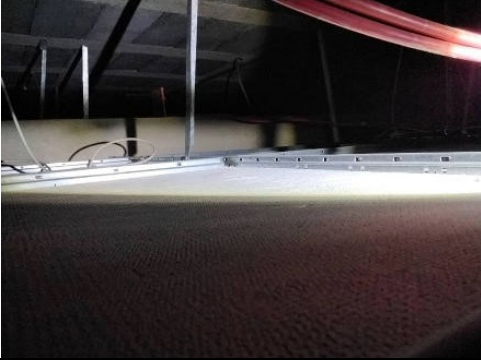
100.	As KX000912	Ceiling void beam cladding	Block 1, Ground Floor, Store Room (Room G/034)	Does not contain asbestos.

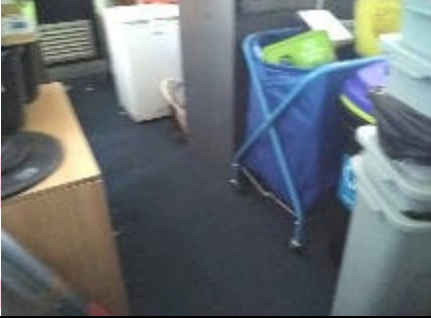
101.	As KX000907	Floor adhesive residue under floor covering	Block 1, Ground Floor, Store Room (Room G/034)	Contains asbestos - Any change in its appearance should be recorded and passed to Property Services.

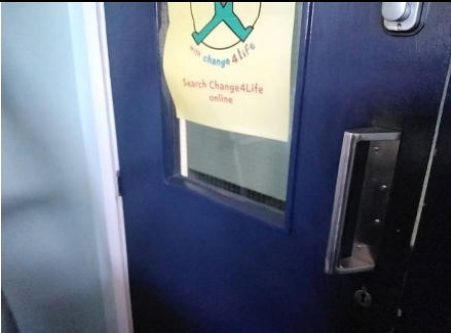
102.	As KX000914	Door window beading	Block 1, Ground Floor, Store Room (Room G/034)	Does not contain asbestos.

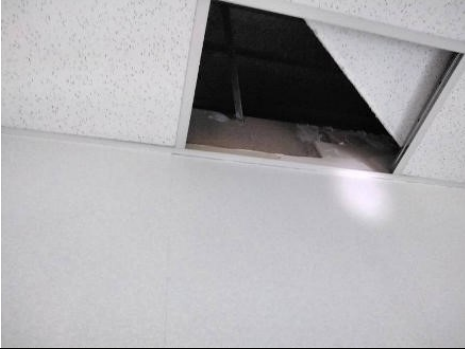
103.	As KX000912	Ceiling void beam cladding	Block 1, Ground Floor, Large Office (Room G/035)	Does not contain asbestos.

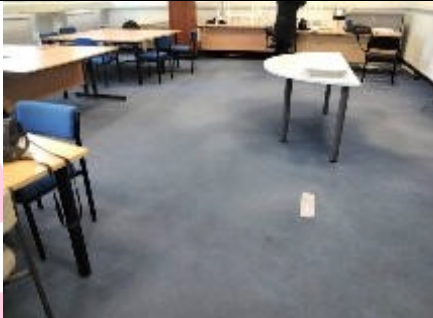
104.	As KX000907	Floor adhesive residue under floor covering	Block 1, Ground Floor, Large Office (Room G/035)	Contains asbestos - Any change in its appearance should be recorded and passed to Property Services.

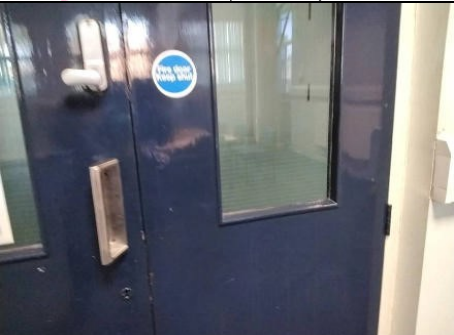
105.	As KX000914	Door window beading	Block 1, Ground Floor, Large Office (Room G/035)	Does not contain asbestos.

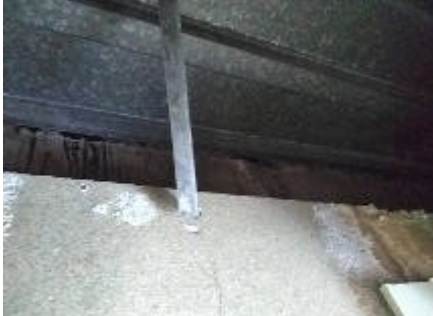
106.	As KX000906	Ceiling void debris to stench pipe penetration	Block 1, Ground Floor, Large Office (Room G/035)	Contains asbestos - Any change in its appearance should be recorded and passed to Property Services.

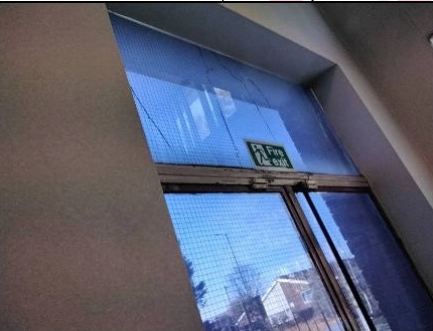
107.	KX000898	Window Putty/seal	Block 1, Ground Floor, Large Office (Room G/035)	Does not contain asbestos.

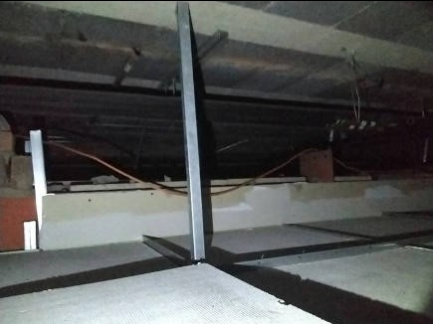
108.	As KX000912	Ceiling void beam cladding	Block 1, Ground Floor, Kitchen (Room G/036)	Does not contain asbestos.

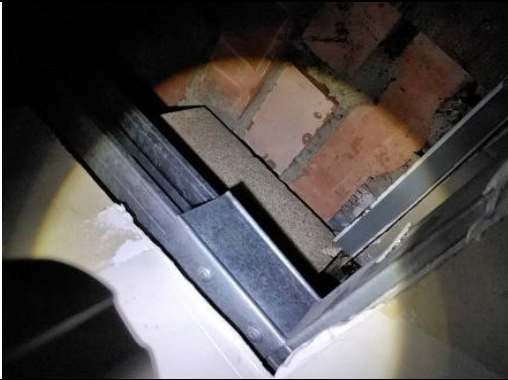
112.	KX000916	Wall putty to column	Block 1, Ground Floor, Kitchen (Room G/036)	Does not contain asbestos.

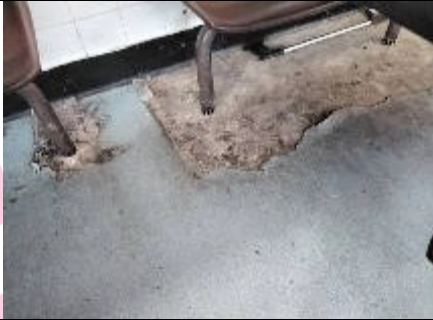
113.	KX000917	Floor adhesive residue under lino	Block 1, Ground Floor, Staff Room (Room G/037)	Contains asbestos - Any change in its appearance should be recorded and passed to Property Services.

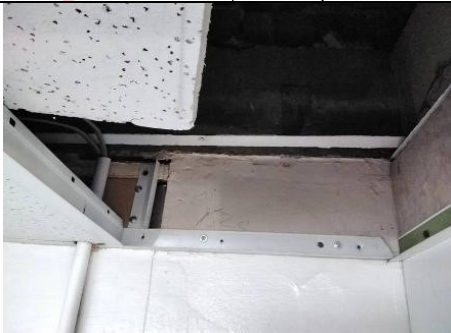
114.	KX000918	Ceiling void debris to upper ceiling grid	Block 1, Ground Floor, Staff Room (Room G/037)	Does not contain asbestos.

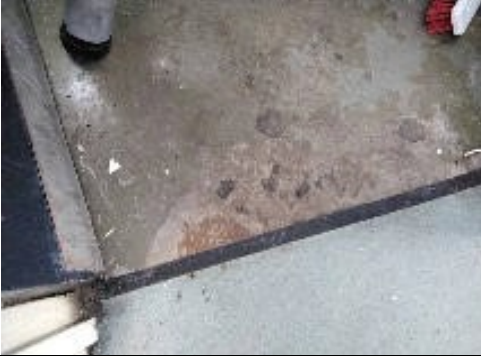
118.	As KX000917	Floor adhesive residue under lino	Block 1, Ground Floor, Tank Room (Room G/038)	Contains asbestos - Any change in its appearance should be recorded and passed to Property Services.

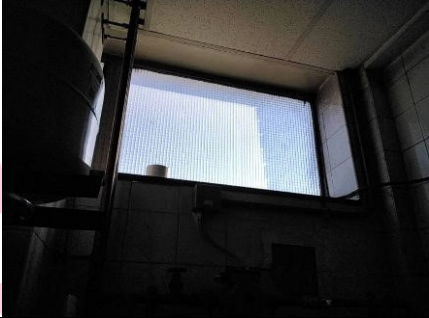
119.	As KX000903	Window putty/seal	Block 1, Ground Floor, Tank Room (Room G/038)	Does not contain asbestos.

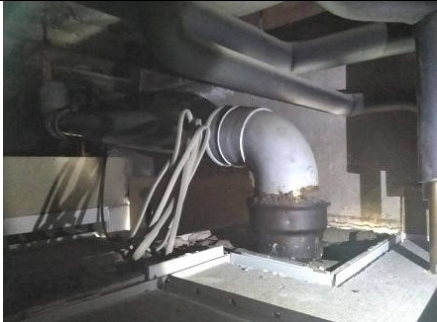
120.	KX000919	Pipe joints caulking/packing to metal/plastic	Block 1, Ground Floor, Tank Room (Room G/038)	Does not contain asbestos.

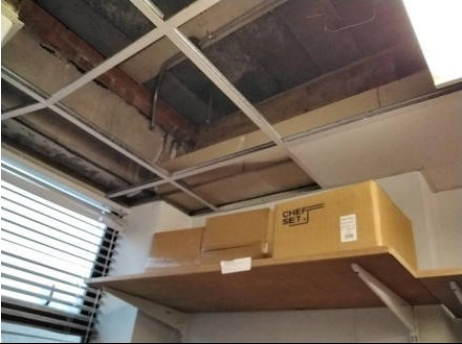
121.	As KX000912	Ceiling void beam cladding	Block 1, Ground Floor, Store Room (Room G/039)	Does not contain asbestos.

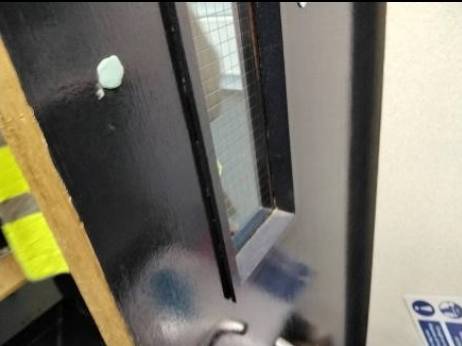
122.	As KX000914	Door window beading	Block 1, Ground Floor, Store Room (Room G/039)	Does not contain asbestos.

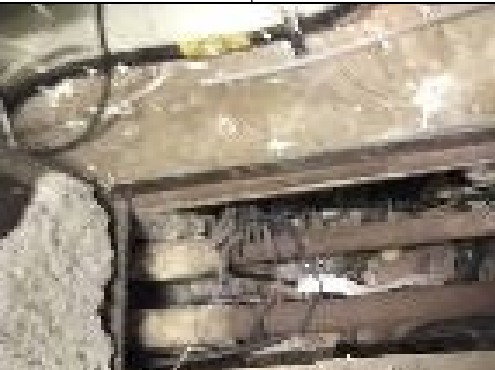
123.	KX000936	Floor void duct debris	Block 1, Ground Floor, Hub/Network Room (Room G/040)	Contains asbestos - Any change in its appearance should be recorded and passed to Property Services.

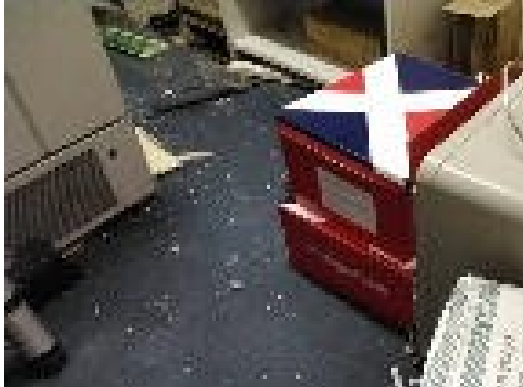
124.	As KX000936	Floor tile (under floor covering)	Block 1, Ground Floor, Hub/Network Room (Room G/040)	Contains asbestos - Any change in its appearance should be recorded and passed to Property Services.

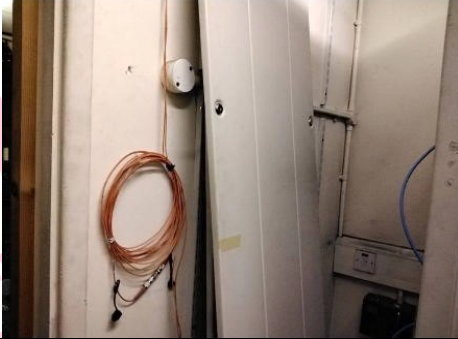
125.	KX000937	Wall	Block 1, Ground Floor, Hub/Network Room (Room G/041)	Does not contain asbestos.

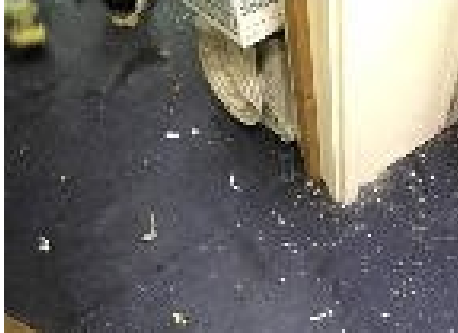
126.	As KX000936	Floor tile (under floor covering)	Block 1, Ground Floor, Hub/Network Room (Room G/041)	Contains asbestos - Any change in its appearance should be recorded and passed to Property Services.

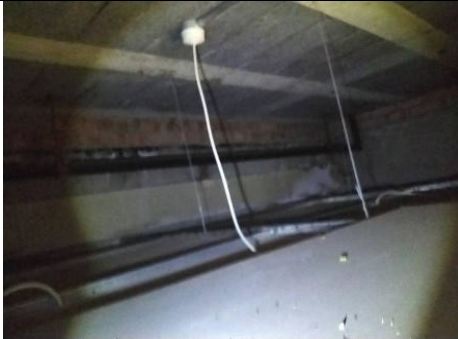
127.	As KX000912	Ceiling void beam cladding	Block 1, Ground Floor, Storage Area (Room G/042)	Does not contain asbestos.

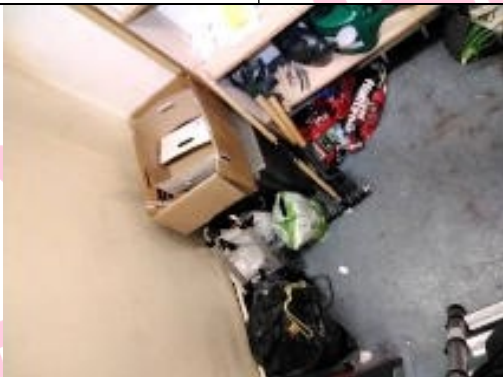
128.	As KX000907	Floor adhesive residue under floor covering	Block 1, Ground Floor, Storage Area (Room G/042)	Contains asbestos - Any change in its appearance should be recorded and passed to Property Services.

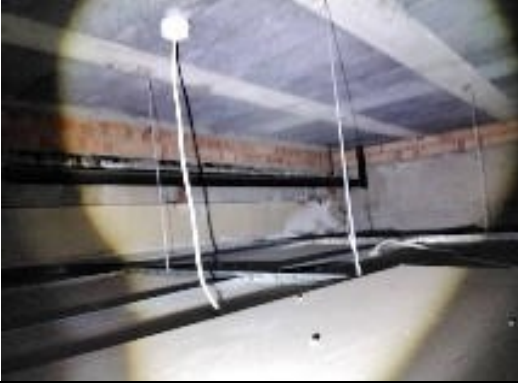
130.	As KX000906	Ceiling void debris to wall	Block 1, Ground Floor, Storage Area (Room G/042)	Contains asbestos - Any change in its appearance should be recorded and passed to Property Services.

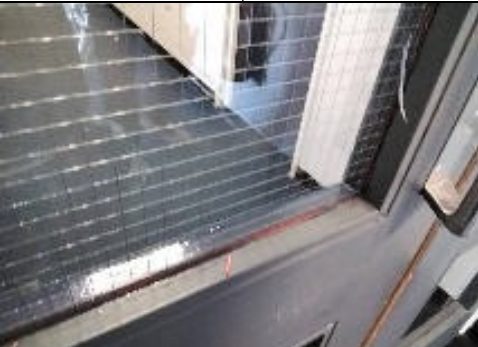
132.	KX000929	Door window beading including to header	Block 1, First Floor, Landing within Stairwell (Room 1/001)	Contains asbestos - Any change in its appearance should be recorded and passed to Property Services.

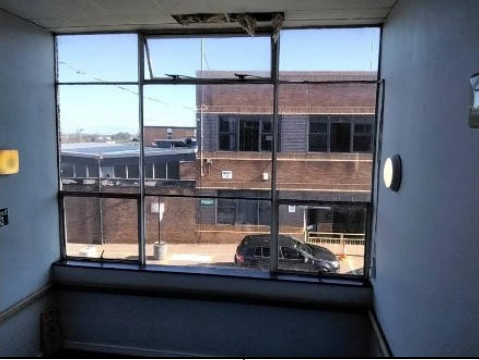
133.	As KX000903	Window putty/seal	Block 1, First floor, Landing within Stairwell (room 1/001)	Does not contain asbestos.

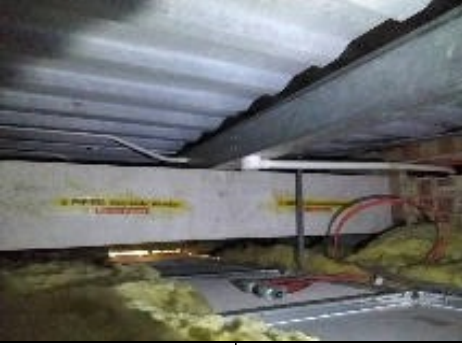
136.	As KX000928	Ceiling void beam cladding x4	Block 1, First Floor, Corridor (Room 1/002)	Contains asbestos - Any change in its appearance should be recorded and passed to Property Services.

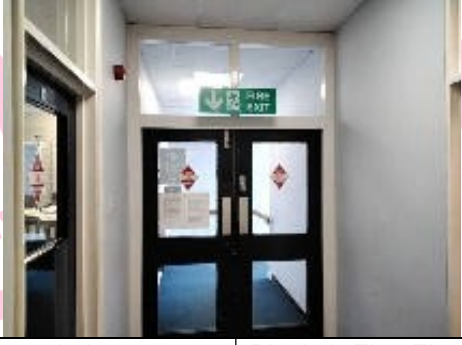
137.	As KX000929	Door window beading including to header	Block 1, First Floor, Corridor (Room 1/002)	Contains asbestos - Any change in its appearance should be recorded and passed to Property Services.

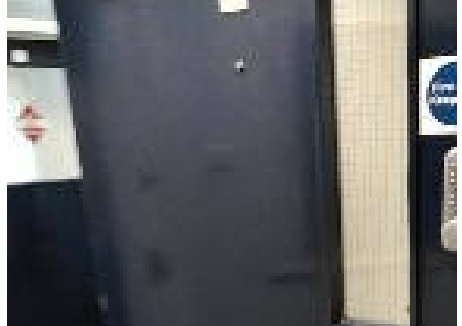
138.	As KX000929	Door window beading including to header	Block 1, First Floor, Office (Room 1/003)	Contains asbestos - Any change in its appearance should be recorded and passed to Property Services.

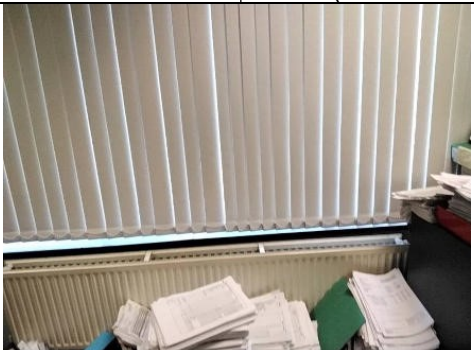
139.	As KX000903	Window putty/seal	Block 1, First floor, Office (room 1/003)	Does not contain asbestos.

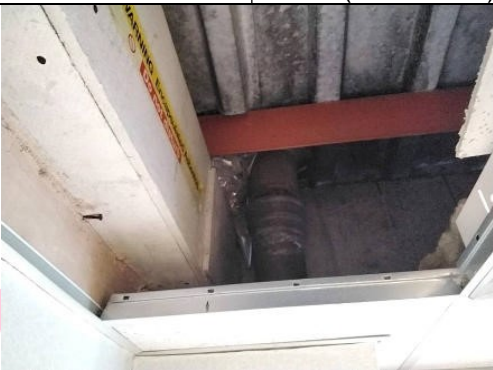
140.	KX000931	Ceiling void roof felt from below	Block 1, First floor, Office (room 1/003)	Does not contain asbestos.

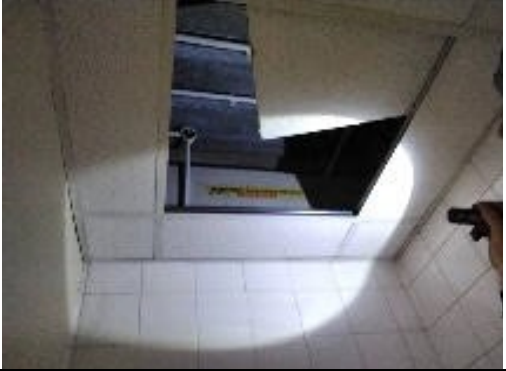
142.	As KX000928	Ceiling void beam cladding	Block 1, First Floor, Kitchen (Room 1/004)	Contains asbestos - Any change in its appearance should be recorded and passed to Property Services.

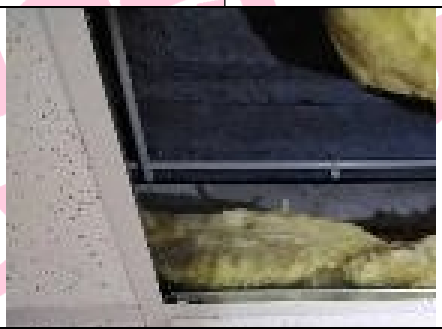
143.	As KX000928	Ceiling void beam cladding	Block 1, First Floor, Hallway/passageway to female toilets (Room 1/005)	Contains asbestos - Any change in its appearance should be recorded and passed to Property Services.

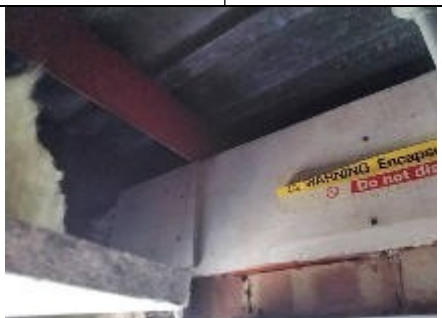
144	As KX000928	Ceiling void beam cladding	Block 1, First Floor, Female toilets (Room 1/006)	Low Risk
145	Presumed	Bunny Burner/Sanitary towel incinerator	Block 1, First Floor, Female toilets (Room 1/006)	Low Risk
146	KX000932	Seal to flue on Bunny Burner	Block 1, First Floor, Female toilets (Room 1/006)	No Risk
147	KX000933	Handles x 2 to bunny burner	Block 1, First Floor, Female toilets (Room 1/006)	No Risk
148	As KX000903	Window putty/seal	Block 1, First Floor, Female toilets (Room 1/006)	No Risk
149	As KX000928	Ceiling void beam cladding x 2	Block 1, First Floor, Store Room (Room 1/007)	Low Risk
150	As KX000903	Window putty/seal	Block 1, First Floor, Store Room (Room 1/007)	No Risk
151	As KX000928	Ceiling void beam cladding	Block 1, First Floor, Office ceiling void from adjacent room (Room 1/008)	Low Risk
152	As KX000903	Window putty/seal	Block 1, First Floor, Office ceiling void from adjacent room (Room 1/008)	No Risk

144.	As KX000928	Ceiling void beam cladding	Block 1, First Floor, Female toilets (Room 1/006)	Contains asbestos - Any change in its appearance should be recorded and passed to Property Services.

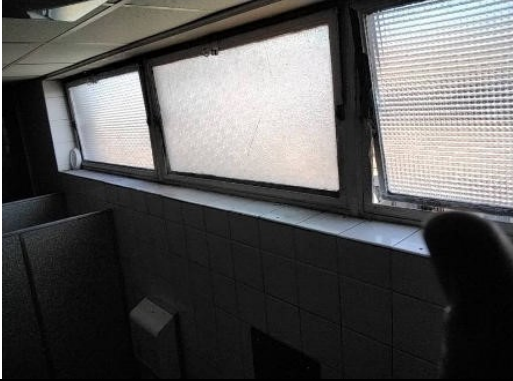
148.	As KX000903	Window putty/seal	Block 1, First Floor, Female toilets (Room 1/006)	Does not contain asbestos.

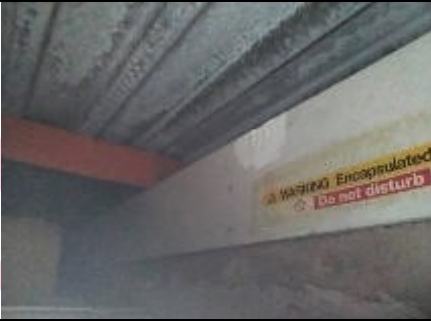
149.	As KX000928	Ceiling void beam cladding x 2	Block 1, First Floor, Store Room (Room 1/007)	Contains asbestos - Any change in its appearance should be recorded and passed to Property Services.

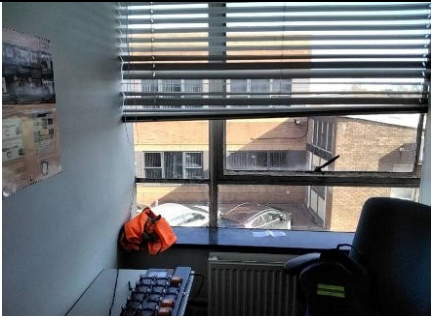
150.	As KX000903	Window putty/seal	Block 1, First Floor, Store Room (Room 1/007)	Does not contain asbestos.

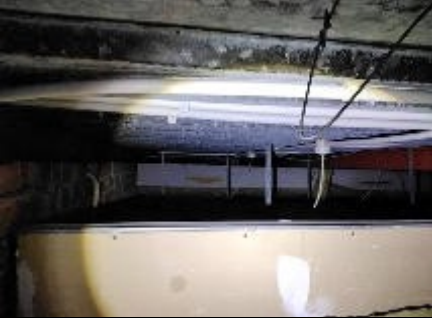
151.	As KX000928	Ceiling void beam cladding	Block 1, First Floor, Office ceiling void from adjacent room (Room 1/008)	Contains asbestos - Any change in its appearance should be recorded and passed to Property Services.

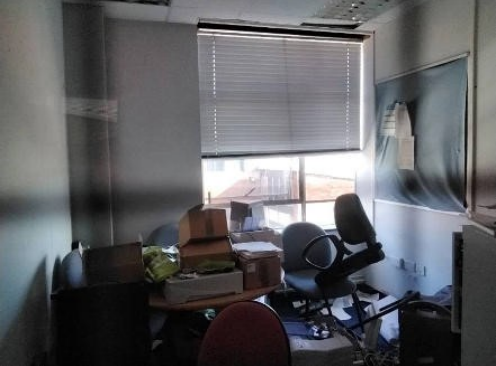
152.	As KX000903	Window putty/seal	Block 1, First Floor, Office ceiling void from adjacent room (Room 1/008)	Does not contain asbestos.

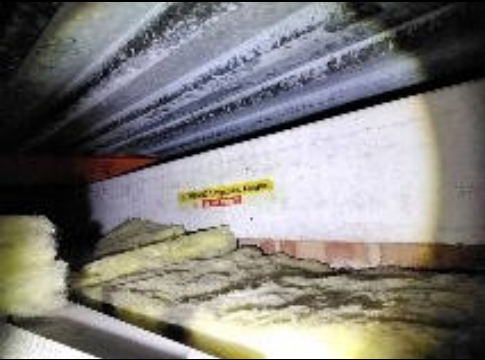
154.	As KX000928	Ceiling void beam cladding	Block 1, First Floor, Office (Room 1/009)	Contains asbestos - Any change in its appearance should be recorded and passed to Property Services.

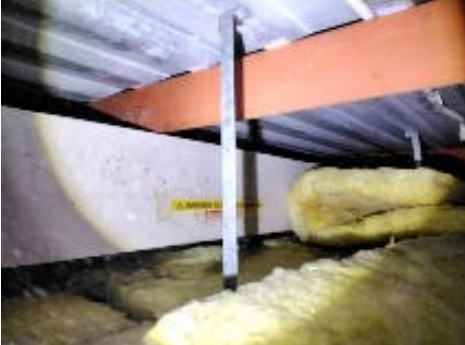
157.	As KX000928	Ceiling void beam cladding	Block 1, First Floor, Office (Room 1/010)	Contains asbestos - Any change in its appearance should be recorded and passed to Property Services.

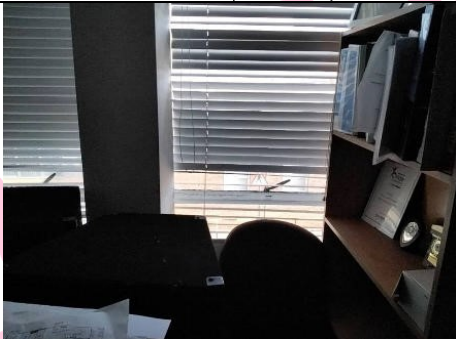
158.	As KX000903	Window putty/seal	Block 1, First Floor, Office (Room 1/010)	Does not contain asbestos.

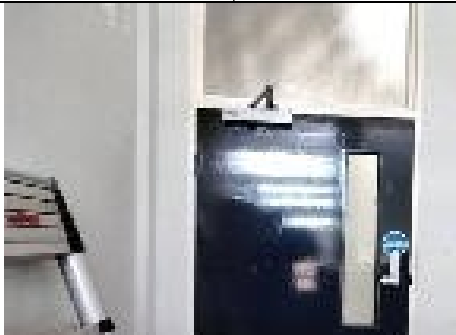
159.	As KX000929	Door window beading including to header	Block 1, First Floor, Office (Room 1/010)	Contains asbestos - Any change in its appearance should be recorded and passed to Property Services.

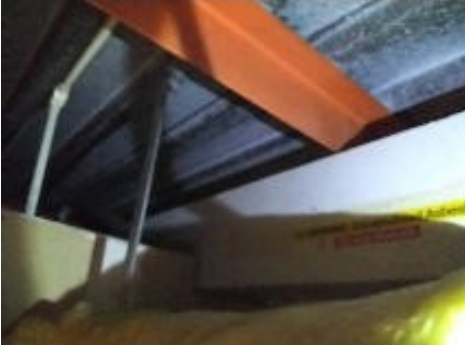
160.	As KX000928	Ceiling void beam cladding	Block 1, First Floor, Store Room (Room 1/011)	Contains asbestos - Any change in its appearance should be recorded and passed to Property Services.

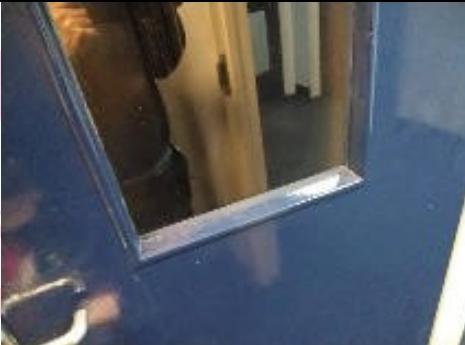
161.	As KX000929	Door window beading including to header	Block 1, First Floor, Store Room (Room 1/011)	Contains asbestos - Any change in its appearance should be recorded and passed to Property Services.

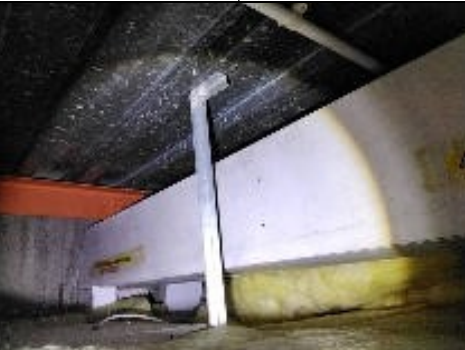
162.	As KX000928	Ceiling void beam cladding	Block 1, First Floor, Office (Room 1/012)	Contains asbestos - Any change in its appearance should be recorded and passed to Property Services.

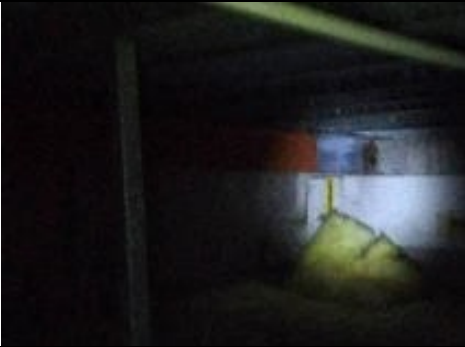
169.	As KX000928	Ceiling void column cladding	Block 1, First Floor, Office Small (Room 1/014)	Contains asbestos - Any change in its appearance should be recorded and passed to Property Services.

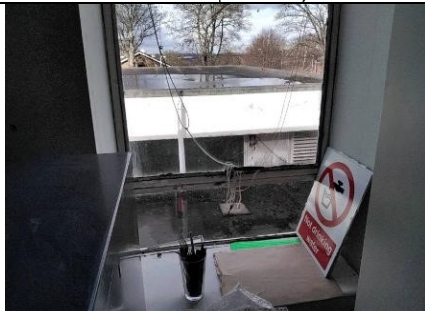
171.	As KX000903	Window putty/seal	Block 1, First Floor, Office Small (Room 1/015)	Does not contain asbestos.

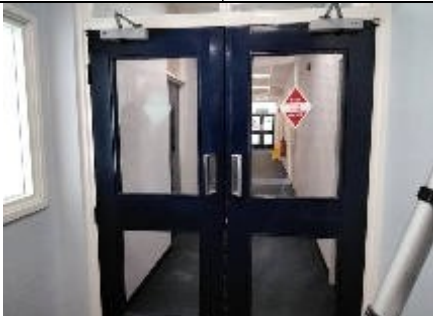
174.	As KX000929	Door window beading including to header panels	Block 1, First Floor, Hallway/passageway (Room 1/016)	Contains asbestos - Any change in its appearance should be recorded and passed to Property Services.

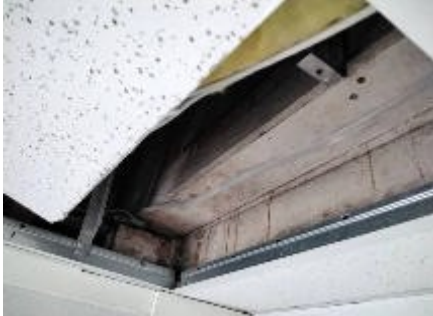
175.	As KX000928	Ceiling void beam cladding	Block 1, First Floor, Office (Room 1/017)	Contains asbestos - Any change in its appearance should be recorded and passed to Property Services.

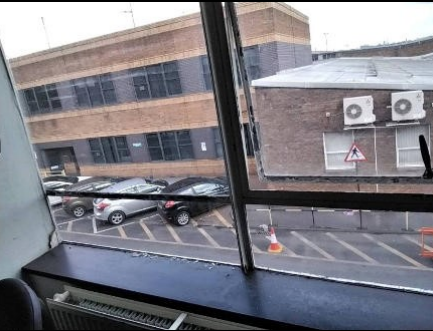
176.	As KX000903	Window putty/seal	Block 1, First Floor, Office (Room 1/017)	Does not contain asbestos.

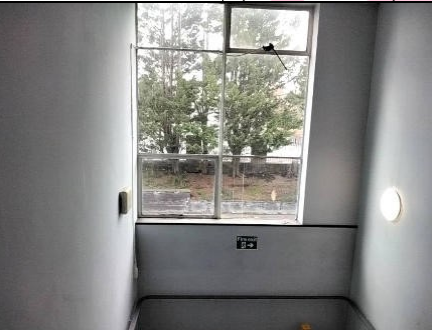
179.	As KX000903	Window putty/seal	Block 1, First Floor, Landing and Stairwell (Room 1/018)	Does not contain asbestos.

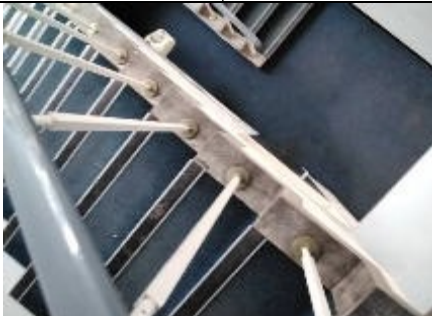
180.	As KX000892	Floor screed to stairs	Block 1, First Floor, Landing and Stairwell (Room 1/018)	Contains asbestos - Any change in its appearance should be recorded and passed to Property Services.

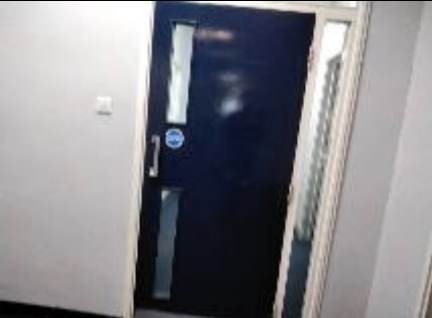
182.	As KX000929	Door window beading including to header panels	Block 1, First Floor, Corridor (Room 1/019)	Contains asbestos - Any change in its appearance should be recorded and passed to Property Services.

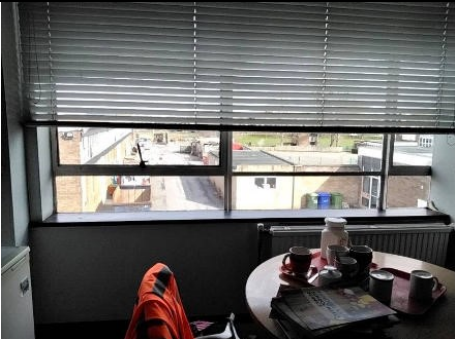
184.	As KX000903	Window putty/seal	Block 1, First Floor, Office (Room 1/22)	Does not contain asbestos.

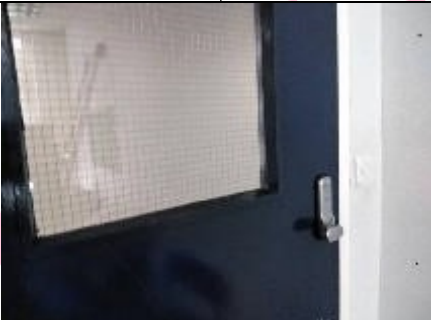
185.	As KX000929	Door window beading	Block 1, First Floor, Office (Room 1/022)	Contains asbestos - Any change in its appearance should be recorded and passed to Property Services.

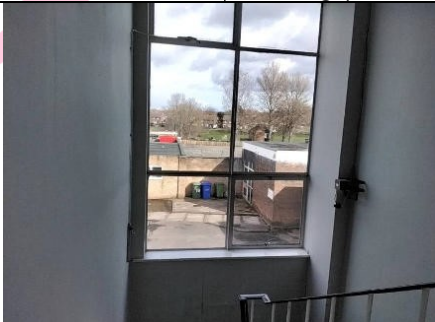
186.	As KX000903	Window putty/seal	Block 1, First Floor, Landing (Room 1/23)	Does not contain asbestos.

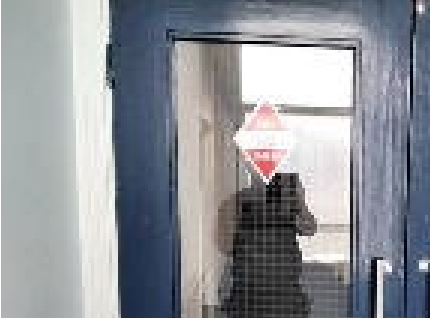
187.	As KX000929	Door window beading	Block 1, First Floor, Landing (Room 1/023)	Contains asbestos - Any change in its appearance should be recorded and passed to Property Services.

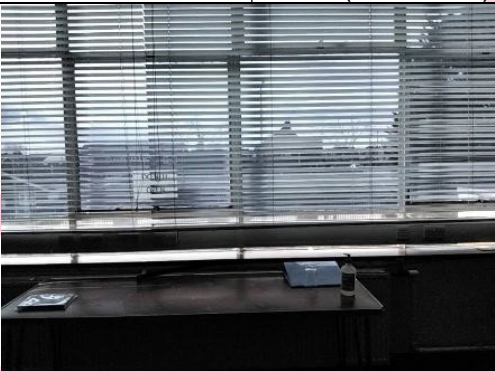
188.	As KX000903	Window putty/seal	Block 1, First Floor, Office (Room 1/24)	Does not contain asbestos.

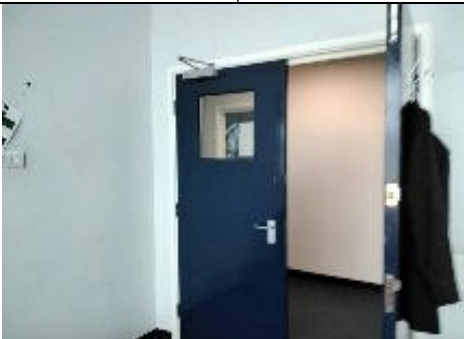
189.	As KX000929	Door window beading	Block 1, First Floor, Office (Room 1/024)	Contains asbestos - Any change in its appearance should be recorded and passed to Property Services.

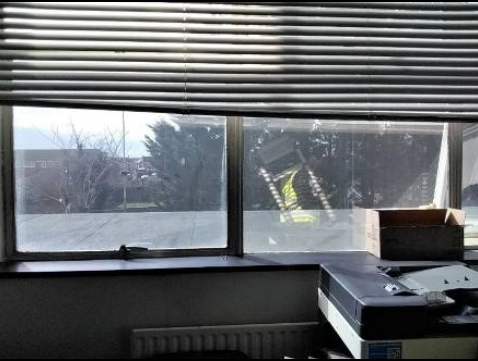
190.	As KX000903	Window putty/seal	Block 1, First Floor, Office (Room 1/25)	Does not contain asbestos.

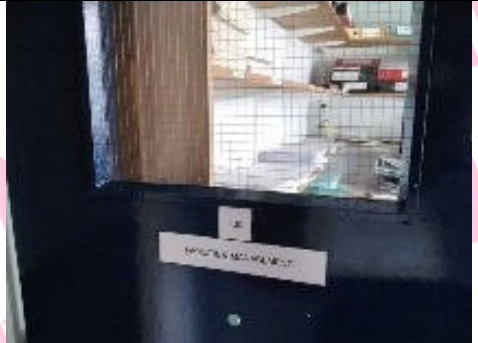
191.	As KX000929	Door window beading	Block 1, First Floor, Office (Room 1/025)	Contains asbestos - Any change in its appearance should be recorded and passed to Property Services.

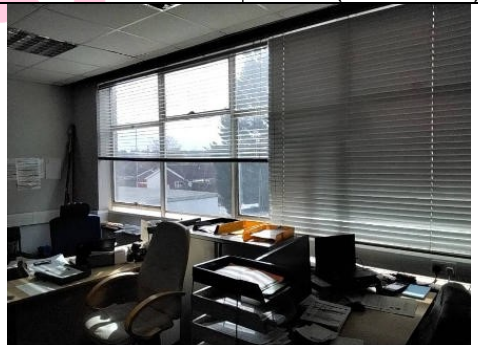
192.	As KX000903	Window putty/seal	Block 1, First Floor, Office (Room 1/26)	Does not contain asbestos.

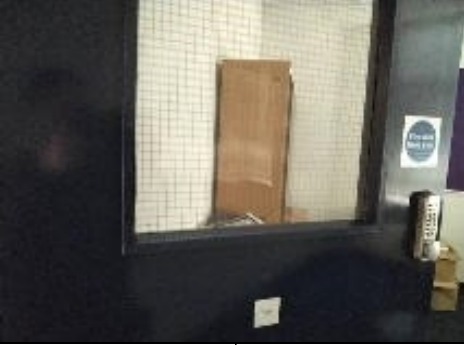
196.	As KX000929	Door window beading	Block 1, First Floor, Office (Room 1/028)	Contains asbestos - Any change in its appearance should be recorded and passed to Property Services.

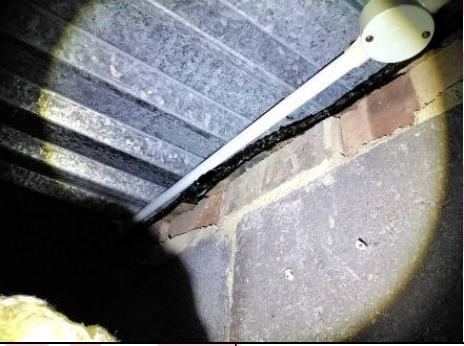
197.	KX000935	Ceiling void Packer to timber	Block 1, First Floor, Office (Room 1/28)	Does not contain asbestos.

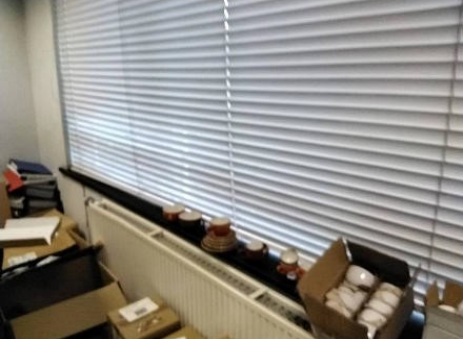
198.	As KX000903	Window putty/seal	Block 1, First Floor, Office (Room 1/29)	Does not contain asbestos.

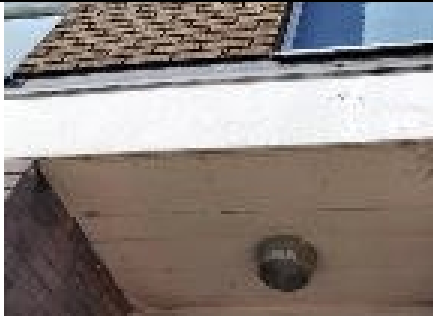
207.	As KX000895	Canopy ceiling external canopy to mess room	Block 1, External (Room E/001)	Contains asbestos - Any change in its appearance should be recorded and passed to Property Services.

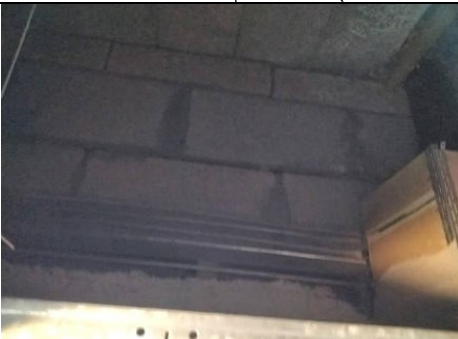
217.	As KX000931	Ceiling void sampled from office 1/3	Block 1, External (Room E/001)	Does not contain asbestos.
No Photographic Evidence				
218.	KX000938	Wall lining	Block 2, Ground Floor, Toilets (Room G/009)	Does not contain asbestos.

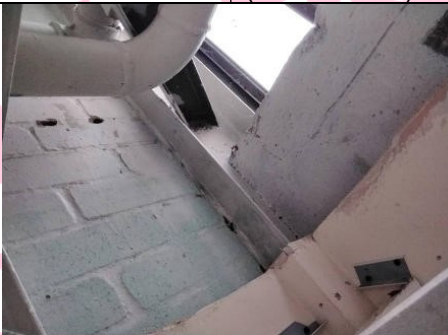
219.	KX000942	Putty to column	Block 2, Ground Floor, Office Service Support (Room G/015)	Does not contain asbestos.

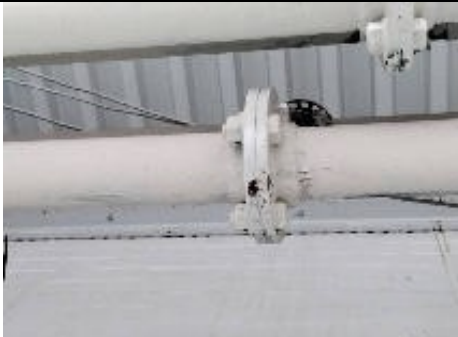
220.	Presumed	Ceiling void pipework	Block 2, Ground Floor, Office Service Support (Room G/015)	Presumed to contain asbestos - Any change in its appearance should be recorded and passed to Property Services.

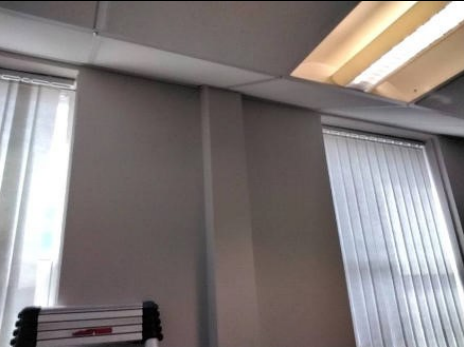
223.	KX000944	Wall coating	Block 2, Ground Floor, Office Service Support (Room G/015)	Does not contain asbestos.

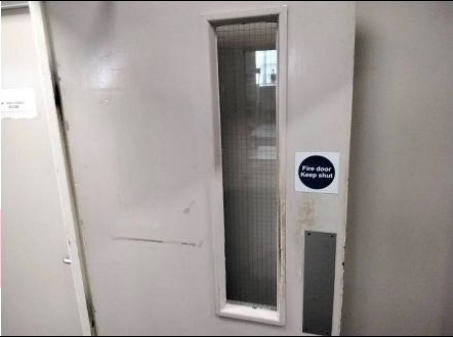
224.	KX000945	Door window beading	Block 2, Ground Floor, Office Service Support (Room G/015)	Does not contain asbestos.

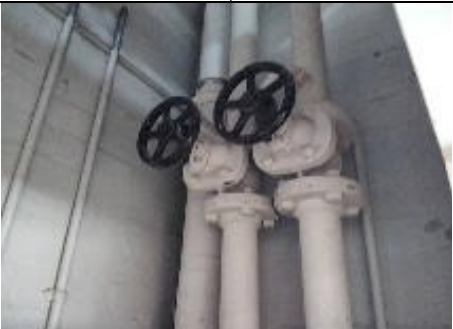
225.	Presumed	Pipework gasket	Block 2, Ground Floor, Cupboard Services (Room G/018)	Presumed to contain asbestos - Any change in its appearance should be recorded and passed to Property Services.

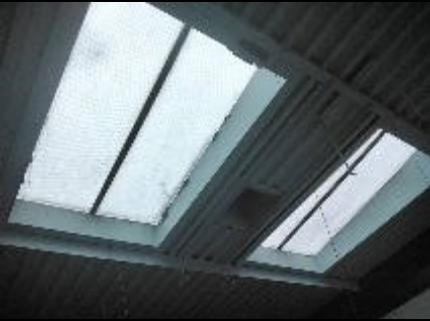
235.	Presumed	Roof skylight gasket	Block 2, Ground Floor, Office (Room G/022)	Presumed to contain asbestos - Any change in its appearance should be recorded and passed to Property Services.

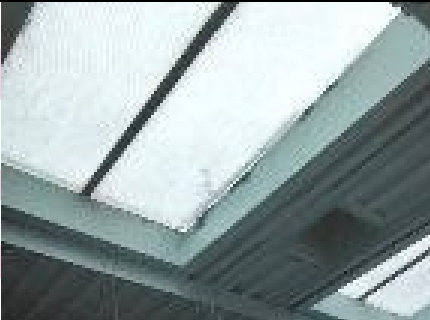
236.	Presumed	Roof vent lining upstands between skylights	Block 2, Ground Floor, Office (Room G/022)	Presumed to contain asbestos - Any change in its appearance should be recorded and passed to Property Services.

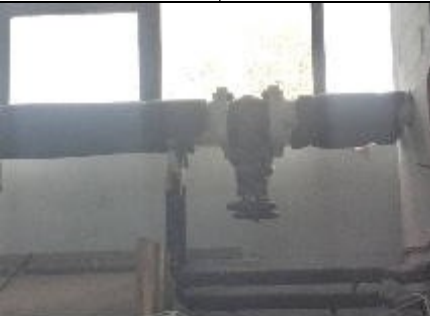
237.	As KX000951	Pipework gaskets	Block 2, Ground Floor, Office (Room G/022)	Contains asbestos - Any change in its appearance should be recorded and passed to Property Services.

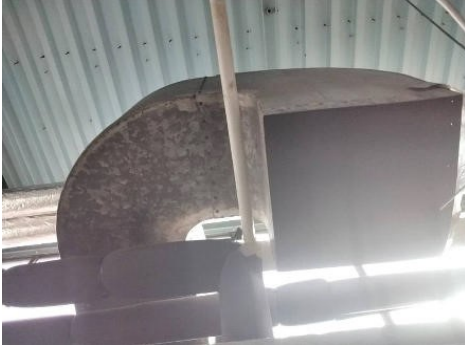
238.	KX000949	Ceiling void ductwork jointing	Block 2, Ground Floor, Office (Room G/022)	Does not contain asbestos.

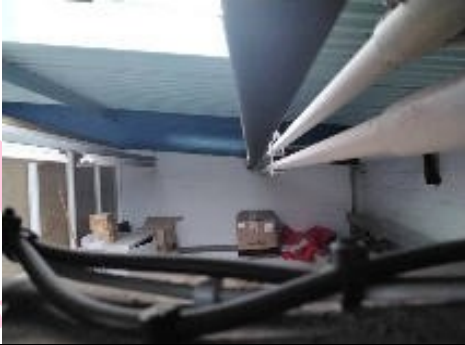
239.	As KX000948	Firebreak above beams to roof cladding	Block 2, Ground Floor, Store Room (Room G/023)	Contains asbestos - Any change in its appearance should be recorded and passed to Property Services.

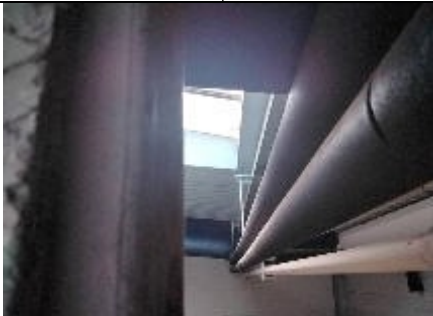
240.	Presumed	Roof skylight gasket	Block 2, Ground Floor, Store Room (Room G/023)	Presumed to contain asbestos - Any change in its appearance should be recorded and passed to Property Services.

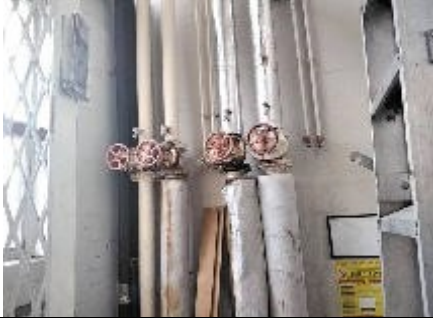
244.	KX000951	Pipework Gaskets	Block 2, Ground Floor, Switch Room (Room G/025)	Contains asbestos - Any change in its appearance should be recorded and passed to Property Services.

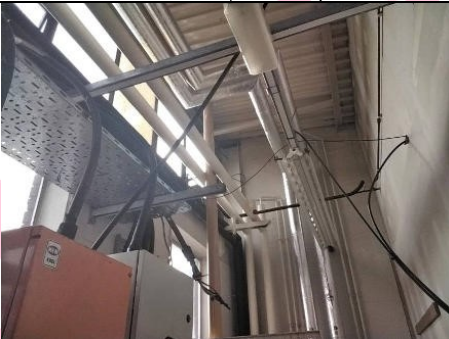
245.	As KX000942	Putty to column	Block 2, Ground Floor, Switch Room (Room G/025)	Does not contain asbestos.

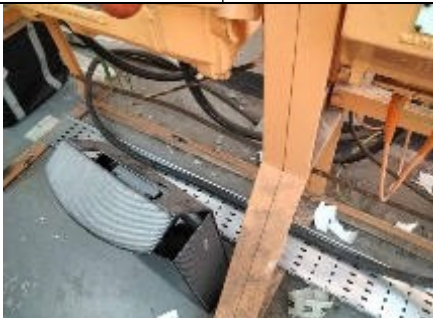
246.	KX000952	Debris poured bitumen set to floor	Block 2, Ground Floor, Switch Room (Room G/025)	Contains asbestos - Any change in its appearance should be recorded and passed to Property Services.

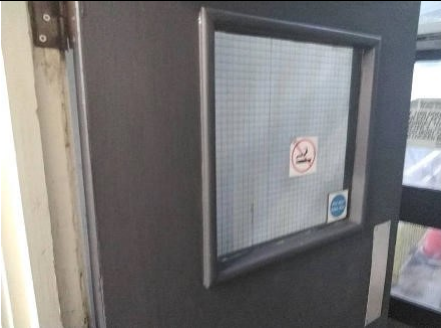
253.	As KX000945	Door window beading including door header panel	Block 2, Ground Floor, Locker Room (Room G/030)	Does not contain asbestos.

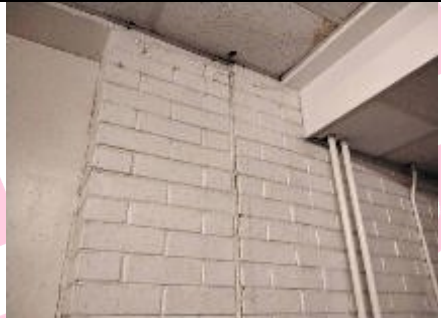
254.	As KX000947	Wall expansion joint	Block 2, Ground Floor, Locker Room (Room G/030)	Contains asbestos - Any change in its appearance should be recorded and passed to Property Services.

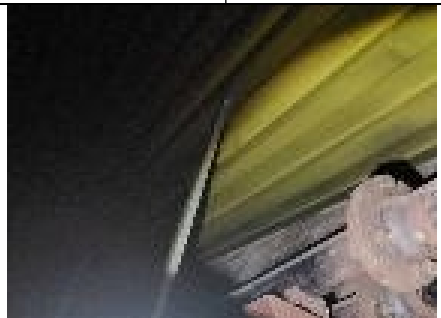
255.	Presumed	Pipework Gasket	Block 2, Ground Floor, Locker Room (Room G/030)	Presumed to contain asbestos - Any change in its appearance should be recorded and passed to Property Services.

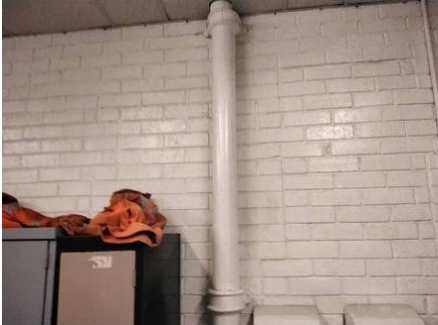
256.	KX000956	Pipe Joints	Block 2, Ground Floor, Locker Room (Room G/030)	Does not contain asbestos.

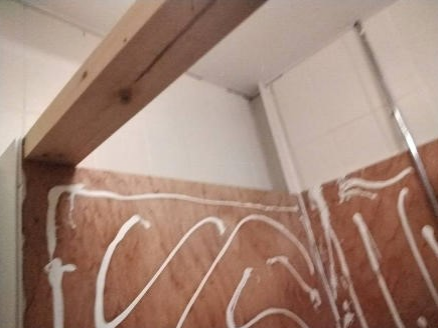
257.	As KX000942	Putty to column	Block 2, Ground Floor, Shower Room (Room G/031)	Does not contain asbestos.
