ASBESTOS SURVEY REPORT FOR SOUTH HYLTON HOUSE, SOUTH HYLTON BANK, SR4 0JL.

Asbestos Register for

South Hylton House, South Hylton Bank, SR4 0JL

Date: 24 March 2025

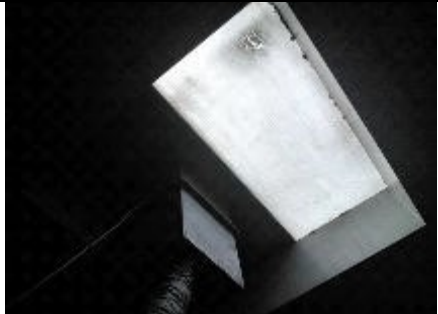
258.	Presumed	Roof Skylight Gasket	Block 2, Ground Floor, Male Toilets (Room G/032)	Presumed to contain asbestos - Any change in its appearance should be recorded and passed to Property Services.

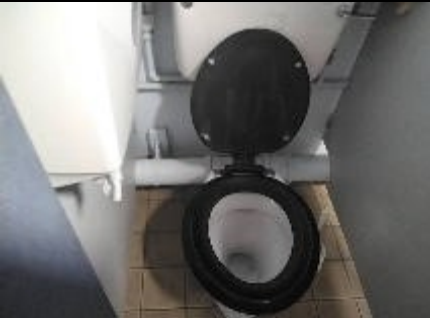
259.	Presumed	Toilet seats	Block 2, Ground Floor, Male Toilets (Room G/032)	Presumed to contain asbestos - Any change in its appearance should be recorded and passed to Property Services.

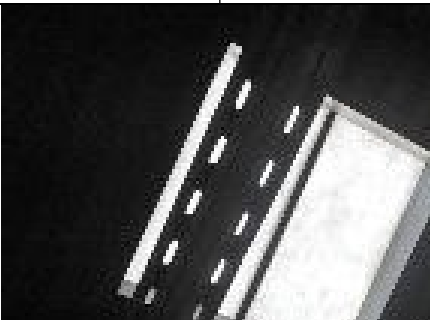
261.	Presumed	Roof Skylight Gasket	Block 2, Ground Floor, Workshop Mechanical (Room G/034)	Presumed to contain asbestos - Any change in its appearance should be recorded and passed to Property Services.

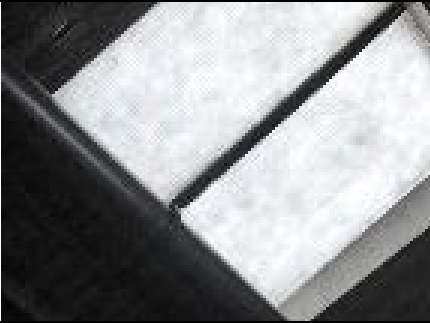
265.	Presumed	Roof Skylight Gasket	Block 2, Ground Floor, Workshop joinery (Room G/036)	Presumed to contain asbestos - Any change in its appearance should be recorded and passed to Property Services.

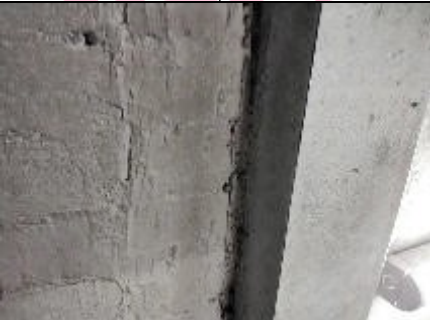
266.	KX000963	Wall packing to structural columns	Block 2, Ground Floor, Garage (Room G/037)	Contains asbestos - Any change in its appearance should be recorded and passed to Property Services.

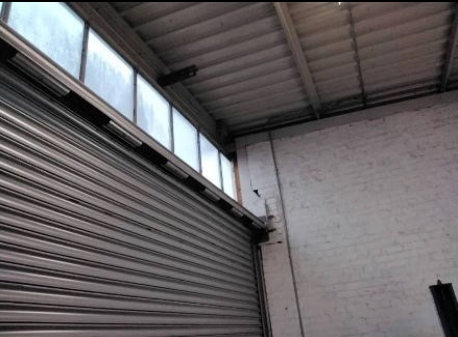
267.	As KX000964	Column cladding rear of panel on other side of wall	Block 2, Ground Floor, Garage (Room G/037)	Does not contain asbestos.

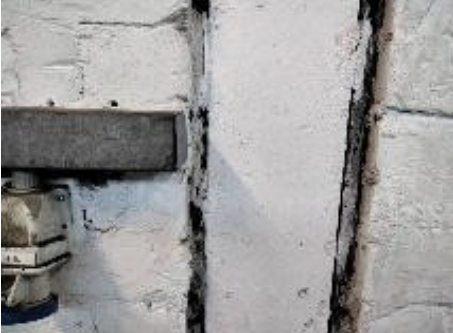
268.	As KX000963	Wall packing to structural columns	Block 2, Ground Floor, Garage (Room G/038)	Contains asbestos - Any change in its appearance should be recorded and passed to Property Services.

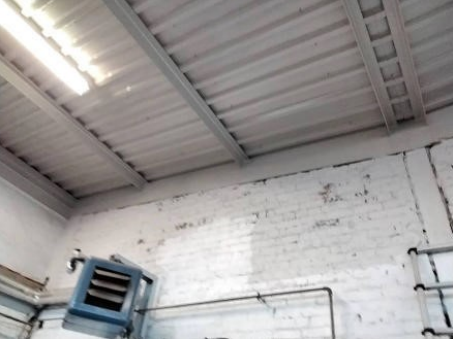
269.	KX000964	Beam cladding	Block 2, Ground Floor, Garage (Room G/038)	Does not contain asbestos.

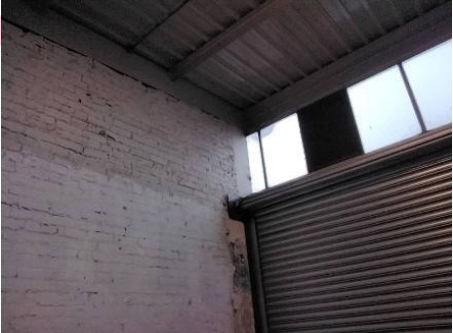
270.	As KX000964	Column cladding	Block 2, Ground Floor, Garage (Room G/038)	Does not contain asbestos.

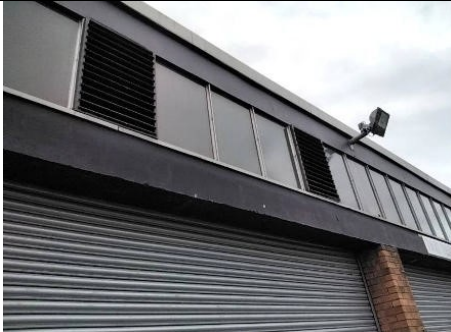
277.	KX000966	Window beading seal around metal frame window	External car port/vehicle store (E/003)	Does not contain asbestos.

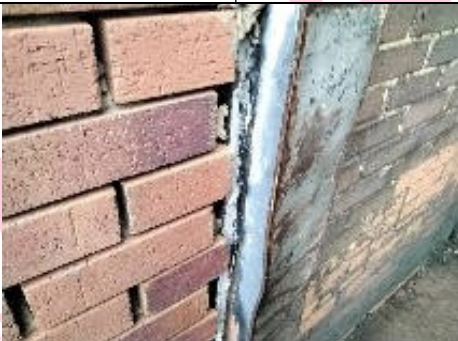
278.	As KX000963	Wall packing to structural columns	External Garage (E/004)	Contains asbestos - Any change in its appearance should be recorded and passed to Property Services.

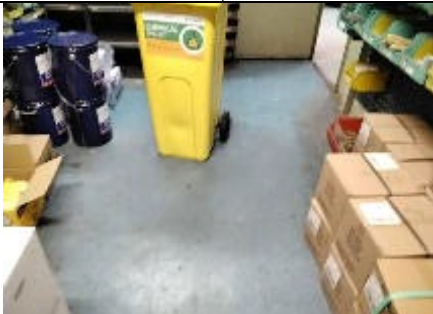
279.	KX000967	Floor tile blue	Block 3, Ground Floor, Store Room (Room G/003)	Contains asbestos - Any change in its appearance should be recorded and passed to Property Services.

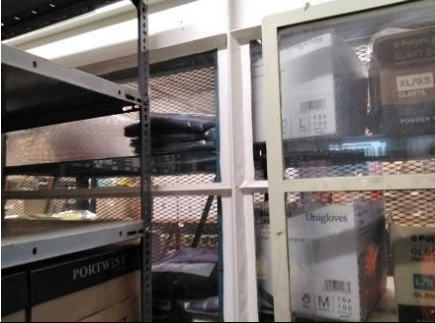
280.	KX000968	Window putty seal	Block 3, Ground Floor, Store Room (Room G/003)	Does not contain asbestos.

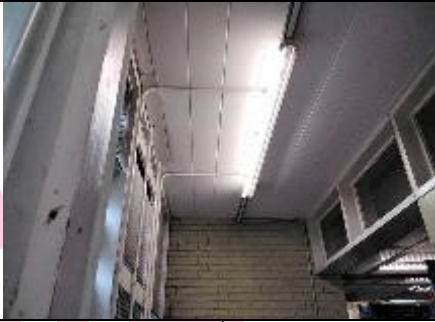
281.	As KX000969	Ceiling Cladding	Block 3, Ground Floor, Office (Room G/004)	Contains asbestos - Any change in its appearance should be recorded and passed to Property Services.

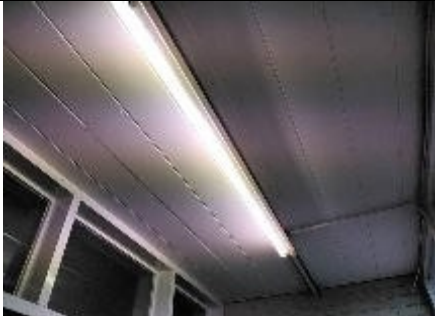
282.	KX000969	Ceiling Cladding	Block 3, Ground Floor, Reception/Entrance (Room G/005)	Contains asbestos - Any change in its appearance should be recorded and passed to Property Services.

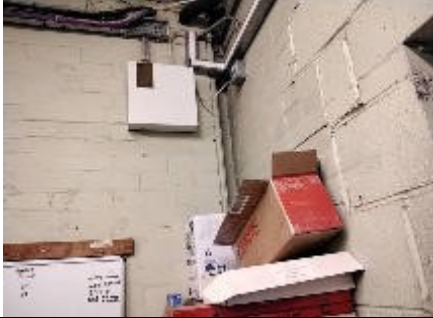
283.	As KX000963	Wall packing to structural column	Block 3, Ground Floor, Office (Room G/006)	Contains asbestos - Any change in its appearance should be recorded and passed to Property Services.

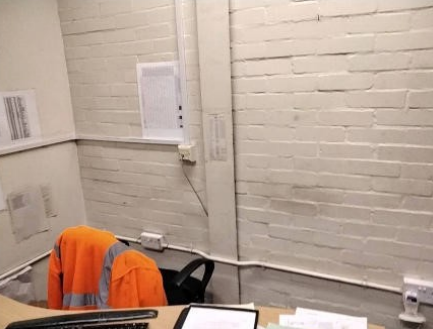
284.	KX000970	Wall packing to column	Block 3, Ground Floor, Office (Room G/008)	Does not contain asbestos.

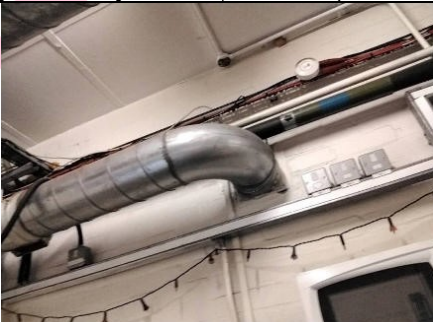
285.	KX000971	Ductwork beige and grey seals to joints	Block 3, Ground Floor, Kitchen (Room G/010)	Does not contain asbestos.

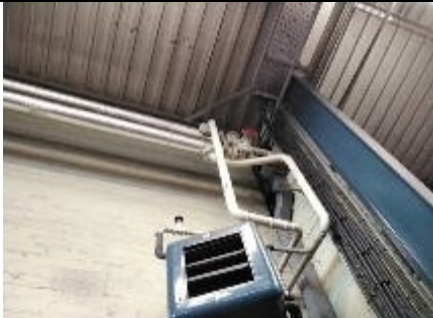
286.	Presumed	Pipework gaskets	Block 3, Ground Floor, Garage (Room G/013)	Presumed to contain asbestos - Any change in its appearance should be recorded and passed to Property Services.

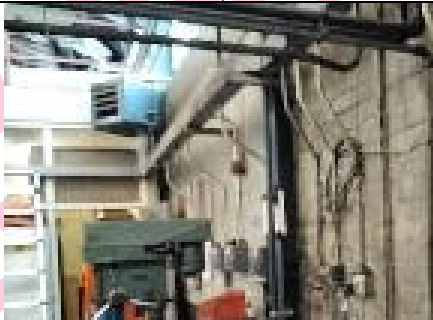
287.	KX000972	Wall seal to column	Block 3, Ground Floor, Garage (Room G/013)	Contains asbestos - Any change in its appearance should be recorded and passed to Property Services.

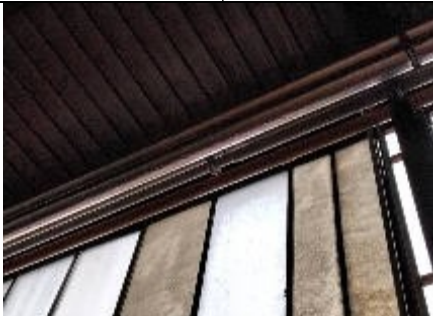
288.	Presumed	Pipework gaskets	Block 3, Ground Floor, Garage (Room G/014)	Presumed to contain asbestos - Any change in its appearance should be recorded and passed to Property Services.

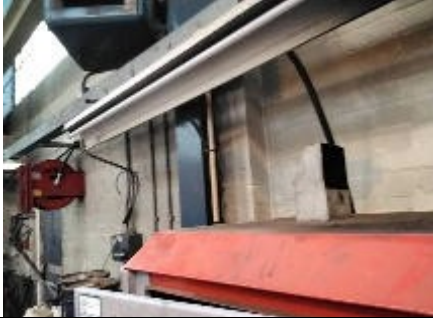
289.	As KX000972	Wall seal to column	Block 3, Ground Floor, Garage (Room G/014)	Contains asbestos - Any change in its appearance should be recorded and passed to Property Services.

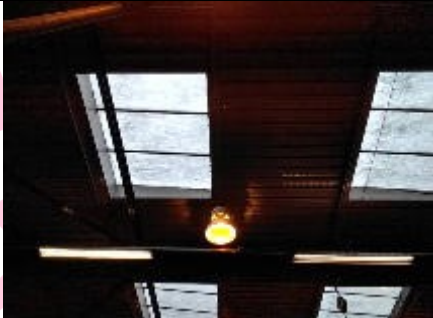
290.	Presumed	Roof skylight gasket	Block 3, Ground Floor, Garage (Room G/014)	Presumed to contain asbestos - Any change in its appearance should be recorded and passed to Property Services.

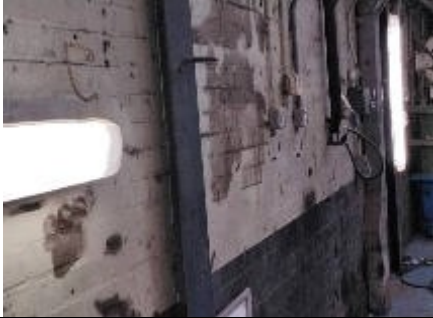
292.	As KX000972	Wall seal to column	Block 3, Ground Floor, Garage (Room G/015)	Contains asbestos - Any change in its appearance should be recorded and passed to Property Services.

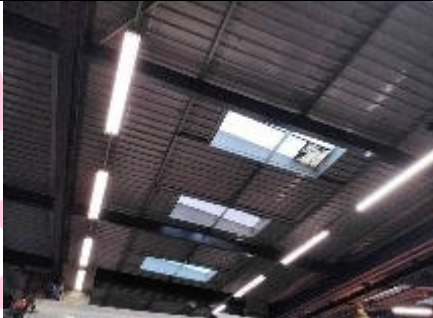
293.	Presumed	Roof skylight gasket	Block 3, Ground Floor, Garage (Room G/015)	Presumed to contain asbestos - Any change in its appearance should be recorded and passed to Property Services.

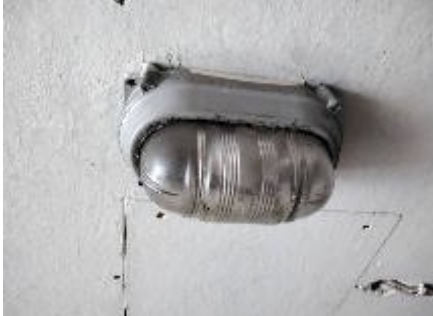
301.	KX000988	Electrical services putty	Garages, Ground Floor, Garage (Room G/002)	Contains asbestos - Any change in its appearance should be recorded and passed to Property Services.

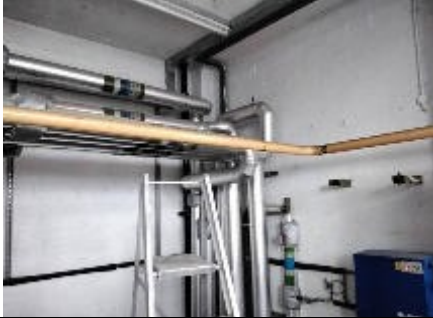
307.	KX000980	Debris/Residue right hand wall behind pipes leading to duct	Boiler House, Ground Floor, Boiler Room (G/001)	Contains asbestos - Any change in its appearance should be recorded and passed to Property Services.

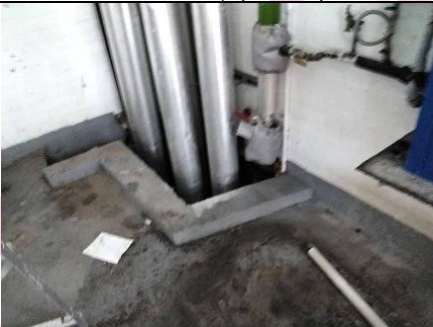
308.	KX000981	Damp Proof Course	Boiler House, Ground Floor, Boiler Room (G/001)	Does not contain asbestos.

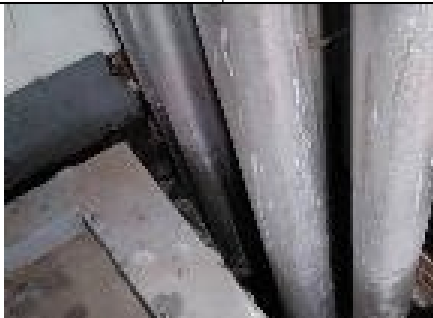
309.	Presumed	Gaskets at bottom of floor duct	Boiler House, Ground Floor, Boiler Room (G/001)	Presumed to contain asbestos - Any change in its appearance should be recorded and passed to Property Services.

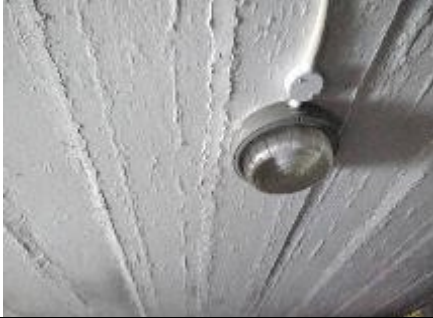
316.	KX100102	Electrical services door seal gasket to round ceiling lamps	Gas Cylinder Store, Ground Floor, Store Room (Room G/001)	Contains asbestos - Any change in its appearance should be recorded and passed to Property Services.

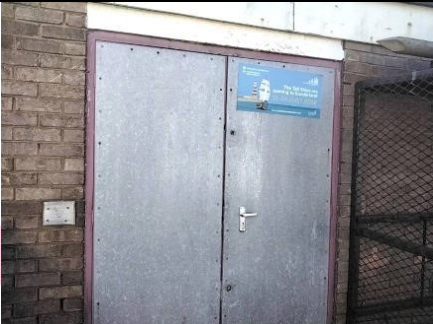
317.	KX000989	Door frame beading	Gas Cylinder Store, External (E/001)	Does not contain asbestos.

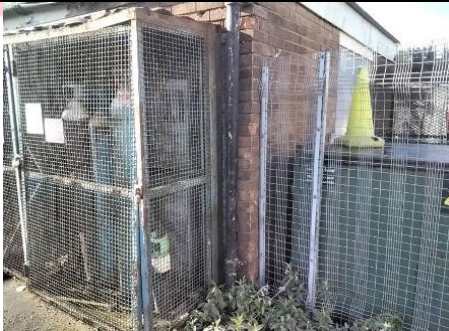
318.	KX000990	Pipe joints caulking/packing to metal rainwater goods	Gas Cylinder Store, External (E/001)	Does not contain asbestos.

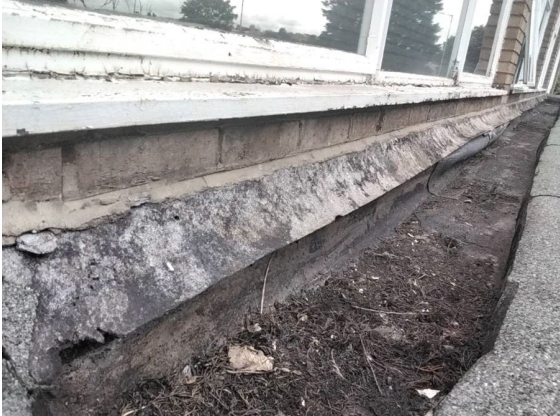
325.	OE003165 (J202643)	Roof felt light grey coloured flashing to gutter area	External (E/001)	Very Low Risk

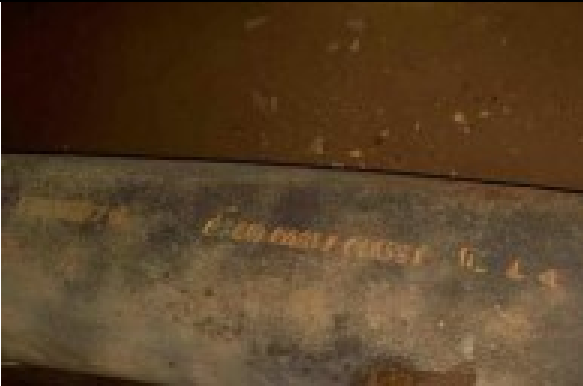
328	24-71128-3	Rope	Area 001 (Internal pipe run)	Does not contain asbestos

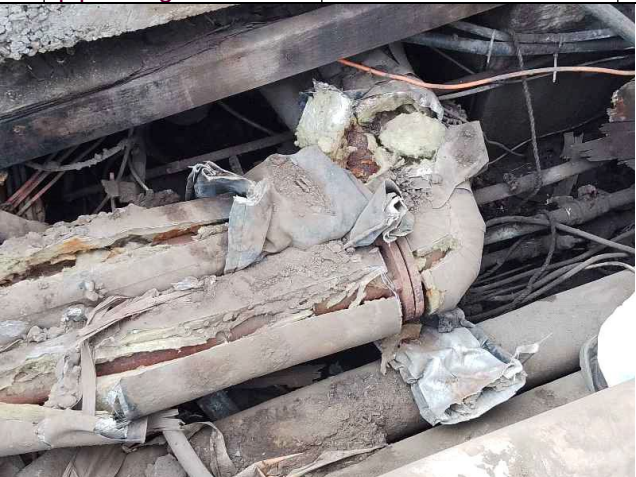
334	Presumed	Gasket within sealed pipe flange	External Duct 1/001	Very Low Risk
