ASBESTOS SURVEY REPORT FOR SOUTH HYLTON HOUSE, SOUTH HYLTON BANK, SR4 0JL.

South Hylton House, South Hylton Bank, SR4 0JL

Date: 23 January 2025

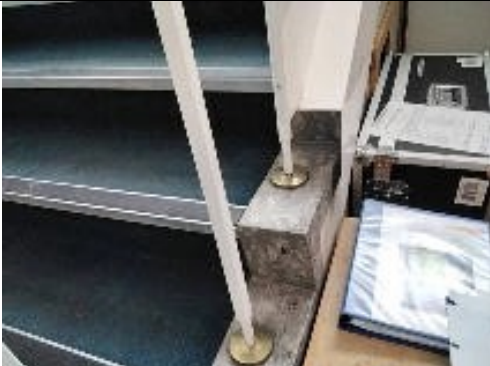
| Item No. | Sample Ref. | Area Sampled | Location Name | Inspection Frequency |
|---|---|--|---|---|
| 1 | KX000892 | Floor screed to stairs | Block 1, Ground Floor, Reception/Entrance Hall (Room G/002) | Low Risk |

| 1. | KX000892 | Floor screed to stairs | Block 1, Ground Floor, Reception/Entrance Hall (Room G/002) | Contains asbestos - Any change in its appearance should be recorded and passed to Property Services. |

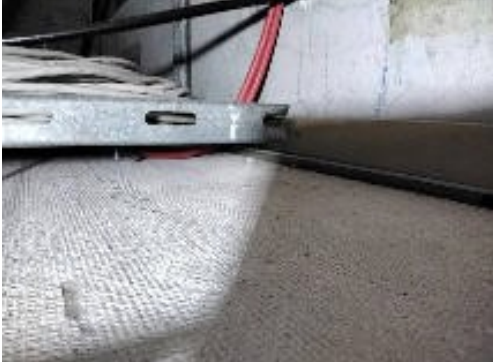
| Item No. | Sample Ref. | Area Sampled | Location Name | Inspection Frequency |
|---|---|--|---|---|
| 4 | As KX000893 | Ceiling void debris on tiles adjacent window header panel | Block 1, Ground Floor, Reception/Entrance Hall (Room G/002) | Medium Risk |

| 4. | As KX000893 | Ceiling void debris on tiles adjacent window header panel | Block 1, Ground Floor, Reception/Entrance Hall (Room G/002) | Contains asbestos - Any change in its appearance should be recorded and passed to Property Services. |

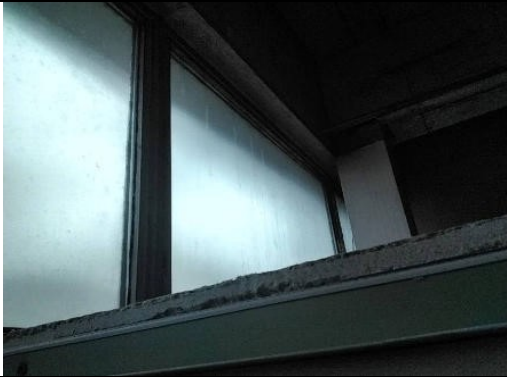
| 25. | As KX000898 | Window Putty seal | Block 1, Ground Floor, Cupboard (Room G/009) | Does not contain asbestos. |

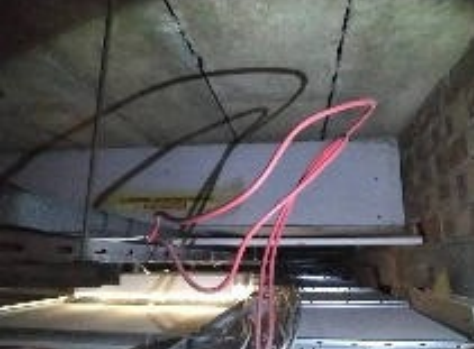
| 36. | As KX000894 | Ceiling Void Beam cladding x 4 | Block 1, Ground Floor, Corridor (Room G/017) | Contains asbestos - Any change in its appearance should be recorded and passed to Property Services. |

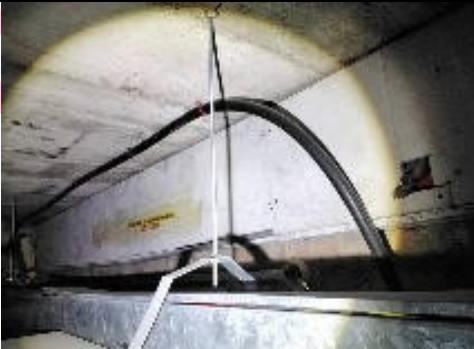
| 39. | As KX000894 | Ceiling Void Beam cladding | Block 1, Ground Floor, Office (Room G/018) | Contains asbestos - Any change in its appearance should be recorded and passed to Property Services. |

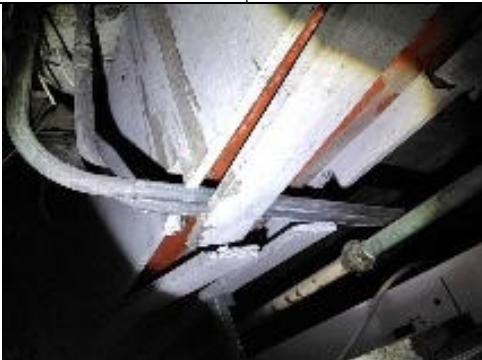
| 43. | As KX000894 | Ceiling Void Beam cladding | Block 1, Ground Floor, Office (Room G/019) | Contains asbestos - Any change in its appearance should be recorded and passed to Property Services. |

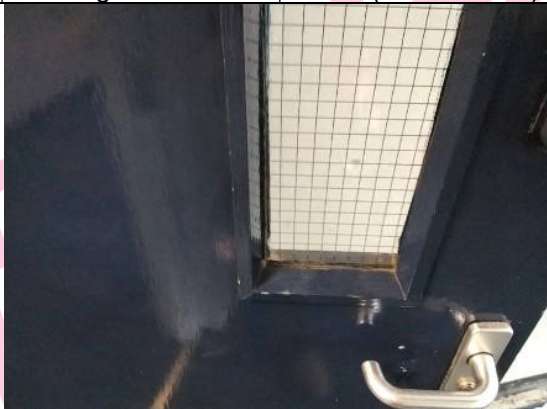
| 44. | KX000905 | Door window beading | Block 1, Ground Floor, Office (Room G/019) | Does not contain asbestos. |

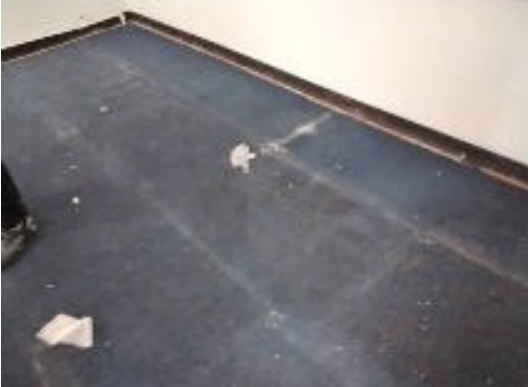
| 46. | KX000907 | Floor adhesive residue under floor covering | Block 1, Ground Floor, Office (Room G/019) | Contains asbestos - Any change in its appearance should be recorded and passed to Property Services. |

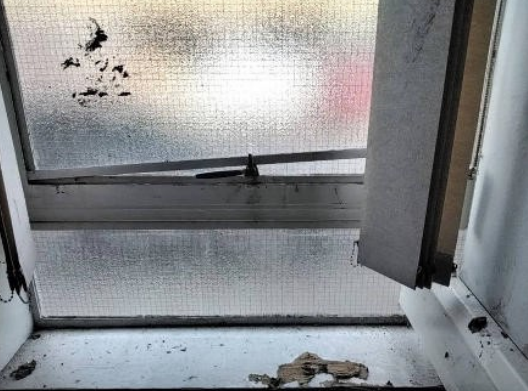
| 47. | As KX000898 | Window Putty seal | Block 1, Ground Floor, Office (Room G/019) | Does not contain asbestos. |

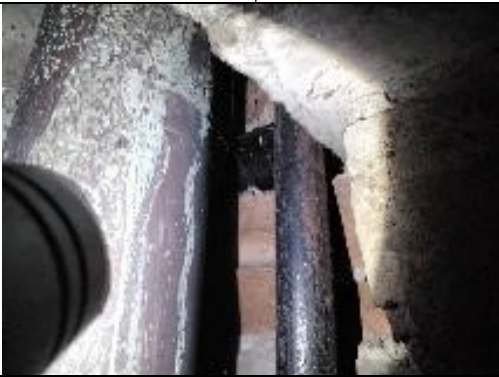
| 52. | As KX000906 | Ceiling void debris to stench pipe penetration | Block 1, Ground Floor, Office (Room G/020) | Contains asbestos - Any change in its appearance should be recorded and passed to Property Services. |

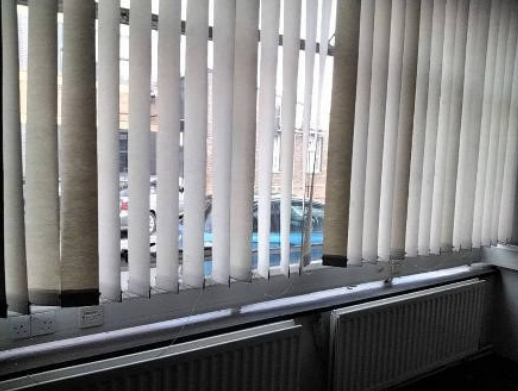
| 53. | As KX000898 | Window Putty seal | Block 1, Ground Floor, Office (Room G/020) | Does not contain asbestos. |

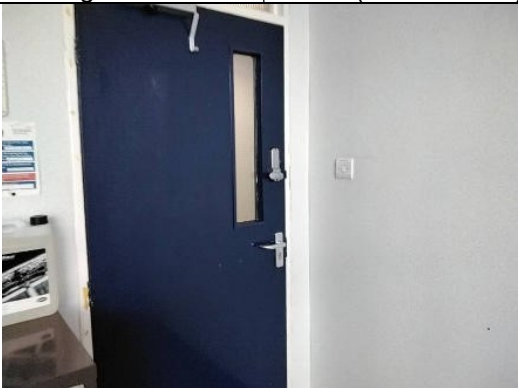
| 55. | As KX000905 | Door window beading | Block 1, Ground Floor, Office (Room G/021) | Does not contain asbestos. |

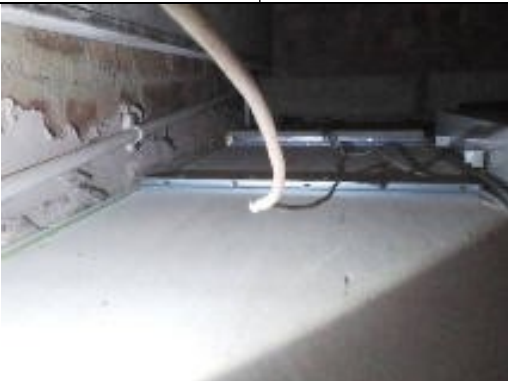
| 61 | As KX000894 | Ceiling void debris hanging off damaged beams | Block 1, Ground Floor, Office (Room G/022) | Medium Risk |

| 61. | As KX000894 | Ceiling void debris hanging off damaged beams | Block 1, Ground Floor, Office (Room G/022) | Contains asbestos - Any change in its appearance should be recorded and passed to Property Services. |

| | hanging off damaged beams | (Room G/022) | | | | | inspect |

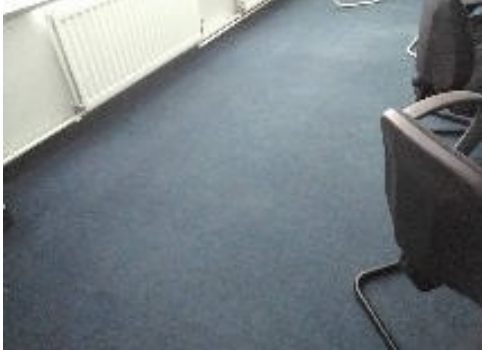
| 67. | As KX000907 | Floor adhesive residue under floor covering | Block 1, Ground Floor, Office (Room G/023) | Contains asbestos - Any change in its appearance should be recorded and passed to Property Services. |

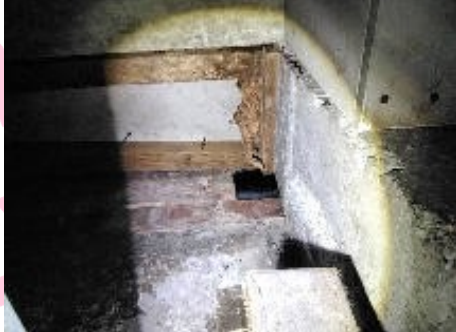
| 68. | As KX000906 | Ceiling void debris to stench pipe penetration | Block 1, Ground Floor, Office (Room G/023) | Contains asbestos - Any change in its appearance should be recorded and passed to Property Services. |

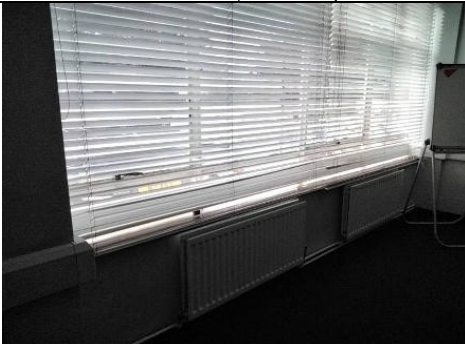
| 69. | As KX000898 | Window Putty seal | Block 1, Ground Floor, Office (Room G/023) | Does not contain asbestos. |

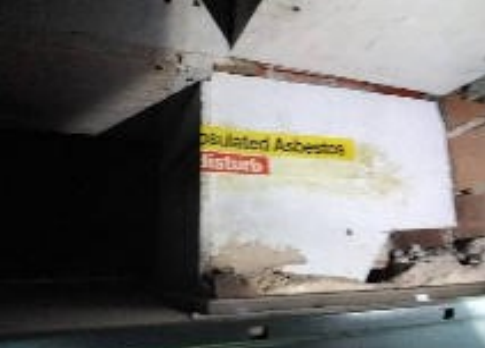
| 70. | As KX000897 | Ceiling void column cladding | Block 1, Ground Floor, Office (Room G/023) | Contains asbestos - Any change in its appearance should be recorded and passed to Property Services. |

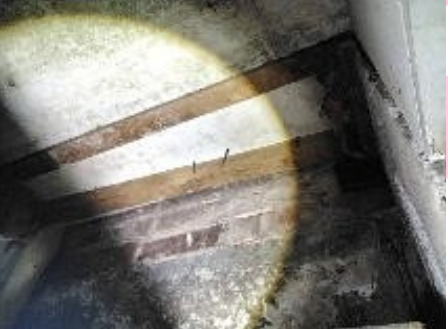
| 71. | KX000908 | Ceiling void ceiling above possible shuttering to outer left hand corner adjacent window | Block 1, Ground Floor, Office (Room G/023) | Contains asbestos - Any change in its appearance should be recorded and passed to Property Services. |

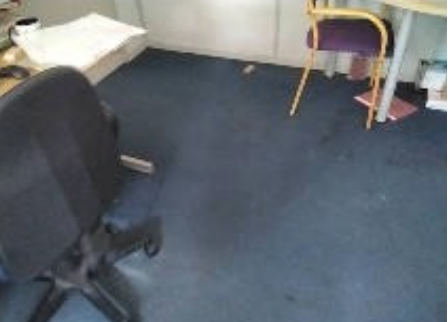
| 72. | As KX000907 | Floor adhesive residue under floor covering | Block 1, Ground Floor, Office (Room G/024) | Contains asbestos - Any change in its appearance should be recorded and passed to Property Services. |

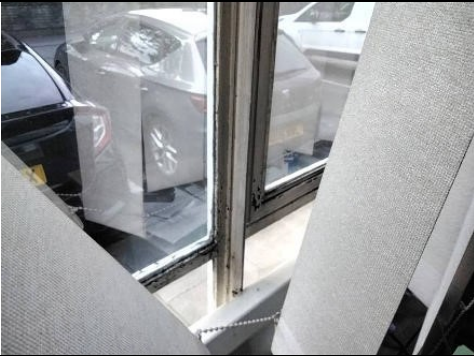
| 73. | As KX000898 | Window Putty seal | Block 1, Ground Floor, Office (Room G/024) | Does not contain asbestos. |

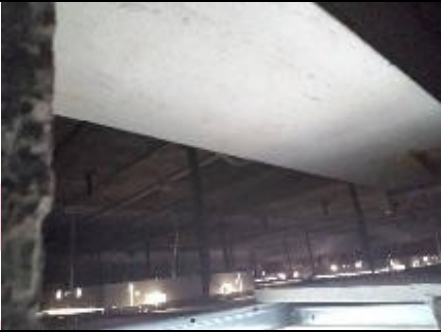
| 74. | As KX000894 | Ceiling void beam cladding | Block 1, Ground Floor, Large Office (Room G/025) | Contains asbestos - Any change in its appearance should be recorded and passed to Property Services. |

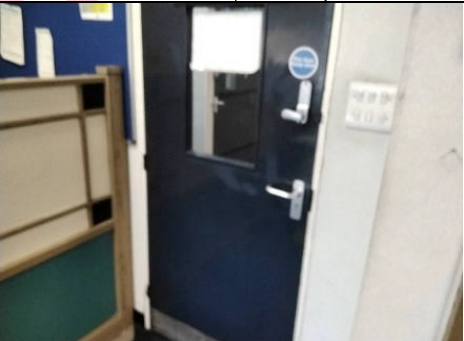
| 75. | As KX000905 | Door window beading | Block 1, Ground Floor, Large Office (Room G/025) | Does not contain asbestos. |

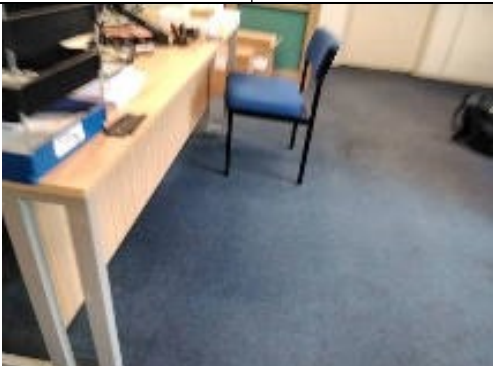
| 76. | As KX000907 | Floor adhesive residue under floor covering | Block 1, Ground Floor, Large Office (Room G/025) | Contains asbestos - Any change in its appearance should be recorded and passed to Property Services. |

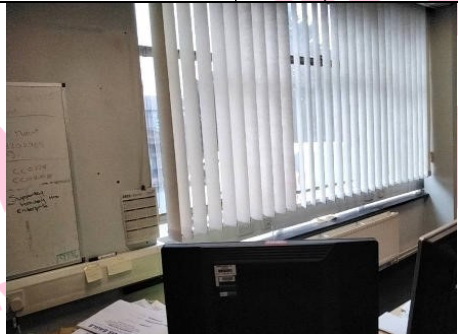
| 77. | As KX000898 | Window Putty seal | Block 1, Ground Floor, Large Office (Room G/025) | Does not contain asbestos. |

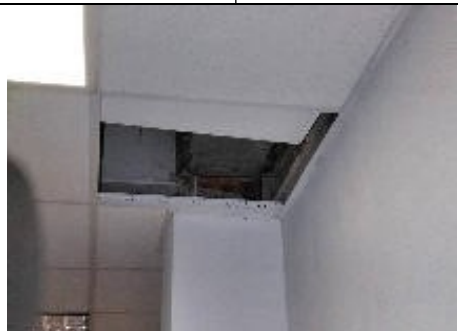
| 78. | As KX000897 | Ceiling void column cladding remnants | Block 1, Ground Floor, Large Office (Room G/025) | Contains asbestos - Any change in its appearance should be recorded and passed to Property Services. |

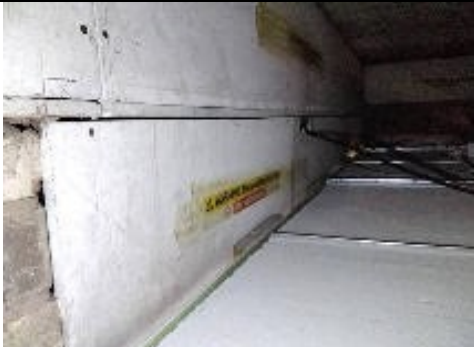
| 79. | As KX000893 | Ceiling Void Window Header Panel | Block 1, Ground Floor, Large Office (Room G/025) | Contains asbestos - Any change in its appearance should be recorded and passed to Property Services. |

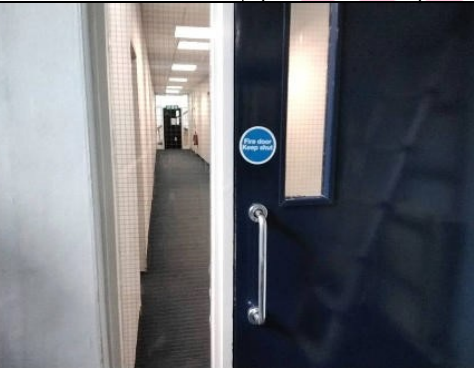
| 80. | As KX000900 | Door window beading | Block 1, Ground Floor, Staircase/Stairwell (Room G/026) | Does not contain asbestos. |

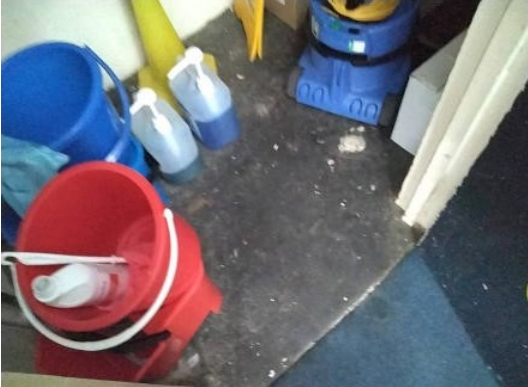
| 81. | KX000909 | Floor tile | Block 1, Ground Floor, Cupboard understairs (Room G/027) | Does not contain asbestos. |

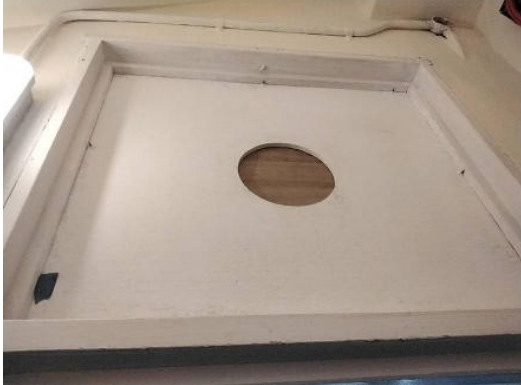
| 82. | KX000910 | Door header panel behind wooden panel, wooden board screwed through AIB | Block 1, Ground Floor, Cupboard understairs (Room G/027) | Does not contain asbestos. |

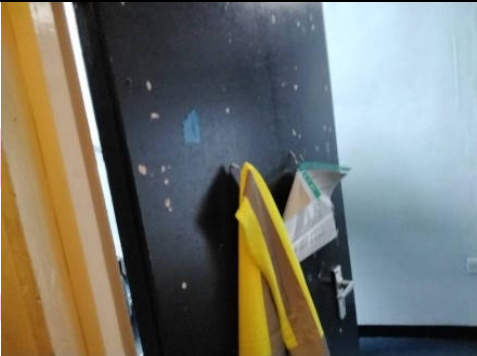
| 83. | KX000911 | Door protection board. | Block 1, Ground Floor, Cupboard understairs (Room G/027) | Does not contain asbestos. |

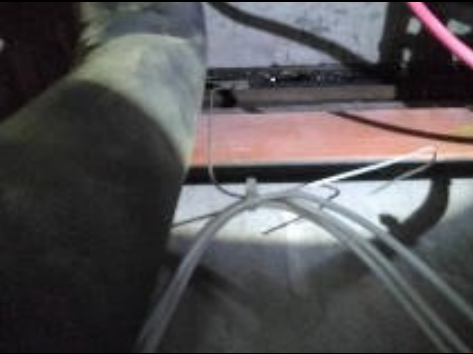
| 85. | As KX000906 | Ceiling void debris to timber frame | Block 1, Ground Floor, Corridor (Room G/028) | Contains asbestos - Any change in its appearance should be recorded and passed to Property Services. |

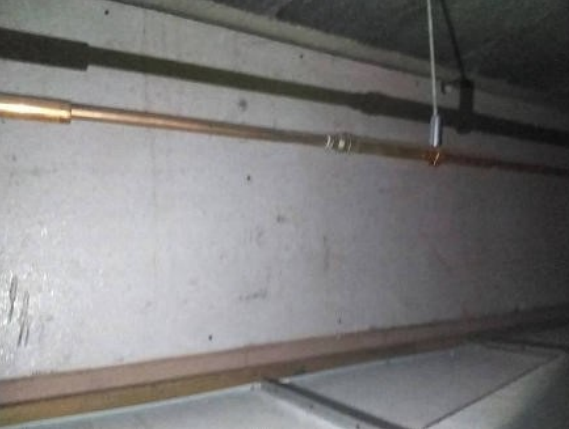
| 86. | KX000913 | Ceiling void fire breaks | Block 1, Ground Floor, Corridor (Room G/028) | Does not contain asbestos. |

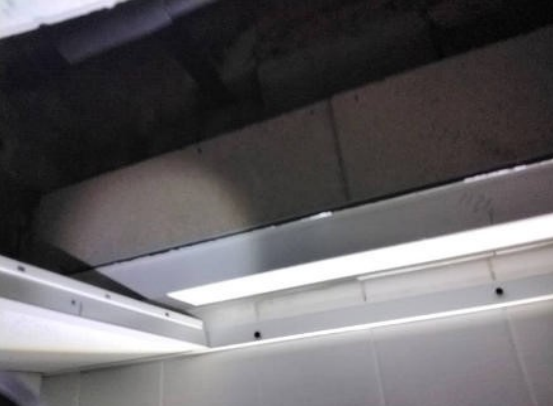
| 87. | As KX000912 | Ceiling void beam cladding | Block 1, Ground Floor, Hallway/Passageway (Room G/029) | Does not contain asbestos. |

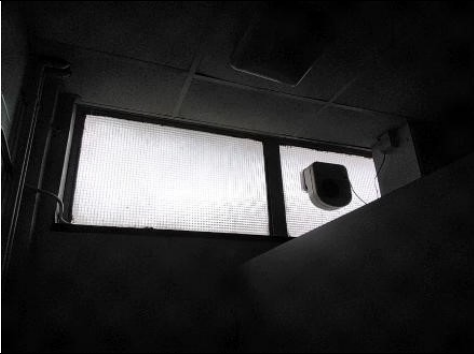
| 89. | As KX000903 | Window putty/seal | Block 1, Ground Floor, Toilets Female (Room G/030) | Does not contain asbestos. |

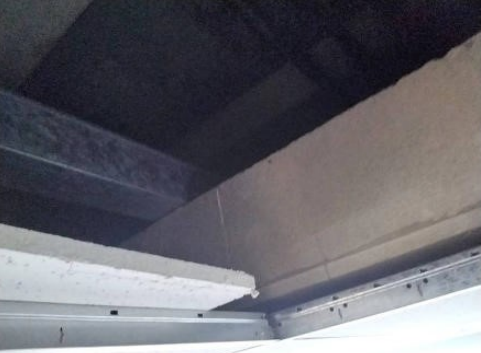
| 90. | As KX000912 | Ceiling void beam cladding | Block 1, Ground Floor, Corridor (Room G/031) | Does not contain asbestos. |

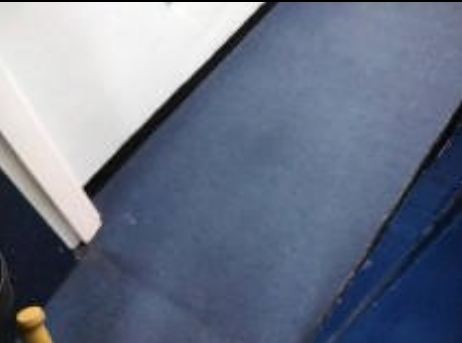
| 91. | As KX000907 | Floor adhesive residue under floor covering | Block 1, Ground Floor, Corridor (Room G/031) | Contains asbestos - Any change in its appearance should be recorded and passed to Property Services. |

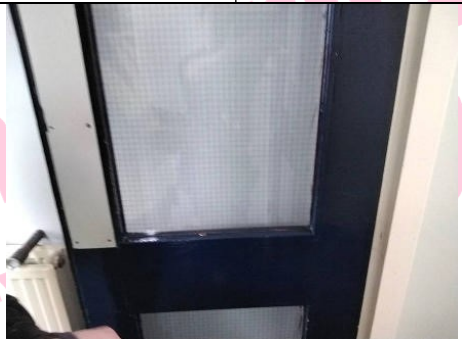
| 92. | KX000914 | Door window beading | Block 1, Ground Floor, Corridor (Room G/031) | Does not contain asbestos. |

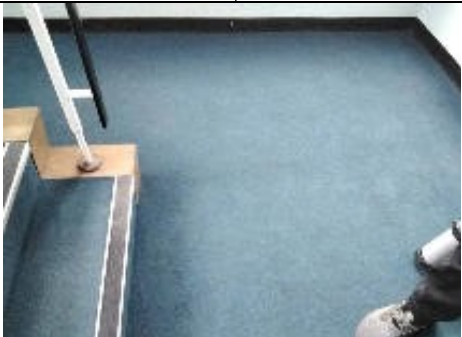
| 93. | As KX000907 | Floor adhesive residue under floor covering | Block 1, Ground Floor, Stairwell/Staircase (Room G/032) | Contains asbestos - Any change in its appearance should be recorded and passed to Property Services. |

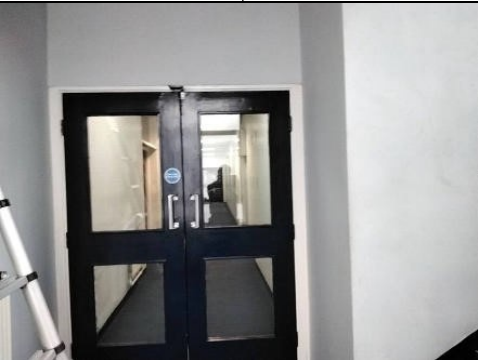
| 94. | As KX000914 | Door window beading | Block 1, Ground Floor, Stairwell/Staircase (Room G/032) | Does not contain asbestos. |

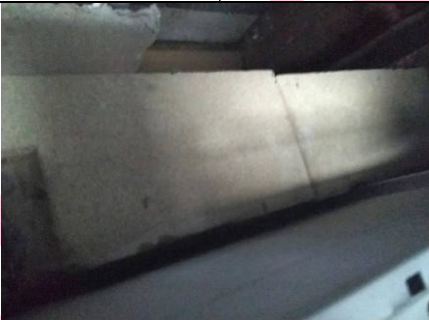
| 95. | As KX000912 | Ceiling void beam cladding | Block 1, Ground Floor, Stairwell/Staircase (Room G/032) | Does not contain asbestos. |

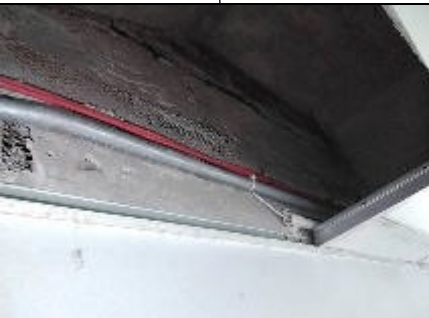
| 96. | As KX000906 | Wall lining visible in ceiling void | Block 1, Ground Floor, Stairwell/Staircase (Room G/032) | Contains asbestos - Any change in its appearance should be recorded and passed to Property Services. |

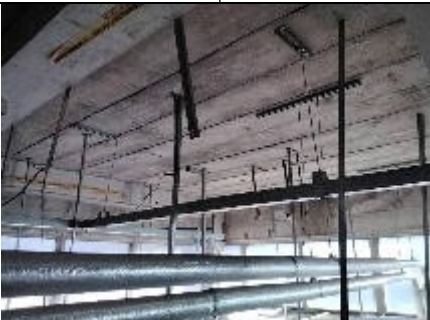
| 97. | As KX000894 | Ceiling void beam cladding | Block 1, Ground Floor, Store Room Ceiling void inspected only (Room G/033) | Contains asbestos - Any change in its appearance should be recorded and passed to Property Services. |

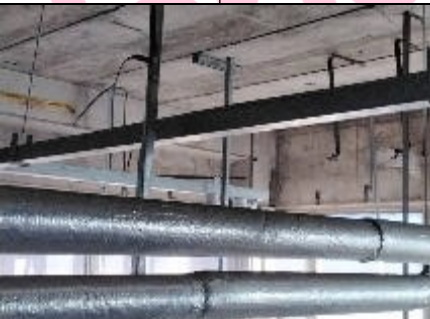
| 98. | As KX000897 | Ceiling void column cladding | Block 1, Ground Floor, Store Room Ceiling void inspected only (Room G/033) | Contains asbestos - Any change in its appearance should be recorded and passed to Property Services. |

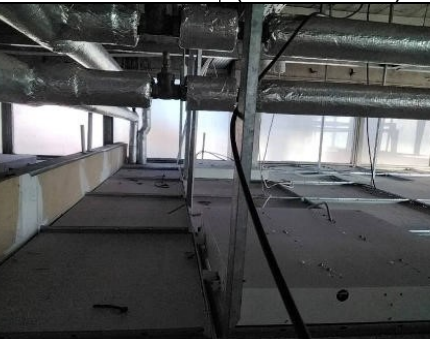
| 99. | KX000898 | Window Putty/seal | Block 1, Ground Floor, Store Room Ceiling void inspected only (Room G/033) | Does not contain asbestos. |

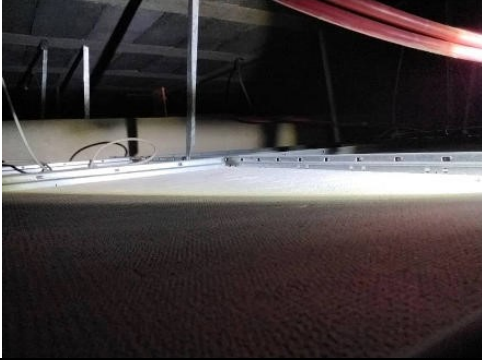
| 100. | As KX000912 | Ceiling void beam cladding | Block 1, Ground Floor, Store Room (Room G/034) | Does not contain asbestos. |

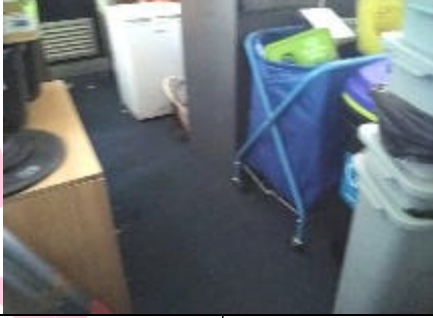
| 101. | As KX000907 | Floor adhesive residue under floor covering | Block 1, Ground Floor, Store Room (Room G/034) | Contains asbestos - Any change in its appearance should be recorded and passed to Property Services. |

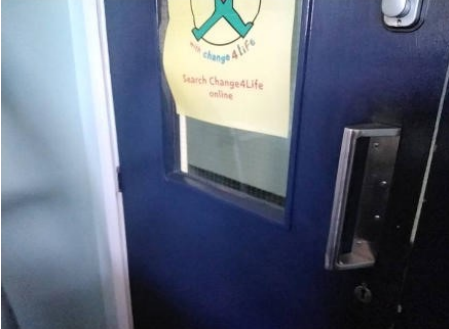
| 102. | As KX000914 | Door window beading | Block 1, Ground Floor, Store Room (Room G/034) | Does not contain asbestos. |

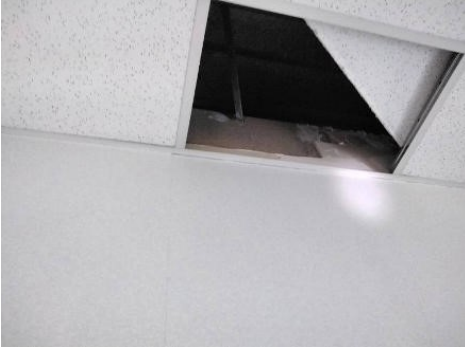
| 103. | As KX000912 | Ceiling void beam cladding | Block 1, Ground Floor, Large Office (Room G/035) | Does not contain asbestos. |

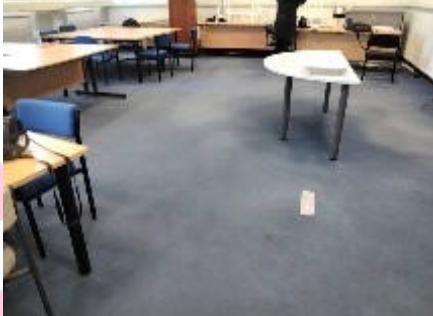
| 104. | As KX000907 | Floor adhesive residue under floor covering | Block 1, Ground Floor, Large Office (Room G/035) | Contains asbestos - Any change in its appearance should be recorded and passed to Property Services. |

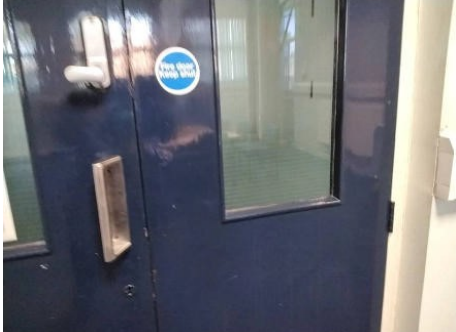
| 105. | As KX000914 | Door window beading | Block 1, Ground Floor, Large Office (Room G/035) | Does not contain asbestos. |

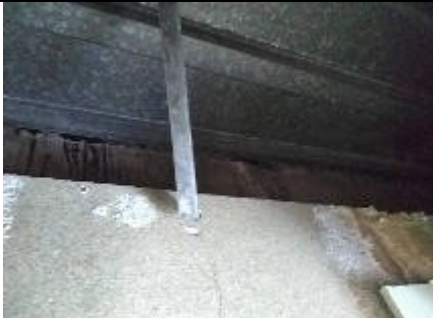
| 106. | As KX000906 | Ceiling void debris to stench pipe penetration | Block 1, Ground Floor, Large Office (Room G/035) | Contains asbestos - Any change in its appearance should be recorded and passed to Property Services. |

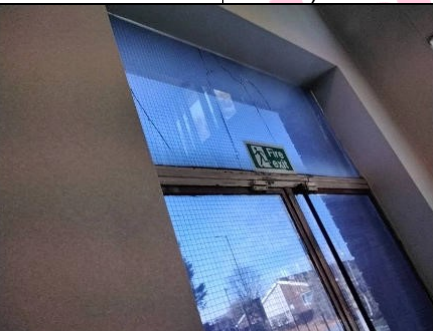
| 107. | KX000898 | Window Putty/seal | Block 1, Ground Floor, Large Office (Room G/035) | Does not contain asbestos. |

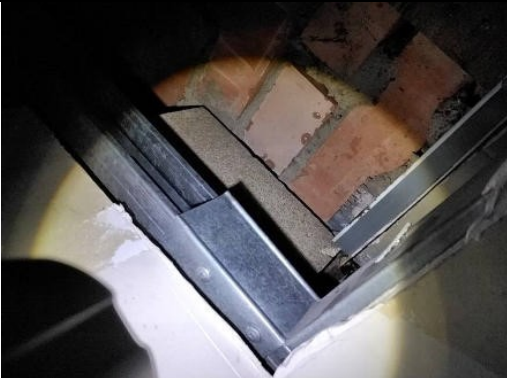
| 112. | KX000916 | Wall putty to column | Block 1, Ground Floor, Kitchen (Room G/036) | Does not contain asbestos. |

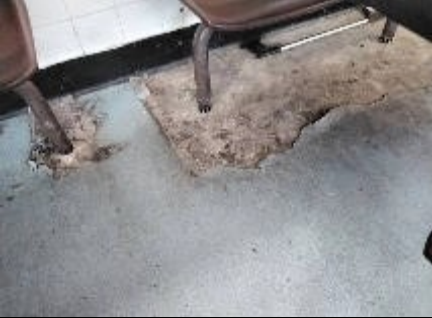
| 113. | KX000917 | Floor adhesive residue under lino | Block 1, Ground Floor, Staff Room (Room G/037) | Contains asbestos - Any change in its appearance should be recorded and passed to Property Services. |

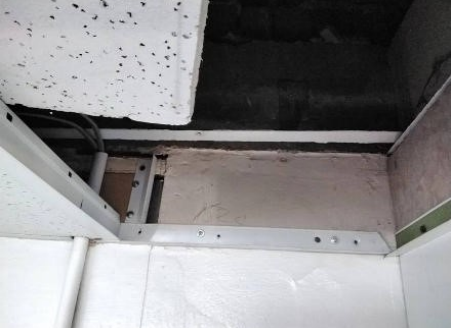
| 114. | KX000918 | Ceiling void debris to upper ceiling grid | Block 1, Ground Floor, Staff Room (Room G/037) | Does not contain asbestos. |

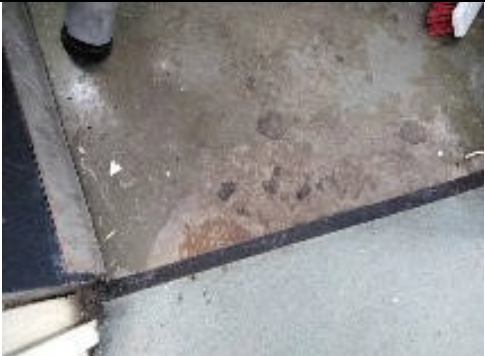
| 118. | As KX000917 | Floor adhesive residue under lino | Block 1, Ground Floor, Tank Room (Room G/038) | Contains asbestos - Any change in its appearance should be recorded and passed to Property Services. |

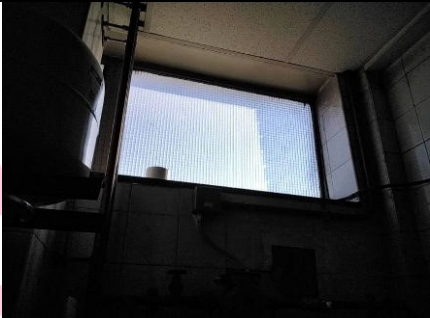
| 119. | As KX000903 | Window putty/seal | Block 1, Ground Floor, Tank Room (Room G/038) | Does not contain asbestos. |

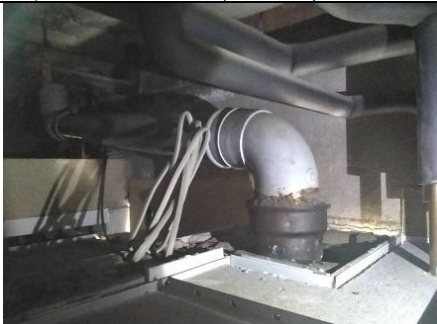
| 120. | KX000919 | Pipe joints caulking/packing to metal/plastic | Block 1, Ground Floor, Tank Room (Room G/038) | Does not contain asbestos. |

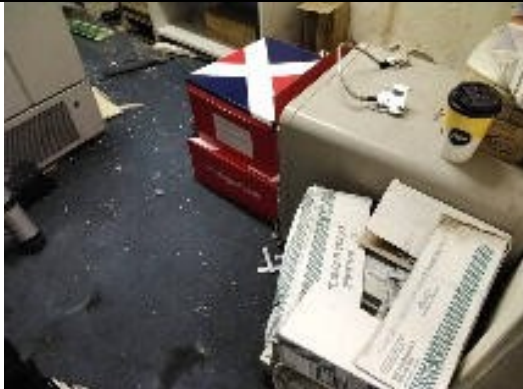
| 124. | As KX000936 | Floor tile (under floor covering) | Block 1, Ground Floor, Hub/Network Room (Room G/040) | Contains asbestos - Any change in its appearance should be recorded and passed to Property Services. |

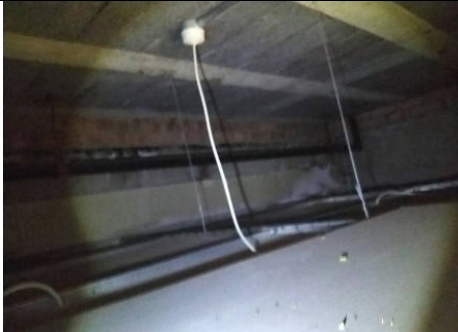
| 127. | As KX000912 | Ceiling void beam cladding | Block 1, Ground Floor, Storage Area (Room G/042) | Does not contain asbestos. |

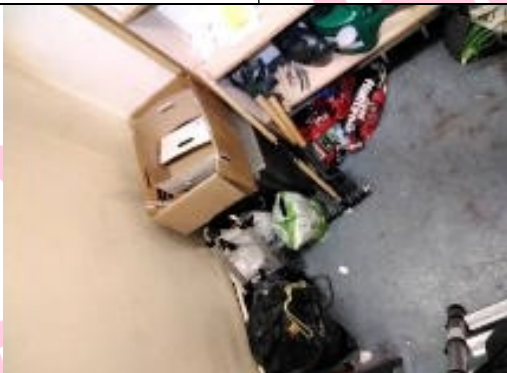
| 128. | As KX000907 | Floor adhesive residue under floor covering | Block 1, Ground Floor, Storage Area (Room G/042) | Contains asbestos - Any change in its appearance should be recorded and passed to Property Services. |

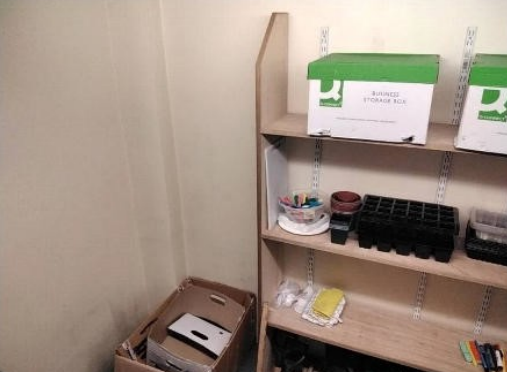
| 129. | KX000904 | Boxing vertical adhesive residue under floor covering | Block 1, Ground Floor, Storage Area (Room G/042) | Does not contain asbestos. |

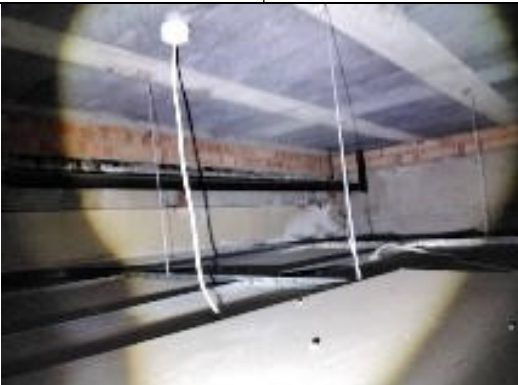
| 130. | As KX000906 | Ceiling void debris to wall | Block 1, Ground Floor, Storage Area (Room G/042) | Contains asbestos - Any change in its appearance should be recorded and passed to Property Services. |

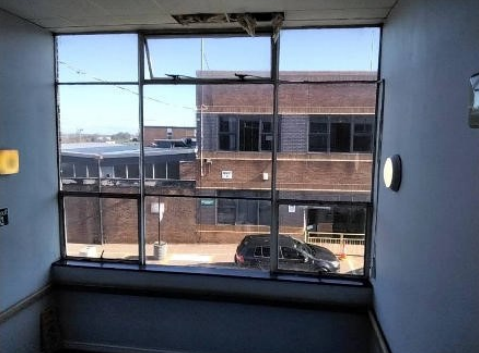
| 133. | As KX000903 | Window putty/seal | Block 1, First floor, Landing within Stairwell (room 1/001) | Does not contain asbestos. |

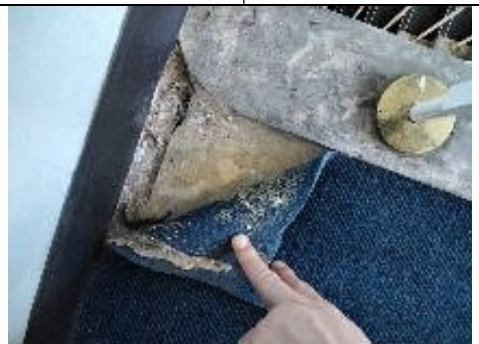
| 135. | KX000930 | Floor screed under carpet | Block 1, First Floor, Landing within Stairwell (Room 1/001) | Contains asbestos - Any change in its appearance should be recorded and passed to Property Services. |

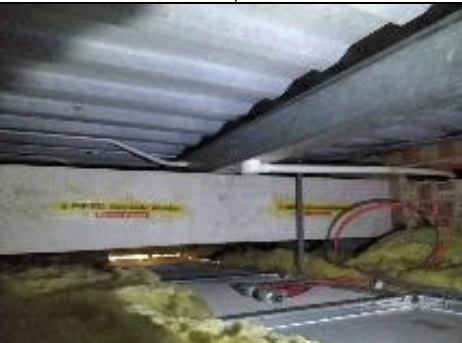
| 136. | As KX000928 | Ceiling void beam cladding x4 | Block 1, First Floor, Corridor (Room 1/002) | Contains asbestos - Any change in its appearance should be recorded and passed to Property Services. |

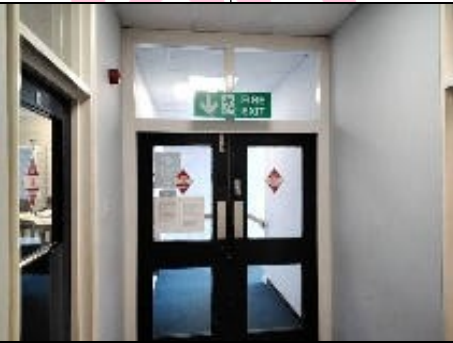
| 137. | As KX000929 | Door window beading including to header | Block 1, First Floor, Corridor (Room 1/002) | Contains asbestos - Any change in its appearance should be recorded and passed to Property Services. |

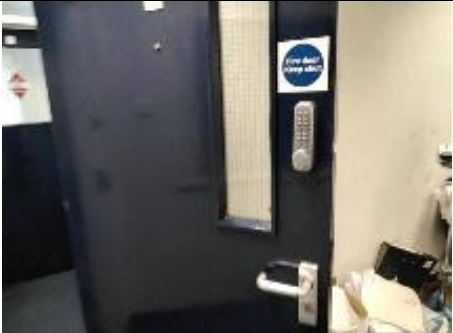
| 138. | As KX000929 | Door window beading including to header | Block 1, First Floor, Office (Room 1/003) | Contains asbestos - Any change in its appearance should be recorded and passed to Property Services. |

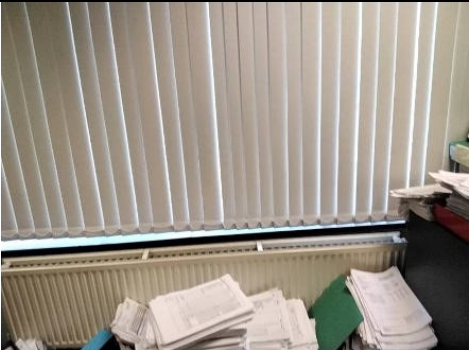
| 139. | As KX000903 | Window putty/seal | Block 1, First floor, Office (room 1/003) | Does not contain asbestos. |

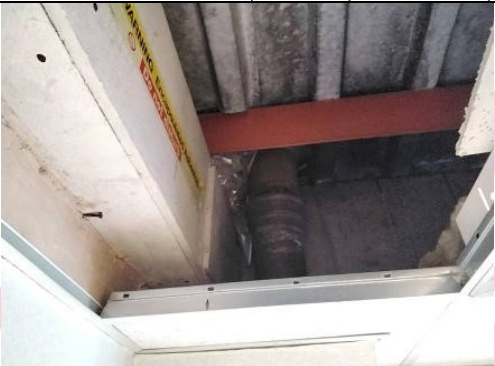
| 140. | KX000931 | Ceiling void roof felt from below | Block 1, First floor, Office (room 1/003) | Does not contain asbestos. |

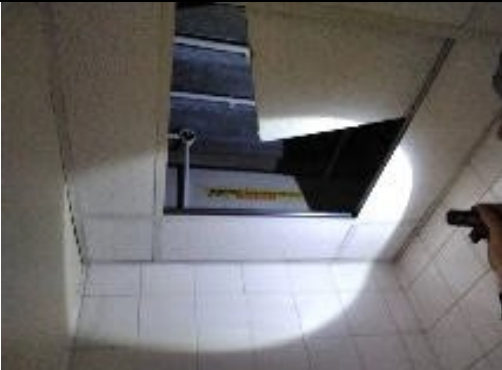
| 142. | As KX000928 | Ceiling void beam cladding | Block 1, First Floor, Kitchen (Room 1/004) | Contains asbestos - Any change in its appearance should be recorded and passed to Property Services. |

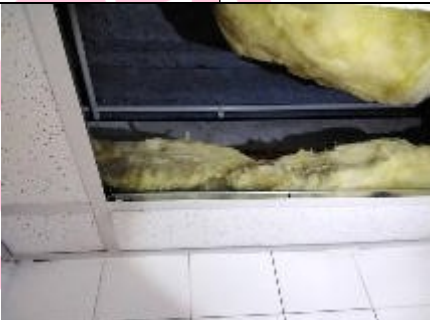
| 143. | As KX000928 | Ceiling void beam cladding | Block 1, First Floor, Hallway/passageway to female toilets (Room 1/005) | Contains asbestos - Any change in its appearance should be recorded and passed to Property Services. |

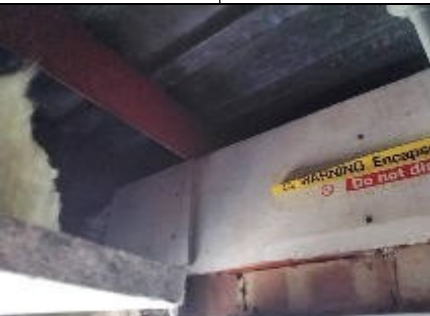
| 144. | As KX000928 | Ceiling void beam cladding | Block 1, First Floor, Female toilets (Room 1/006) | Contains asbestos - Any change in its appearance should be recorded and passed to Property Services. |

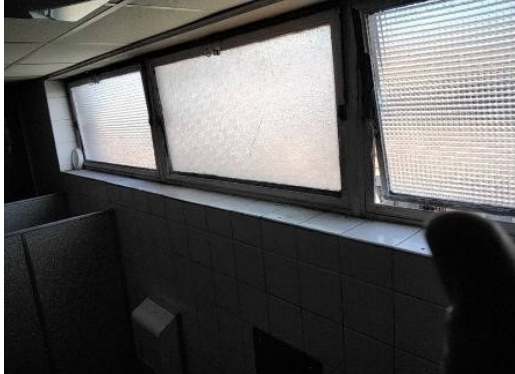
| 148. | As KX000903 | Window putty/seal | Block 1, First Floor, Female toilets (Room 1/006) | Does not contain asbestos. |

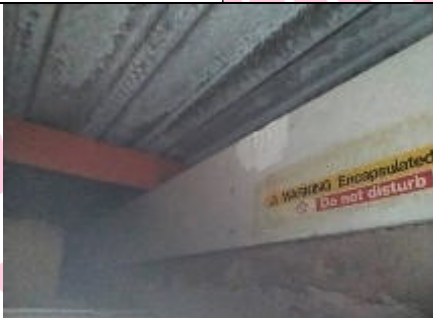
| 149. | As KX000928 | Ceiling void beam cladding x 2 | Block 1, First Floor, Store Room (Room 1/007) | Contains asbestos - Any change in its appearance should be recorded and passed to Property Services. |

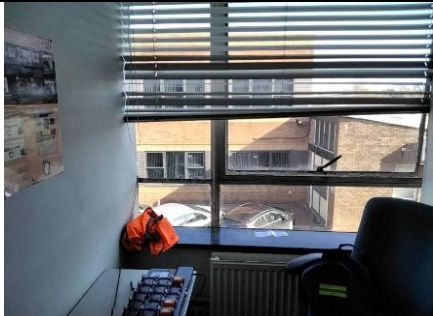
| 150. | As KX000903 | Window putty/seal | Block 1, First Floor, Store Room (Room 1/007) | Does not contain asbestos. |

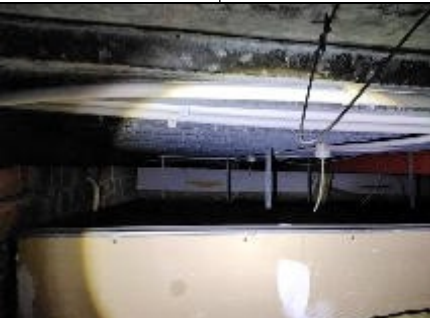
| 151. | As KX000928 | Ceiling void beam cladding | Block 1, First Floor, Office ceiling void from adjacent room (Room 1/008) | Contains asbestos - Any change in its appearance should be recorded and passed to Property Services. |

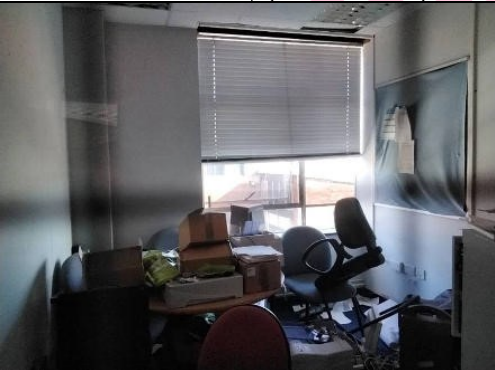
| 152. | As KX000903 | Window putty/seal | Block 1, First Floor, Office ceiling void from adjacent room (Room 1/008) | Does not contain asbestos. |

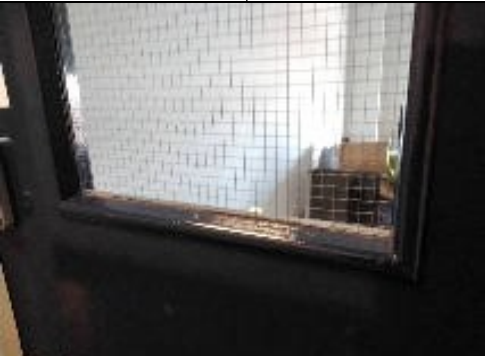
| 153. | As KX000929 | Door window beading including to header | Block 1, First Floor, Office ceiling void from adjacent room (Room 1/008) | Contains asbestos - Any change in its appearance should be recorded and passed to Property Services. |

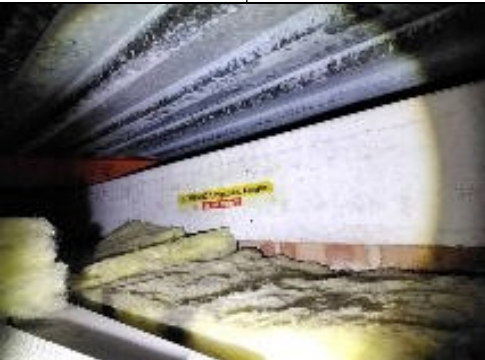
| 154. | As KX000928 | Ceiling void beam cladding | Block 1, First Floor, Office (Room 1/009) | Contains asbestos - Any change in its appearance should be recorded and passed to Property Services. |

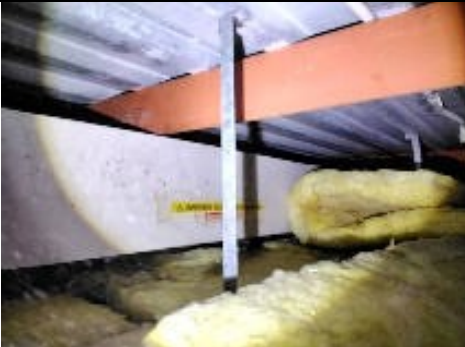
| 157. | As KX000928 | Ceiling void beam cladding | Block 1, First Floor, Office (Room 1/010) | Contains asbestos - Any change in its appearance should be recorded and passed to Property Services. |

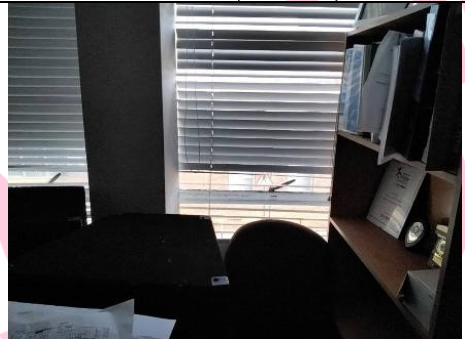
| 158. | As KX000903 | Window putty/seal | Block 1, First Floor, Office (Room 1/010) | Does not contain asbestos. |

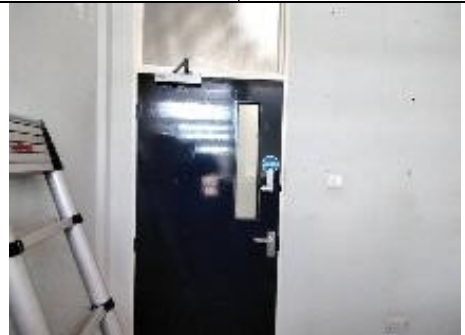
| 159. | As KX000929 | Door window beading including to header | Block 1, First Floor, Office (Room 1/010) | Contains asbestos - Any change in its appearance should be recorded and passed to Property Services. |

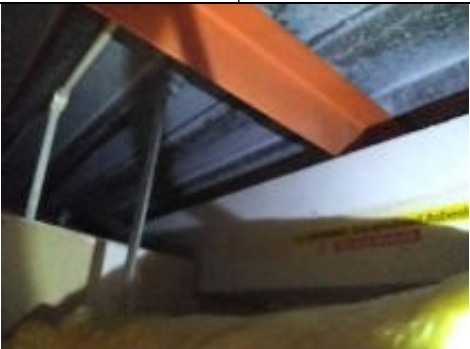
| 160. | As KX000928 | Ceiling void beam cladding | Block 1, First Floor, Store Room (Room 1/011) | Contains asbestos - Any change in its appearance should be recorded and passed to Property Services. |

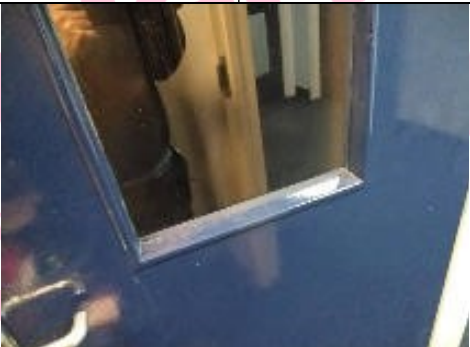
| 161. | As KX000929 | Door window beading including to header | Block 1, First Floor, Store Room (Room 1/011) | Contains asbestos - Any change in its appearance should be recorded and passed to Property Services. |

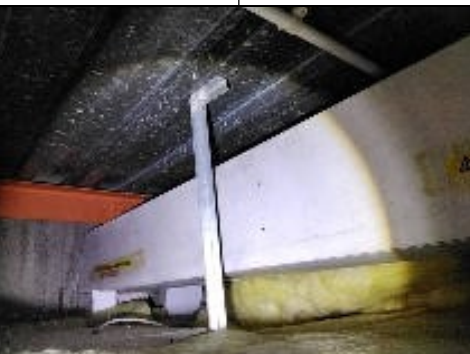
| 162. | As KX000928 | Ceiling void beam cladding | Block 1, First Floor, Office (Room 1/012) | Contains asbestos - Any change in its appearance should be recorded and passed to Property Services. |

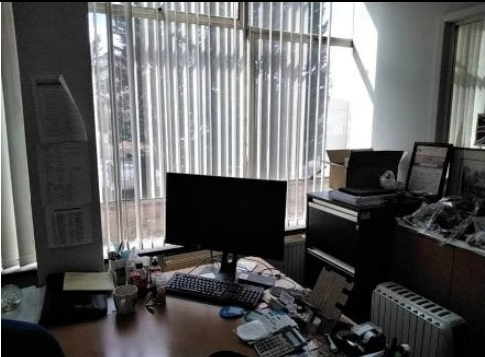
| 163. | As KX000903 | Window putty/seal | Block 1, First Floor, Office (Room 1/012) | Does not contain asbestos. |

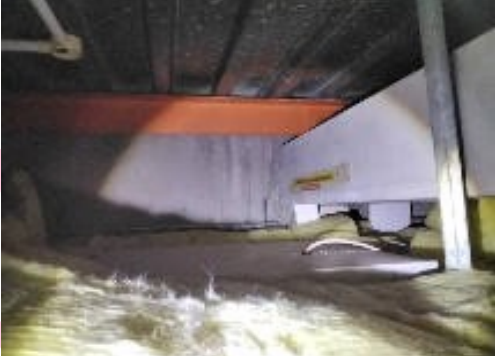
| 164. | As KX000928 | Ceiling void column cladding | Block 1, First Floor, Office (Room 1/012) | Contains asbestos - Any change in its appearance should be recorded and passed to Property Services. |

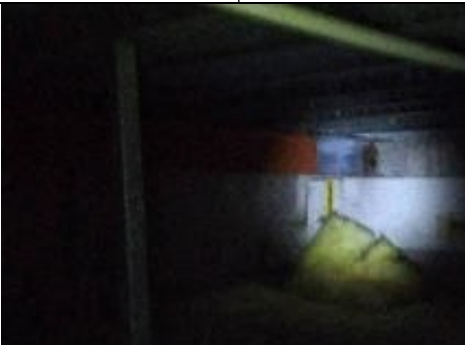
| 169. | As KX000928 | Ceiling void column cladding | Block 1, First Floor, Office Small (Room 1/014) | Contains asbestos - Any change in its appearance should be recorded and passed to Property Services. |

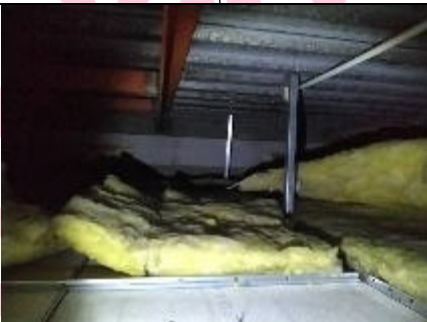
| 170. | As KX000928 | Ceiling void beam cladding | Block 1, First Floor, Office Small (Room 1/015) | Contains asbestos - Any change in its appearance should be recorded and passed to Property Services. |

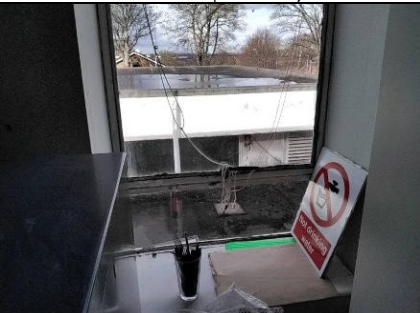
| 171. | As KX000903 | Window putty/seal | Block 1, First Floor, Office Small (Room 1/015) | Does not contain asbestos. |

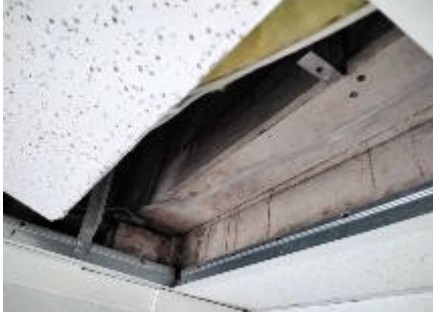
| 175. | As KX000928 | Ceiling void beam cladding | Block 1, First Floor, Office (Room 1/017) | Contains asbestos - Any change in its appearance should be recorded and passed to Property Services. |

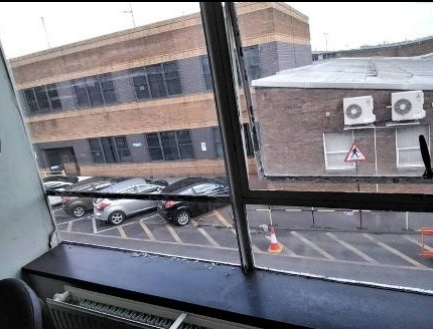
| 176. | As KX000903 | Window putty/seal | Block 1, First Floor, Office (Room 1/017) | Does not contain asbestos. |

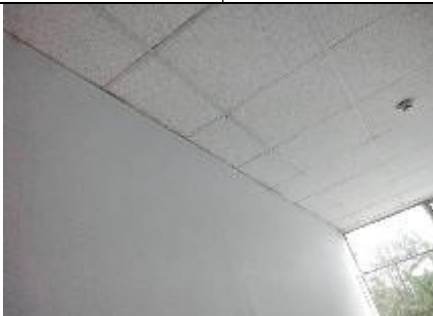
| 177. | As KX000928 | Ceiling void beam cladding | Block 1, First Floor, Landing and Stairwell (Room 1/018) | Contains asbestos - Any change in its appearance should be recorded and passed to Property Services. |

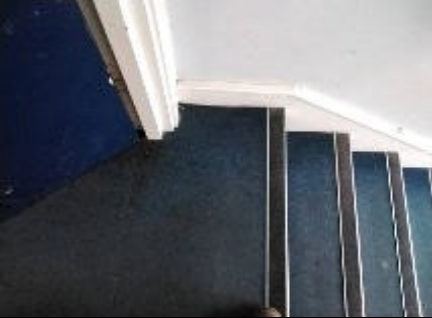
| 181. | As KX000930 | Floor screed under carpet | Block 1, First Floor, Landing and Stairwell (Room 1/018) | Contains asbestos - Any change in its appearance should be recorded and passed to Property Services. |

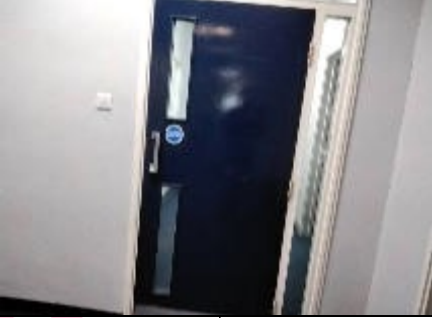
| 182. | As KX000929 | Door window beading including to header panels | Block 1, First Floor, Corridor (Room 1/019) | Contains asbestos - Any change in its appearance should be recorded and passed to Property Services. |

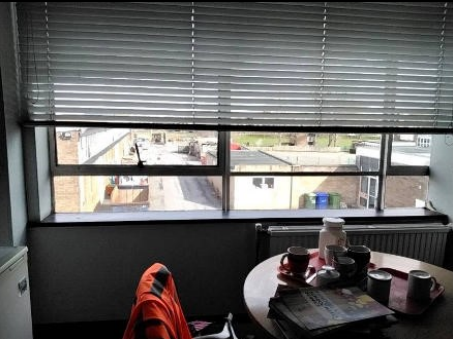
| 184. | As KX000903 | Window putty/seal | Block 1, First Floor, Office (Room 1/22) | Does not contain asbestos. |

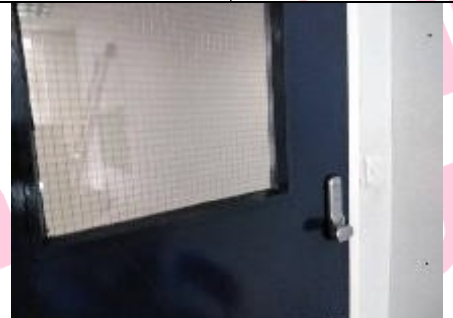
| 185. | As KX000929 | Door window beading | Block 1, First Floor, Office (Room 1/22) | Contains asbestos - Any change in its appearance should be recorded and passed to Property Services. |

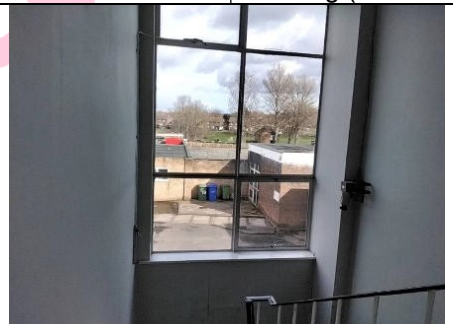
| 186. | As KX000903 | Window putty/seal | Block 1, First Floor, Landing (Room 1/23) | Does not contain asbestos. |

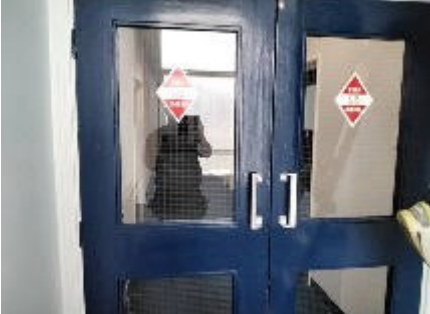
| 187. | As KX000929 | Door window beading | Block 1, First Floor, Landing (Room 1/023) | Contains asbestos - Any change in its appearance should be recorded and passed to Property Services. |

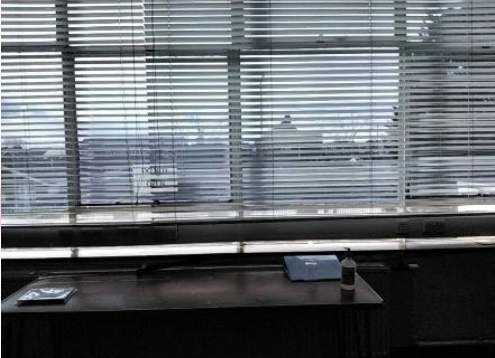
| 188. | As KX000903 | Window putty/seal | Block 1, First Floor, Office (Room 1/24) | Does not contain asbestos. |

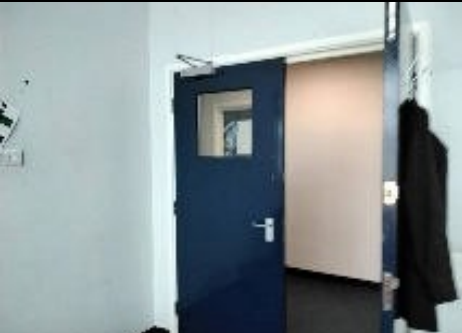
| 189. | As KX000929 | Door window beading | Block 1, First Floor, Office (Room 1/024) | Contains asbestos - Any change in its appearance should be recorded and passed to Property Services. |

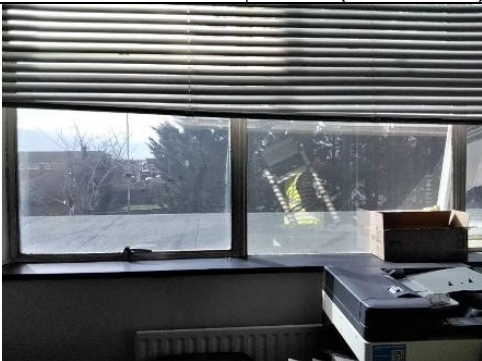
| 190. | As KX000903 | Window putty/seal | Block 1, First Floor, Office (Room 1/25) | Does not contain asbestos. |

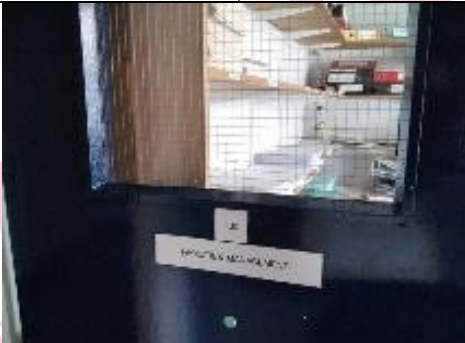
| 191. | As KX000929 | Door window beading | Block 1, First Floor, Office (Room 1/025) | Contains asbestos - Any change in its appearance should be recorded and passed to Property Services. |

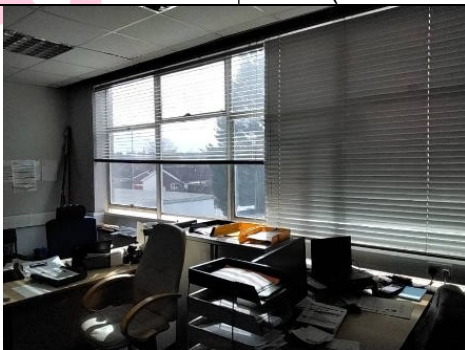
| 192. | As KX000903 | Window putty/seal | Block 1, First Floor, Office (Room 1/26) | Does not contain asbestos. |

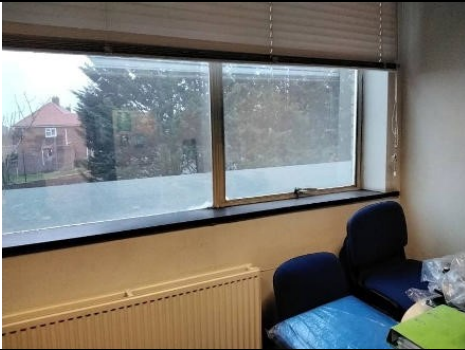
| 193. | As KX000903 | Window putty/seal | Block 1, First Floor, Office (Room 1/27) | Does not contain asbestos. |
