ASBESTOS SURVEY REPORT FOR SOUTH HYLTON HOUSE, SOUTH HYLTON BANK, SR4 0JL.

South Hylton House, South Hylton Bank, SR4 0JL

Date: 23 January 2025

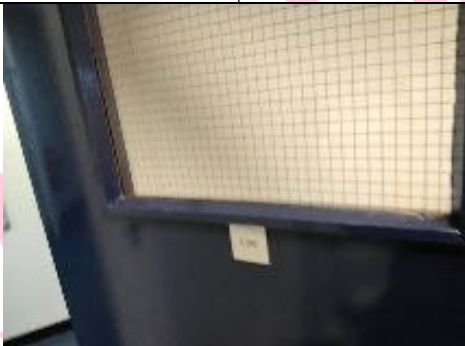
| 194. | As KX000929 | Door window beading | Block 1, First Floor, Office (Room 1/027) | Contains asbestos - Any change in its appearance should be recorded and passed to Property Services. |

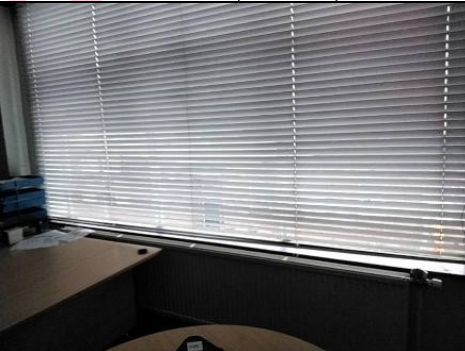
| 195. | As KX000903 | Window putty/seal | Block 1, First Floor, Office (Room 1/28) | Does not contain asbestos. |

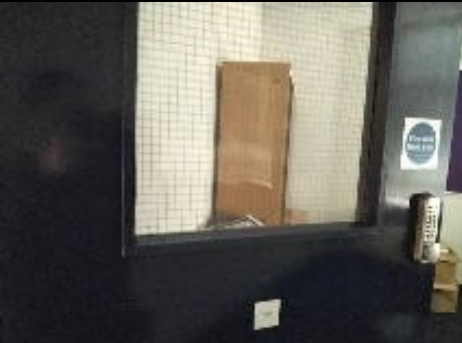
| 196. | As KX000929 | Door window beading | Block 1, First Floor, Office (Room 1/028) | Contains asbestos - Any change in its appearance should be recorded and passed to Property Services. |

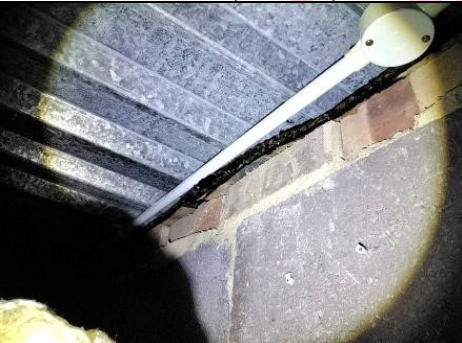
| 197. | KX000935 | Ceiling void Packer to timber | Block 1, First Floor, Office (Room 1/28) | Does not contain asbestos. |

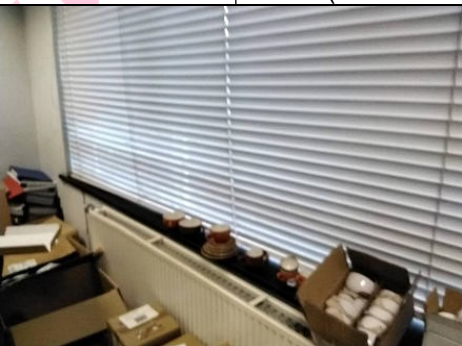
| 198. | As KX000903 | Window putty/seal | Block 1, First Floor, Office (Room 1/29) | Does not contain asbestos. |

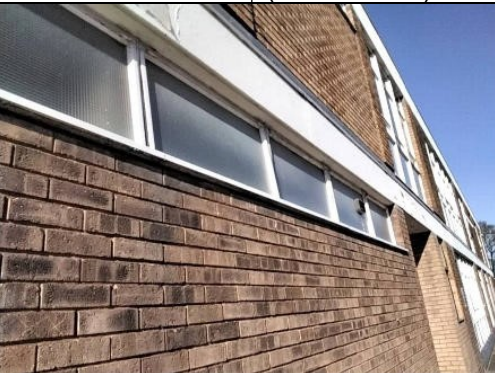
| 205. | KX000921 | Window putty seal | Block 1, External (Room E/001) | Does not contain asbestos. |

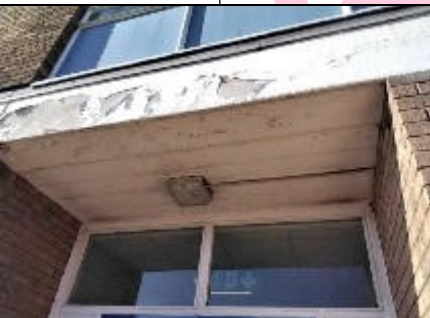
| 206. | As KX000895 | Canopy ceiling external canopy rear double doors | Block 1, External (Room E/001) | Contains asbestos - Any change in its appearance should be recorded and passed to Property Services. |

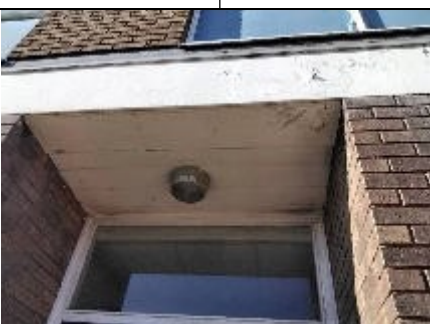
| 207. | As KX000895 | Canopy ceiling external canopy to mess room | Block 1, External (Room E/001) | Contains asbestos - Any change in its appearance should be recorded and passed to Property Services. |

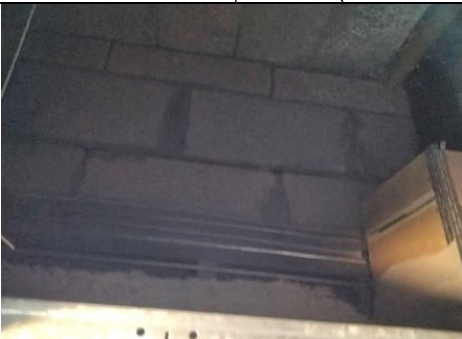
| 218. | KX000938 | Wall lining | Block 2, Ground Floor, Toilets (Room G/009) | Does not contain asbestos. |

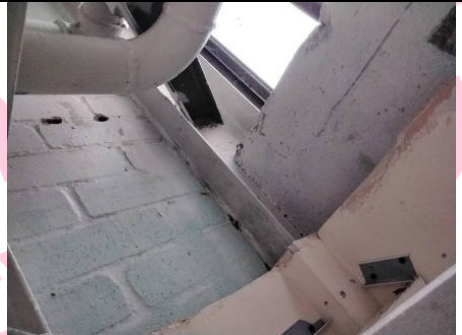
| 219. | KX000942 | Putty to column | Block 2, Ground Floor, Office Service Support (Room G/015) | Does not contain asbestos. |

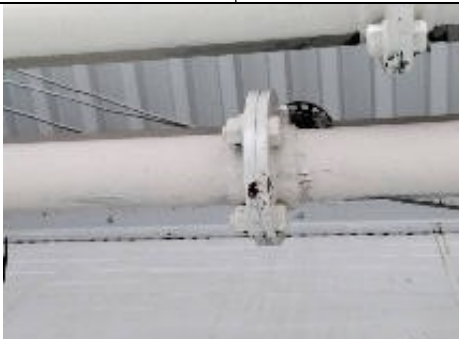
| 220. | Presumed | Ceiling void pipework | Block 2, Ground Floor, Office Service Support (Room G/015) | Presumed to contain asbestos - Any change in its appearance should be recorded and passed to Property Services. |

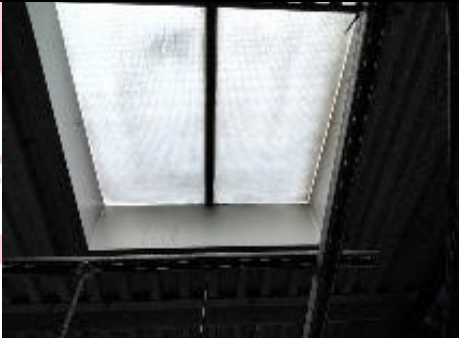
| 221. | Presumed | Roof Skylight gasket | Block 2, Ground Floor, Office Service Support (Room G/015) | Presumed to contain asbestos - Any change in its appearance should be recorded and passed to Property Services. |

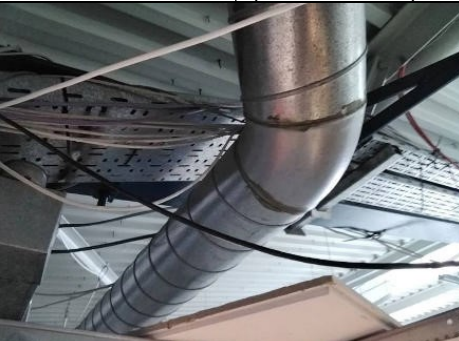
| 222. | KX000943 | Ceiling void ductwork jointing | Block 2, Ground Floor, Office Service Support (Room G/015) | Does not contain asbestos. |

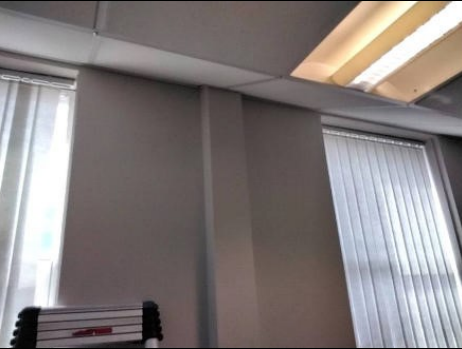
| 223. | KX000944 | Wall coating | Block 2, Ground Floor, Office Service Support (Room G/015) | Does not contain asbestos. |

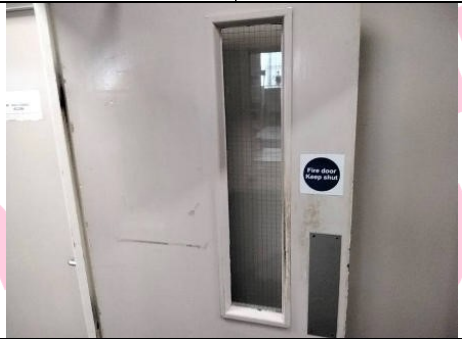
| 224. | KX000945 | Door window beading | Block 2, Ground Floor, Office Service Support (Room G/015) | Does not contain asbestos. |

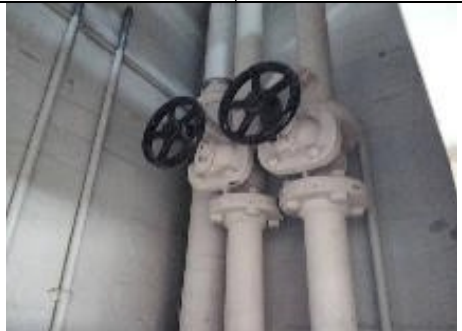
| 225. | Presumed | Pipework gasket | Block 2, Ground Floor, Cupboard Services (Room G/018) | Presumed to contain asbestos - Any change in its appearance should be recorded and passed to Property Services. |

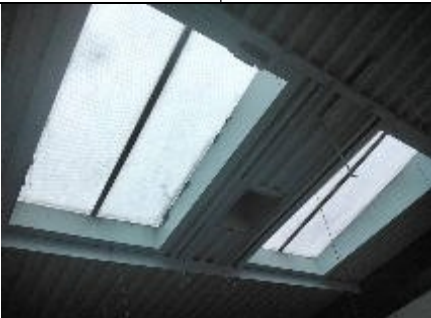
| 235. | Presumed | Roof skylight gasket | Block 2, Ground Floor, Office (Room G/022) | Presumed to contain asbestos - Any change in its appearance should be recorded and passed to Property Services. |

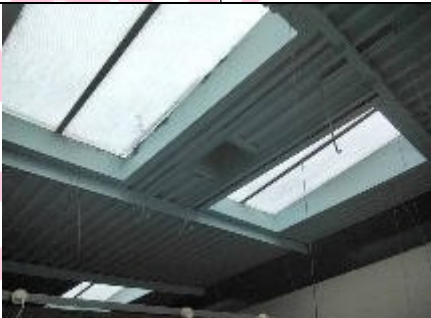
| 236. | Presumed | Roof vent lining upstands between skylights | Block 2, Ground Floor, Office (Room G/022) | Presumed to contain asbestos - Any change in its appearance should be recorded and passed to Property Services. |

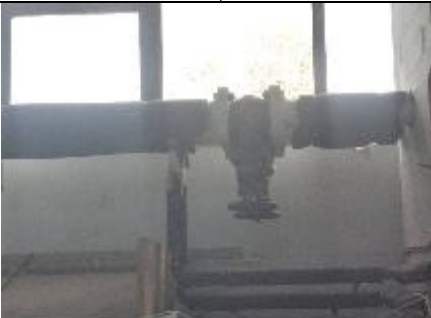
| 237. | As KX000951 | Pipework gaskets | Block 2, Ground Floor, Office (Room G/022) | Contains asbestos - Any change in its appearance should be recorded and passed to Property Services. |

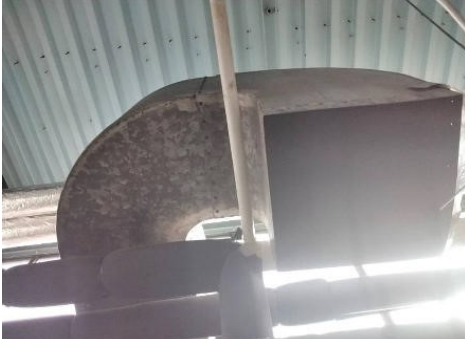
| 238. | KX000949 | Ceiling void ductwork jointing | Block 2, Ground Floor, Office (Room G/022) | Does not contain asbestos. |

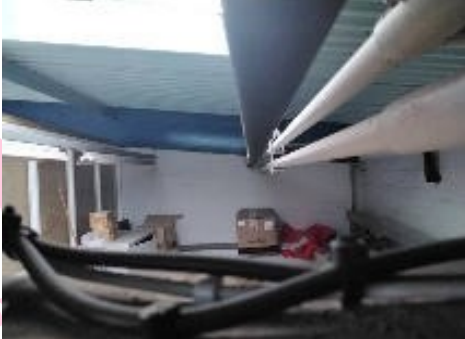
| 239. | As KX000948 | Firebreak above beams to roof cladding | Block 2, Ground Floor, Store Room (Room G/023) | Contains asbestos - Any change in its appearance should be recorded and passed to Property Services. |

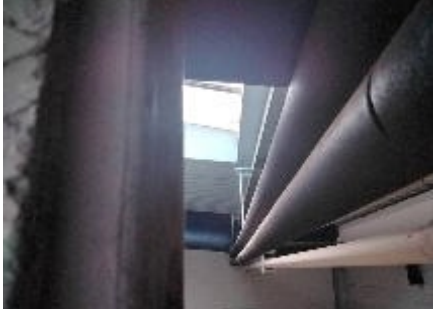
| 240. | Presumed | Roof skylight gasket | Block 2, Ground Floor, Store Room (Room G/023) | Presumed to contain asbestos - Any change in its appearance should be recorded and passed to Property Services. |

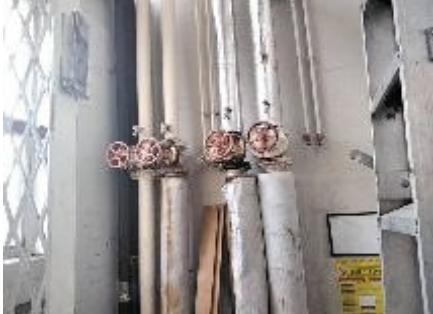
| 244. | KX000951 | Pipework Gaskets | Block 2, Ground Floor, Switch Room (Room G/025) | Contains asbestos - Any change in its appearance should be recorded and passed to Property Services. |

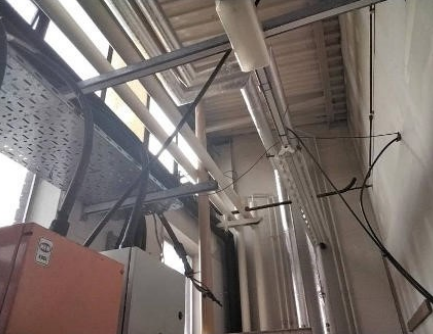
| 245. | As KX000942 | Putty to column | Block 2, Ground Floor, Switch Room (Room G/025) | Does not contain asbestos. |

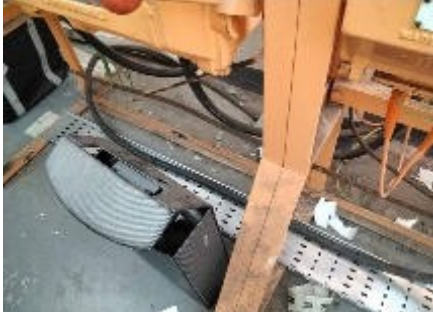
| 246. | KX000952 | Debris poured bitumen set to floor | Block 2, Ground Floor, Switch Room (Room G/025) | Contains asbestos - Any change in its appearance should be recorded and passed to Property Services. |

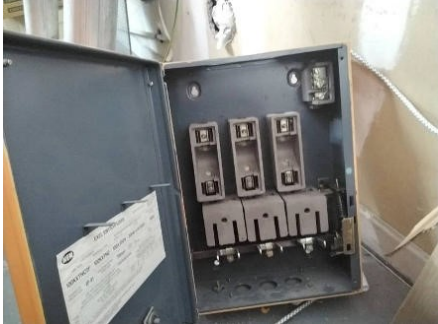
| 247. | KX000953 | Electrical services fuses/flashguards putty behind removed fuses redundant orange fuse box | Block 2, Ground Floor, Switch Room (Room G/025) | Does not contain asbestos. |

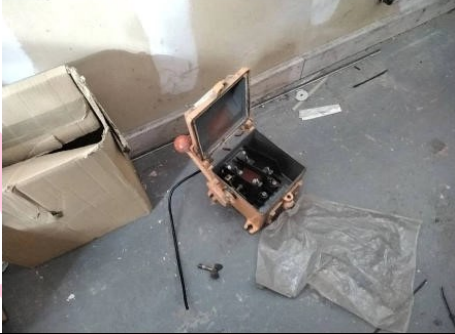
| 248. | KX000954 | Electrical services door seal/gaskets redundant orange switch box | Block 2, Ground Floor, Switch Room (Room G/025) | Does not contain asbestos. |

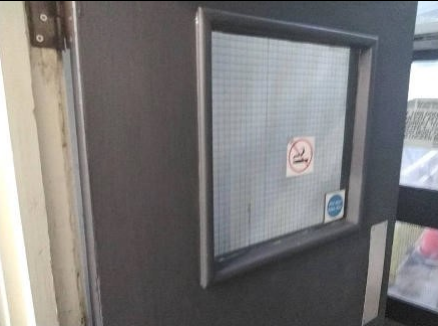
| 253. | As KX000945 | Door window beading including door header panel | Block 2, Ground Floor, Locker Room (Room G/030) | Does not contain asbestos. |

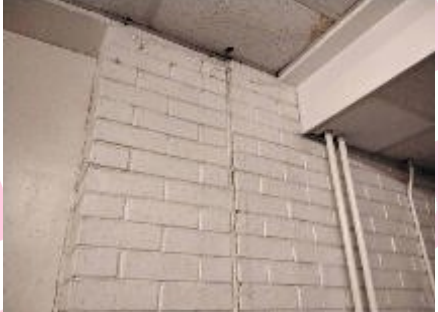
| 254. | As KX000947 | Wall expansion joint | Block 2, Ground Floor, Locker Room (Room G/030) | Contains asbestos - Any change in its appearance should be recorded and passed to Property Services. |

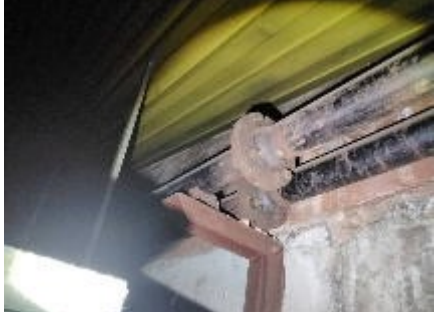
| 255. | Presumed | Pipework Gasket | Block 2, Ground Floor, Locker Room (Room G/030) | Presumed to contain asbestos - Any change in its appearance should be recorded and passed to Property Services. |

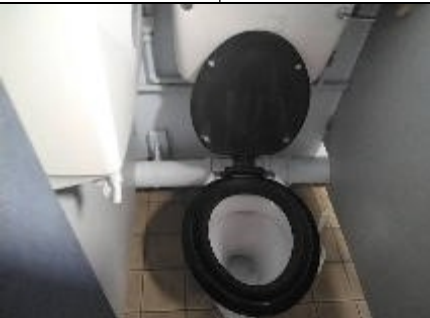
| 259. | Presumed | Toilet seats | Block 2, Ground Floor, Male Toilets (Room G/032) | Presumed to contain asbestos - Any change in its appearance should be recorded and passed to Property Services. |

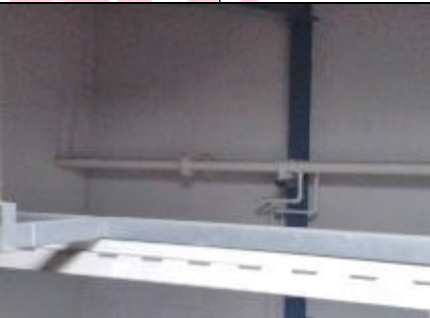
| 260. | Presumed | Pipework Gasket | Block 2, Ground Floor, Store Room (Room G/033) | Presumed to contain asbestos - Any change in its appearance should be recorded and passed to Property Services. |

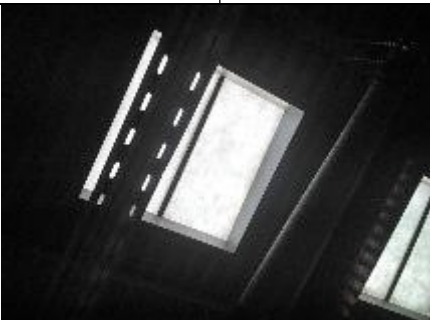
| 261. | Presumed | Roof Skylight Gasket | Block 2, Ground Floor, Workshop Mechanical (Room G/034) | Presumed to contain asbestos - Any change in its appearance should be recorded and passed to Property Services. |

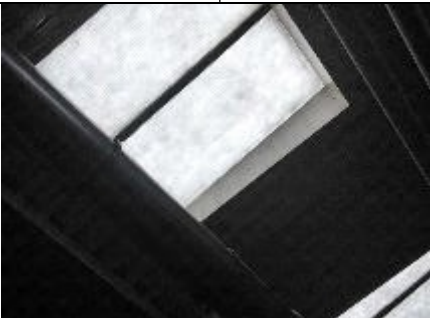
| 265. | Presumed | Roof Skylight Gasket | Block 2, Ground Floor, Workshop joinery (Room G/036) | Presumed to contain asbestos - Any change in its appearance should be recorded and passed to Property Services. |

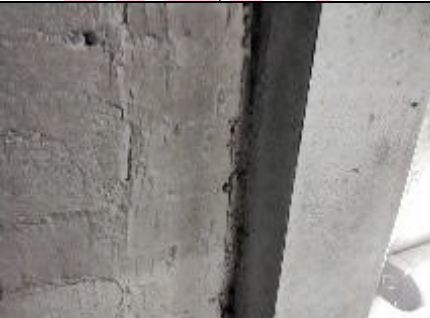
| 266. | KX000963 | Wall packing to structural columns | Block 2, Ground Floor, Garage (Room G/037) | Contains asbestos - Any change in its appearance should be recorded and passed to Property Services. |

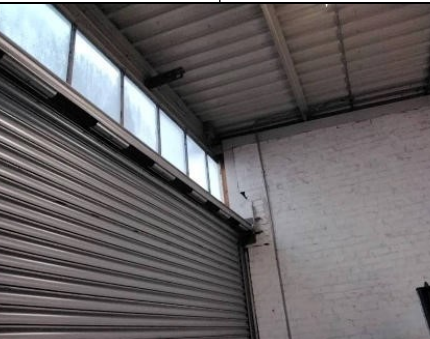
| 267. | As KX000964 | Column cladding rear of panel on other side of wall | Block 2, Ground Floor, Garage (Room G/037) | Does not contain asbestos. |

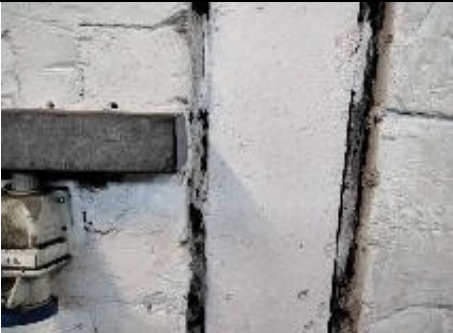
| 268. | As KX000963 | Wall packing to structural columns | Block 2, Ground Floor, Garage (Room G/038) | Contains asbestos - Any change in its appearance should be recorded and passed to Property Services. |

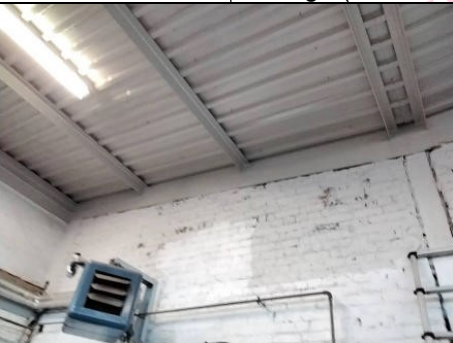
| 269. | KX000964 | Beam cladding | Block 2, Ground Floor, Garage (Room G/038) | Does not contain asbestos. |

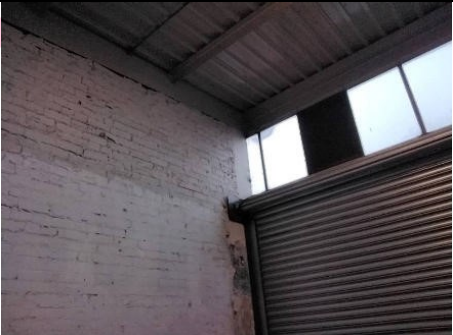
| 270. | As KX000964 | Column cladding | Block 2, Ground Floor, Garage (Room G/038) | Does not contain asbestos. |

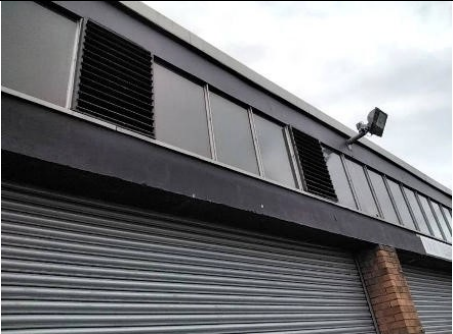
| 277. | KX000966 | Window beading seal around metal frame window | External car port/vehicle store (E/003) | Does not contain asbestos. |

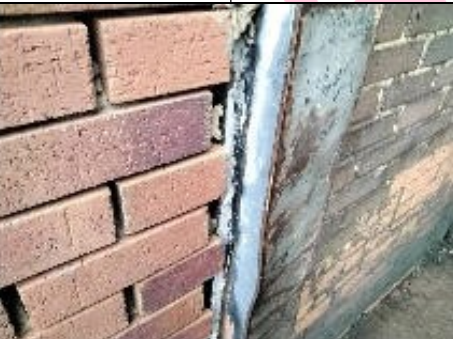
| 278. | As KX000963 | Wall packing to structural columns | External Garage (E/004) | Contains asbestos - Any change in its appearance should be recorded and passed to Property Services. |

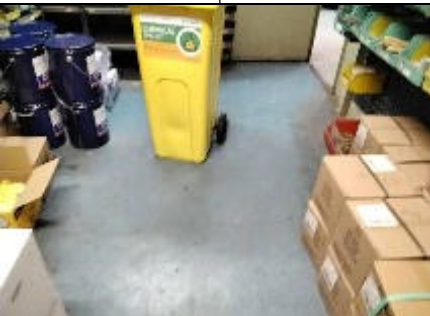
| 279. | KX000967 | Floor tile blue | Block 3, Ground Floor, Store Room (Room G/003) | Contains asbestos - Any change in its appearance should be recorded and passed to Property Services. |

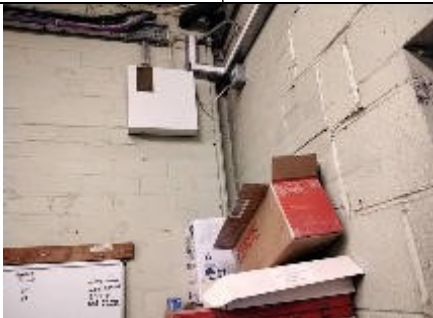
| 283. | As KX000963 | Wall packing to structural column | Block 3, Ground Floor, Office (Room G/006) | Contains asbestos - Any change in its appearance should be recorded and passed to Property Services. |

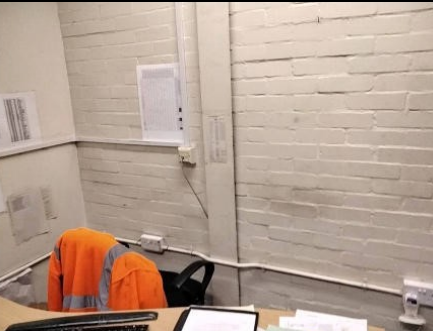
| 284. | KX000970 | Wall packing to column | Block 3, Ground Floor, Office (Room G/008) | Does not contain asbestos. |

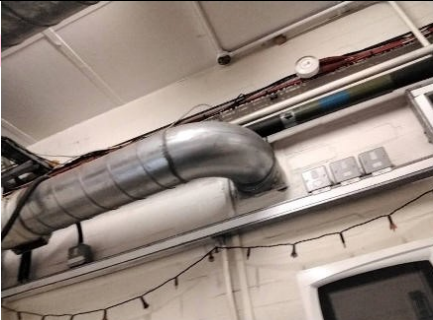
| 285. | KX000971 | Ductwork beige and grey seals to joints | Block 3, Ground Floor, Kitchen (Room G/010) | Does not contain asbestos. |

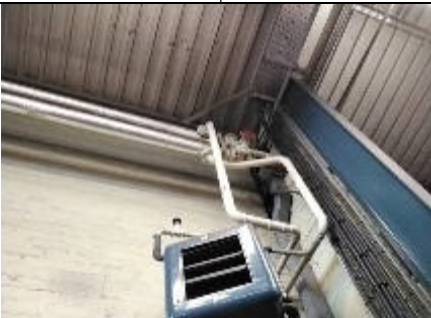
| 286. | Presumed | Pipework gaskets | Block 3, Ground Floor, Garage (Room G/013) | Presumed to contain asbestos - Any change in its appearance should be recorded and passed to Property Services. |

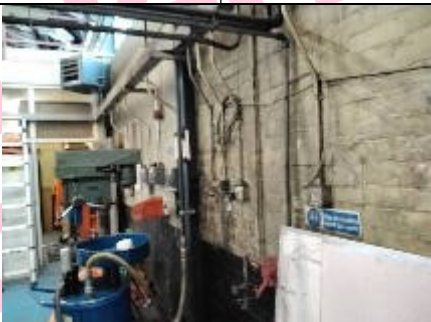
| 287. | KX000972 | Wall seal to column | Block 3, Ground Floor, Garage (Room G/013) | Contains asbestos - Any change in its appearance should be recorded and passed to Property Services. |

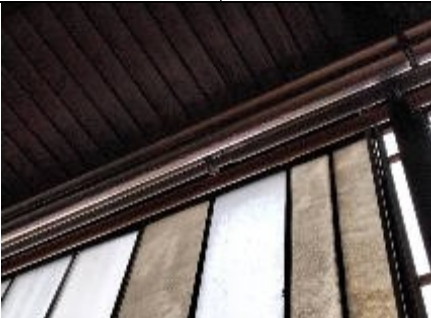
| 288. | Presumed | Pipework gaskets | Block 3, Ground Floor, Garage (Room G/014) | Presumed to contain asbestos - Any change in its appearance should be recorded and passed to Property Services. |

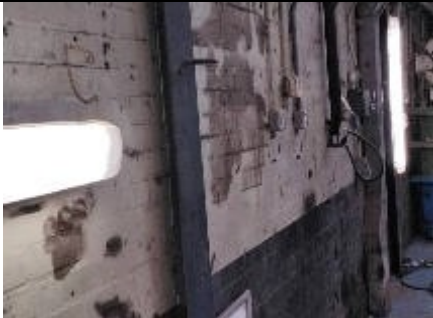
| 292. | As KX000972 | Wall seal to column | Block 3, Ground Floor, Garage (Room G/015) | Contains asbestos - Any change in its appearance should be recorded and passed to Property Services. |

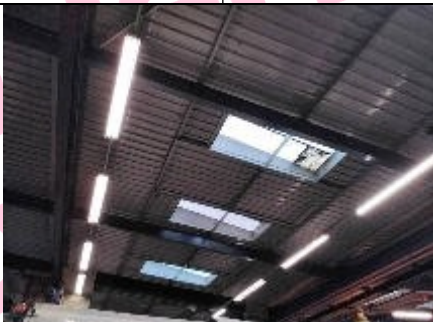
| 293. | Presumed | Roof skylight gasket | Block 3, Ground Floor, Garage (Room G/015) | Presumed to contain asbestos - Any change in its appearance should be recorded and passed to Property Services. |

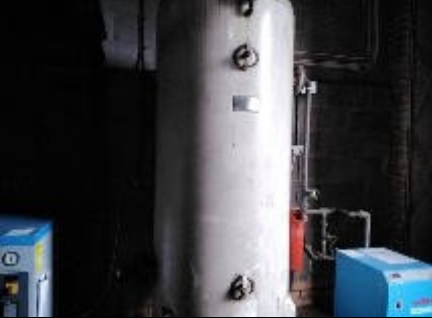
| 295. | KX000974 | Calorifier gasket to pipe outlets | Block 3, External, Oil Tank Room (Room E/002) | Contains asbestos - Any change in its appearance should be recorded and passed to Property Services. |

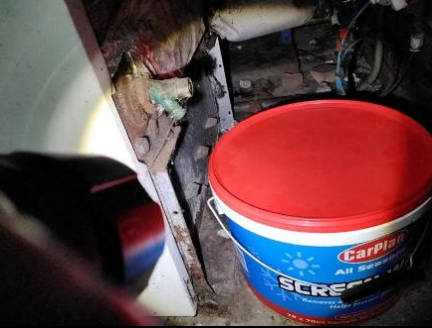
| 296. | KX000975 | Boiler seals to the rear of unit | Block 3, External, Boiler Room (Room E/003) | Does not contain asbestos. |

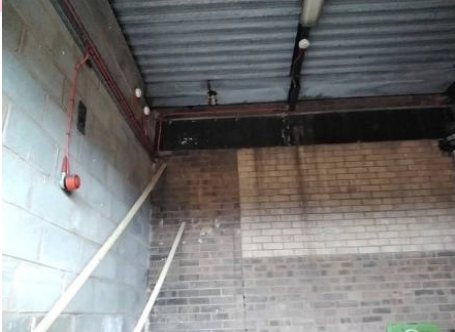
| 297. | As KX000971 | Ductwork beige and grey seals to joints | Block 3, External, Boiler Room (Room E/003) | Does not contain asbestos. |

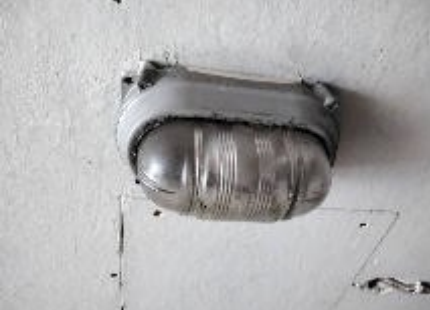
| 301. | KX000988 | Electrical services putty | Garages, Ground Floor, Garage (Room G/002) | Contains asbestos - Any change in its appearance should be recorded and passed to Property Services. |

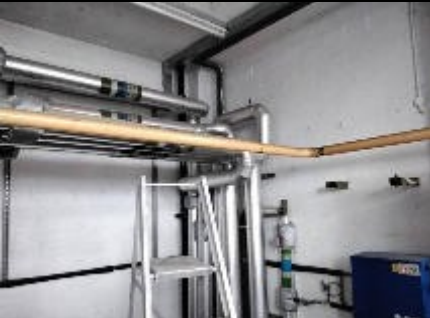
| 307. | KX000980 | Debris/Residue right hand wall behind pipes leading to duct | Boiler House, Ground Floor, Boiler Room (G/001) | Contains asbestos - Any change in its appearance should be recorded and passed to Property Services. |

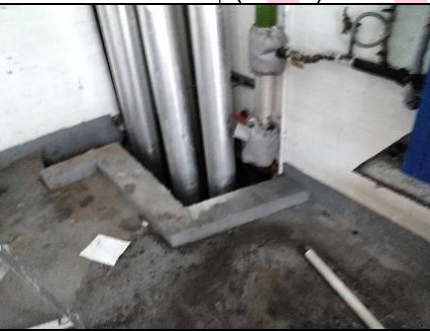
| 308. | KX000981 | Damp Proof Course | Boiler House, Ground Floor, Boiler Room (G/001) | Does not contain asbestos. |

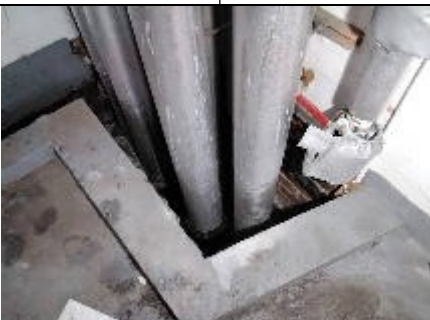
| 309. | Presumed | Gaskets at bottom of floor duct | Boiler House, Ground Floor, Boiler Room (G/001) | Presumed to contain asbestos - Any change in its appearance should be recorded and passed to Property Services. |

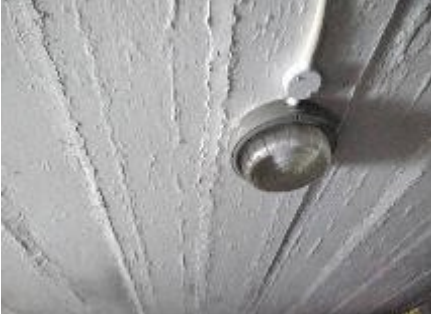
| 316. | KX100102 | Electrical services door seal gasket to round ceiling lamps | Gas Cylinder Store, Ground Floor, Store Room (Room G/001) | Contains asbestos - Any change in its appearance should be recorded and passed to Property Services. |

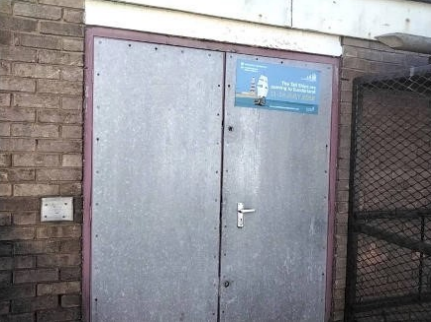
| 317. | KX000989 | Door frame beading | Gas Cylinder Store, External (E/001) | Does not contain asbestos. |

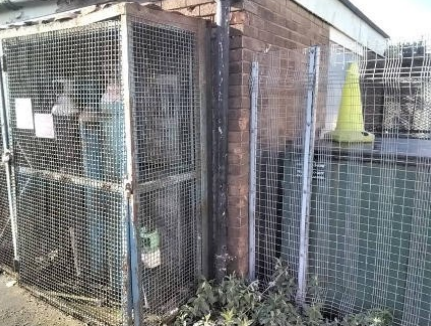
| 318. | KX000990 | Pipe joints caulking/packing to metal rainwater goods | Gas Cylinder Store, External (E/001) | Does not contain asbestos. |
