ASBESTOS SURVEY REPORT FOR BLOCK 1A – 1C EDWARD THOMPSON SITE, RICHMOND STREET, SUNDERLAND, SR5 1BQ

Asbestos Register for Block 1A – 1C Edward Thompson Site, Richmond Street, Sunderland, SR5 1BQ

Date: 26 November 2024

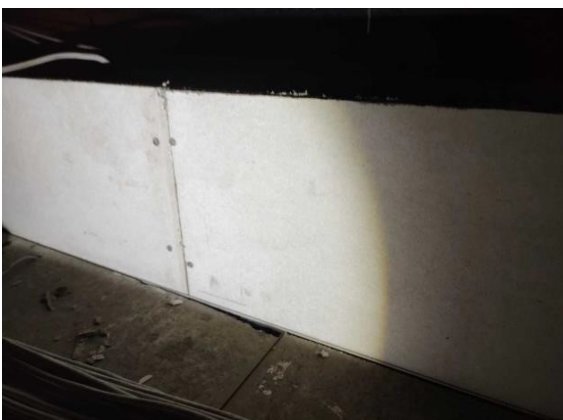
Item 3 Ref: 22-47230-2

3.	22-47230-2	Debris to tops of ceiling tiles	Second Floor, Room 1 Meeting Room	Medium Risk
4.	22-47230-3	Sealant to window seals	Second Floor, Room 1 Meeting Room	Low Risk

The debris to tops of ceiling tiles (insulating board) (Area: Second Floor, Room 1 Meeting Room) contains asbestos.

Any change in its appearance should be recorded and passed to Property Services.

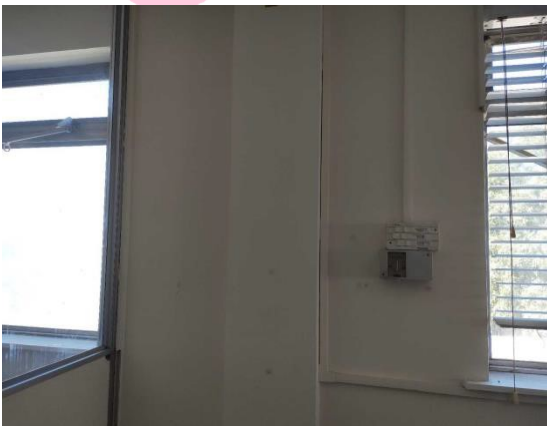
Item 6 Ref: 22-47230-1

The vertical boxing (insulating board) (Area: Second Floor, Room 3 Office 2) contains asbestos.

Any change in its appearance should be recorded and passed to Property Services.

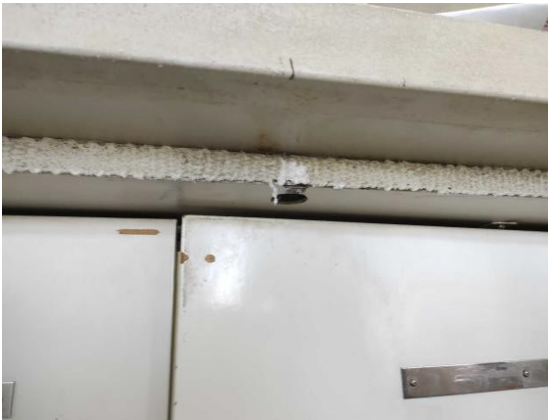
Item 7 Ref: 22-47230-4

7.	22-47230-4	Rope seal to safe door	Second Floor, Room 3 office 2	Low Risk
8.	22-47230-1	High level horizontal boxing	Second Floor, Room 4 Store	Medium Risk

The rope seal to safe door (textile) (Area: Second Floor, Room 3 Office 2) contains asbestos.

Any change in its appearance should be recorded and passed to Property Services.

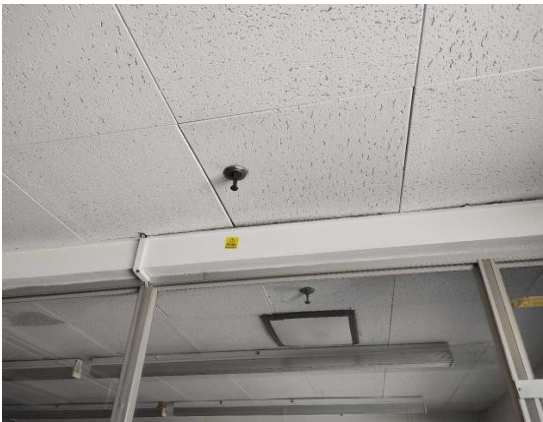
Item 8 Ref: 22-47230-1

The high level horizontal boxing (insulating board) (Area: Second Floor, Room 4 Store) contains asbestos.

Any change in its appearance should be recorded and passed to Property Services.

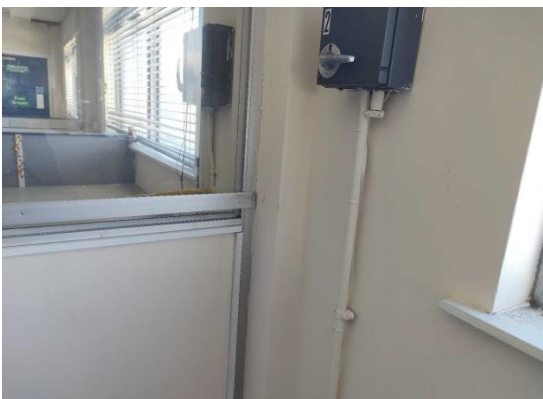
Item 9 Ref: 22-47230-1

The vertical boxing (insulating board) (Area: Second Floor, Room 4 Store) contains asbestos.

Any change in its appearance should be recorded and passed to Property Services.

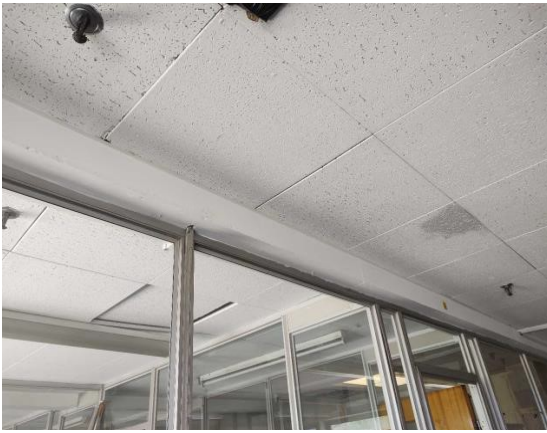
Item 10 Ref: 22-47230-1

The high level horizontal boxing (insulating board) (Area: Second Floor, Room 5 IT Department) contains asbestos.

Any change in its appearance should be recorded and passed to Property Services.

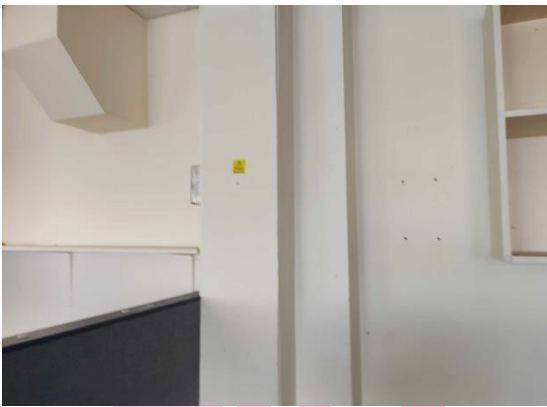
Item 11 Ref: 22-47230-1

The vertical boxing (insulating board) (Area: Second Floor, Room 5 IT Department) contains asbestos.

Any change in its appearance should be recorded and passed to Property Services.

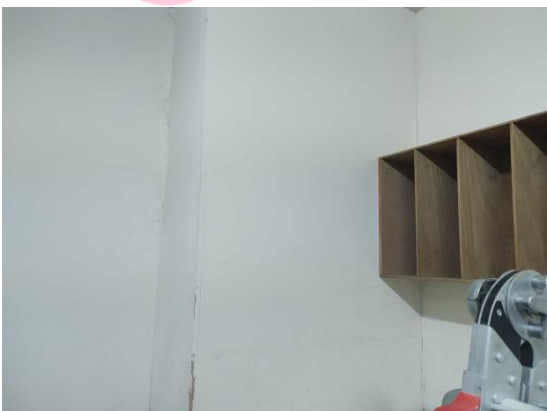
Item 12 Ref: 22-47230-1

The vertical boxing (insulating board) (Area: Second Floor, Room 6 IT Dept Store) contains asbestos.

Any change in its appearance should be recorded and passed to Property Services.

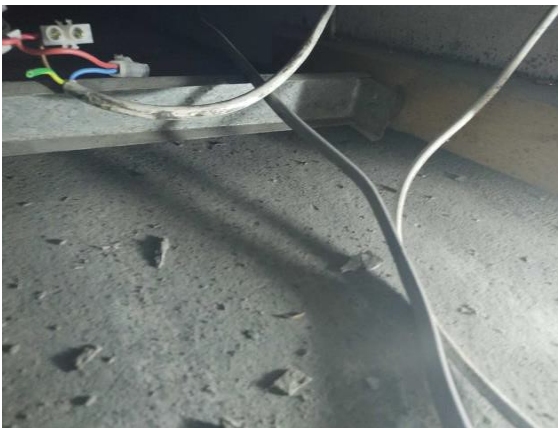
Item 14 Ref: 22-47230-2

The debris to tops of ceiling tiles (insulating board) (Area: Second Floor, Room 6 IT Dept Store) contains asbestos.

Any change in its appearance should be recorded and passed to Property Services.

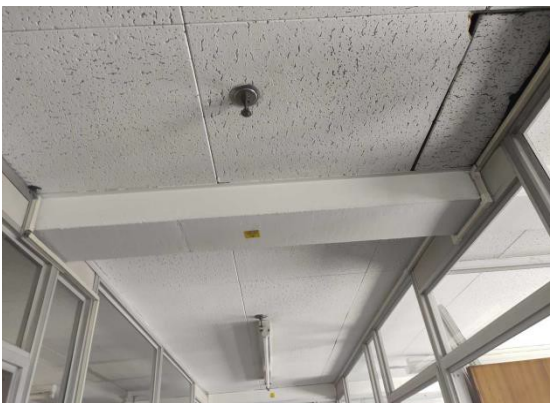
Item 15 Ref: 22-47230-1

The high level horizontal boxing (insulating board) (Area: Second Floor, Room 7 Corridor) contains asbestos.

Any change in its appearance should be recorded and passed to Property Services.

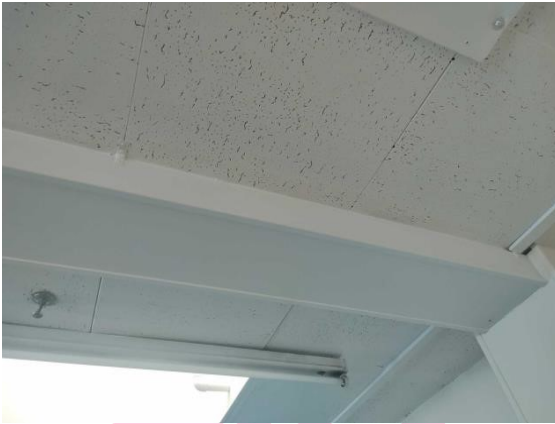
Item 20 Ref: 22-47230-1

The high level horizontal boxing behind wood cladding (insulating board) (Area: Second Floor, Room 9 Sales Office) contains asbestos.

Any change in its appearance should be recorded and passed to Property Services

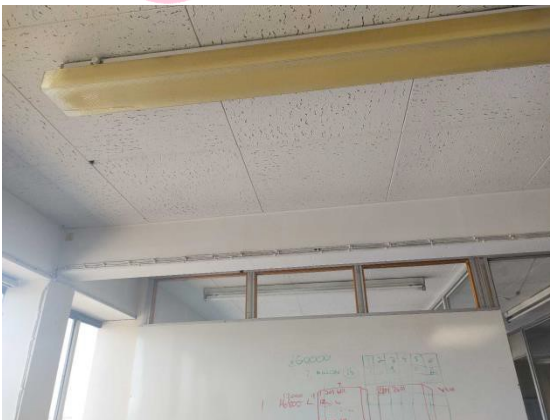
Item 21 Ref: 22-47230-5

The high level horizontal boxing (insulating board) (Area: Second Floor, Room 10 EPS Department) contains asbestos.

Any change in its appearance should be recorded and passed to Property Services

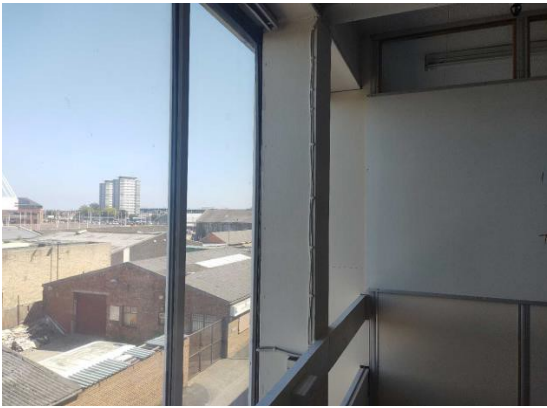
Item 22 Ref: 22-47230-5

The high level horizontal boxing (insulating board) (Area: Second Floor, Room 10 EPS Department) contains asbestos.

Any change in its appearance should be recorded and passed to Property Services.

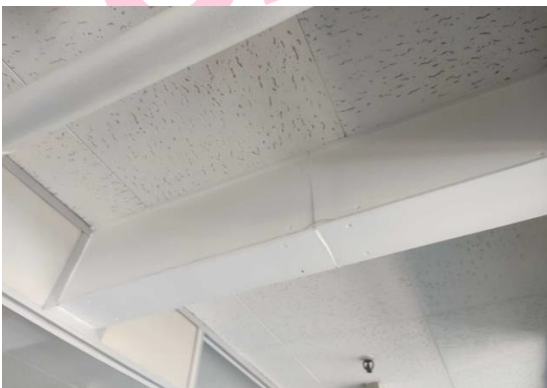
Item 24 Ref: 22-47230-5

The high level horizontal boxing (insulating board) (Area: Second Floor, Room 11 Corridor) contains asbestos.

Any change in its appearance should be recorded and passed to Property Services.

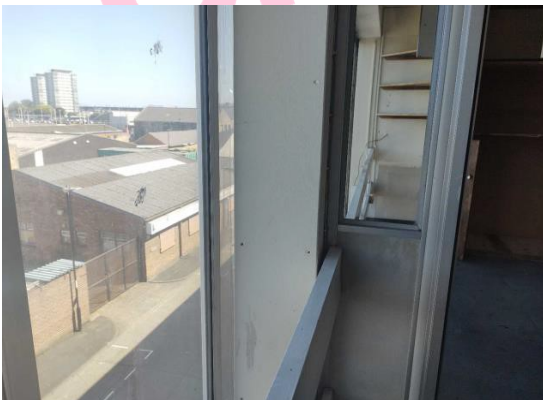
Item 27 Ref: 22-47230-5

The vertical boxing (insulating board) (Area: Second Floor, Room 12 Wages Office) contains asbestos.

Any change in its appearance should be recorded and passed to Property Services.

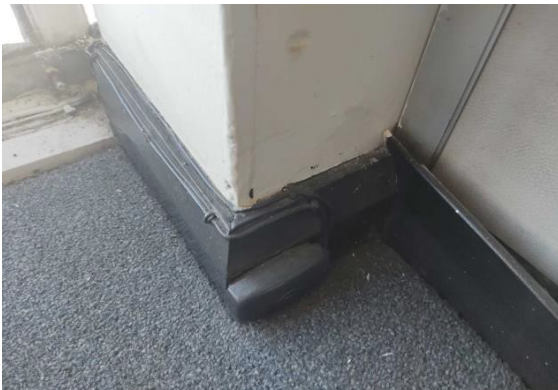
Item 29 Ref: 22-47230-8

The floor (insulating board) (Area: Second Floor, Room 12 Wages Office) contains asbestos.

Any change in its appearance should be recorded and passed to Property Services.

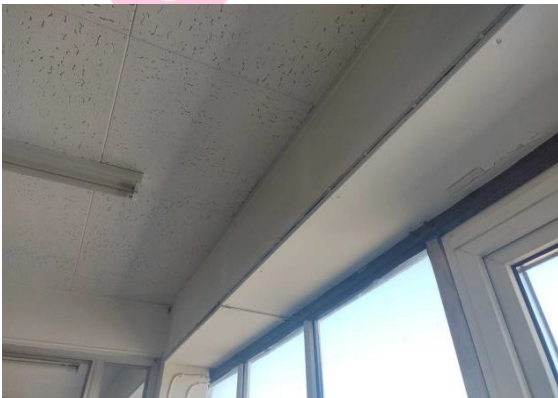
Item 30 Ref: 22-47230-5

The vertical boxing (insulating board) (Area: Second Floor, Room 13 Petty Cash Office) contains asbestos.

Any change in its appearance should be recorded and passed to Property Services.

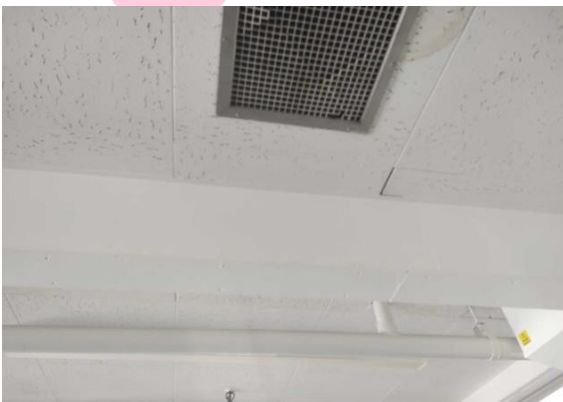
Item 33 Ref: 22-47230-5

The high level horizontal boxing (insulating board) (Area: Second Floor, Room 14 Office 3) contains asbestos.

Any change in its appearance should be recorded and passed to Property Services.

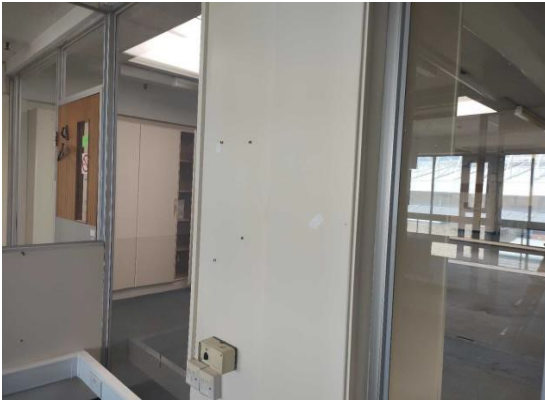
Item 35 Ref: 22-47230-5

The vertical boxing and panel to boxing (insulating board) (Area: Second Floor, Room 14 Office 3) contains asbestos.

Any change in its appearance should be recorded and passed to Property Services.

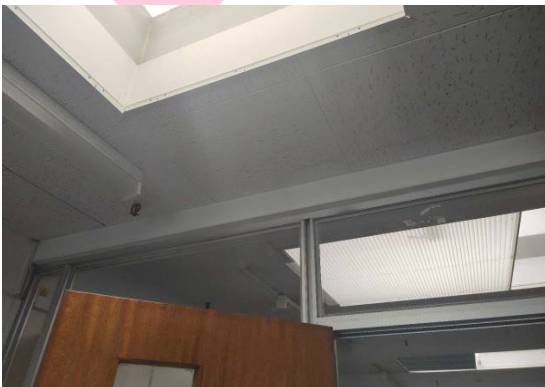
Item 36 Ref: 22-47230-5

The high level horizontal boxing (insulating board) (Area: Second Floor, Room 15 Office 4) contains asbestos.

Any change in its appearance should be recorded and passed to Property Services.

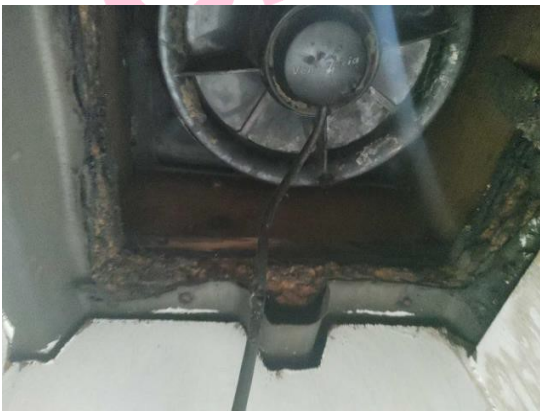
Item 39 Ref: 22-47230-9

The ceiling – felt to roof (bitumen) (Area: Second Floor, Room 15 Office 4) does not contain asbestos.

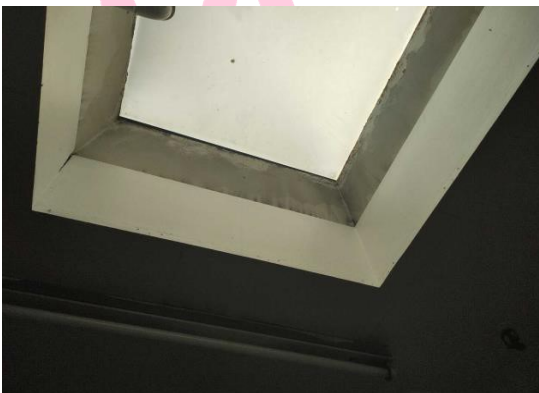
Item 42 Ref: 22-47230-6

The infill panels – upstands to skylights (insulating board) (Area: Second Floor, Room 16 Male WC and Lobby) contains asbestos.

Any change in its appearance should be recorded and passed to Property Services.

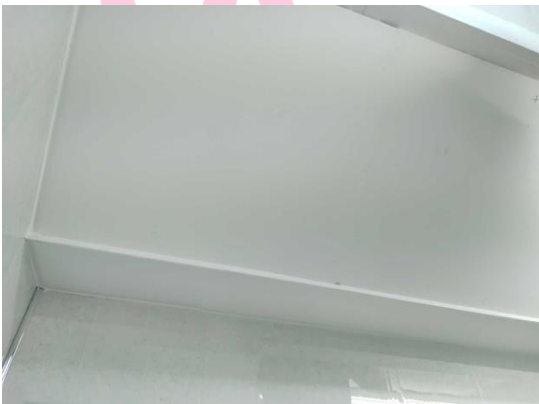
Item 45 Ref: 22-47230-5

The high level horizontal boxing (insulating board) (Area: Second Floor, Room 17 Female WC and Lobby) contains asbestos.

Any change in its appearance should be recorded and passed to Property Services.

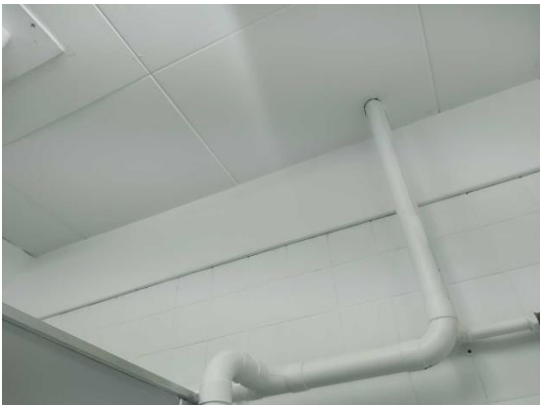
Item 47 Ref: 22-47230-7

The walls – firebreak above door (insulating board) (Area: Second Floor, Room 17 Female WC and Lobby) contains asbestos.

Any change in its appearance should be recorded and passed to Property Services.

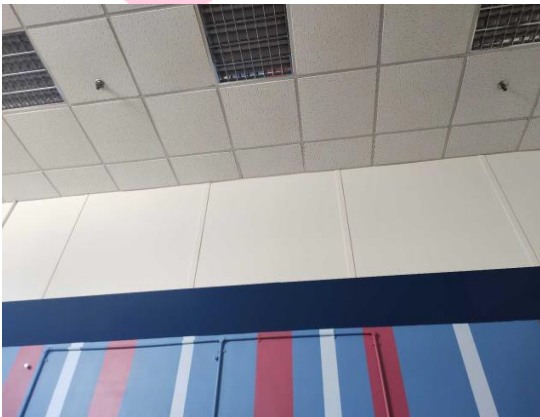
Item 48 Ref: 22-47230-11

The walls – panels to high level wall (insulating board) (Area: Second Floor, Room 18 Contracts Office) contains asbestos.

Any change in its appearance should be recorded and passed to Property Services.

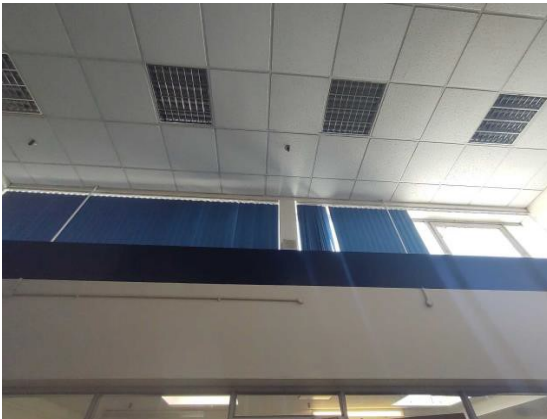
Item 50 Ref: 22-47230-13

The boxing – cladding to RSJs (insulating board) (Area: Second Floor, Room 18 Contracts Office) contains asbestos.

Any change in its appearance should be recorded and passed to Property Services.

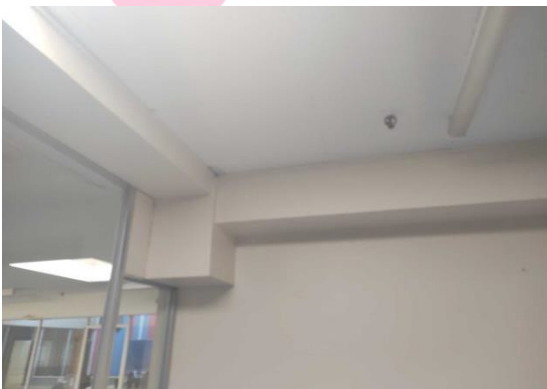
Item 51 Ref: 22-47230-13

The high level horizontal boxing (insulating board) (Area: Second Floor, Room 19 Finance Office) contains asbestos.

Any change in its appearance should be recorded and passed to Property Services.

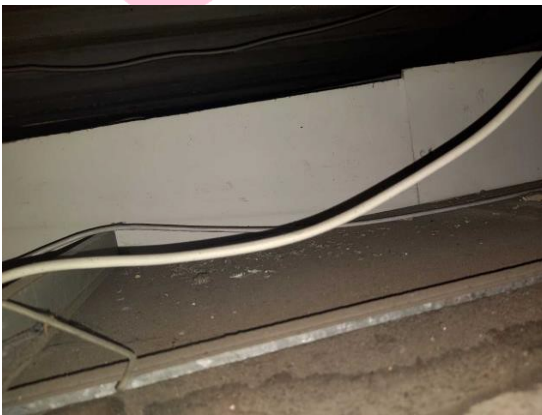
Item 54 Ref: 22-47230-2

The debris to tops of ceiling tiles (insulating board) (Area: Second Floor, Room 19 Finance Office) contains asbestos.

Any change in its appearance should be recorded and passed to Property Services.

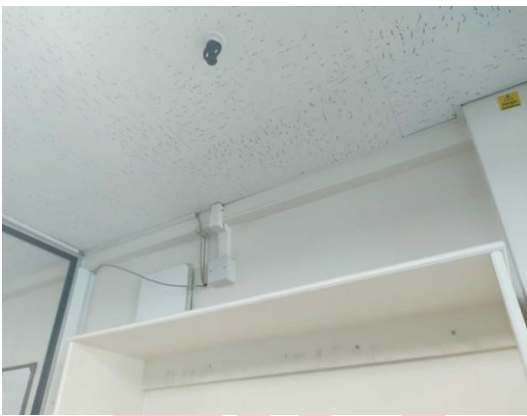
Item 59 Ref: 22-47230-13

The high level horizontal boxing (insulating board) (Area: Second Floor, Room 21 Office 6) contains asbestos.

Any change in its appearance should be recorded and passed to Property Services.

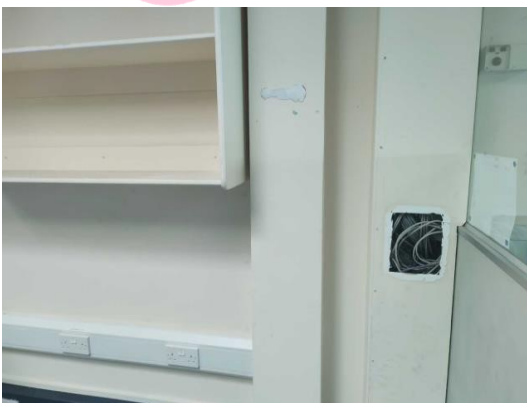
Item 60 Ref: 22-47230-13

The vertical boxing (insulating board) (Area: Second Floor, Room 21 Office 6) contains asbestos.

Any change in its appearance should be recorded and passed to Property Services.

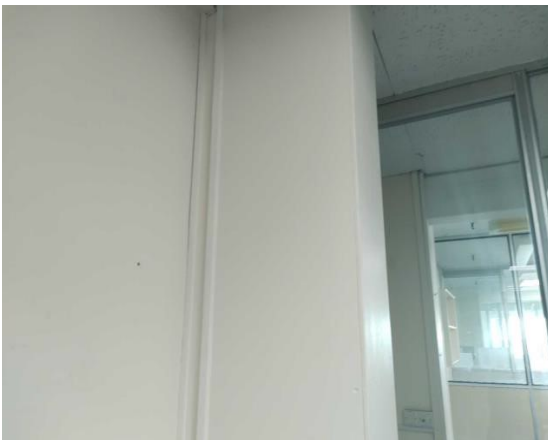
Item 66 Ref: 22-47230-13

The vertical boxing (insulating board) (Area: Second Floor, Room 23 Office 8) contains asbestos.

Any change in its appearance should be recorded and passed to Property Services.

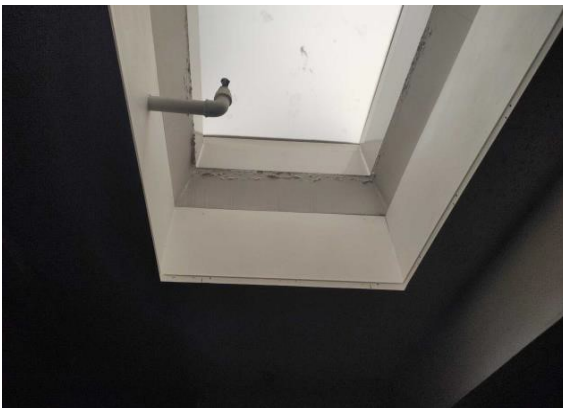
Item 69 Ref: 22-47230-16

The infill panels – upstands to skylight (insulating board)
(Area: Second Floor, Room 24 Office 9) contains asbestos.

Any change in its appearance should be recorded and passed to Property Services.

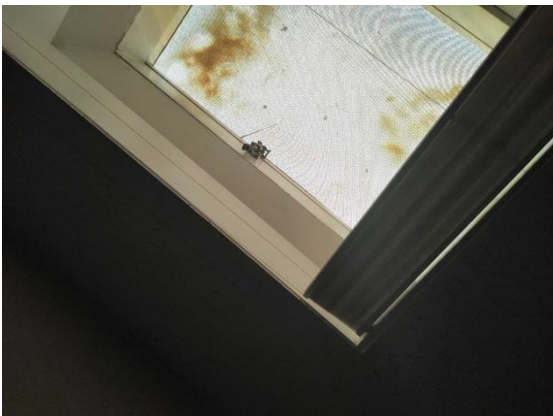
Item 71 Ref: 22-47230-16

The infill panels – upstands to skylight (insulating board) (Area: Second Floor, Room 25 Finance Room 2) contains asbestos.

Any change in its appearance should be recorded and passed to Property Services.

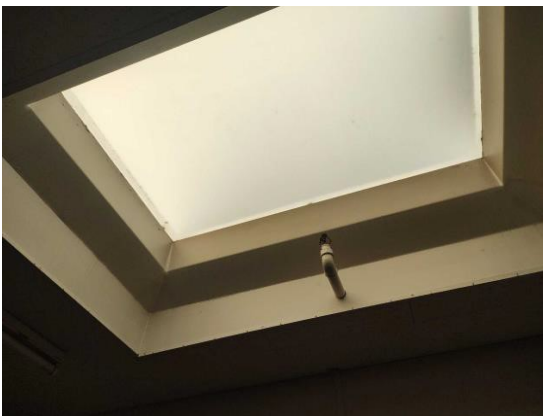
Item 72 Ref: 22-47230-17

The infill panels – upstands to skylight (insulating board) (Area: Second Floor, Room 26 Main Office) contains asbestos.

Any change in its appearance should be recorded and passed to Property Services.

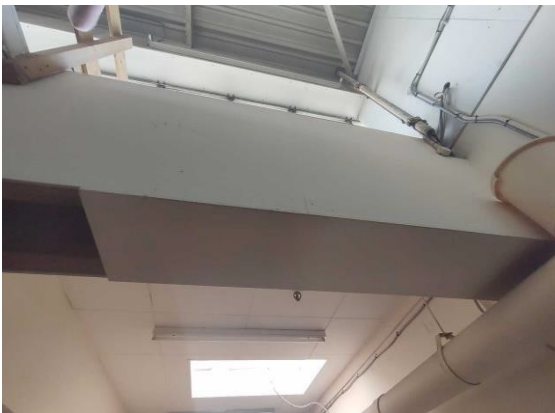
Item 77 Ref: 22-47230-12

The high level horizontal boxing (insulating board) (Area: Second Floor, Room 27 Store Room) contains asbestos.

Any change in its appearance should be recorded and passed to Property Services.

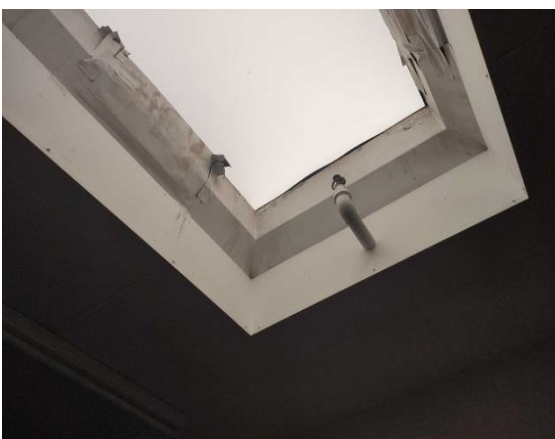
Item 78 Ref: 22-47230-6

The infill panels – upstands to skylight (insulating board) (Area: Second Floor, Room 27 Store Room) contains asbestos.

Any change in its appearance should be recorded and passed to Property Services.

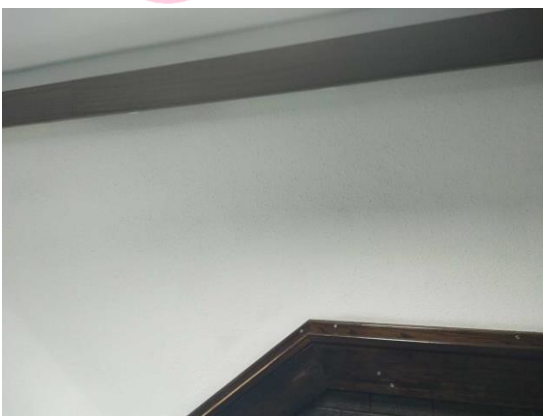
Item 81 Ref: 22-47230-25

The walls (render) (Area: Second Floor, Room 29 Main Lobby and Stairs) does not contain asbestos.

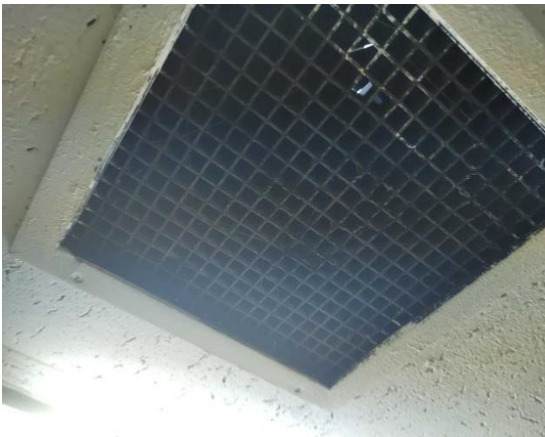
Item 83 Ref: 22-47230-18

The infill panels – extractor fan housing within ceiling void (insulating board) (Area: Second Floor, Room 31 Bingo Store) contains asbestos.

Any change in its appearance should be recorded and passed to Property Services.

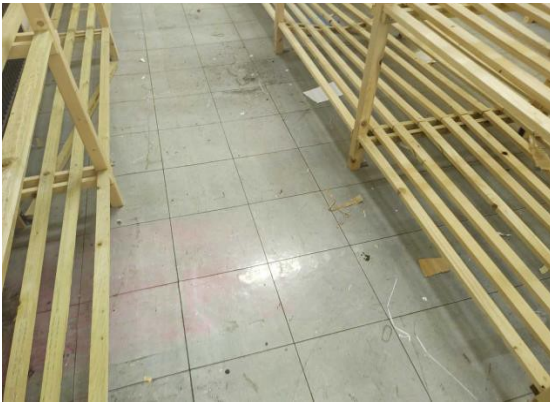
Item 85 Ref: 22-47230-22

The floor (tiles & adhesive)
(Area: Second Floor, Room 31
Bingo Store) does not contain
asbestos.

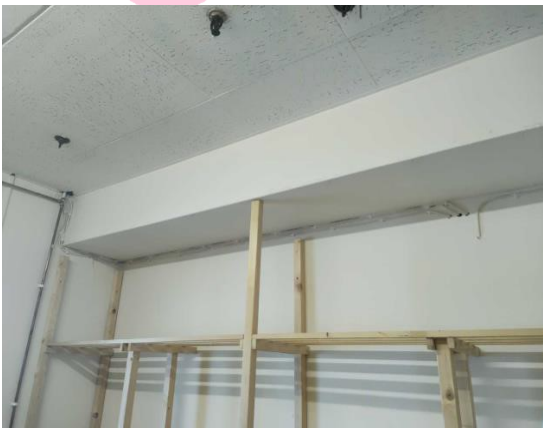
Item 87 Ref: 22-47230-19

The high level horizontal
boxing (insulating board)
(Area: Second Floor, Room 32
Prom Games Store) contains
asbestos.

Any change in its appearance
should be recorded and
passed to Property Services.

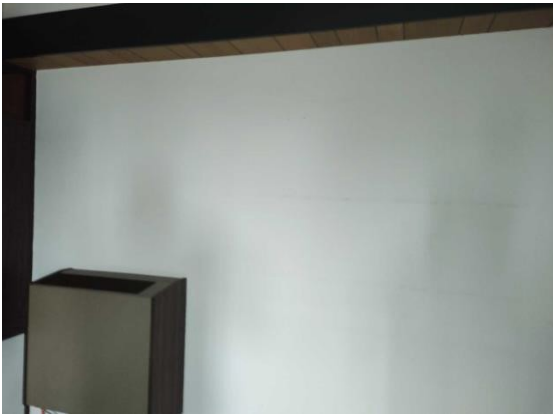
Item 91 Ref: 22-47230-28

The walls (textured coating)
(Area: Second Floor, Room 34
Frank Cronin Office) does not
contain asbestos.

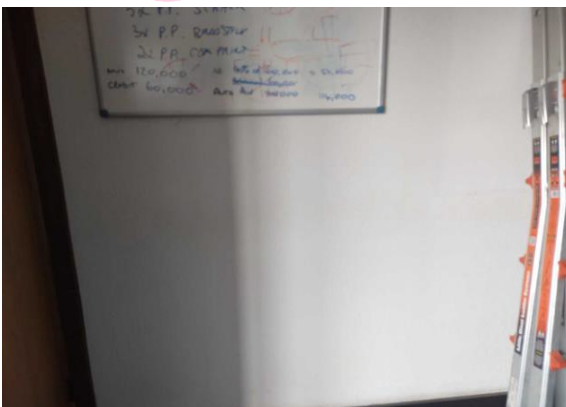
Item 93 Ref: 22-47230-28

The walls (textured coating)
(Area: Second Floor, Room 35
Paddy Cronin Office) does not
contain asbestos.

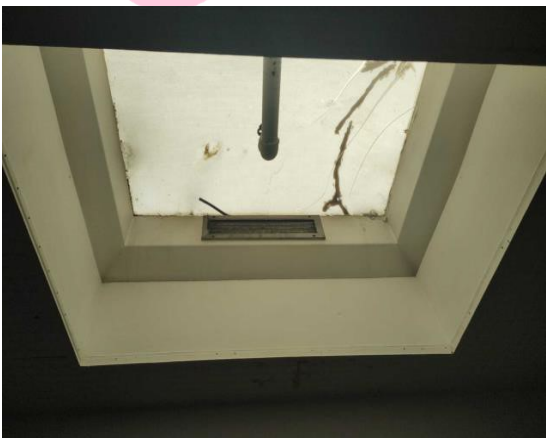
Item 96 Ref: 22-47230-27

The infill panels – upstands to skylight (insulating board) (Area: Second Floor, Room 37 Corridor 3) contains asbestos.

Any change in its appearance should be recorded and passed to Property Services.

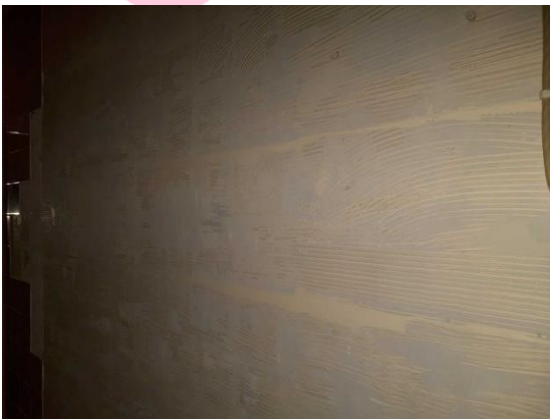
Item 99 Ref: 22-47230-30

The walls – ceramic tile adhesive (adhesive) (Area: Second Floor, Room 38 Squash Court Changing Room) does not contain asbestos.

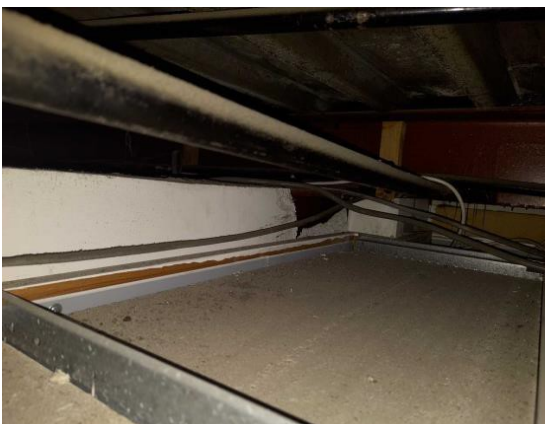
Item 102 Ref: 22-47230-24

The debris to tops of ceiling tiles (insulating board) (Area: Second Floor, Room 40 Reception) contains asbestos.

Any change in its appearance should be recorded and passed to Property Services.

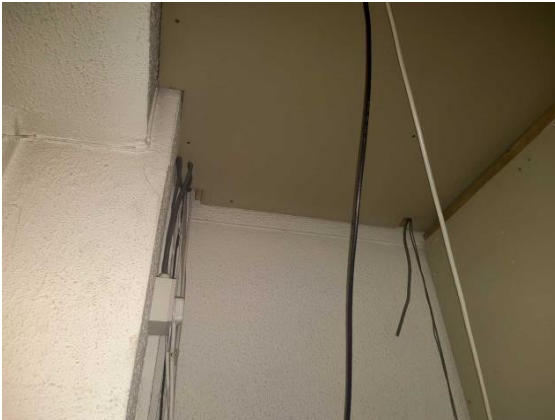
Item 107 Ref: 22-47230-26

The walls – firebreak to top of wall (insulating board) (Area: Second Floor, Room 42 Sound Cupboard) contains asbestos.

Any change in its appearance should be recorded and passed to Property Services.

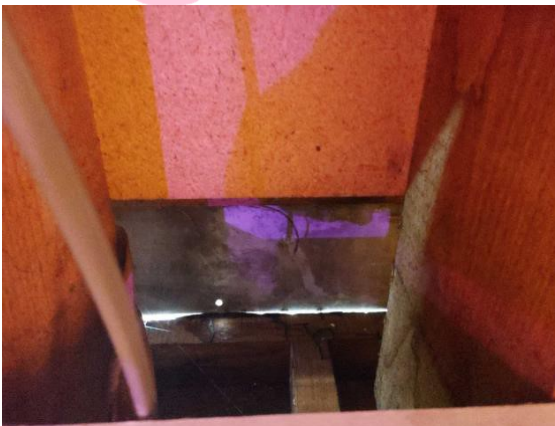
Item 108 Ref: 22-47230-13

The boxing – underside of cladding to RSJ's above and below windows (insulating board) (Area: Second Floor, Room 43 Frank Conin Suite) contains asbestos.

Any change in its appearance should be recorded and passed to Property Services.

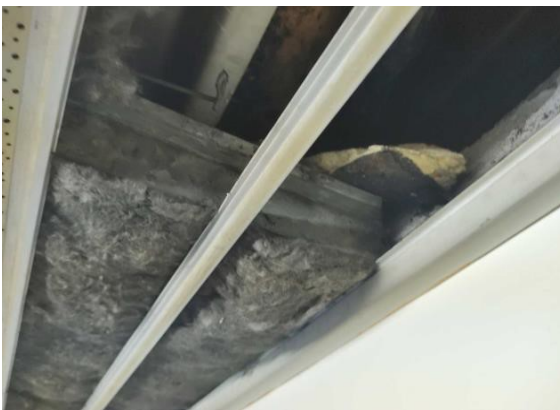
Item 110 Ref: 22-47230-21

The ceiling (bitumen) (Area: Second Floor, Room 44 Corridor 4) does not contain asbestos.

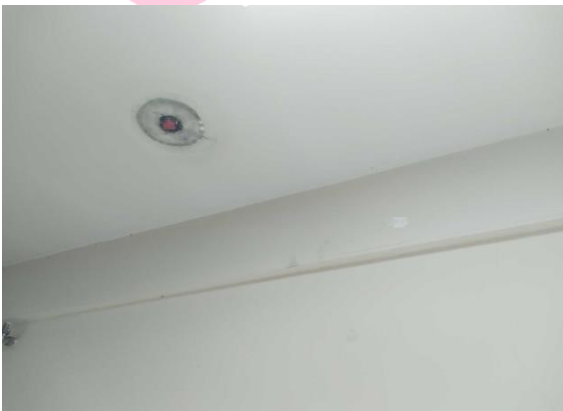
Item 111 Ref: 22-47230-23

The high level horizontal boxing (insulating board) (Area: Second Floor, Room 45 Key Cupboard) contains asbestos.

Any change in its appearance should be recorded and passed to Property Services.

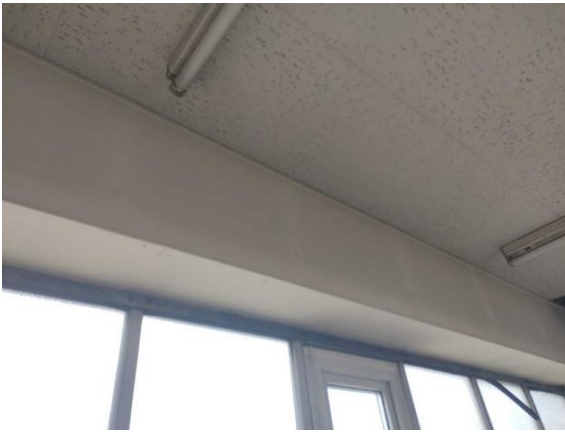
Item 115 Ref: 22-47230-34

The high level horizontal boxing (insulating board) (Area: Second Floor, Room 47 Comms Room) contains asbestos.

Any change in its appearance should be recorded and passed to Property Services.

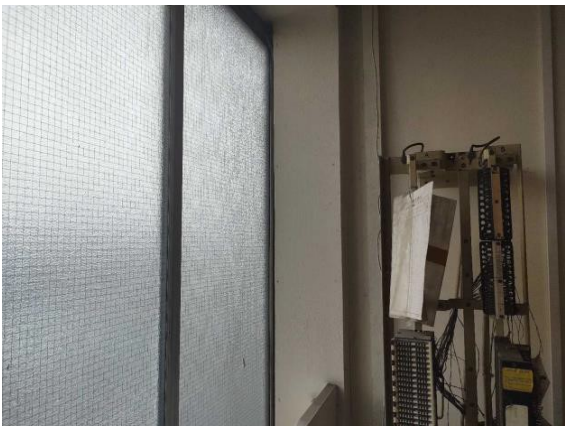
Item 116 Ref: 22-47230-34

The vertical boxing (insulating board) (Area: Second Floor, Room 47 Comms Room) contains asbestos.

Any change in its appearance should be recorded and passed to Property Services.

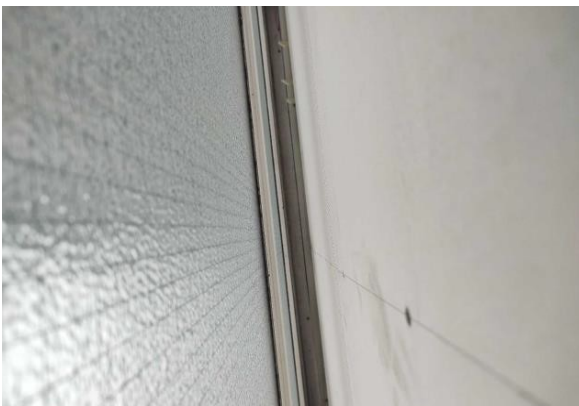
Item 119 Ref: 22-47230-34

The window – fillet to window reveal behind cladded RSJ (insulating board) (Area: Second Floor, Room 48 First Aid Room) contains asbestos.

Any change in its appearance should be recorded and passed to Property Services.

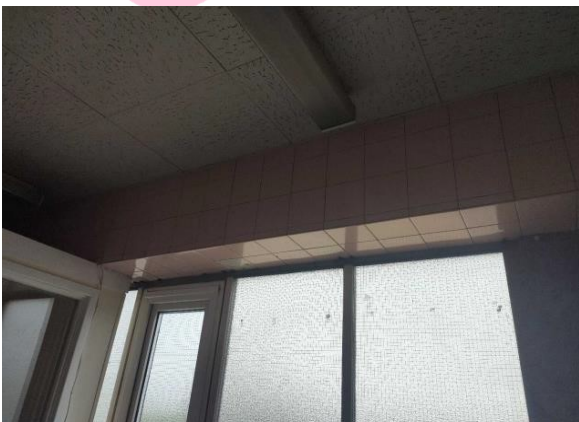
Item 120 Ref: 22-47230-34

The high level horizontal boxing (insulating board) (Area: Second Floor, Room 48 First Aid Room) contains asbestos.

Any change in its appearance should be recorded and passed to Property Services.

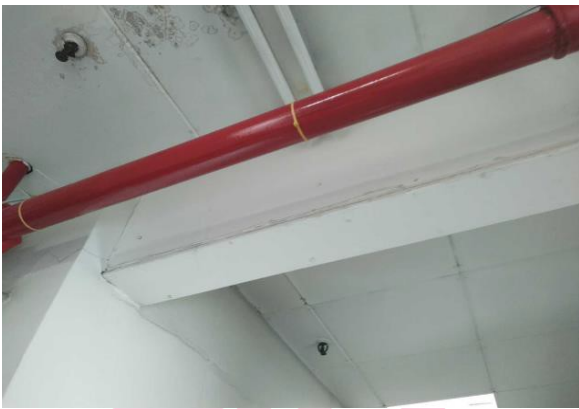
Item 125 Ref: 22-47230-34

The high level horizontal boxing (insulating board) (Area: Second Floor, Room 49 Corridor 5) contains asbestos.

Any change in its appearance should be recorded and passed to Property Services.

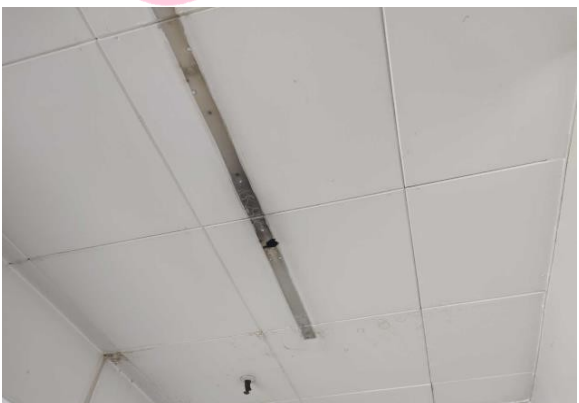
Item 126 Ref: 22-47230-31

The ceiling tiles (insulating board) (Area: Second Floor, Room 50 Corridor 6) contains asbestos.

Any change in its appearance should be recorded and passed to Property Services.

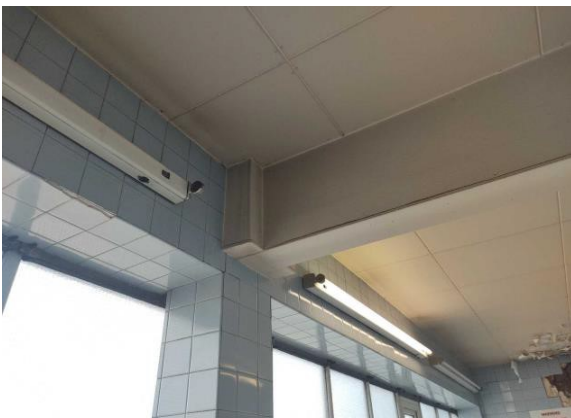
Item 132 Ref: 22-47230-34

The high level horizontal boxing (insulating board) (Area: Second Floor, Room 51 Female WC and Lobby 2) contains asbestos.

Any change in its appearance should be recorded and passed to Property Services.

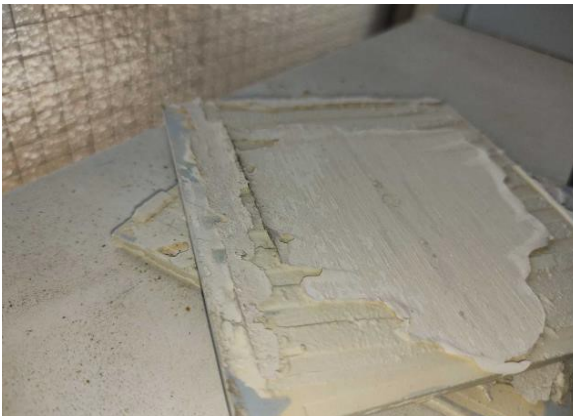
Item 134 Ref: 22-47230-34

The residues to backs of tiles from columns (insulating board) (Area: Second Floor, Room 51 Female WC and Lobby 2) contains asbestos.

Any change in its appearance should be recorded and passed to Property Services.

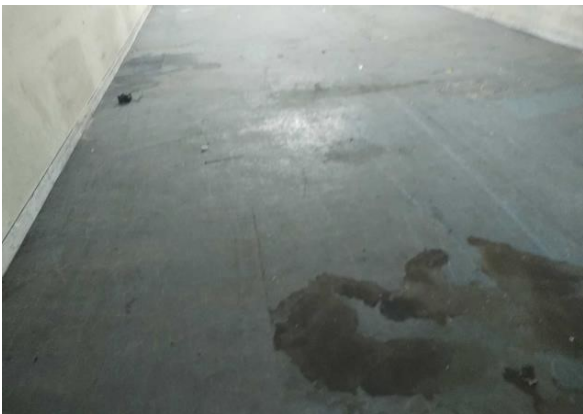
Item 147 Ref: 22-47230-51

The floor (vinyl) (Area: Second Floor, Room 55 Large Store) does not contain asbestos.

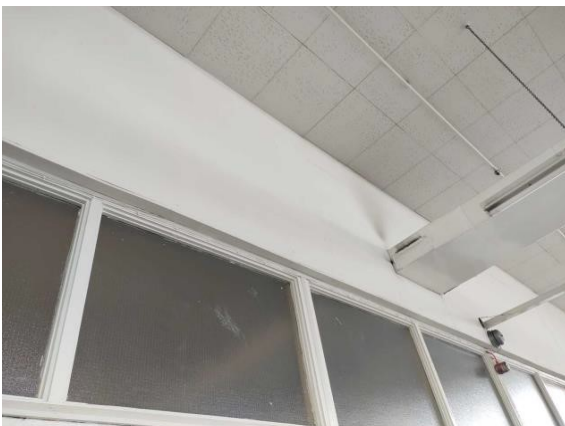
Item 149 Ref: 22-47230-50

The walls – high level panels (insulating board) (Area: Second Floor, Room 56 Racking Store) contains asbestos.

Any change in its appearance should be recorded and passed to Property Services.

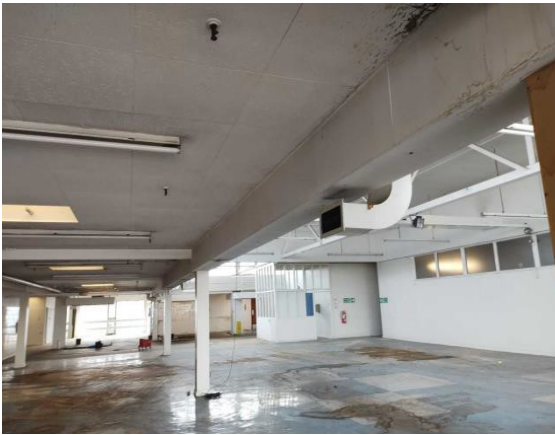
Item 151 Ref: 22-47230-50

The horizontal boxing to RSJ's (insulating board) (Area: Second Floor, Room 56 Racking Store) contains asbestos.

Any change in its appearance should be recorded and passed to Property Services.

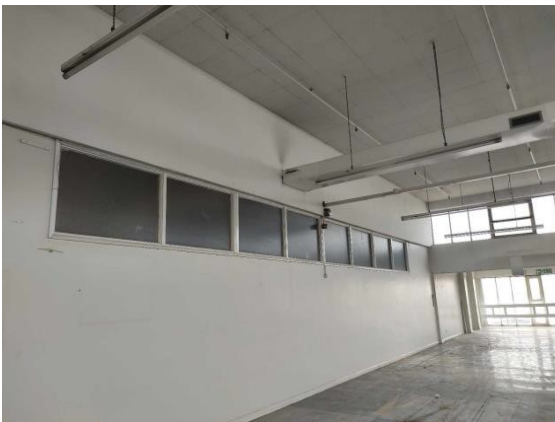
Item 152 Ref: 22-47230-52

The window – beading to high level windows (insulating board) (Area: Second Floor, Room 56 Racking Store) contains asbestos.

Any change in its appearance should be recorded and passed to Property Services.

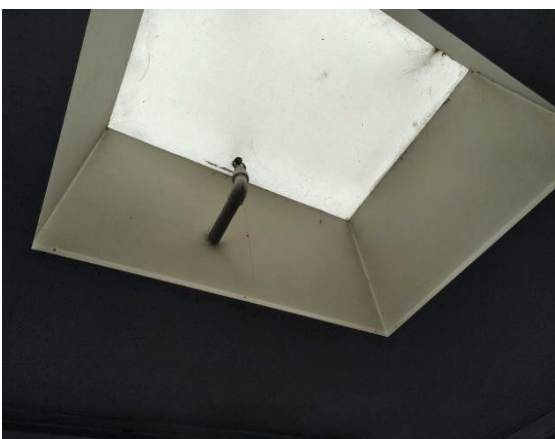
Item 153 Ref: 22-47230-53

The infill panels – upstands to skylights (insulating board) (Area: Second Floor, Room 56 Racking Store) contains asbestos.

Any change in its appearance should be recorded and passed to Property Services.

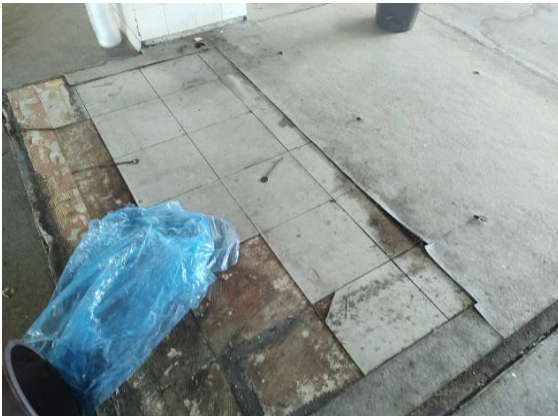
Item 154 Ref: 22-47230-54

The floor (tiles & adhesive)
(Area: Second Floor, Room 56
Racking Store) does not
contain asbestos.

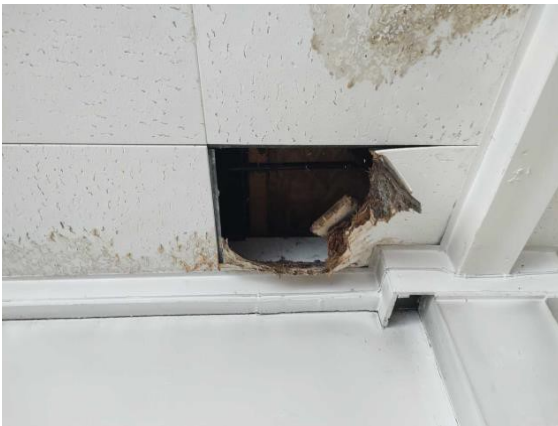
Item 155 Ref: 22-47230-55

The ceiling – debris to ceiling
tile tracking (insulating board)
(Area: Second Floor, Room 56
Racking Store) contains
asbestos.

Any change in its appearance
should be recorded and
passed to Property Services.

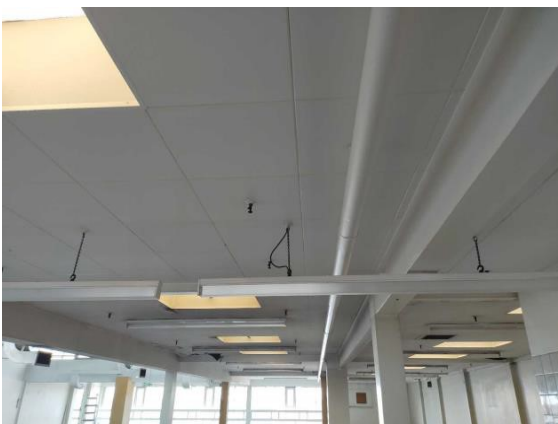
Item 156 Ref: 22-47230-56

The ceiling tiles (insulating
board) (Area: Second Floor,
Room 56 Racking Store)
contains asbestos.

Any change in its appearance
should be recorded and
passed to Property Services.

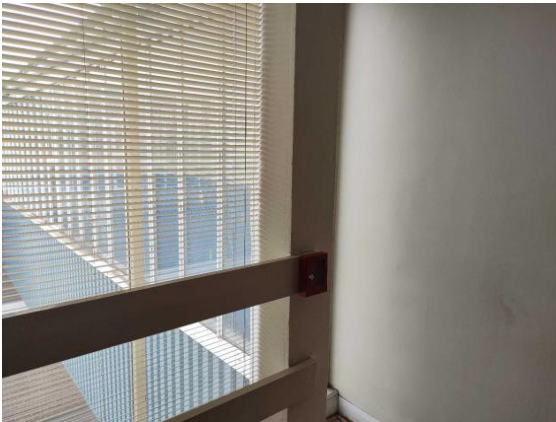
Item 160 Ref: 22-47230-50

The vertical boxing (insulating board) (Area: Second Floor, Room 58 Private Dining Room) contains asbestos.

Any change in its appearance should be recorded and passed to Property Services.

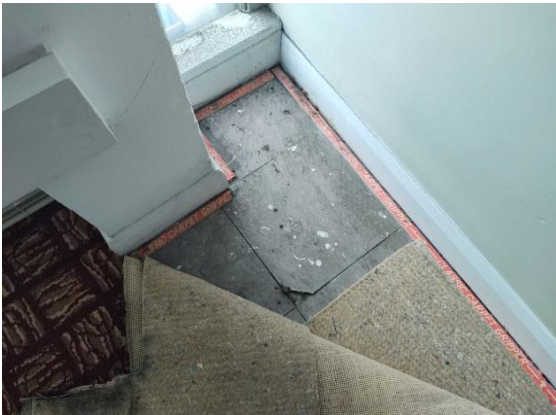
Item 161 Ref: 22-47230-59

The floor (tiles & adhesive) (Area: Second Floor, Room 58 Private Dining Room) does not contain asbestos.

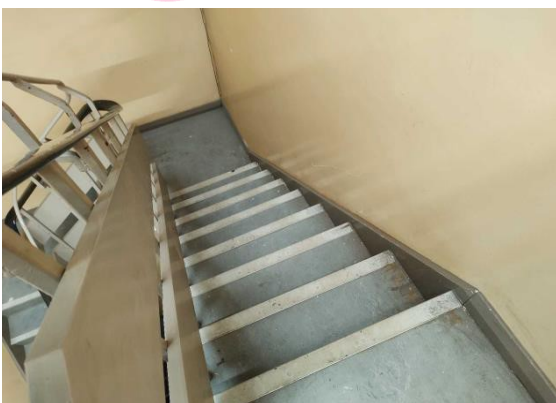
Item 162 Ref: 22-47230-84

The floor - stair nosings (composite) (Area: Second Floor, Room 5A Fire Exit Stairwell 4) contains asbestos.

Any change in its appearance should be recorded and passed to Property Services.

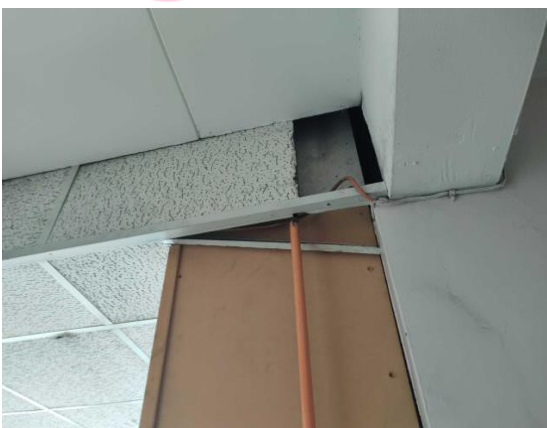
Item 174 Ref: 22-47230-63

The vertical boxing (insulating board) (Area: Second Floor, Room 61 Corridor and Lift Lobby) contains asbestos.

Any change in its appearance should be recorded and passed to Property Services.

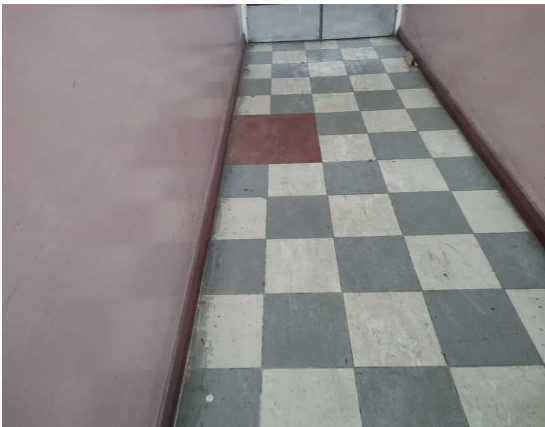
Item 182 Ref: 22-47230-61

The floor (tiles & adhesive) (Area: Second Floor, Room 65 Corridor 8) does not contain asbestos.

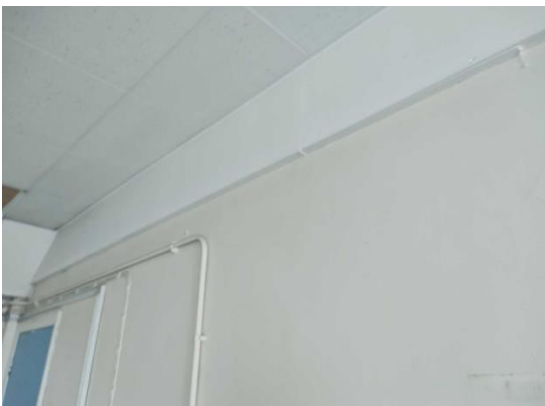
Item 183 Ref: 22-47230-65

The high level horizontal boxing (insulating board) (Area: Second Floor, Room 66 Electric Store 1) contains asbestos.

Any change in its appearance should be recorded and passed to Property Services.

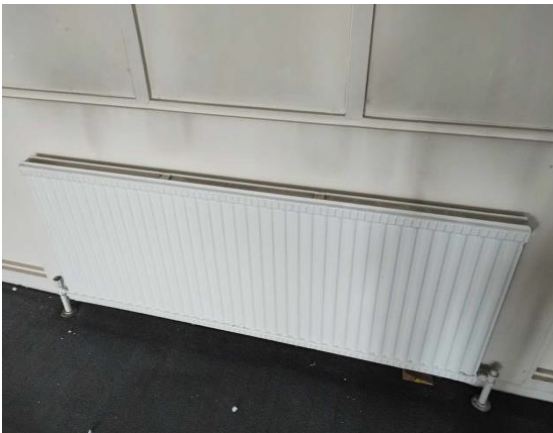
Item 185 Ref: 22-47230-66

The infill panels – panel behind radiator (insulating board) (Area: Second Floor, Room 66 Electric Store 1) contains asbestos.

Any change in its appearance should be recorded and passed to Property Services.

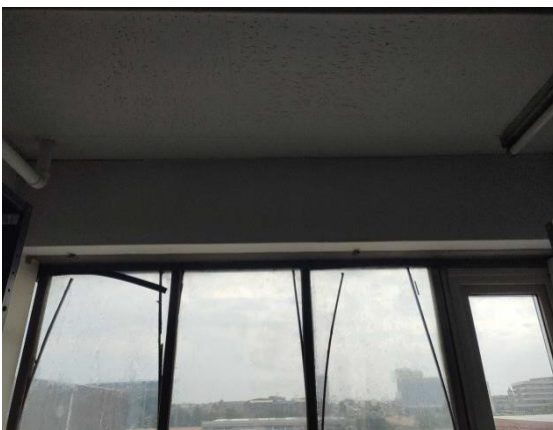
Item 186 Ref: 22-47230-65

The high level horizontal boxing (insulating board) (Area: Second Floor, Room 67 Electric Store 2) contains asbestos.

Any change in its appearance should be recorded and passed to Property Services.

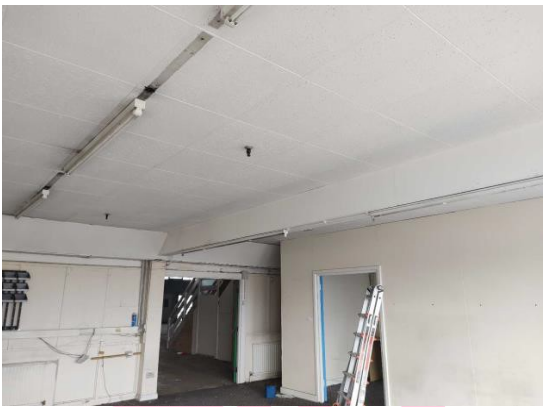
Item 188 Ref: 22-47230-65

The high level horizontal boxing (insulating board) (Area: Second Floor, Room 68 Electric Office) contains asbestos.

Any change in its appearance should be recorded and passed to Property Services.

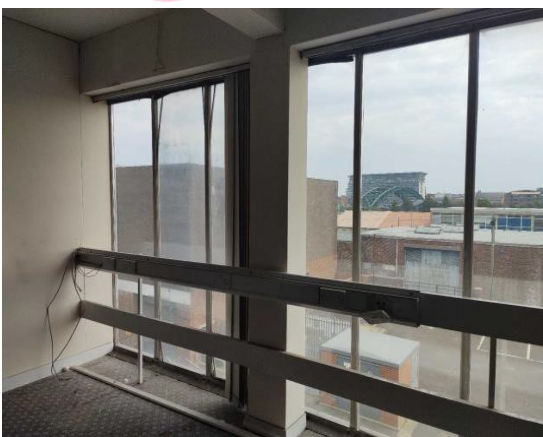
Item 189 Ref: 22-47230-65

The vertical boxing (insulating board) (Area: Second Floor, Room 68 Electric Office) contains asbestos.

Any change in its appearance should be recorded and passed to Property Services.

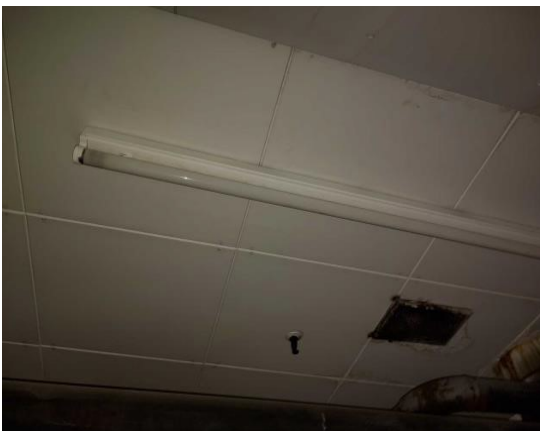
Item 195 Ref: 22-47230-31

The ceiling tiles (insulating
board) (Area: Second Floor,
Room 71 Boiler Room)
contains asbestos.

Any change in its appearance
should be recorded and
passed to Property Services.

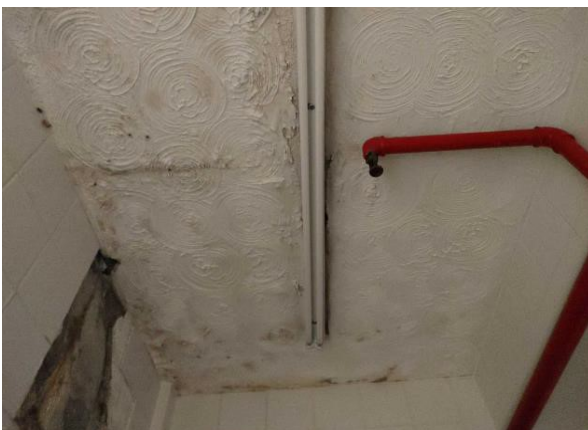
Item 228 Ref: 22-47230-81

The ceiling (textured coating) (Area: First Floor, Room 80 Squash Court Changing Room) does not contain asbestos.

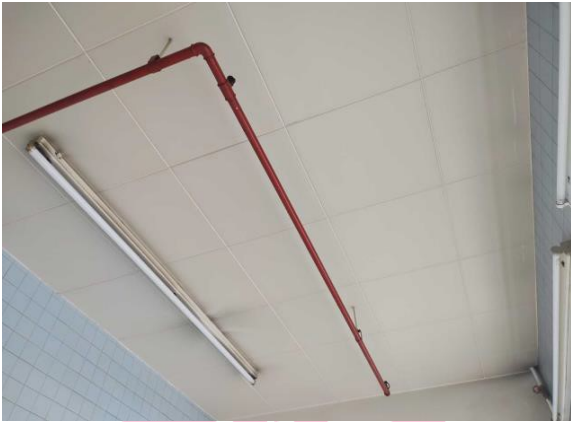
Item 242 Ref: 22-47230-85

The ceiling (insulating board) (Area: First Floor, Room 86 Female WC and Lobby) contains asbestos.

Any change in its appearance should be recorded and passed to Property Services.

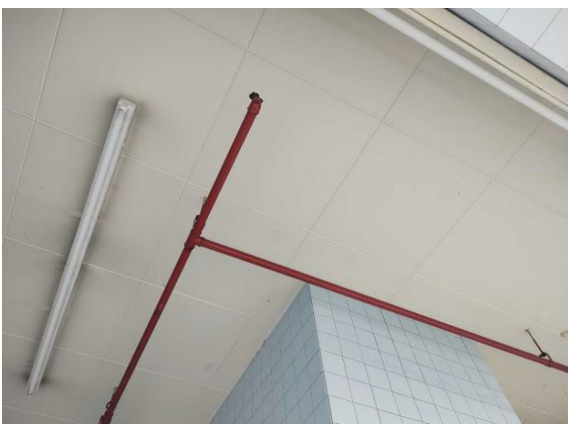
Item 246 Ref: 22-47230-85

The ceiling (insulating board) (Area: First Floor, Room 87 Male WC and Lobby) contains asbestos.

Any change in its appearance should be recorded and passed to Property Services.
