ASBESTOS SURVEY REPORT FOR BLOCK 1A – 1C EDWARD THOMPSON SITE, RICHMOND STREET, SUNDERLAND, SR5 1BQ

Asbestos Register for Block 1A – 1C Edward Thompson Site, Richmond Street, Sunderland, SR5 1BQ

Date: 26 November 2024

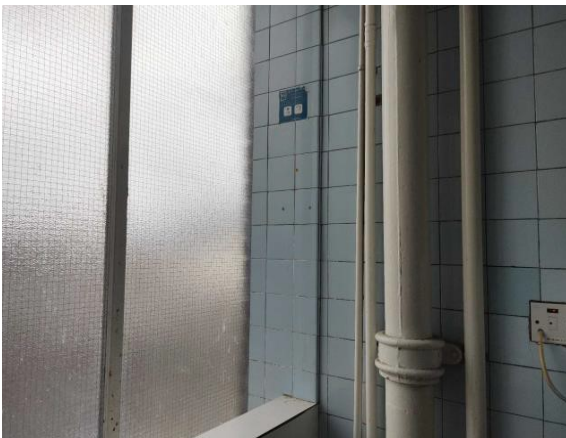
Item 248 Ref: 22-47230-86

The vertical boxing (behind ceramic tiles) (insulating board) (Area: First Floor, Room 87 Male WC and Lobby) contains asbestos.

Any change in its appearance should be recorded and passed to Property Services.

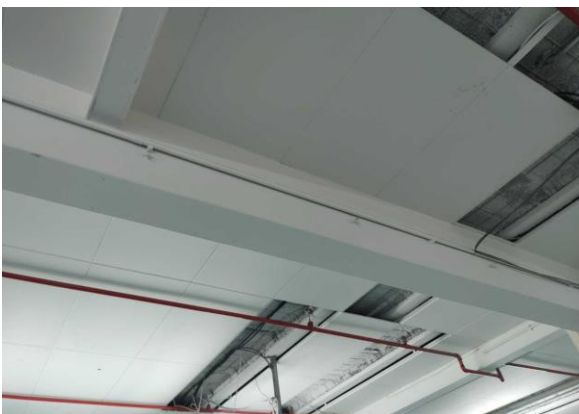
Item 252 Ref: 22-47230-86

The high level horizontal boxing (insulating board) (Area: First Floor, Room 90 Print Room) contains asbestos.

Any change in its appearance should be recorded and passed to Property Services.

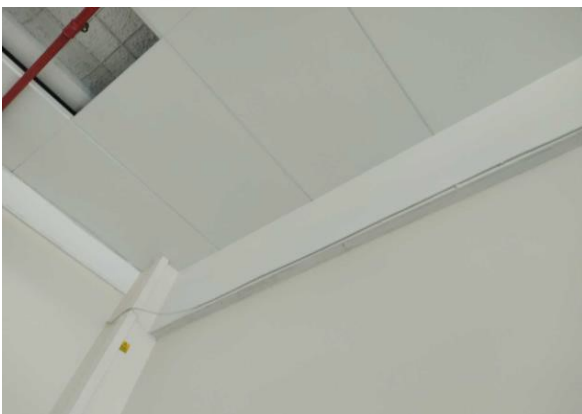
Item 255 Ref: 22-47230-86

The high level horizontal boxing (insulating board) (Area: First Floor, Room 91 Design Room) contains asbestos.

Any change in its appearance should be recorded and passed to Property Services.

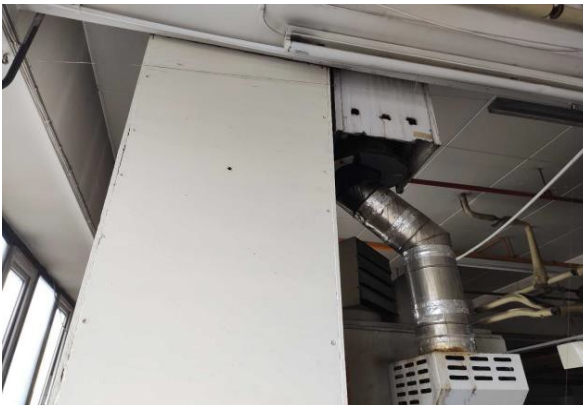
Item 261 Ref: 22-47230-89

The boxing to heater flue (insulating board) (Area: First Floor, Room 95 Main Printer Workshop) contains asbestos.

Any change in its appearance should be recorded and passed to Property Services.

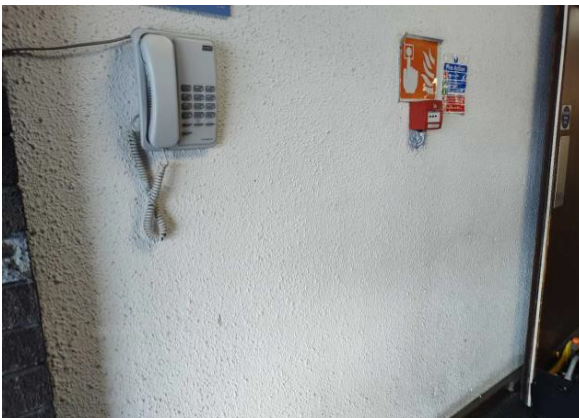
Item 266 Ref: 22-47230-92

The walls (render) (Area: Ground Floor, Room 96 Entrance Lobby) does not contain asbestos.

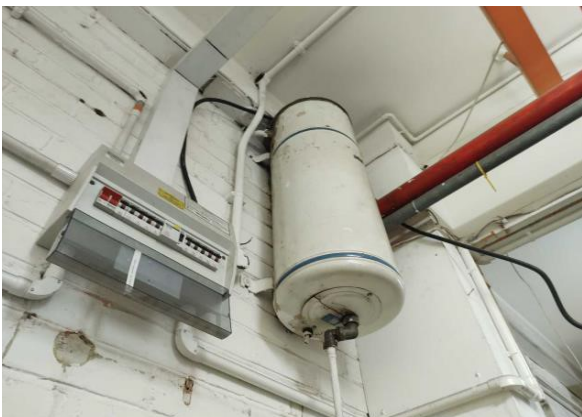
Item 270 Ref: 22-47230-94p

The vessels – presumed gasket within Sadia water heater (gasket) (Area: Ground Floor, Room 101 Maintenance Workshop) is presumed to contain asbestos.

Any change in its appearance should be recorded and passed to Property Services.

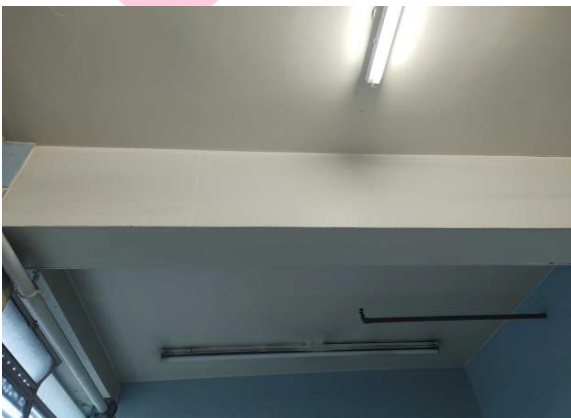
Item 273 Ref: 22-47230-93

The high level horizontal boxing (insulating board) (Area: Ground Floor, Room 105 Female WC and Lobby) contains asbestos.

Any change in its appearance should be recorded and passed to Property Services.

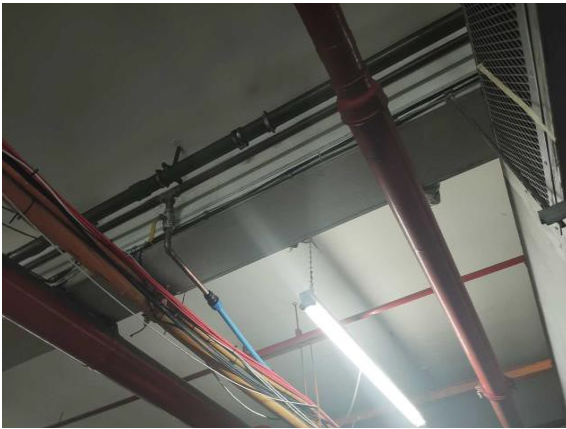
Item 292 Ref: 22-47230-104

The high level horizontal boxing (insulating board) (Area: Ground Floor, Room 119 Main Factory Floor) contains asbestos.

Any change in its appearance should be recorded and passed to Property Services.

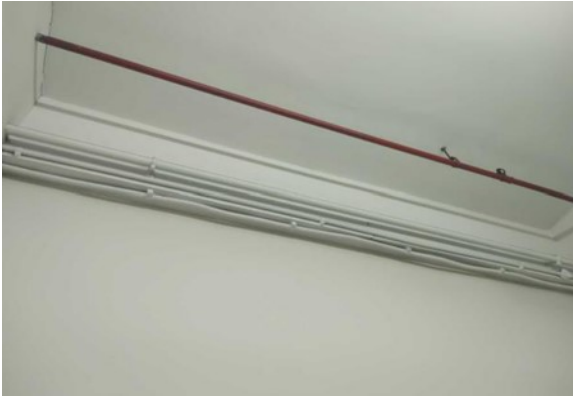
Item 298 Ref: 22-47230-108

The high level horizontal boxing (insulating board) (Area: Ground Floor, Room 123: Office) contains asbestos.

Any change in its appearance should be recorded and passed to Property Services.

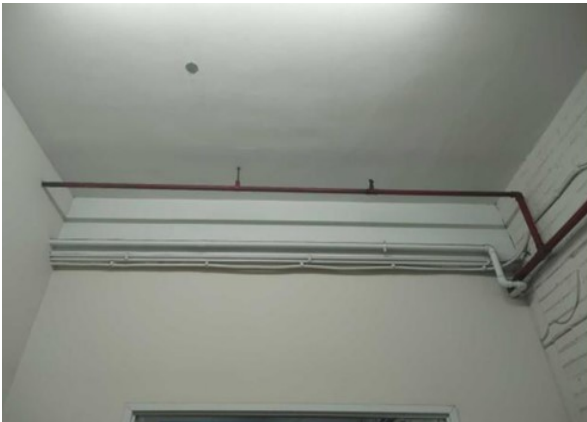
Item 299 Ref: 22-47230-108

The high level horizontal boxing (insulating board) (Area: Ground Floor, Room 124: Office 2) contains asbestos.

Any change in its appearance should be recorded and passed to Property Services.

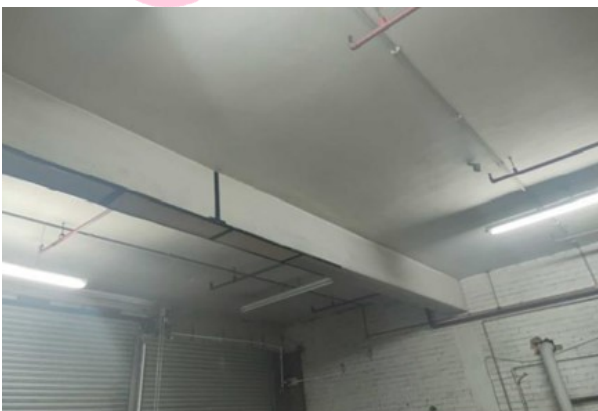
Item 300 Ref: 22-47230-108

The high level horizontal boxing (insulating board) (Area: Ground Floor, Room 126 Vehicle Bay 2) contains asbestos.

Any change in its appearance should be recorded and passed to Property Services.

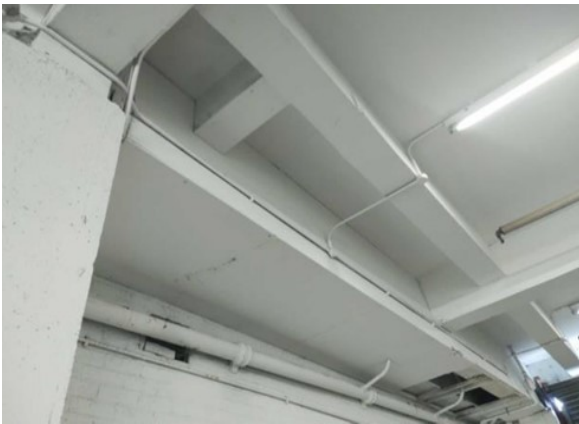
Item 301 Ref: 22-47230-108

The high level horizontal beam boxing (insulating board) (Area: Ground Floor, Room 127: Vehicle Bay 3) contains asbestos.

Any change in its appearance should be recorded and passed to Property Services.

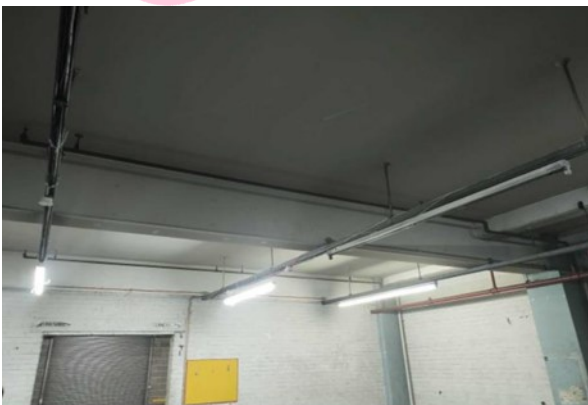
Item 303 Ref: 22-47230-108

The high level horizontal boxing (insulating board) (Area: Ground Floor, Room 129 Vehicle Maintenance Area) contains asbestos.

Any change in its appearance should be recorded and passed to Property Services.

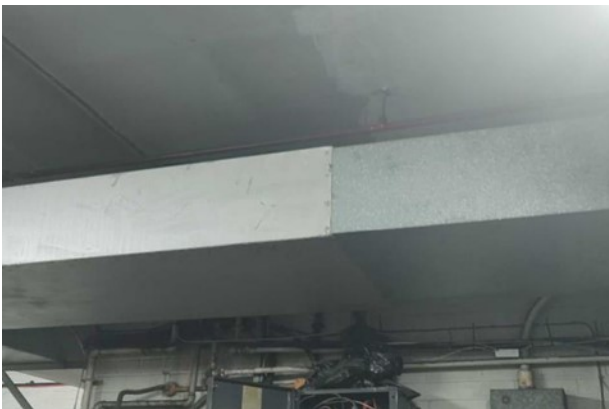
Item 305 Ref: 22-47230-110

The mastic to the ductwork (Area: Ground Floor, Room 129: Vehicle Maintenance Area) does not contain asbestos.

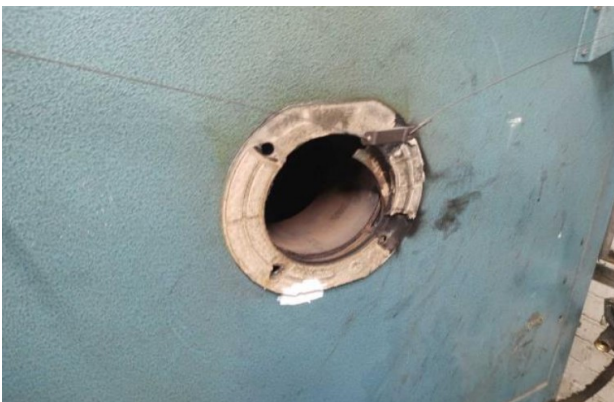
Item 306 Ref: 22-47230-111

The gasket to Benson convector heater boiler (Area: Ground Floor, Room 129: Vehicle Maintenance Area) does not contain asbestos.

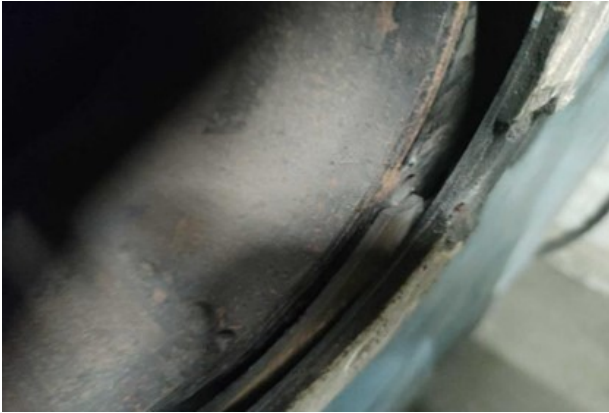
Item 307 Ref: 22-47230-112

The internal gasket to Benson convector heater boiler (Area: Ground Floor, Room 129: Vehicle Maintenance Area) does not contain asbestos.

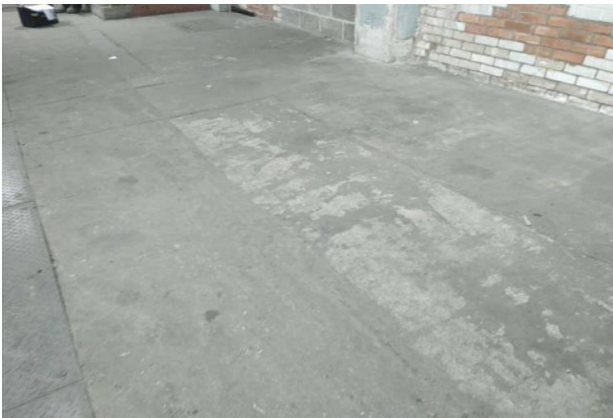
Item 308 Ref: 22-47230-113

The expansion putty to floor (Area: Ground Floor, Room 129: Vehicle Maintenance Area) does not contain asbestos.

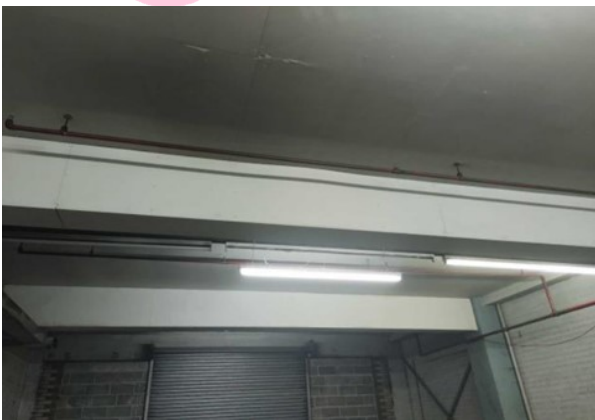
Item 309 Ref: 22-47230-108

The high level horizontal boxing (insulating board) (Area: Ground Floor, Room 130 Vehicle Bay 4) contains asbestos.

Any change in its appearance should be recorded and passed to Property Services.

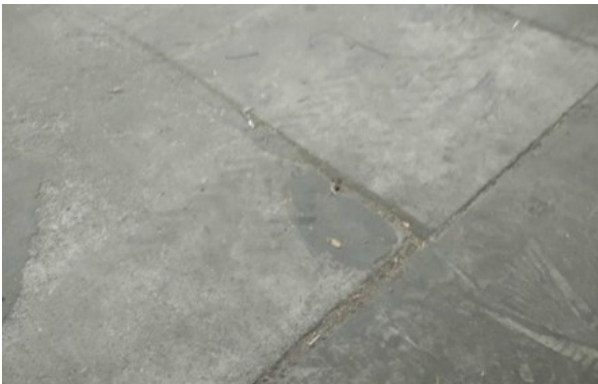
Item 310 Ref: 22-47230-113

The expansion putty to floor (Area: Ground Floor, Room 130: Vehicle Bay 4) does not contain asbestos.

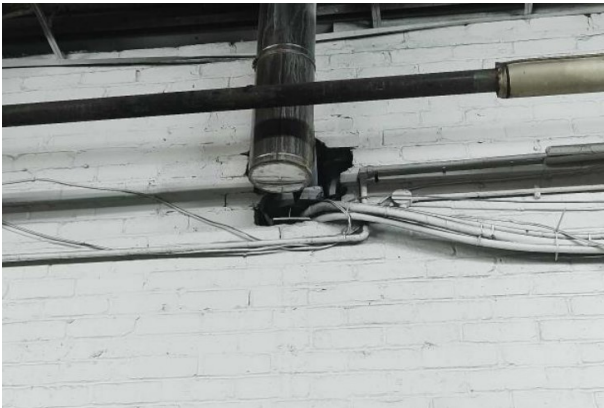
Item 311 Ref: 22-47230-114

The packer to flue penetration (insulating board) (Area: Ground Floor, Room 131 Vehicle Bay 4 (Unit B)) contains asbestos.

Any change in its appearance should be recorded and passed to Property Services.

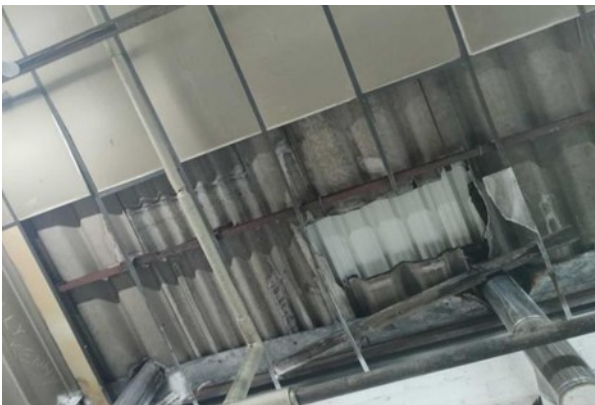
Item 312 Ref: 22-47230-115

The original roof below new external metal roof (Area: Ground Floor, Room 131 Vehicle Bay 4 (Unit B)) contains asbestos.

Any change in its appearance should be recorded and passed to Property Services.

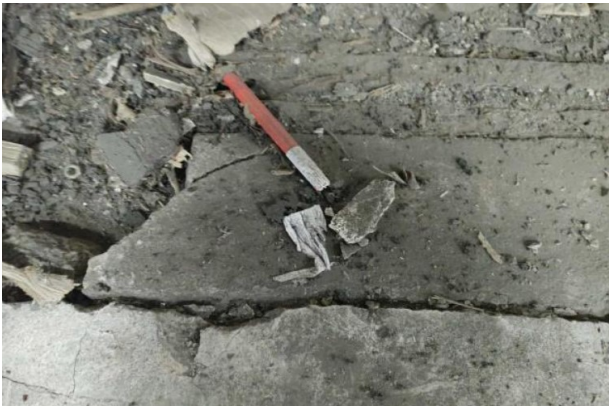
Item 313 Ref: 22-47230-116

The cement debris to floor around perimeter (Area: Ground Floor, Room 131: Vehicle Bay 4 (Unit B)) does not contain asbestos.

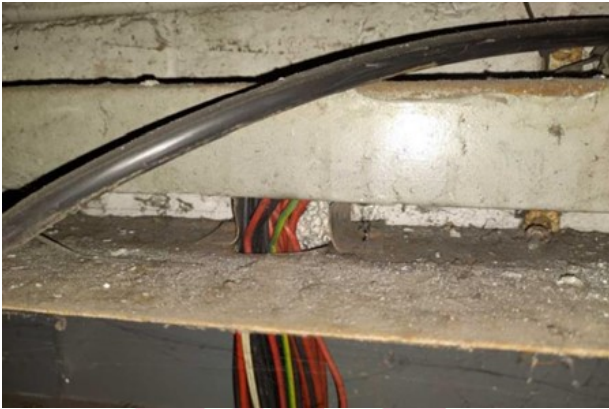
Item 314 Ref: 22-47230-117

The flashpad used as packer within cable trunking (Area: Ground Floor, Room 131 Vehicle Bay 4 (Unit B)) contains asbestos.

Any change in its appearance should be recorded and passed to Property Services.

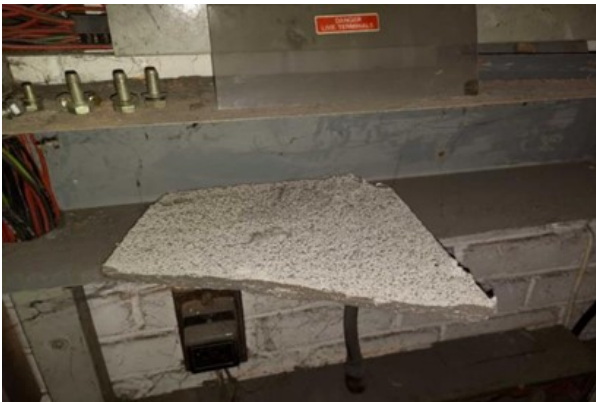
Item 315 Ref: 22-47230-118

315.	22-47230-118	Loose board sitting in trunking	Ground Floor, Room 131 Vehicle Bay 4 Unit B	No Risk
316.	22-47230-119	Floor	Ground Floor, Room 137 Former WC2	Low Risk

The loose board sitting in trunking (Insulating board) (Area: Ground Floor, Room 131 Vehicle Bay 4 (Unit B)) does not contain asbestos.

315.	Loose board sitting in trunking	Ground Floor, Room 131 Vehicle Bay 4 Unit B	No Risk				
316.	Floor	Ground Floor, Room 137 Former WC2	Low Risk – check every 6 months	24/03/24

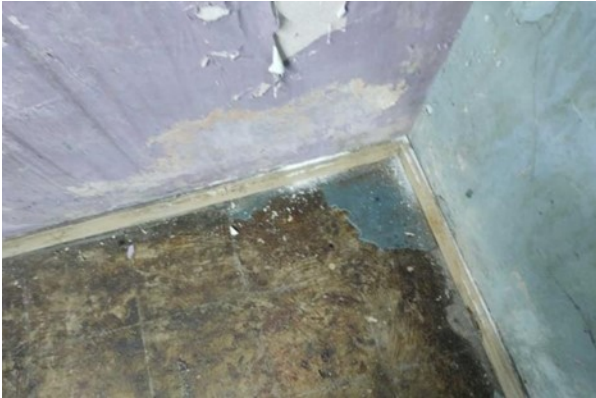
Item 316 Ref: 22-47230-119

The floor (Area: Ground Floor, Room 137: Former WC 2) contains asbestos.

Any change in its appearance should be recorded and passed to Property Services.

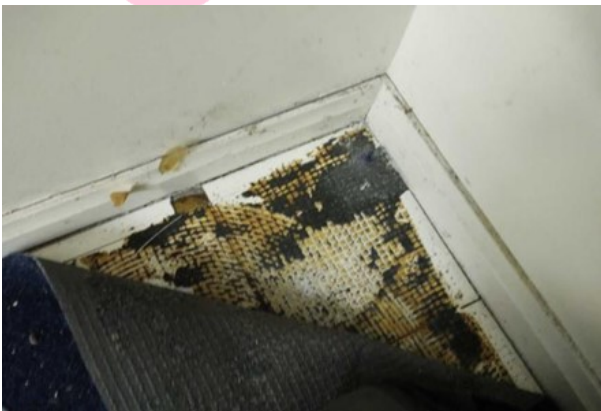
Item 318 Ref: 22-47230-119

The floor (Area: Ground Floor, Room 141: Office) contains asbestos.

Any change in its appearance should be recorded and passed to Property Services.

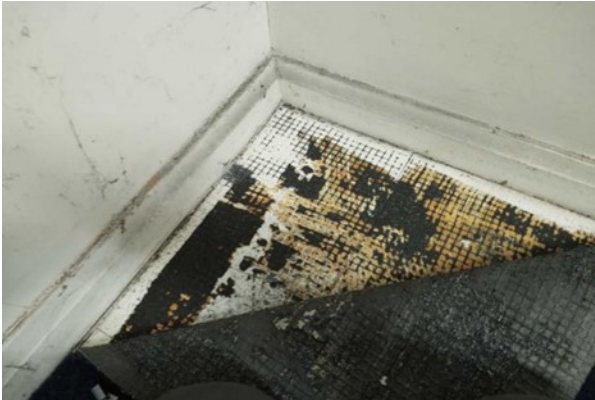
Item 319 Ref: 22-47230-119

The floor (Area: Ground Floor, Room 142: Office) contains asbestos.

Any change in its appearance should be recorded and passed to Property Services.

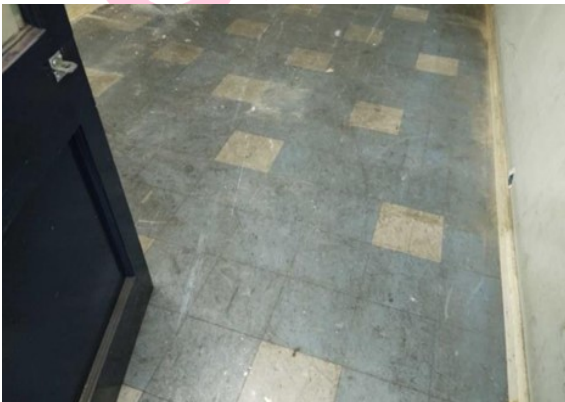
Item 321 Ref: 22-47230-119

The floor (Area: Ground Floor, Room 144: Store Room) contains asbestos.

Any change in its appearance should be recorded and passed to Property Services.

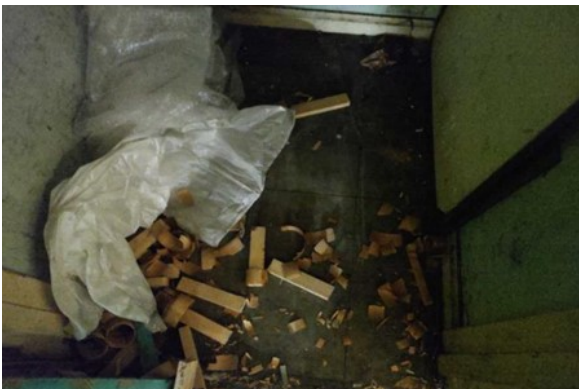
Item 324 Ref: 22-47230-120

The floor tiles and adhesive (Area: Ground Floor, Room 146: Store Cupboard) contains asbestos.

Any change in its appearance should be recorded and passed to Property Services.

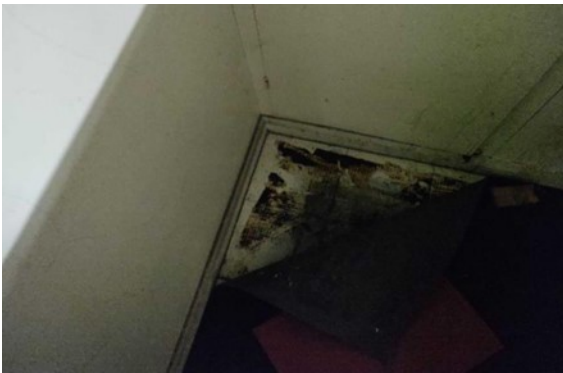
Item 325 Ref: 22-47230-119

The floor (Area: Ground Floor, Room 147: Kitchenette) contains asbestos.

Any change in its appearance should be recorded and passed to Property Services.

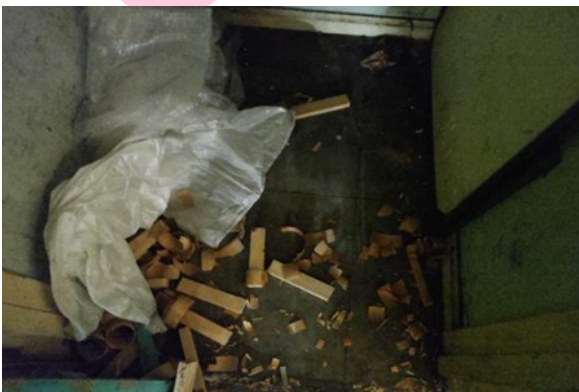
Item 327 Ref: 22-47230-77

The debris to the floor adjacent to oil tank (Area: Room 149: Floor Roof) contains asbestos.

Any change in its appearance should be recorded and passed to Property Services.

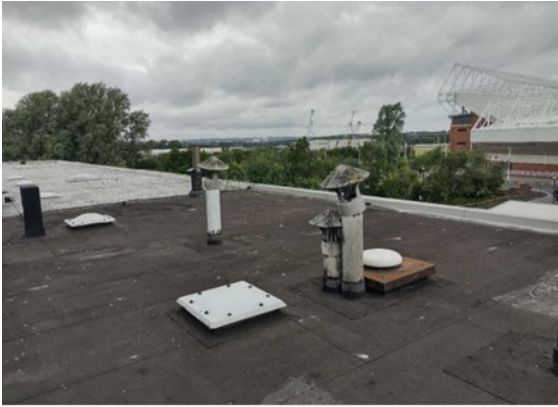
Item 328 Ref: 22-47230-78

The flue and cowls (Area: Room 149: Floor Roof) contains asbestos.

Any change in its appearance should be recorded and passed to Property Services.

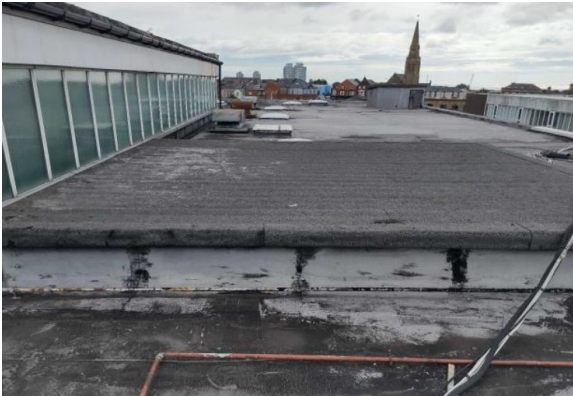
Item 329 Ref: 22-47230-79

The felt to the roof (Area: Room 149: Floor Roof) does not contain asbestos.

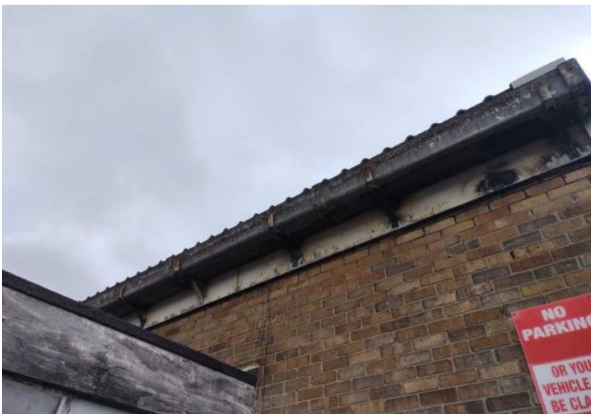
Item 332 Ref: 22-47230-122

The rainwater goods to block 1B gable end (Area: Floor 0, Room 152: External) contains asbestos.

Any change in its appearance should be recorded and passed to Property Services.

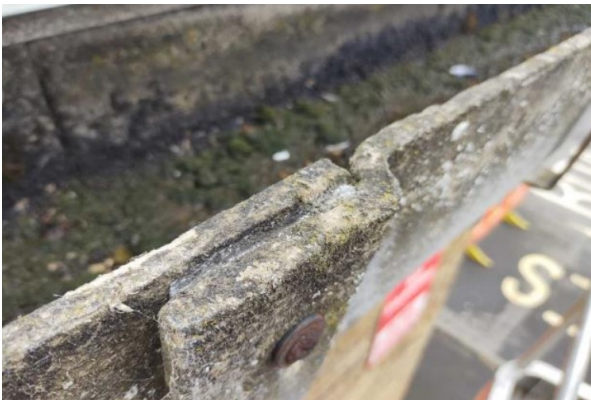
Item 333 Ref: 22-47230-123

The rainwater goods jointing compound between cement gutters to block 1B gable end (Area: Floor 0, Room 152: External) contains asbestos.

Any change in its appearance should be recorded and passed to Property Services.

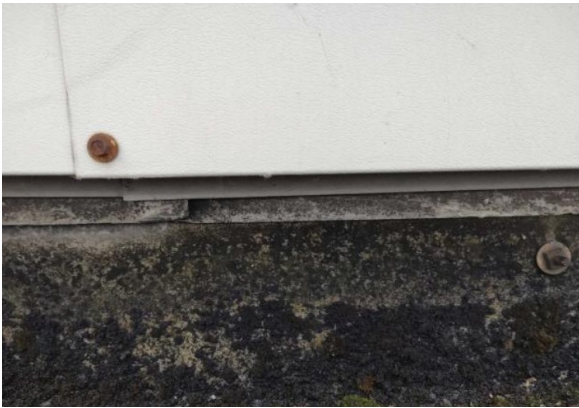
Item 334 Ref: 22-47230-124

The fascia cement behind metal profile to block 1B gable end (Area: Floor 0, Room 152: External) contains asbestos.

Any change in its appearance should be recorded and passed to Property Services.

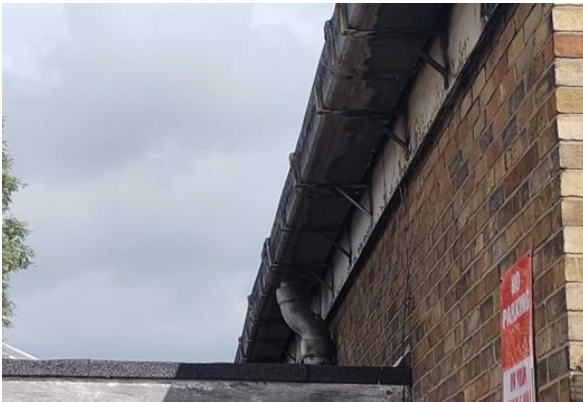
Item 335 Ref: 22-47230-125

The downpipes to block 1B gable end (Area: Floor 0, Room 152: External) contains asbestos.

Any change in its appearance should be recorded and passed to Property Services.

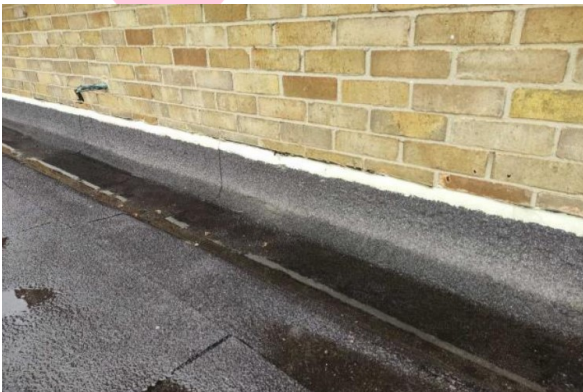
Item 336 Ref: 22-47230-127

The damp proof to walls above flat roof to 1C (Area: Floor 0, Room 152: External) do not contain asbestos.

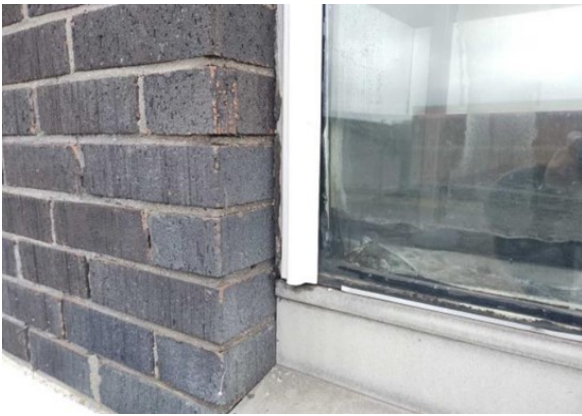
Item 337 Ref: 22-47230-127

The window mastic to pvc windows on Block 1A (Area: Floor 0, Room 152: External) do not contain asbestos.

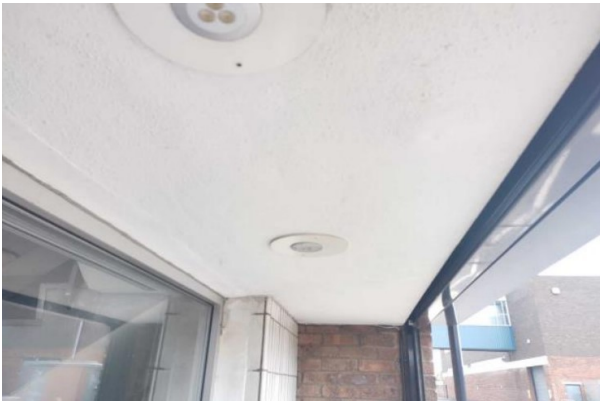
Item 338 Ref: 22-47230-128

The render to concrete entrance canopy (Area: Floor 0, Room 152: External) do not contain asbestos.

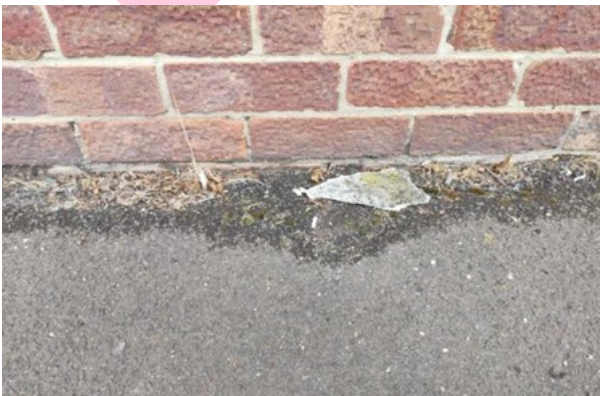
Item 339 Ref: 22-47230-129

The debris to path at front elevation (Insulating board) (Area: Floor roof, Room 150: Header tank room) contains asbestos.

Removed as sample

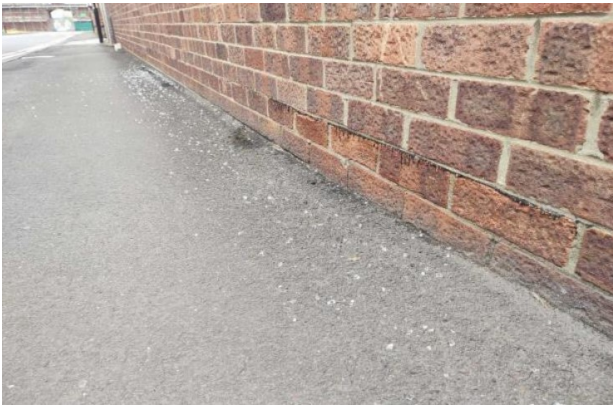
Item 341 Ref: 22-47230-131

The damp proof course to Block 1A (Area: Floor 0, Room 152: External) contains asbestos.

Any change in its appearance should be recorded and passed to Property Services.

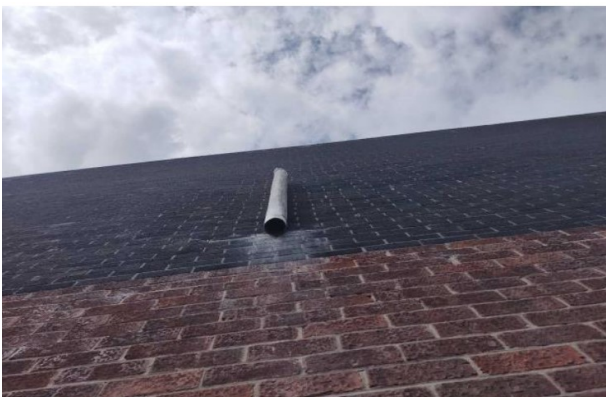
Item 342 Ref: 22-47230-132

The down pipes to gable end (Area: Floor 0, Room 152: External) contains asbestos.

Any change in its appearance should be recorded and passed to Property Services.

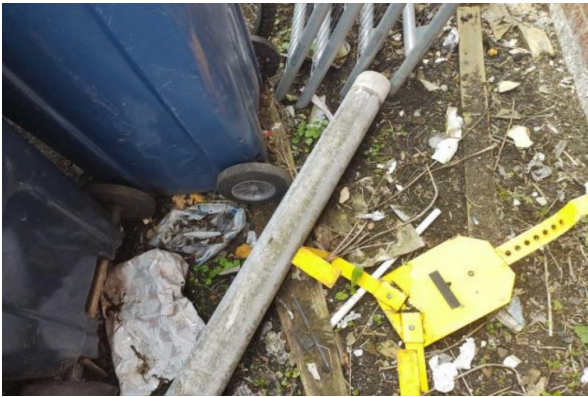
Item 343 Ref: 22-47230-133

The downpipe debris under sampled downpipe (Area: Floor 0, Room 152: External) contains asbestos.

Any change in its appearance should be recorded and passed to Property Services.

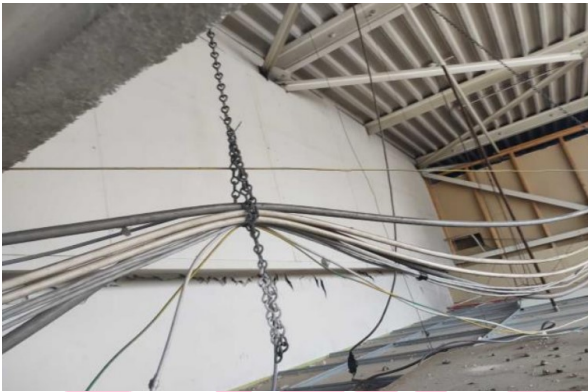
Item 344 Ref: 22-47230-20

The fire breaks to tops of wall outside female wc (Area: Second Floor, Room 26a: Tank room (within ceiling void)) contains asbestos.

Any change in its appearance should be recorded and passed to Property Services.

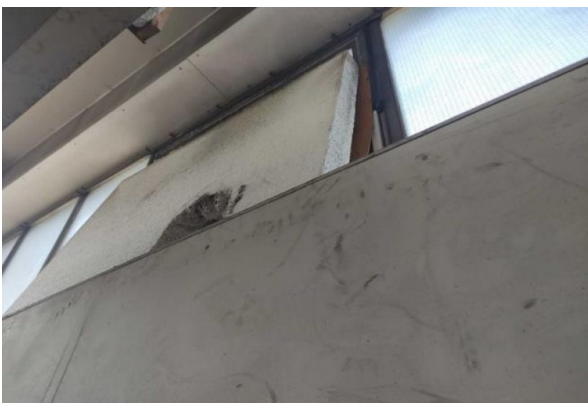
Item 345 Ref: 22-47230-20

The boxing to RSJ's (insulating Board) (Area: Second Floor, Room 26a: Tank room (within ceiling void)) contains asbestos.

Any change in its appearance should be recorded and passed to Property Services.

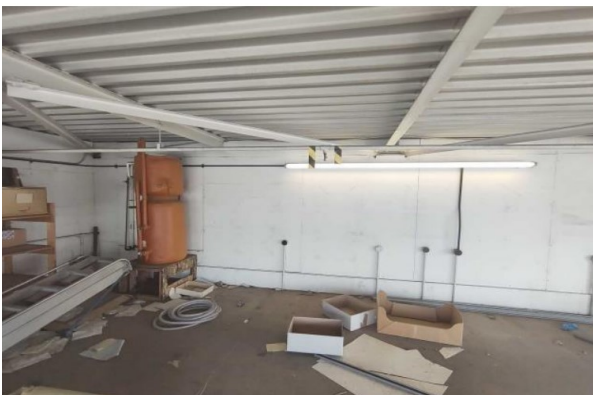
Item 348 Ref: 22-47230-14

The walls (insulating Board) (Area: Mezzanine Floor, Room 27a: above room 27) contains asbestos.

Any change in its appearance should be recorded and passed to Property Services.

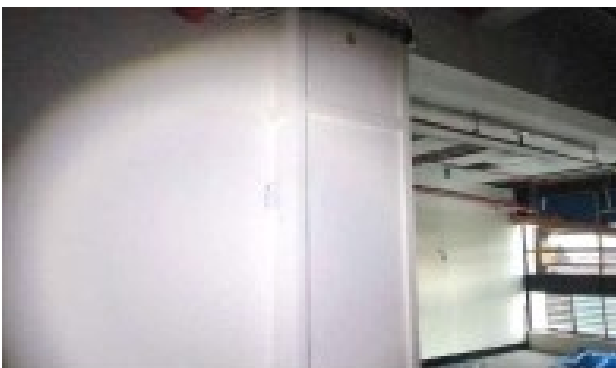
Item 351 Ref: Presumed

The column cladding inner cladding to column at location of PIR sensor (First Floor Staircase/Stairwell 1/002) is presumed to contain asbestos.

Any change in its appearance should be recorded and passed to Property Services.

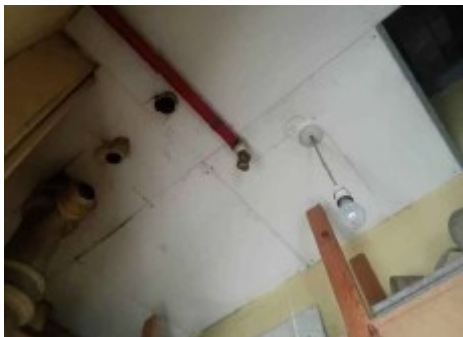
Item 356 Ref: As TL000363

The ceiling tile in First Floor Cupboard Store Room 1/078 contains asbestos.
