### ASBESTOS SURVEY REPORT FOR WASHINGTON COMMUNITY RESOURCE CENTRE, AYTON ROAD, WASHINGTON, NE38 0DA.

### **Asbestos Register for**

### **Washington Resource Centre, Washington, NE38 0DA**

**UPRN: - 401888**

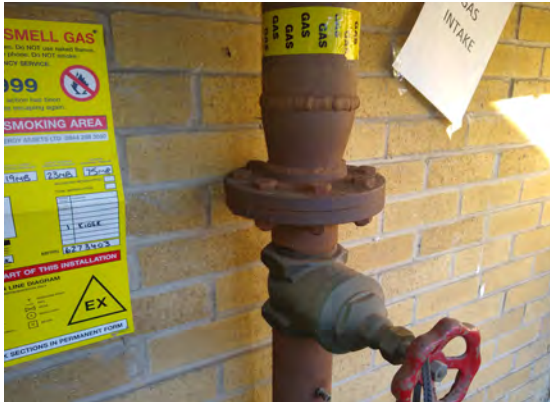
### **Item 1 Ref: Presumed**

The close coupled pipework flange gasket in the Gas Meter House (Rm 0/01) contains asbestos.

Any change in its appearance should be recorded and passed to Property Services.

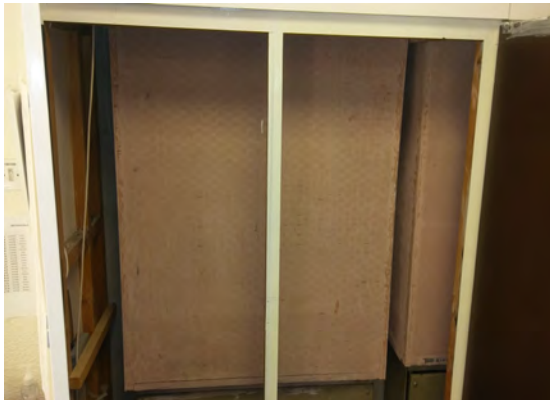
### **Item 2 Ref: 401888-11**

The insulation to heaters and associated debris to floor in the Managers Office (Rm 0/02) does not contain asbestos.

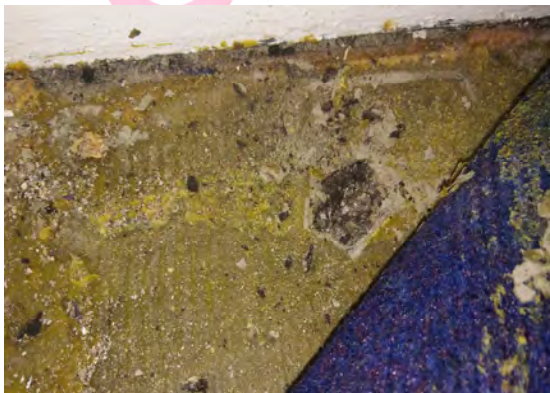
### **Item 3 Ref: 401888-13**

The floor screed in the Computer Suite (Rm 0/03) does not contain asbestos.

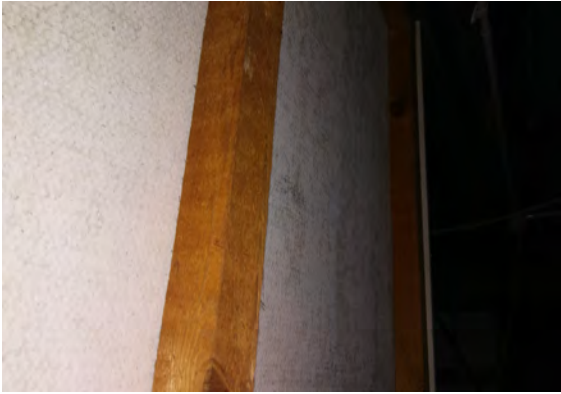
**Item 4 Ref: 401888-12**

The panels to skylights in the Computer Suite – ceiling void (Rm 0/03) do not contain asbestos.

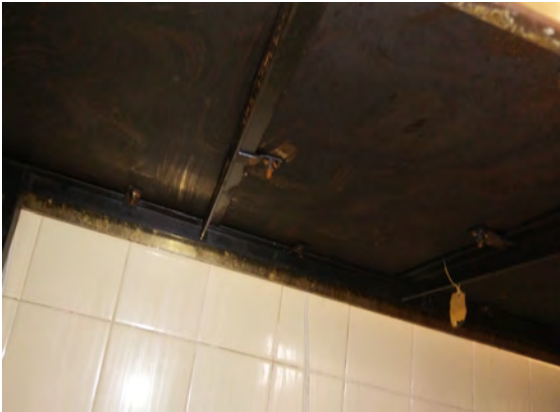
### **Item 25 Ref: 401888-19**

The coating to the underside of worktops in the Kitchen (Rm 0/25) does contain asbestos.

Any change in its appearance should be recorded and passed to Property Services.

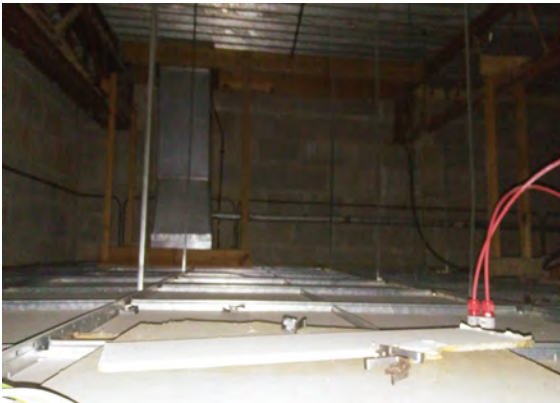
### **Item 26 Ref: As 401888-16**

The mastic to ducting in the Kitchen – ceiling void (Rm 0/25) does not contain asbestos.

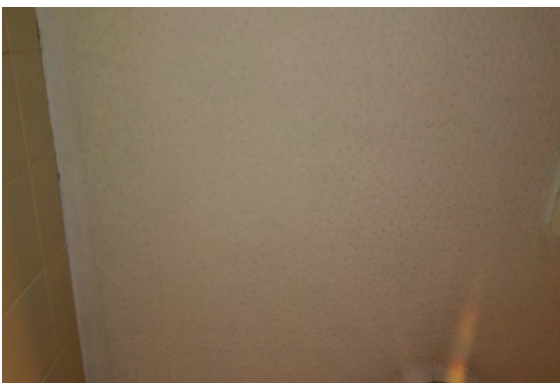
### **Item 27 Ref: As 401888-14**

The textured coated ceiling in the Kitchen Store (Rm 0/26) contains asbestos.

Any change in its appearance should be recorded and passed to Property Services.

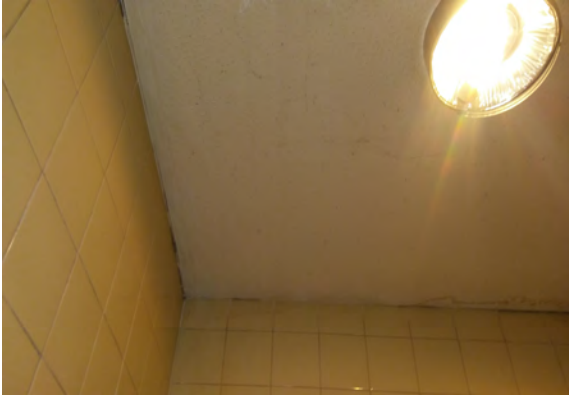
### **Item 28 Ref: As 401888-14**

The textured coated ceiling in the Kitchen Store (Rm 0/27) contains asbestos.

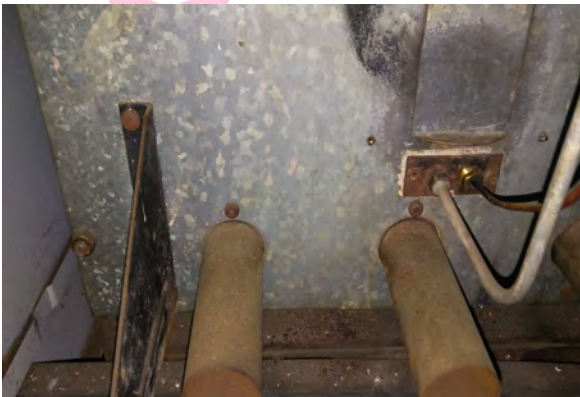
### **Item 30 Ref: 401888-21**

The packers to boilers in the Boiler Room (Rm 0/30) contains asbestos.

Removed November 2021.

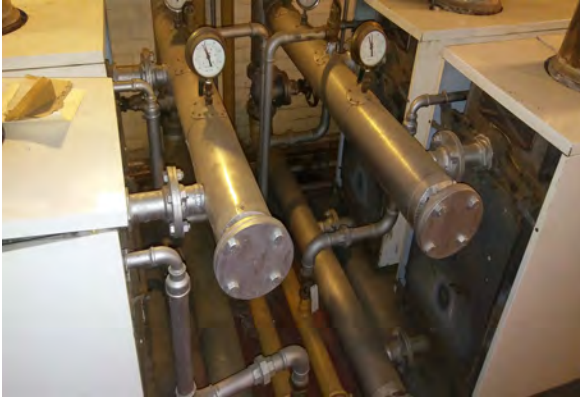
### **Item 31 Ref: 401888-22**

The lagging to boiler pipework in the Boiler Room (Rm 0/30) does not contain asbestos.

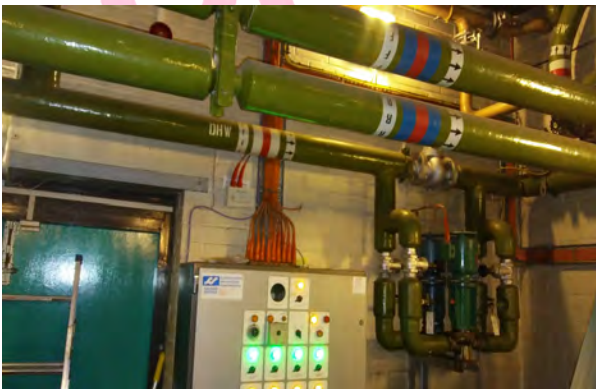
### **Item 33 Ref: 401888-24**

The pipework lagging to green pipework in the Boiler Room (Rm 0/30) does not contain asbestos.

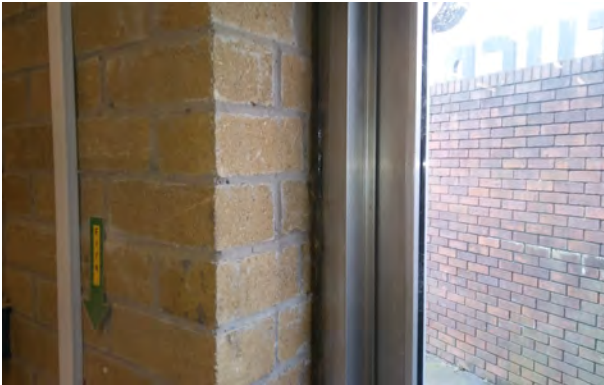
### **Item 44 Ref: 401888-20**

The remnant mastic to fire exit door in the Workshop (Rm 0/32) contains asbestos.

Any change in its appearance should be recorded and passed to Property Services.

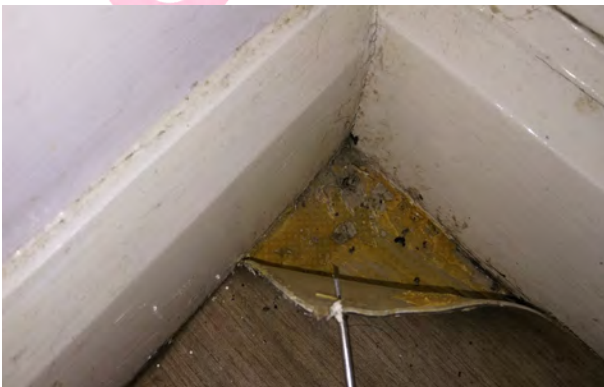
### **Item 45 Ref: As 401888-15**

The floor screed in the Ayton Suite 5 (Rm 0/33) does not contain asbestos.

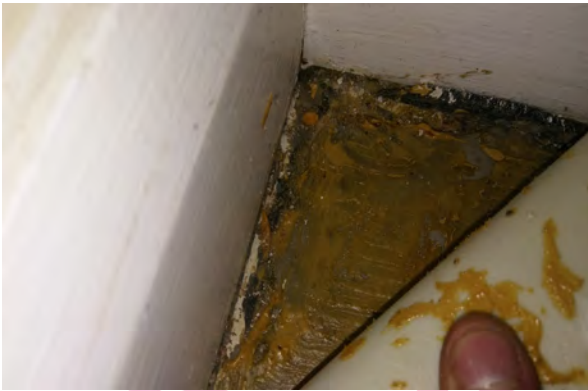
**Item 47 Ref: As 401888-15**

The floor screed in the Ayton Suite 4 (Rm 0/35) does not contain asbestos.

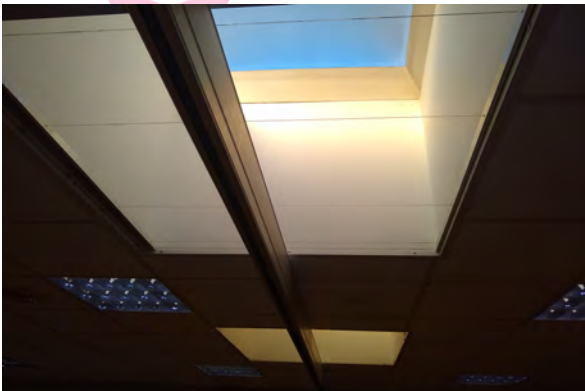
### **Item 54 Ref: As 401888-5**

The panels to skylights in the Ayton Suite 1 (Rm 0/48) do not contain asbestos.

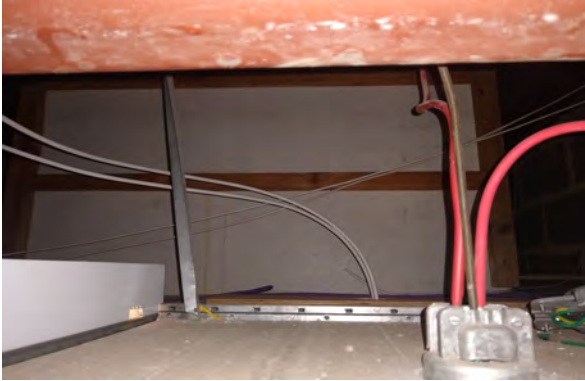
### **Item 58 Ref: 401888-2**

The skylight surrounds in the Ayton Suite 2 – ceiling void (Rm 0/51) do not contain asbestos.

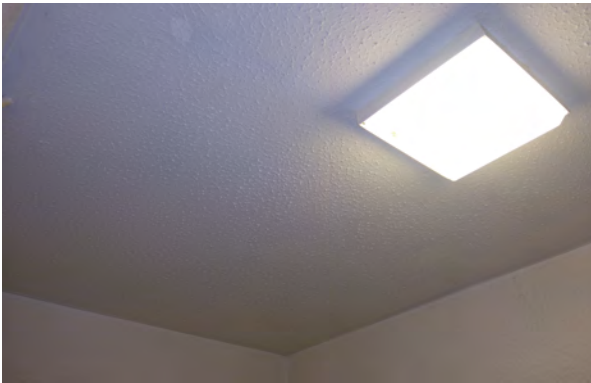
### **Item 59 Ref: 401888-3**

The textured coating ceiling in the Cupboard (Rm 0/56) contains asbestos.

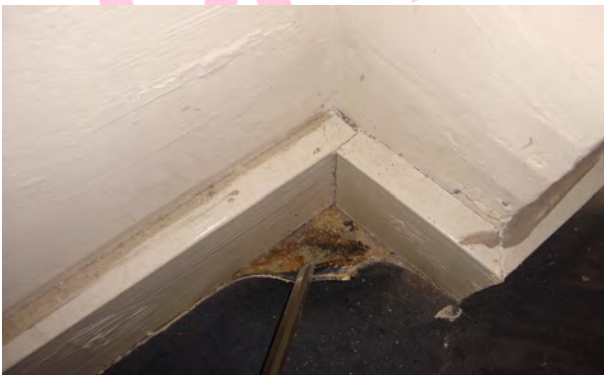
### **Item 72 Ref: As 401888-7**

The floor screed in the Store Cupboard (Rm 0/80) does not contain asbestos.

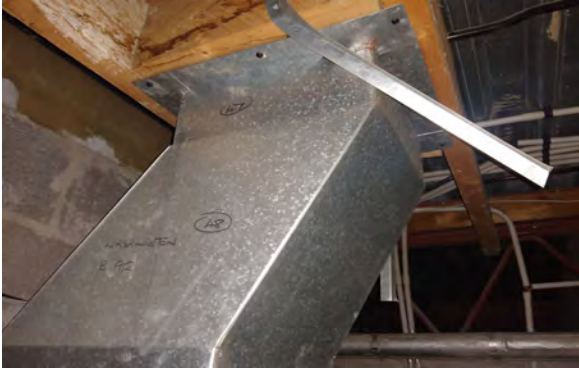
### **Item 73 Ref: As 401888-1**

The mastic to ducting in the Reception Main Office – ceiling void (Rm 0/81) does not contain asbestos.

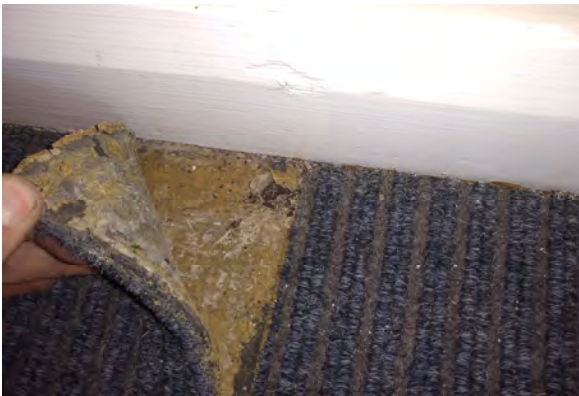
### **Item 74 Ref: 401888-7**

The floor screed in the Entrance Lobby (Rm 0/83) does not contain asbestos.

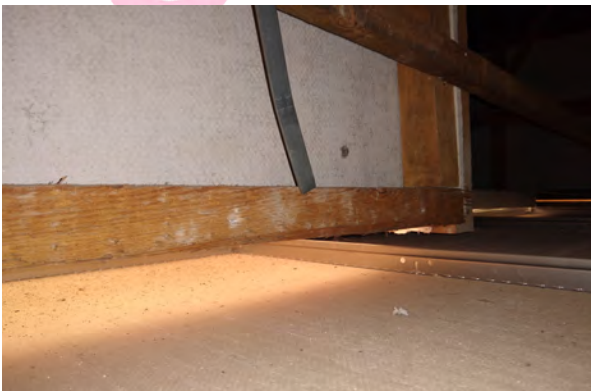
**Item 78 Ref: As 401888-6**

The debris to the top of the suspended ceiling below skylights in the Corridor – ceiling void (Rm 0/83a) does not contain asbestos.

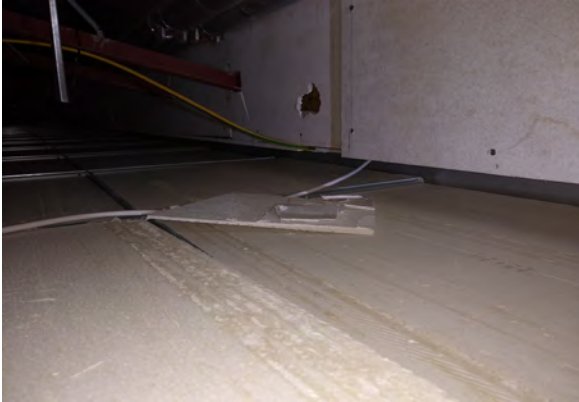
### **Item 82 Ref: 401888-10**

The debris to topside of suspended ceiling below in the Dining Hall – high level ceiling void (Rm 0/85) does not contain asbestos.

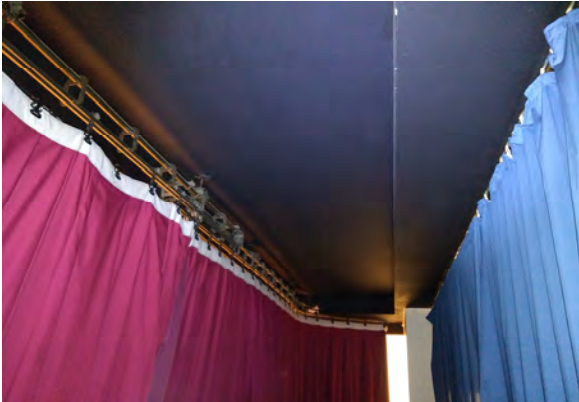
### **Item 83 Ref: 401888-30**

The fixed ceiling above stage in the Stage Area (Rm 0/86) does not contain asbestos.

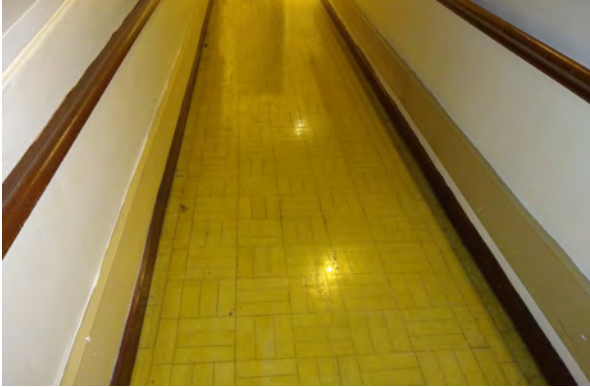
### **Item 85 Ref: As 401888-29**

The floor covering to ramp in the Stage Area (Rm 0/86) does not contain asbestos.

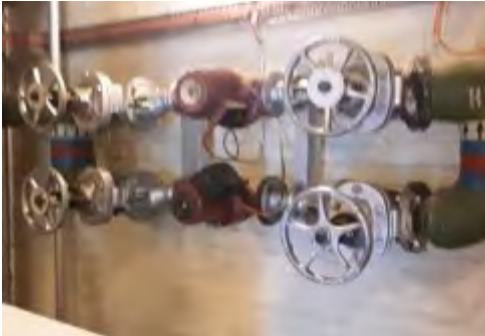
**Item 96 Ref: 20-27272-11**

The electrical equipment within redundant barrel fuses to switchgear in Boiler Room does not contain asbestos.

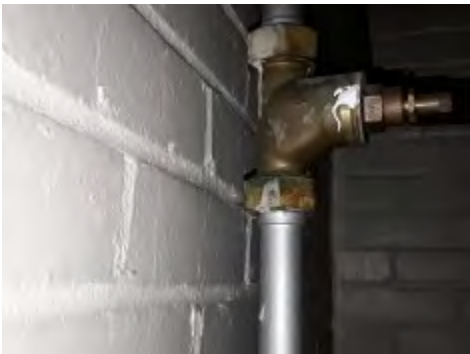
**Item 97 Ref: 20-27272-12**

The pipes above tank to stopcock gasket in Boiler Room does not contain asbestos.

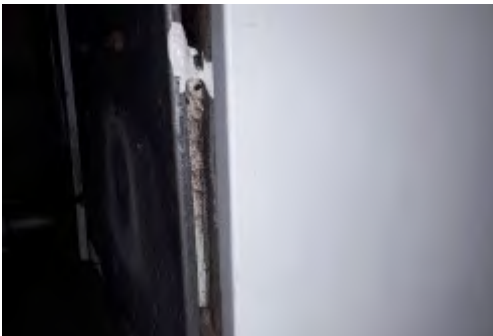
**Item 98 Ref: 20-27272-14**

The vessels behind rear metal boiler plates x 5 in Boiler Room does not contain asbestos.

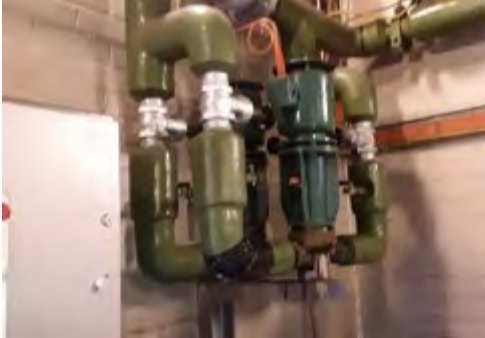
**Item 99 Ref: 20-27272-3**

The pipes small bore adjacent to control panel in Boiler Room does not contain asbestos.

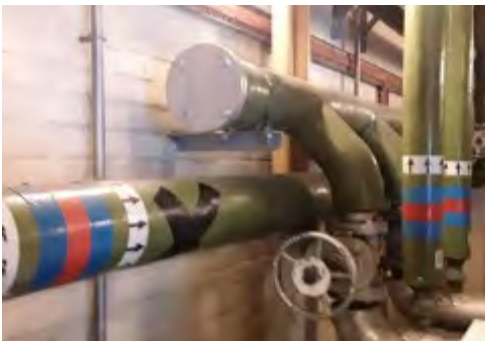
**Item 100 Ref: 20-27272-4**

The pipes large bore behind boiler in Boiler Room does not contain asbestos.

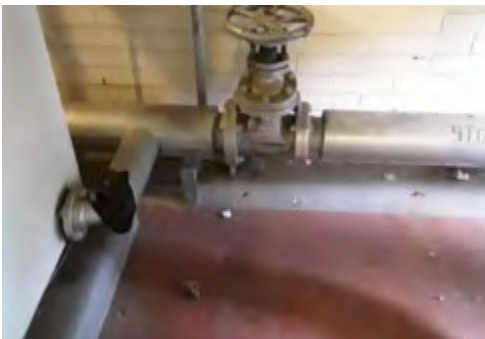
**Item 101 Ref: 20-27272-6**

The pipes metal clad adjacent to tank and boiler in Boiler Room does not contain asbestos.

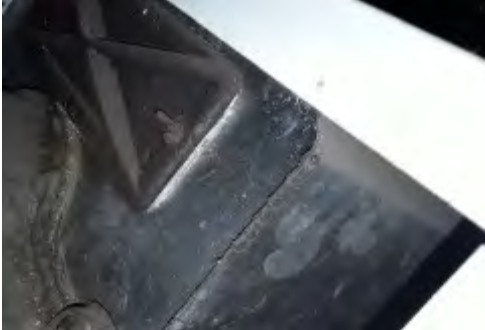
**Item 102 Ref: 20-27272-8**

The vessels rear access plates to boilers in Boiler Room does not contain asbestos.

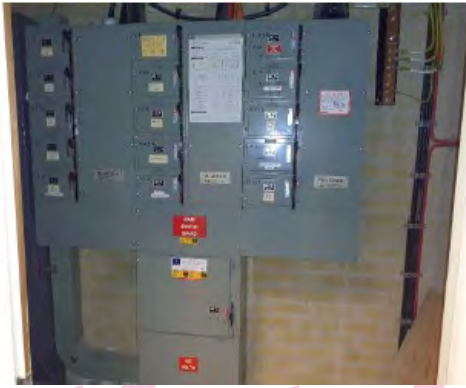
**Item 103 Ref: Presumed**

The flash guards in the Electrical Switch Board (Electrical Switch Room G/002) is presumed to contain asbestos.

Any change in its appearance should be recorded and passed to Property Services.

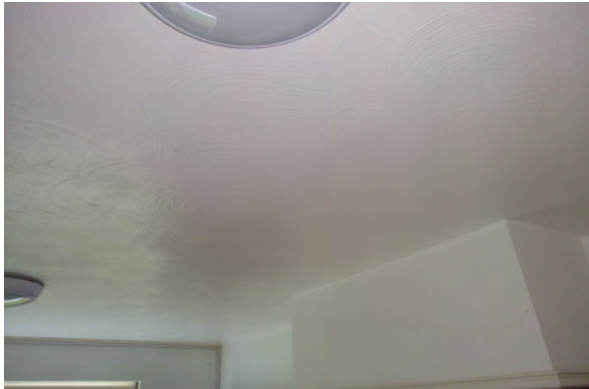
**Item 91 Ref: 401888-33**

The textured coating ceiling in the Living Room – Caretakers House (Rm 0/05) contains asbestos.

Any change in its appearance should be recorded and passed to Property Services.

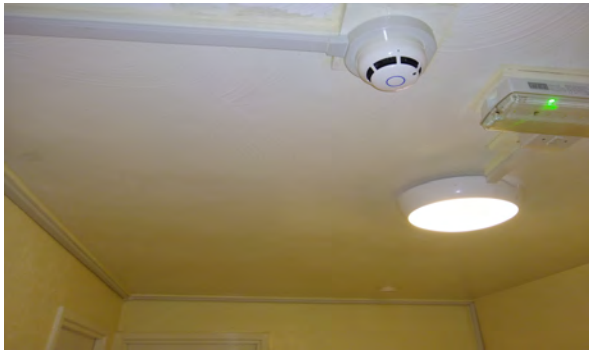
**Item 92 Ref: 401888-31**

The textured coating ceiling in the Stairwell & Landing – Caretakers House (Rm 1/01) contains asbestos.

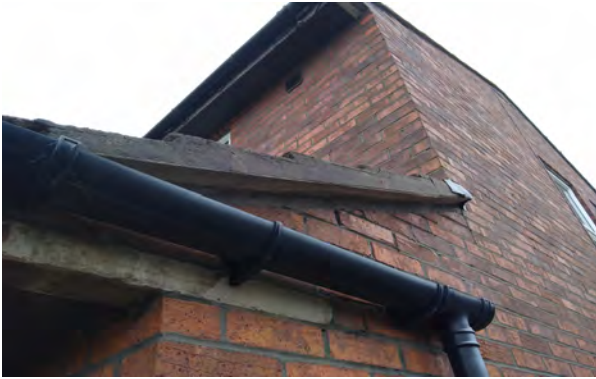
**Item 94 Ref: 401888-35**

The undercloaking to house & porch – Caretakers House (External) contains asbestos.

Any change in its appearance should be recorded and passed to Property Services.

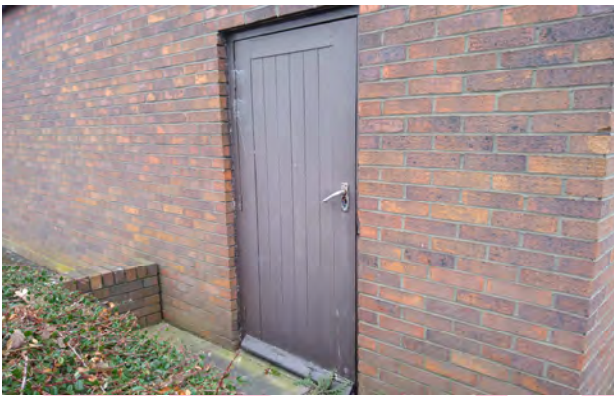
**Item 95 Ref: 401888-38**

The sealant to door frame – Garage Block (External) does not contain asbestos.
