ASBESTOS SURVEY REPORT FOR DEPTFORD & MILLFIELD CA, SUNDERLAND

Asbestos Register for DEPTFORD & MILLFIELD CA, SUNDERLAND

Date: 26 September 2024

Last updated 26/09/2024 – Depford and Millfield CA – Version 2

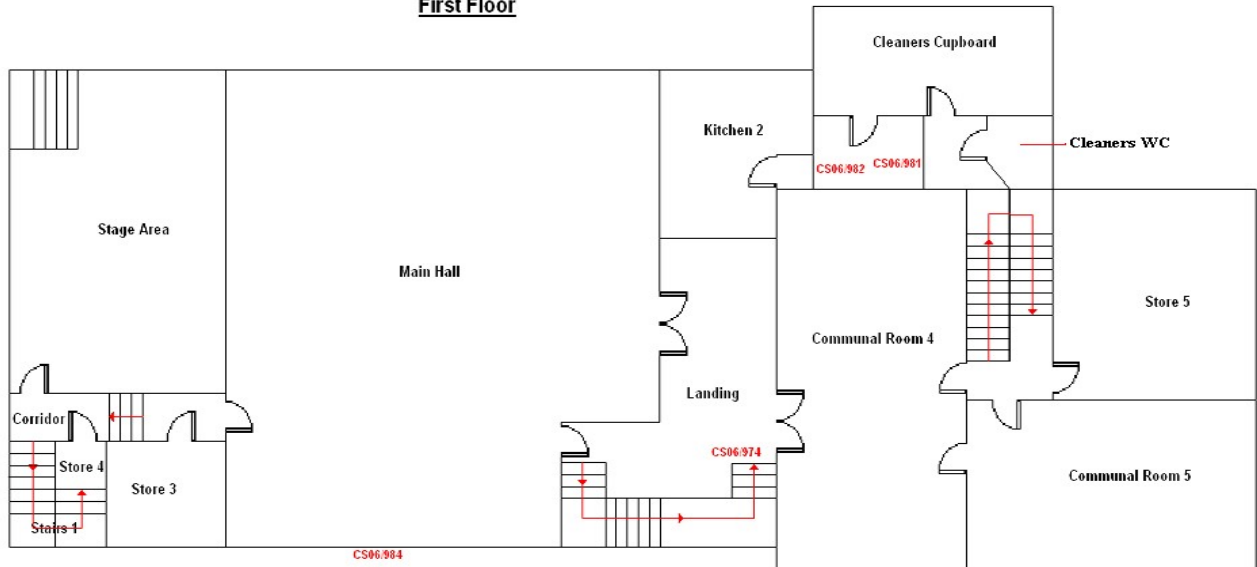
First Floor

CS06/967 – Floor Tiles (Disabled Male WC) (Item 1) No Risk
CS06/969 – Flooring (Communal Room 1) (Item 2) No Risk
CS06/970 & 250834-5 – Ceiling Tiles (communal Room 1) (Item 3) No Risk
As CS06/970 & As 250834-5 – Ceiling Tiles (Office) (Item 4) No Risk
As CS06/972 – Ceiling Panels (Stair Lobby) (Item 5) Low Risk
CS06/971 – Gaskets (Under Stairs Cupboard) (Item 6) Low Risk
CS06/972 & 250834-7 – Ceiling Panels (Kitchen) (Item 7) Low Risk
CS06/973 & 250834-1– Stair Nosing (Foyer, Stairs & Landing) (Item 8) No Risk
CS06/974 & 250834-8 – Grey Floor Tiles (Foyer, Stairs & Landing) (Item 9) No Risk
CS06/975 – Red Vinyl Flooring & Adhesive (Dressing Rm) (Item 10) No Risk
CS06/976 – Green Vinyl Flooring & Adhesive (Dressing Rm 2) (Item 11) No Risk
CS06/977 & 250834-9 – Cement Panels to Side of Door (2nd floor landing) (Item 12) Low Risk
CS06/978 – Beige Under Carpet (Corridor 3) (Item 13) No Risk
CS06/979 – Red Vinyl Covering Under Carpet (Store 8) (Item 14) No Risk
