### ASBESTOS SURVEY REPORT FOR CONTAINER PARK OFFICES Gr FI 1 EAST SIDE COMMUNITY BLOCK, PORT OF SUNDERLAND

## **Asbestos Register for**

**CONTAINER PARK OFFICES, Gr FI1, EAST SIDE  
HUDSON DOCK, PORT OF SUNDERLAND**

**Date: 8<sup>th</sup> July 2024**

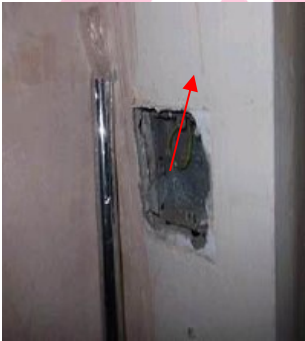
The boxing to the columns in the canteen (Room 3) room does not contain asbestos.

Similar boxing is located in rooms 5, 9, 10, 11, 12, 14, 17 and 18.
