### ASBESTOS SURVEY REPORT FOR CONTAINER PARK OFFICES Gr FI 1 EAST SIDE COMMUNITY BLOCK, PORT OF SUNDERLAND

**CONTAINER PARK OFFICES, Gr FI1, EAST SIDE  
HUDSON DOCK, PORT OF SUNDERLAND**

**Premises Manager / Samo: - Tenant      Date: 31<sup>st</sup> July 2023**

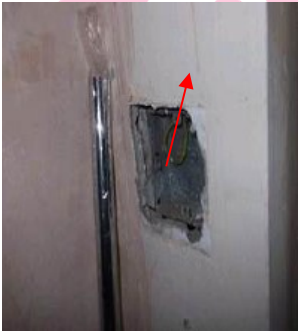
The boxing to the columns in the canteen (Room 3) room does not contain asbestos.

Similar boxing is located in rooms 5, 9, 10, 11, 12, 14, 17 and 18.
