ASBESTOS SURVEY REPORT FOR BLOCK 1A – 1C EDWARD THOMPSON SITE, RICHMOND STREET, SUNDERLAND, SR5 1BQ

Asbestos Register for Block 1A – 1C Edward Thompson Site, Richmond Street, Sunderland, SR5 1BQ

Date: 14 February 2025

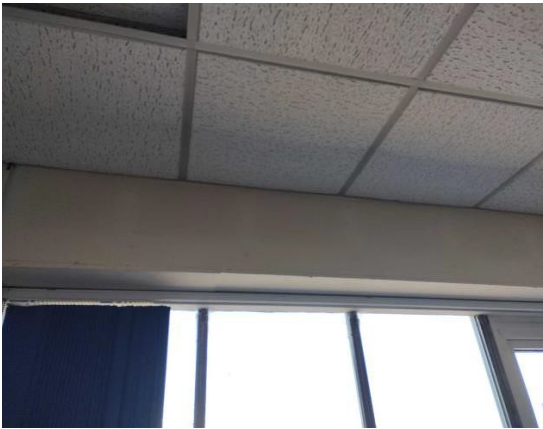
Item 1 Ref: 22-47230-1

Item No	Sample Ref.	Location		Inspection Frequency
1.	22-47230-1	High level boxing	Second Floor, Room 1 Meeting Room	Medium Risk
2.	22-47230-2	Debris to tops of ceiling tiles	Second Floor, Room 1 Meeting Room	Medium Risk

The high level boxing (insulating board) (Area: Second Floor, Room 1 Meeting Room) contains asbestos.

Any change in its appearance should be recorded and passed to Property Services.

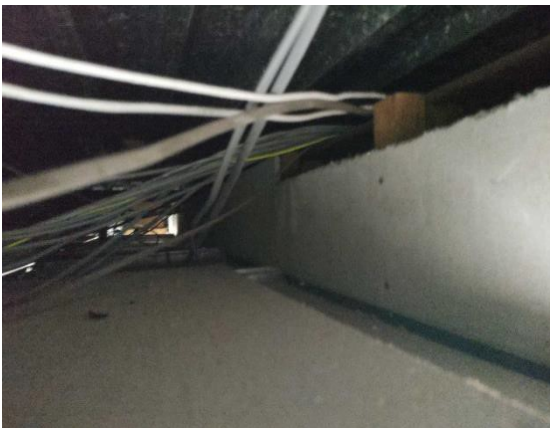
Item 2 Ref: 22-47230-2

The debris to tops of ceiling tiles (insulating board) (Area: Second Floor, Room 1 Meeting Room) contains asbestos.

Any change in its appearance should be recorded and passed to Property Services.

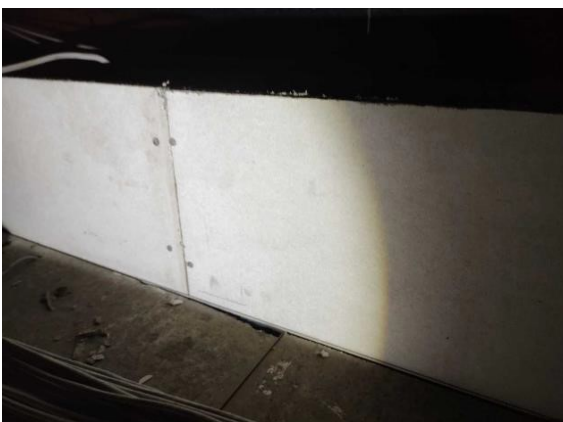
Item 3 Ref: 22-47230-2

3.	22-47230-2	Debris to tops of ceiling tiles	Second Floor, Room 1 Meeting Room	Medium Risk
4.	22-47230-3	Sealant to window seals	Second Floor, Room 1 Meeting Room	Low Risk

The debris to tops of ceiling tiles (insulating board) (Area: Second Floor, Room 1 Meeting Room) contains asbestos.

Any change in its appearance should be recorded and passed to Property Services.

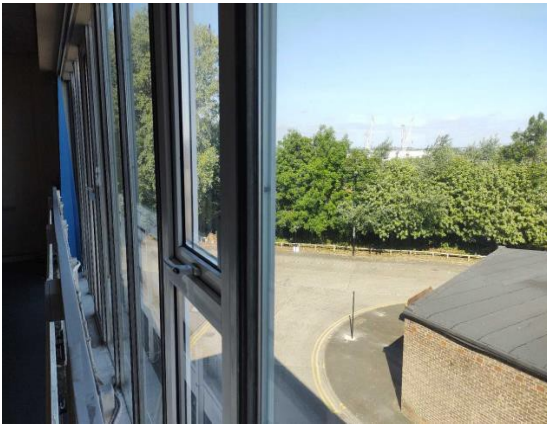
Item 4 Ref: 22-47230-3

The sealant to window seals (mastic) (Area: Second Floor, Room 1 Meeting Room) contains asbestos.

Any change in its appearance should be recorded and passed to Property Services.

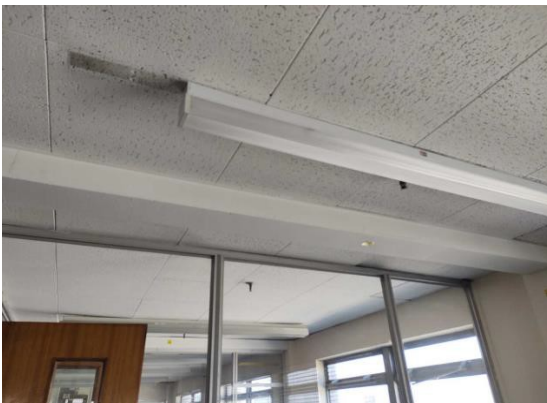
Item 5 Ref: 22-47230-1

5.	22-47230-1	High level horizontal boxing	Second Floor, Room 3 office 2	Medium Risk
6.	22-47230-1	Vertical boxing	Second Floor, Room 3 office 2	Medium Risk

The high level horizontal boxing (insulating board) (Area: Second Floor, Room 3 Office 2) contains asbestos.

Any change in its appearance should be recorded and passed to Property Services.

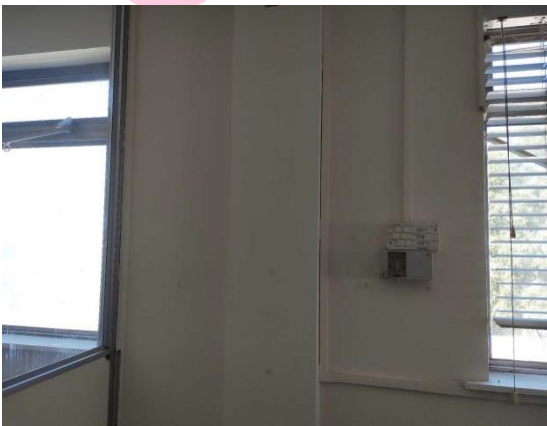
Item 6 Ref: 22-47230-1

The vertical boxing (insulating board) (Area: Second Floor, Room 3 Office 2) contains asbestos.

Any change in its appearance should be recorded and passed to Property Services.

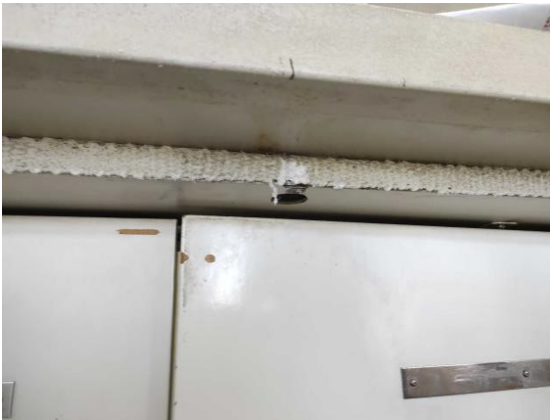
Item 7 Ref: 22-47230-4

7.	22-47230-4	Rope seal to safe door	Second Floor, Room 3 office 2	Low Risk
8.	22-47230-1	High level horizontal boxing	Second Floor, Room 4 Store	Medium Risk

The rope seal to safe door (textile) (Area: Second Floor, Room 3 Office 2) contains asbestos.

Any change in its appearance should be recorded and passed to Property Services.

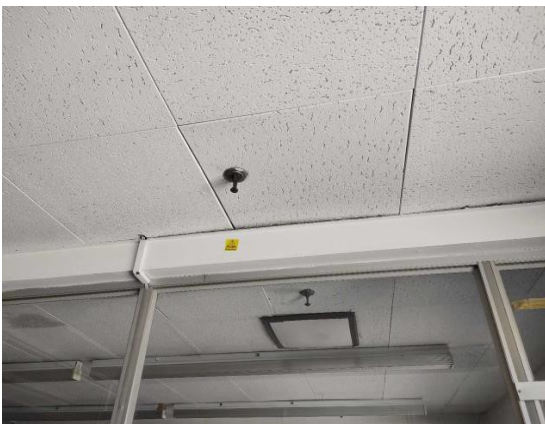
Item 8 Ref: 22-47230-1

The high level horizontal boxing (insulating board) (Area: Second Floor, Room 4 Store) contains asbestos.

Any change in its appearance should be recorded and passed to Property Services.

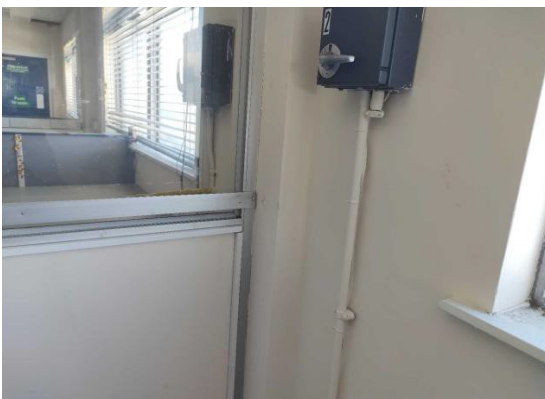
Item 9 Ref: 22-47230-1

The vertical boxing (insulating board) (Area: Second Floor, Room 4 Store) contains asbestos.

Any change in its appearance should be recorded and passed to Property Services.

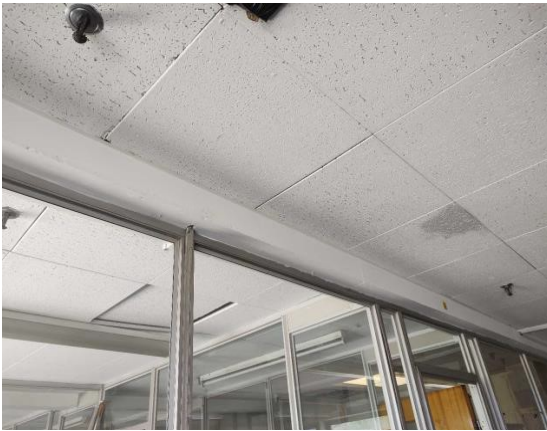
Item 10 Ref: 22-47230-1

The high level horizontal boxing (insulating board) (Area: Second Floor, Room 5 IT Department) contains asbestos.

Any change in its appearance should be recorded and passed to Property Services.

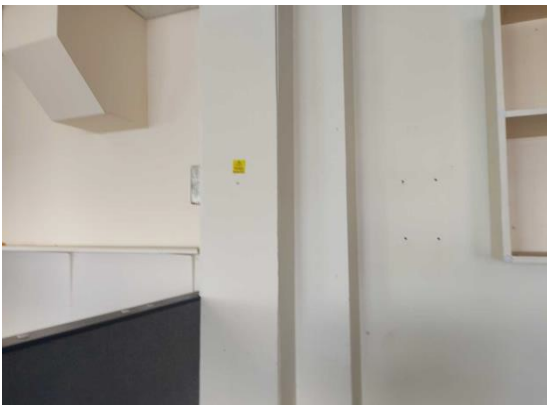
Item 11 Ref: 22-47230-1

The vertical boxing (insulating board) (Area: Second Floor, Room 5 IT Department) contains asbestos.

Any change in its appearance should be recorded and passed to Property Services.

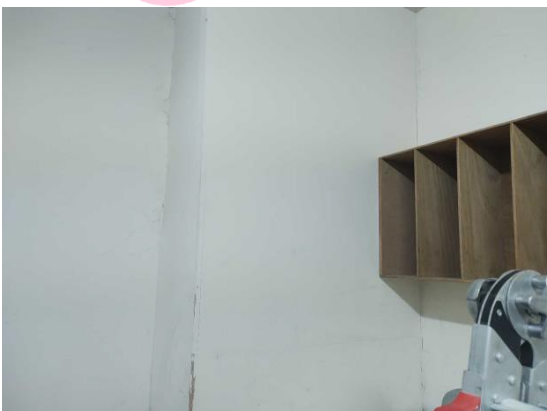
Item 12 Ref: 22-47230-1

The vertical boxing (insulating board) (Area: Second Floor, Room 6 IT Dept Store) contains asbestos.

Any change in its appearance should be recorded and passed to Property Services.

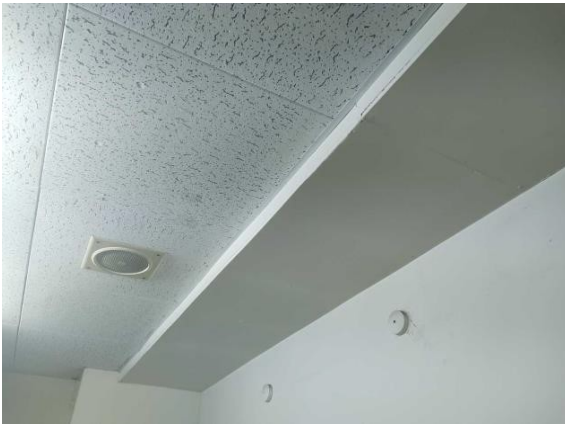
Item 13 Ref: 22-47230-1

The high level horizontal boxing (insulating board) (Area: Second Floor, Room 6 IT Dept Store) contains asbestos.

Any change in its appearance should be recorded and passed to Property Services.

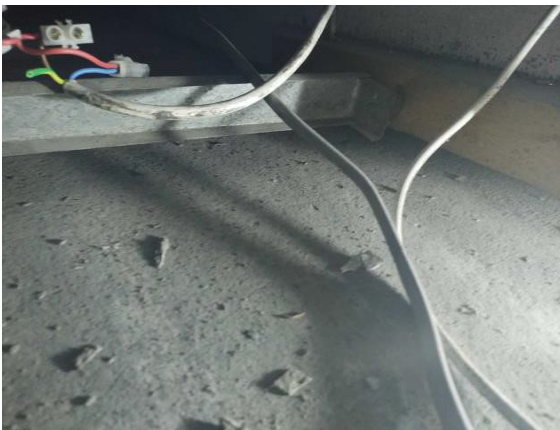
Item 14 Ref: 22-47230-2

The debris to tops of ceiling tiles (insulating board) (Area: Second Floor, Room 6 IT Dept Store) contains asbestos.

Any change in its appearance should be recorded and passed to Property Services.

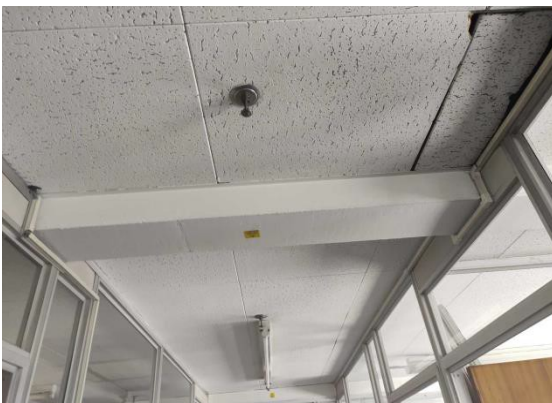
Item 15 Ref: 22-47230-1

The high level horizontal boxing (insulating board) (Area: Second Floor, Room 7 Corridor) contains asbestos.

Any change in its appearance should be recorded and passed to Property Services.

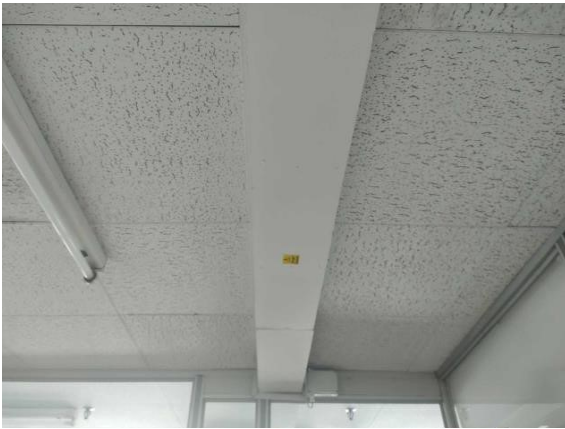
Item 16 Ref: 22-47230-1

The high level horizontal boxing (insulating board) (Area: Second Floor, Room 8 Server Room) contains asbestos.

Any change in its appearance should be recorded and passed to Property Services.

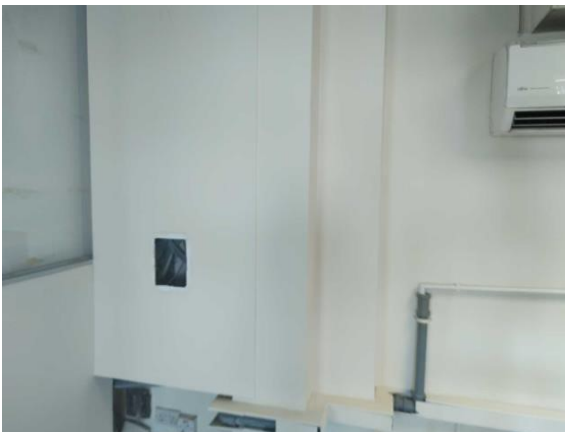
Item 17 Ref: 22-47230-1

The vertical boxing (insulating board) (Area: Second Floor, Room 8 Server Room) contains asbestos.

Any change in its appearance should be recorded and passed to Property Services.

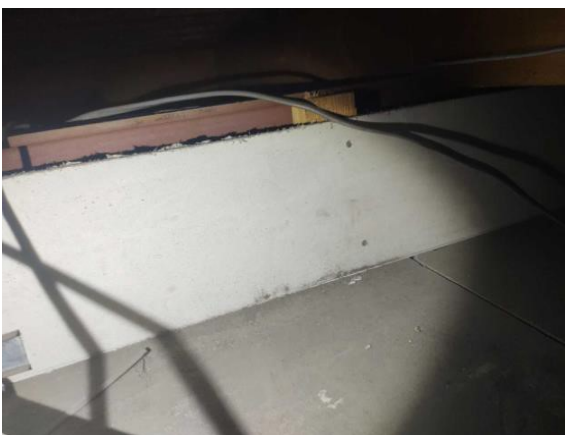
Item 18 Ref: 22-47230-2

The debris to tops of ceiling tiles (insulating board) (Area: Second Floor, Room 8 Server Room) contains asbestos.

Any change in its appearance should be recorded and passed to Property Services.

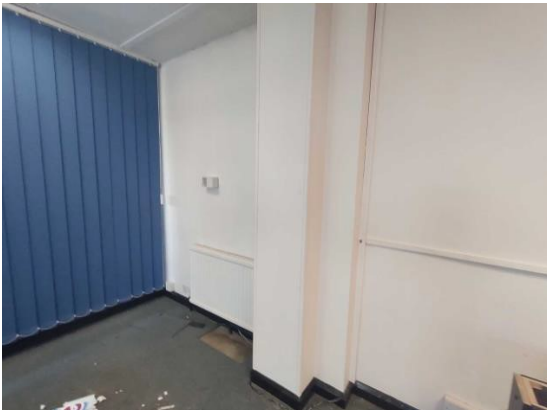
Item 19 Ref: 22-47230-1

The vertical boxing behind wood cladding (insulating board) (Area: Second Floor, Room 9 Sales Office) contains asbestos.

Any change in its appearance should be recorded and passed to Property Services.

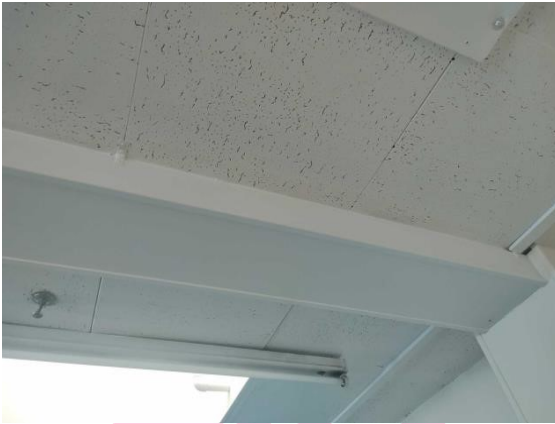
Item 20 Ref: 22-47230-1

The high level horizontal boxing behind wood cladding (insulating board) (Area: Second Floor, Room 9 Sales Office) contains asbestos.

Any change in its appearance should be recorded and passed to Property Services

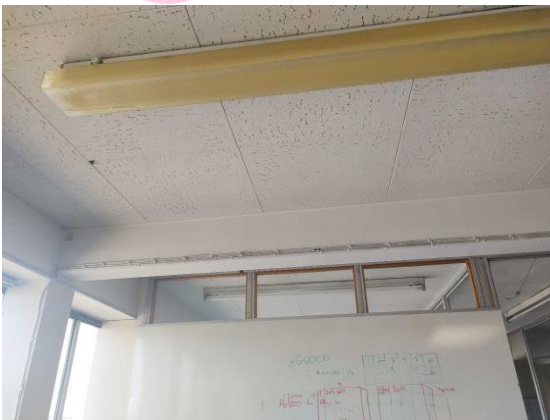
Item 21 Ref: 22-47230-5

The high level horizontal boxing (insulating board) (Area: Second Floor, Room 10 EPS Department) contains asbestos.

Any change in its appearance should be recorded and passed to Property Services

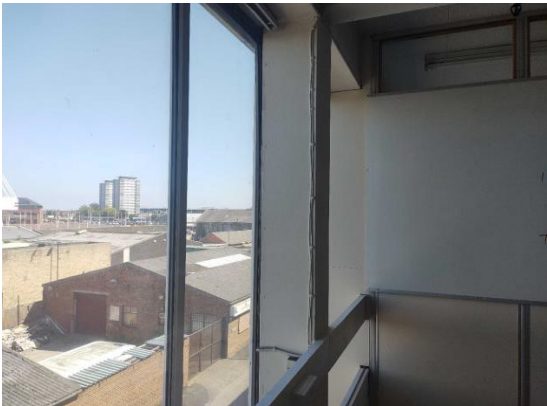
Item 22 Ref: 22-47230-5

The high level horizontal boxing (insulating board) (Area: Second Floor, Room 10 EPS Department) contains asbestos.

Any change in its appearance should be recorded and passed to Property Services.

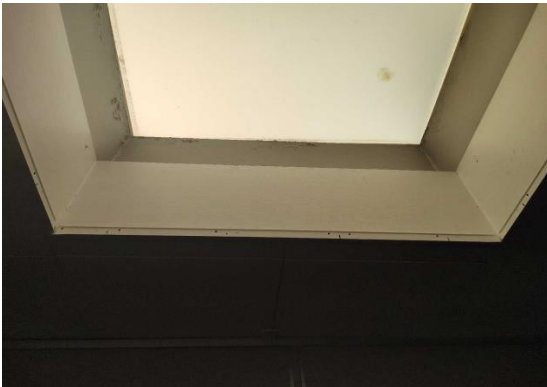
Item 23 Ref: 22-47230-1

The infill panels – upstands to skylight (insulating board) (Area: Second Floor, Room 10 EPS Department) contains asbestos.

Any change in its appearance should be recorded and passed to Property Services.

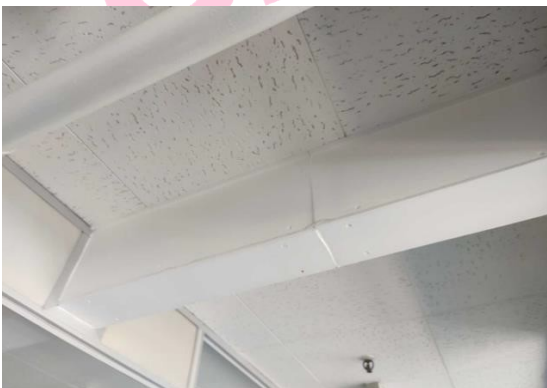
Item 24 Ref: 22-47230-5

The high level horizontal boxing (insulating board) (Area: Second Floor, Room 11 Corridor) contains asbestos.

Any change in its appearance should be recorded and passed to Property Services.

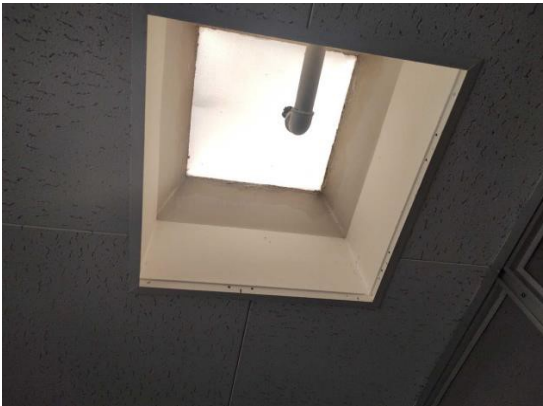
Item 25 Ref: 22-47230-5

The infill panels – upstands to skylight (insulating board) (Area: Second Floor, Room 11 Corridor) contains asbestos.

Any change in its appearance should be recorded and passed to Property Services.

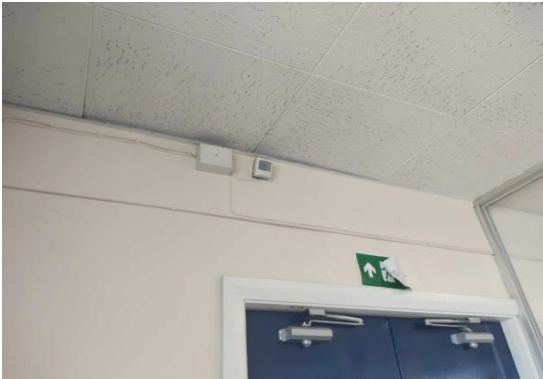
Item 26 Ref: 22-47230-7

The walls – firebreak above door (insulating board) (Area: Second Floor, Room 11 Corridor) contains asbestos.

Any change in its appearance should be recorded and passed to Property Services.

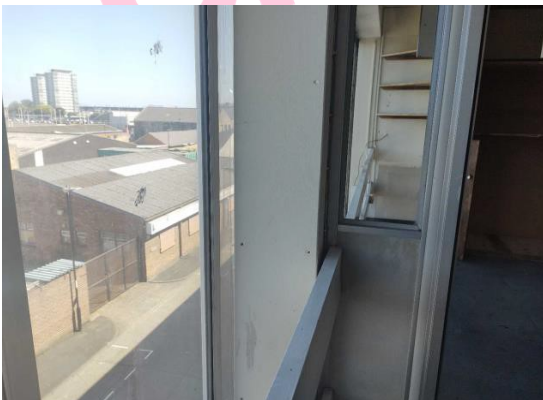
Item 27 Ref: 22-47230-5

The vertical boxing (insulating board) (Area: Second Floor, Room 12 Wages Office) contains asbestos.

Any change in its appearance should be recorded and passed to Property Services.

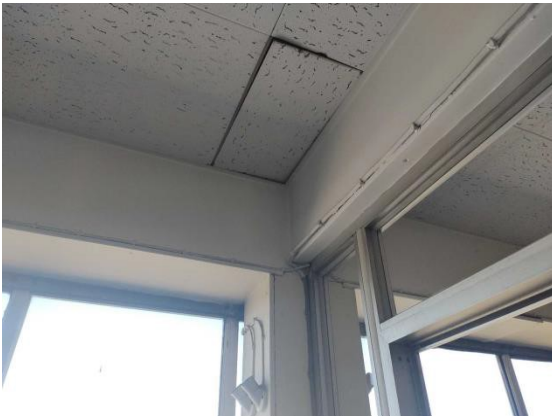
Item 28 Ref: 22-47230-5

The high level horizontal boxing (insulating board) (Area: Second Floor, Room 12 Wages Office) contains asbestos.

Any change in its appearance should be recorded and passed to Property Services.

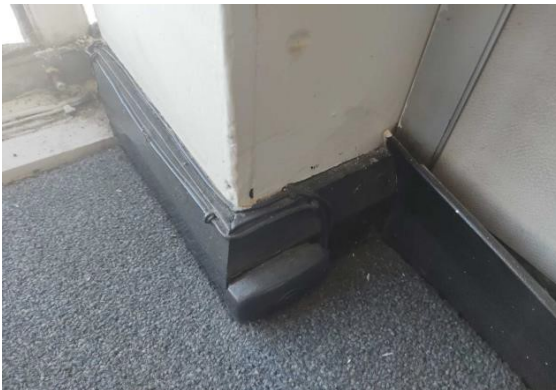
Item 29 Ref: 22-47230-8

The floor (insulating board) (Area: Second Floor, Room 12 Wages Office) contains asbestos.

Any change in its appearance should be recorded and passed to Property Services.

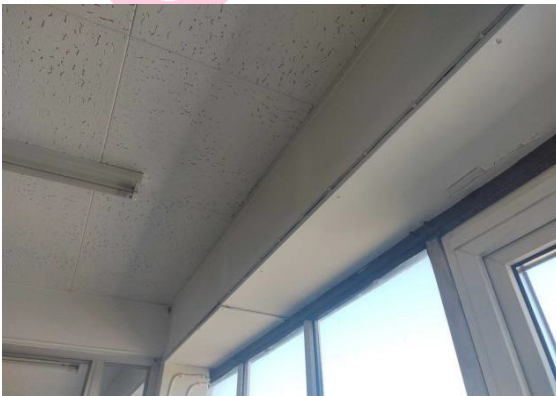
Item 30 Ref: 22-47230-5

The vertical boxing (insulating board) (Area: Second Floor, Room 13 Petty Cash Office) contains asbestos.

Any change in its appearance should be recorded and passed to Property Services.

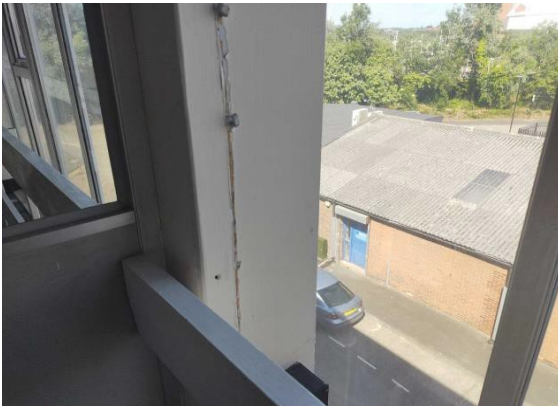
Item 31 Ref: 22-47230-5

The vertical boxing (insulating board) (Area: Second Floor, Room 13 Petty Cash Office) contains asbestos.

Any change in its appearance should be recorded and passed to Property Services.

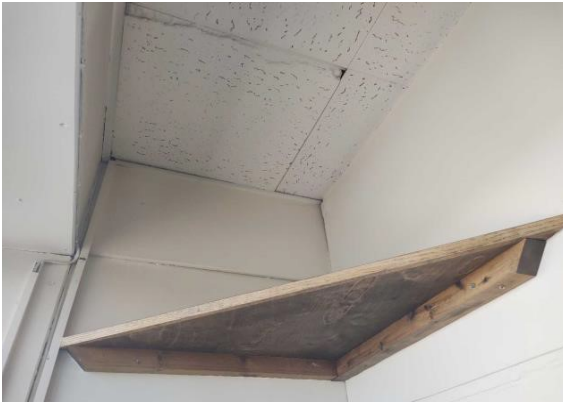
Item 32 Ref: 22-47230-7

The walls – firebreak above door (insulating board) (Area: Second Floor, Room 13 Petty Cash Office) contains asbestos.

Any change in its appearance should be recorded and passed to Property Services.

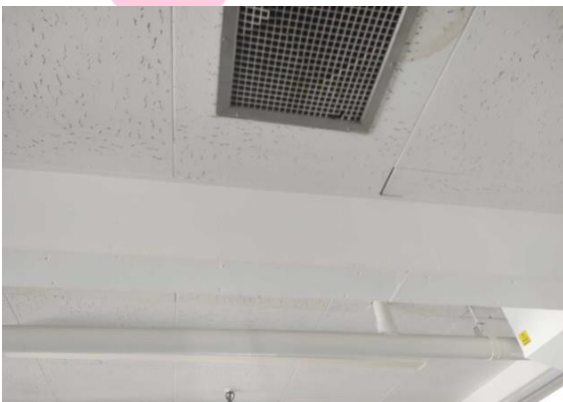
Item 33 Ref: 22-47230-5

The high level horizontal boxing (insulating board) (Area: Second Floor, Room 14 Office 3) contains asbestos.

Any change in its appearance should be recorded and passed to Property Services.

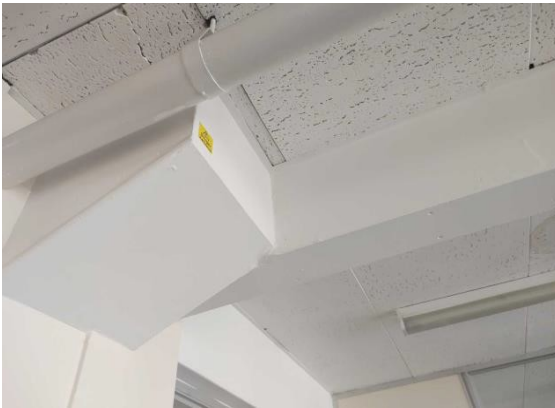
Item 34 Ref: 22-47230-5

The high level horizontal boxing (insulating board) (Area: Second Floor, Room 14 Office 3) contains asbestos.

Any change in its appearance should be recorded and passed to Property Services.

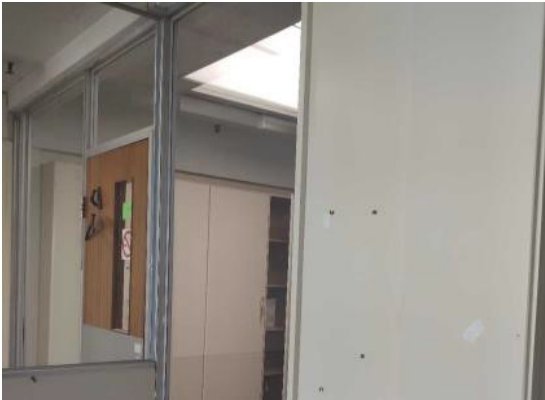
Item 35 Ref: 22-47230-5

The vertical boxing and panel to boxing (insulating board) (Area: Second Floor, Room 14 Office 3) contains asbestos.

Any change in its appearance should be recorded and passed to Property Services.

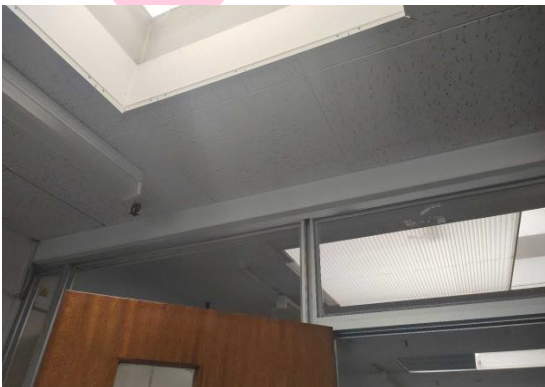
Item 36 Ref: 22-47230-5

The high level horizontal boxing (insulating board) (Area: Second Floor, Room 15 Office 4) contains asbestos.

Any change in its appearance should be recorded and passed to Property Services.

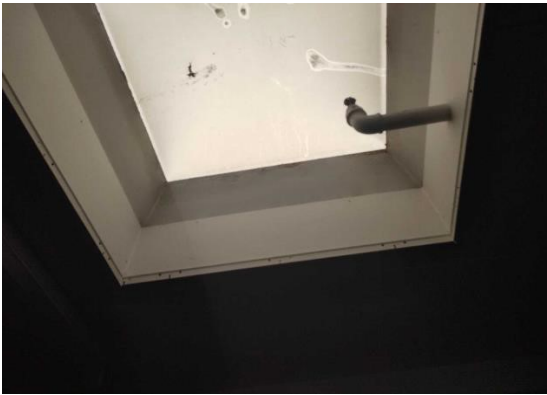
Item 37 Ref: 22-47230-6

The infill panels – upstands to skylight (insulating board) (Area: Second Floor, Room 15 Office 4) contains asbestos.

Any change in its appearance should be recorded and passed to Property Services.

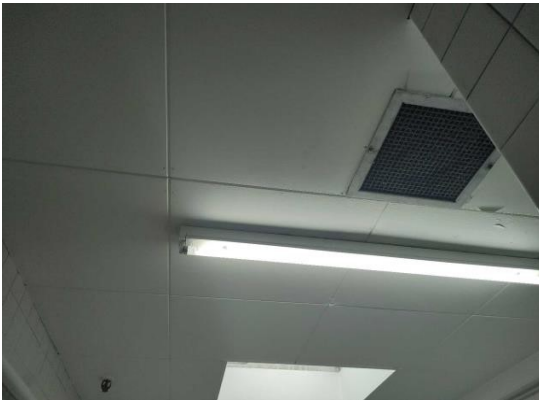
Item 40 Ref: 22-47230-10

The ceiling tiles (insulating board) (Area: Second Floor, Room 16 Male WC and Lobby) contains asbestos.

Any change in its appearance should be recorded and passed to Property Services.

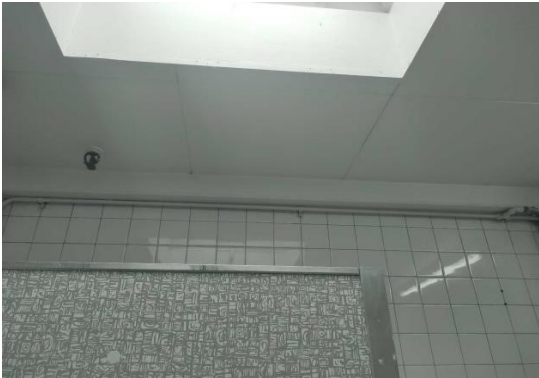
Item 41 Ref: 22-47230-5

The high level horizontal boxing (insulating board) (Area: Second Floor, Room 16 Male WC and Lobby) contains asbestos.

Any change in its appearance should be recorded and passed to Property Services.

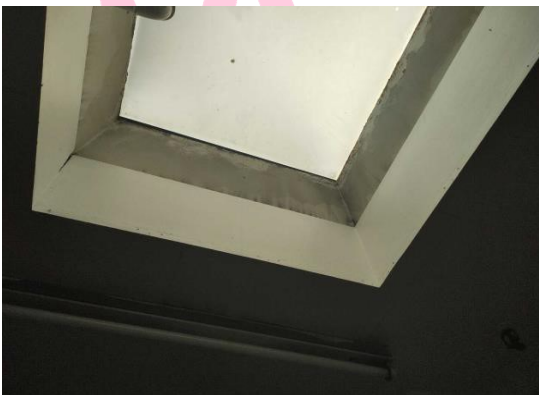
Item 42 Ref: 22-47230-6

The infill panels – upstands to skylights (insulating board) (Area: Second Floor, Room 16 Male WC and Lobby) contains asbestos.

Any change in its appearance should be recorded and passed to Property Services.

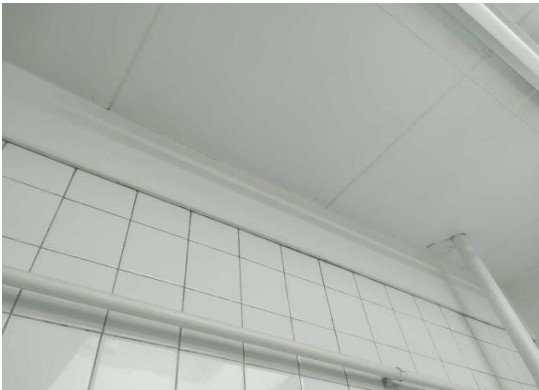
Item 43 Ref: 22-47230-7

The walls – firebreak above door (insulating board) (Area: Second Floor, Room 16 Male WC and Lobby) contains asbestos.

Any change in its appearance should be recorded and passed to Property Services.

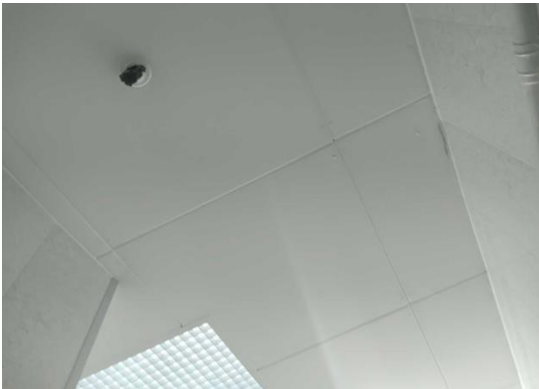
Item 44 Ref: 22-47230-10

The ceiling tiles (insulating board) (Area: Second Floor, Room 17 Female WC and Lobby) contains asbestos.

Any change in its appearance should be recorded and passed to Property Services.

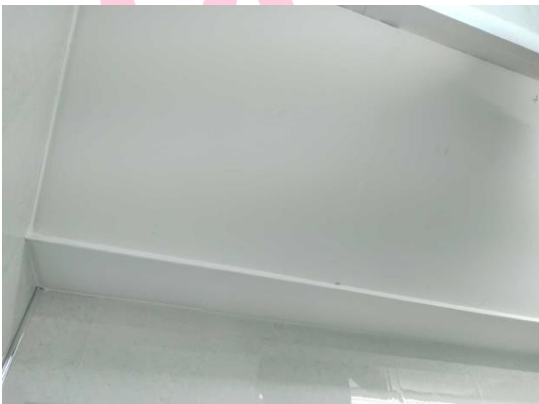
Item 45 Ref: 22-47230-5

The high level horizontal boxing (insulating board) (Area: Second Floor, Room 17 Female WC and Lobby) contains asbestos.

Any change in its appearance should be recorded and passed to Property Services.

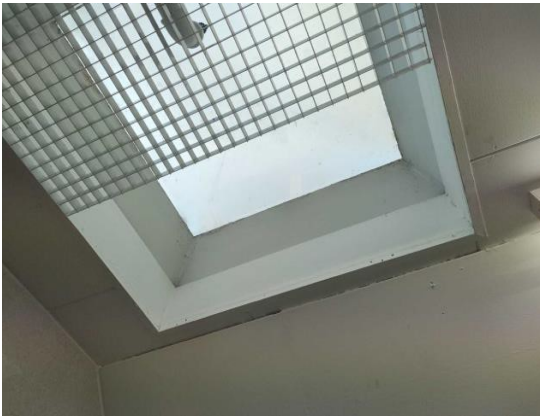
Item 46 Ref: 22-47230-6

The infill panels – upstands to skylight (insulating board) (Area: Second Floor, Room 17 Female WC and Lobby) contains asbestos.

Any change in its appearance should be recorded and passed to Property Services.

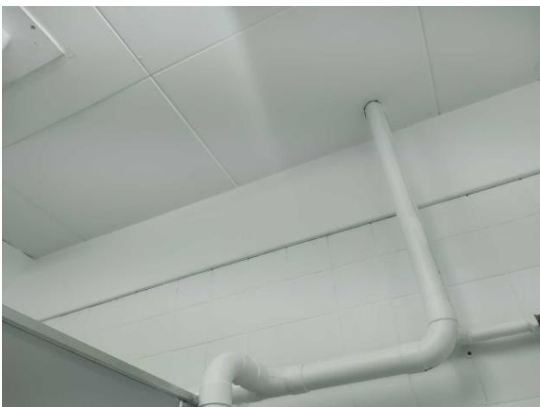
Item 47 Ref: 22-47230-7

The walls – firebreak above door (insulating board) (Area: Second Floor, Room 17 Female WC and Lobby) contains asbestos.

Any change in its appearance should be recorded and passed to Property Services.

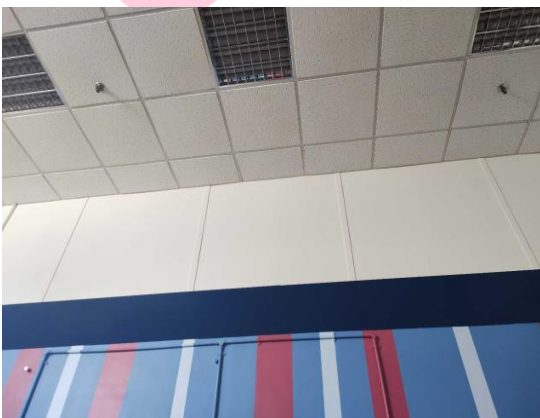
Item 48 Ref: 22-47230-11

The walls – panels to high level wall (insulating board) (Area: Second Floor, Room 18 Contracts Office) contains asbestos.

Any change in its appearance should be recorded and passed to Property Services.

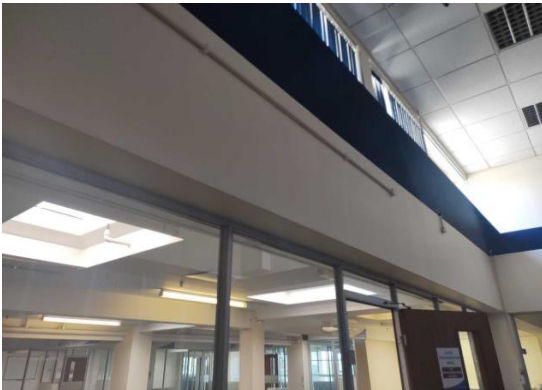
Item 49 Ref: 22-47230-12

The boxing (insulating board) (Area: Second Floor, Room 18 Contracts Office) contains asbestos.

Any change in its appearance should be recorded and passed to Property Services.

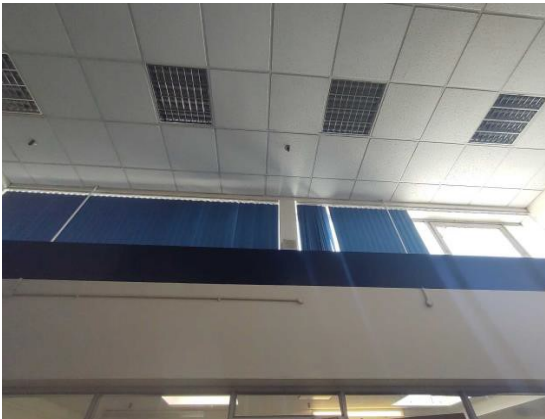
Item 50 Ref: 22-47230-13

The boxing – cladding to RSJs (insulating board) (Area: Second Floor, Room 18 Contracts Office) contains asbestos.

Any change in its appearance should be recorded and passed to Property Services.

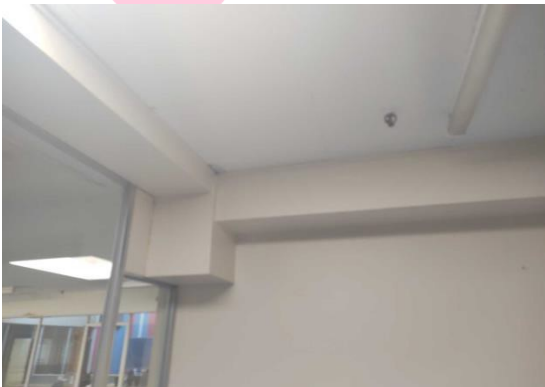
Item 51 Ref: 22-47230-13

The high level horizontal boxing (insulating board) (Area: Second Floor, Room 19 Finance Office) contains asbestos.

Any change in its appearance should be recorded and passed to Property Services.

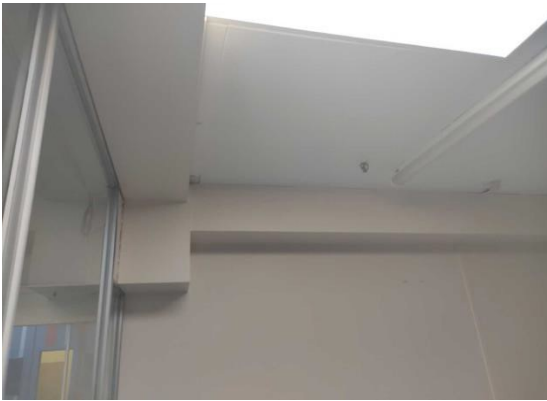
Item 52 Ref: 22-47230-13

The high level horizontal boxing (insulating board) (Area: Second Floor, Room 19 Finance Office) contains asbestos.

Any change in its appearance should be recorded and passed to Property Services.

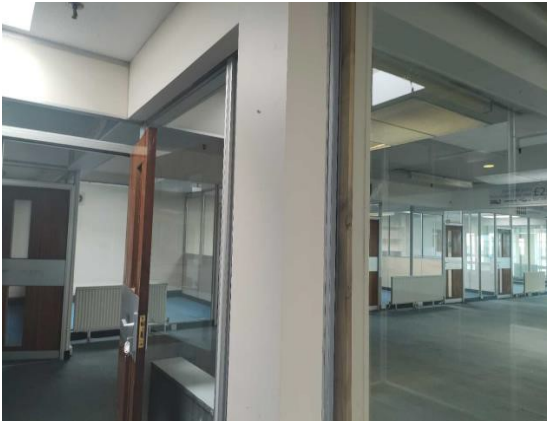
Item 53 Ref: 22-47230-13

The vertical boxing (insulating board) (Area: Second Floor, Room 19 Finance Office) contains asbestos.

Any change in its appearance should be recorded and passed to Property Services.

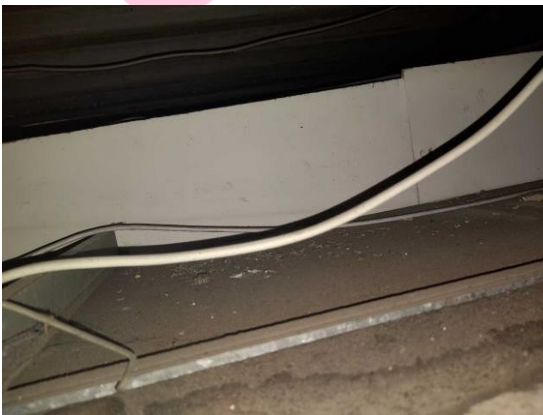
Item 54 Ref: 22-47230-2

The debris to tops of ceiling tiles (insulating board) (Area: Second Floor, Room 19 Finance Office) contains asbestos.

Any change in its appearance should be recorded and passed to Property Services.

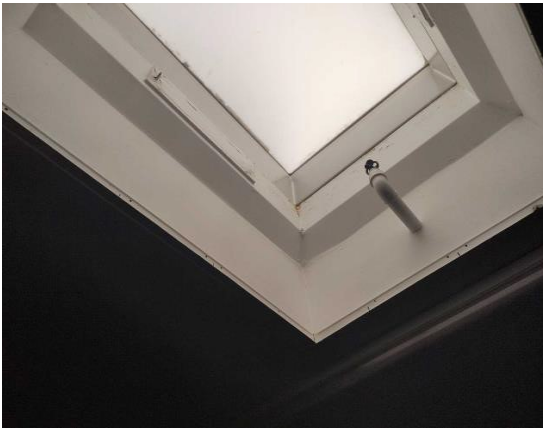
Item 55 Ref: 22-47230-6

The infill panels – upstands to skylight (insulating board) (Area: Second Floor, Room 19 Finance Office) contains asbestos.

Any change in its appearance should be recorded and passed to Property Services.

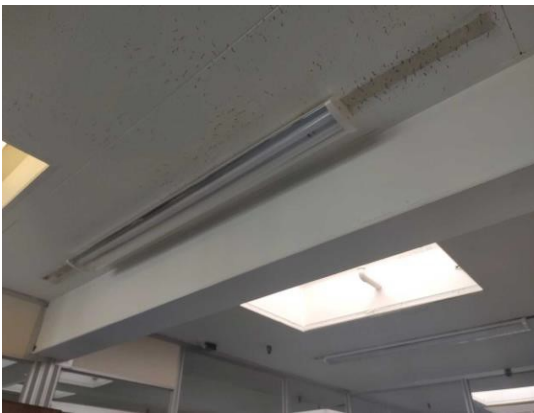
Item 56 Ref: 22-47230-13

The high level horizontal boxing (insulating board) (Area: Second Floor, Room 20 Office 5) contains asbestos.

Any change in its appearance should be recorded and passed to Property Services.

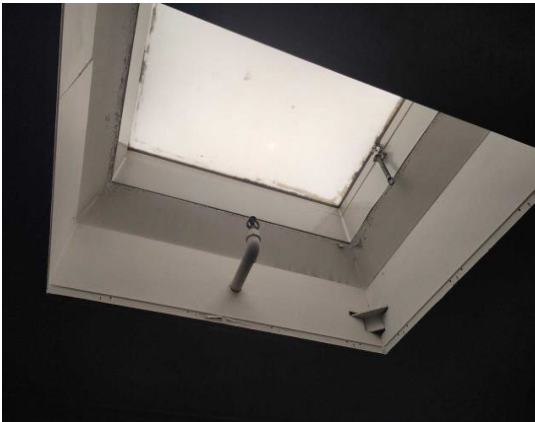
Item 58 Ref: 22-47230-16

The infill panels – upstands to skylight (insulating board) (Area: Second Floor, Room 20 Office 5) contains asbestos.

Any change in its appearance should be recorded and passed to Property Services.

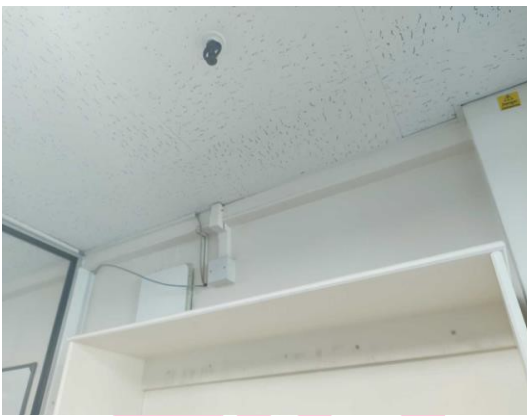
Item 59 Ref: 22-47230-13

The high level horizontal boxing (insulating board) (Area: Second Floor, Room 21 Office 6) contains asbestos.

Any change in its appearance should be recorded and passed to Property Services.

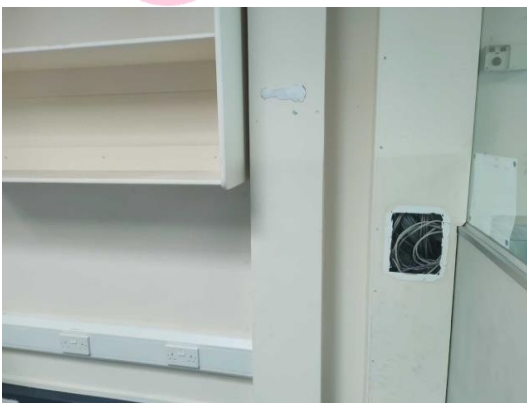
Item 60 Ref: 22-47230-13

The vertical boxing (insulating board) (Area: Second Floor, Room 21 Office 6) contains asbestos.

Any change in its appearance should be recorded and passed to Property Services.

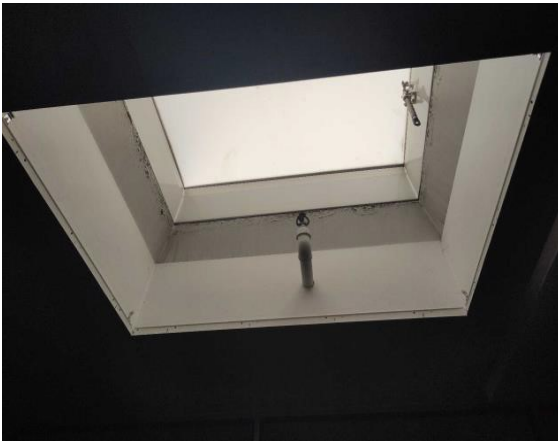
Item 61 Ref: 22-47230-16

The infill panels – upstands to skylight (insulating board) (Area: Second Floor, Room 21 Office 6) contains asbestos.

Any change in its appearance should be recorded and passed to Property Services.

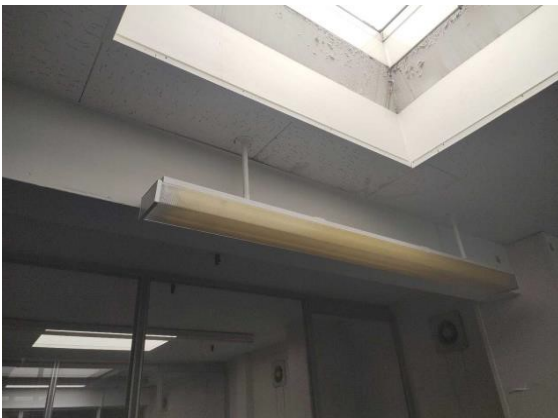
Item 62 Ref: 22-47230-13

The high level horizontal boxing (insulating board) (Area: Second Floor, Room 22 Office 7) contains asbestos.

Any change in its appearance should be recorded and passed to Property Services.

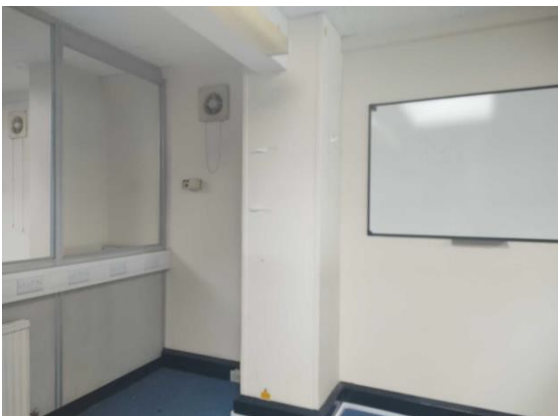
Item 63 Ref: 22-47230-13

The vertical boxing behind wood cladding (insulating board) (Area: Second Floor, Room 22 Office 7) contains asbestos.

Any change in its appearance should be recorded and passed to Property Services.

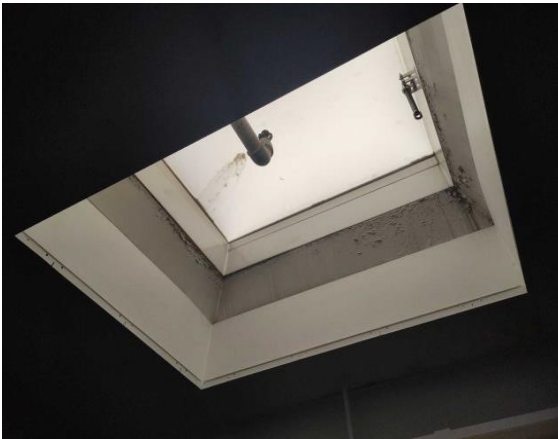
Item 64 Ref: 22-47230-16

The infill panels – upstands to skylight (insulating board) (Area: Second Floor, Room 22 Office 7) contains asbestos.

Any change in its appearance should be recorded and passed to Property Services.

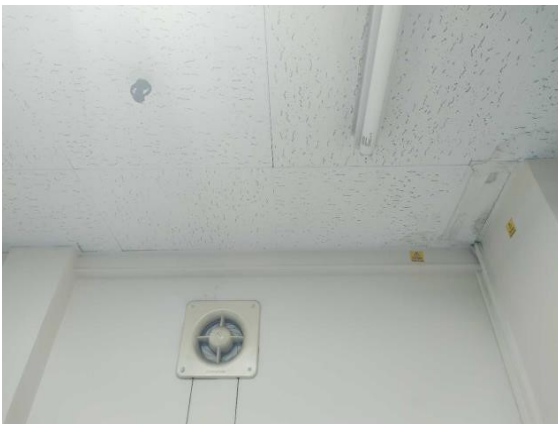
Item 65 Ref: 22-47230-13

The high level horizontal boxing (insulating board) (Area: Second Floor, Room 23 Office 8) contains asbestos.

Any change in its appearance should be recorded and passed to Property Services.

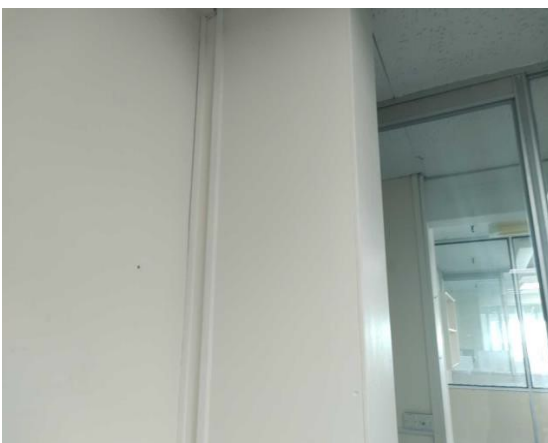
Item 66 Ref: 22-47230-13

The vertical boxing (insulating board) (Area: Second Floor, Room 23 Office 8) contains asbestos.

Any change in its appearance should be recorded and passed to Property Services.

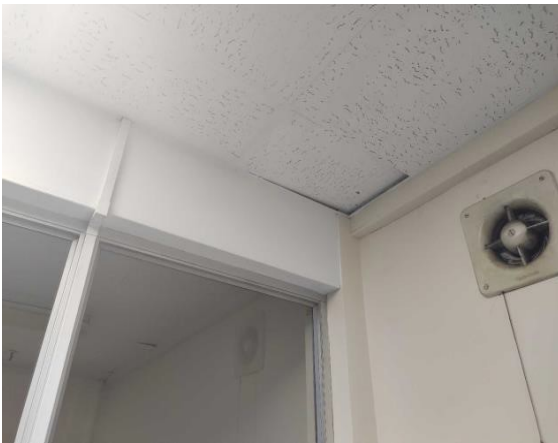
Item 68 Ref: 22-47230-13

The high level horizontal boxing (insulating board)
(Area: Second Floor, Room 24 Office 9) contains asbestos.

Any change in its appearance should be recorded and passed to Property Services.

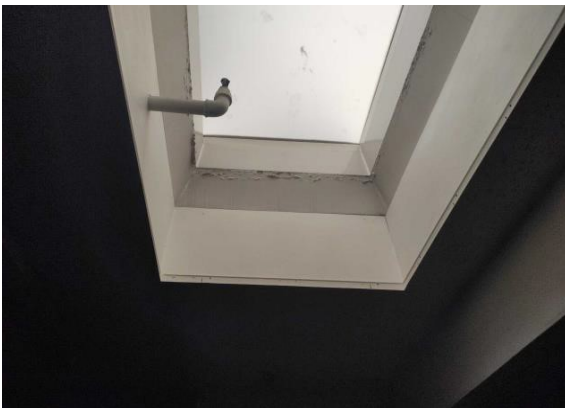
Item 69 Ref: 22-47230-16

The infill panels – upstands to skylight (insulating board)
(Area: Second Floor, Room 24 Office 9) contains asbestos.

Any change in its appearance should be recorded and passed to Property Services.

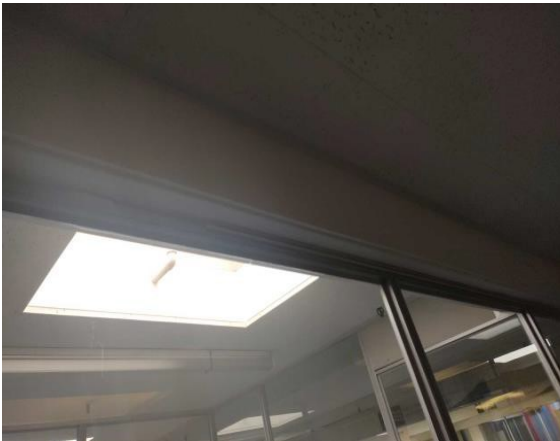
Item 70 Ref: 22-47230-13

The high level horizontal boxing (insulating board) (Area: Second Floor, Room 25 Finance Room 2) contains asbestos.

Any change in its appearance should be recorded and passed to Property Services.

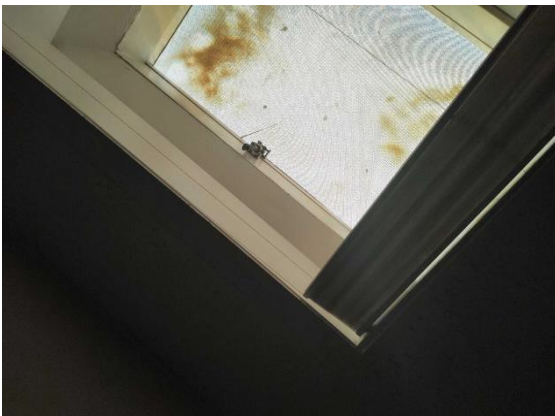
Item 71 Ref: 22-47230-16

The infill panels – upstands to skylight (insulating board) (Area: Second Floor, Room 25 Finance Room 2) contains asbestos.

Any change in its appearance should be recorded and passed to Property Services.

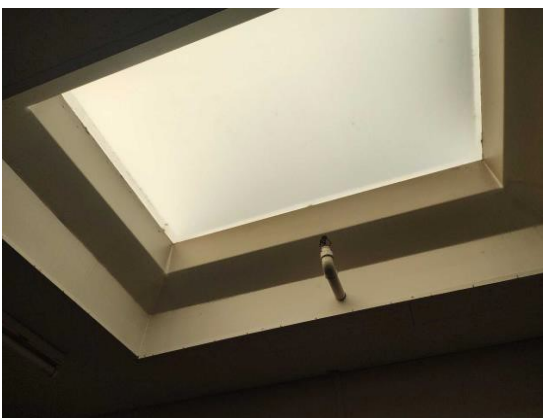
Item 72 Ref: 22-47230-17

The infill panels – upstands to skylight (insulating board) (Area: Second Floor, Room 26 Main Office) contains asbestos.

Any change in its appearance should be recorded and passed to Property Services.

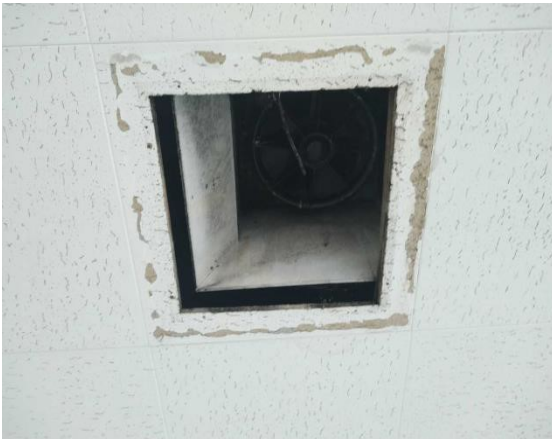
Item 73 Ref: 22-47230-18

The infill panels – extractor fan housing within ceiling void (insulating board) (Area: Second Floor, Room 26 Main Office) contains asbestos.

Any change in its appearance should be recorded and passed to Property Services.

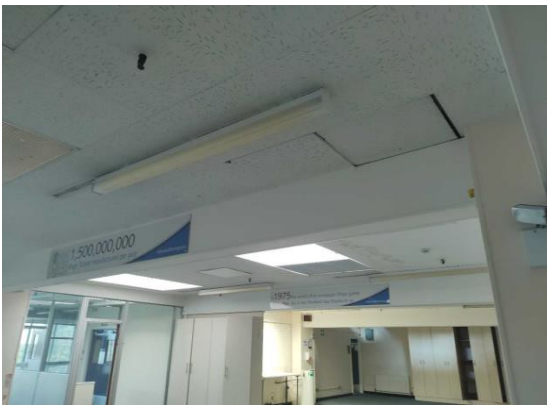
Item 74 Ref: 22-47230-19

The high level horizontal boxing (insulating board) (Area: Second Floor, Room 26 Main Office) contains asbestos.

Any change in its appearance should be recorded and passed to Property Services.

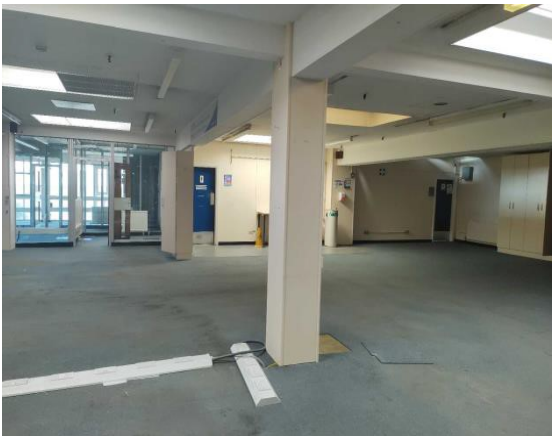
Item 75 Ref: 22-47230-19

The vertical boxing over columns and RSJ's (insulating board) (Area: Second Floor, Room 26 Main Office) contains asbestos.

Any change in its appearance should be recorded and passed to Property Services.

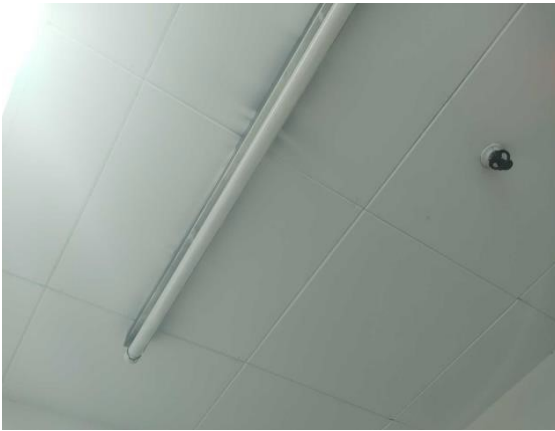
Item 76 Ref: 22-47230-10

The ceiling tiles (insulating board) (Area: Second Floor, Room 27 Store Room) contains asbestos.

Any change in its appearance should be recorded and passed to Property Services.

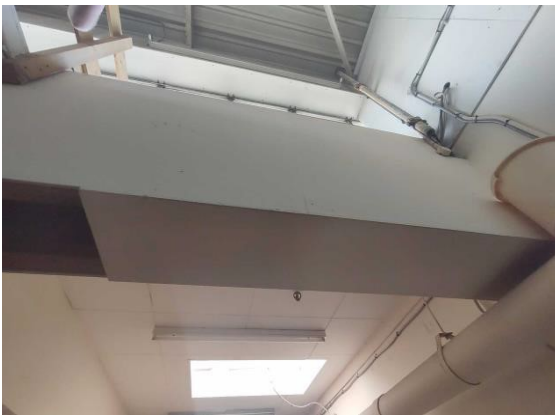
Item 77 Ref: 22-47230-12

The high level horizontal boxing (insulating board) (Area: Second Floor, Room 27 Store Room) contains asbestos.

Any change in its appearance should be recorded and passed to Property Services.

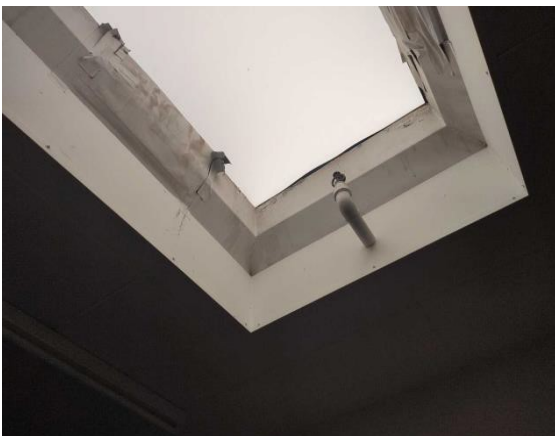
Item 78 Ref: 22-47230-6

The infill panels – upstands to skylight (insulating board) (Area: Second Floor, Room 27 Store Room) contains asbestos.

Any change in its appearance should be recorded and passed to Property Services.

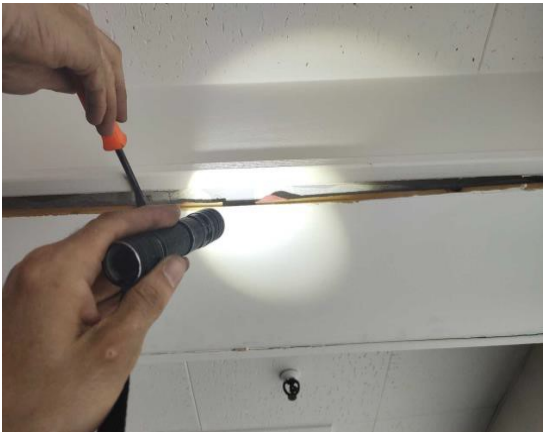
Item 79 Ref: 22-47230-19

The high level horizontal boxing (insulating board) (Area: Second Floor, Room 28 Canteen) contains asbestos.

Any change in its appearance should be recorded and passed to Property Services.

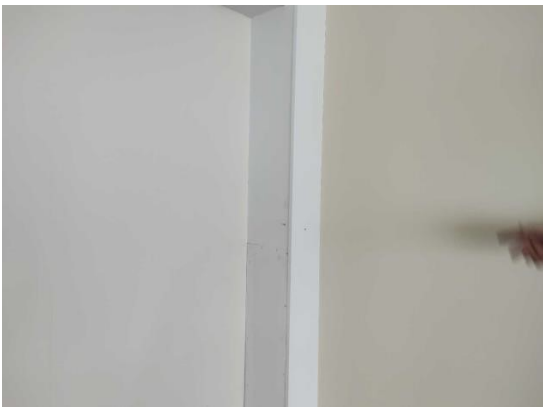
Item 80 Ref: 22-47230-19

The vertical boxing (insulating board) (Area: Second Floor, Room 28 Canteen) contains asbestos.

Any change in its appearance should be recorded and passed to Property Services.

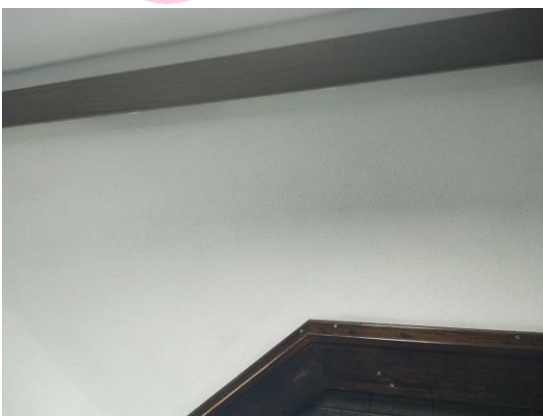
Item 81 Ref: 22-47230-25

The walls (render) (Area: Second Floor, Room 29 Main Lobby and Stairs) does not contain asbestos.

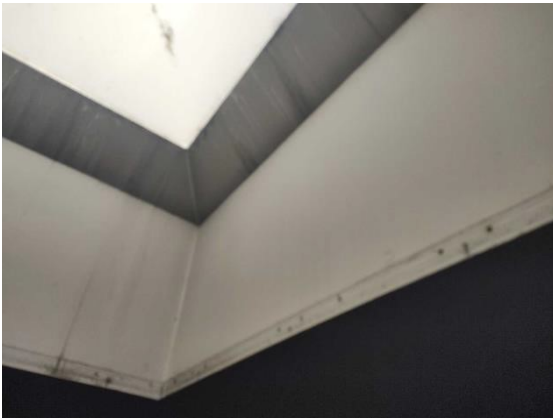
Item 82 Ref: 22-47230-27

The infill panels – upstands to skylight (insulating board) (Area: Second Floor, Room 29 Main Lobby and Stairs) contains asbestos.

Any change in its appearance should be recorded and passed to Property Services.
