ASBESTOS SURVEY REPORT FOR BLOCK 1A – 1C EDWARD THOMPSON SITE, RICHMOND STREET, SUNDERLAND, SR5 1BQ

Asbestos Register for Block 1A – 1C Edward Thompson Site, Richmond Street, Sunderland, SR5 1BQ

Date: 14 February 2025

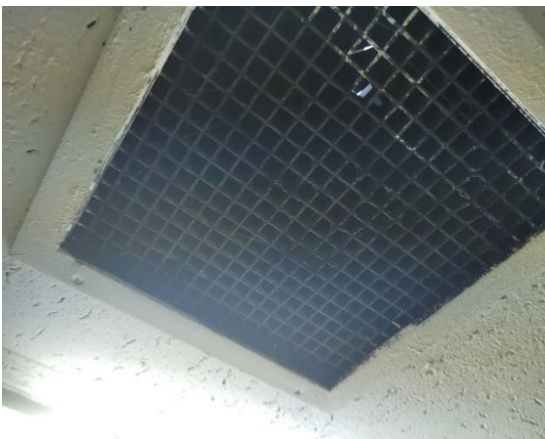
Item 83 Ref: 22-47230-18

The infill panels – extractor fan housing within ceiling void (insulating board) (Area: Second Floor, Room 31 Bingo Store) contains asbestos.

Any change in its appearance should be recorded and passed to Property Services.

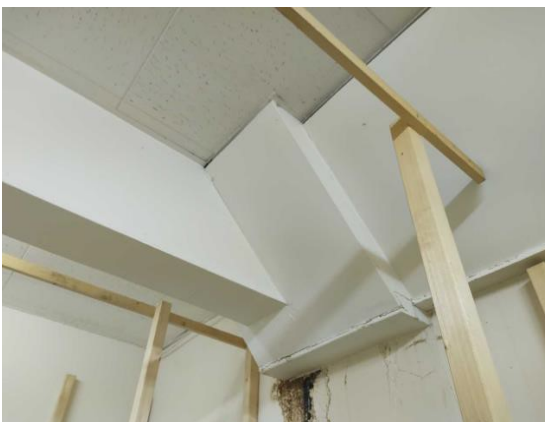
Item 84 Ref: 22-47230-19

The high level horizontal boxing (insulating board) (Area: Second Floor, Room 31 Bingo Store) contains asbestos.

Any change in its appearance should be recorded and passed to Property Services.

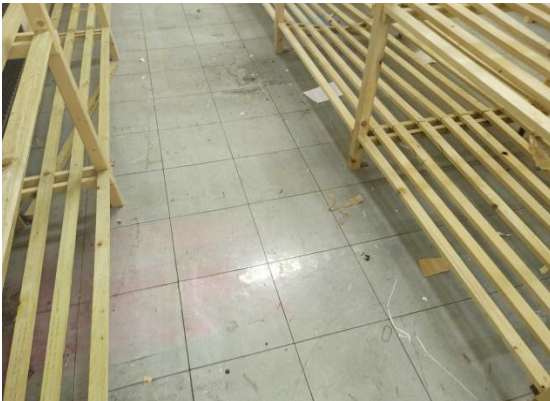
Item 85 Ref: 22-47230-22

The floor (tiles & adhesive)
(Area: Second Floor, Room 31
Bingo Store) does not contain
asbestos.

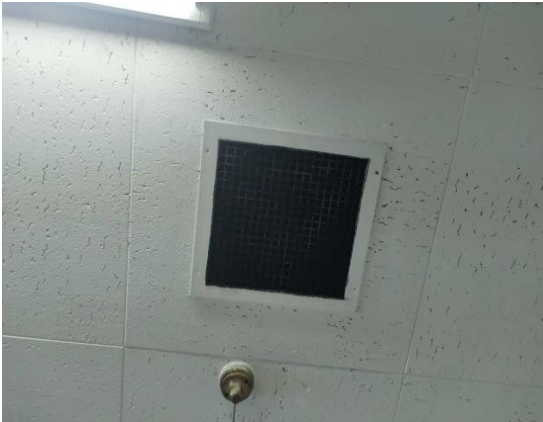
Item 86 Ref: 22-47230-18

The infill panels – extractor
fan housing within ceiling void
(insulating board) (Area:
Second Floor, Room 32 Prom
Games Store) contains
asbestos.

Any change in its appearance
should be recorded and
passed to Property Services.

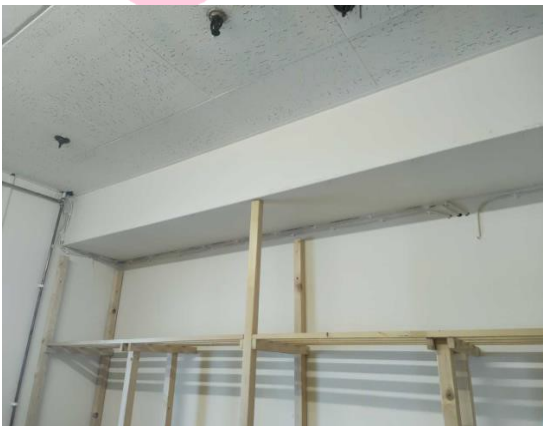
Item 87 Ref: 22-47230-19

The high level horizontal
boxing (insulating board)
(Area: Second Floor, Room 32
Prom Games Store) contains
asbestos.

Any change in its appearance
should be recorded and
passed to Property Services.

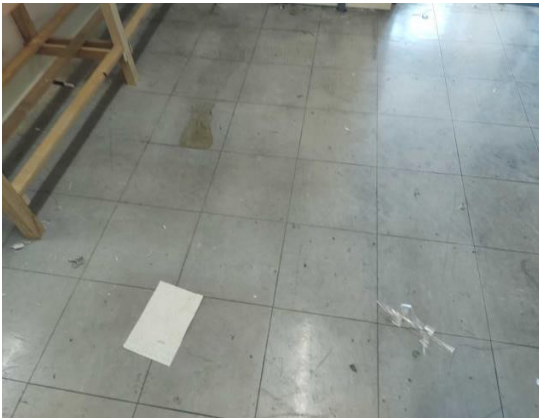
Item 88 Ref: 22-47230-22

The floor (tiles & adhesive)
(Area: Second Floor, Room 32
Prom Games Store) does not
contain asbestos.

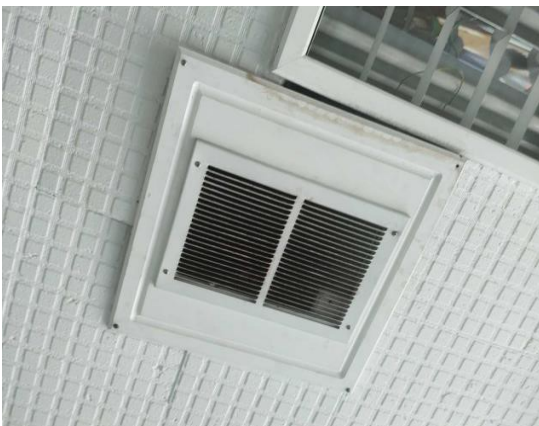
Item 89 Ref: 22-47230-18

The infill panels – extractor
fan housing within ceiling void
(insulating board) (Area:
Second Floor, Room 34 Frank
Cronin Office) contains
asbestos.

Any change in its appearance
should be recorded and
passed to Property Services.

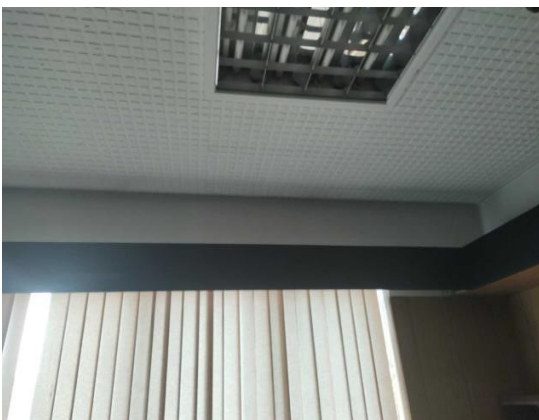
Item 90 Ref: 22-47230-23

The high level horizontal
boxing (insulating board)
(Area: Second Floor, Room 34
Frank Cronin Office) contains
asbestos.

Any change in its appearance
should be recorded and
passed to Property Services.

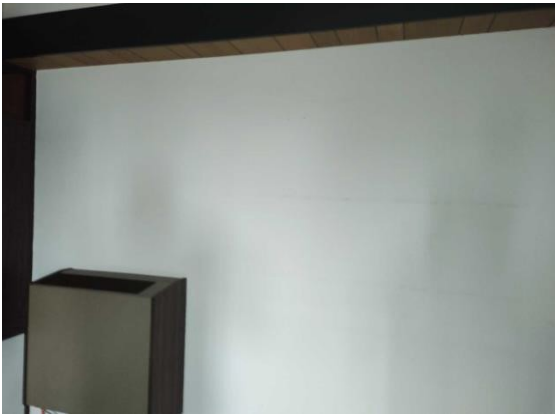
Item 91 Ref: 22-47230-28

The walls (textured coating)
(Area: Second Floor, Room 34
Frank Cronin Office) does not
contain asbestos.

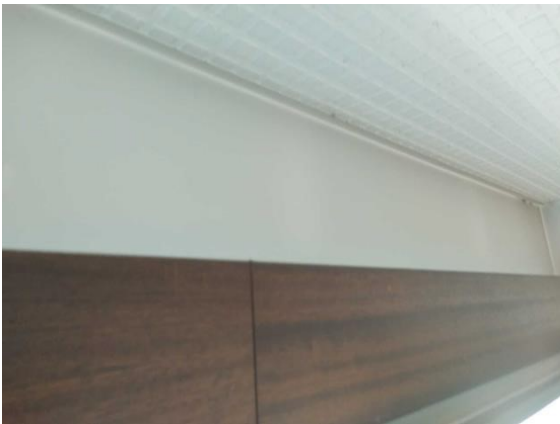
Item 92 Ref: 22-47230-23

The high level horizontal
boxing (insulating board)
(Area: Second Floor, Room 35
Paddy Cronin Office) contains
asbestos.

Any change in its appearance
should be recorded and
passed to Property Services.

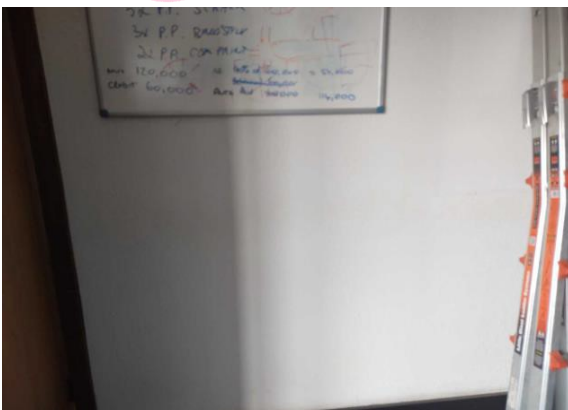
Item 93 Ref: 22-47230-28

The walls (textured coating)
(Area: Second Floor, Room 35
Paddy Cronin Office) does not
contain asbestos.

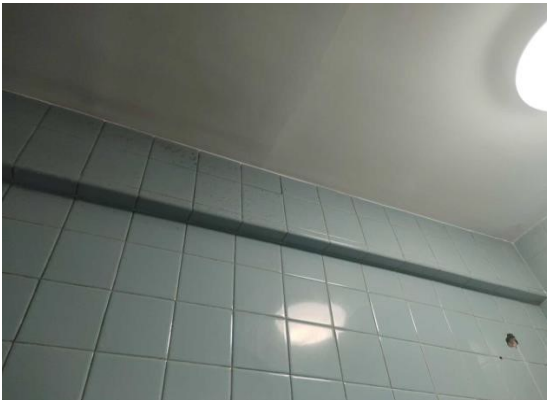
Item 94 Ref: 22-47230-23

The high level horizontal boxing (insulating board) (Area: Second Floor, Room 36 WC and Lobby) contains asbestos.

Any change in its appearance should be recorded and passed to Property Services.

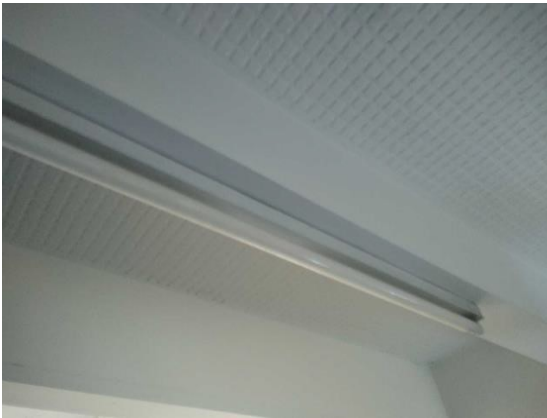
Item 95 Ref: 22-47230-23

The high level horizontal boxing (insulating board) (Area: Second Floor, Room 37 Corridor 3) contains asbestos.

Any change in its appearance should be recorded and passed to Property Services.

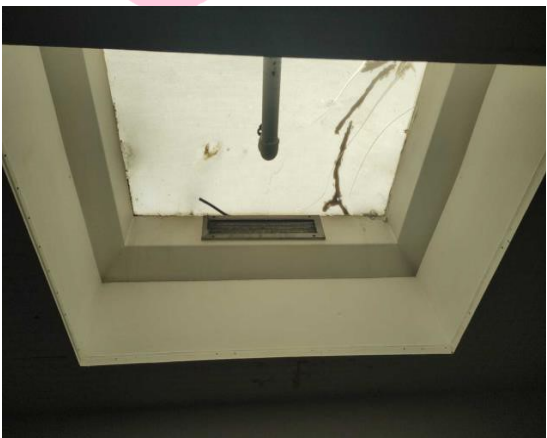
Item 96 Ref: 22-47230-27

The infill panels – upstands to skylight (insulating board) (Area: Second Floor, Room 37 Corridor 3) contains asbestos.

Any change in its appearance should be recorded and passed to Property Services.

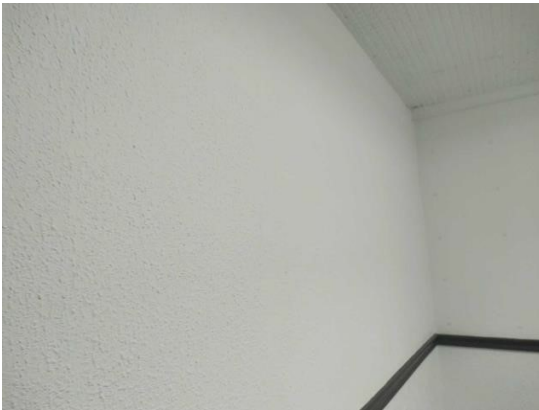
Item 97 Ref: 22-47230-28

The walls (textured coating) (Area: Second Floor, Room 37 Corridor 3) does not contain asbestos.

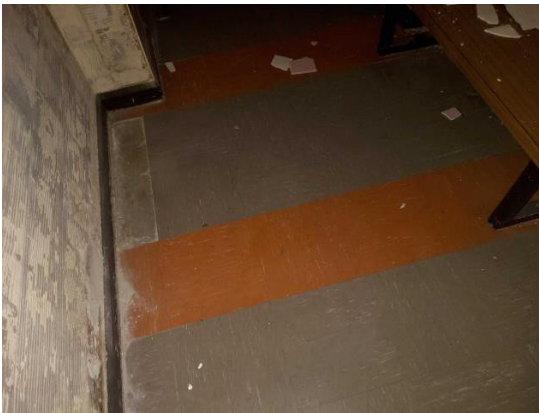
Item 98 Ref: 22-47230-29

The floor – grey and red tiles to concrete (tiles & adhesive) (Area: Second Floor, Room 38 Squash Court Changing Room) contains asbestos.

Any change in its appearance should be recorded and passed to Property Services.

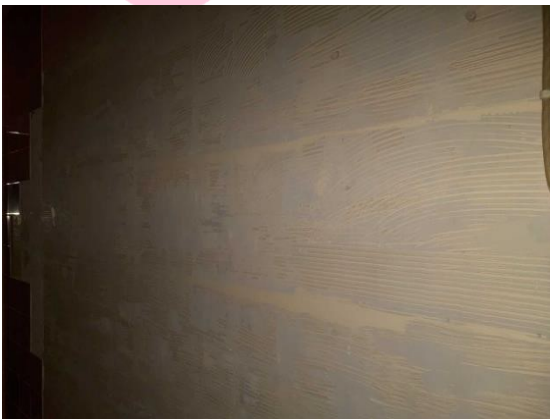
Item 99 Ref: 22-47230-30

The walls – ceramic tile adhesive (adhesive) (Area: Second Floor, Room 38 Squash Court Changing Room) does not contain asbestos.

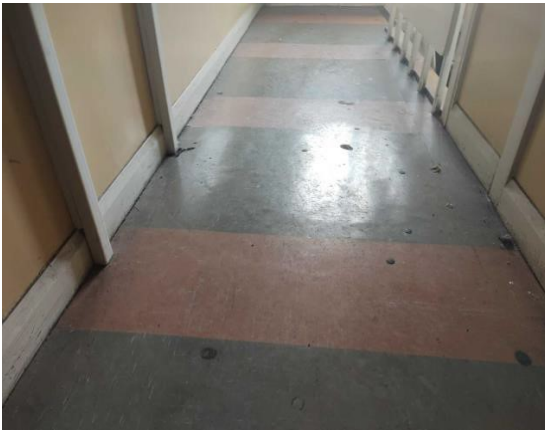
Item 100 Ref: 22-47230-29

The floor – grey and red tiles to concrete (tiles & adhesive) (Area: Second Floor, Room 39 Squash Court Viewing Area) contains asbestos.

Any change in its appearance should be recorded and passed to Property Services.

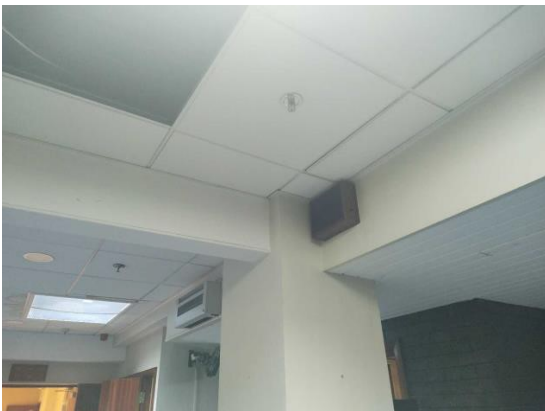
Item 101 Ref: 22-47230-23

The high level horizontal boxing (insulating board) (Area: Second Floor, Room 40 Reception) contains asbestos.

Any change in its appearance should be recorded and passed to Property Services.

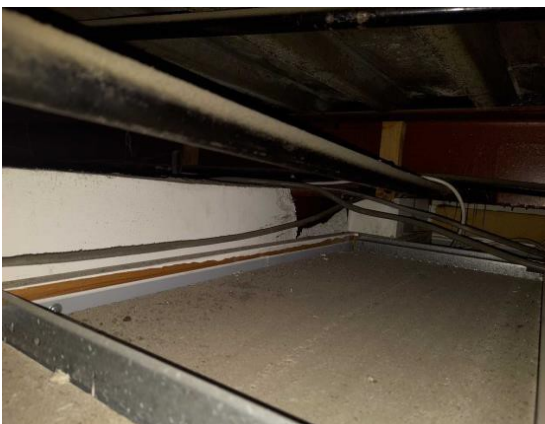
Item 102 Ref: 22-47230-24

The debris to tops of ceiling tiles (insulating board) (Area: Second Floor, Room 40 Reception) contains asbestos.

Any change in its appearance should be recorded and passed to Property Services.

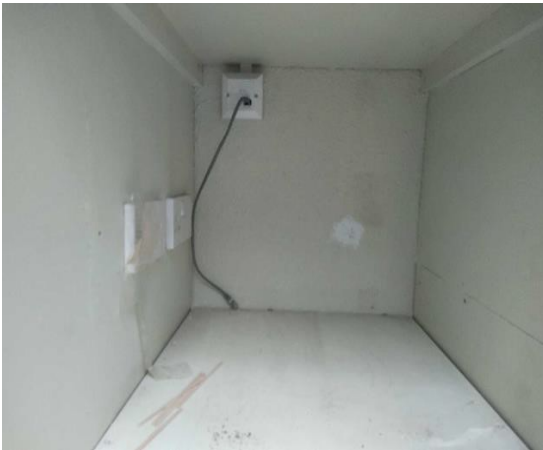
Item 103 Ref: 22-47230-25

The walls (render) (Area: Second Floor, Room 41 Cupboard) does not contain asbestos.

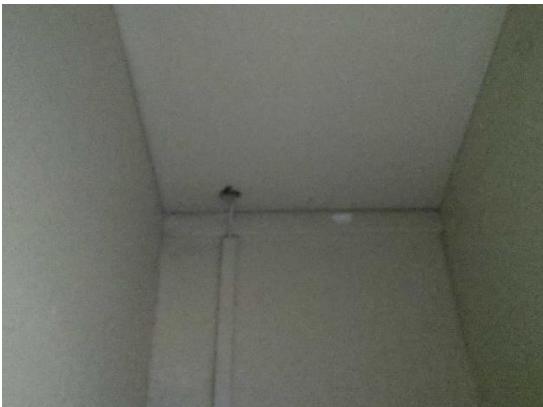
Item 104 Ref: 22-47230-26

The walls – firebreak to top of wall (insulating board) (Area: Second Floor, Room 41 Cupboard) contains asbestos.

Any change in its appearance should be recorded and passed to Property Services.

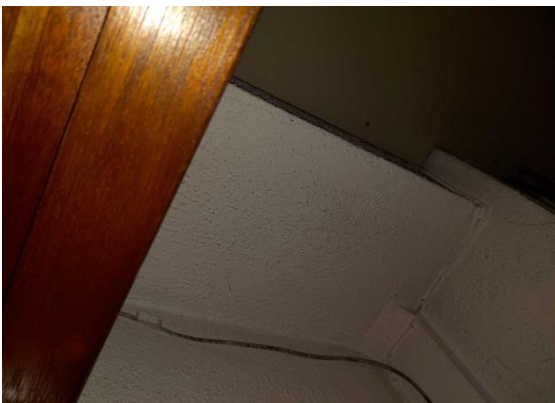
Item 105 Ref: 22-47230-23

The high level horizontal boxing (insulating board) (Area: Second Floor, Room 42 Sound Cupboard) contains asbestos.

Any change in its appearance should be recorded and passed to Property Services.

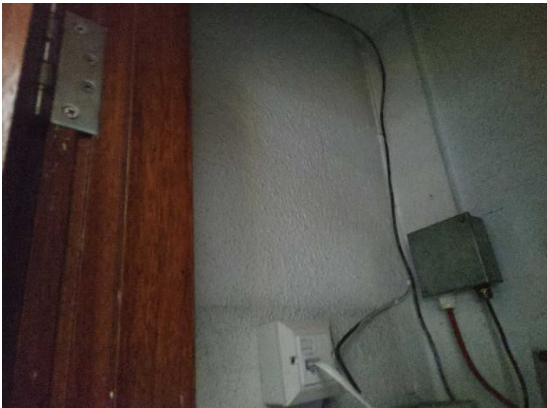
Item 106 Ref: 22-47230-25

The walls (render) (Area: Second Floor, Room 42 Sound Cupboard) does not contain asbestos.

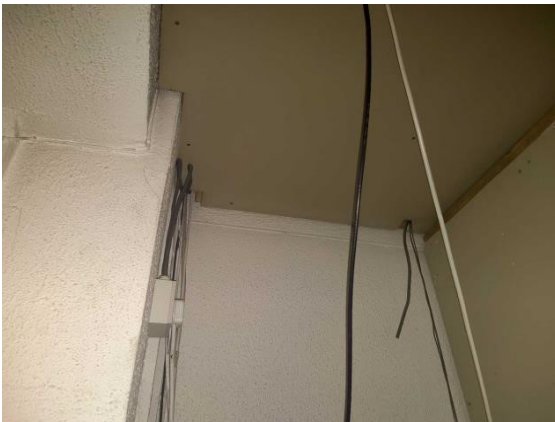
Item 107 Ref: 22-47230-26

The walls – firebreak to top of wall (insulating board) (Area: Second Floor, Room 42 Sound Cupboard) contains asbestos.

Any change in its appearance should be recorded and passed to Property Services.

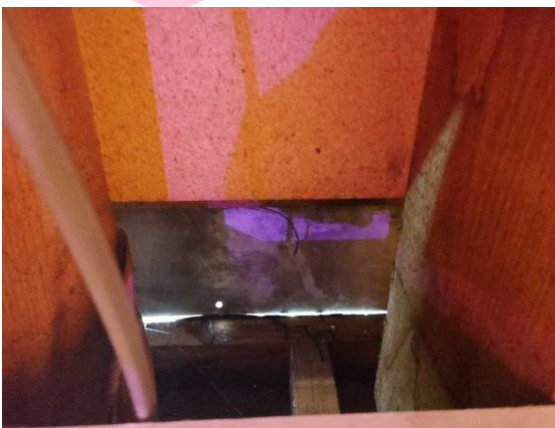
Item 108 Ref: 22-47230-13

The boxing – underside of cladding to RSJ's above and below windows (insulating board) (Area: Second Floor, Room 43 Frank Conin Suite) contains asbestos.

Any change in its appearance should be recorded and passed to Property Services.

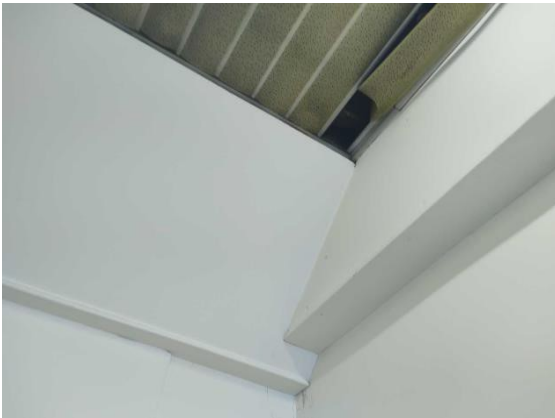
Item 109 Ref: 22-47230-19

The high level horizontal boxing (insulating board) (Area: Second Floor, Room 44 Corridor 4) contains asbestos.

Any change in its appearance should be recorded and passed to Property Services.

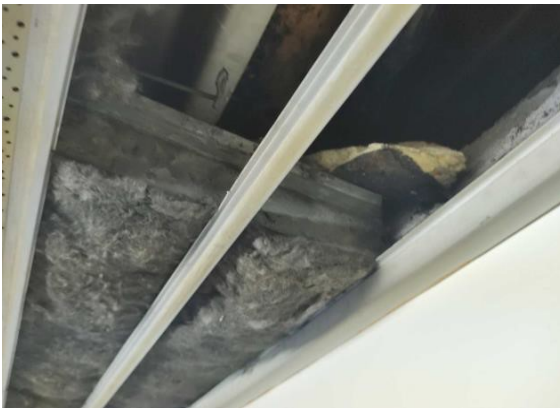
Item 110 Ref: 22-47230-21

The ceiling (bitumen) (Area: Second Floor, Room 44 Corridor 4) does not contain asbestos.

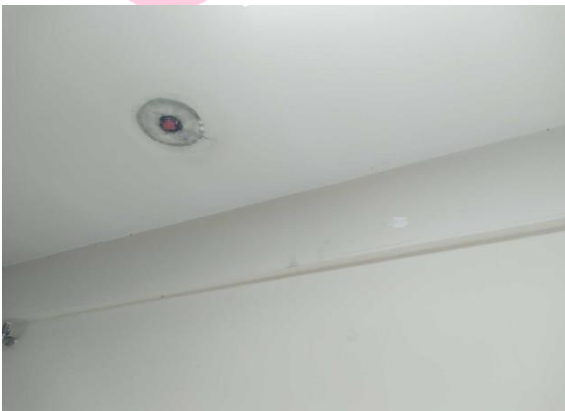
Item 111 Ref: 22-47230-23

The high level horizontal boxing (insulating board) (Area: Second Floor, Room 45 Key Cupboard) contains asbestos.

Any change in its appearance should be recorded and passed to Property Services.

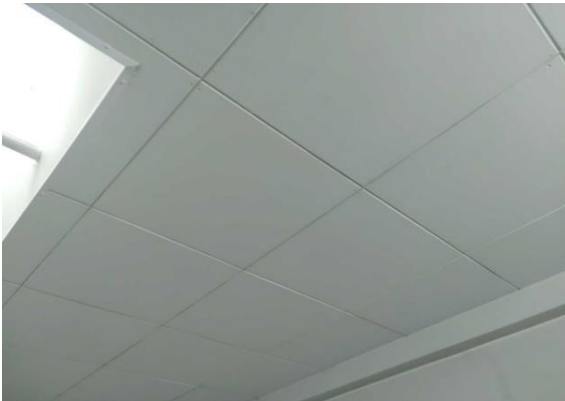
Item 112 Ref: 22-47230-31

The ceiling tiles (insulating board) (Area: Second Floor, Room 46 Fire Exit Stairwell 1) contains asbestos.

Any change in its appearance should be recorded and passed to Property Services.

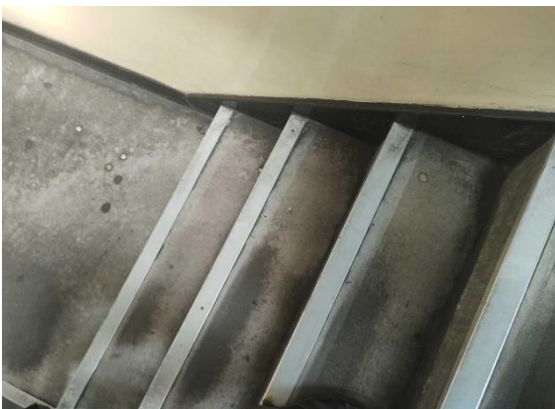
Item 114 Ref: 22-47230-33

The floor – stair nosings (composite) (Area: Second Floor, Room 46 Fire Exit Stairwell 1) contains asbestos.

Any change in its appearance should be recorded and passed to Property Services.

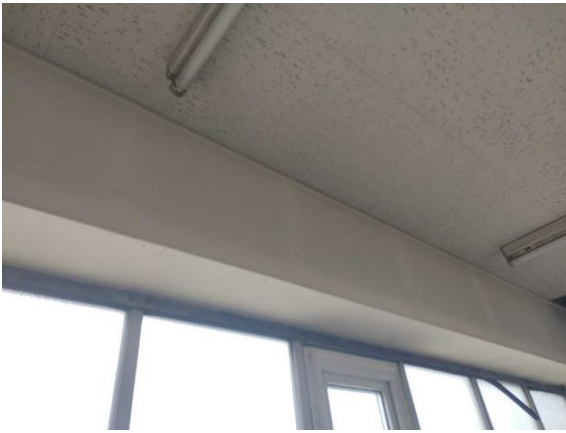
Item 115 Ref: 22-47230-34

The high level horizontal boxing (insulating board) (Area: Second Floor, Room 47 Comms Room) contains asbestos.

Any change in its appearance should be recorded and passed to Property Services.

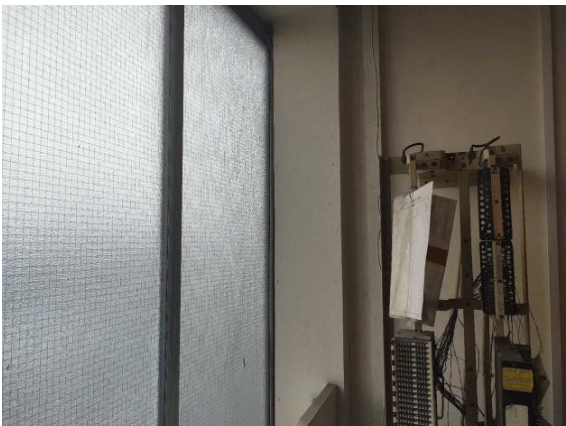
Item 116 Ref: 22-47230-34

The vertical boxing (insulating board) (Area: Second Floor, Room 47 Comms Room) contains asbestos.

Any change in its appearance should be recorded and passed to Property Services.

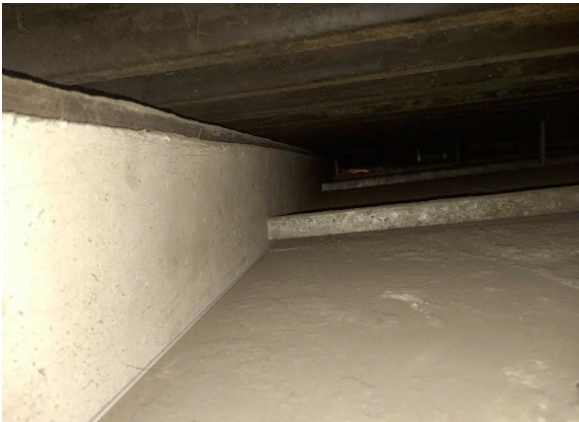
Item 118 Ref: 22-47230-35

The debris to tops of ceiling tiles (insulating board) (Area: Second Floor, Room 47 Comms Room) contains asbestos.

Any change in its appearance should be recorded and passed to Property Services.

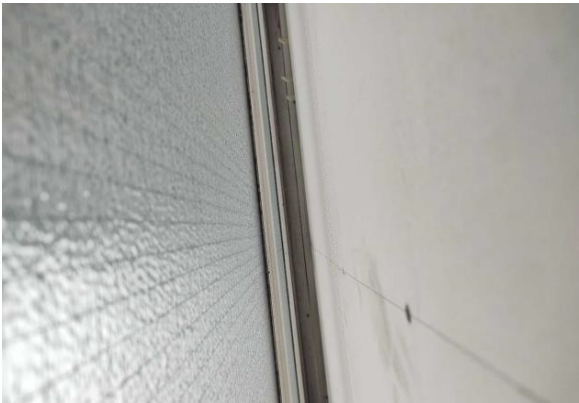
Item 119 Ref: 22-47230-34

The window – fillet to window reveal behind cladded RSJ (insulating board) (Area: Second Floor, Room 48 First Aid Room) contains asbestos.

Any change in its appearance should be recorded and passed to Property Services.

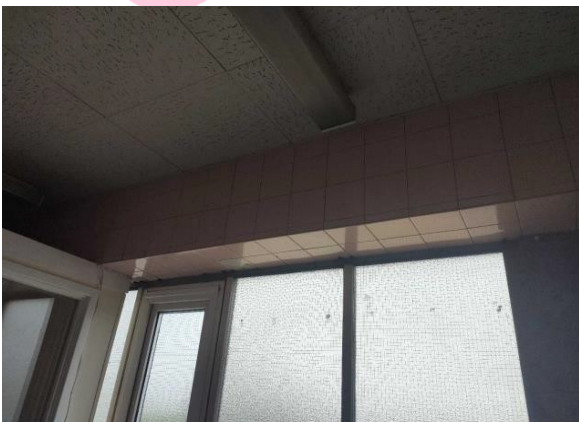
Item 120 Ref: 22-47230-34

The high level horizontal boxing (insulating board) (Area: Second Floor, Room 48 First Aid Room) contains asbestos.

Any change in its appearance should be recorded and passed to Property Services.

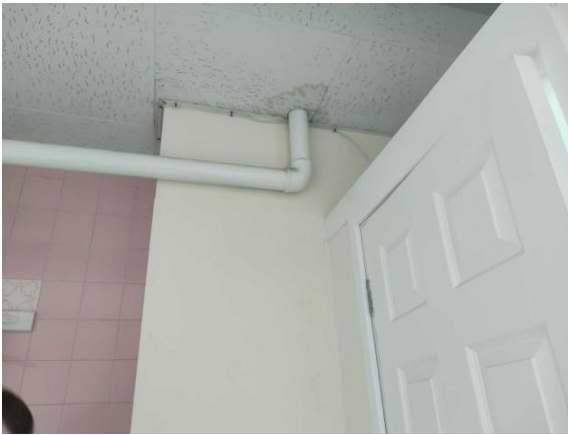
Item 121 Ref: 22-47230-36

The vertical boxing (insulating board) (Area: Second Floor, Room 48 First Aid Room) contains asbestos.

Any change in its appearance should be recorded and passed to Property Services.

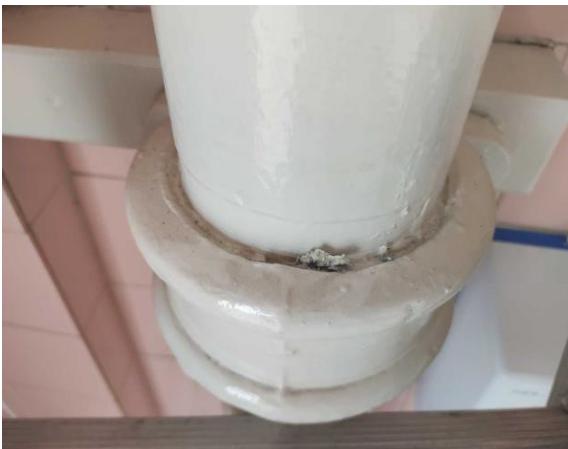
Item 122 Ref: 22-47230-37

The downpipes – filling to pipe flange knuckle (insulation) (Area: Second Floor, Room 48 First Aid Room) does not contain asbestos.

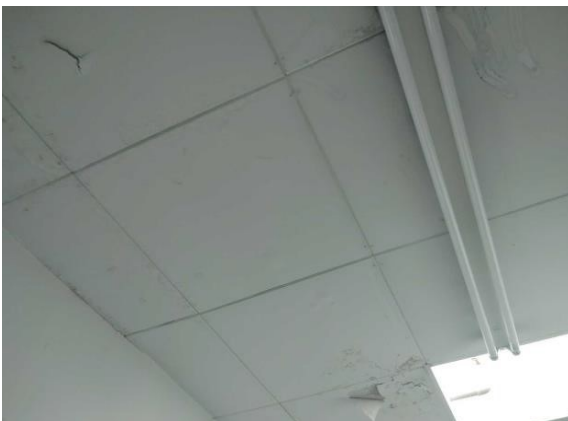
Item 123 Ref: 22-47230-31

The ceiling tiles (insulating board) (Area: Second Floor, Room 49 Corridor 5) contains asbestos.

Any change in its appearance should be recorded and passed to Property Services.

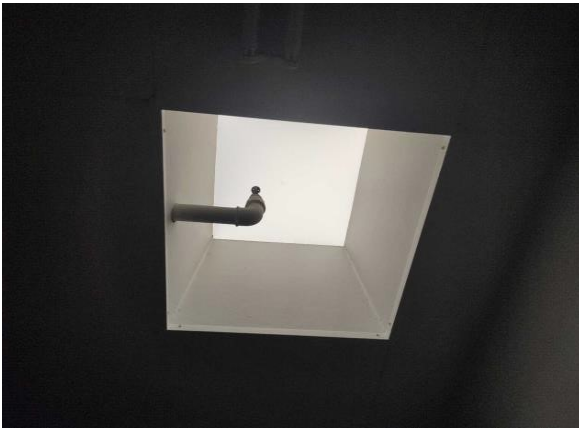
Item 124 Ref: 22-47230-32

The infill panels – upstands to skylights (insulating board) (Area: Second Floor, Room 49 Corridor 5) contains asbestos.

Any change in its appearance should be recorded and passed to Property Services.

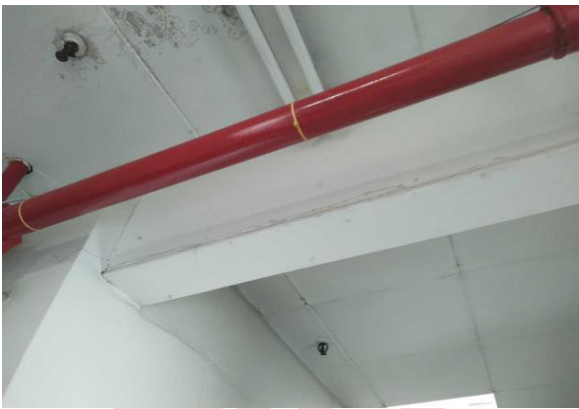
Item 125 Ref: 22-47230-34

The high level horizontal boxing (insulating board) (Area: Second Floor, Room 49 Corridor 5) contains asbestos.

Any change in its appearance should be recorded and passed to Property Services.

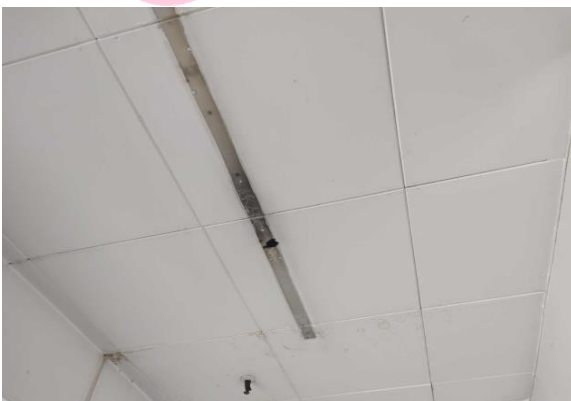
Item 126 Ref: 22-47230-31

The ceiling tiles (insulating board) (Area: Second Floor, Room 50 Corridor 6) contains asbestos.

Any change in its appearance should be recorded and passed to Property Services.

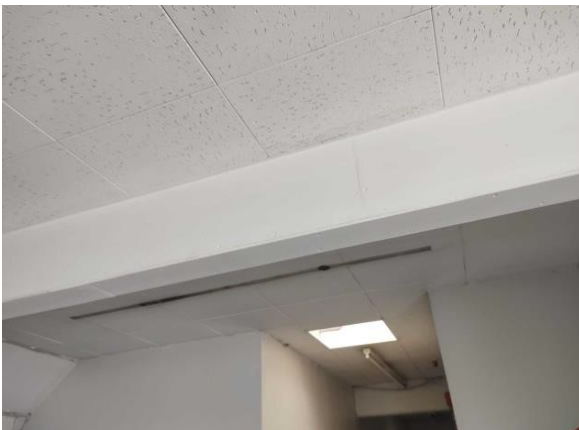
Item 128 Ref: 22-47230-34

The high level horizontal boxing (insulating board) (Area: Second Floor, Room 50 Corridor 6) contains asbestos.

Any change in its appearance should be recorded and passed to Property Services.

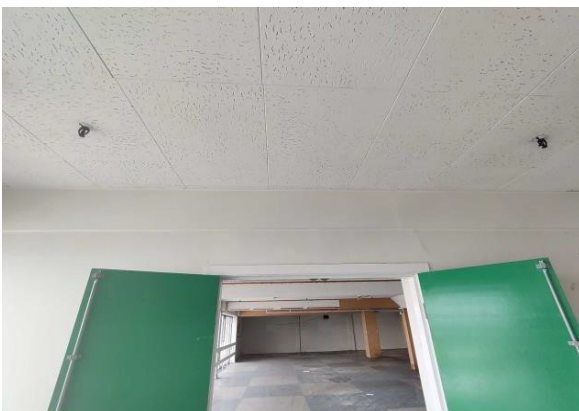
Item 129 Ref: 22-47230-34

The walls – firebreak above wall (to rack storage) (insulating board) (Area: Second Floor, Room 50 Corridor 6) contains asbestos.

Any change in its appearance should be recorded and passed to Property Services.

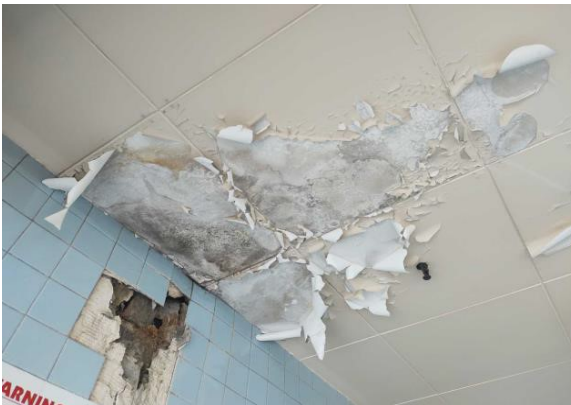
Item 131 Ref: 22-47230-31

The ceiling tiles (insulating board) (Area: Second Floor, Room 51 Female WC and Lobby 2) contains asbestos.

Any change in its appearance should be recorded and passed to Property Services.

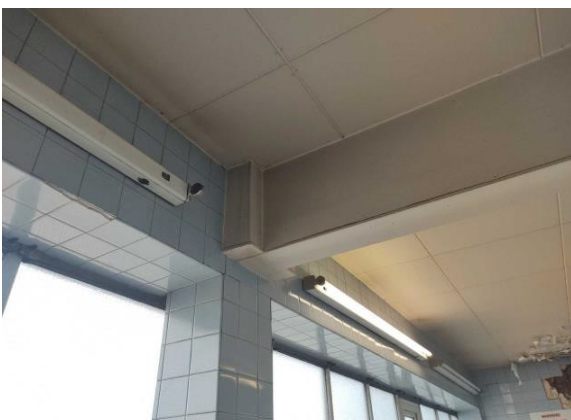
Item 132 Ref: 22-47230-34

The high level horizontal boxing (insulating board) (Area: Second Floor, Room 51 Female WC and Lobby 2) contains asbestos.

Any change in its appearance should be recorded and passed to Property Services.

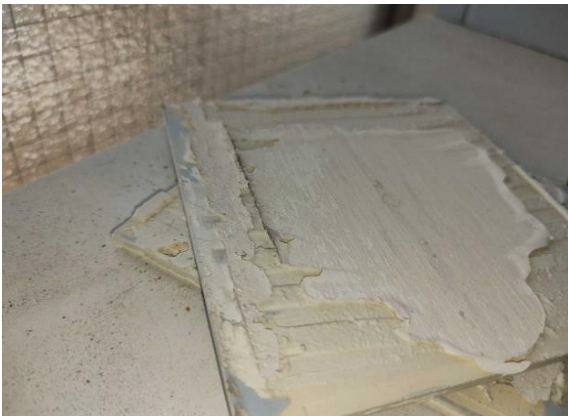
Item 134 Ref: 22-47230-34

The residues to backs of tiles from columns (insulating board) (Area: Second Floor, Room 51 Female WC and Lobby 2) contains asbestos.

Any change in its appearance should be recorded and passed to Property Services.

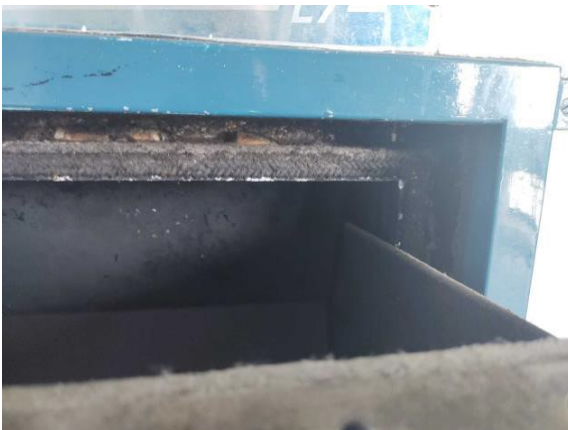
Item 135 Ref: 22-47230-38

The vessels – rope seal to incinerator (textile) (Area: Second Floor, Room 51 Female WC and Lobby 2) contains asbestos.

Any change in its appearance should be recorded and passed to Property Services.

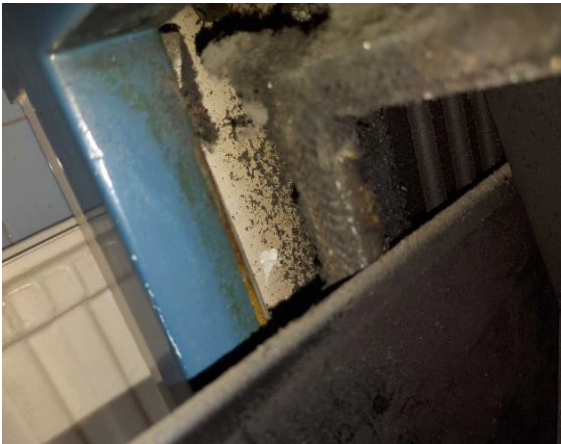
Item 137 Ref: 22-47230-40

The vessels – internal lining to incinerator (insulating board) (Area: Second Floor, Room 51 Female WC and Lobby 2) contains asbestos.

Any change in its appearance should be recorded and passed to Property Services.

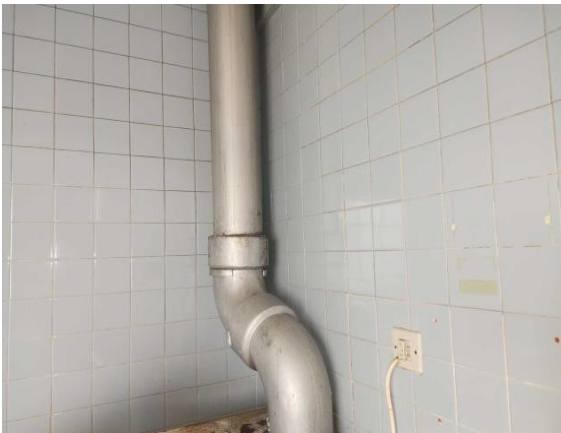
Item 138 Ref: 22-47230-41

The flue (cement) (Area: Second Floor, Room 51 Female WC and Lobby 2) contains asbestos.

Any change in its appearance should be recorded and passed to Property Services.

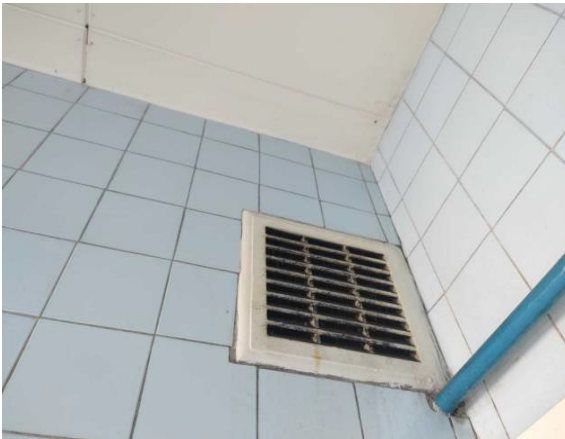
Item 139 Ref: 22-47230-18

The infill panels – lining to venting within wall cavity (insulating board) (Area: Second Floor, Room 52 Male WC and Lobby) contains asbestos.

Any change in its appearance should be recorded and passed to Property Services.

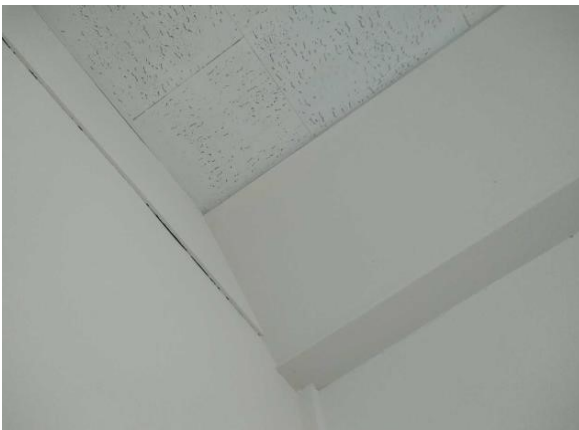
Item 143 Ref: 22-47230-34

The high level horizontal boxing (insulating board) (Area: Second Floor, Room 54 Ex Store) contains asbestos.

Any change in its appearance should be recorded and passed to Property Services.

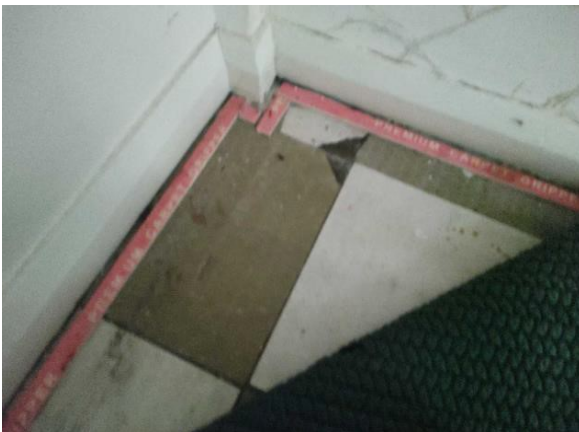
Item 144 Ref: 22-47230-42

The floor (tiles & adhesive) (Area: Second Floor, Room 54 Ex Store) does not contain asbestos.

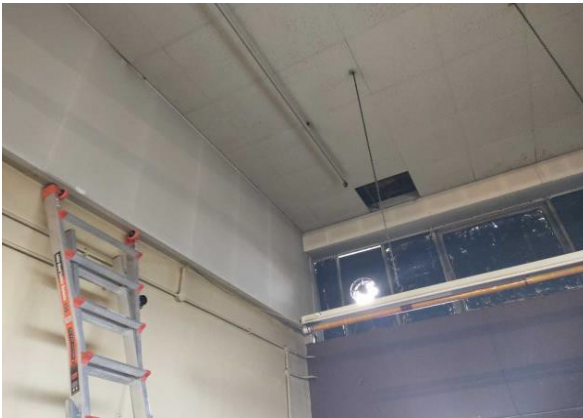
Item 145 Ref: 22-47230-50

The high level wall panels (insulating board) (Area: Second Floor, Room 55 Large Store) contains asbestos.

Any change in its appearance should be recorded and passed to Property Services.

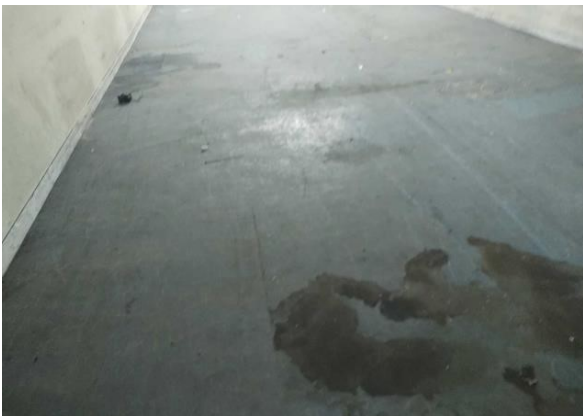
Item 147 Ref: 22-47230-51

The floor (vinyl) (Area: Second Floor, Room 55 Large Store) does not contain asbestos.

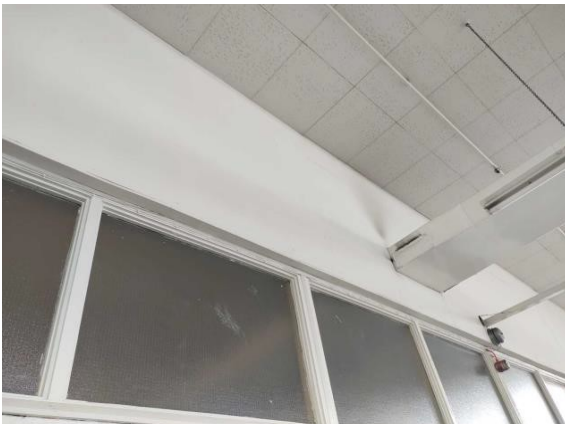
Item 149 Ref: 22-47230-50

The walls – high level panels (insulating board) (Area: Second Floor, Room 56 Racking Store) contains asbestos.

Any change in its appearance should be recorded and passed to Property Services.

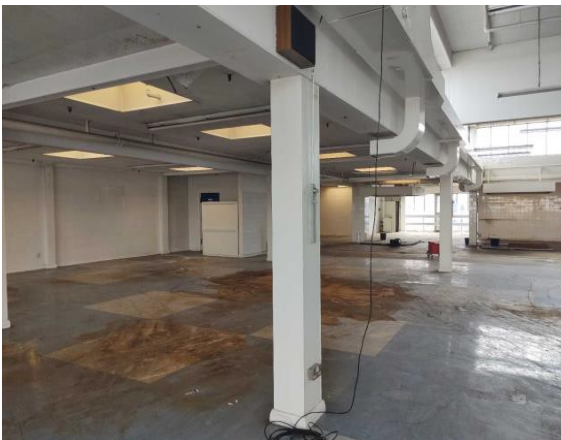
Item 150 Ref: 22-47230-50

The boxing – cladding to columns (insulating board) (Area: Second Floor, Room 56 Racking Store) does not contain asbestos.

Any change in its appearance should be recorded and passed to Property Services.

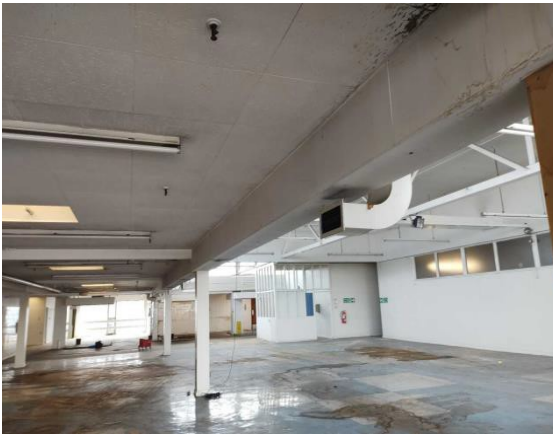
Item 151 Ref: 22-47230-50

The horizontal boxing to RSJ's (insulating board) (Area: Second Floor, Room 56 Racking Store) contains asbestos.

Any change in its appearance should be recorded and passed to Property Services.

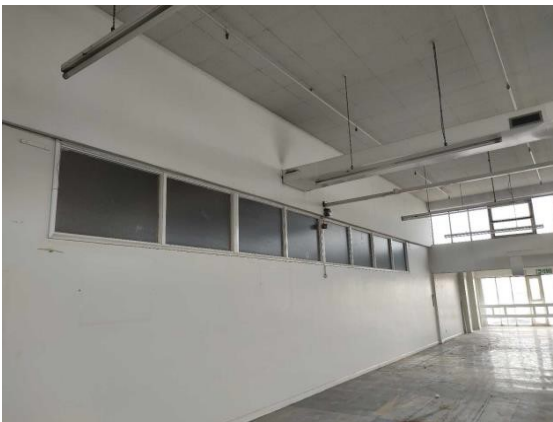
Item 152 Ref: 22-47230-52

The window – beading to high level windows (insulating board) (Area: Second Floor, Room 56 Racking Store) contains asbestos.

Any change in its appearance should be recorded and passed to Property Services.

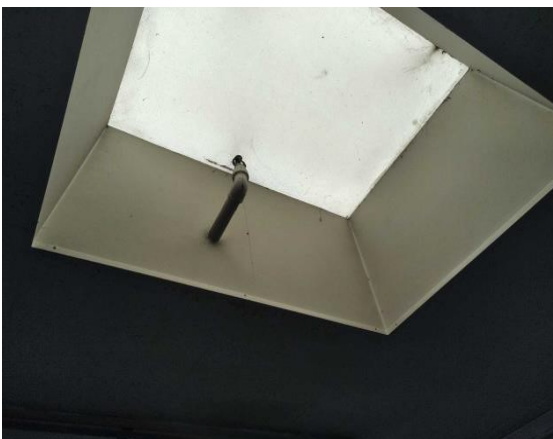
Item 153 Ref: 22-47230-53

The infill panels – upstands to skylights (insulating board) (Area: Second Floor, Room 56 Racking Store) contains asbestos.

Any change in its appearance should be recorded and passed to Property Services.

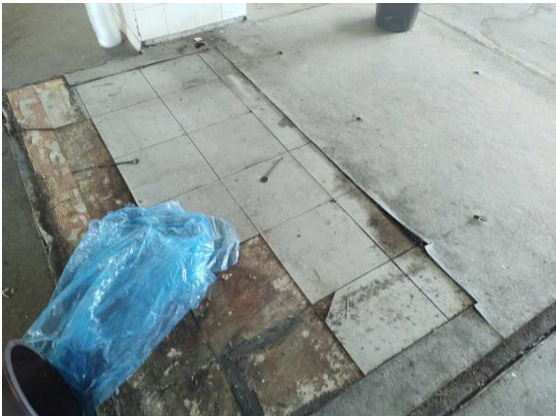
Item 154 Ref: 22-47230-54

The floor (tiles & adhesive)
(Area: Second Floor, Room 56
Racking Store) does not
contain asbestos.

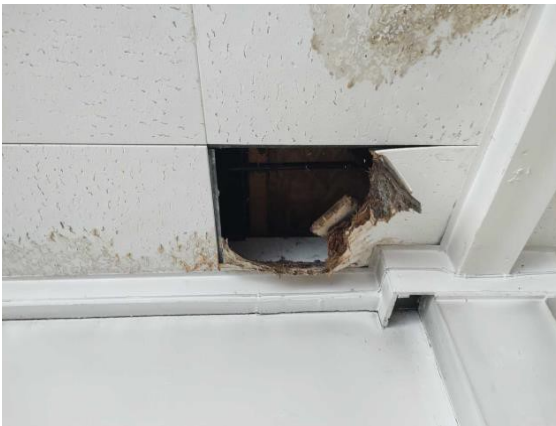
Item 155 Ref: 22-47230-55

The ceiling – debris to ceiling
tile tracking (insulating board)
(Area: Second Floor, Room 56
Racking Store) contains
asbestos.

Any change in its appearance
should be recorded and
passed to Property Services.

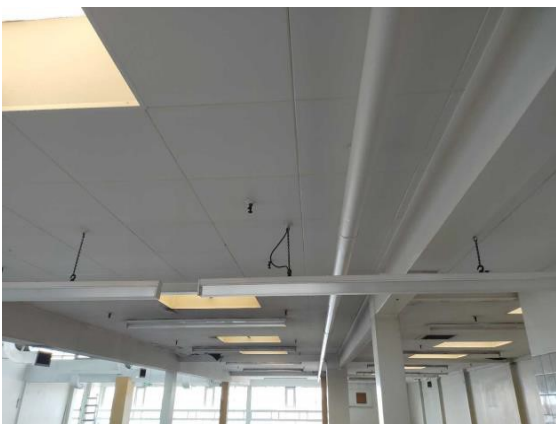
Item 156 Ref: 22-47230-56

The ceiling tiles (insulating
board) (Area: Second Floor,
Room 56 Racking Store)
contains asbestos.

Any change in its appearance
should be recorded and
passed to Property Services.

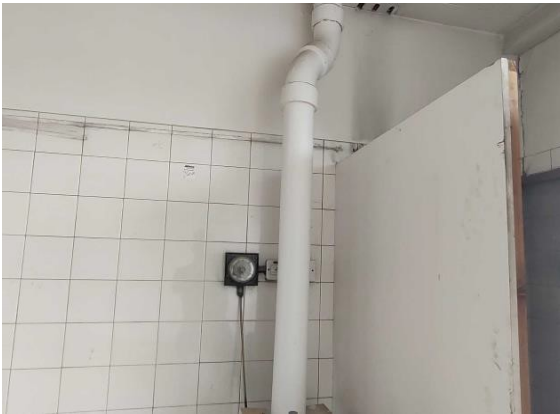
Item 157 Ref: 22-47230-57

The flue to Thorn boiler (cement) (Area: Second Floor, Room 56 Racking Store) contains asbestos.

Any change in its appearance should be recorded and passed to Property Services.

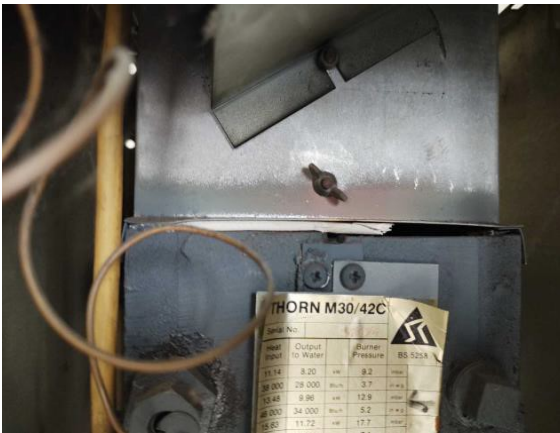
Item 158 Ref: 22-47230-58

The vessels – lining to boiler (millboard) (Area: Second Floor, Room 56 Racking Store) contains asbestos.

Any change in its appearance should be recorded and passed to Property Services.

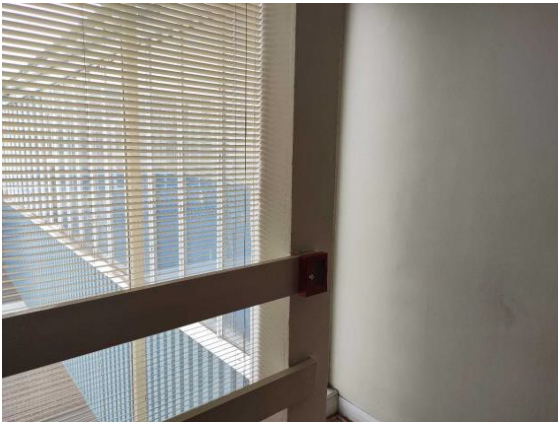
Item 160 Ref: 22-47230-50

The vertical boxing (insulating board) (Area: Second Floor, Room 58 Private Dining Room) contains asbestos.

Any change in its appearance should be recorded and passed to Property Services.

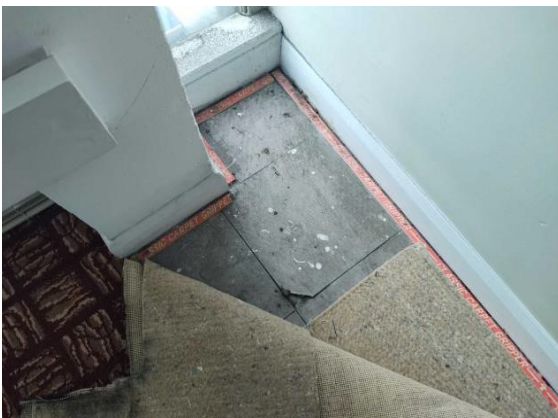
Item 161 Ref: 22-47230-59

The floor (tiles & adhesive) (Area: Second Floor, Room 58 Private Dining Room) does not contain asbestos.

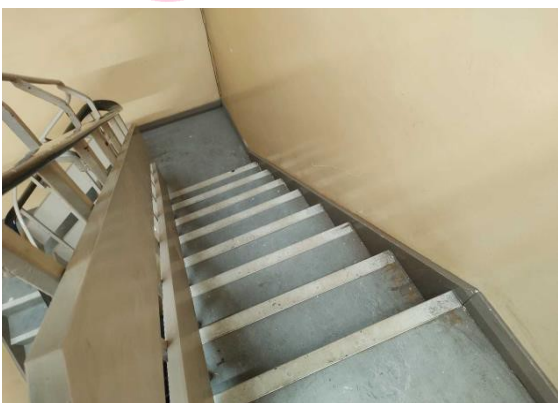
Item 162 Ref: 22-47230-84

The floor - stair nosings (composite) (Area: Second Floor, Room 5A Fire Exit Stairwell 4) contains asbestos.

Any change in its appearance should be recorded and passed to Property Services.

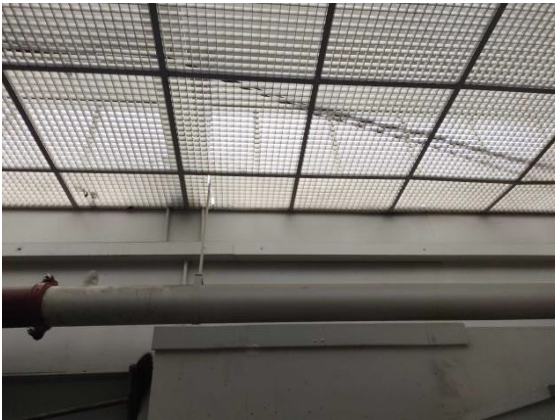
Item 163 Ref: 22-47230-50

The high level horizontal boxing (insulating board) (Area: Second Floor, Room 60 Store Room) contains asbestos.

Any change in its appearance should be recorded and passed to Property Services.

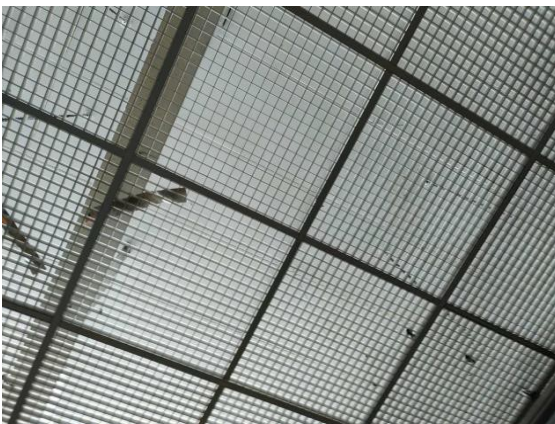
Item 164 Ref: 22-47230-56

The ceiling tiles (insulating board) (Area: Second Floor, Room 60 Store Room) contains asbestos.

Any change in its appearance should be recorded and passed to Property Services.

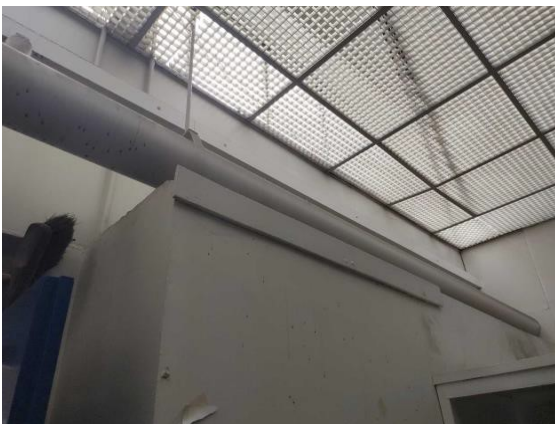
Item 165 Ref: 22-47230-60

The walls – fillet to top of wall (insulating board) (Area: Second Floor, Room 60 Store Room) contains asbestos.

Any change in its appearance should be recorded and passed to Property Services.

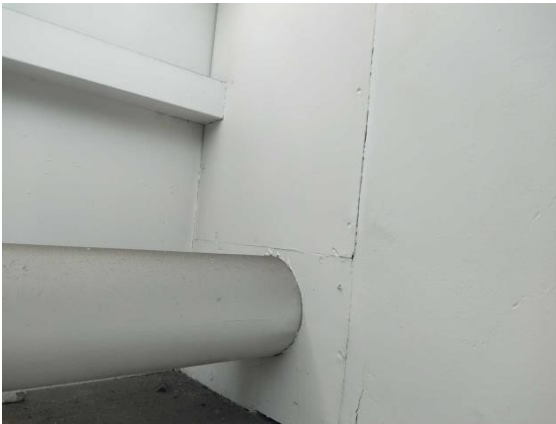
Item 166 Ref: 22-47230-60

The boxing – panel to pipe penetration (insulating board) (Area: Second Floor, Room 60 Store Room) contains asbestos.

Any change in its appearance should be recorded and passed to Property Services.

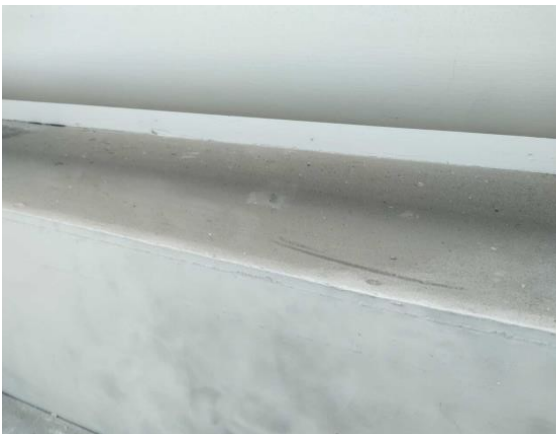
Item 167 Ref: 22-47230-60

The fillet to top of wall (insulating board) (Area: Second Floor, Room 60 Store Room) contains asbestos.

Any change in its appearance should be recorded and passed to Property Services.

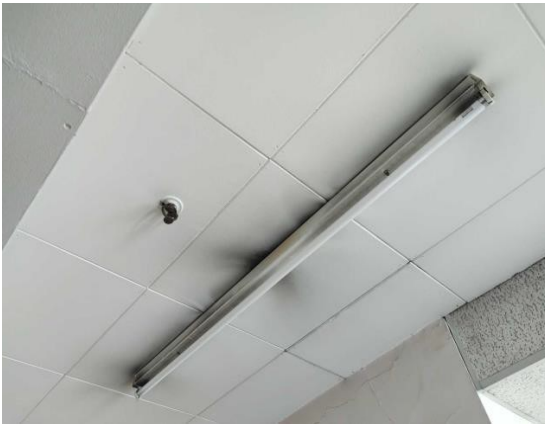
Item 169 Ref: 22-47230-56

The ceiling tiles (insulating board) (Area: Second Floor, Room 61 Corridor and Lift Lobby) contains asbestos.

Any change in its appearance should be recorded and passed to Property Services.

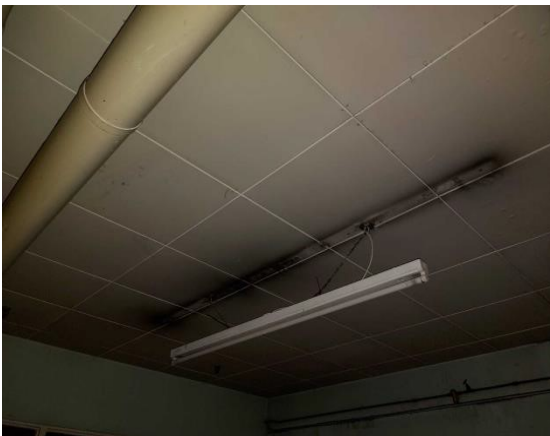
Item 170 Ref: 22-47230-56

The ceiling tiles (insulating board) (Area: Second Floor, Room 61 Corridor and Lift Lobby) contains asbestos.

Any change in its appearance should be recorded and passed to Property Services.

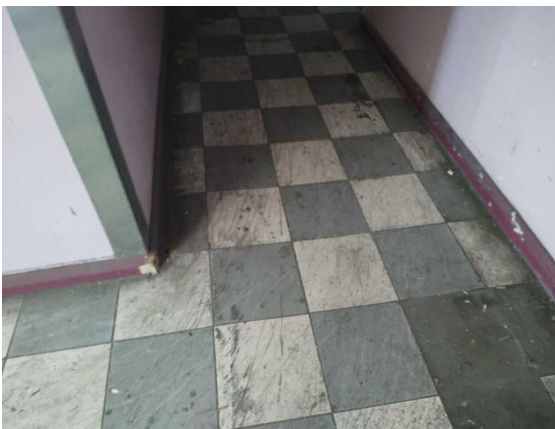
Item 171 Ref: 22-47230-61

The floor (tiles & adhesive) (Area: Second Floor, Room 61 Corridor and Lift Lobby) does not contain asbestos.

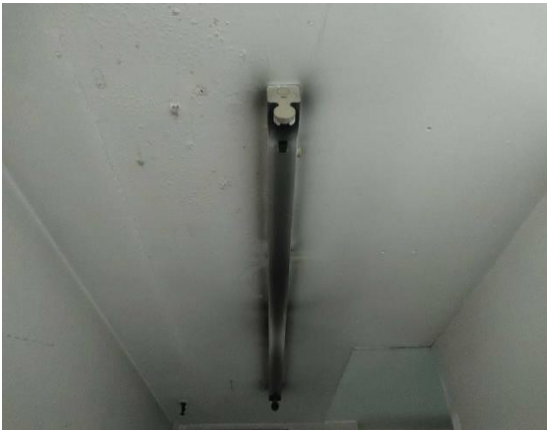
Item 172 Ref: 22-47230-62

The ceiling panel (insulating board) (Area: Second Floor, Room 61 Corridor and Lift Lobby) contains asbestos.

Any change in its appearance should be recorded and passed to Property Services.

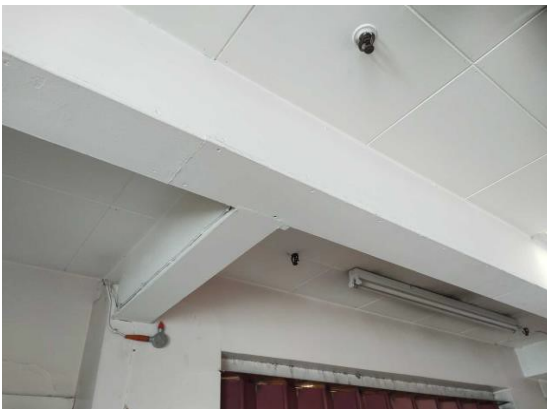
Item 173 Ref: 22-47230-63

The high level horizontal boxing (insulating board) (Area: Second Floor, Room 61 Corridor and Lift Lobby) contains asbestos.

Any change in its appearance should be recorded and passed to Property Services.
