ASBESTOS SURVEY REPORT FOR BLOCK 1A – 1C EDWARD THOMPSON SITE, RICHMOND STREET, SUNDERLAND, SR5 1BQ

Asbestos Register for Block 1A – 1C Edward Thompson Site, Richmond Street, Sunderland, SR5 1BQ

Date: 14 February 2025

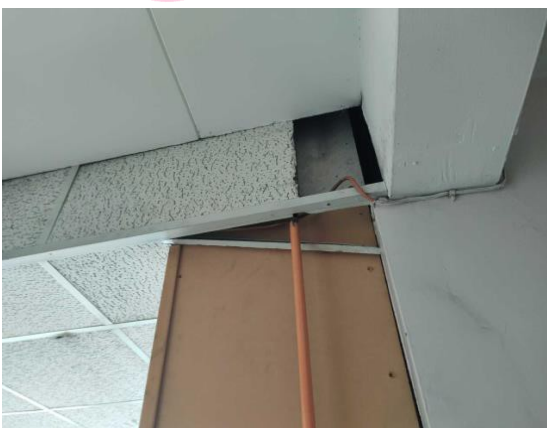
Item 174 Ref: 22-47230-63

The vertical boxing (insulating board) (Area: Second Floor, Room 61 Corridor and Lift Lobby) contains asbestos.

Any change in its appearance should be recorded and passed to Property Services.

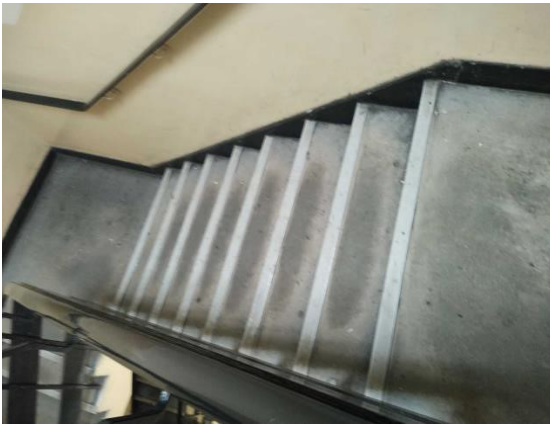
Item 175 Ref: 22-47230-33

The floor - stair nosings (composite) (Area: Second Floor, Room 63 Fire Exit Stairwell 3) contains asbestos.

Any change in its appearance should be recorded and passed to Property Services.

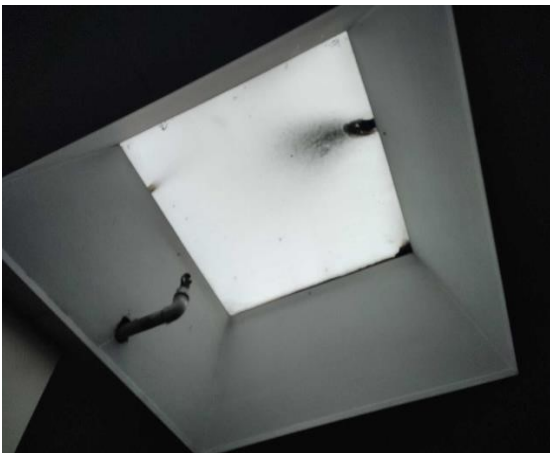
Item 176 Ref: 22-47230-53

The infill panels – upstands to skylights (insulating board) (Area: Second Floor, Room 63 Fire Exit Stairwell 3) contains asbestos.

Any change in its appearance should be recorded and passed to Property Services.

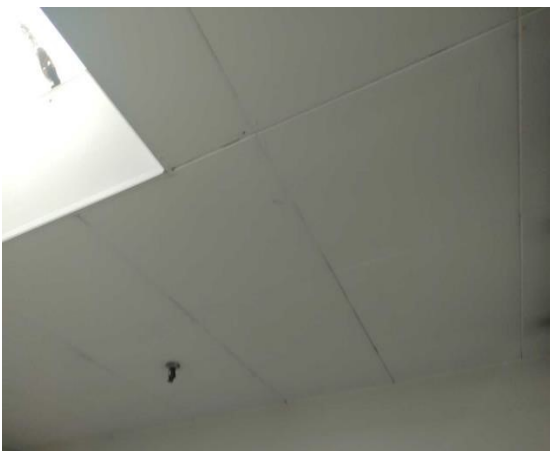
Item 177 Ref: 22-47230-56

The ceiling tiles (insulating board) (Area: Second Floor, Room 63 Fire Exit Stairwell 3) contains asbestos.

Any change in its appearance should be recorded and passed to Property Services.

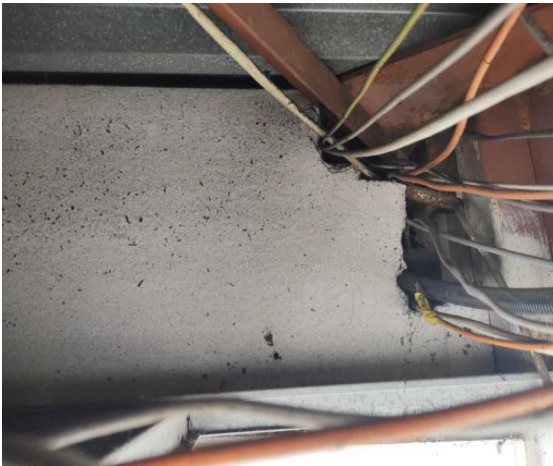
Item 178 Ref: 22-47230-64

The infill panels – door header panel (insulating board) (Area: Second Floor, Room 64 Link Bridge) does not contain asbestos.

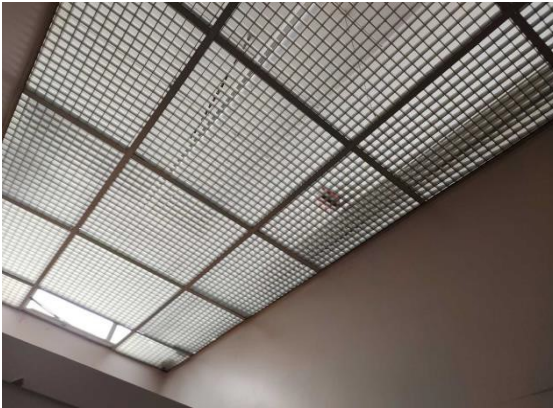
Item 179 Ref: 22-47230-50

The high level horizontal boxing over RSJ's (insulating board) (Area: Second Floor, Room 65 Corridor 8) contains asbestos.

Any change in its appearance should be recorded and passed to Property Services.

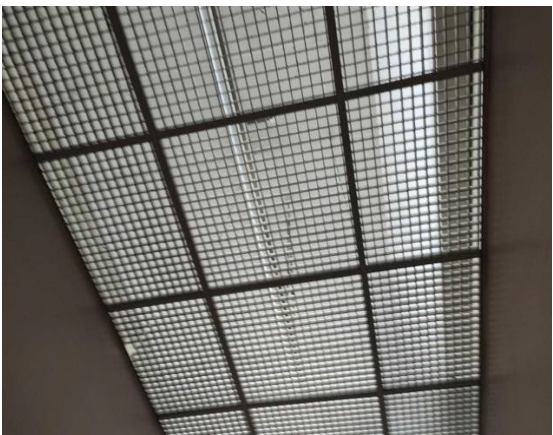
Item 180 Ref: 22-47230-56

The ceiling tiles (insulating board) (Area: Second Floor, Room 65 Corridor 8) contains asbestos.

Any change in its appearance should be recorded and passed to Property Services.

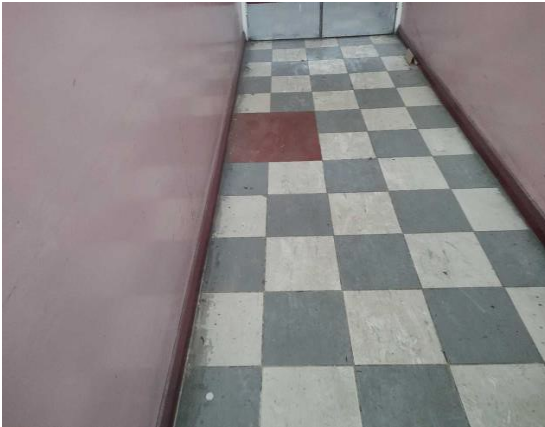
Item 182 Ref: 22-47230-61

The floor (tiles & adhesive) (Area: Second Floor, Room 65 Corridor 8) does not contain asbestos.

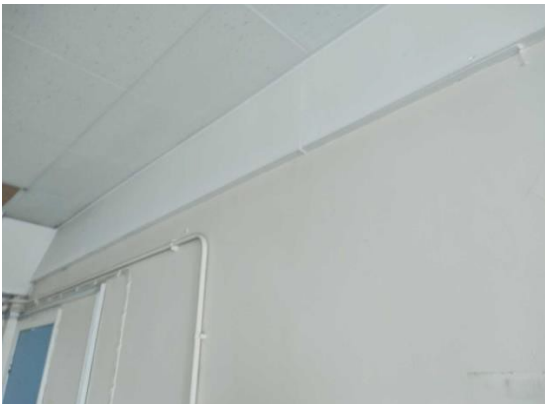
Item 183 Ref: 22-47230-65

The high level horizontal boxing (insulating board) (Area: Second Floor, Room 66 Electric Store 1) contains asbestos.

Any change in its appearance should be recorded and passed to Property Services.

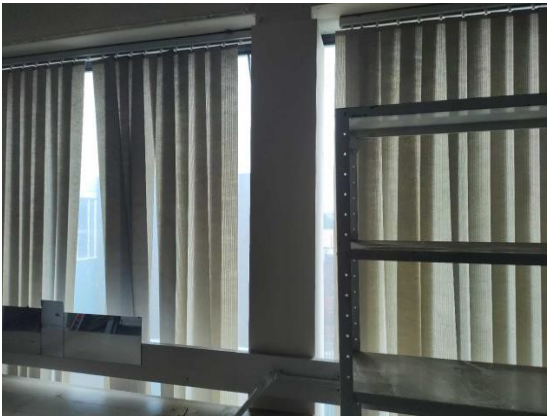
Item 184 Ref: 22-47230-65

The vertical boxing (insulating board) (Area: Second Floor, Room 66 Electric Store 1) contains asbestos.

Any change in its appearance should be recorded and passed to Property Services.

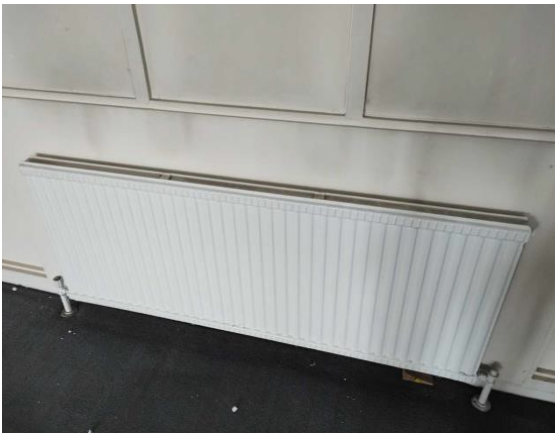
Item 185 Ref: 22-47230-66

The infill panels – panel behind radiator (insulating board) (Area: Second Floor, Room 66 Electric Store 1) contains asbestos.

Any change in its appearance should be recorded and passed to Property Services.

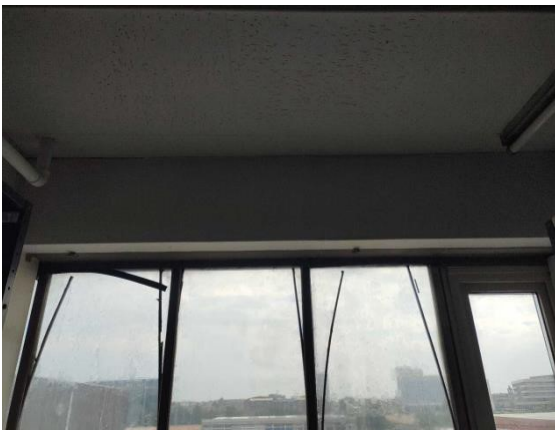
Item 186 Ref: 22-47230-65

The high level horizontal boxing (insulating board) (Area: Second Floor, Room 67 Electric Store 2) contains asbestos.

Any change in its appearance should be recorded and passed to Property Services.

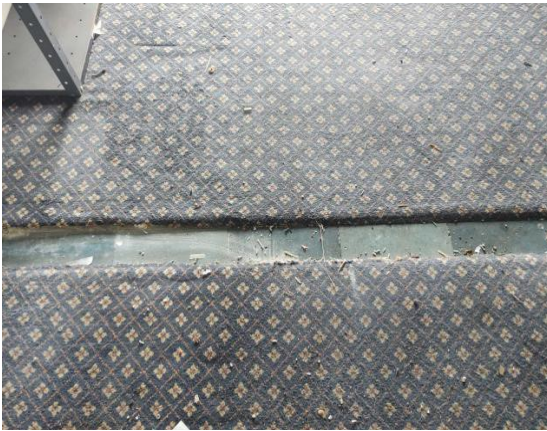
Item 187 Ref: 22-47230-67

The floor (tiles & adhesive) (Area: Second Floor, Room 67 Electric Store 2) does not contain asbestos.

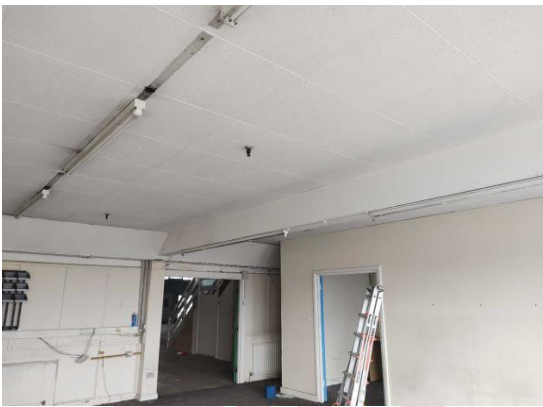
Item 188 Ref: 22-47230-65

The high level horizontal boxing (insulating board) (Area: Second Floor, Room 68 Electric Office) contains asbestos.

Any change in its appearance should be recorded and passed to Property Services.

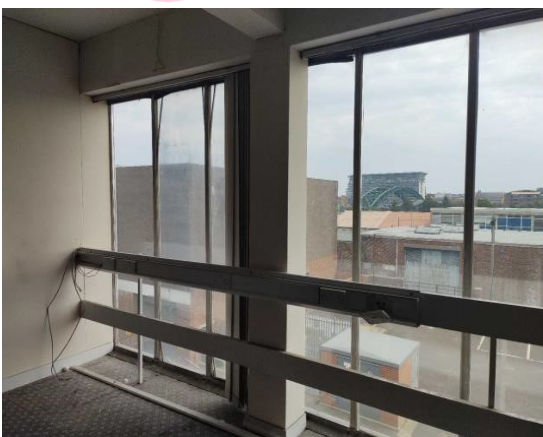
Item 189 Ref: 22-47230-65

The vertical boxing (insulating board) (Area: Second Floor, Room 68 Electric Office) contains asbestos.

Any change in its appearance should be recorded and passed to Property Services.

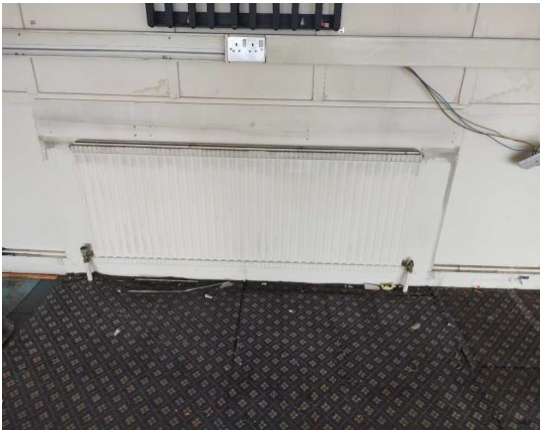
Item 190 Ref: 22-47230-66

The infill panels – panel behind 2x radiators (insulating board) (Area: Second Floor, Room 68 Electric Office) contains asbestos.

Any change in its appearance should be recorded and passed to Property Services.

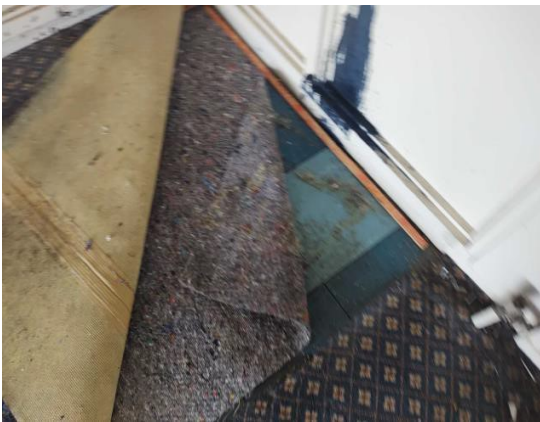
Item 191 Ref: 22-47230-67

The floor (tiles & adhesive) (Area: Second Floor, Room 68 Electric Office) does not contain asbestos.

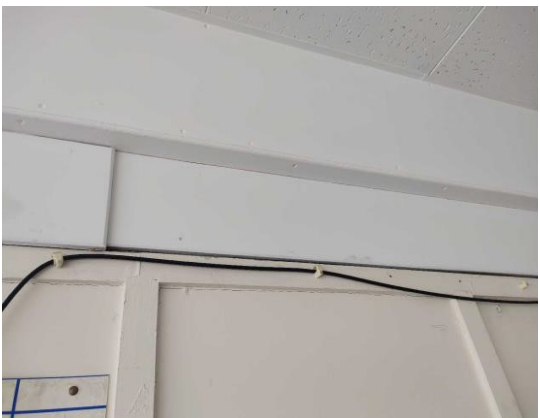
Item 192 Ref: 22-47230-68

The walls – firebreak panels between RSJ and walls (insulating board) (Area: Second Floor, Room 68 Electric Office) contains asbestos.

Any change in its appearance should be recorded and passed to Property Services.

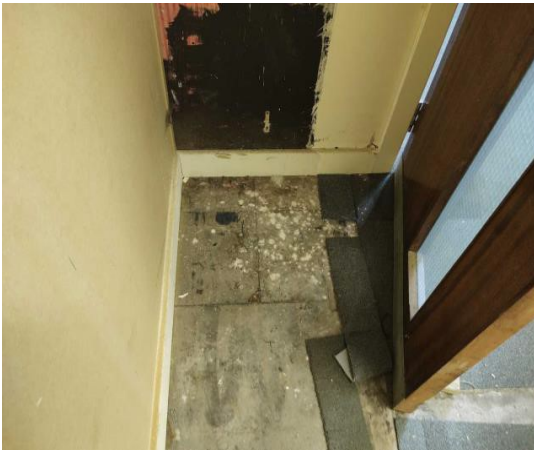
Item 193 Ref: 22-47230-69

The floor (tiles & adhesive)
(Area: Second Floor, Room 69
Store 3) does not contain
asbestos.

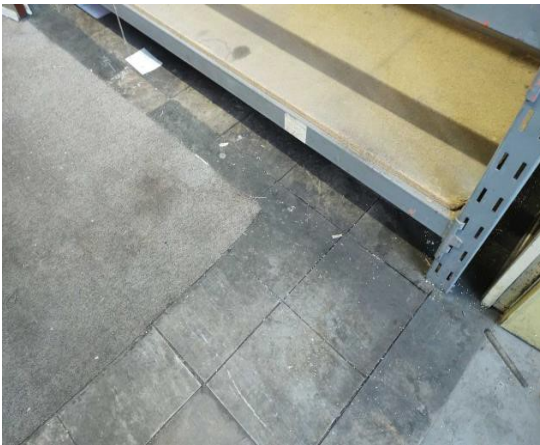
Item 194 Ref: 22-47230-69

The floor (tiles & adhesive)
(Area: Second Floor, Room 70
Filing Store) does not contain
asbestos.

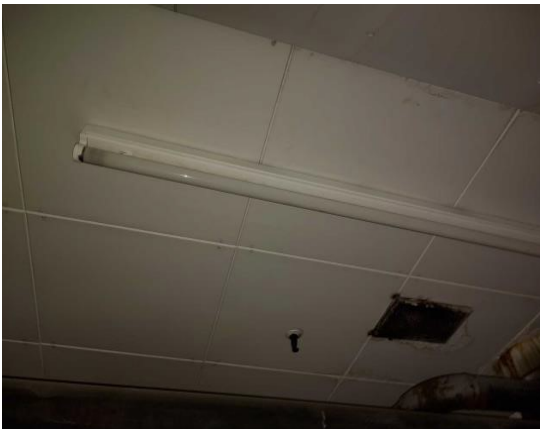
Item 195 Ref: 22-47230-31

The ceiling tiles (insulating
board) (Area: Second Floor,
Room 71 Boiler Room)
contains asbestos.

Any change in its appearance
should be recorded and
passed to Property Services.

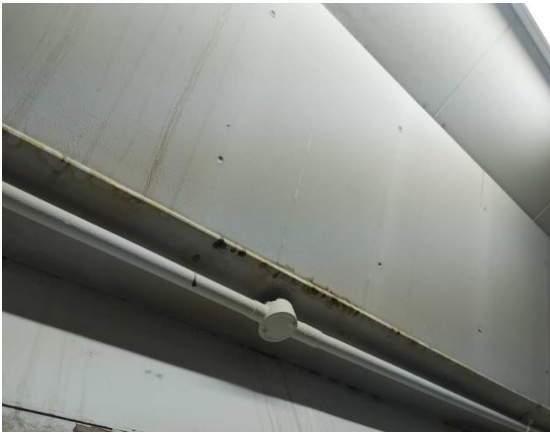
Item 196 Ref: 22-47230-34

The high level horizontal boxing (insulating board) (Area: Second Floor, Room 71 Boiler Room) contains asbestos.

Any change in its appearance should be recorded and passed to Property Services.

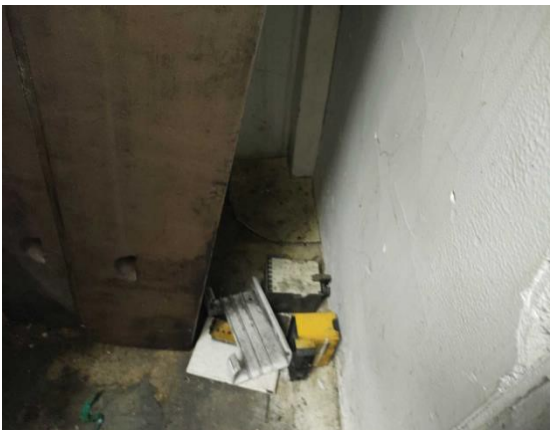
Item 197 Ref: 22-47230-43

The floor (tiles & adhesive) (Area: Second Floor, Room 71 Boiler Room) does not contain asbestos.

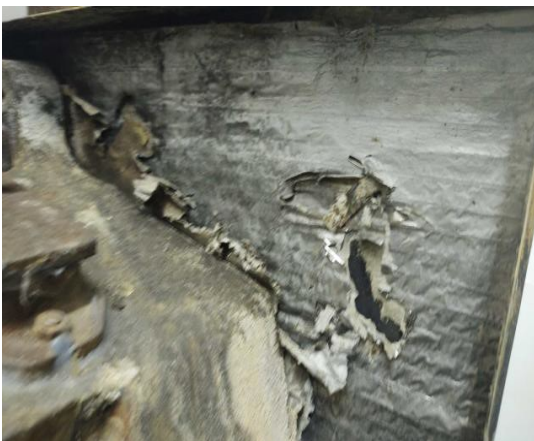
Item 198 Ref: 22-47230-44

The vessels – aircell lining to boiler (textile) (Area: Second Floor, Room 71 Boiler Room) contains asbestos.

Any change in its appearance should be recorded and passed to Property Services.

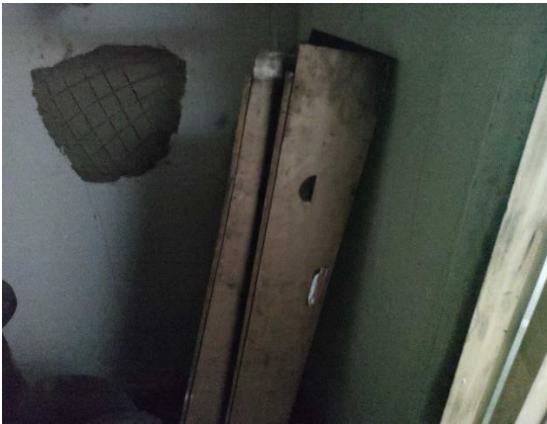
Item 199 Ref: 22-47230-44

The aircell lining to boiler casing (textile) (Area: Second Floor, Room 71 Boiler Room) contains asbestos.

Any change in its appearance should be recorded and passed to Property Services.

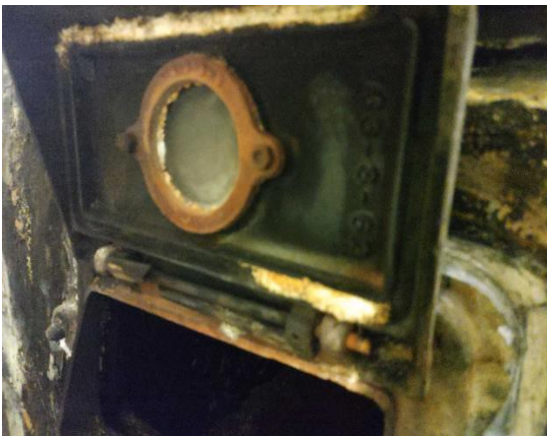
Item 200 Ref: 22-47230-45

The vessels – rope seal to door lining and viewing glass (textile) (Area: Second Floor, Room 71 Boiler Room) contains asbestos.

Any change in its appearance should be recorded and passed to Property Services.

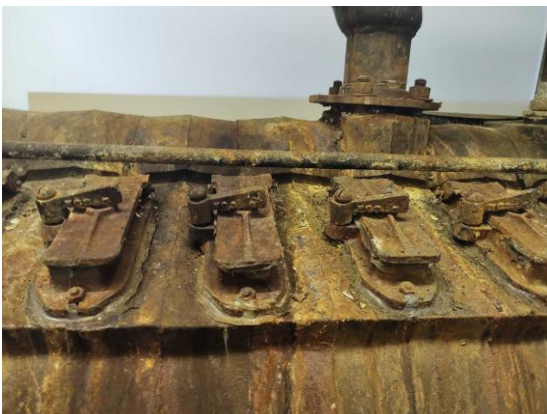
Item 201 Ref: 22-47230-46

The vessels – debris to boiler (textile) (Area: Second Floor, Room 71 Boiler Room) contains asbestos.

Any change in its appearance should be recorded and passed to Property Services.

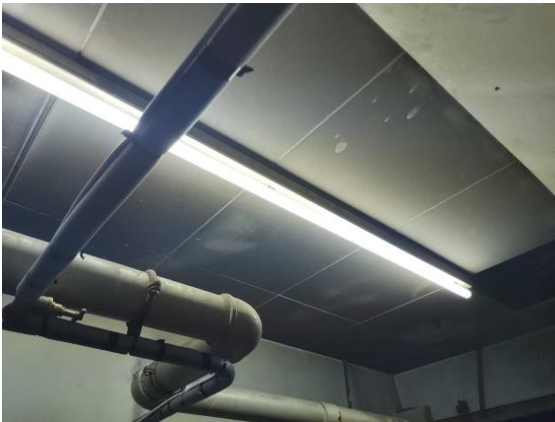
Item 202 Ref: 22-47230-31

The ceiling tiles (insulating board) (Area: Second Floor, Room 72 Tank Cupboard) contains asbestos.

Any change in its appearance should be recorded and passed to Property Services.

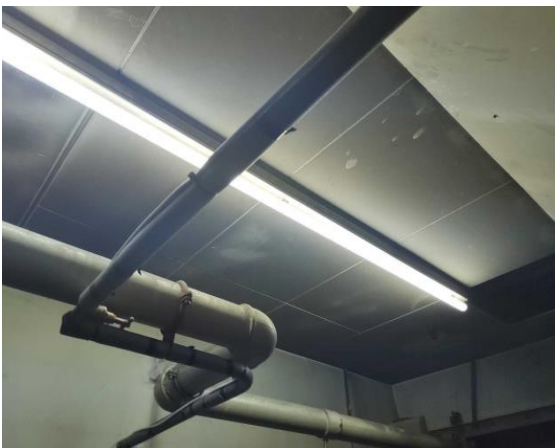
Item 203 Ref: 22-47230-31

The ceiling tiles (insulating board) (Area: Second Floor, Room 72 Tank Cupboard) contains asbestos.

Any change in its appearance should be recorded and passed to Property Services.

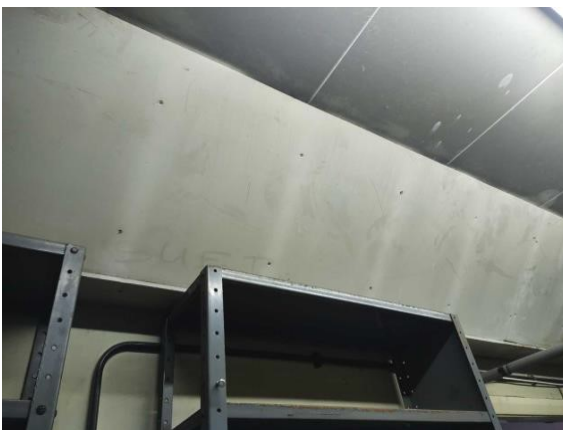
Item 204 Ref: 22-47230-34

The vertical boxing (insulating board) (Area: Second Floor, Room 72 Tank Cupboard) contains asbestos.

Any change in its appearance should be recorded and passed to Property Services.

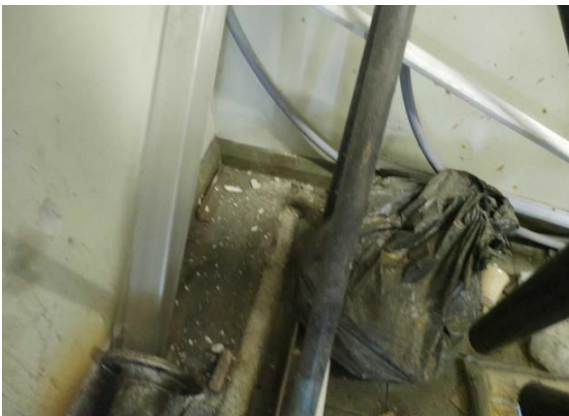
Item 206 Ref: 22-47230-47

The debris to floor (insulating board) (Area: Second Floor, Room 72 Tank Cupboard) contains asbestos.

Any change in its appearance should be recorded and passed to Property Services.

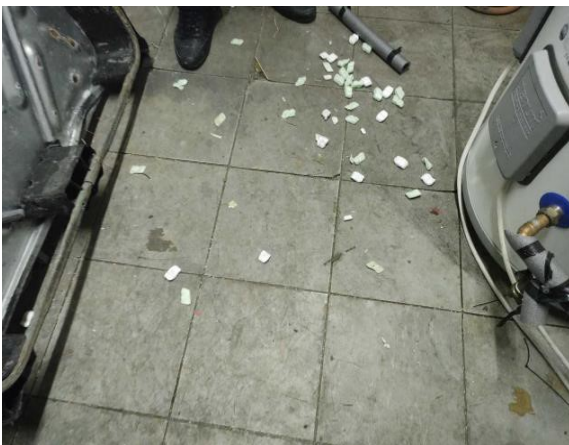
Item 207 Ref: 22-47230-48

The floor (tiles & adhesive) (Area: Second Floor, Room 72 Tank Cupboard) does not contain asbestos.

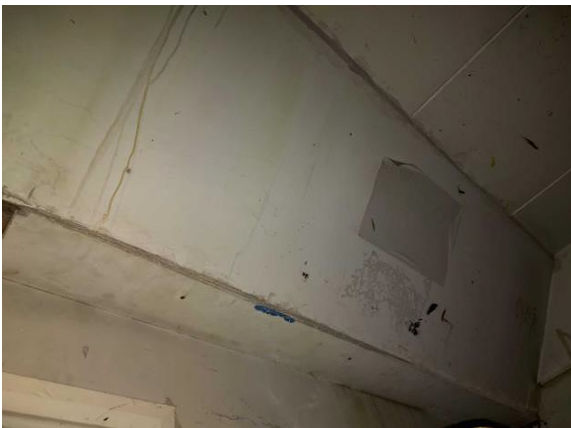
Item 210 Ref: 22-47230-34

The high level horizontal boxing (insulating board) (Area: Second Floor, Room 73 Paint Store) contains asbestos.

Any change in its appearance should be recorded and passed to Property Services.

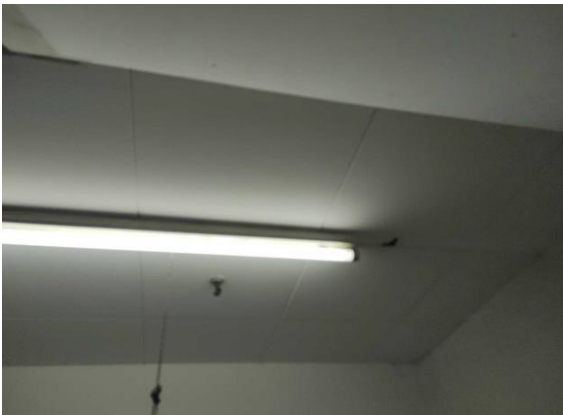
Item 212 Ref: 22-47230-31

The ceiling tiles (insulating board) (Area: Second Floor, Room 74 Uniform Store) contains asbestos.

Any change in its appearance should be recorded and passed to Property Services.

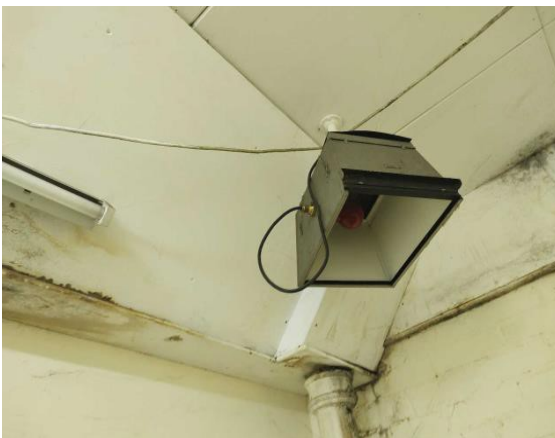
Item 213 Ref: 22-47230-34

The high level horizontal boxing (insulating board) (Area: Second Floor, Room 74 Uniform Store) contains asbestos.

Any change in its appearance should be recorded and passed to Property Services.

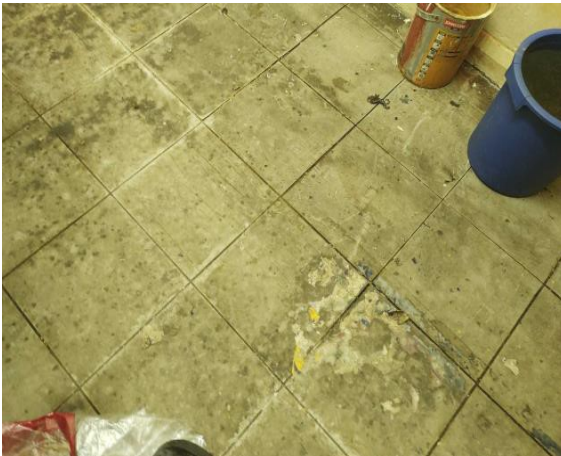
Item 214 Ref: 22-47230-48

The floor (tiles & adhesive)
(Area: Second Floor, Room 74
Uniform Store) does not
contain asbestos.

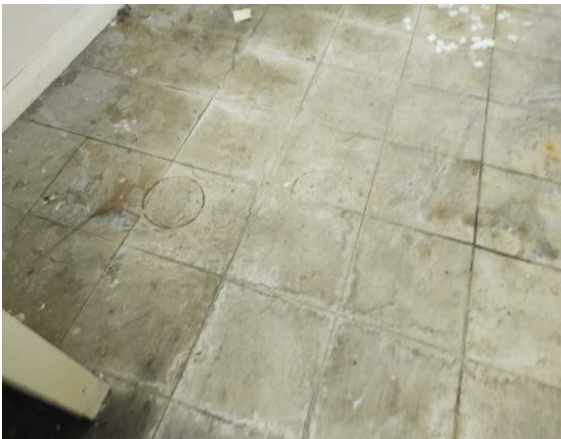
Item 215 Ref: 22-47230-49

The debris to floor (insulating
board) (Area: Second Floor,
Room 74 Uniform Store) does
not contain asbestos.

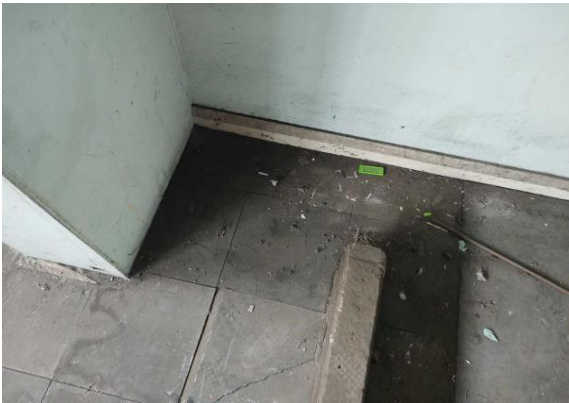
Item 220 Ref: 22-47230-72

The debris to floor adjacent convector heater (insulating board) (Area: Second Floor, Room 75 Main Workshop) contains asbestos.

220.	Debris to floor adjacent convector heater	Second Floor, Room 75 Main Workshop	High Risk		Removed 2023		
221.	Loose lying panel behind convector heater	Second Floor, Room 75 Main Workshop	High Risk		Removed 2023

Any change in its appearance should be recorded and passed to Property Services.

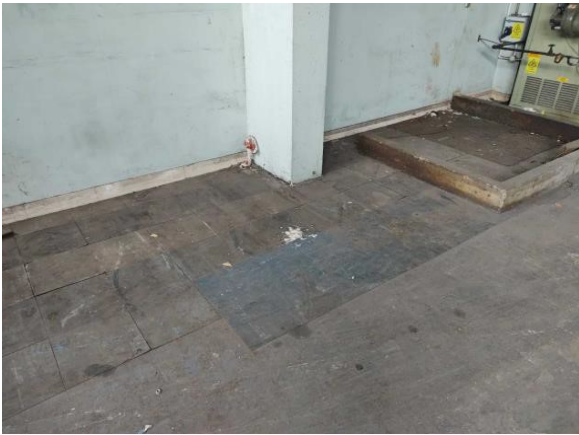
Item 223 Ref: 22-47230-73

The floor (tiles & adhesive) (Area: Second Floor, Room 75 Main Workshop) does not contain asbestos.

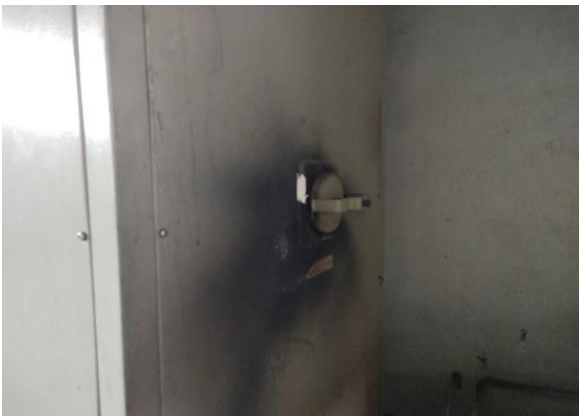
Item 224 Ref: 22-47230-74

The electrical equipment – gasket to rear of heater (gasket) (Area: Second Floor, Room 75 Main Workshop) does not contain asbestos.

224.	Electrical equipment – Gasket to rear of heater	Second Floor, Room 75 Main Workshop	No Risk				
225.	Loose panels within conduits	Second Floor, Room 75 Main Workshop	Medium Risk – check every 3 months	24/03/25	unsealed

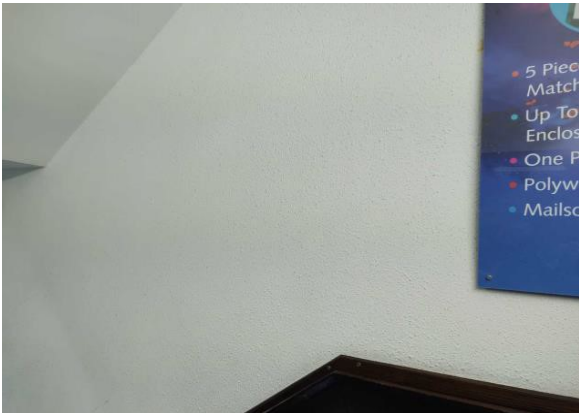
Item 227 Ref: 22-47230-80

The walls (render) (Area: First Floor, Room 76 Main Stairwell) does not contain asbestos.

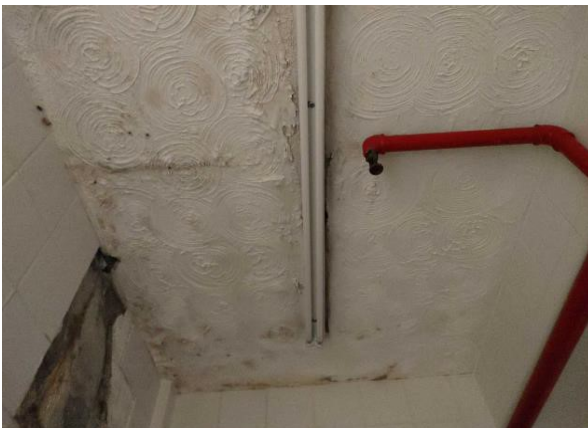
Item 228 Ref: 22-47230-81

The ceiling (textured coating) (Area: First Floor, Room 80 Squash Court Changing Room) does not contain asbestos.

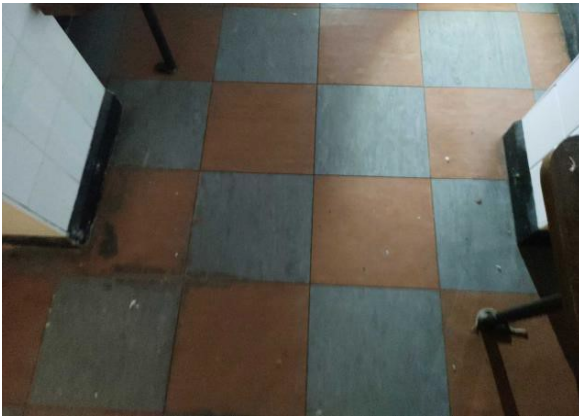
Item 229 Ref: 22-47230-82

The floor (tiles & adhesive)
(Area: First Floor, Room 80
Squash Court Changing
Room) contains asbestos.

Any change in its appearance
should be recorded and
passed to Property Services.

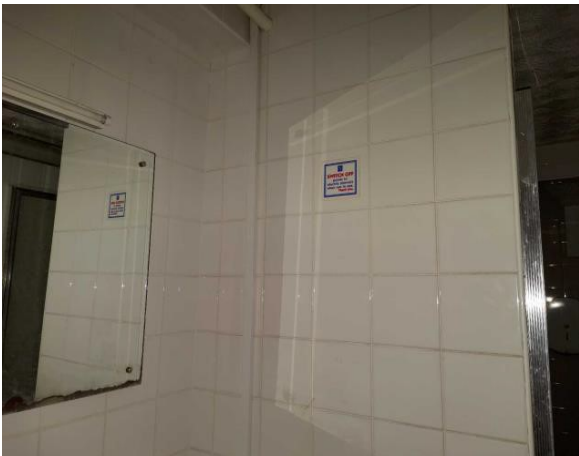
Item 230 Ref: 22-47230-83

The walls – ceramic tile
adhesive (adhesive) (Area:
First Floor, Room 80 Squash
Court Changing Room) does
not contain asbestos.

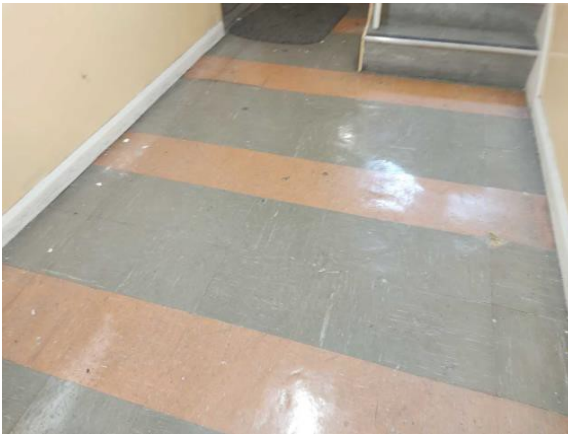
Item 232 Ref: 22-47230-82

The floor (tiles & adhesive)
(Area: First Floor, Room 82
Squash Court Lobby and
Stairs) contains asbestos.

Any change in its appearance
should be recorded and
passed to Property Services.

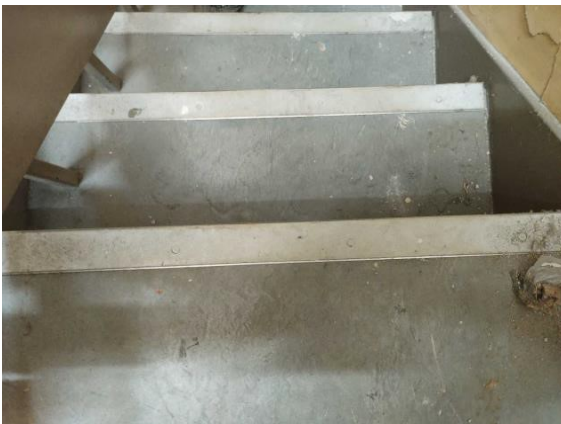
Item 233 Ref: 22-47230-85

The floor – stair nosings
(composite) (Area: First Floor,
Room 83 Stairwell) contains
asbestos.

Any change in its appearance
should be recorded and
passed to Property Services.

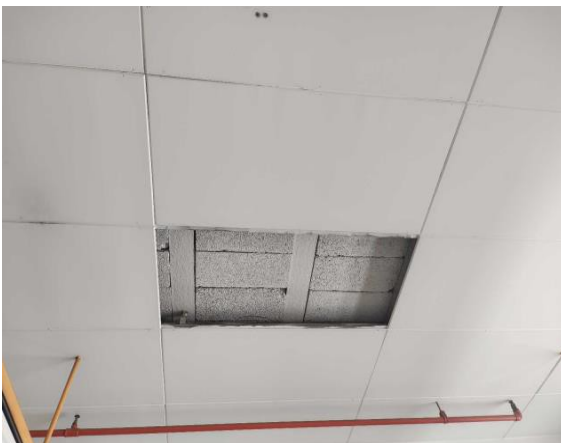
Item 234 Ref: 22-47230-85

The ceiling (insulating board)
(Area: First Floor, Room 84
Maintenance Workshop)
contains asbestos.

Any change in its appearance
should be recorded and
passed to Property Services.

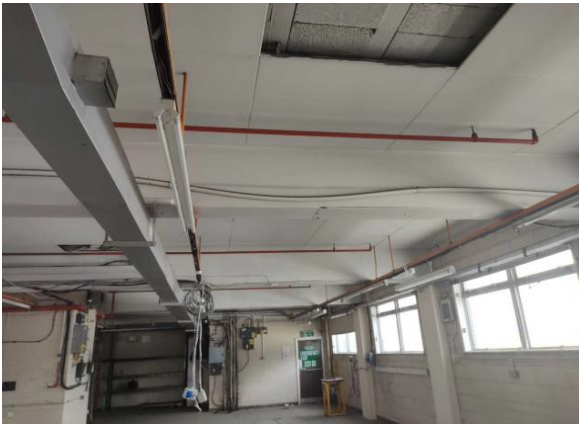
Item 235 Ref: 22-47230-86

The high level horizontal boxing (insulating board) (Area: First Floor, Room 84 Maintenance Workshop) contains asbestos.

Any change in its appearance should be recorded and passed to Property Services.

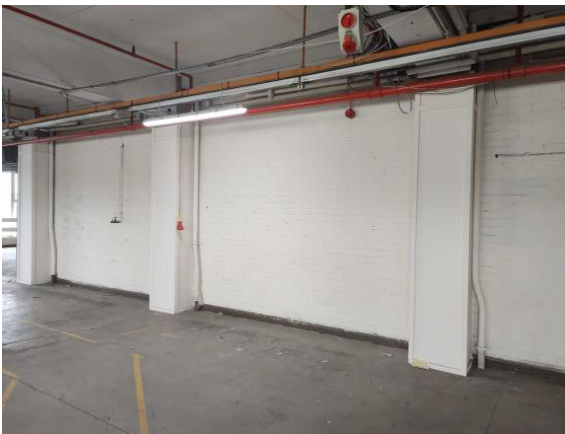
Item 236 Ref: 22-47230-86

The vertical boxing (insulating board) (Area: First Floor, Room 84 Maintenance Workshop) contains asbestos.

Any change in its appearance should be recorded and passed to Property Services.

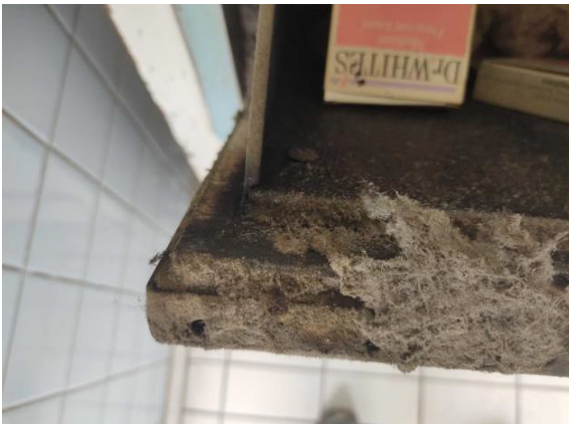
Item 239 Ref: 22-47230-39

The pad to opening hatch (insulating board) (Area: First Floor, Room 86 Female WC and Lobby) contains asbestos.

Any change in its appearance should be recorded and passed to Property Services.

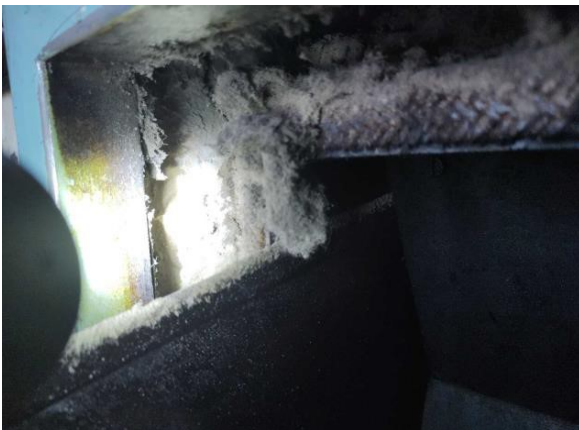
Item 240 Ref: 22-47230-40

The internal lining to incinerator (insulating board) (Area: First Floor, Room 86 Female WC and Lobby) contains asbestos.

Any change in its appearance should be recorded and passed to Property Services.

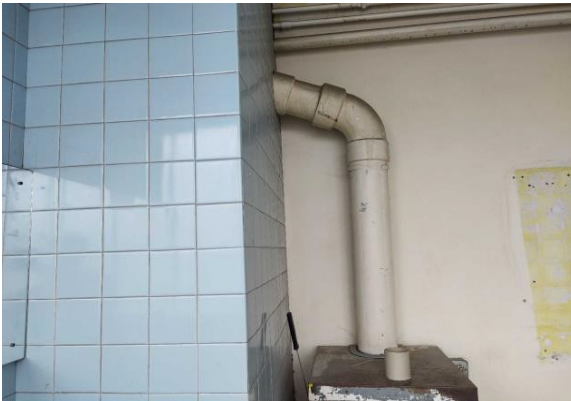
Item 241 Ref: 22-47230-41

The flue (cement) (Area: First Floor, Room 86 Female WC and Lobby) contains asbestos.

Any change in its appearance should be recorded and passed to Property Services.

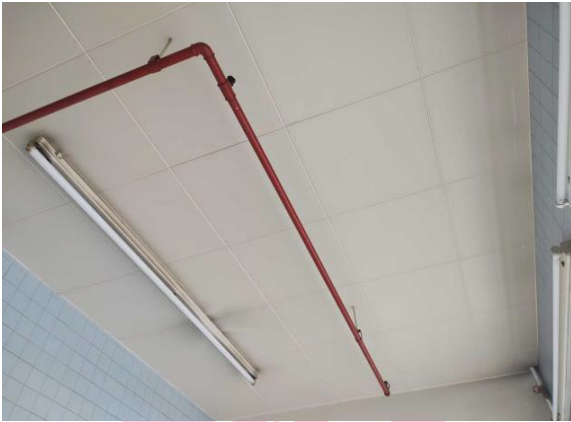
Item 242 Ref: 22-47230-85

The ceiling (insulating board) (Area: First Floor, Room 86 Female WC and Lobby) contains asbestos.

Any change in its appearance should be recorded and passed to Property Services.

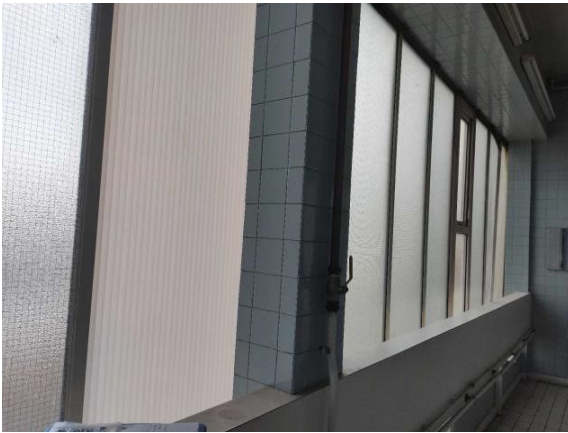
Item 244 Ref: 22-47230-86

The vertical boxing (insulating board) (Area: First Floor, Room 86 Female WC and Lobby) contains asbestos.

Any change in its appearance should be recorded and passed to Property Services.

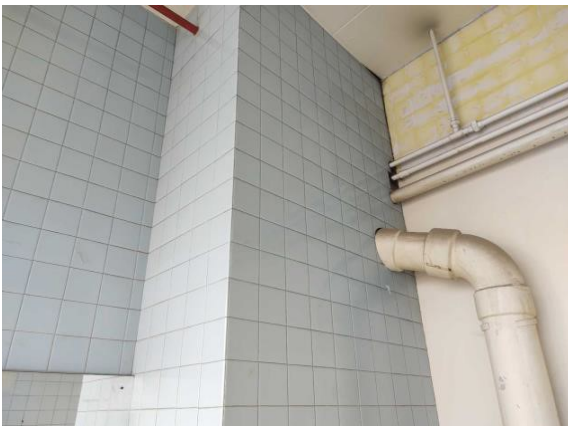
Item 245 Ref: 22-47230-86

The infill panels – lining to vertical boxing housing flue (insulating board) (Area: First Floor, Room 86 Female WC and Lobby) contains asbestos.

Any change in its appearance should be recorded and passed to Property Services.

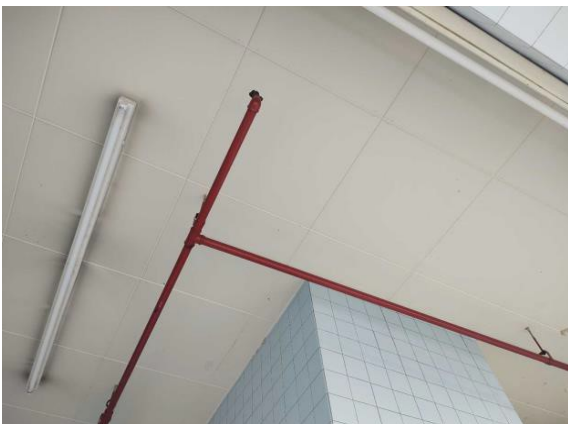
Item 246 Ref: 22-47230-85

The ceiling (insulating board) (Area: First Floor, Room 87 Male WC and Lobby) contains asbestos.

Any change in its appearance should be recorded and passed to Property Services.

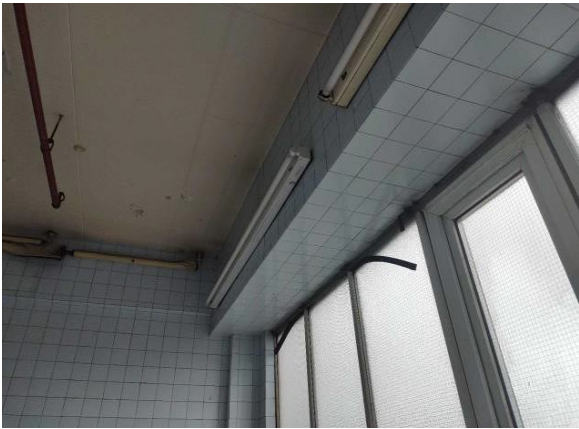
Item 247 Ref: 22-47230-86

The high level horizontal boxing (insulating board) (Area: First Floor, Room 87 Male WC and Lobby) contains asbestos.

Any change in its appearance should be recorded and passed to Property Services.

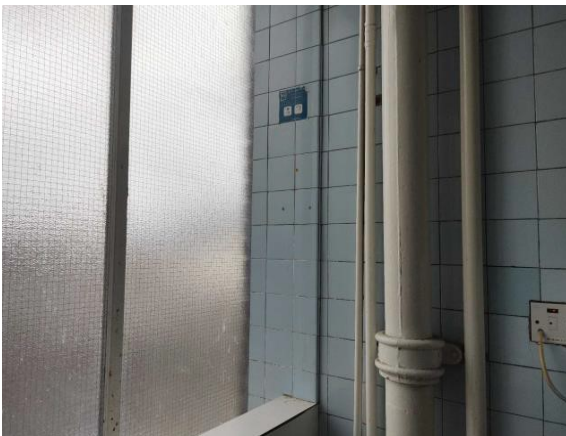
Item 248 Ref: 22-47230-86

The vertical boxing (behind ceramic tiles) (insulating board) (Area: First Floor, Room 87 Male WC and Lobby) contains asbestos.

Any change in its appearance should be recorded and passed to Property Services.

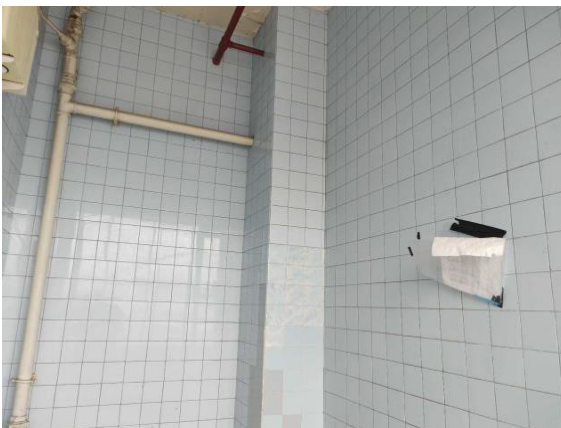
Item 249 Ref: 22-47230-86

The infill panels – lining to vertical boxing pipework (insulating board) (Area: First Floor, Room 87 Male WC and Lobby) contains asbestos.

Any change in its appearance should be recorded and passed to Property Services.

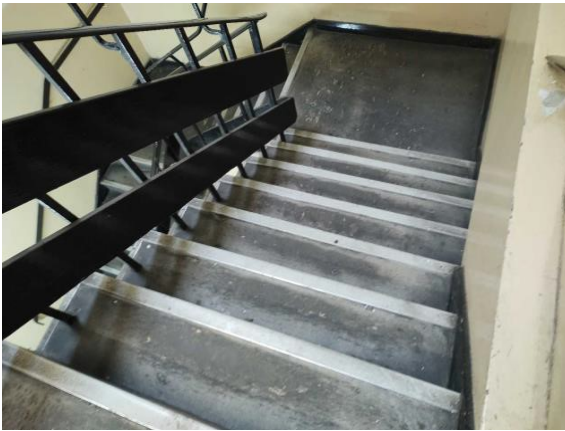
Item 250 Ref: 22-47230-84

The floor – stair nosings (composite) (Area: First Floor, Room 88 Fire Exit Stairwell 2) contains asbestos.

Any change in its appearance should be recorded and passed to Property Services.

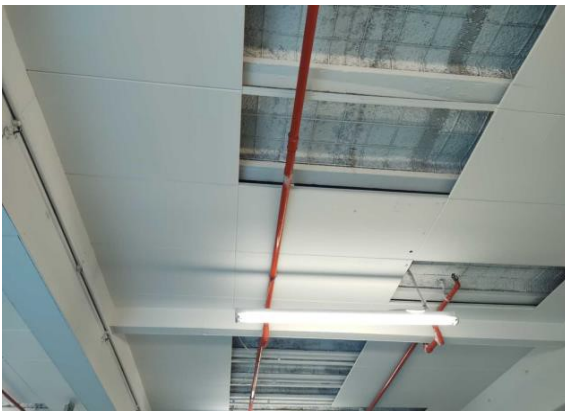
Item 251 Ref: 22-47230-85

The ceiling (insulating board) (Area: First Floor, Room 90 Print Room) contains asbestos.

Any change in its appearance should be recorded and passed to Property Services.

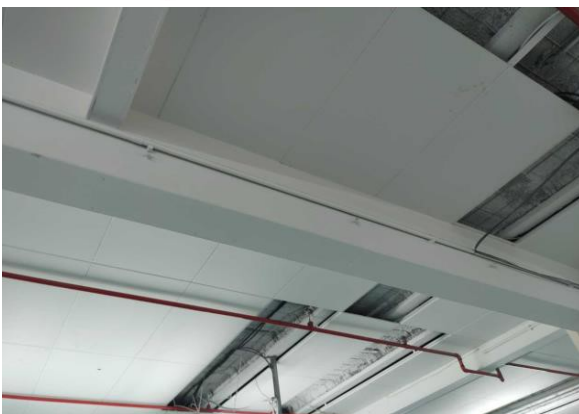
Item 252 Ref: 22-47230-86

The high level horizontal boxing (insulating board) (Area: First Floor, Room 90 Print Room) contains asbestos.

Any change in its appearance should be recorded and passed to Property Services.

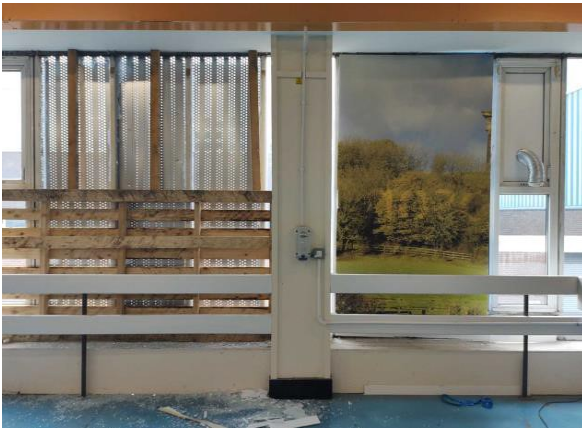
Item 253 Ref: 22-47230-86

The vertical boxing (insulating board) (Area: First Floor, Room 90 Print Room) contains asbestos.

Any change in its appearance should be recorded and passed to Property Services.

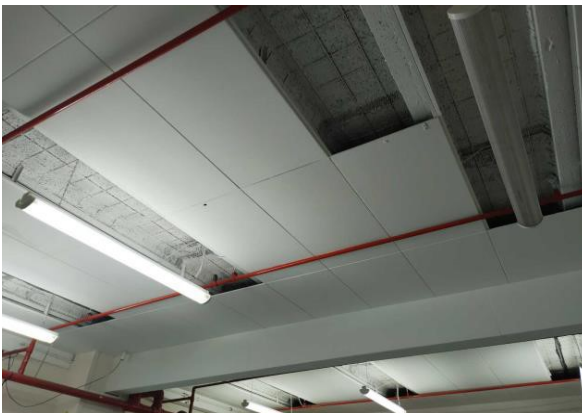
Item 254 Ref: 22-47230-85

The ceiling (insulating board) (Area: First Floor, Room 91 Design Room) contains asbestos.

Any change in its appearance should be recorded and passed to Property Services.

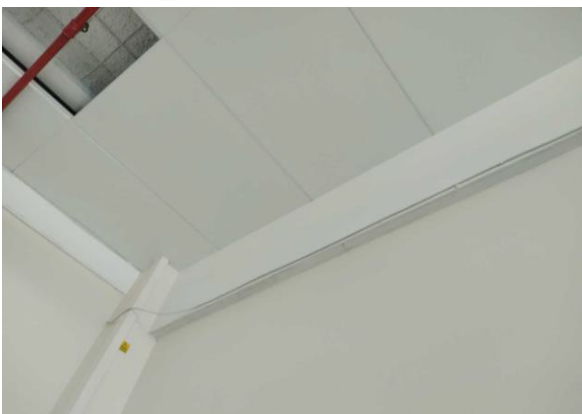
Item 255 Ref: 22-47230-86

The high level horizontal boxing (insulating board) (Area: First Floor, Room 91 Design Room) contains asbestos.

Any change in its appearance should be recorded and passed to Property Services.

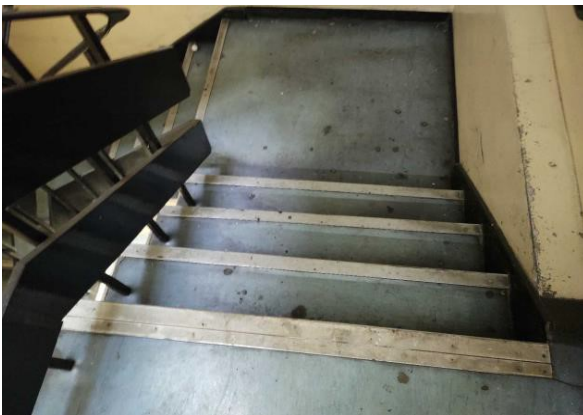
Item 257 Ref: 22-47230-84

The floor – stair nosings (composite) (Area: First Floor, Room 93 Fire Exit Stairwell 3) contains asbestos.

Any change in its appearance should be recorded and passed to Property Services.

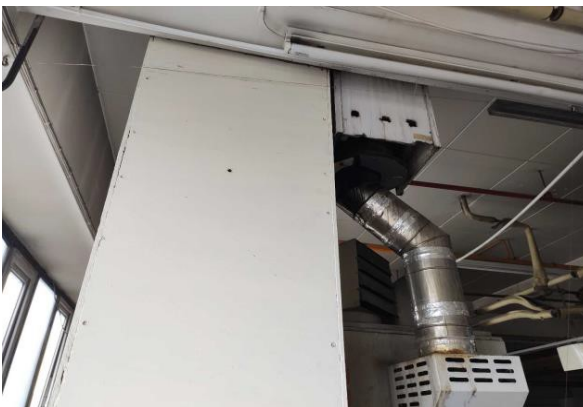
Item 261 Ref: 22-47230-89

The boxing to heater flue (insulating board) (Area: First Floor, Room 95 Main Printer Workshop) contains asbestos.

Any change in its appearance should be recorded and passed to Property Services.

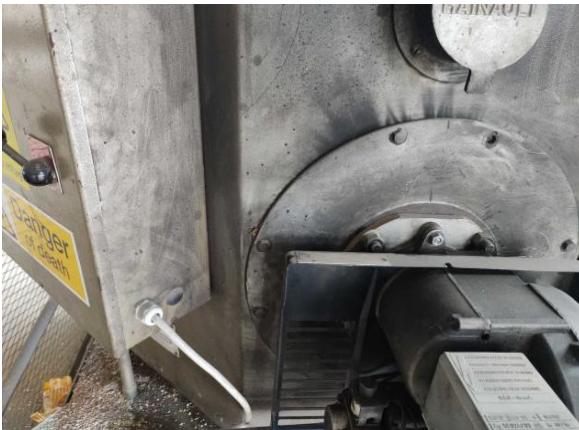
Item 263 Ref: 22-47230-90

262.	22-47230-89	Loose boards within trunking	First Floor, Room 95 Main Printer Workshop	Medium Risk
263.	22-47230-90	Vessels – gasket to boiler	First Floor, Room 95 Main Printer Workshop	Medium Risk

The vessels – gasket to boiler (textile) (Area: First Floor, Room 95 Main Printer Workshop) contains asbestos.

262.	Loose boards within trunking	First Floor, Room 95 Main Printer Workshop	Medium Risk – check every 3 months	24/03/25	unsealed		
263.	Vessels – gasket to boiler	First Floor, Room 95 Main Printer Workshop	Medium Risk – check every 3 months	24/03/25

Any change in its appearance should be recorded and passed to Property Services.

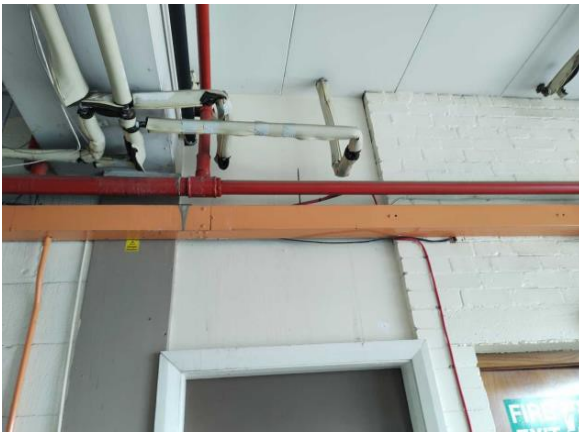
Item 264 Ref: 22-47230-91

The infill panels – door header above store (79) (insulating board) (Area: First Floor, Room 95 Main Printer Workshop) contains asbestos.

Any change in its appearance should be recorded and passed to Property Services.

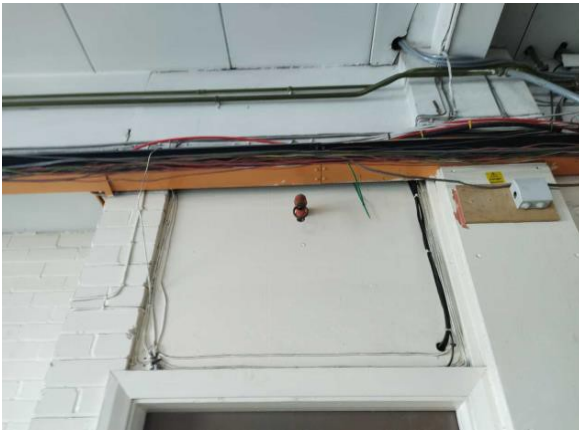
Item 265 Ref: 22-47230-91

The infill panels – door header above store (78) (insulating board) (Area: First Floor, Room 95 Main Printer Workshop) contains asbestos.

Any change in its appearance should be recorded and passed to Property Services.

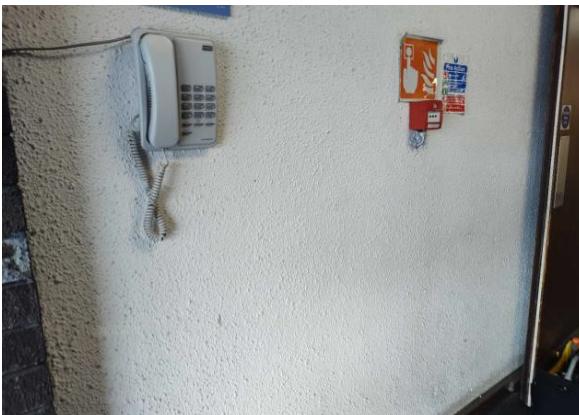
Item 266 Ref: 22-47230-92

The walls (render) (Area: Ground Floor, Room 96 Entrance Lobby) does not contain asbestos.

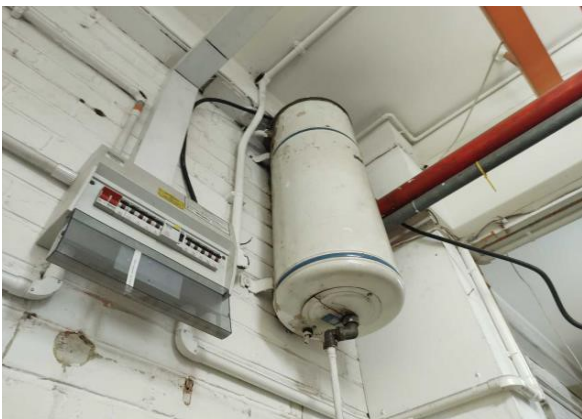
Item 270 Ref: 22-47230-94p

The vessels – presumed gasket within Sadia water heater (gasket) (Area: Ground Floor, Room 101 Maintenance Workshop) is presumed to contain asbestos.

Any change in its appearance should be recorded and passed to Property Services.

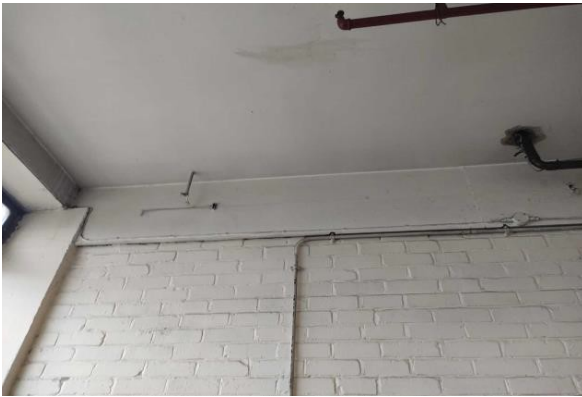
Item 271 Ref: 22-47230-93

The high level horizontal boxing (insulating board) (Area: Ground Floor, Room 102 Maintenance Workshop 2) contains asbestos.

Any change in its appearance should be recorded and passed to Property Services.

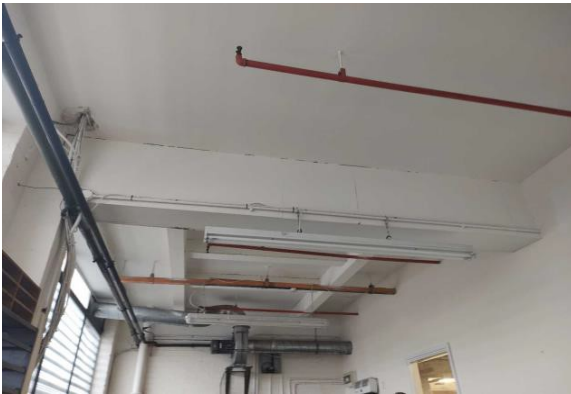
Item 272 Ref: 22-47230-93

The high level horizontal boxing (insulating board) (Area: Ground Floor, Room 104 Electric Store Room) contains asbestos.

Any change in its appearance should be recorded and passed to Property Services.

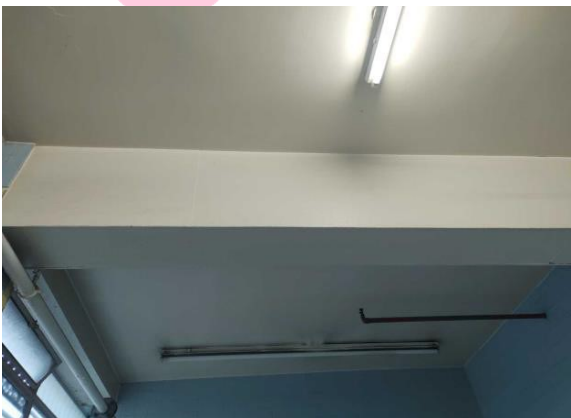
Item 273 Ref: 22-47230-93

The high level horizontal boxing (insulating board) (Area: Ground Floor, Room 105 Female WC and Lobby) contains asbestos.

Any change in its appearance should be recorded and passed to Property Services.

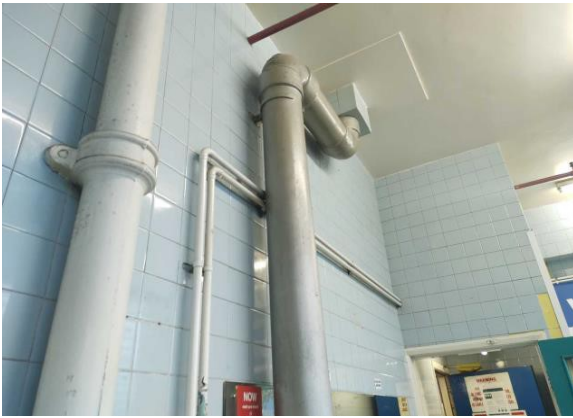
Item 274 Ref: 22-47230-95

274.	22-47230-95	Flue	Ground Floor, Room 105 Female WC & Lobby	Low Risk
275.	22-47230-96	Surround to hatch and burner	Ground Floor, Room 105 Female WC & Lobby	Medium Risk

The flue (cement) (Area: Ground Floor, Room 105 Female WC and Lobby) contains asbestos.

274.	Flue	Ground Floor, Room 105 Female WC & Lobby	Low Risk – check every 6 months	24/03/25			
275.	Surround to hatch and burner	Ground Floor, Room 105 Female WC & Lobby	Medium Risk – check every 3 months	24/03/25

Any change in its appearance should be recorded and passed to Property Services.
