ASBESTOS SURVEY REPORT FOR BLOCK 1A – 1C EDWARD THOMPSON SITE, RICHMOND STREET, SUNDERLAND, SR5 1BQ

Asbestos Register for Block 1A – 1C Edward Thompson Site, Richmond Street, Sunderland, SR5 1BQ

Date: 14 February 2025

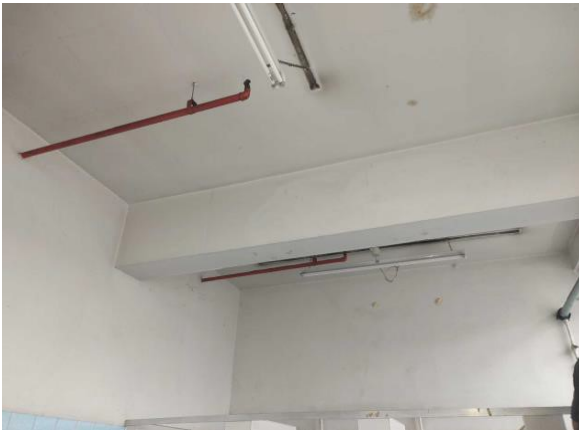
Item 277 Ref: 22-47230-93

The high level horizontal boxing (insulating board) (Area: Ground Floor, Room 106 Male WC and Lobby) contains asbestos.

Any change in its appearance should be recorded and passed to Property Services.

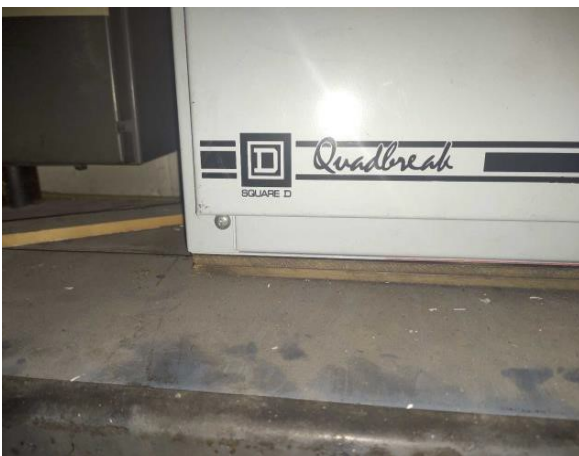
Item 279 Ref: 22-47230-98

The electrical equipment – panels between square D isolating box (bakelite) (Area: Ground Floor, Room 109 Switch Room) does not contain asbestos.

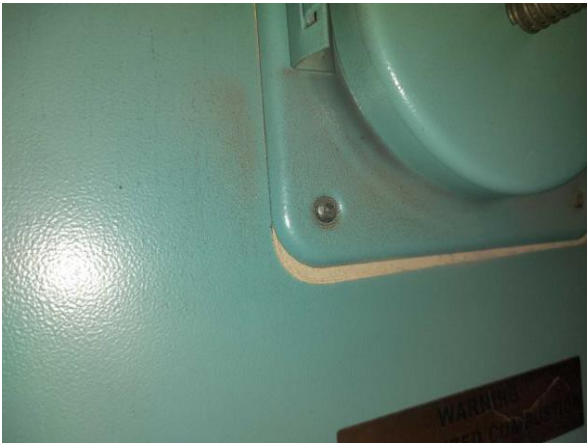
Item 280 Ref: 22-47230-100

The vessels – gasket to heater (Area: Ground Floor, Room 110 Gas Intake / Heater Area) does not contain asbestos.

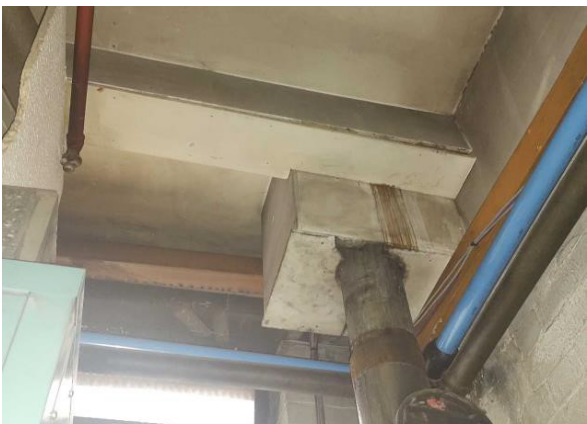
Item 282 Ref: 22-47230-101

The high level horizontal boxing (insulating board) (Area: Ground Floor, Room 110 Gas Intake / Heater Area) contains asbestos.

Any change in its appearance should be recorded and passed to Property Services.

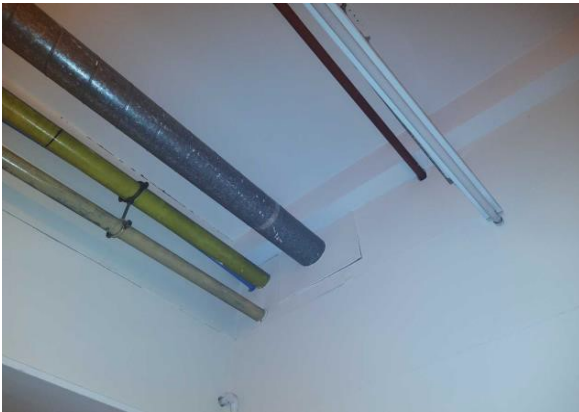
Item 283 Ref: 22-47230-93

The high level horizontal boxing (insulating board) (Area: Ground Floor, Room 111 Photo Production Area) contains asbestos.

Any change in its appearance should be recorded and passed to Property Services.

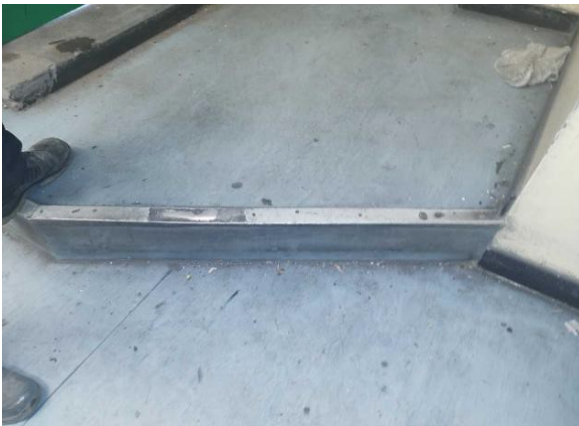
Item 284 Ref: 22-47230-99

The floor – stair nosing (composite) (Area: Ground Floor, Room 112 Fire Exit Lobby) contains asbestos.

Any change in its appearance should be recorded and passed to Property Services.

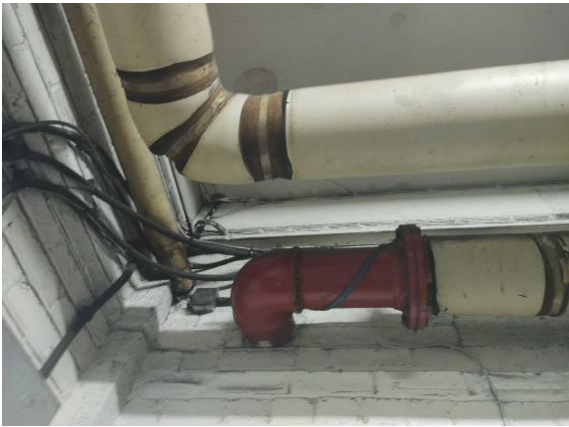
Item 286 Ref: 22-47230-101

The high level horizontal boxing (insulating board) (Area: Ground Floor, Room 115 Sprinkler Outlet Room) contains asbestos.

Any change in its appearance should be recorded and passed to Property Services.

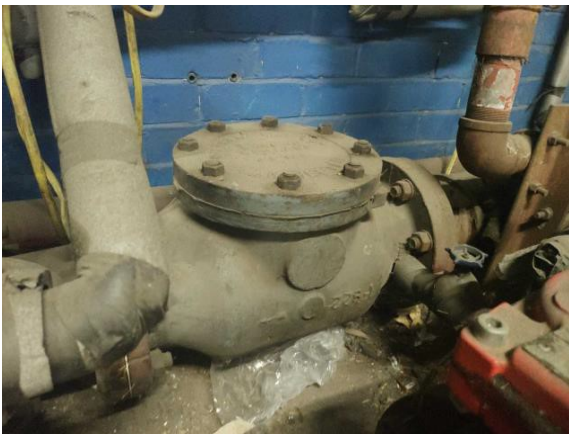
Item 287 Ref: 22-47230-102

The pipes (gasket) (Area: Ground Floor, Room 115 Sprinkler Outlet Room) does not contain asbestos.

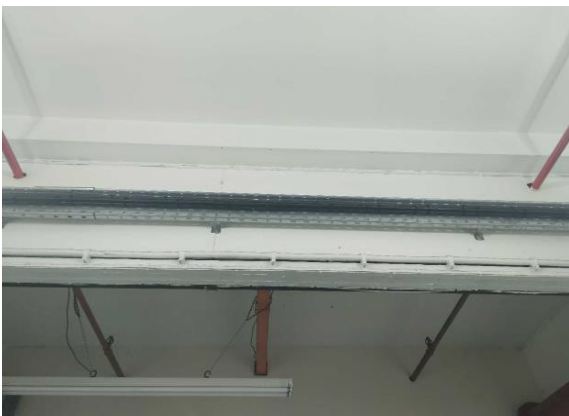
Item 288 Ref: 22-47230-101

The high level horizontal boxing (insulating board) (Area: Ground Floor, Room 116 Plate Room) contains asbestos.

Any change in its appearance should be recorded and passed to Property Services.

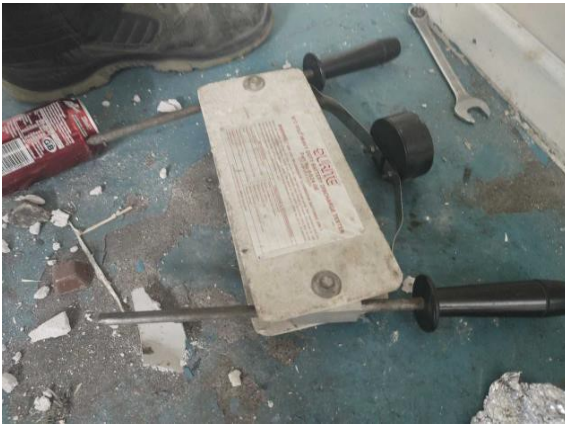
Item 289 Ref: 22-47230-103

The pads to battery tester (insulating board) (Area: Ground Floor, Room 116 Plate Room) does not contain asbestos.

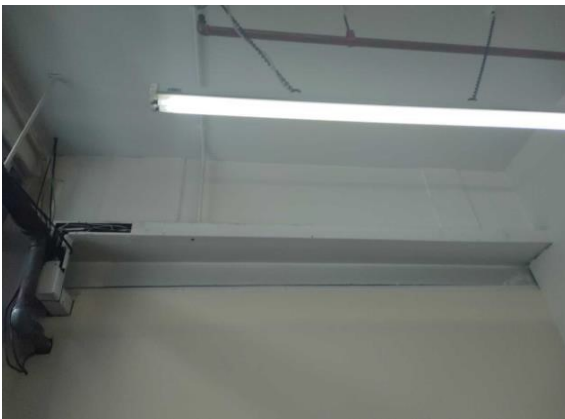
Item 290 Ref: 22-47230-101

The high level horizontal boxing (insulating board) (Area: Ground Floor, Room 117 Store Room) contains asbestos.

Any change in its appearance should be recorded and passed to Property Services.

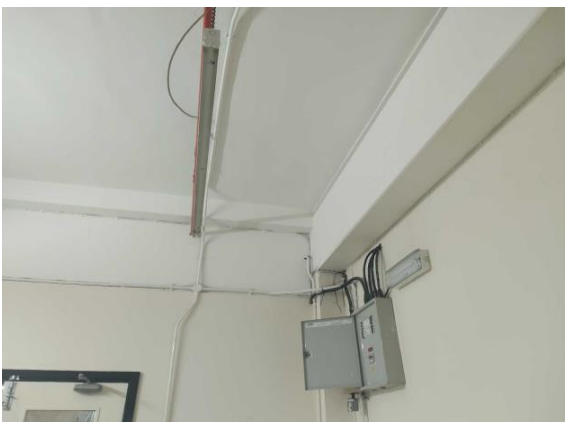
Item 291 Ref: 22-47230-101

The high level horizontal boxing (insulating board) (Area: Ground Floor, Room 118 Security Room) contains asbestos.

Any change in its appearance should be recorded and passed to Property Services.

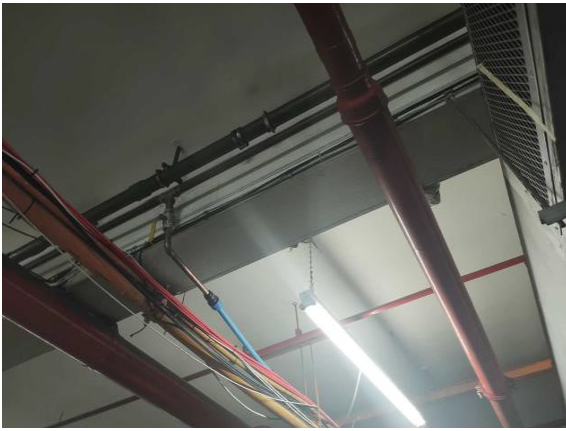
Item 292 Ref: 22-47230-104

The high level horizontal boxing (insulating board) (Area: Ground Floor, Room 119 Main Factory Floor) contains asbestos.

Any change in its appearance should be recorded and passed to Property Services.

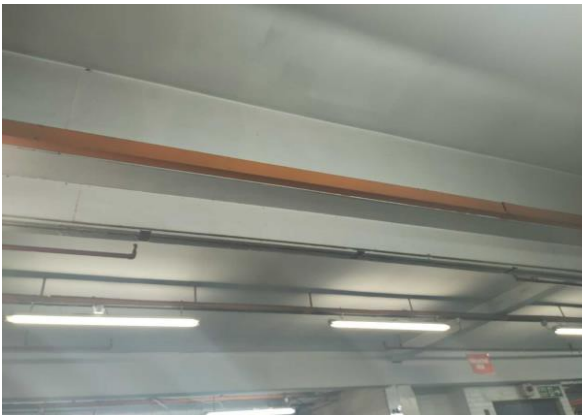
Item 293 Ref: 22-47230-104

The horizontal boxing above former wall (insulating board) (Area: Ground Floor, Room 119 Main Factory Floor) contains asbestos.

Any change in its appearance should be recorded and passed to Property Services.

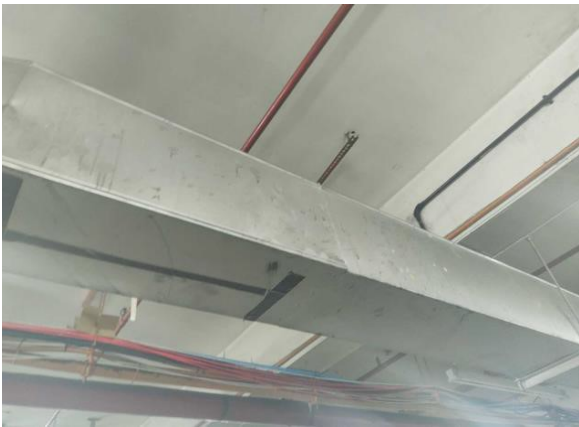
Item 294 Ref: 22-47230-105

The sealing mastic to ducting joints (mastic) (Area: Ground Floor, Room 119 Main Factory Floor) contains asbestos.

Any change in its appearance should be recorded and passed to Property Services.

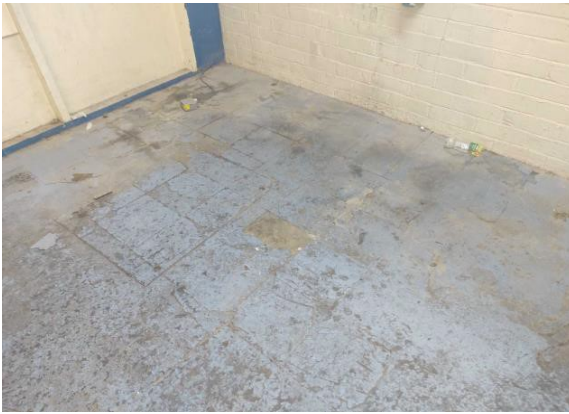
Item 295 Ref: 22-47230-106

The floor – tiles to section left rear of factory floor (tiles and adhesive) (Area: Ground Floor, Room 119 Main Factory Floor) does not contain asbestos.

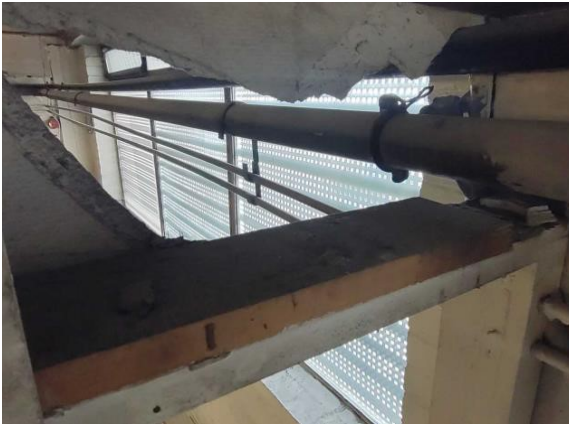
Item 296 Ref: 22-47230-107

The debris to horizontal timber boxing (insulating board) (Area: Ground Floor, Room 119 Main Factory Floor) contains asbestos.

Any change in its appearance should be recorded and passed to Property Services.

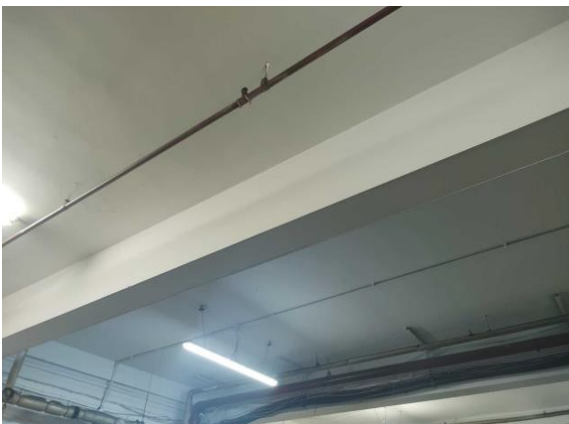
Item 297 Ref: 22-47230-108

The high level horizontal boxing (insulating board) (Area: Ground Floor, Room 122 Vehicle Bay 1) contains asbestos.

Any change in its appearance should be recorded and passed to Property Services.

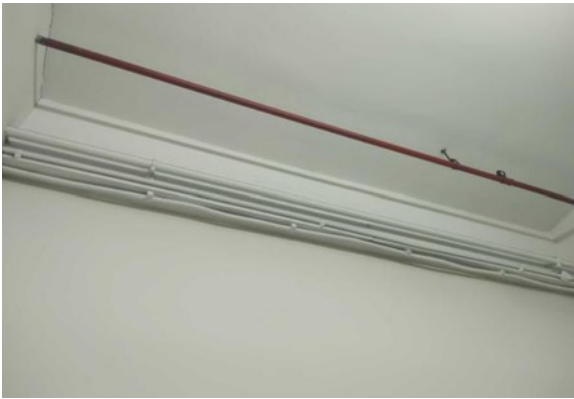
Item 298 Ref: 22-47230-108

The high level horizontal boxing (insulating board) (Area: Ground Floor, Room 123: Office) contains asbestos.

Any change in its appearance should be recorded and passed to Property Services.

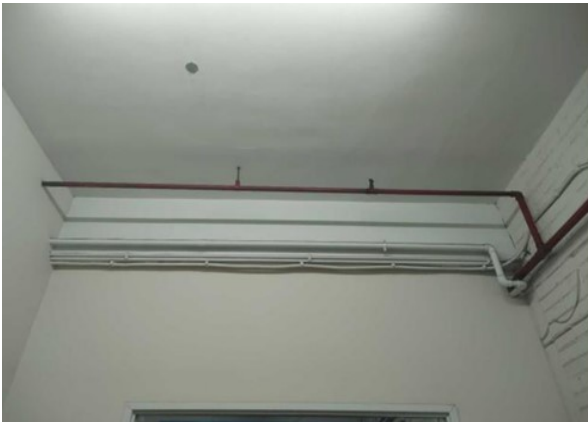
Item 299 Ref: 22-47230-108

The high level horizontal boxing (insulating board) (Area: Ground Floor, Room 124: Office 2) contains asbestos.

Any change in its appearance should be recorded and passed to Property Services.

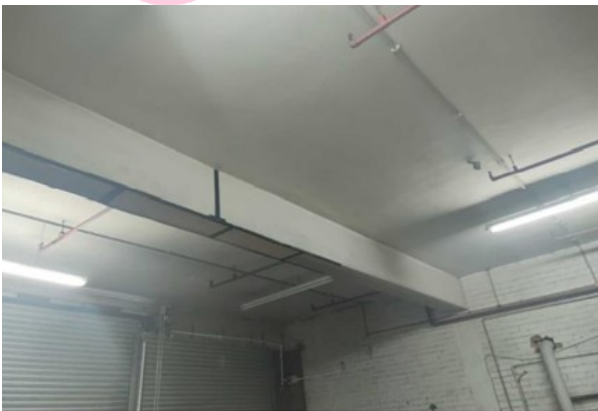
Item 300 Ref: 22-47230-108

The high level horizontal boxing (insulating board) (Area: Ground Floor, Room 126 Vehicle Bay 2) contains asbestos.

Any change in its appearance should be recorded and passed to Property Services.

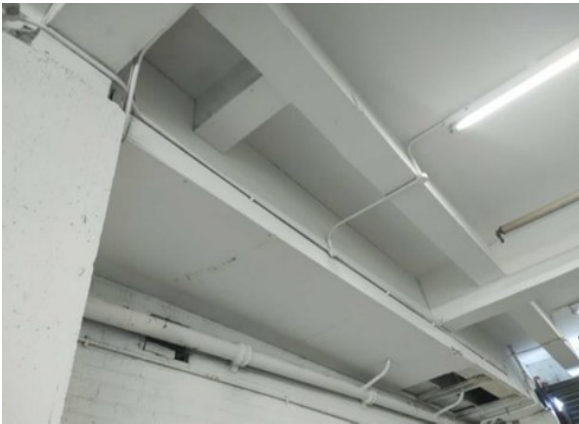
Item 301 Ref: 22-47230-108

The high level horizontal beam boxing (insulating board) (Area: Ground Floor, Room 127: Vehicle Bay 3) contains asbestos.

Any change in its appearance should be recorded and passed to Property Services.

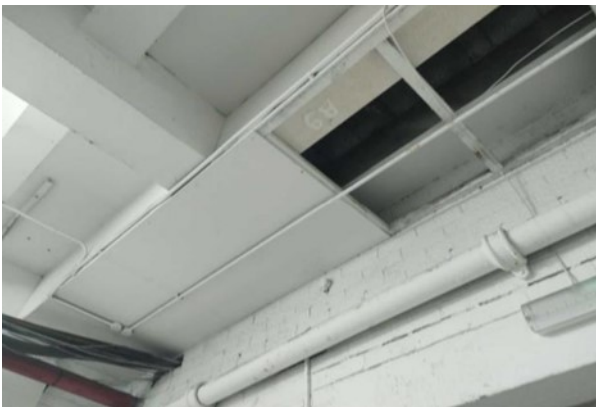
Item 302 Ref: 22-47230-108

The high level bulkhead boxing (insulating board) (Area: Ground Floor, Room 127: Vehicle Bay 3) contains asbestos.

Any change in its appearance should be recorded and passed to Property Services.

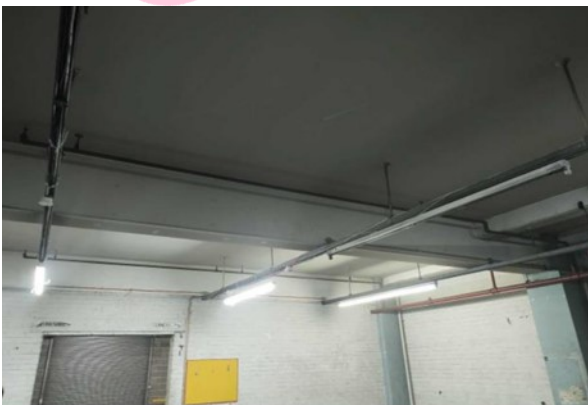
Item 303 Ref: 22-47230-108

The high level horizontal boxing (insulating board) (Area: Ground Floor, Room 129 Vehicle Maintenance Area) contains asbestos.

Any change in its appearance should be recorded and passed to Property Services.

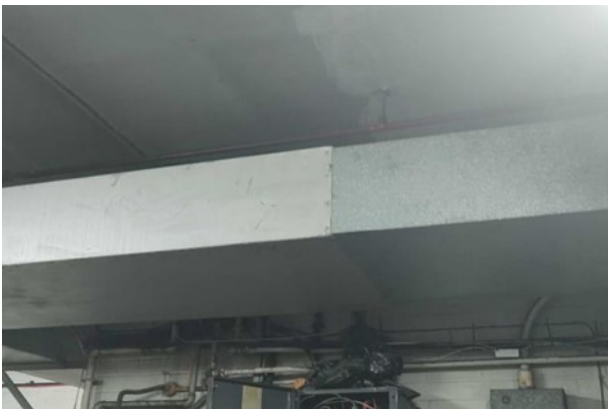
Item 305 Ref: 22-47230-110

The mastic to the ductwork (Area: Ground Floor, Room 129: Vehicle Maintenance Area) does not contain asbestos.

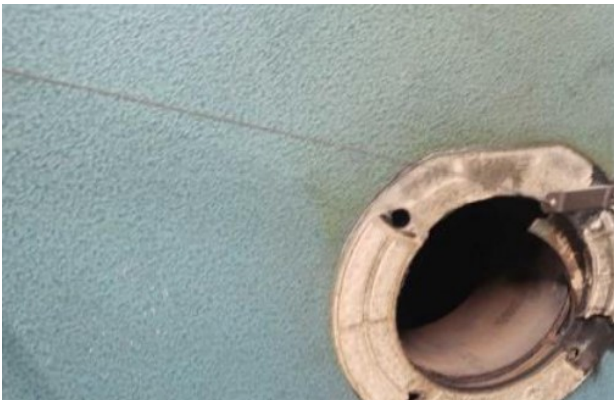
Item 306 Ref: 22-47230-111

The gasket to Benson convector heater boiler (Area: Ground Floor, Room 129: Vehicle Maintenance Area) does not contain asbestos.

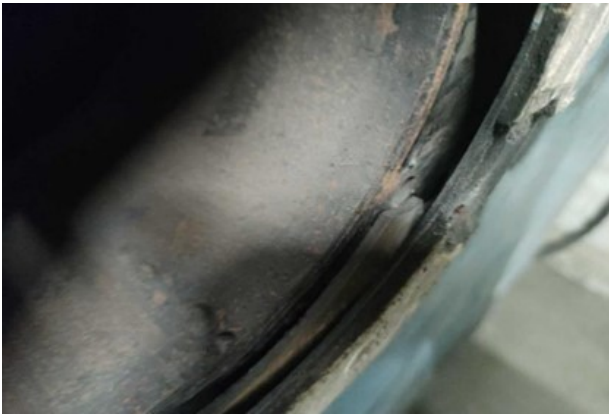
Item 307 Ref: 22-47230-112

The internal gasket to Benson convector heater boiler (Area: Ground Floor, Room 129: Vehicle Maintenance Area) does not contain asbestos.

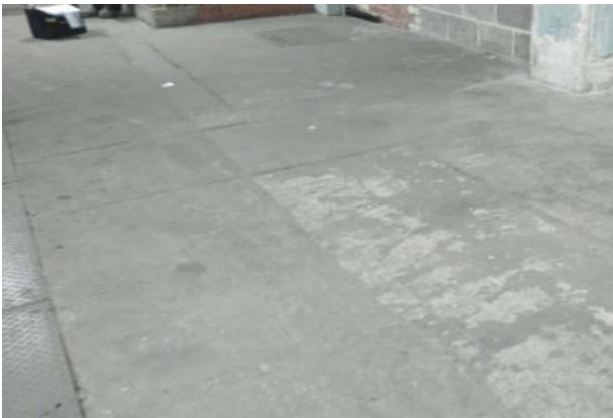
Item 308 Ref: 22-47230-113

The expansion putty to floor (Area: Ground Floor, Room 129: Vehicle Maintenance Area) does not contain asbestos.

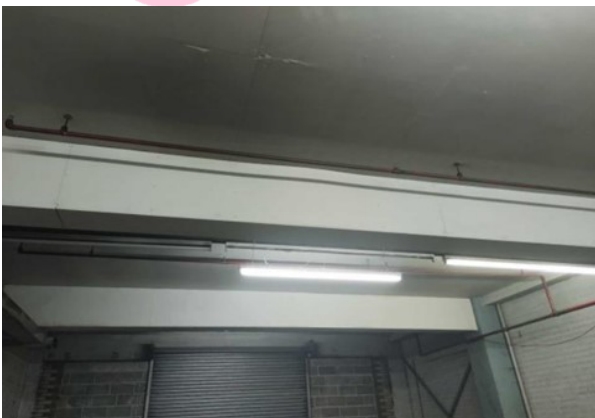
Item 309 Ref: 22-47230-108

The high level horizontal boxing (insulating board) (Area: Ground Floor, Room 130 Vehicle Bay 4) contains asbestos.

Any change in its appearance should be recorded and passed to Property Services.

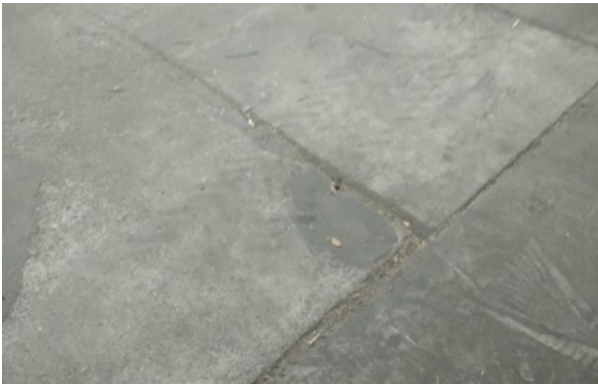
Item 310 Ref: 22-47230-113

The expansion putty to floor (Area: Ground Floor, Room 130: Vehicle Bay 4) does not contain asbestos.

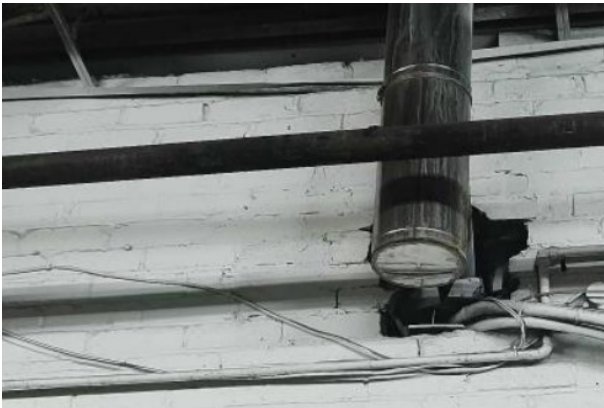
Item 311 Ref: 22-47230-114

The packer to flue penetration (insulating board) (Area: Ground Floor, Room 131 Vehicle Bay 4 (Unit B)) contains asbestos.

Any change in its appearance should be recorded and passed to Property Services.

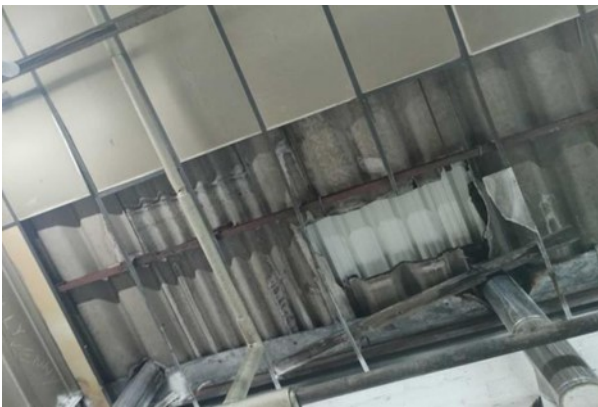
Item 312 Ref: 22-47230-115

The original roof below new external metal roof (Area: Ground Floor, Room 131 Vehicle Bay 4 (Unit B)) contains asbestos.

Any change in its appearance should be recorded and passed to Property Services.

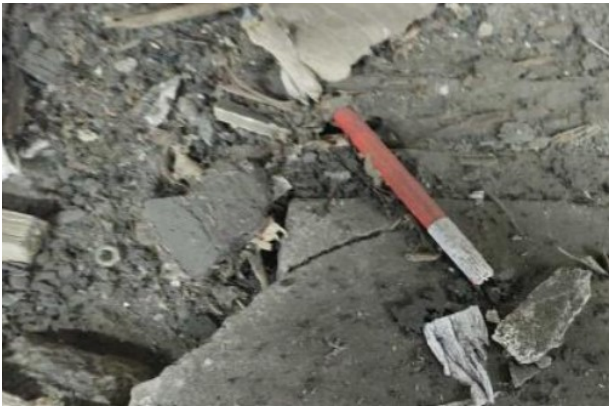
Item 313 Ref: 22-47230-116

The cement debris to floor around perimeter (Area: Ground Floor, Room 131: Vehicle Bay 4 (Unit B)) does not contain asbestos.

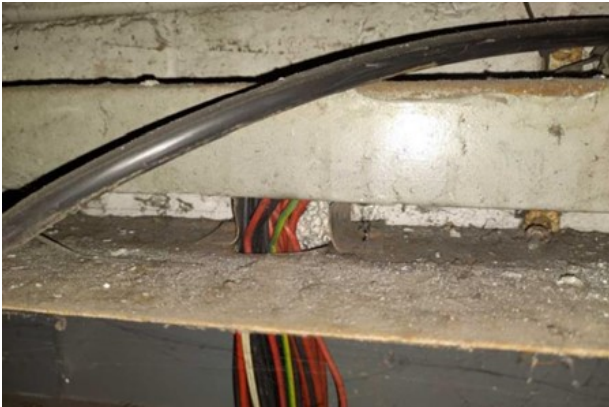
Item 314 Ref: 22-47230-117

The flashpad used as packer within cable trunking (Area: Ground Floor, Room 131 Vehicle Bay 4 (Unit B)) contains asbestos.

Any change in its appearance should be recorded and passed to Property Services.

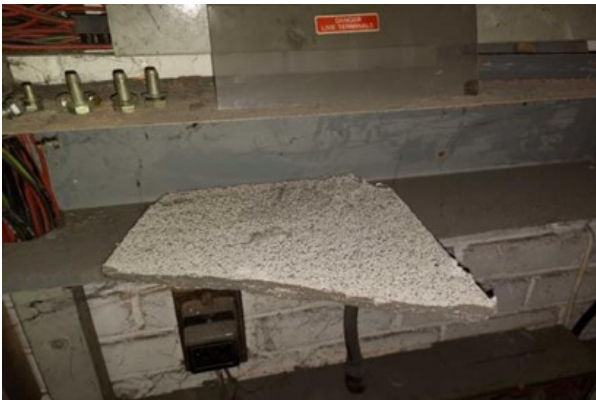
Item 315 Ref: 22-47230-118

315.	22-47230-118	Loose board sitting in trunking	Ground Floor, Room 131 Vehicle Bay 4 Unit B	No Risk
316.	22-47230-119	Floor	Ground Floor, Room 137 Former WC2	Low Risk

The loose board sitting in trunking (Insulating board) (Area: Ground Floor, Room 131 Vehicle Bay 4 (Unit B)) does not contain asbestos.

315.	Loose board sitting in trunking	Ground Floor, Room 131 Vehicle Bay 4 Unit B	No Risk				
316.	Floor	Ground Floor, Room 137 Former WC2	Low Risk – check every 6 months	24/03/25

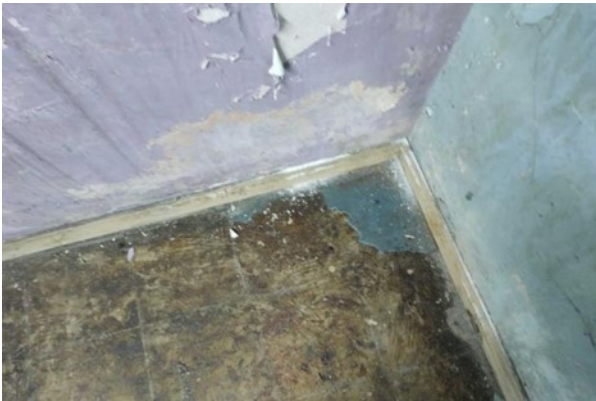
Item 316 Ref: 22-47230-119

The floor (Area: Ground Floor, Room 137: Former WC 2) contains asbestos.

Any change in its appearance should be recorded and passed to Property Services.

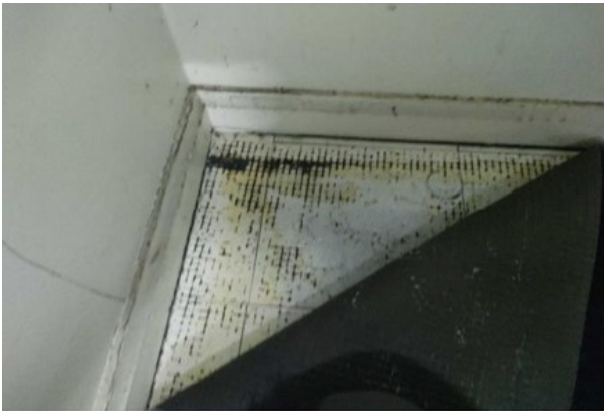
Item 317 Ref: 22-47230-119

The floor (Area: Ground Floor, Room 139: Exit Lobby) contains asbestos.

Any change in its appearance should be recorded and passed to Property Services.

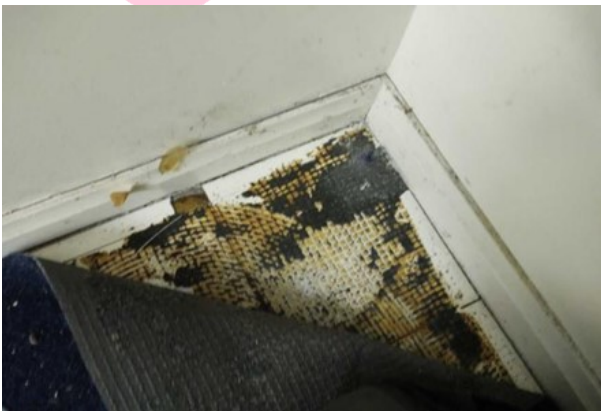
Item 318 Ref: 22-47230-119

The floor (Area: Ground Floor, Room 141: Office) contains asbestos.

Any change in its appearance should be recorded and passed to Property Services.

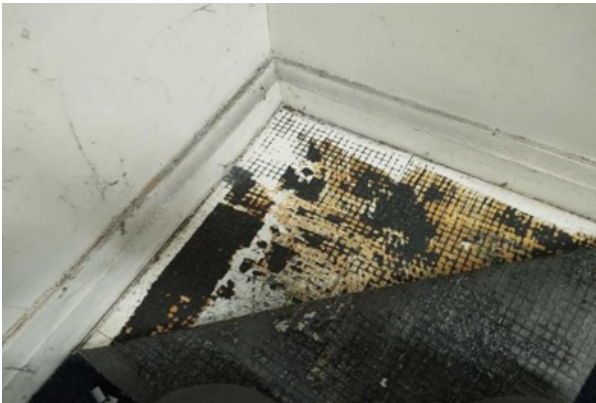
Item 319 Ref: 22-47230-119

The floor (Area: Ground Floor, Room 142: Office) contains asbestos.

Any change in its appearance should be recorded and passed to Property Services.

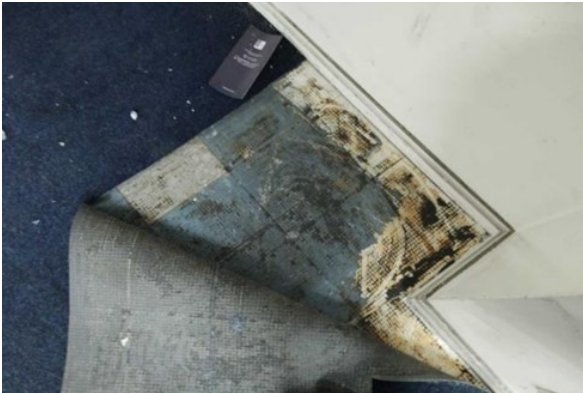
Item 320 Ref: 22-47230-119

The floor (Area: Ground Floor, Room 143: Staff Room) contains asbestos.

Any change in its appearance should be recorded and passed to Property Services.

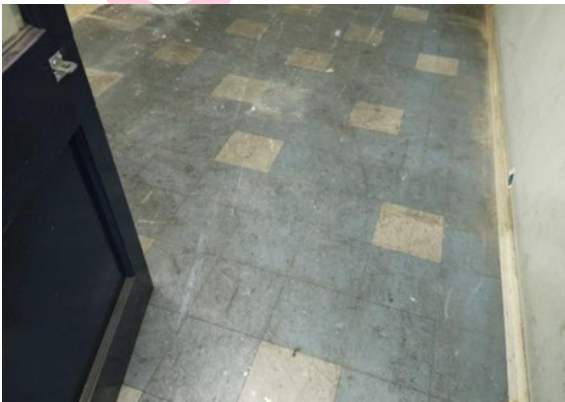
Item 321 Ref: 22-47230-119

The floor (Area: Ground Floor, Room 144: Store Room) contains asbestos.

Any change in its appearance should be recorded and passed to Property Services.

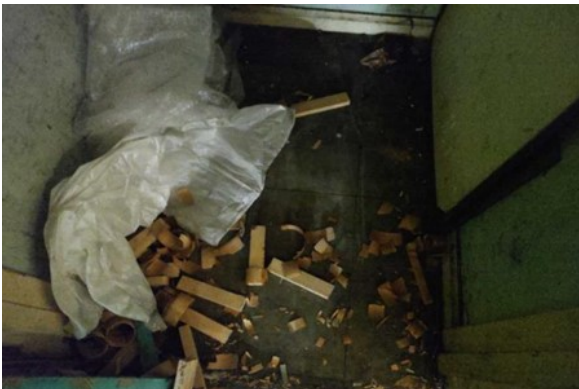
Item 324 Ref: 22-47230-120

The floor tiles and adhesive (Area: Ground Floor, Room 146: Store Cupboard) contains asbestos.

Any change in its appearance should be recorded and passed to Property Services.

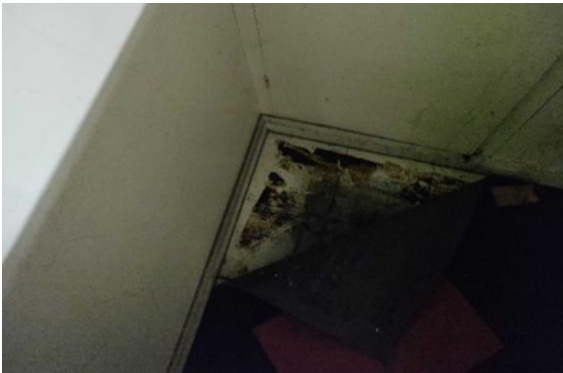
Item 325 Ref: 22-47230-119

The floor (Area: Ground Floor, Room 147: Kitchenette) contains asbestos.

Any change in its appearance should be recorded and passed to Property Services.

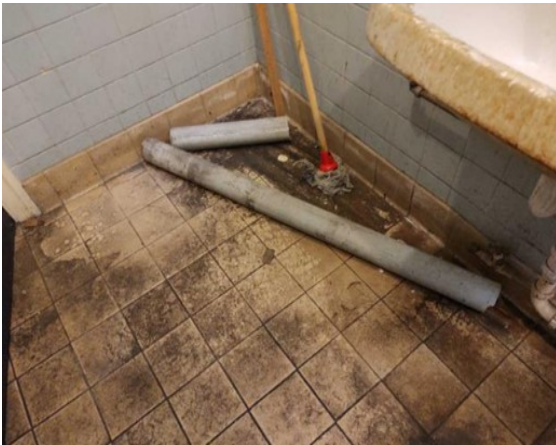
Item 326 Ref: 22-47230-121

The flue from former sanitary incinerator (Area: Ground Floor, Room 148: Staff WC) contains asbestos.

Any change in its appearance should be recorded and passed to Property Services.

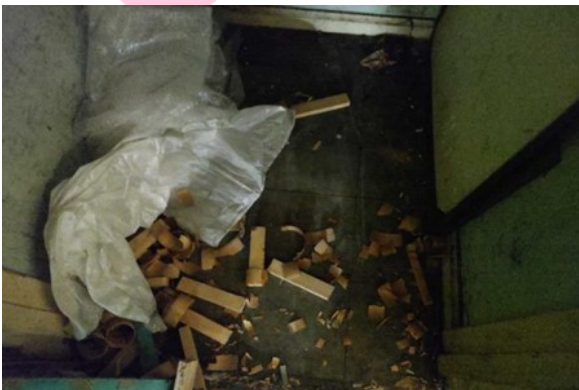
Item 327 Ref: 22-47230-77

The debris to the floor adjacent to oil tank (Area: Room 149: Floor Roof) contains asbestos.

Any change in its appearance should be recorded and passed to Property Services.

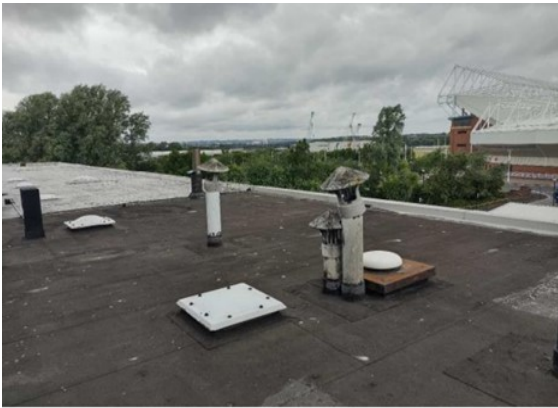
Item 328 Ref: 22-47230-78

The flue and cowls (Area: Room 149: Floor Roof) contains asbestos.

328.	Flue and cowls	Floor Roof, Room 149 Roof	Low Risk – check every 6 months	24/03/25			
329.	Felt to roof	Floor Roof, Room 149 Roof	No Risk				
330.	Loose lying panels	Floor Roof, Room 150 Header tank room	Medium Risk – check every 3 months	24/03/25	Unsealed

Any change in its appearance should be recorded and passed to Property Services.

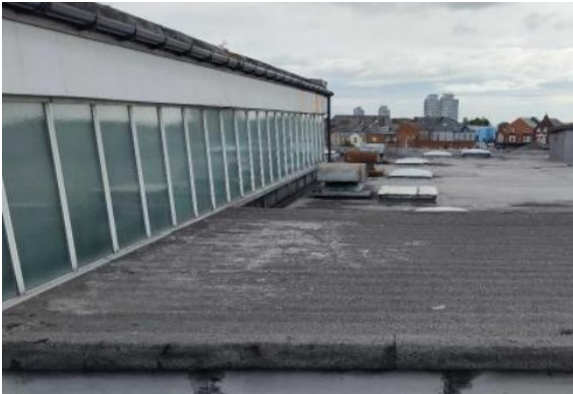
Item 329 Ref: 22-47230-79

The felt to the roof (Area: Room 149: Floor Roof) does not contain asbestos.

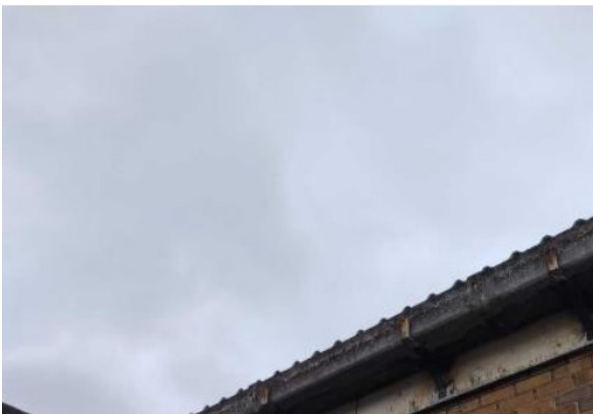
Item 332 Ref: 22-47230-122

The rainwater goods to block 1B gable end (Area: Floor 0, Room 152: External) contains asbestos.

Any change in its appearance should be recorded and passed to Property Services.

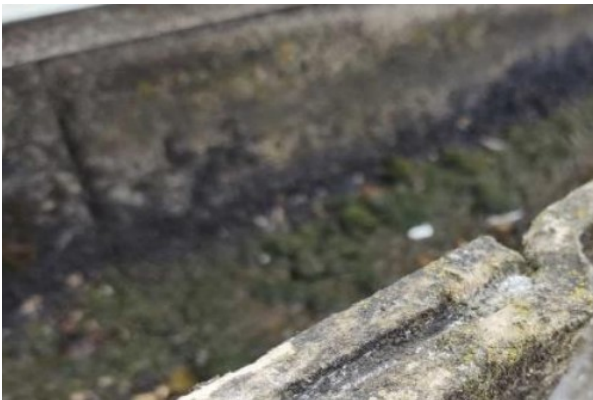
Item 333 Ref: 22-47230-123

The rainwater goods jointing compound between cement gutters to block 1B gable end (Area: Floor 0, Room 152: External) contains asbestos.

Any change in its appearance should be recorded and passed to Property Services.

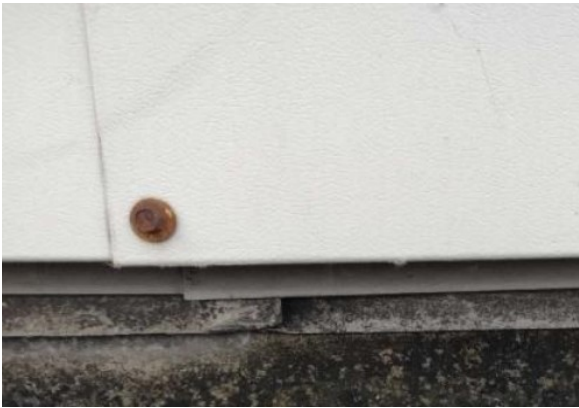
Item 334 Ref: 22-47230-124

The fascia cement behind metal profile to block 1B gable end (Area: Floor 0, Room 152: External) contains asbestos.

Any change in its appearance should be recorded and passed to Property Services.

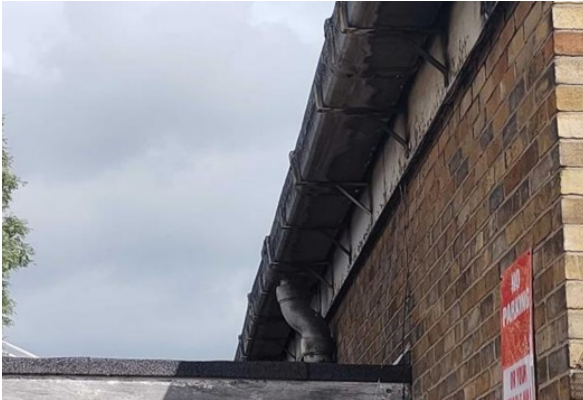
Item 335 Ref: 22-47230-125

The downpipes to block 1B gable end (Area: Floor 0, Room 152: External) contains asbestos.

Any change in its appearance should be recorded and passed to Property Services.

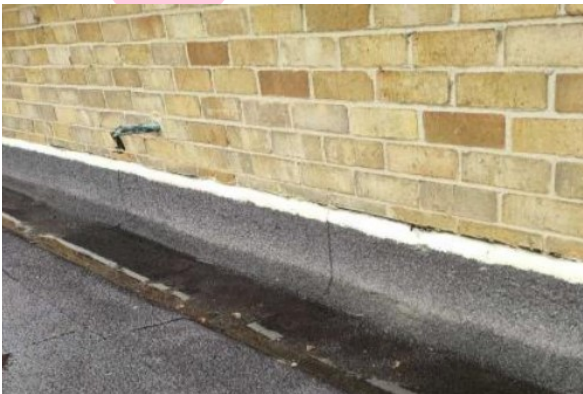
Item 336 Ref: 22-47230-127

The damp proof to walls above flat roof to 1C (Area: Floor 0, Room 152: External) do not contain asbestos.

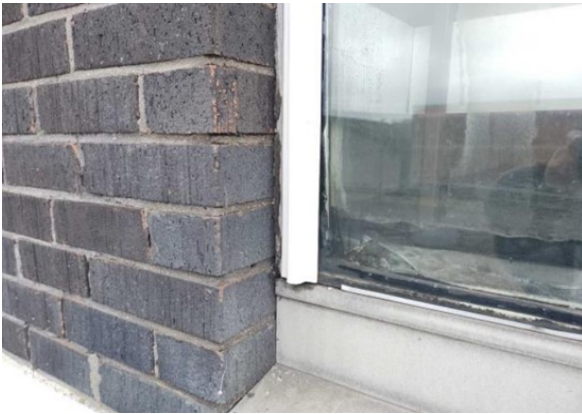
Item 337 Ref: 22-47230-127

The window mastic to pvc windows on Block 1A (Area: Floor 0, Room 152: External) do not contain asbestos.

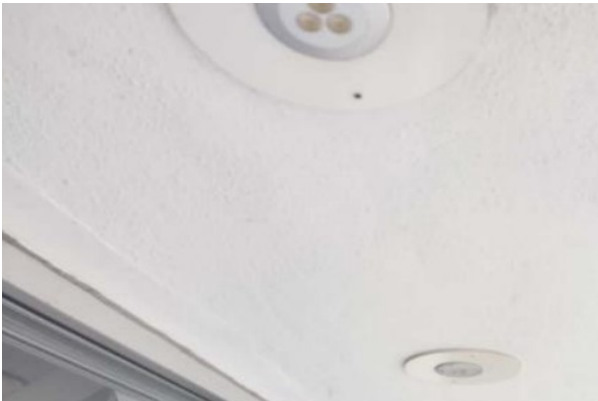
Item 338 Ref: 22-47230-128

The render to concrete entrance canopy (Area: Floor 0, Room 152: External) do not contain asbestos.

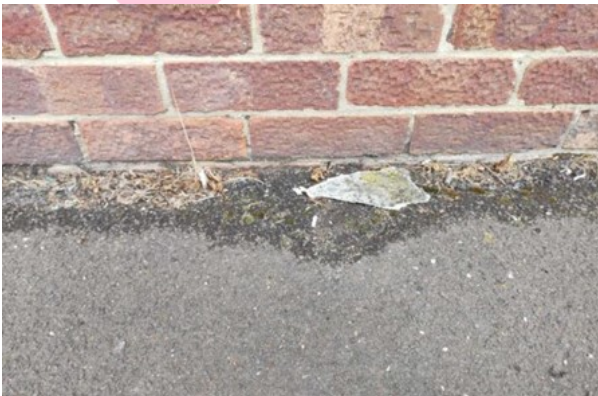
Item 339 Ref: 22-47230-129

The debris to path at front elevation (Insulating board) (Area: Floor roof, Room 150: Header tank room) contains asbestos.

Removed as sample

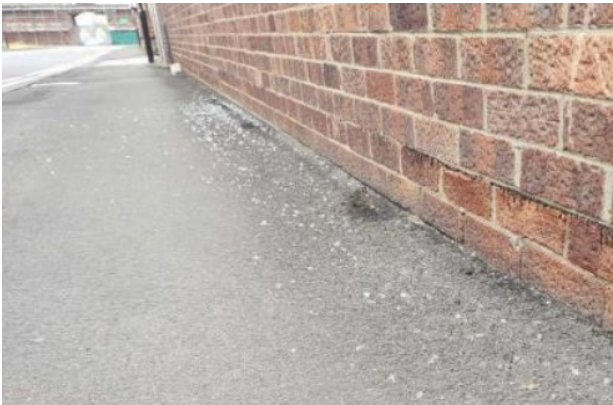
Item 341 Ref: 22-47230-131

The damp proof course to Block 1A (Area: Floor 0, Room 152: External) contains asbestos.

Any change in its appearance should be recorded and passed to Property Services.

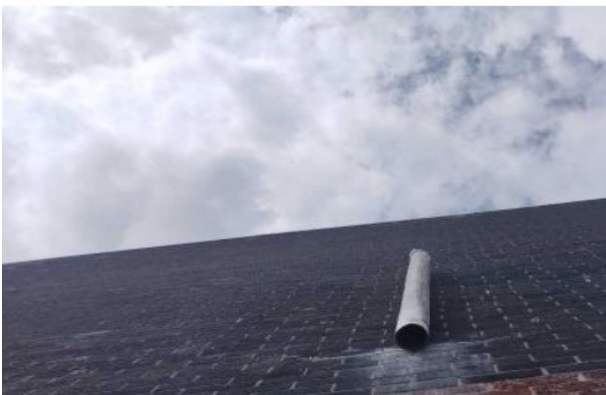
Item 342 Ref: 22-47230-132

The down pipes to gable end (Area: Floor 0, Room 152: External) contains asbestos.

Any change in its appearance should be recorded and passed to Property Services.

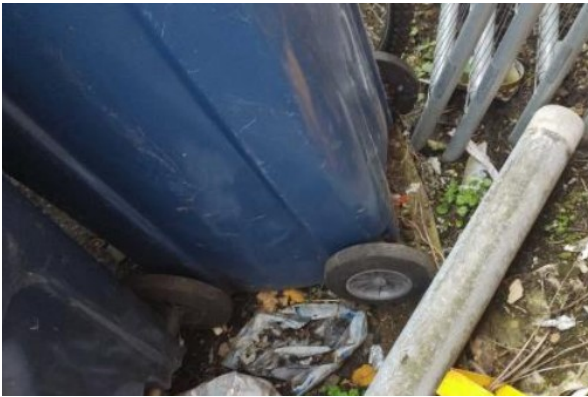
Item 343 Ref: 22-47230-133

The downpipe debris under sampled downpipe (Area: Floor 0, Room 152: External) contains asbestos.

Any change in its appearance should be recorded and passed to Property Services.

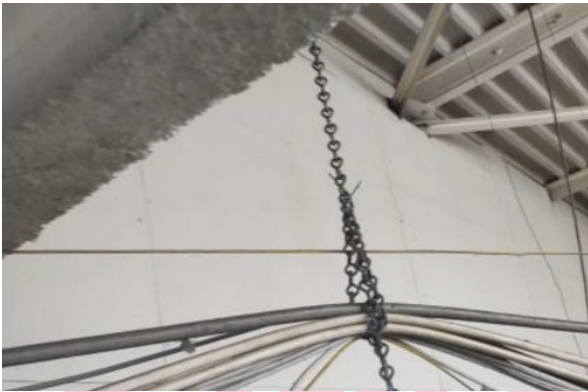
Item 344 Ref: 22-47230-20

The fire breaks to tops of wall outside female wc (Area: Second Floor, Room 26a: Tank room (within ceiling void)) contains asbestos.

Any change in its appearance should be recorded and passed to Property Services.

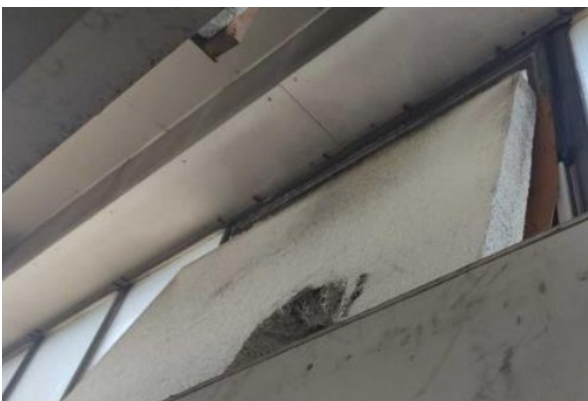
Item 345 Ref: 22-47230-20

The boxing to RSJ's (insulating Board) (Area: Second Floor, Room 26a: Tank room (within ceiling void)) contains asbestos.

Any change in its appearance should be recorded and passed to Property Services.

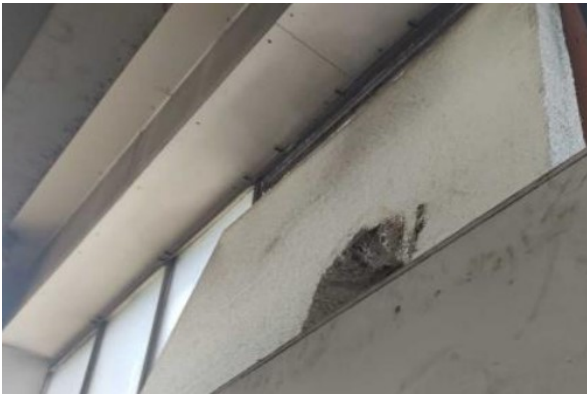
Item 346 Ref: 22-47230-20

The boxing to RSJ's (insulating Board) (Area: Second Floor, Room 26a: Tank room (within ceiling void)) contains asbestos.

Any change in its appearance should be recorded and passed to Property Services.

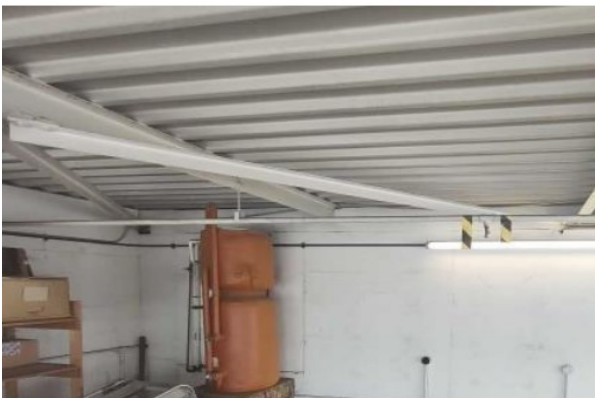
Item 348 Ref: 22-47230-14

The walls (insulating Board) (Area: Mezzanine Floor, Room 27a: above room 27) contains asbestos.

Any change in its appearance should be recorded and passed to Property Services.

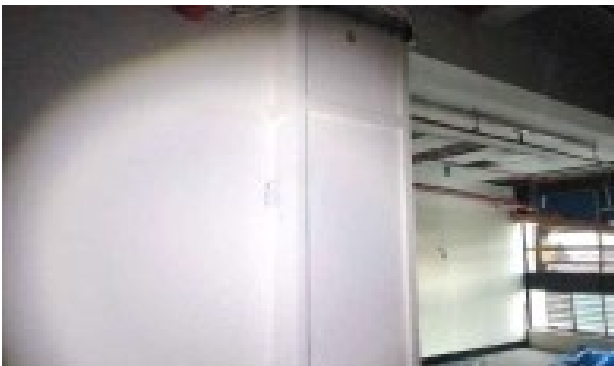
Item 351 Ref: Presumed

The column cladding inner cladding to column at location of PIR sensor (First Floor Staircase/Stairwell 1/002) is presumed to contain asbestos.

Any change in its appearance should be recorded and passed to Property Services.

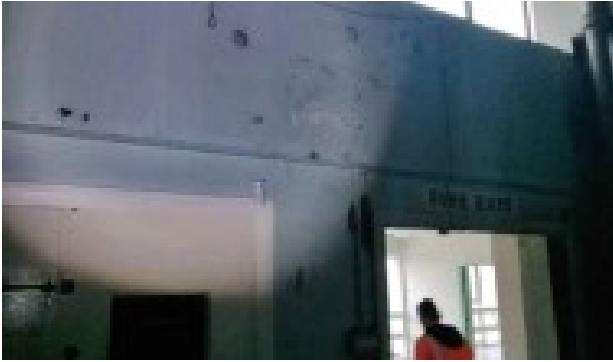
Item 352 Ref: Presumed

The fascia panel above PIR sensor (Second Floor Print Room 2/002) is presumed to contain asbestos.

Any change in its appearance should be recorded and passed to Property Services.

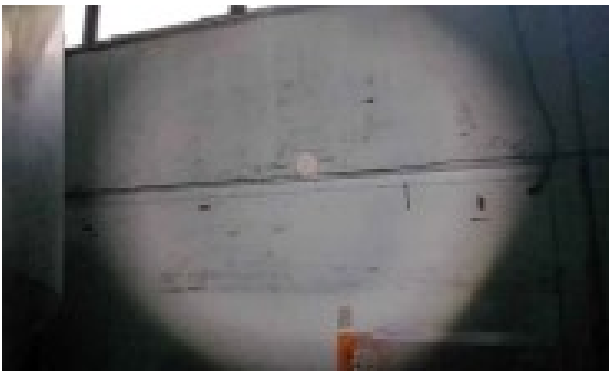
Item 353 Ref: Presumed

The fascia panels smoke head attached to asbestos (Second Floor Print Room 2/002) are presumed to contain asbestos.

Any change in its appearance should be recorded and passed to Property Services.

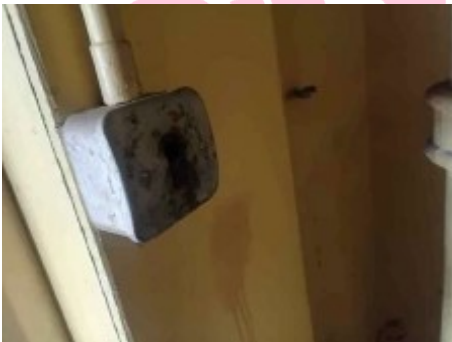
Item 354 Ref: TL000363

The boxing vertical in First Floor Cupboard Store Room 1/078 contains asbestos.

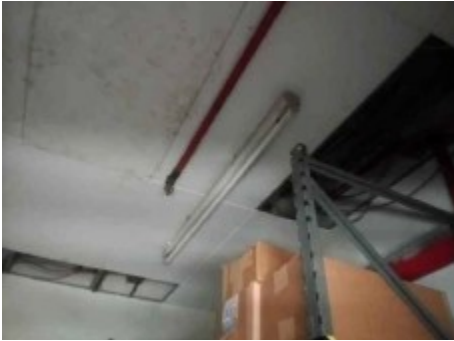
Item 358 Ref: As TL000363

357.	As TL000363	Boxing vertical damaged, enclose or removal required	First Floor Cupboard Store Room 1/078	Low Risk
358.	As TL000363	Ceiling Tile – Solid	First Floor Cupboard Store Room	Low Risk

The ceiling tile – solid in First Floor Cupboard Store Room 1/078 contains asbestos.

Any change in its appearance should be recorded and passed to Property Services.

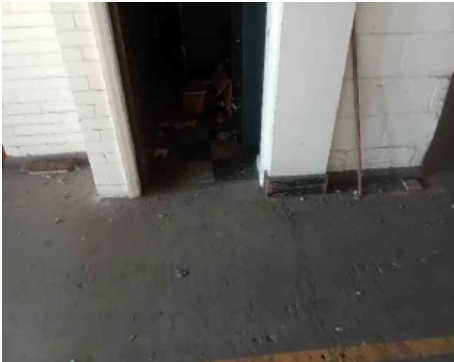
Item 359 Ref: TL000364

The Floor tile (with adhesive) black and white in First Floor Cupboard Store Room 1/078 does not contain asbestos.
