ASBESTOS SURVEY REPORT FOR ASHLEY PRIMARY ACADEMY, TEMPLE PARK ROAD, SOUTH SHIELDS, NE33 0QA

Asbestos Register for ASHLEY PRIMARY ACADEMY, TEMPLE PARK ROAD

Date: 16 June 2025

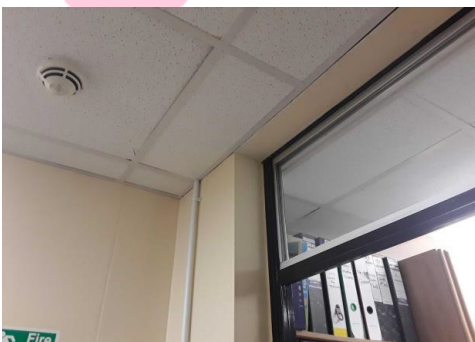
Item 39 Ref: Presumed

The walls – lining inside clasp columns - Ground Floor, Room 18, Deputy Head teachers office – are presumed to contain asbestos.

Any change in its appearance should be recorded and passed to Property Services.

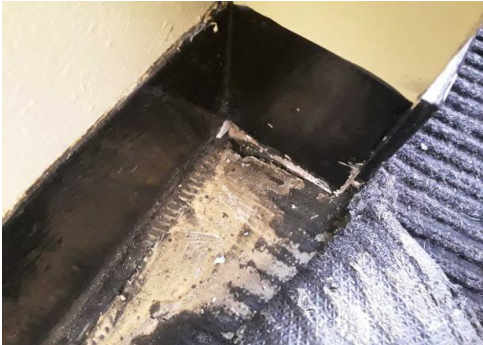
Item 43 Ref: 22-53098-3

The floor – residual adhesive beneath floor screed - Ground Floor, Room 19, Fire exit hallway and cloak rooms - contains asbestos.

Any change in its appearance should be recorded and passed to Property Services.

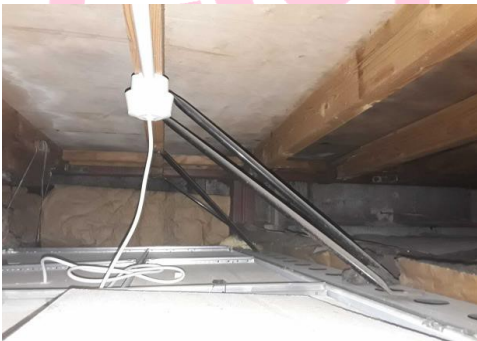
Item 45 Ref: Presumed

The walls – lining inside clasp columns - Ground Floor, Room 20, Boys Toilet – are presumed to contain asbestos.

Any change in its appearance should be recorded and passed to Property Services.

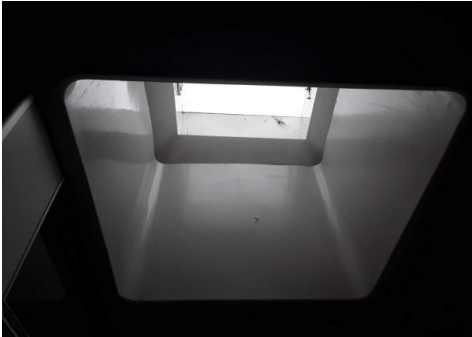
Item 46 Ref: Presumed

The ceiling – textile rope seal to fibreglass skylight - Ground Floor, Room 20, Boys Toilet – is presumed to contain asbestos.

Any change in its appearance should be recorded and passed to Property Services.

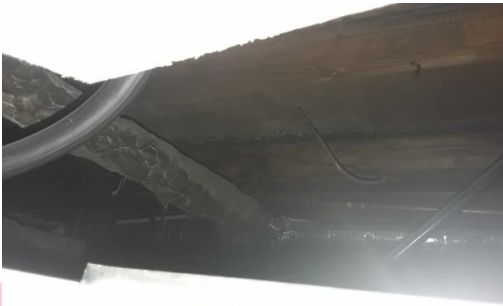
Item 53 Ref: 22-53098-1

The pipes – string to mmmf
lagged metal pipes - Ground
Floor, Room 25, Classroom
store cupboard - do not
contain asbestos

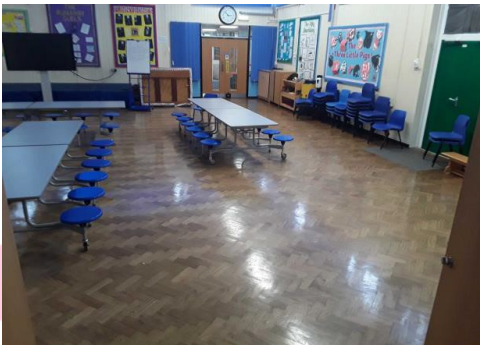
Item 62 Ref: Presumed

The floor -adhesive beneath parquet flooring - Ground Floor, Room 28, Main School Hall – is presumed to contain asbestos.

Any change in its appearance should be recorded and passed to Property Services.

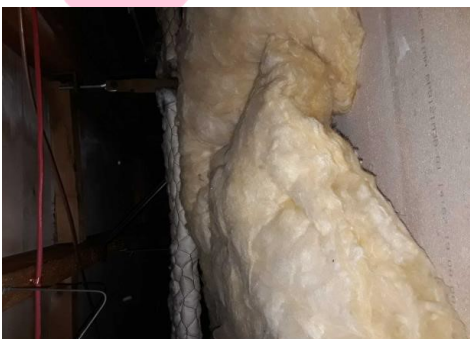
Item 63 Ref: 22-53098-1

The pipes – string to mmmf lagged metal pipes - Ground Floor, Room 29, Hall Store Room - do not contain asbestos

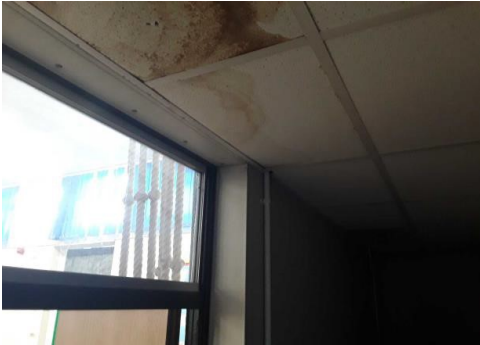
Item 64 Ref: Presumed

The walls – lining inside clasp columns - Ground Floor, Room 29, Hall Store Room – are presumed to contain asbestos.

Any change in its appearance should be recorded and passed to Property Services.

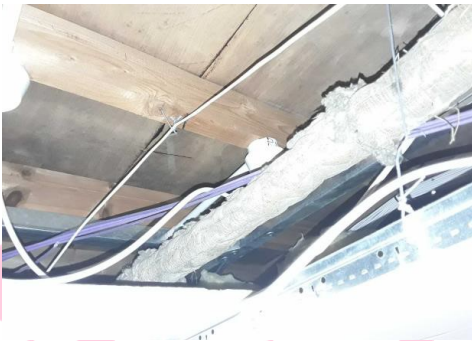
Item 65 Ref: 22-53098-1

The pipes – string to mmmf lagged metal pipes - Ground Floor, Room 30, Corridor and Study Areas - do not contain asbestos

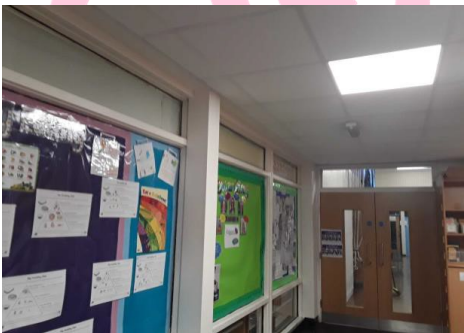
Item 66 Ref: Presumed

The walls – lining inside clasp columns - Ground Floor, Room 30, Corridor ad Study Areas – are presumed to contain asbestos.

Any change in its appearance should be recorded and passed to Property Services.

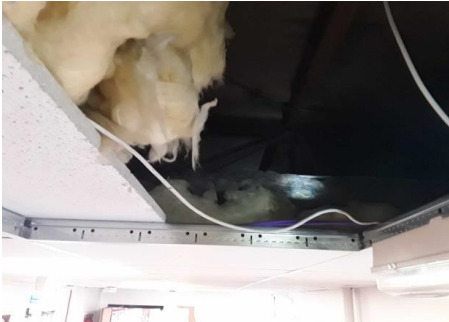
Item 67 Ref: 22-53098-1

The pipes – string to mmmf lagged metal pipes - Ground Floor, Room 31, Cloakroom, classroom - do not contain asbestos

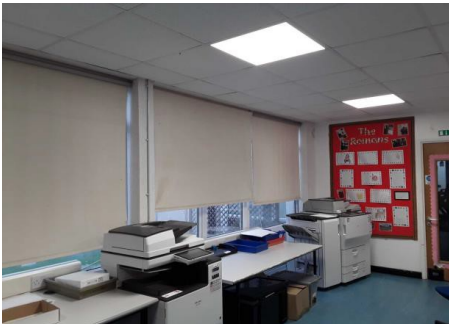
Item 68 Ref: Presumed

The walls – lining inside clasp columns - Ground Floor, Room 31, Cloakroom, classroom – are presumed to contain asbestos.

Any change in its appearance should be recorded and passed to Property Services.

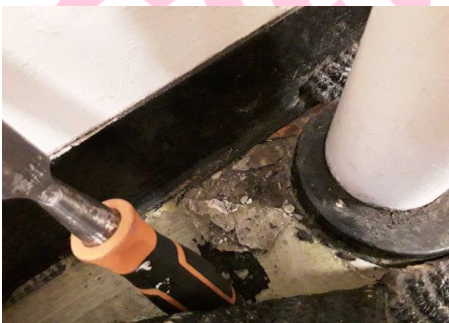
Item 69 Ref: 22-53098-7

The floor – residual adhesive beneath floor screed - Ground Floor, Room 31, Cloakroom, classroom - contains asbestos.

Any change in its appearance should be recorded and passed to Property Services.

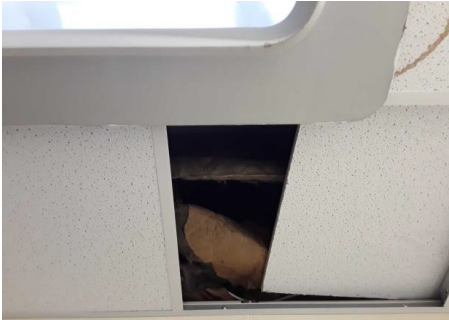
Item 70 Ref: 22-53098-1

The pipes – string to mmmf lagged metal pipes - Ground Floor, Room 32, Girl's toilet - do not contain asbestos

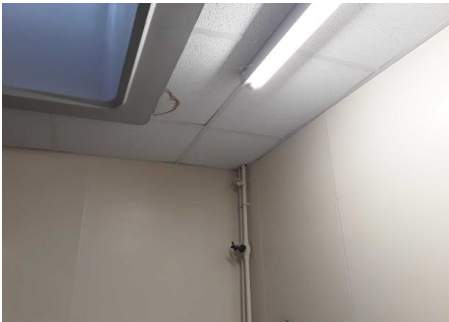
Item 71 Ref: Presumed

The walls – lining inside clasp columns - Ground Floor, Room 32, Girl's toilet – are presumed to contain asbestos.

Any change in its appearance should be recorded and passed to Property Services.

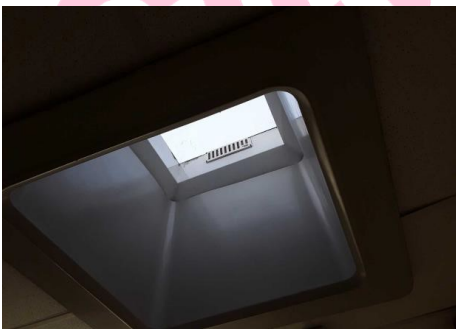
Item 72 Ref: Presumed

The ceiling – textile rope seal to fibreglass skylight - Ground Floor, Room 32, Girl's toilet – is presumed to contain asbestos.

Any change in its appearance should be recorded and passed to Property Services.

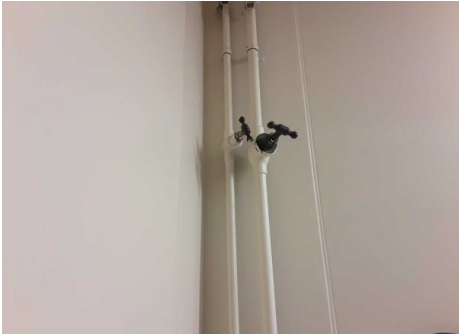
Item 73 Ref: Presumed

The pipes – stop taps (gaskets) – Ground Floor, Room 32, Girl's toilet - are presumed to contain asbestos.

Any change in its appearance should be recorded and passed to Property Services.

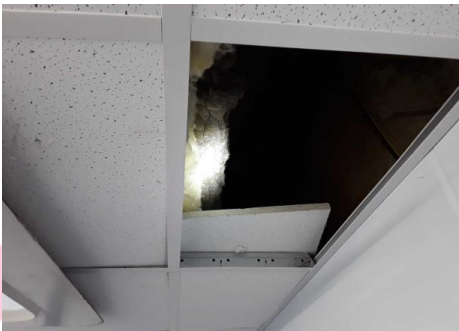
Item 74 Ref: 22-53098-1

The pipes – string to mmmf lagged metal pipes - Ground Floor, Room 33, Boy's toilet - do not contain asbestos

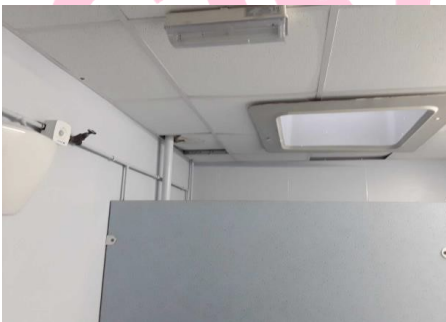
Item 75 Ref: Presumed

The walls – lining inside clasp columns - Ground Floor, Room 33, Boy's toilet – are presumed to contain asbestos.

Any change in its appearance should be recorded and passed to Property Services.

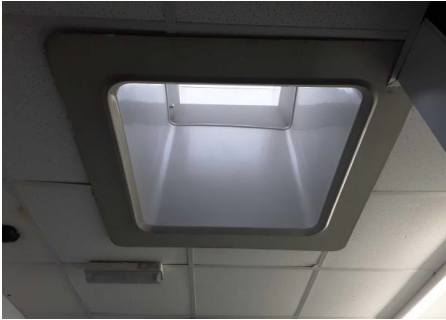
Item 76 Ref: Presumed

The ceiling – textile rope seal to fibreglass skylight - Ground Floor, Room 33, Boy's toilet – is presumed to contain asbestos.

Any change in its appearance should be recorded and passed to Property Services.

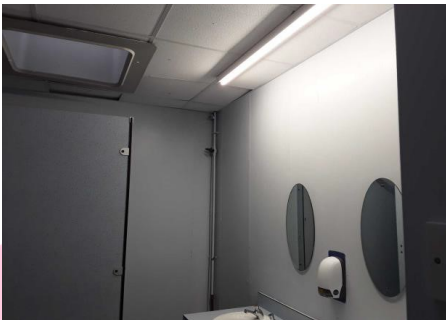
Item 77 Ref: Presumed

The pipes – stop taps (gaskets) – Ground Floor, Room 33, Boy's toilet - are presumed to contain asbestos.

Any change in its appearance should be recorded and passed to Property Services.

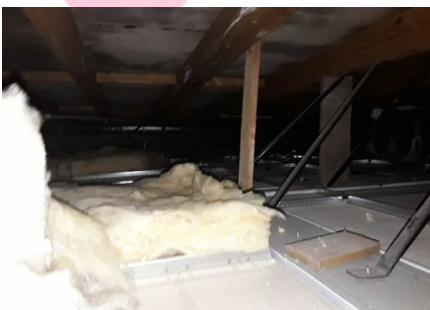
Item 78 Ref: 22-53098-1

The pipes – string to mmmf lagged metal pipes - Ground Floor, Room 34, Classroom - do not contain asbestos

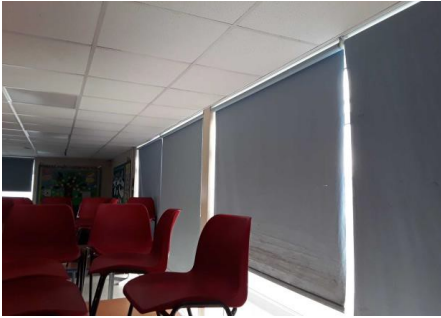
Item 79 Ref: Presumed

The walls – lining inside clasp columns - Ground Floor, Room 34, Classroom – are presumed to contain asbestos.

Any change in its appearance should be recorded and passed to Property Services.

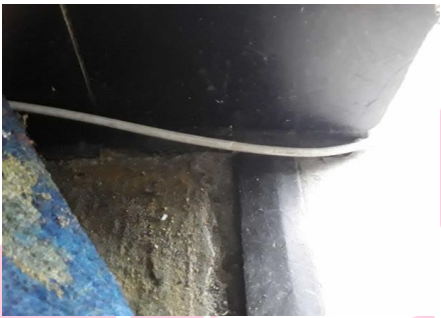
Item 80 Ref: 22-53098-7

The floor – residual adhesive beneath floor screed - Ground Floor, Room 34, Classroom - contains asbestos.

Any change in its appearance should be recorded and passed to Property Services.

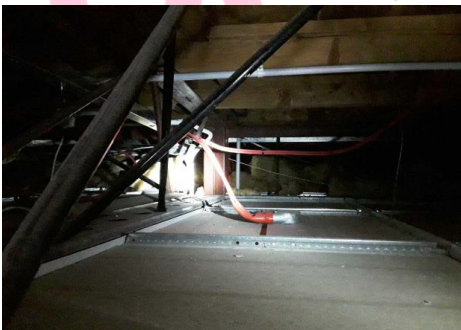
Item 81 Ref: Presumed

The walls – lining inside clasp columns - Ground Floor, Room 35 Hallway between Classrooms – are presumed to contain asbestos.

Any change in its appearance should be recorded and passed to Property Services.

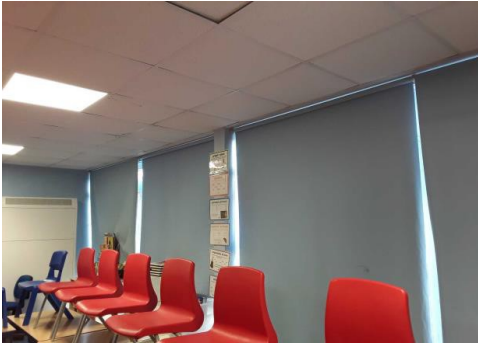
Item 82 Ref: Presumed

The walls – lining inside clasp columns - Ground Floor, Room 36, Classroom – are presumed to contain asbestos.

Any change in its appearance should be recorded and passed to Property Services.

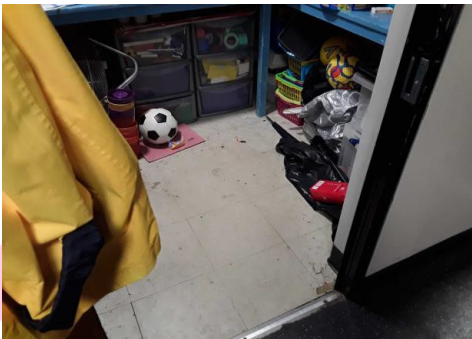
Item 83 Ref: 22-53098-10

The floor – tiles and adhesive - Ground Floor, Room 37, Classroom cupboard - contains asbestos.

Any change in its appearance should be recorded and passed to Property Services.

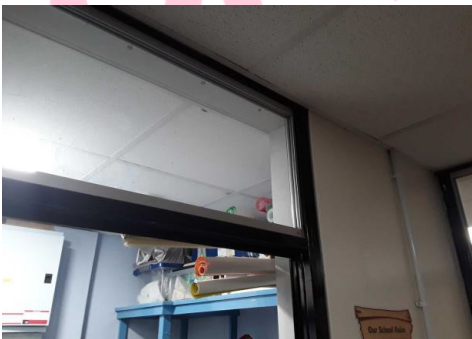
Item 84 Ref: Presumed

The walls – lining inside clasp columns - Ground Floor, Room 37, Classroom cupboard – are presumed to contain asbestos.

Any change in its appearance should be recorded and passed to Property Services.

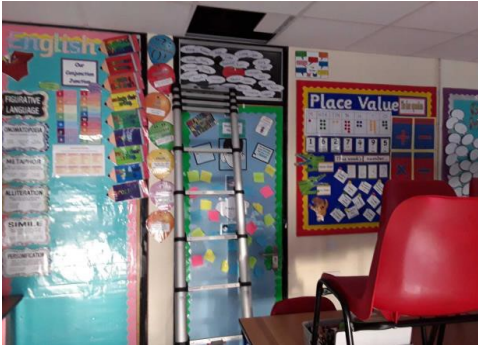
Item 85 Ref: Presumed

The walls – lining inside clasp columns - Ground Floor, Room 37, Classroom cupboard – are presumed to contain asbestos.

Any change in its appearance should be recorded and passed to Property Services.

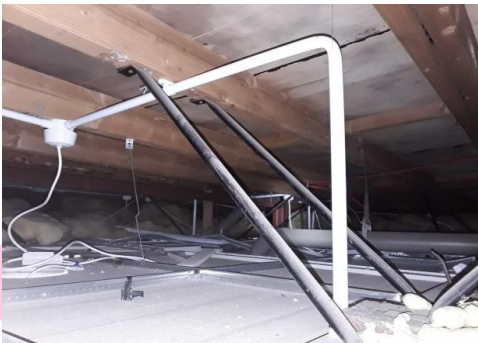
Item 86 Ref: Presumed

The walls – lining inside clasp columns - Ground Floor, Room 38, Classroom cupboard – are presumed to contain asbestos.

Any change in its appearance should be recorded and passed to Property Services.

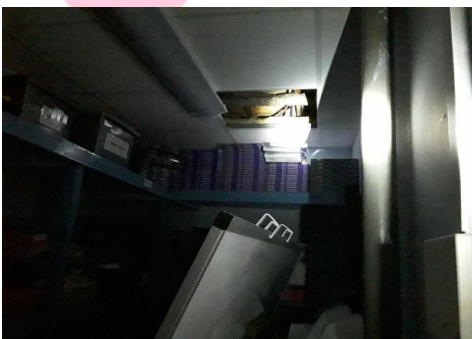
Item 87 Ref: 22-53098-1

The pipes – string to mmmf lagged metal pipes - Ground Floor, Room 39, Store Cupboard - do not contain asbestos

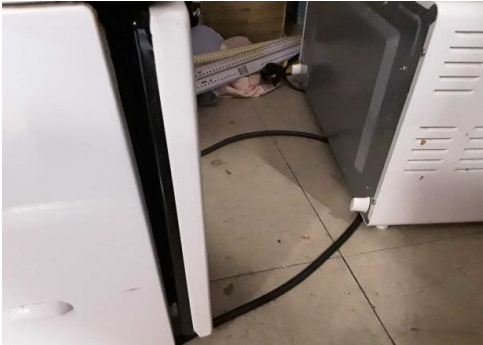
Item 88 Ref: 22-53098-10

The floor – tiles and adhesive
- Ground Floor, Room 39,
Store Cupboard - contains
asbestos.

Any change in its appearance
should be recorded and
passed to Property Services.

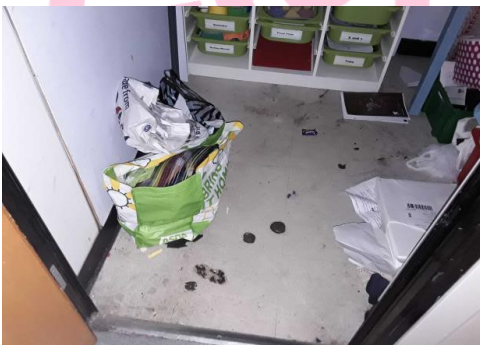
Item 96 Ref: 22-53098-10

The floor – tiles and adhesive - Ground Floor, Room 42, Classroom Cupboard - contains asbestos.

Any change in its appearance should be recorded and passed to Property Services.

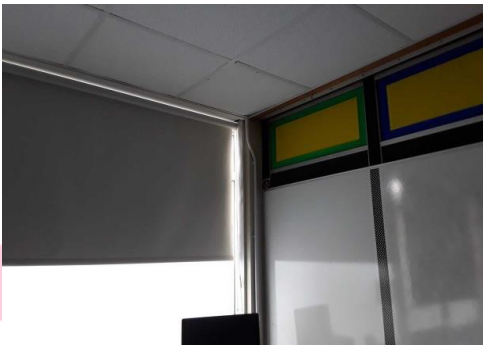
Item 98 Ref: Presumed

The walls – lining inside clasp columns - Ground Floor, Room 43, Classroom between two classrooms – are presumed to contain asbestos.

Any change in its appearance should be recorded and passed to Property Services.

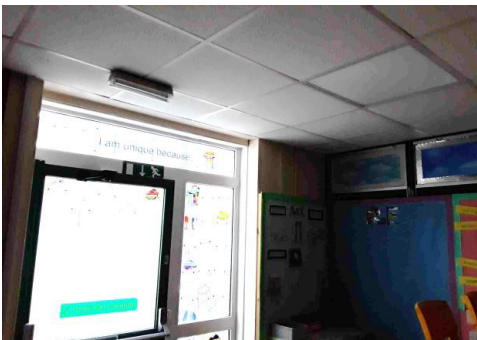
Item 99 Ref: Presumed

The walls – lining inside clasp columns - Ground Floor, Room 44, Classroom – are presumed to contain asbestos.

Any change in its appearance should be recorded and passed to Property Services.

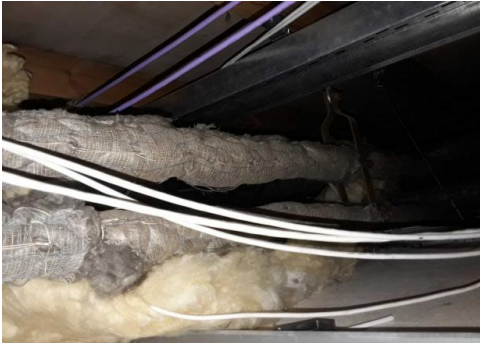
Item 100 Ref: 22-53098-1

The pipes – string to mmmf lagged metal pipes - Ground Floor, Room 45, Classroom - do not contain asbestos

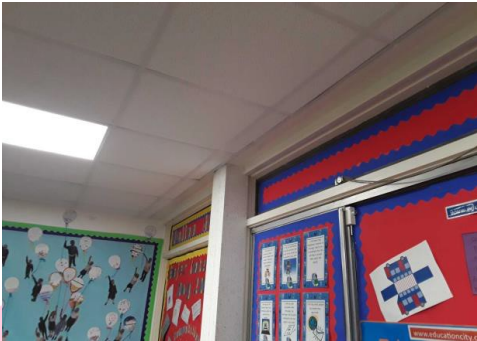
Item 101 Ref: Presumed

The walls – lining inside clasp columns - Ground Floor, Room 45, Classroom – are presumed to contain asbestos.

Any change in its appearance should be recorded and passed to Property Services.

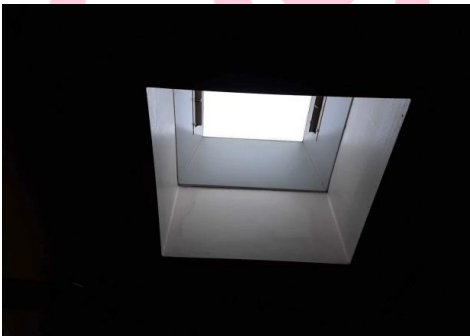
Item 102 Ref: Presumed

The ceiling – textile rope seal to fibreglass skylight - Ground Floor, Room 45, Cloakroom & Computer Room – is presumed to contain asbestos.

Any change in its appearance should be recorded and passed to Property Services.

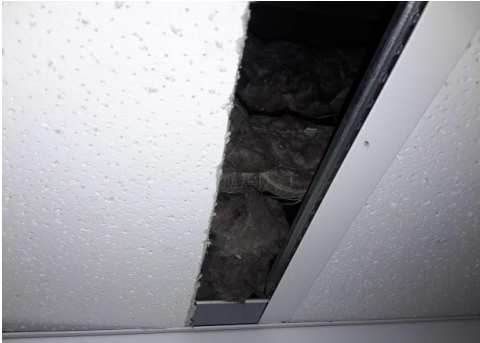
Item 103 Ref: 22-53098-1

The pipes – string to mmmf lagged metal pipes - Ground Floor, Room 46, Girls Toilet - do not contain asbestos

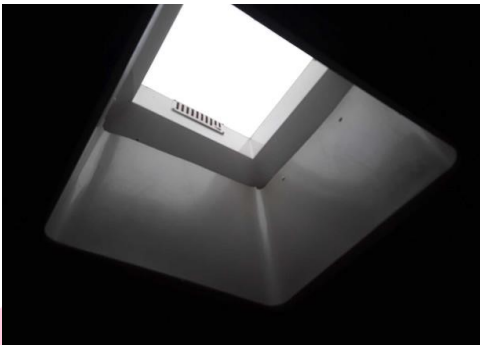
Item 104 Ref: Presumed

The ceiling – textile rope seal to fibreglass skylight - Ground Floor, Room 46, Girls Toilet – is presumed to contain asbestos.

Any change in its appearance should be recorded and passed to Property Services.

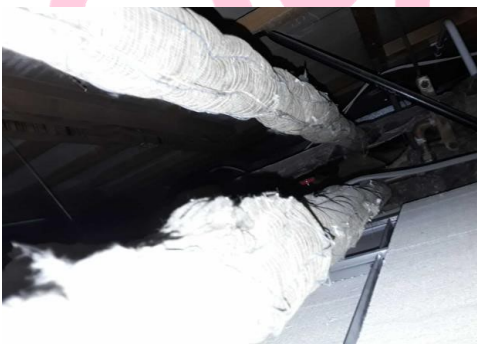
Item 105 Ref: Presumed

The pipes – string to mmmf lagged metal pipes - Ground Floor, Room 47 Boys Toilet - do not contain asbestos

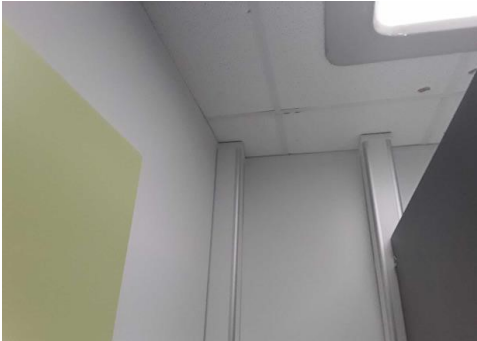
Item 106 Ref: Presumed

The walls – lining inside clasp columns - Ground Floor, Room 47 Boys Toilet – are presumed to contain asbestos.

Any change in its appearance should be recorded and passed to Property Services.

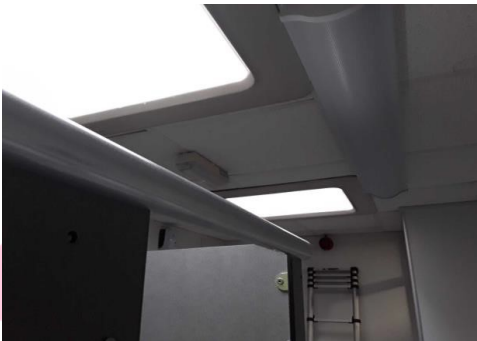
Item 107 Ref: Presumed

The ceiling – textile rope seal to fibreglass skylight - Ground Floor, Room 47 Boy's Toilet – is presumed to contain asbestos.

Any change in its appearance should be recorded and passed to Property Services.

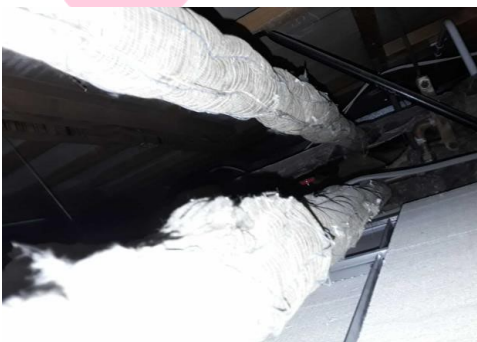
Item 108 Ref: 22-53098-1

The pipes – string to mmmf lagged metal pipes - Ground Floor, Room 51 Classroom - do not contain asbestos

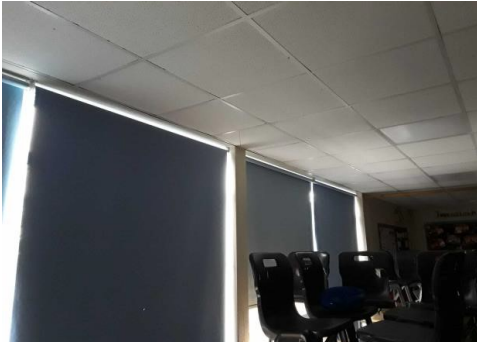
Item 109 Ref: Presumed

The walls – lining inside clasp columns - Ground Floor, Room 51 Classroom – are presumed to contain asbestos.

Any change in its appearance should be recorded and passed to Property Services.

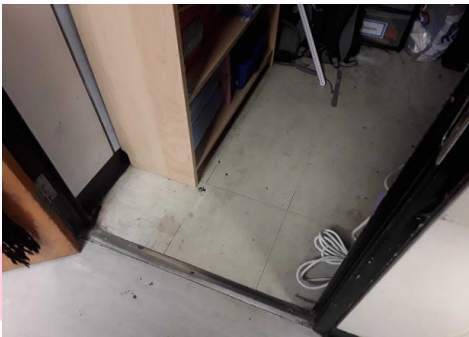
Item 110 Ref: 22-53098-10

The floor – tiles and adhesive - Ground Floor, Room 52, Classroom Cupboard - contains asbestos.

Any change in its appearance should be recorded and passed to Property Services.

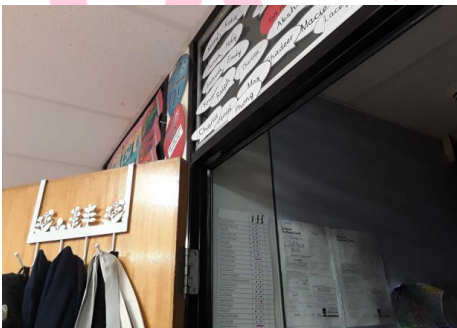
Item 111 Ref: Presumed

The walls – lining inside clasp columns - Ground Floor, Room 52 Classroom – are presumed to contain asbestos.

Any change in its appearance should be recorded and passed to Property Services.

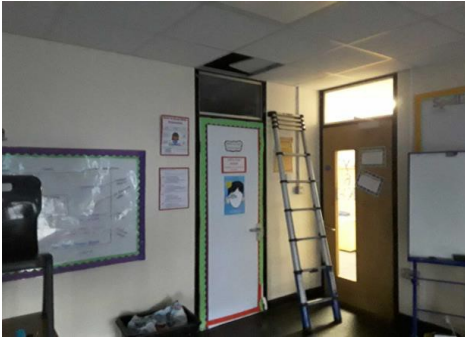
Item 112 Ref: Presumed

The walls – lining inside clasp columns - Ground Floor, Room 52 Classroom cupboard – are presumed to contain asbestos.

Any change in its appearance should be recorded and passed to Property Services.

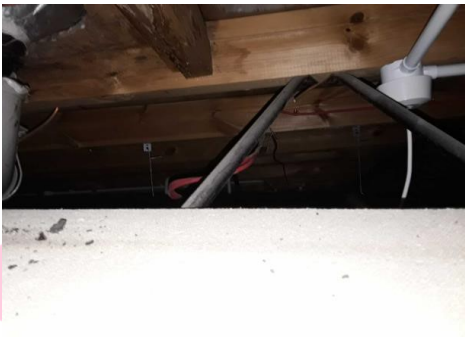
Item 113 Ref: 22-53098-1

The pipes – string to mmmf lagged metal pipes - Ground Floor, Room 53 Classroom - do not contain asbestos

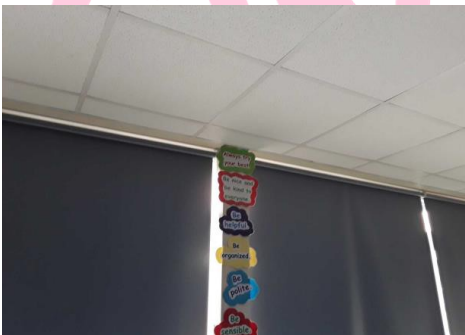
Item 114 Ref: Presumed

The walls – lining inside clasp columns - Ground Floor, Room 53 Classroom – are presumed to contain asbestos.

Any change in its appearance should be recorded and passed to Property Services.

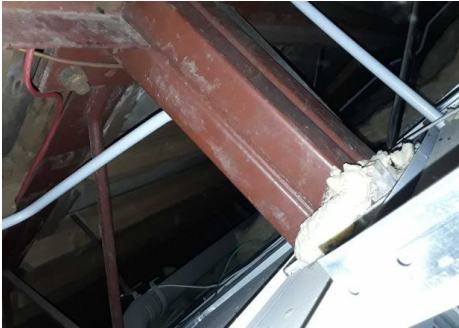
Item 115 Ref: Presumed

The walls – lining inside clasp columns - Ground Floor, Room 54 Classroom cupboard – are presumed to contain asbestos.

Any change in its appearance should be recorded and passed to Property Services.

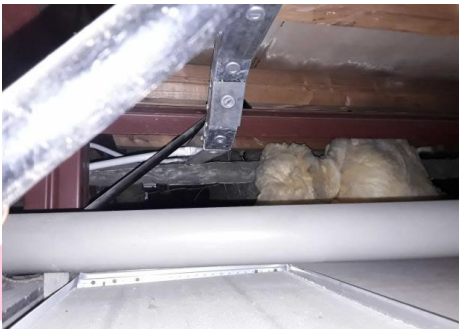
Item 116 Ref: 22-53098-1

The pipes – string to mmmf lagged metal pipes - Ground Floor, Room 55 Classroom - do not contain asbestos

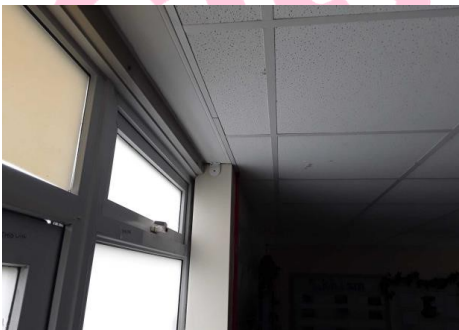
Item 117 Ref: Presumed

The walls – lining inside clasp columns - Ground Floor, Room 55 Classroom – are presumed to contain asbestos.

Any change in its appearance should be recorded and passed to Property Services.

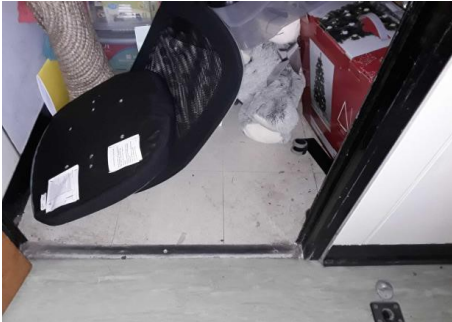
Item 118 Ref: 22-53098-10

The floor – tiles and adhesive
- Ground Floor, Room 56,
Classroom Cupboard -
contains asbestos.

Any change in its appearance
should be recorded and
passed to Property Services.

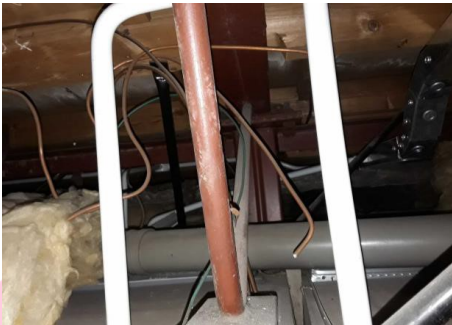
Item 119 Ref: Presumed

The walls – lining inside clasp
columns - Ground Floor,
Room 56, Classroom
Cupboard – are presumed to
contain asbestos.

Any change in its appearance
should be recorded and
passed to Property Services.

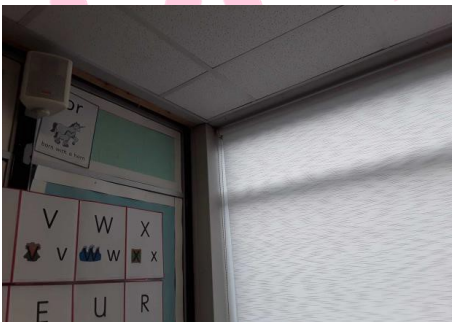
Item 120 Ref: Presumed

The walls – lining inside clasp
columns - Ground Floor,
Room 57, Classroom between
Classroom – are presumed to
contain asbestos.

Any change in its appearance
should be recorded and
passed to Property Services.

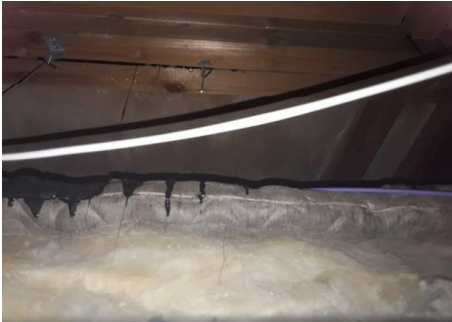
Item 121 Ref: 22-53098-1

The pipes – string to mmmf lagged metal pipes - Ground Floor, Room 58 Classroom - do not contain asbestos

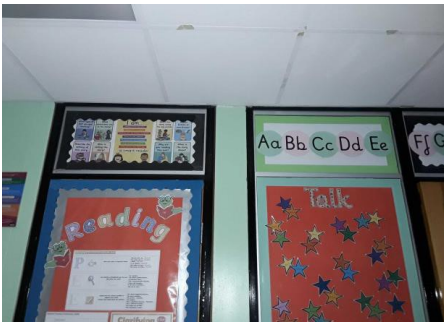
Item 122 Ref: Presumed

The walls – lining inside clasp columns - Ground Floor, Room 58 Classroom – are presumed to contain asbestos.

Any change in its appearance should be recorded and passed to Property Services.

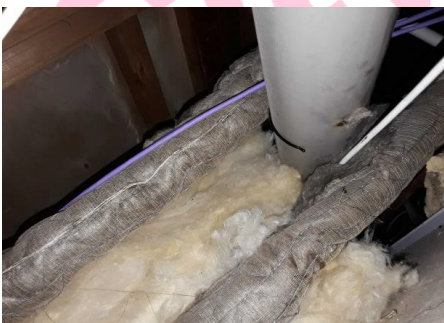
Item 123 Ref: 22-53098-1

The pipes – string to mmmf lagged metal pipes - Ground Floor, Room 59 Classroom cupboard - do not contain asbestos

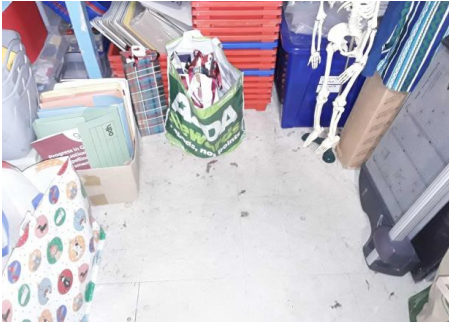
Item 124 Ref: 22-53098-10

The floor – tiles and adhesive
- Ground Floor, Room 59,
Classroom Cupboard -
contains asbestos.

Any change in its appearance
should be recorded and
passed to Property Services.

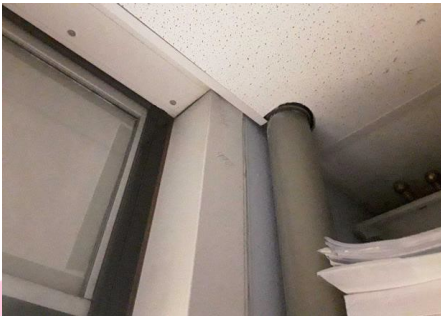
Item 125 Ref: Presumed

The walls – lining inside clasp
columns - Ground Floor,
Room 59 Classroom cupboard
– are presumed to contain
asbestos.

Any change in its appearance
should be recorded and
passed to Property Services.

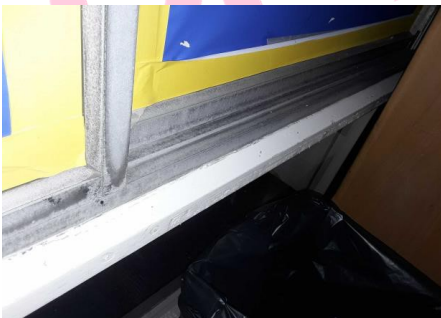
Item 126 Ref: 22-53098-11

The window – internal wood
windows - Ground Floor,
Room 60 Library - does not
contain asbestos

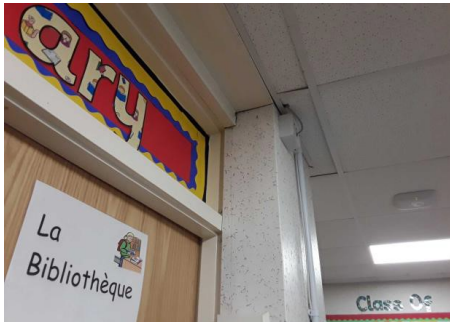
Item 127 Ref: Presumed

The walls – lining inside clasp columns - Ground Floor, Room 60 Library – are presumed to contain asbestos.

Any change in its appearance should be recorded and passed to Property Services.

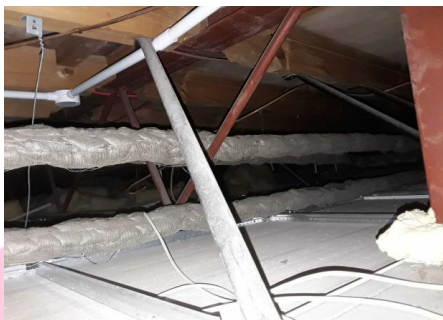
Item 128 Ref: 22-53098-1

The pipes – string to mmmf lagged metal pipes - Ground Floor, Room 61 Computer Room and store cupboard - do not contain asbestos

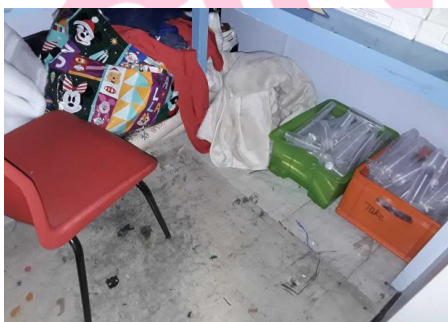
Item 129 Ref: 22-53098-12

The floor – tiles and adhesive - Ground Floor, Room 61 Computer Room and store cupboard - contains asbestos.

Any change in its appearance should be recorded and passed to Property Services.

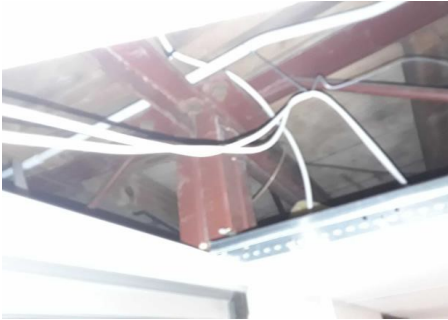
Item 130 Ref: Presumed

The walls – lining inside clasp columns - Ground Floor, Room 61 Computer Room and store cupboard – are presumed to contain asbestos.

Any change in its appearance should be recorded and passed to Property Services.

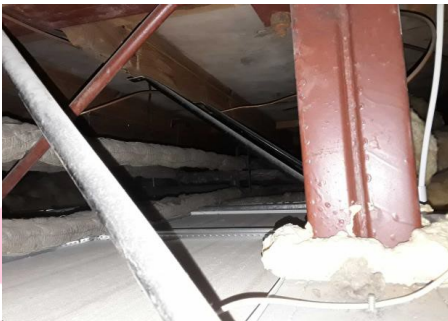
Item 131 Ref: 22-53098-1

The pipes – string to mmmf lagged metal pipes - Ground Floor, Room 62 Paper store cupboard - do not contain asbestos

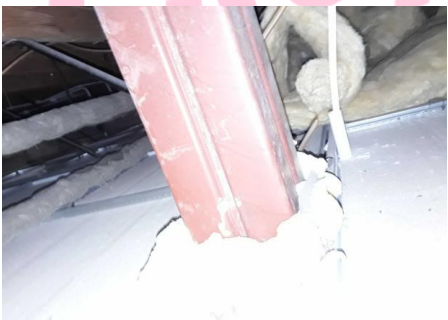
Item 132 Ref: Presumed

The walls – lining inside clasp columns - Ground Floor, Room 62 Paper store cupboard – are presumed to contain asbestos.

Any change in its appearance should be recorded and passed to Property Services.

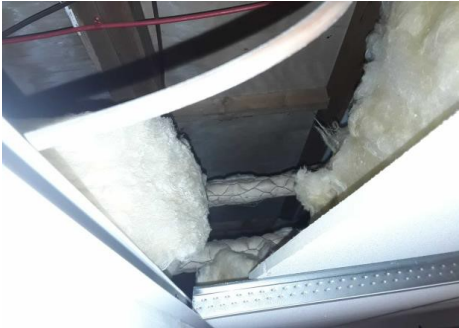
Item 133 Ref: 22-53098-1

The pipes – string to mmmf lagged metal pipes - Ground Floor, Room 63 Main School hall store cupboard - do not contain asbestos

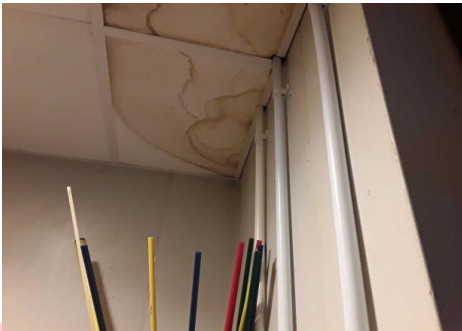
Item 134 Ref: Presumed

The walls – lining inside clasp columns - Ground Floor, Room 63 Main School hall store cupboard – are presumed to contain asbestos.

Any change in its appearance should be recorded and passed to Property Services.

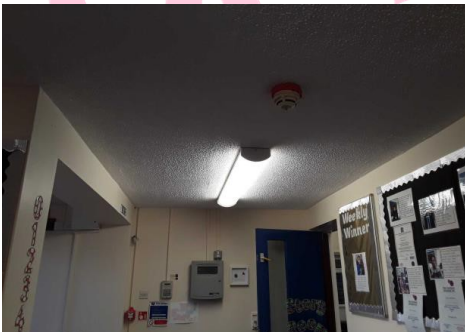
Item 135 Ref: 22-53098-13

The ceiling – textured coating - Ground Floor, Room 64, Entrance hall, Nursery - contains asbestos.

Any change in its appearance should be recorded and passed to Property Services.

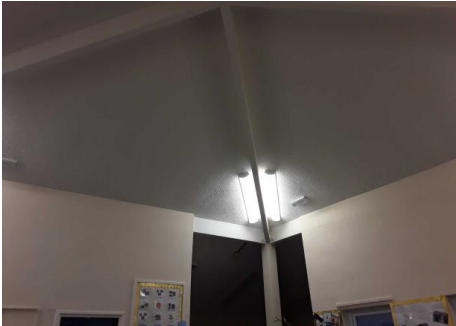
Item 136 Ref: 22-53098-13

The ceiling – textured coating
- Ground Floor, Room 65,
Main Nursery Area 1 -
contains asbestos.

Any change in its appearance
should be recorded and
passed to Property Services.

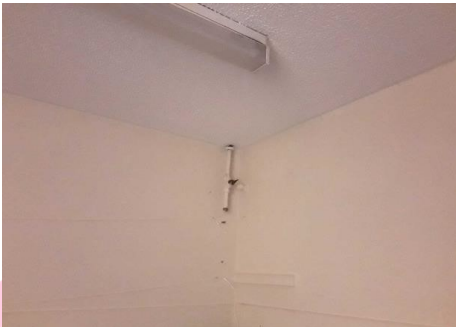
Item 137 Ref: Presumed

The pipes – stop taps
(Gaskets) – Ground Floor,
Room 65, Main Nursery Area
1 - are presumed to contain
asbestos.

Any change in its appearance
should be recorded and
passed to Property Services.

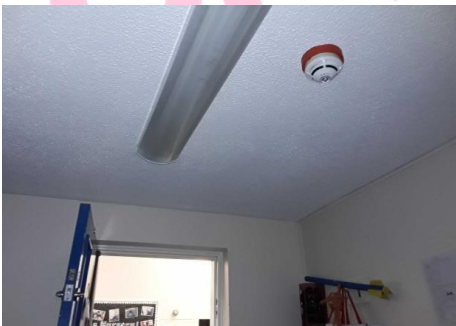
Item 138 Ref: 22-53098-13

The ceiling – textured coating
- Ground Floor, Room 66
Office, Nursery - contains
asbestos.

Any change in its appearance
should be recorded and
passed to Property Services.

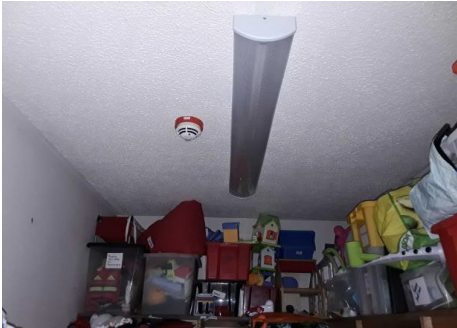
Item 139 Ref: 22-53098-13

The ceiling – textured coating
- Ground Floor, Room 67
Store Cupboard, nursery -
contains asbestos.

Any change in its appearance
should be recorded and
passed to Property Services.

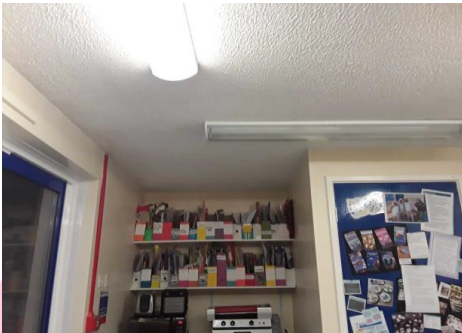
Item 140 Ref: 22-53098-13

The ceiling – textured coating
- Ground Floor, Room 68,
Kitchen, Nursery - contains
asbestos.

Any change in its appearance
should be recorded and
passed to Property Services.

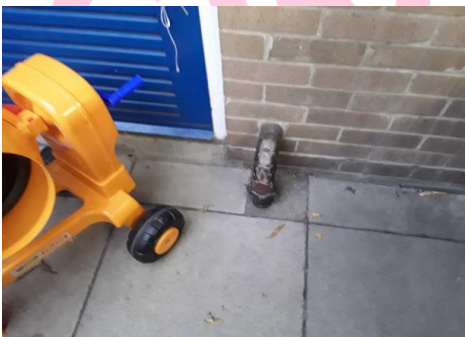
Item 141 Ref: 22-53098-14

The floor - intake pipe -
Ground Floor, Room 69,
External store area, Nursery -
does not contain asbestos.

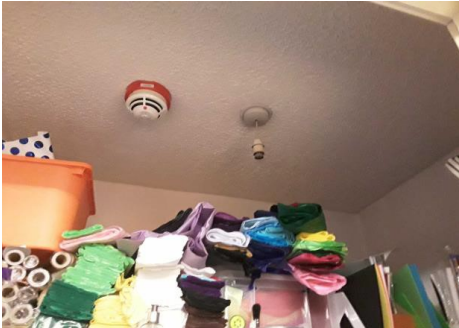
Item 142 Ref: 22-53098-13

The ceiling – textured coating
- Ground Floor, Room 71,
Kitchen Store Cupboard,
Nursery - contains asbestos.

Any change in its appearance
should be recorded and
passed to Property Services.

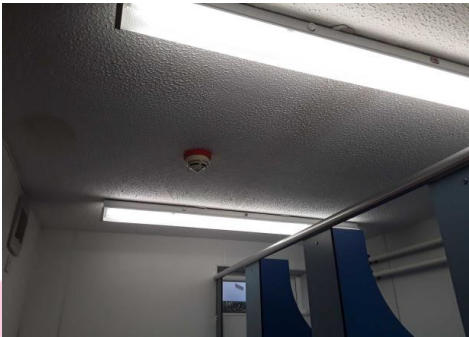
Item 143 Ref: 22-53098-13

The ceiling – textured coating
- Ground Floor, Room 72,
Nursery Toilets - contains
asbestos.

Any change in its appearance
should be recorded and
passed to Property Services.

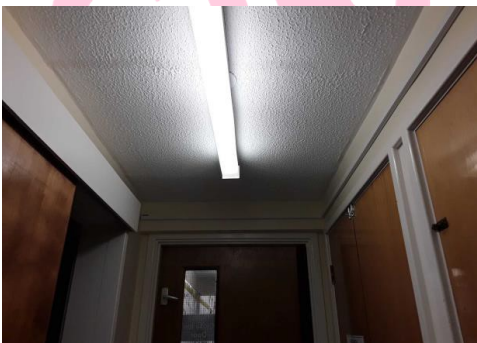
Item 144 Ref: 22-53098-13

The ceiling – textured coating
- Ground Floor, Room 73,
Corridor Nursery - contains
asbestos.

Any change in its appearance
should be recorded and
passed to Property Services.

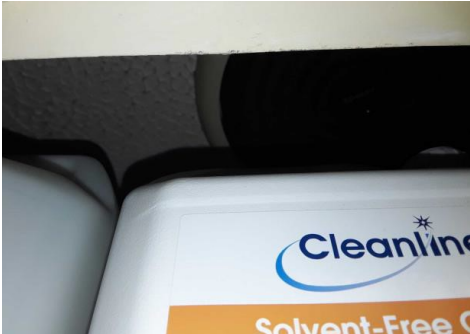
Item 145 Ref: 22-53098-13

The ceiling – textured coating
- Ground Floor, Room 74,
Cleaners Cupboard, Nursery -
contains asbestos.

Any change in its appearance
should be recorded and
passed to Property Services.

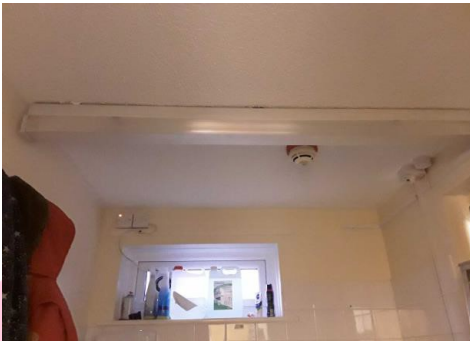
Item 146 Ref: 22-53098-13

The ceiling – textured coating
- Ground Floor, Room 76,
Cleaners Store Cupboard,
Nursery - contains asbestos.

Any change in its appearance
should be recorded and
passed to Property Services.

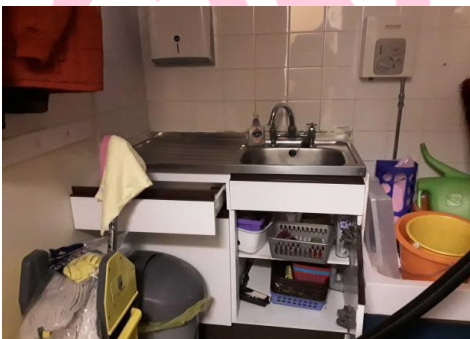
Item 147 Ref: 22-53098-16

The sink pad - Ground Floor,
Room 76, Cleaners Store
Cupboard, Nursery – does not
contain asbestos.

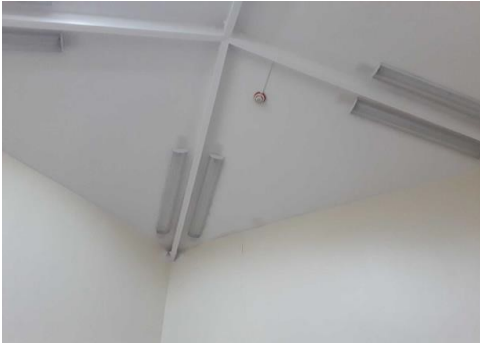
Item 148 Ref: 22-53098-13

The ceiling – textured coating
- Ground Floor, Room 77
Nursery area 2 - contains asbestos.

Any change in its appearance should be recorded and passed to Property Services.

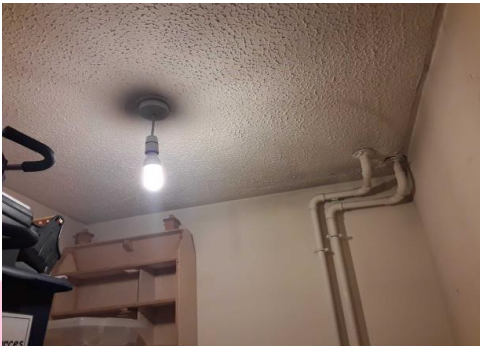
Item 149 Ref: 22-53098-13

The ceiling – textured coating
- Ground Floor, Room 78
Nursery area 2 store cupboard
- contains asbestos.

Any change in its appearance should be recorded and passed to Property Services.

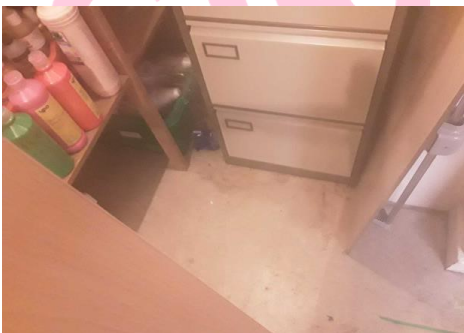
Item 150 Ref: 22-53098-20

The floor – tiles and adhesive
- Ground Floor, Room 78
Nursery area 2 store cupboard
- contains asbestos.

Any change in its appearance should be recorded and passed to Property Services.

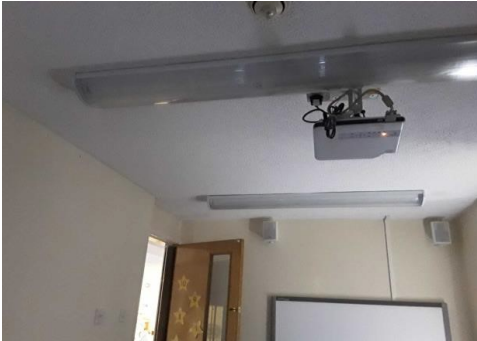
Item 151 Ref: 22-53098-13

The ceiling – textured coating
- Ground Floor, Room 79
Classroom Nursery - contains
asbestos.

Any change in its appearance
should be recorded and
passed to Property Services.

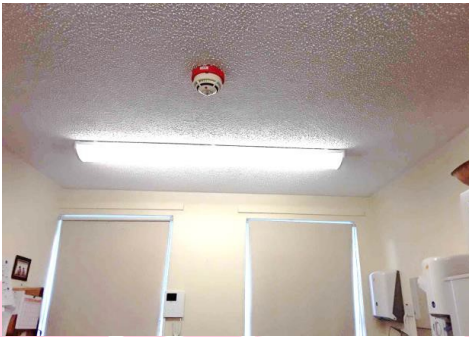
Item 152 Ref: 22-53098-13

The ceiling – textured coating
- Ground Floor, Room 80 Staff
Room Nursery - contains
asbestos.

Any change in its appearance
should be recorded and
passed to Property Services.

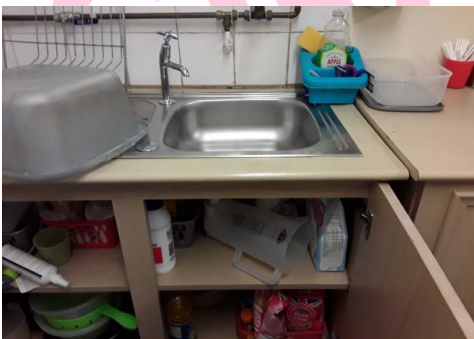
Item 153 Ref: 22-53098-17

The sink pad - Ground Floor,
Room 80 Staff Room Nursery
– does not contain asbestos.

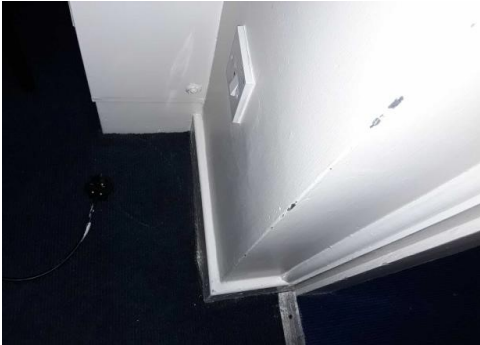
Item 154 Ref: 22-53098-18

The floor – tiles and adhesive
- Ground Floor, Room 80 Staff
Room Nursery - contains
asbestos.

Removed Jan 2025

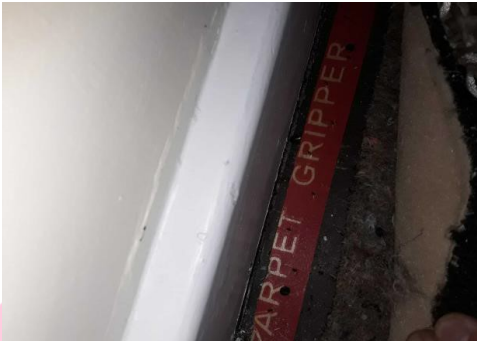
Item 155 Ref: 22-53098-19

The floor – tiles and adhesive
- Ground Floor, Room 81
Reading Room Nursery -
contains asbestos.

Removed Jan 2025

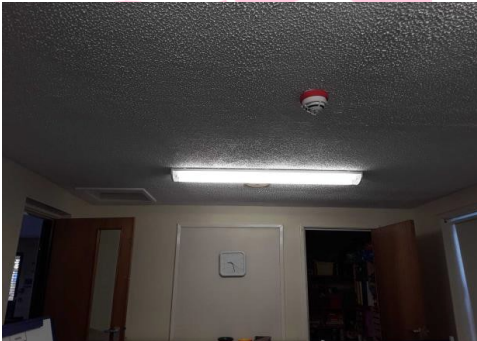
Item 156 Ref: 22-53098-13

The ceiling – textured coating
- Ground Floor, Room 82
Classroom Nursery - contains
asbestos.

Removed Jan 2025

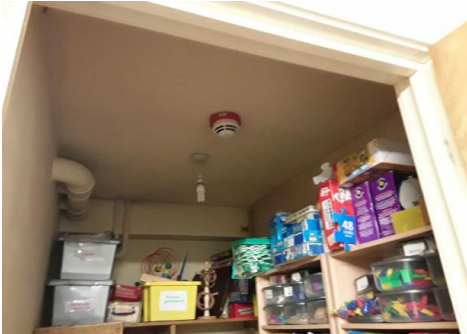
Item 157 Ref: 22-53098-13

The ceiling – textured coating
- Ground Floor, Room 83
Store Room Nursery -
contains asbestos.

Any change in its appearance
should be recorded and
passed to Property Services.

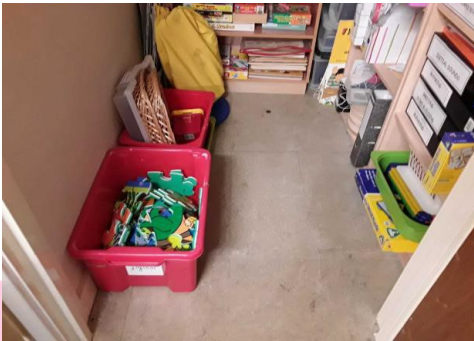
Item 158 Ref: 22-53098-20

The floor – tiles and adhesive
- Ground Floor, Room 83
Store Room Nursery -
contains asbestos.

Any change in its appearance
should be recorded and
passed to Property Services.

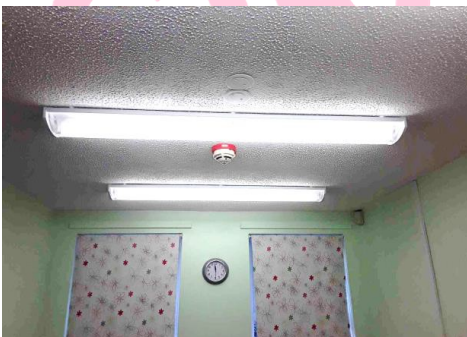
Item 159 Ref: 22-53098-13

The ceiling – textured coating
- Ground Floor, Room 84
Office Nursery - contains
asbestos.

Any change in its appearance
should be recorded and
passed to Property Services.

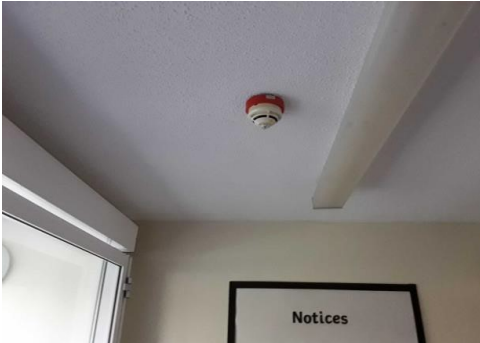
Item 160 Ref: 22-53098-13

The ceiling – textured coating
- Ground Floor, Room 85 Rear
Entrance Hall Nursery -
contains asbestos.

Any change in its appearance
should be recorded and
passed to Property Services.

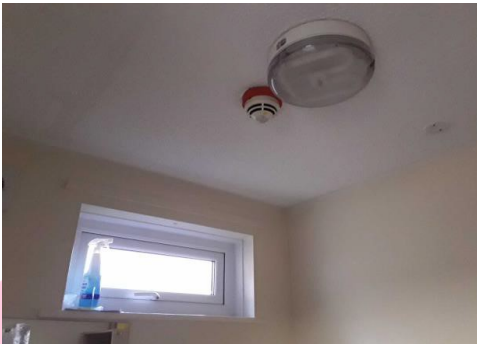
Item 161 Ref: 22-53098-13

The ceiling – textured coating
- Ground Floor, Room 88
Disabled Toilet Nursery -
contains asbestos.

Any change in its appearance
should be recorded and
passed to Property Services.

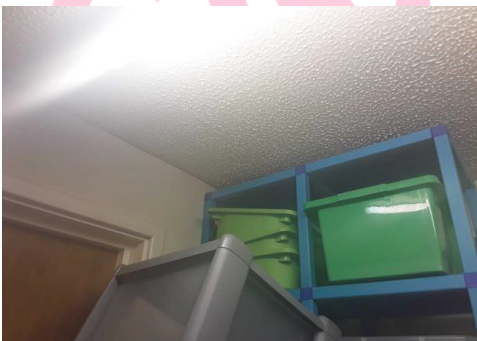
Item 162 Ref: 22-53098-13

The ceiling – textured coating
- Ground Floor, Room 89
Nursery area 2 Store
cupboard 1- contains
asbestos.

Any change in its appearance
should be recorded and
passed to Property Services.

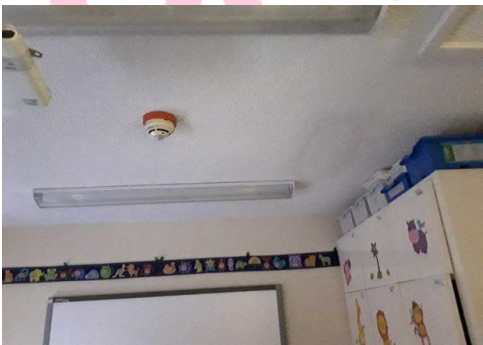
Item 165 Ref: 22-53098-13

The ceiling – textured coating
- Ground Floor, Room 91
Interview Room Nursery -
contains asbestos.

Any change in its appearance
should be recorded and
passed to Property Services.

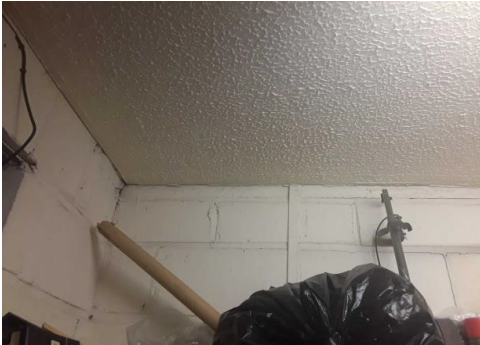
Item 166 Ref: 22-53098-13

The ceiling – textured coating
- Ground Floor, Room 93
External Store Nursery -
contains asbestos.

Any change in its appearance
should be recorded and
passed to Property Services.

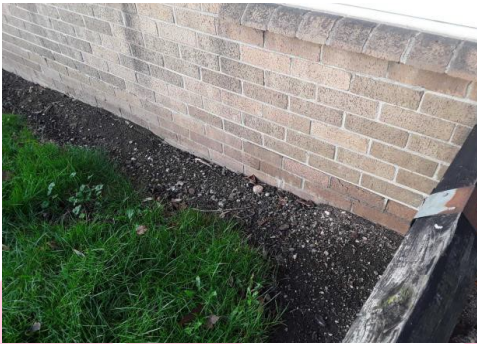
Item 167 Ref: 22-53098-21

The damp proof course -
Room 94, Externals of nursery
- contains asbestos.

Any change in its appearance
should be recorded and
passed to Property Services.

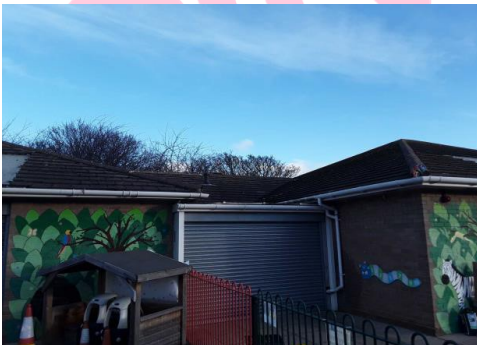
Item 168 Ref: Presumed

The roof – ridge vents - Room
94, Externals of nursery – is
presumed to contain
asbestos.

Any change in its appearance
should be recorded and
passed to Property Services.

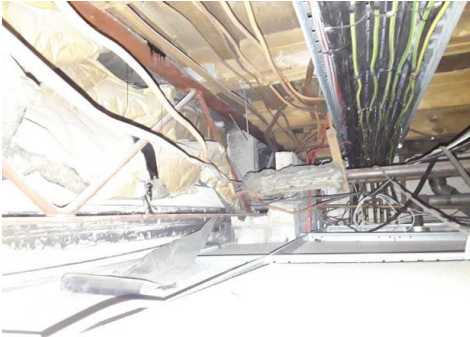
Item 169 Ref: 22-53098-1

The pipes – string to mmmf lagged metal pipes - Ground Floor, Room 98 Boiler Room - do not contain asbestos

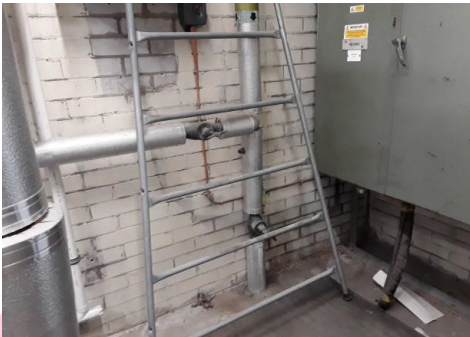
Item 170 Ref: Presumed

The pipes – Stop taps (Gaskets) - Ground Floor, Room 98 Boiler Room – are presumed to contain asbestos.

Any change in its appearance should be recorded and passed to Property Services.

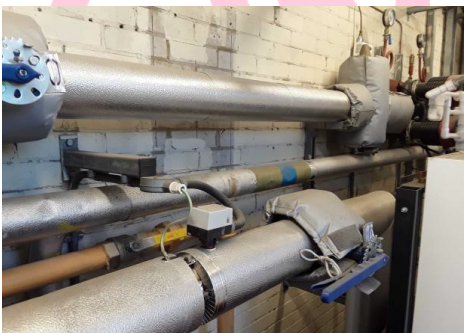
Item 171 Ref: 22-53098-24

The walls – residual insulation to walls - Ground Floor, Room 98 Boiler Room - do not contain asbestos

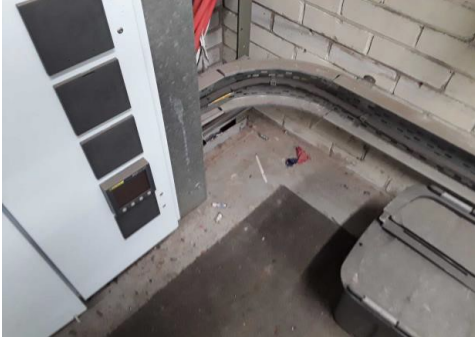
Item 172 Ref: 22-53098-25

The floor – redundant barrel fuses - Ground Floor, Room 98 Boiler Room - do not contain asbestos

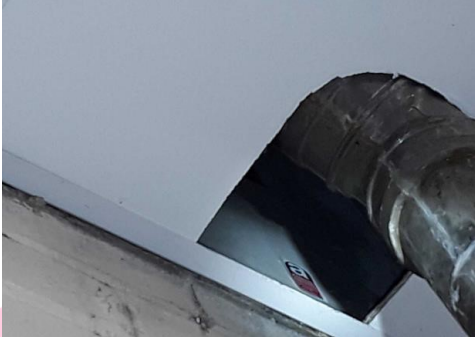
Item 173 Ref: Presumed

The walls – firebreak above suspended ceiling tiles between boiler room and kitchen and hall area of school – Ground Floor, Room 98 Boiler Room - are presumed to contain asbestos.

Any change in its appearance should be recorded and passed to Property Services.

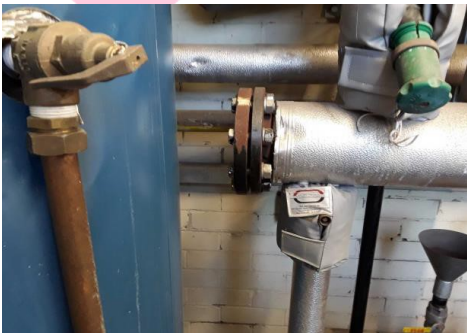
Item 174 Ref: 22-53098-27

The pipes – flange (Gaskets) - Ground Floor, Room 98 Boiler Room - do not contain asbestos
