ASBESTOS SURVEY REPORT FOR ASHLEY PRIMARY ACADEMY, TEMPLE PARK ROAD, SOUTH SHIELDS, NE33 0QA

Asbestos Register for ASHLEY PRIMARY ACADEMY, TEMPLE PARK ROAD

Date: 16 June 2025

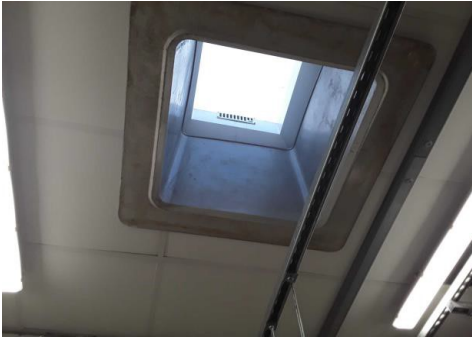
Item 175 Ref: Presumed

The ceiling – textured coating
- Ground Floor, Room 98
Boiler Room – are presumed
to contain asbestos.

Any change in its appearance
should be recorded and
passed to Property Services.

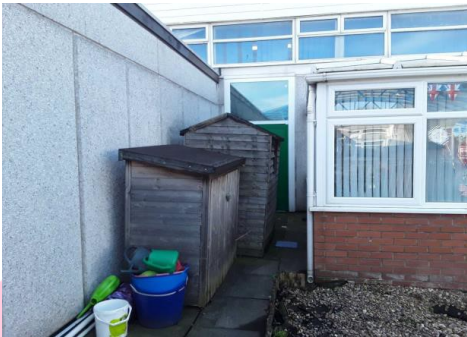
Item 176 Ref: 22-53098-28

The roof – shed roof felts -
Ground Floor, Room 101,
Sheds in school courtyard –
does not contain asbestos.

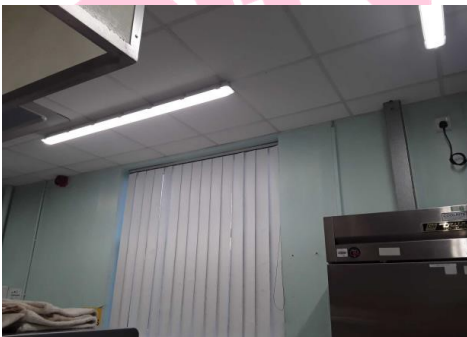
Item 177 Ref: Presumed

The walls – lining inside clasp
columns - Ground Floor,
Room 104 Kitchen - are
presumed to contain
asbestos.

Any change in its appearance
should be recorded and
passed to Property Services.

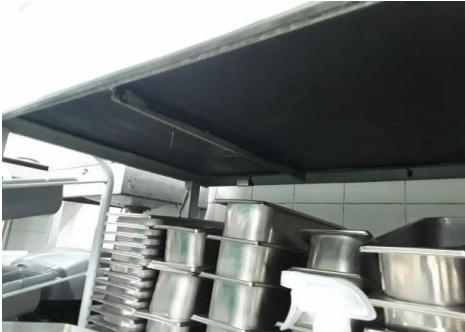
Item 178 Ref: 22-53098-30

The sink pad – coating to underside of drainers – Ground Floor, Room 104 Kitchen - does not contain asbestos.

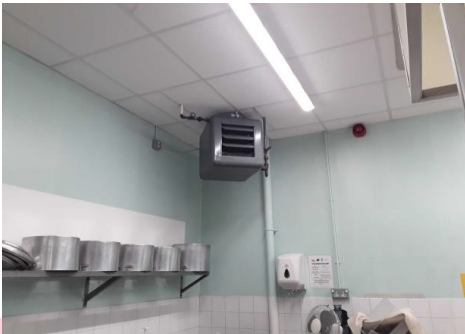
Item 179 Ref: Presumed

The vessels – lining inside ceiling heater - Ground Floor, Room 104 Kitchen - are presumed to contain asbestos.

Any change in its appearance should be recorded and passed to Property Services.

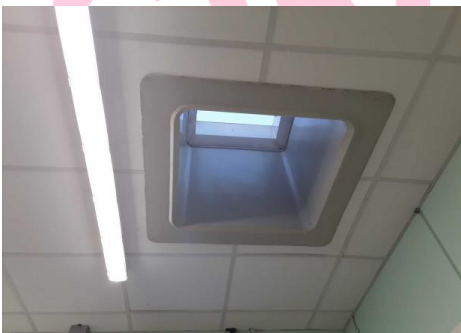
Item 180 Ref: Presumed

The ceiling – textile rope seal to fibreglass skylight - Ground Floor, Room 104 Kitchen - is presumed to contain asbestos.

Any change in its appearance should be recorded and passed to Property Services.

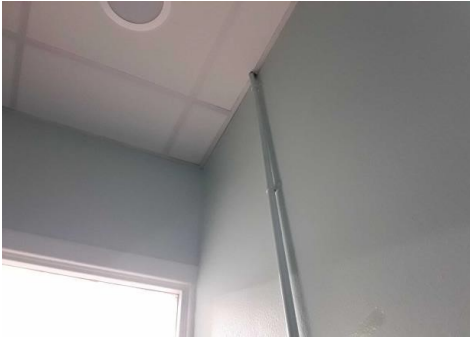
Item 181 Ref: Presumed

The walls – lining inside clasp columns - Ground Floor, Room 105 Kitchen Office - are presumed to contain asbestos.

Any change in its appearance should be recorded and passed to Property Services.

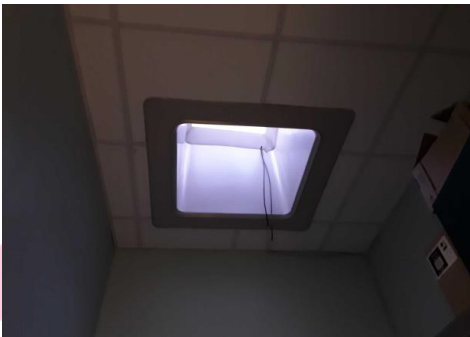
Item 182 Ref: Presumed

The ceiling – textile rope seal to fibreglass skylight - Ground Floor, Room 105 Kitchen Office - is presumed to contain asbestos.

Any change in its appearance should be recorded and passed to Property Services.

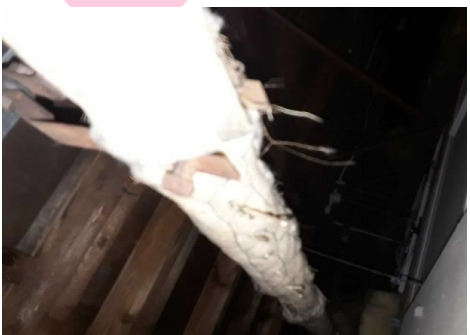
Item 183 Ref: 22-53098-1

The pipes – string to mmmf lagged metal pipes - Ground Floor, Room 106 Kitchen Pantry - do not contain asbestos

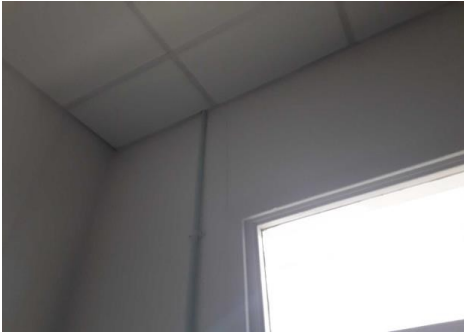
Item 184 Ref: Presumed

The walls – lining inside clasp columns - Ground Floor, Room 106 Kitchen Pantry - are presumed to contain asbestos.

Any change in its appearance should be recorded and passed to Property Services.

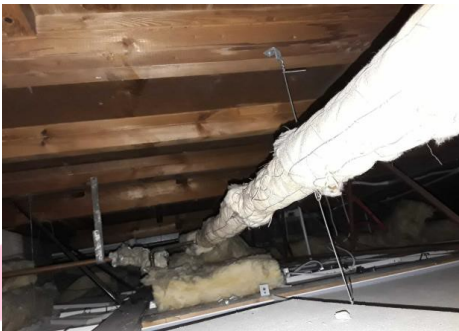
Item 185 Ref: 22-53098-1

The pipes – string to mmmf lagged metal pipes - Ground Floor, Room 107 Kitchen Store Cupboard - do not contain asbestos

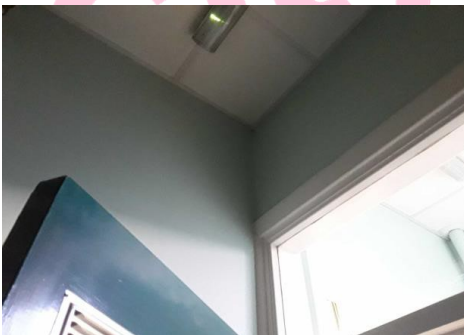
Item 186 Ref: Presumed

The walls – lining inside clasp columns - Ground Floor, Room 107 Kitchen Store Cupboard - are presumed to contain asbestos.

Any change in its appearance should be recorded and passed to Property Services.

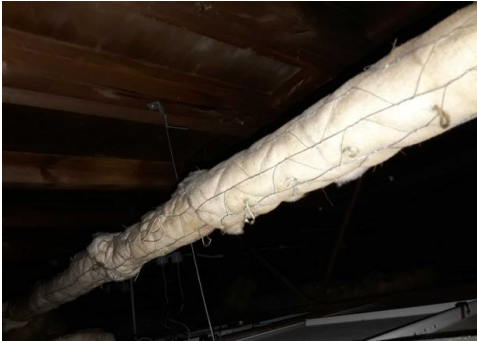
Item 187 Ref: 22-53098-1

The pipes – string to mmmf lagged metal pipes - Ground Floor, Room 108 Kitchen Fire Exit Hallway - do not contain asbestos

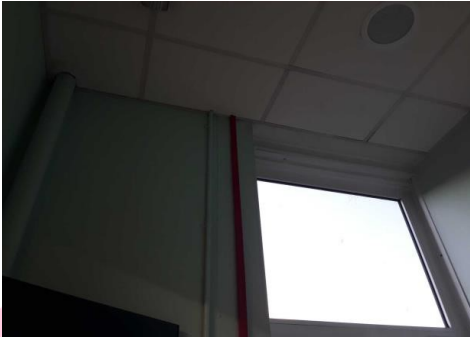
Item 188 Ref: Presumed

The walls – lining inside clasp columns - Ground Floor, Room 108 Kitchen Fire Exit Hallway - are presumed to contain asbestos.

Any change in its appearance should be recorded and passed to Property Services.

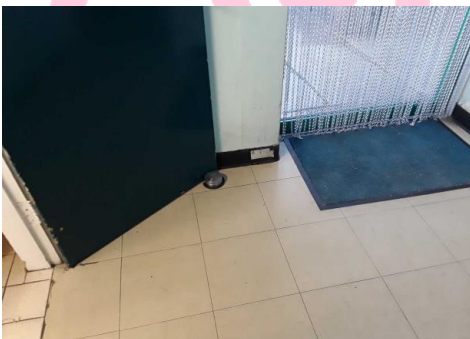
Item 189 Ref: 22-53098-31

The floor – tiles and adhesive - Ground Floor, Room 108 Kitchen Fire Exit Hallway - contains asbestos.

Any change in its appearance should be recorded and passed to Property Services.

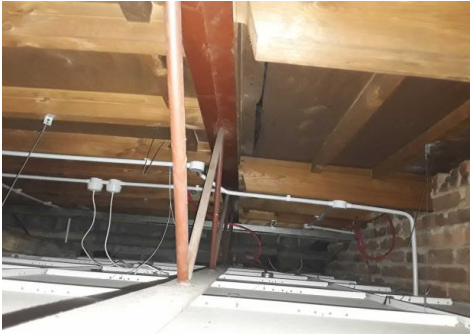
Item 190 Ref: 22-53098-1

The pipes – string to mmmf lagged metal pipes - Ground Floor, Room 109 Kitchen Staff Cloakroom - do not contain asbestos

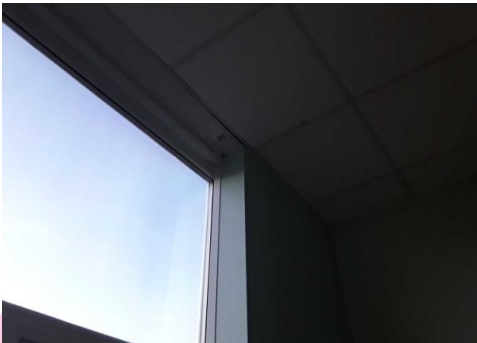
Item 191 Ref: Presumed

The walls – lining inside clasp columns - Ground Floor, Room 109 Kitchen Staff Cloakroom - are presumed to contain asbestos.

Any change in its appearance should be recorded and passed to Property Services.

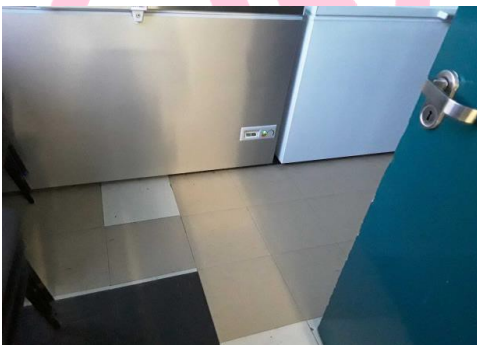
Item 192 Ref: 22-53098-31

The floor – tiles and adhesive - Ground Floor, Room 109 Kitchen Staff Cloakroom - contains asbestos.

Any change in its appearance should be recorded and passed to Property Services.

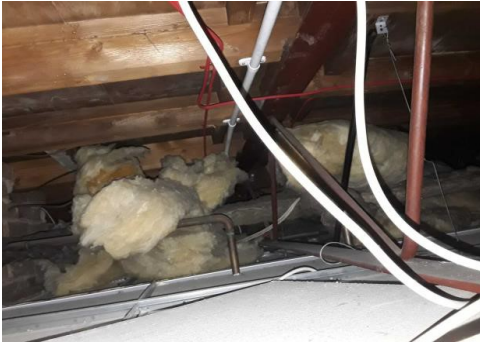
Item 193 Ref: 22-53098-1

The pipes – string to mmmf lagged metal pipes - Ground Floor, Room 110 Kitchen Staff Toilet - do not contain asbestos

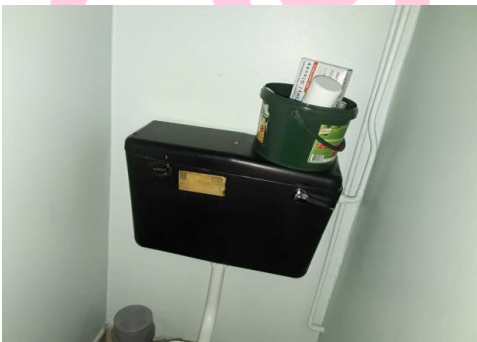
Item 195 Ref: 22-53098-32

The toilet cistern – Ground Floor, Room 110 Kitchen Staff Toilet - contains asbestos.

Any change in its appearance should be recorded and passed to Property Services.

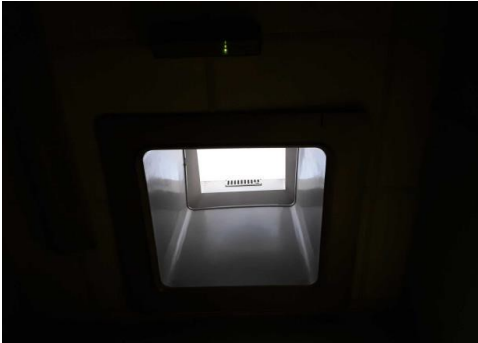
Item 196 Ref: Presumed

The ceiling – textile rope seal to fibreglass skylight - Ground Floor, Room 110 Kitchen Staff Toilet - is presumed to contain asbestos.

Any change in its appearance should be recorded and passed to Property Services.

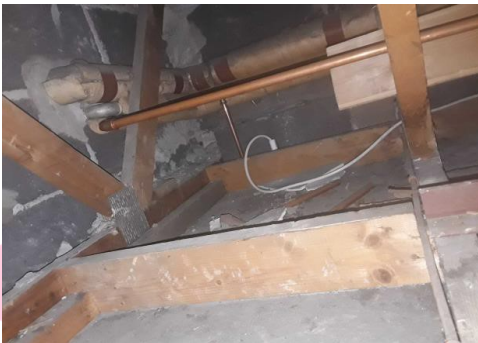
Item 197 Ref: 22-53098-34

The floor - 1st Floor, Room 111 Loft above boiler room in nursery – does not contain asbestos.

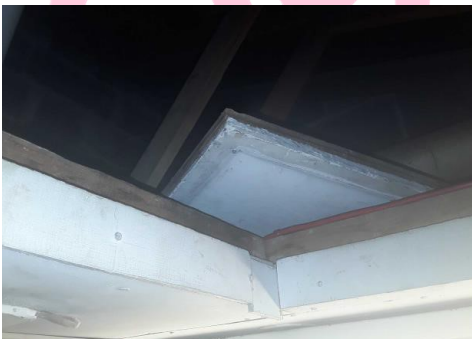
Item 198 Ref: 22-53098-35

The door hatch - 1st Floor, Room 111 Loft above boiler room in nursery – does not contain asbestos.

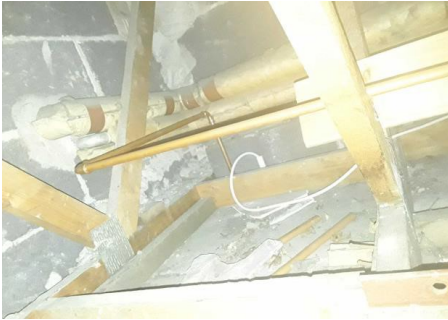
Item 199 Ref: 22-53098-36

The floor – debris to floor - 1st Floor, Room 111 Loft above boiler room in nursery – does not contain asbestos.

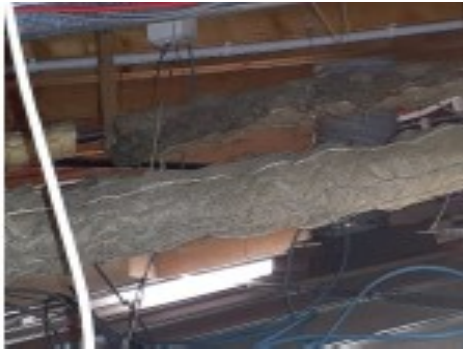
Item 208 Ref: OU002710

The string around the hessian covered pipework in Staff Room 3 (G/01) does not contain asbestos.

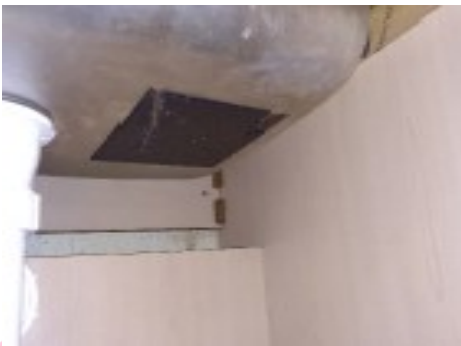
Item 209 Ref: OU002711

The bitumen sink pad in Staff Room 3 (G/01) does not contain asbestos.
