ASBESTOS SURVEY REPORT FOR CASTLETOWN PRIMARY SCHOOL

Asbestos Register for CASTLETOWN PRIMARY SCHOOL

Date: 21 January 2025

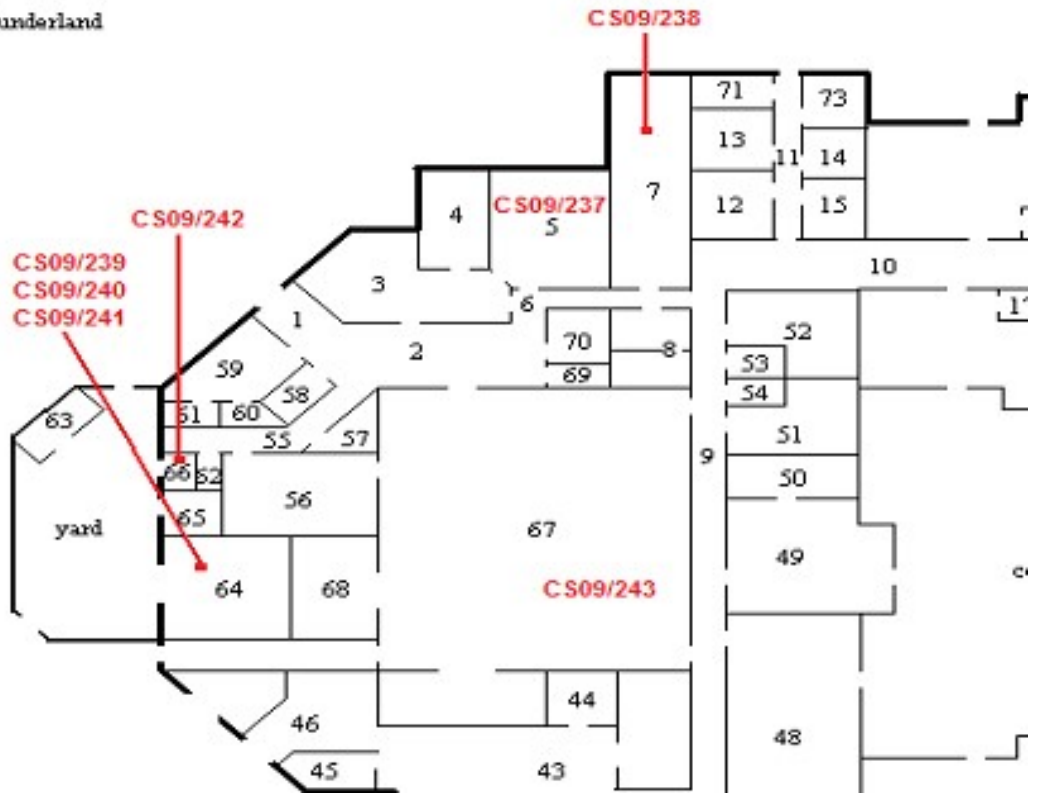
Castletown Primary, Sunderland
not to scale.

Refurbishment Survey 22-45929 was carried out to the nursery area. No samples were taken as no asbestos was noted.

No Suspect Asbestos Containing Materials Were Noted in The Following Areas:

Main Entrance	Foyer	Office	File Store	Corridor 1
Corridor 2	Corridor 3	Games Entrance	Girls Changing Rooms/Shower/WC	Boys Changing Rooms/Shower/WC
Male Staff Changing Room/Shower/WC	Disabled WC	Corridor/Junior Entrance	Junior Boys WC	Junior Girls WC
Corridor 5	Infant Entrance/Corridor	Disabled WC	Infant Boys WC	Infant Girls WC
Corridor 7	Corridor 8 (Reception Area)	Cloaks Area 1	Reception/Girls WC	Reception/Boys WC
Nursery Entrance/Cloaks Area	Secure Store 2	Computer Room/Server Room	Library	Male Staff WC Off Corridor 2
Female Staff WC Off Corridor 2	Disabled WC Off Corridor 2	Corridor 9	Servery	Foyer Disabled WC
Deputy Heads Room	Deputy Heads WC	Bin Store	Interview Room	External Cupboard Near Therapy Room
Water Tank Room	Therapy Room	Hall Fire Exit Corridor	Nursery WC and Shower	Nursery Disables WC
Corridor 6	Externals
