ASBESTOS SURVEY REPORT FOR WHITBURN VILLAGE PRIMARY SCHOOL, CLEADON LANE, WHITBURN, SUNDERLAND, TYNE AND WEAR, SR6 7NS

Asbestos Register for

**Whitburn Village Primary School, Cleadon Lane, Whitburn,
Sunderland, Tyne and Wear, SR6 7NS**

Date: 12 February 2025

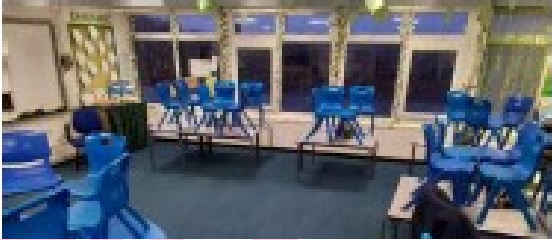
35	As OQ002225	Floor - former tile adhesive, beneath carpet	Ground Floor G/031 Classroom - Year 2	Very Low Risk – Check every 12 months
Photo 1: Wide Angle			Photo 2: Close

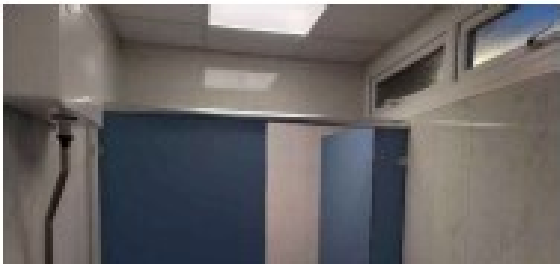
66	As OQ002242	Wall - all walls, beneath plastic cladding	Ground Floor G/073 Toilet(s)	Low Risk – Check every 6 months
Photo 1: Wide Angle			Photo 2: Close-up
