ASBESTOS SURVEY REPORT FOR ROSEBERRY PRIMARY SCHOOL,
MARSH HOUSE AVENUE, BILLINGHAM, COUNTY DURHAM, TS23 2HJ

Asbestos Register for Roseberry Primary School

Date: 09 June 2025

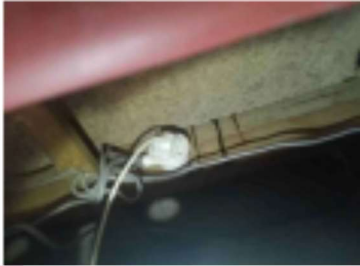
2	TL001086	Ceiling Void Residue to beams Composite Bitumen	Store Room G/001	Very Low Risk – to be checked every 12 months
Photo 1: Wide Angle		Photo 2: Close-up

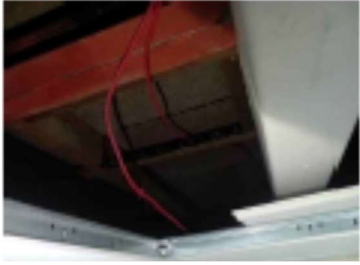
12	As TL001086	Ceiling Void Residue to beams Composite Bitumen	Staff Room G/010	Low Risk – to be checked every 6 months
Photo 1: Wide Angle			Photo 2: Close-up

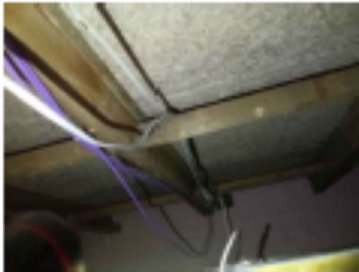
14	As TL001086	Ceiling Void Residue to beams Composite Bitumen	Office G/011	Low Risk – to be checked every 6 months
Photo 1: Wide Angle			Photo 2: Close-up

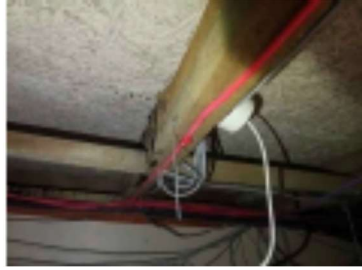
16	As TL001086	Ceiling Void Residue to beams Composite Bitumen	Office G/012	Low Risk – to be checked every 6 months
Photo 1: Wide Angle		Photo 2: Close-up

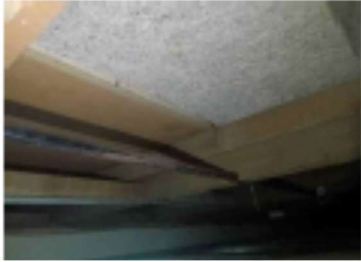
22	As TL001086	Ceiling Void Residue to beams Composite Bitumen	Classroom G/016	Low Risk – to be checked every 6 months
Photo 1: Wide Angle		Photo 2: Close-up

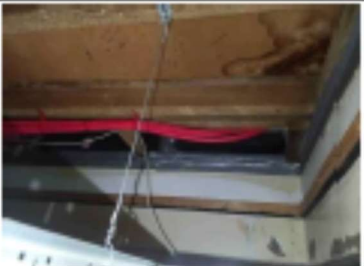
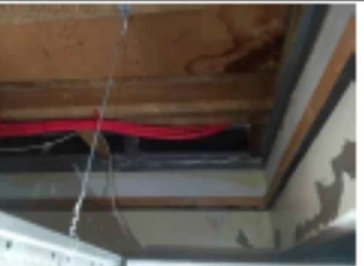
36	Presumed	Ceiling Void Enclosed with polythene, presumption only Insulating Board	Entrance Hall/Foyer/Lobby G/025	Low Risk – to be checked every 6 months
Photo 1: Wide Angle		Photo 2: Close-up

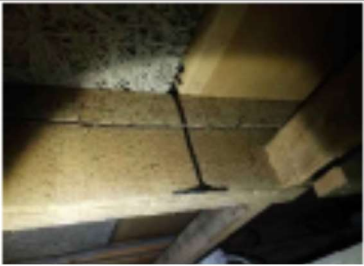
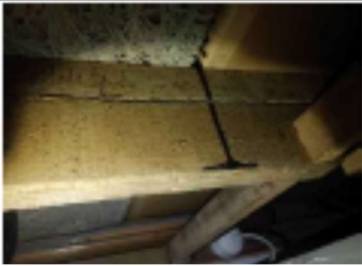
39	As TL001086	Ceiling Void Residue to beams Composite Bitumen	Corridor G/027	Low Risk – to be checked every 6 months
Photo 1: Wide Angle		Photo 2: Close-up

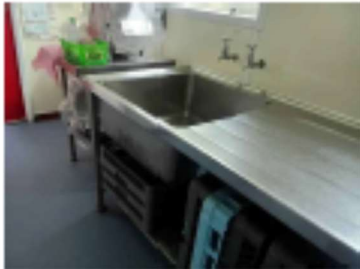
53	TL001098	Under Sink Mat Composite Bitumen	Lower School Kitchen 31	Low Risk – to be checked every 6 months
Photo 1: Wide Angle			Photo 2: Close-up

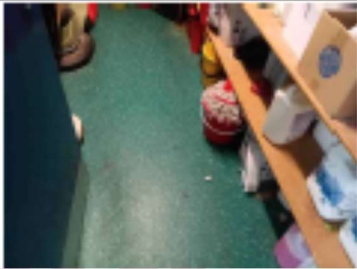
71	As TL001106	Floor - Covering Beneath modern Composite Bitumen	Lower School Store Room 21	Low Risk – to be checked every 6 months
Photo 1: Wide Angle		Photo 2: Close-up

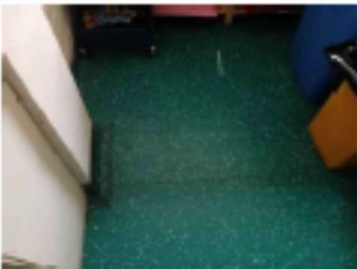
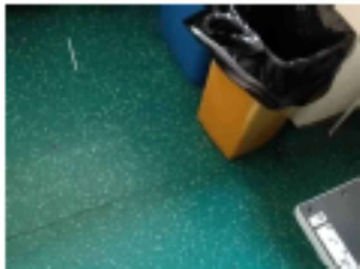
No Photographic Evidence Available		
72	As TL001106	Floor - Covering Beneath modern Composite Bitumen	Lower School Photocopy Room 23	Low Risk – to be checked every 6 months
Photo 1: Wide Angle		Photo 2: Close-up
