ASBESTOS SURVEY REPORT FOR RAINBOW FAMILY CENTRE, SUNDERLAND

Asbestos Register for
RAINBOW FAMILY CENTRE, SUNDERLAND

Date: 17 November 2022

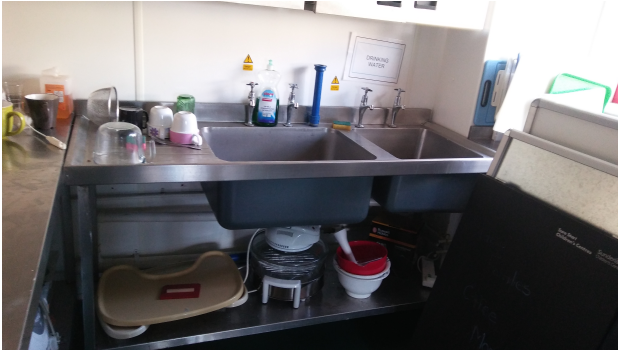
Item 1 Ref: 218304-1

The sink paint in the kitchen (Rm 0/33) does not contain asbestos.

218304-1 – Sink Paint (Rm 0/33/Kitchen) (Item 1) – No Risk

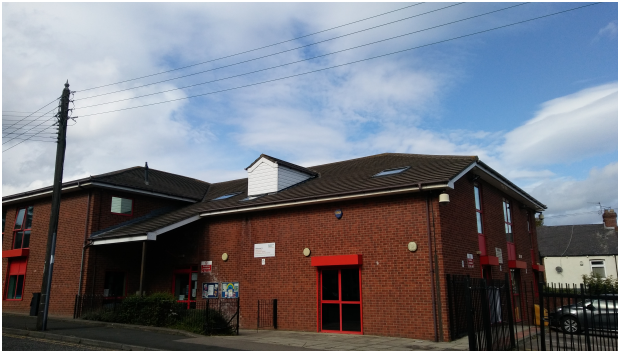
Item 2 - Ref: 218304-2

The roof undercloakes (external) does not contain asbestos.

218304-2 – Roof Undercloaks Cement (999-Externals) (Item 2) – No Risk
