ASBESTOS SURVEY REPORT FOR HETTON PUBLIC CONVENIENCE,  
FRONT STREET, HETTON LE HOLE, DH5 9HJ.

## **Asbestos Register for**

**Hetton Public Convenience, Front Street, Hetton le Hole**

**Date: 26 September 2024**

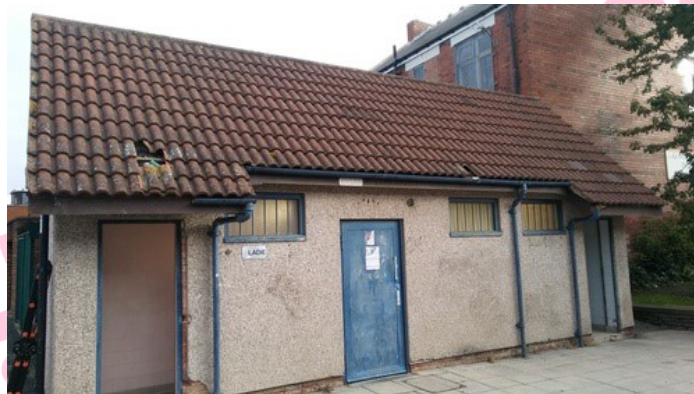
### **Plan of Building and Samples Location**

- 218447-1 – Textured coating (Room 001) (Item 1) – No Risk
- 218447-2 – Textured coating (Room 002) (Item 2) – No Risk
- 218447-3 – Roof undercloaking (External) (Item 3) - Very Low Risk
- 218447-4 – Damp proof course (External) (Item 4) – No Risk
- 218447-5 – Sarking (External) (Item 5) – No Risk

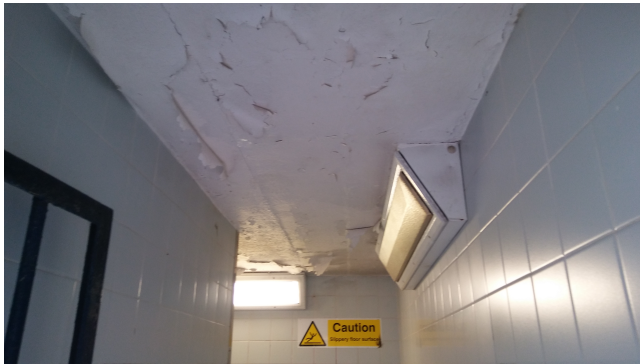
### **Item 1 Ref: 218447-1**

The textured coating to the ceiling in the mens toilet (Rm 001) does not contain asbestos.

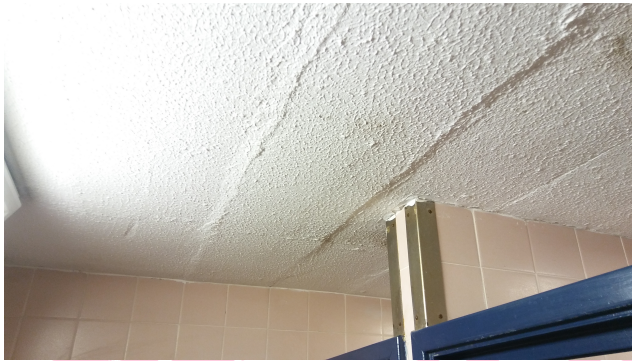
### **Item 2 Ref: 218447-2**

The textured coating to the ceiling in the female toilet (Rm 002) does not contain asbestos.

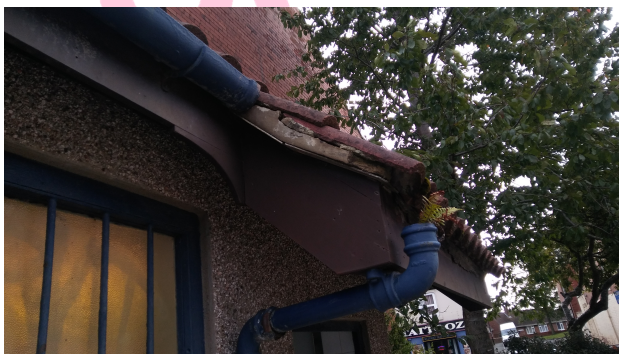
### **Item 3 Ref: 218447-3**

The roof undercloaking (external) contains asbestos.

Any change in appearance should be reported to Property Services.

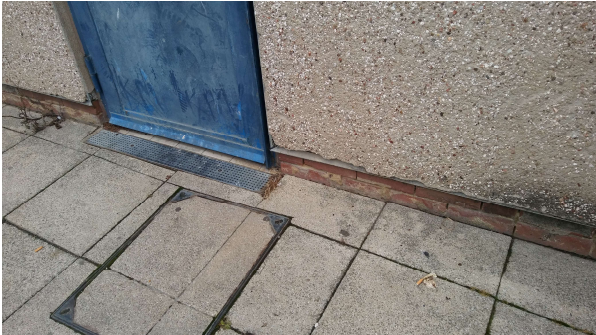
**Item 4 Ref: 218447-4**

The damp proof course (external) does not contain asbestos

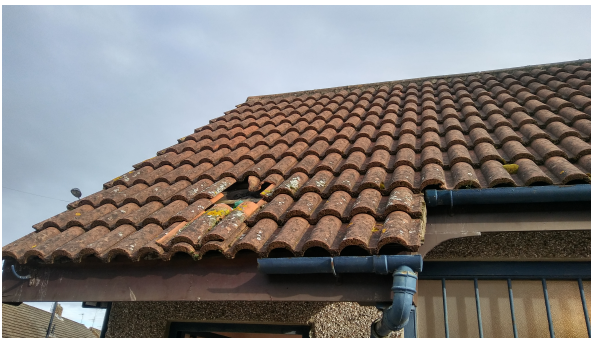
**Item 5 Ref: 218447-2**

The sarking does not contain asbestos (external) does not contain asbestos.
