ASBESTOS SURVEY REPORT FOR LOCOMOTION SHED, PORT OF SUNDERLAND, SOUTH DOCK

Asbestos Register for

**Locomotion Shed, South Dock
Port of Sunderland**

Date: 08 May 2025

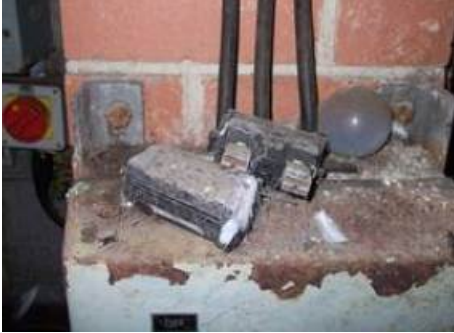
Item 1 – WP002163

VP002163 – Flash guards to fuses (Room 1) (Item 1) - Very Low Risk

The flash guards to the fuse box in Room 1 contain Asbestos.

Any change in its appearance should be noted and passed to Property Services.

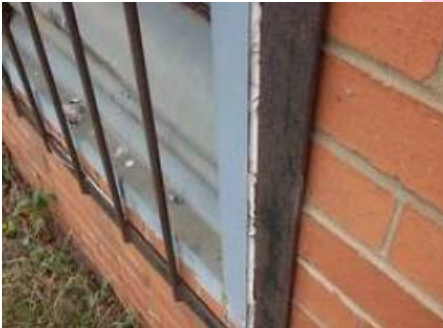
Item 2 – WP002164

VP002164 – External Sealant to door and ventilation grill (Item 2) (No Risk)

The sealant to the door and ventilation grill framework to the external of the building does not contain asbestos.
