### ASBESTOS SURVEY REPORT FOR LOCOMOTION SHED, PORT OF SUNDERLAND, SOUTH DOCK

**Asbestos Register for**  
**Locomotion Shed, South Dock**  
**Port of Sunderland**

**Date: 25 October 2023**

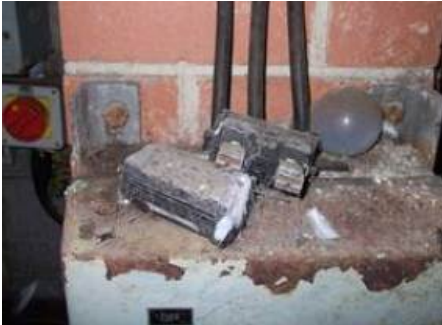
### **Item 1 – WP002163**

The flash guards to the fuse box in Room 1 contain Asbestos.

Any change in its appearance should be noted and passed to Property Services.

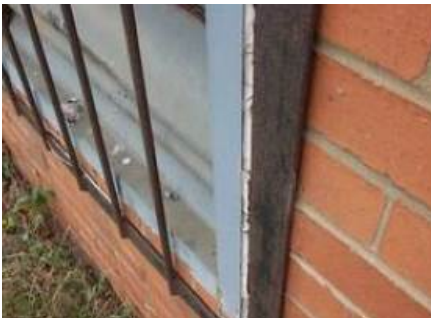
### **Item 2 – WP002164**

The sealant to the door and ventilation grill framework to the external of the building does not contain asbestos.
